## ICOMOS Technical Review

<b>Property</b>	<b>Bagrati Cathedral and Gelati Monastery</b>
<b>State Party</b>	<b>Georgia</b>
<b>Property ID</b>	<b>710</b>
<b>Date inscription</b>	<b>1994</b>
<b>Criteria</b>	<b>(iv)</b>
<b>Project</b>	<b>Proposal for reinforcing the base of the drum of the dome of Gelati monastery</b>

ICOMOS received a report on the *Project of the Arrangement of the Metal Belt on the Bottom Point of the Drum at the Church of the Virgin of Gelati Monastery*, submitted to the World Heritage Centre by the State Party on 20 July 2015.

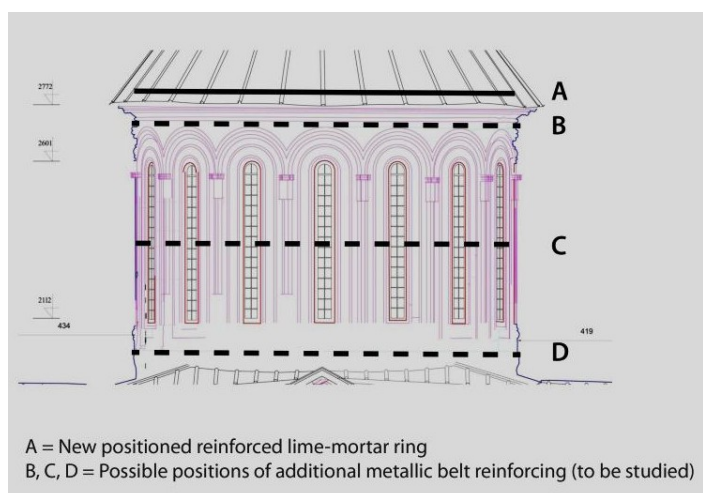
**Figure 67.** The cupola : position of the established ring and additional reinforcing

**C.** The already installed reinforced ring-beam at the base of the hemisphere (place A of Figure 67) and the additional proposed metallic belt at the base of the drum (place D of Figure 67) will undoubtedly enhance the static stiffness of the drum at its upper and lower ends. Regardless of these interventions, the behavior of the body of the drum (place C of Figure 67) remains problematic in the case of a future strong seismic act. After this, the most weakened parts of the drum remain the elongated “free-standing” masonry piers. This is proved by the “Structural Analysis” of the **“Proposal for reinforcing the base of the drum of the dome”**: displacement along the axes X and Y (plans F1X and F1Y in all three versions I-II-III), where the cupola is more vulnerable to the directions E → W and S → N instead of W → E and N → S because of the already walled windows of the drum.

ICOMOS agrees with the proposal for the reinforcement of the lower part of the drum with a metallic belt which will be attached onto the drum structure and to the pendentives with anchors. From a structural point of view, the metallic ring appears to be efficient. The tension stresses are absorbed by the resistance of the metallic ring. This circumstance gives an important role to the structural behavior of cupola-drum system.

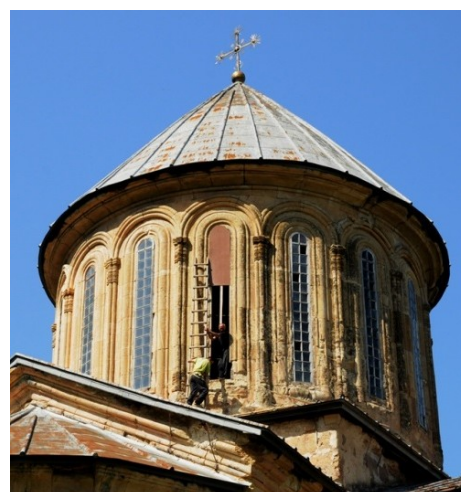
**Fig. 18.** The cupola : condition before hypothetical starting the architectural rehabilitation works

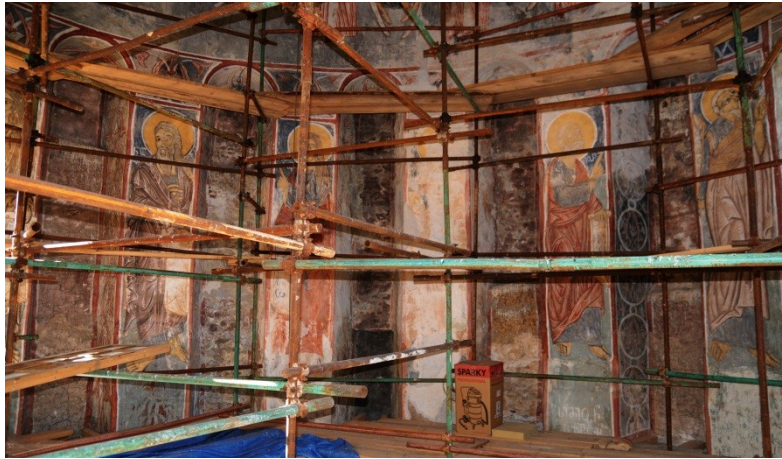
**Figure 68.** The S-W windows of the drum, closed with masonry of bricks / stones in mortar

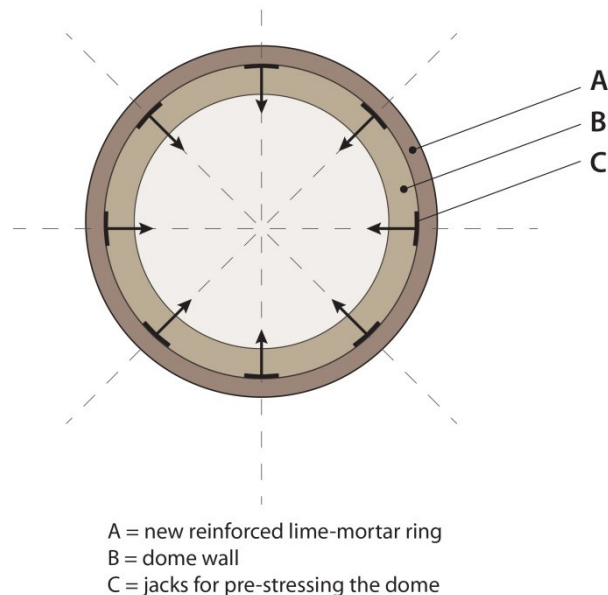
**Figure 79.** Proposed jacks for pre-stressing the dome

**A.** In order to ensure better adhesion between the metallic ring and the stone construction of the dome, it is proposed to introduce a filling in the space between the two mating surfaces. On the issue of this kind of collaboration between the two materials, in the **Report** it was recommended that “... if necessary, the ring-beam’s contribution can be improved by inserting, between the ring-beam and the base of the dome, a system of jacks able to produce supplementary horizontal radial inward forces (fig.79, fig.80, fig.81), pre-stressing, by this way, the dome ...” (Report page 41, par. 5.3.1). The system of jacks can ensure satisfactory adhesion between the ring-beam and the cupola construction, and therefore a constant and controlled cooperation between them in a more “flexible” way, which additionally could “undertake” future tensions resulting negatively to further opening of the cracks.

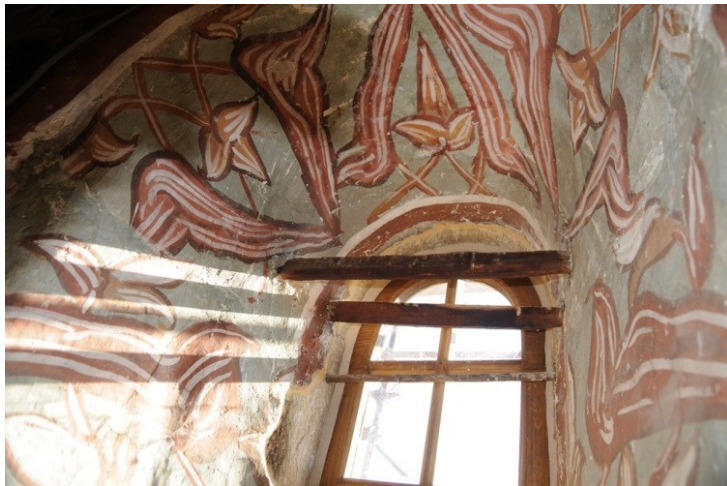
In the Gelati Monastery *katholikon*, wood tie-beams are still preserved in some of the drum's window openings. There is no information provided as to whether they are original. Furthermore, it is unknown whether timber tie-beams were used as horizontal lintels in the already walled window openings of the drum. It would be worth investigating when these openings were walled, which in any case should have been before the existing wall-painting of the dome (Figures 7, 8).

**Figure 7.** Wood tie-beams still preserved on drum window openings

In this connection, the issue of strengthening the drum window piers and openings appears crucial. As it is not possible to establish an anchorage truss system for the drum (which would be visible), it is of particular interest that the Georgian experts are considering the possible effects of the introduction of horizontal wooden joints for strengthening the window openings. The idea is studied in the “Table of results, Scenario III”, but the results do not seem to improve the behavior of the dome construction and this is at least strange. On this matter, more details regarding the size and location of the considered timber tie-beams in the window openings should be provided.

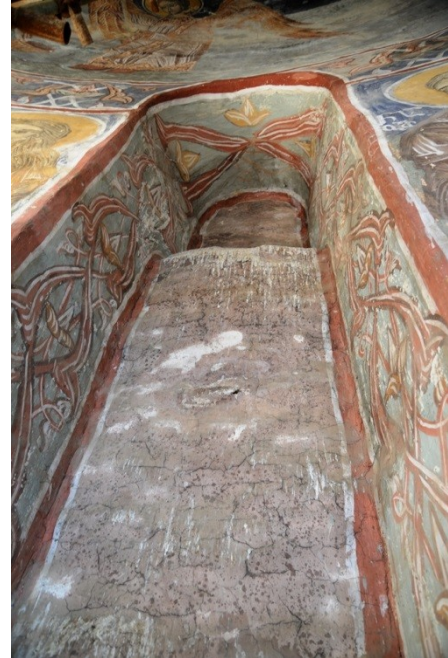
**Figure 8.** Walled drum window openings

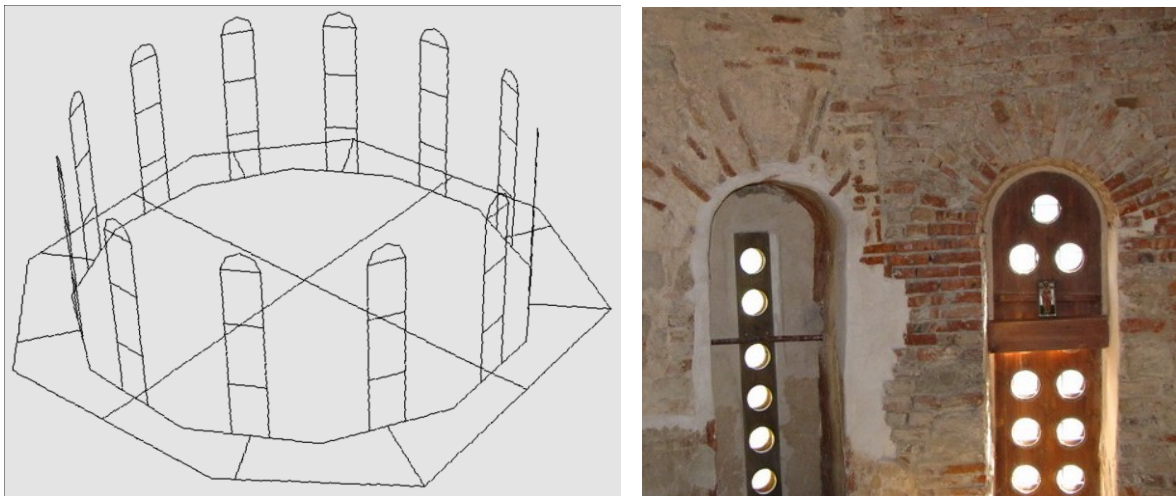
**Figure 14.** Schematic proposal for supporting the drum of the dome, consisting of metal rings and metal frames on the windows, while covered by full length metal sills

In such a case, for further improvement of the stability of the drum, it would be advisable to consider the idea of setting up specially-designed steel elements in the form of full length metallic windows, with strong steel frames, connected between them, in order to “close” the window openings, leaving small round intermediate openings for lighting the dome: this would be in practice an imitation of medieval full-length wooden windows. Such a construction requires additional calculations, taking into account the possible thickness of the metallic windows and the dimensions of the steel frames.
