United Nations
Educational, Scientific and
Cultural Organization

Organisation
des Nations Unies
pour l'éducation,
la science et la culture

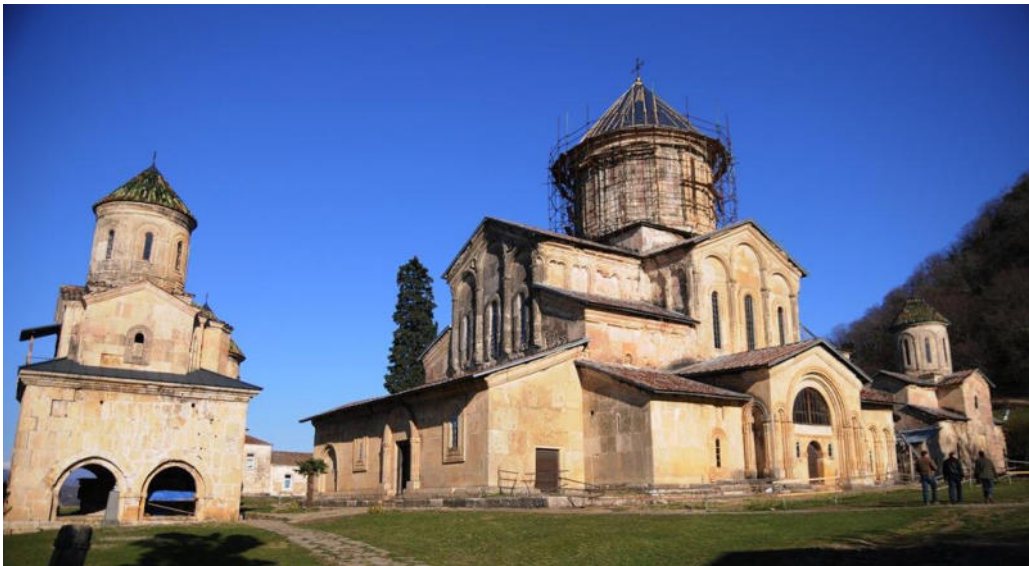
The monastery complex in 2015.

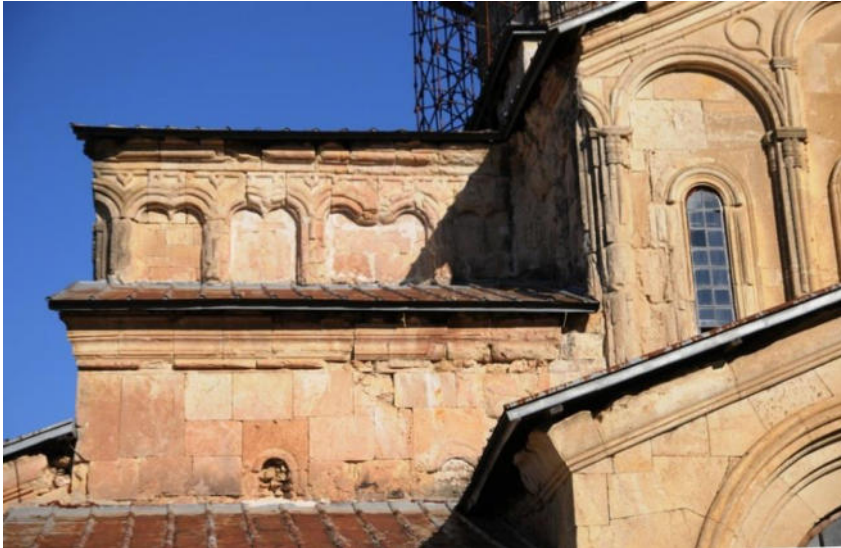
Detail of the upper western part – view from south (Fig.11 of the 2015 mission report).

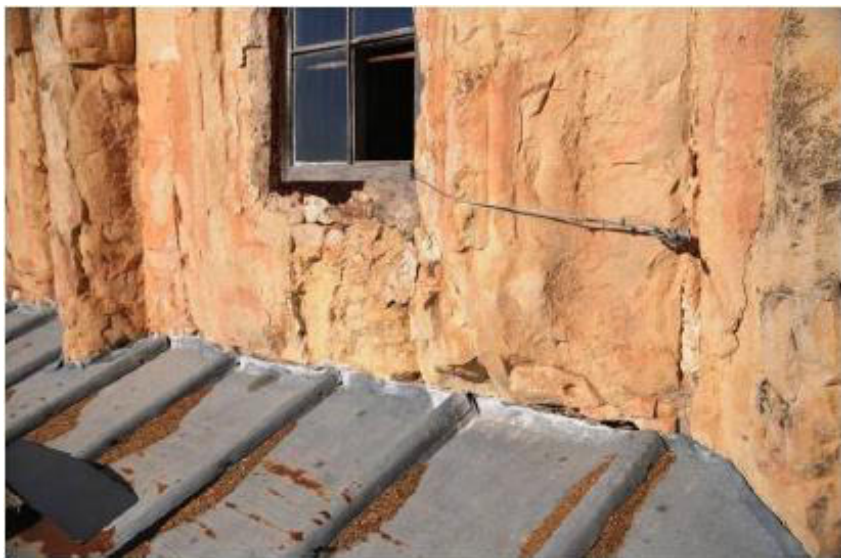
Facing masonry to the tin covering – existing condition (Fig.13 of the 2015 mission report).

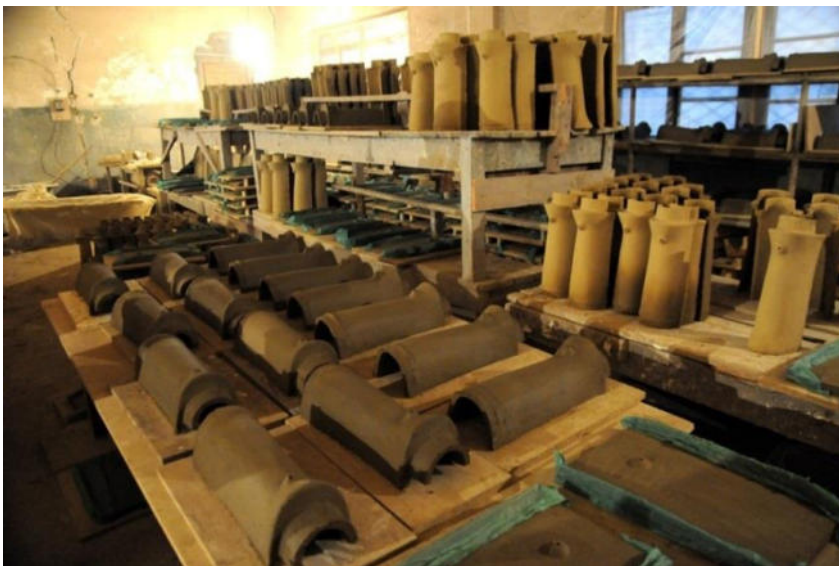
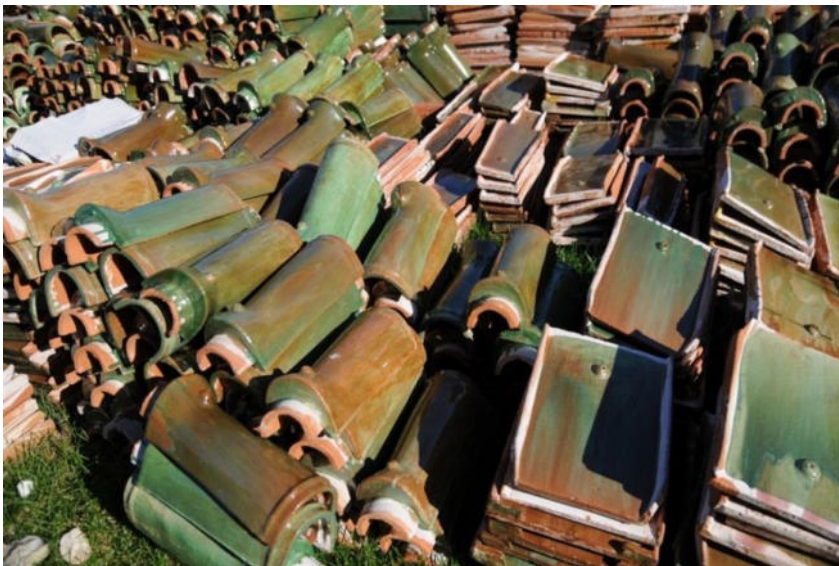
Pictures from the process of production of the glazed tiles for the restoration of the church roofing (Figs. 88 and 95 of the 2015 mission report)

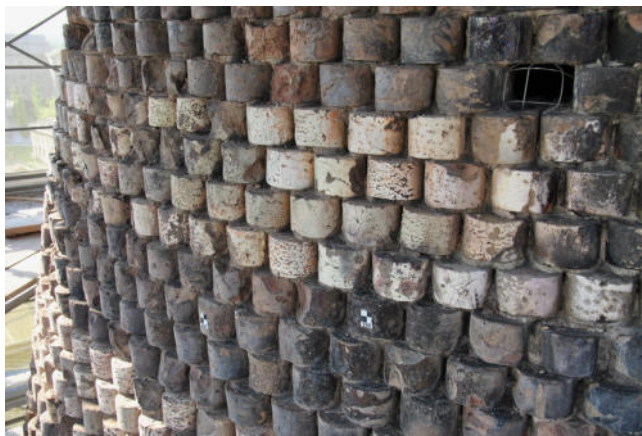
Fig. 2. Particular of the conic spire, realized with dichromatic glazed bricks: white and black. The masonry shows deterioration, cracks and erosion of the bricks.

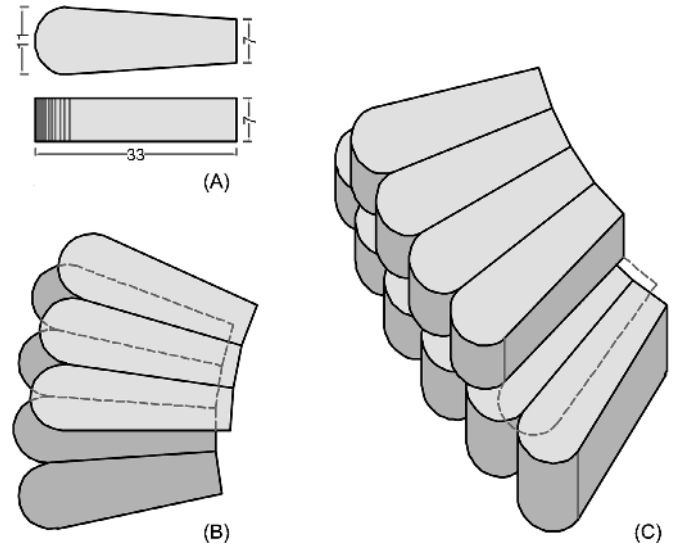
Fig. 3. (A) Dimensions and shape of the bricks. (B) and (C) Overlapping model of the bricks.

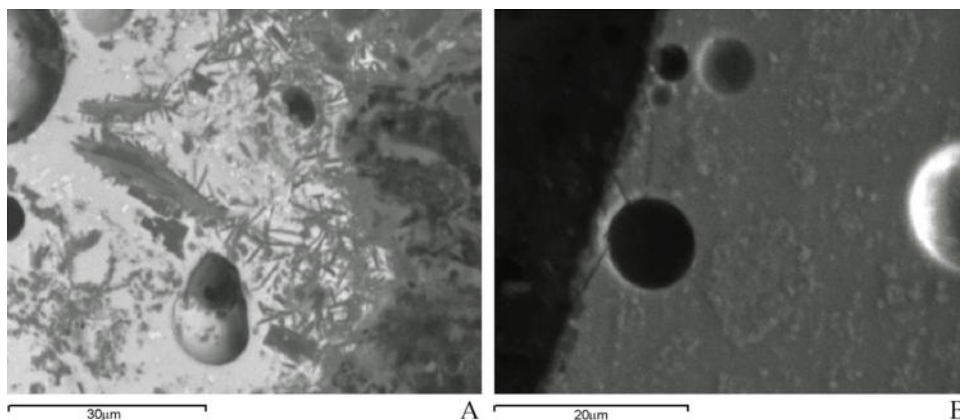
Fig. 7. Sample CD_6. (A) Interface: illite grains from the clay body show the growth of lead–potassium feldspar crystallites around. Within the glaze may be noted bright inclusions of tin oxide. (B) Heterogeneous distribution of tin oxide crystals in the glaze.

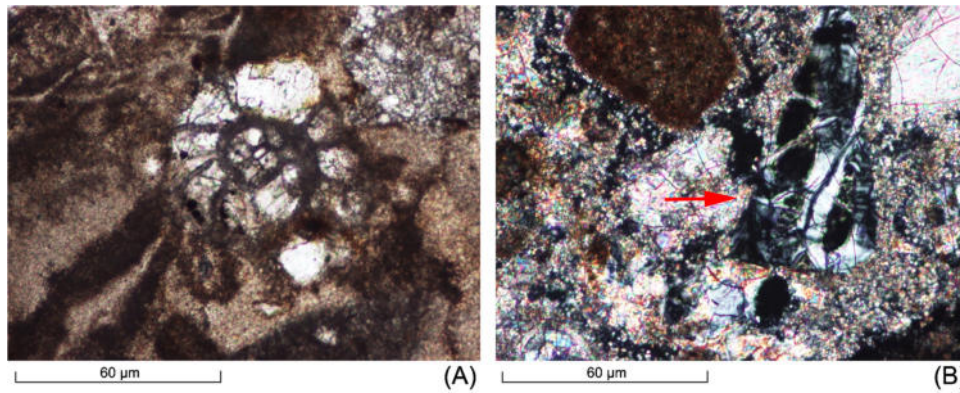
Fig. 10. (A) Sample CD_13. Microfossils (*Pliocene gastropoda*) (optical microscope, 10 \times , transmitted light, parallel polarizers). (B) Sample CD_9. Ophiolite grain found in the mortar of the end of the XVI century (optical microscope, 10 \times , transmitted light, crossed polarizers).
