In line to the State of Conservation Report for the World Heritage Property “Gelati Monastery”, submitted by the State Party on January 31, 2020, I would like to provide an additional information on the recent condition deterioration at Gelati Monastery WHS, in particular, the issues and damages of roofs revealed in February-March, 2020, that led to the water infiltration into the interior of the Church and the immediate steps already taken by the State Party in this regard and to be implemented.

Annex 2: The implemented project documentation for the temporary roofing and scaffolding for the Church of Virgin.

Information on the State of Conservation of the Church of Virgin of Gelati Monastery WH Property, Georgia

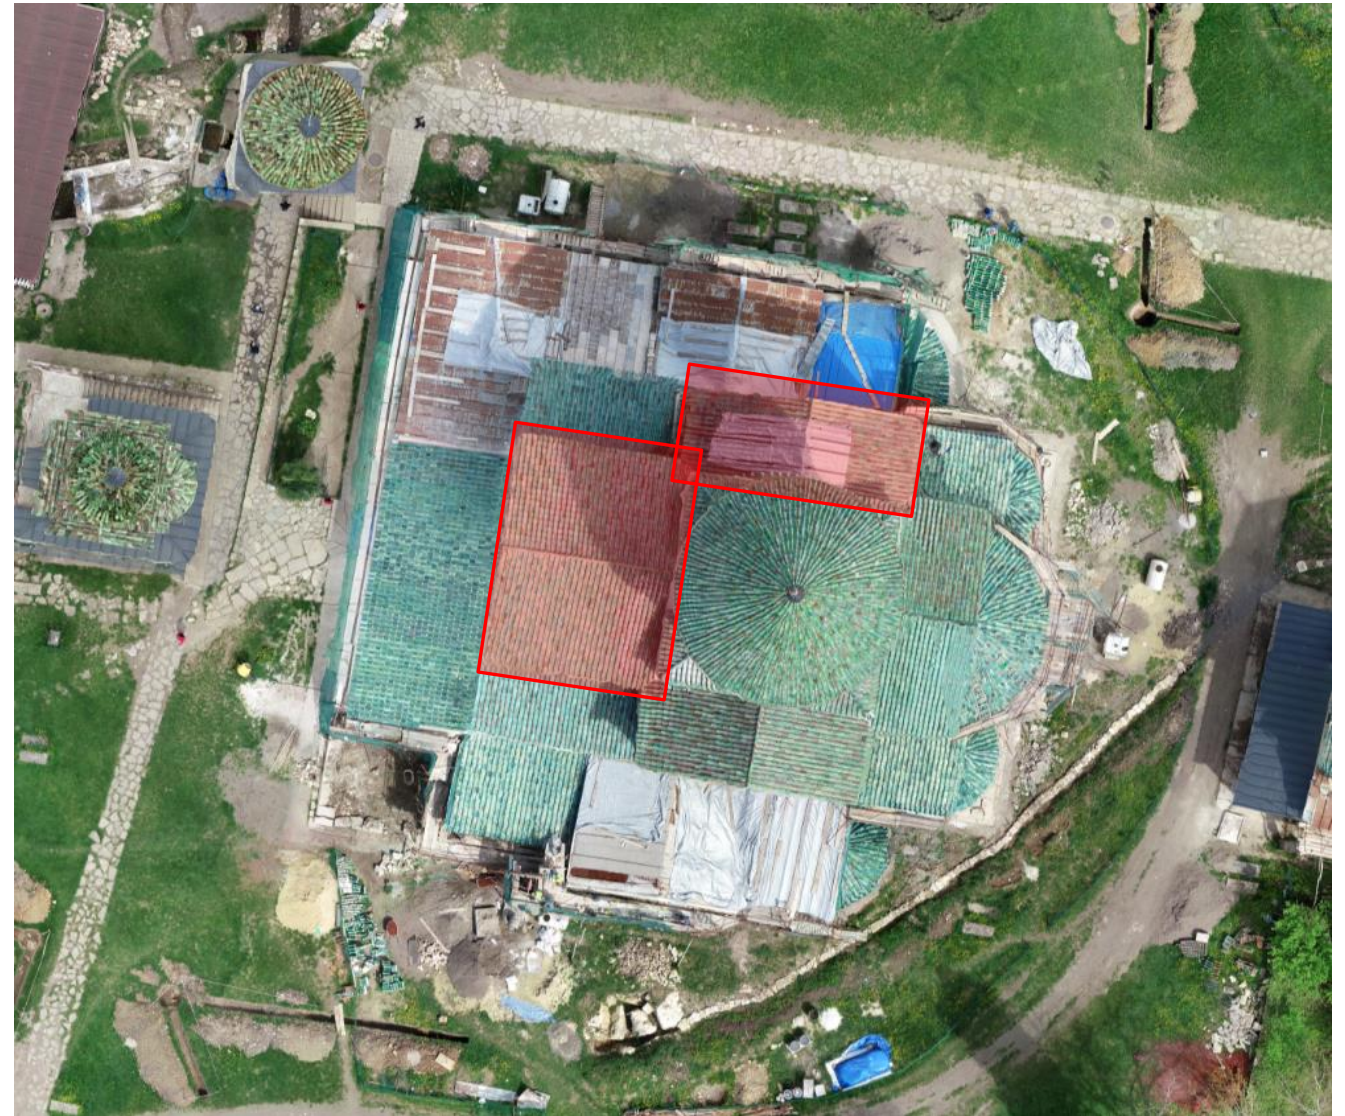
Photo 2019.

West arm;
presumably the North arm.

Roofing defects are likely to be related to amortized fillings of lime, especially in the area of joints of the roofing and the walls.

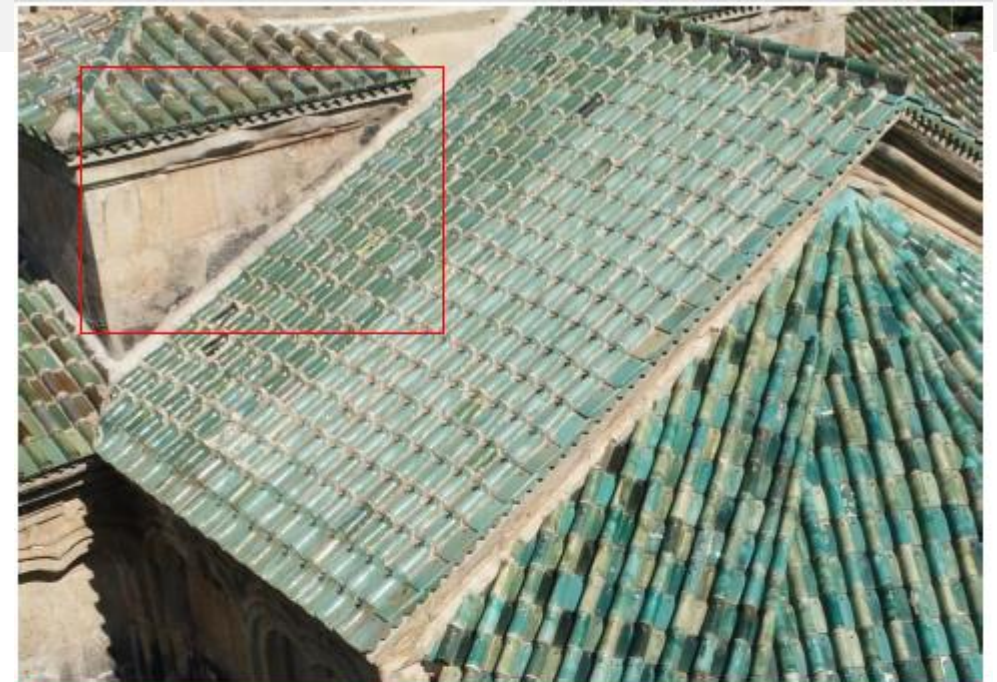
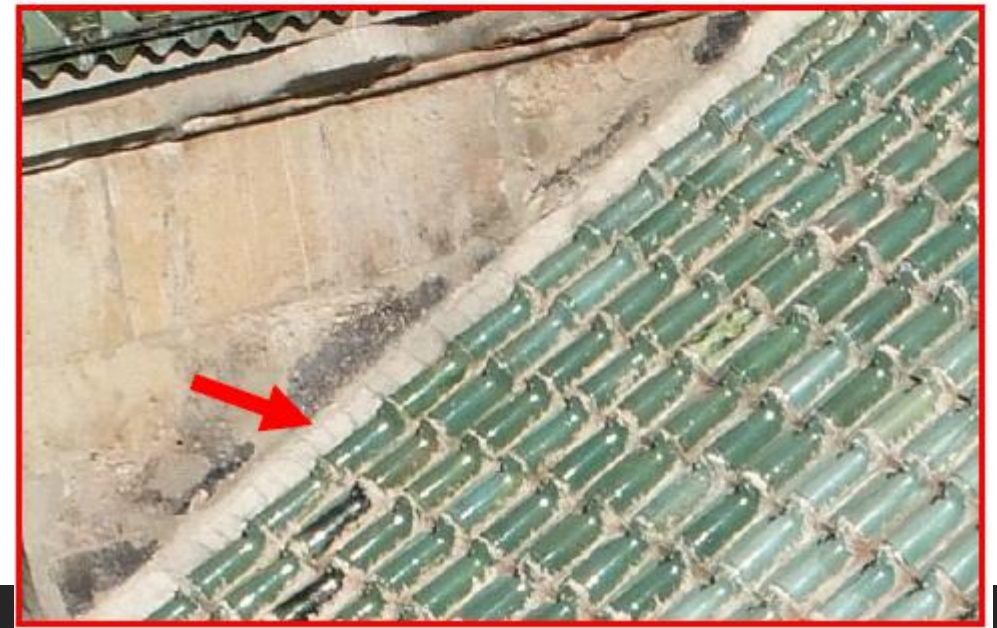
As a result, the following damages are observed locally:

- Salt efflorescence;
- Bioactivity;
- Stone color alteration (assumedly moisture);
- On the fillings made during the stone conservation: color alteration (assumedly moisture) and loss of cohesion and adhesion;
- On the joints between the tiles: 1. Loss; 2. Cracks; 3. loss of adhesion;

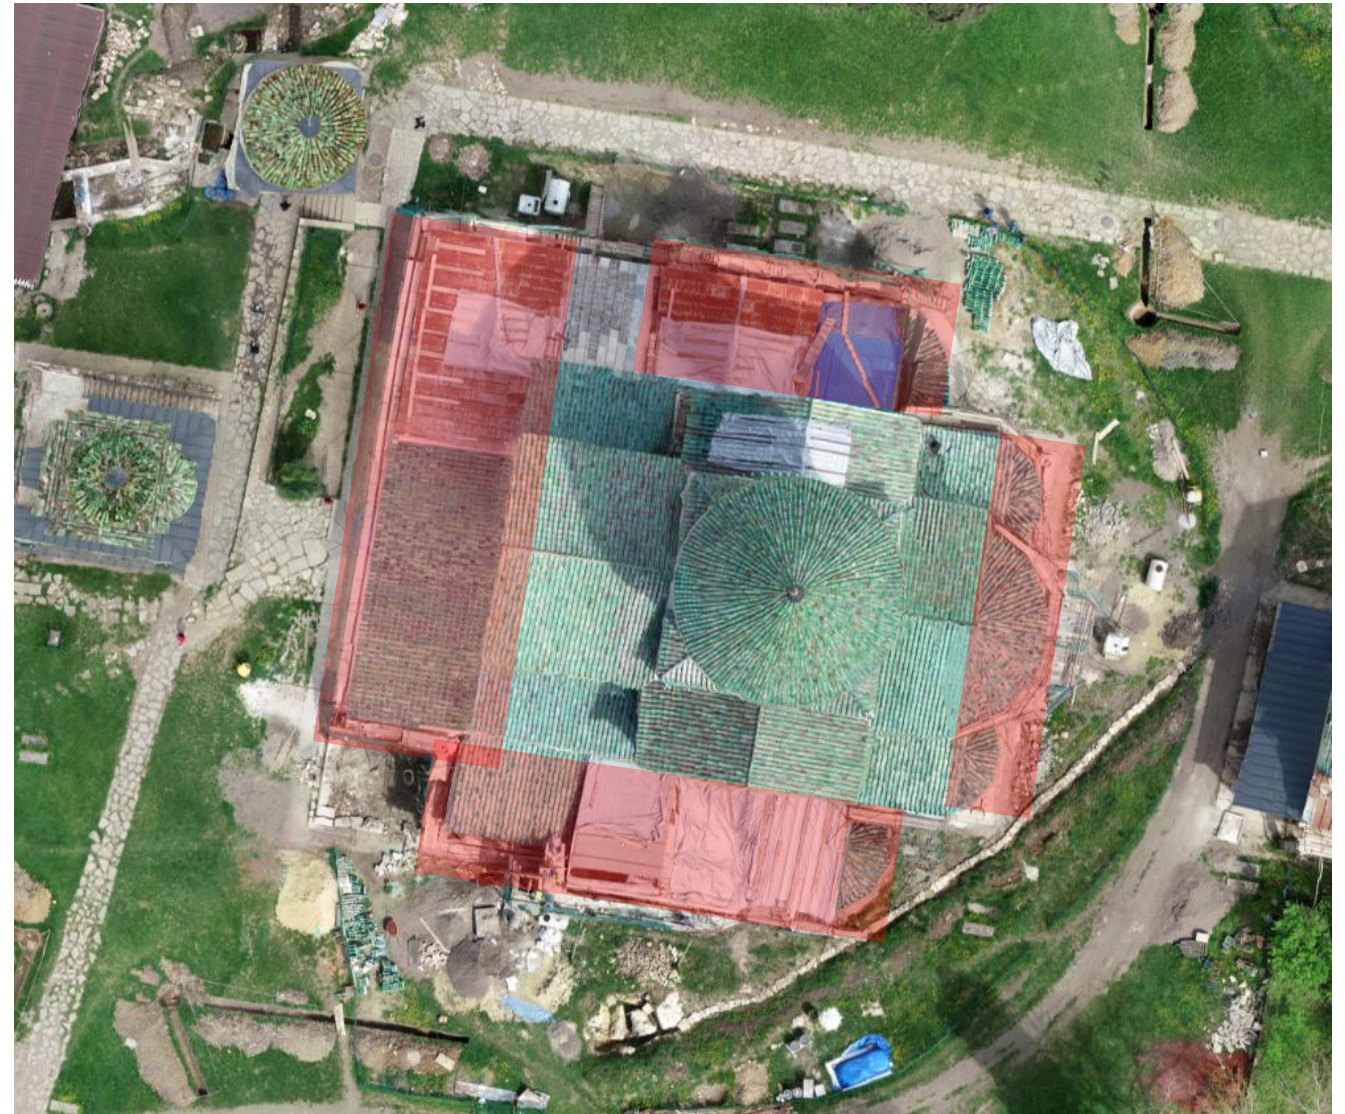
Full and partial loss of roofing tiles, cracks and micro-cracks are observed;

Damages appeared on the roofs in 2020, and on-site assessment revealed that these glazed ceramic tiles are of low quality and are not suitable for roofing with lime mortar.

The gravest damages appear on the roofing of St. Marine Chapel (south-west chapel).

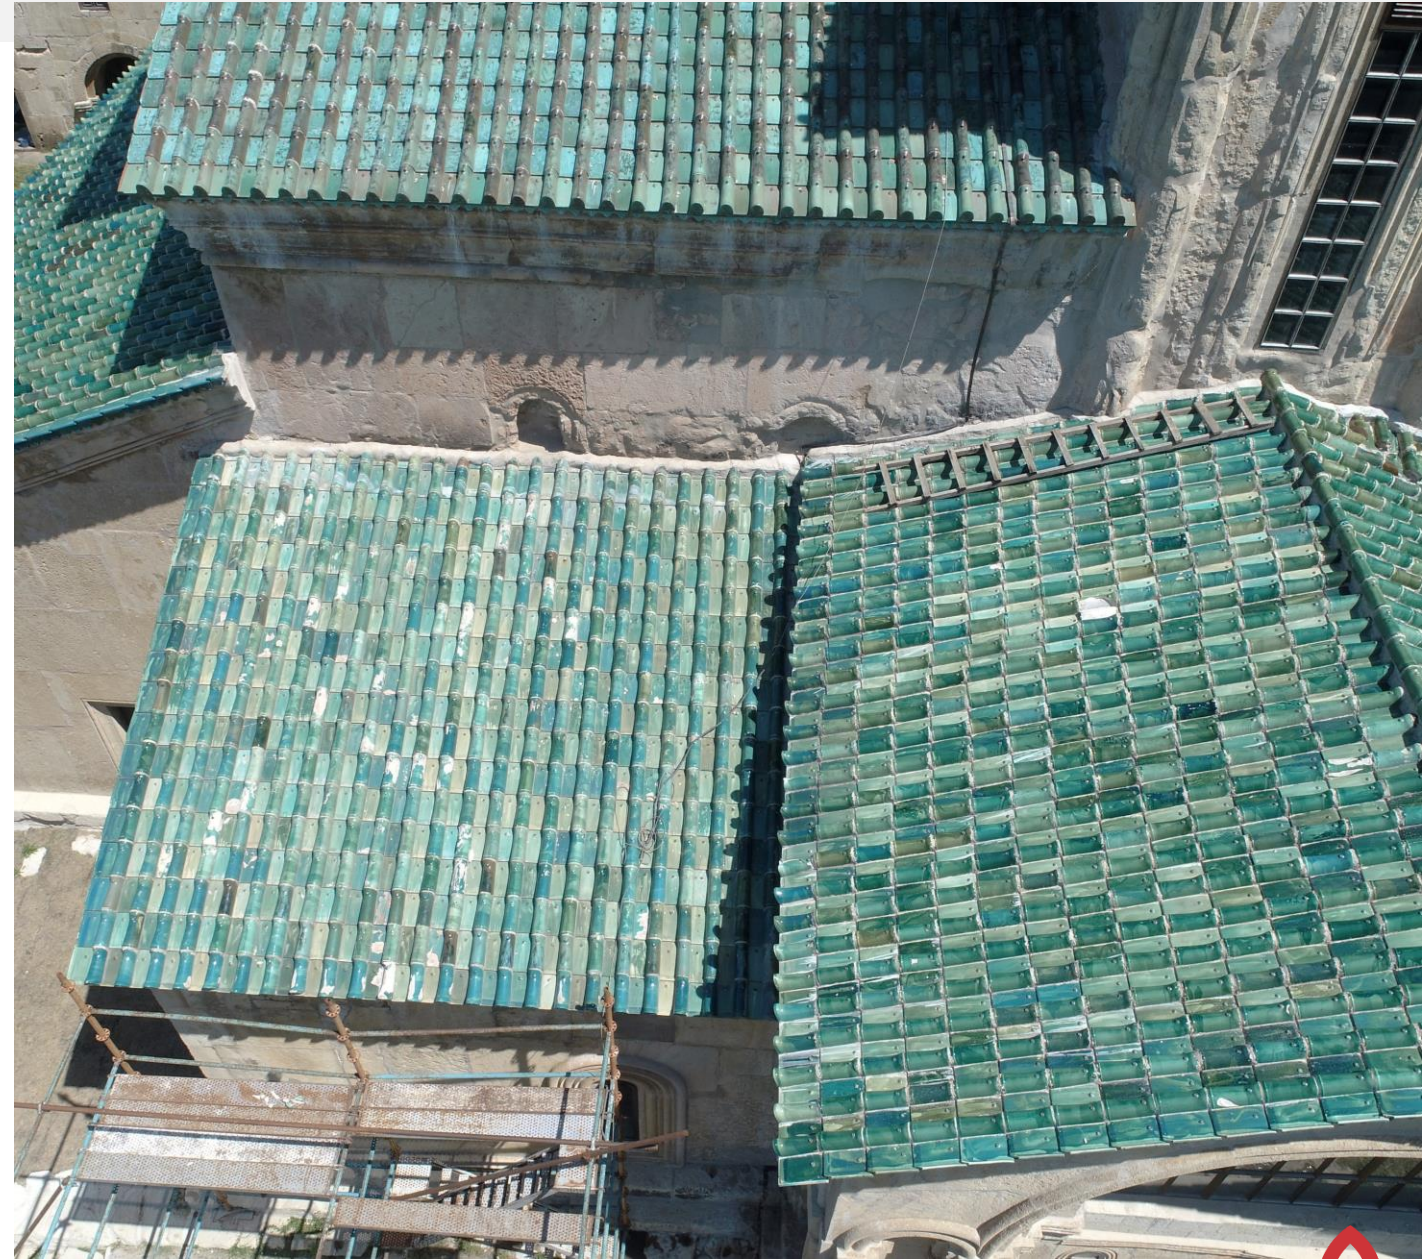
As a result, the following damages are observed locally:

- Salt efflorescence;
- Bioactivity;
- Stone color alteration (assumedly moisture);
- On the fillings made during the stone conservation: color alteration (assumedly moisture) and loss of cohesion and adhesion;
- On the joints between the tiles: 1. Loss; 2. Cracks; 3. loss of adhesion;

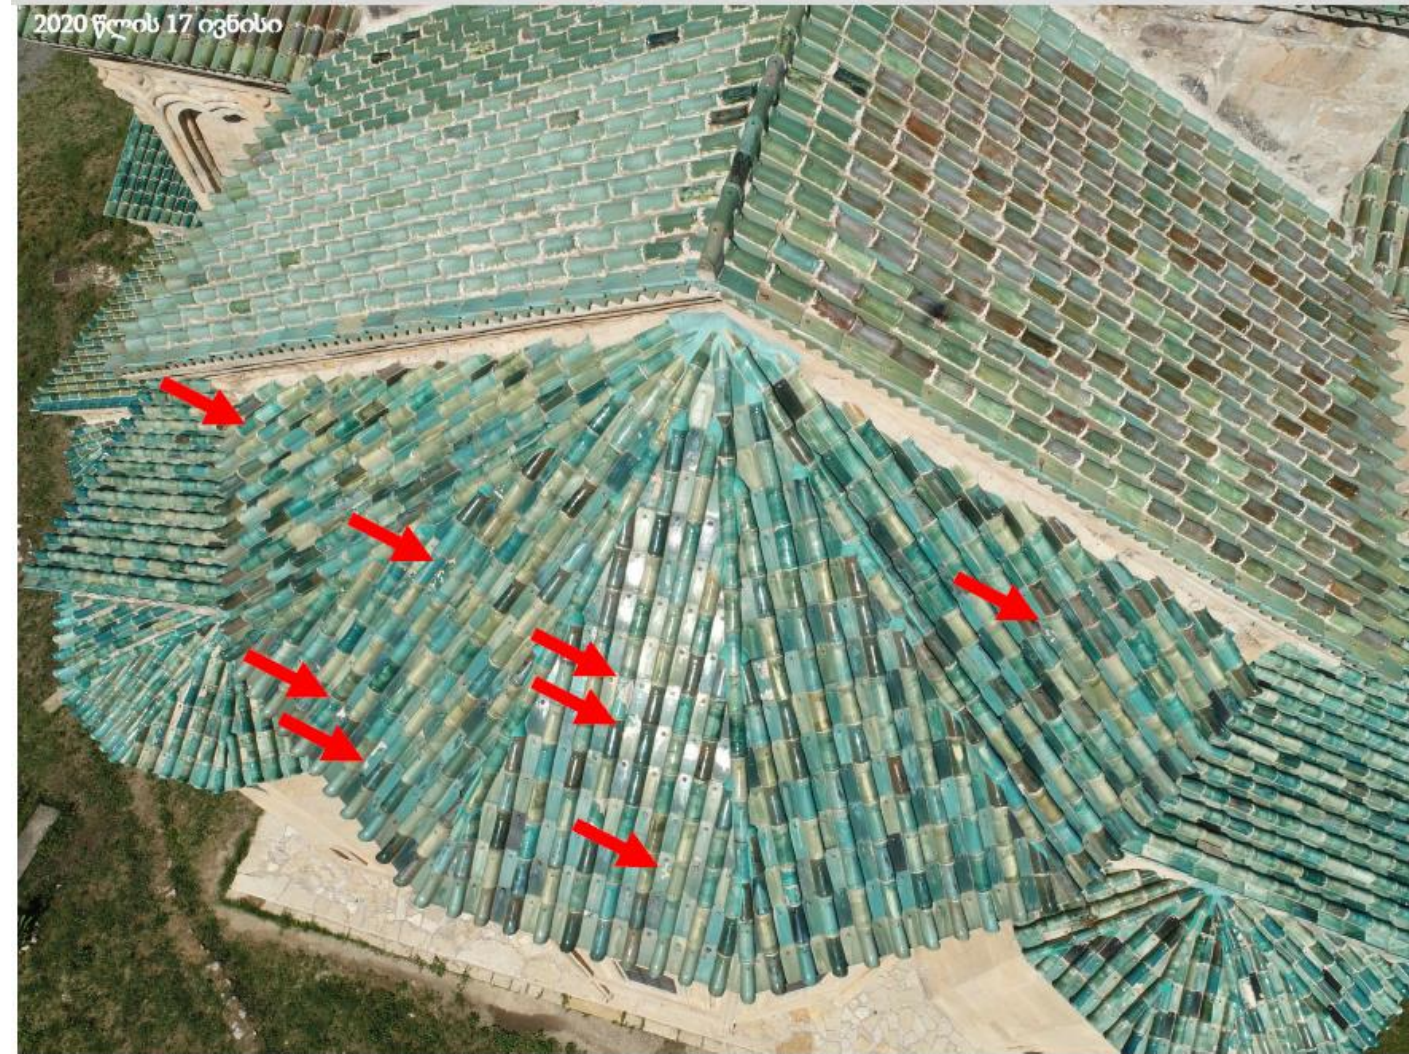
The salt efflorescence has been detected as an main cause of deterioration, which is related to the water infiltration through damaged roofs and environmental conditions of the interior. Salt crystallization cycles have caused cohesion and adhesion failures of paint and plaster layers, loss of repair materials applied during previous interventions in the XX century as well as small wall painting fragment pieces from the original technology. The bioactivity has also been observed.

The mentioned condition phenomena have been detected in various places, however, the most critical issues are found in the Church's West arm's vault.

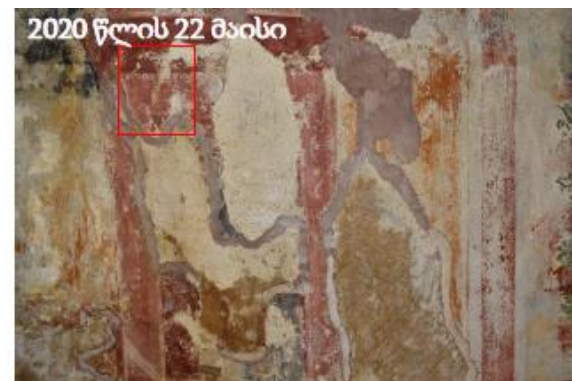
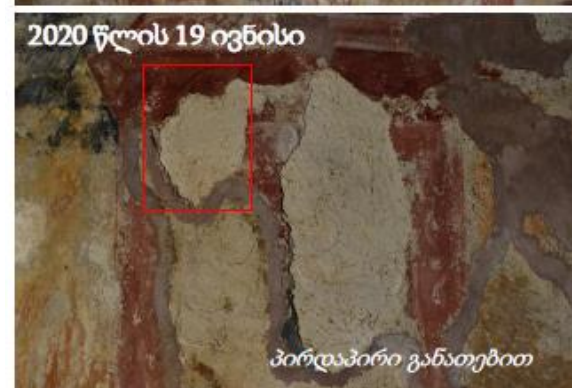
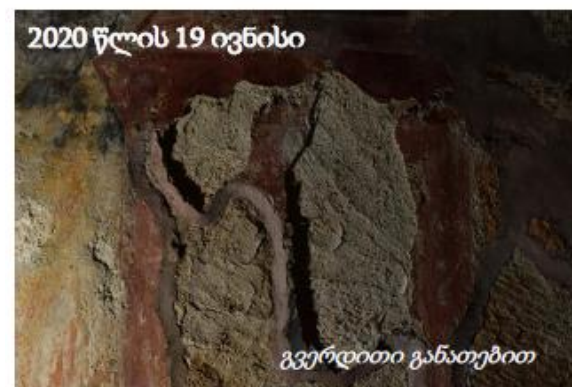
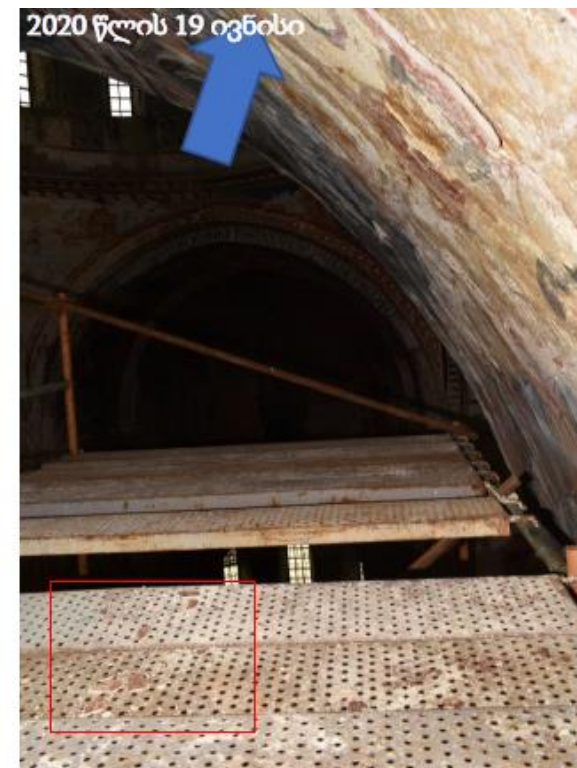
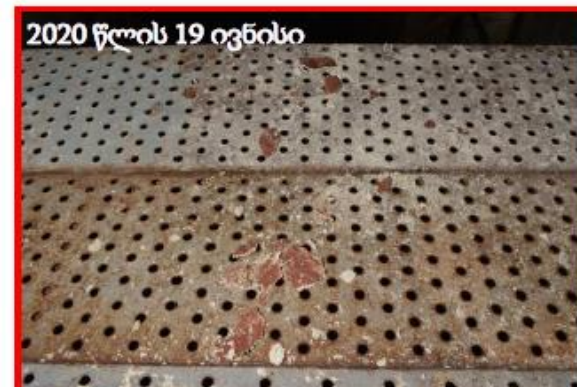
The South wall of the West arm - fragment loss

An amount of fallen fragments of plastering with original paintings were observed on the platforms of the scaffolding, arranged in the West arm of the main church.

Falling of the above-mentioned fragments occurred between May 22 and June 17, 2020 from the South wall of the vault of the West arm (the left scene, upper register).

In addition to fragments, great amount of salt crystals are fallen on the platform of scaffolding.

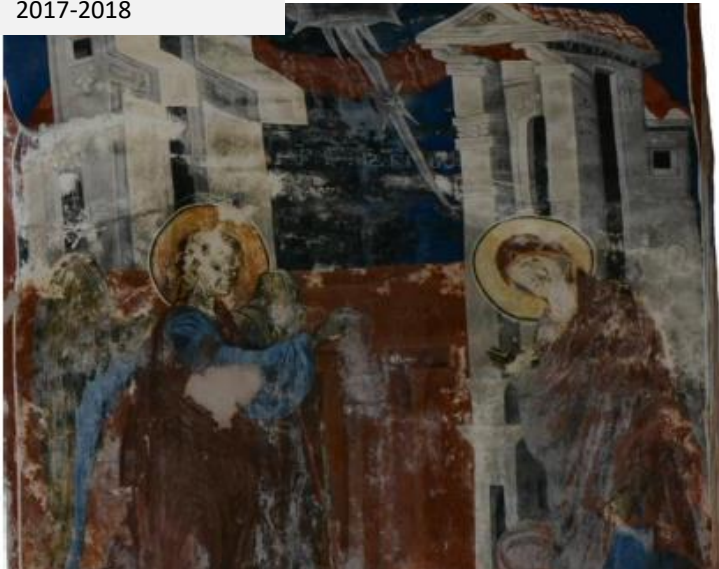
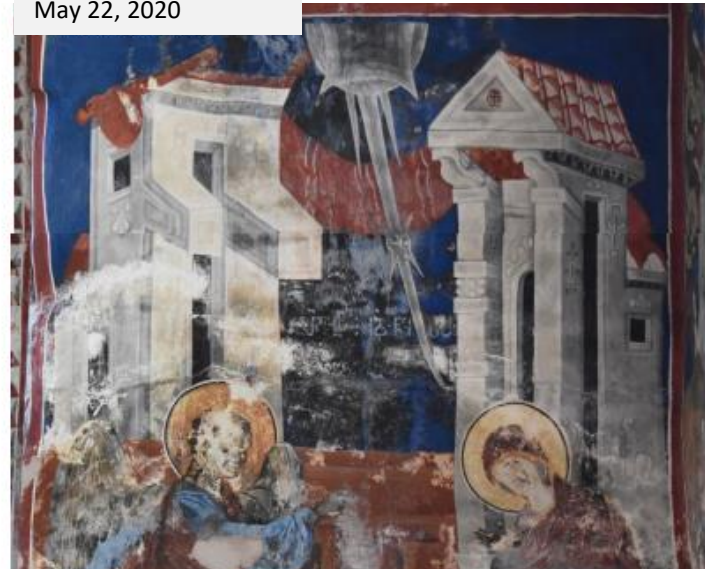
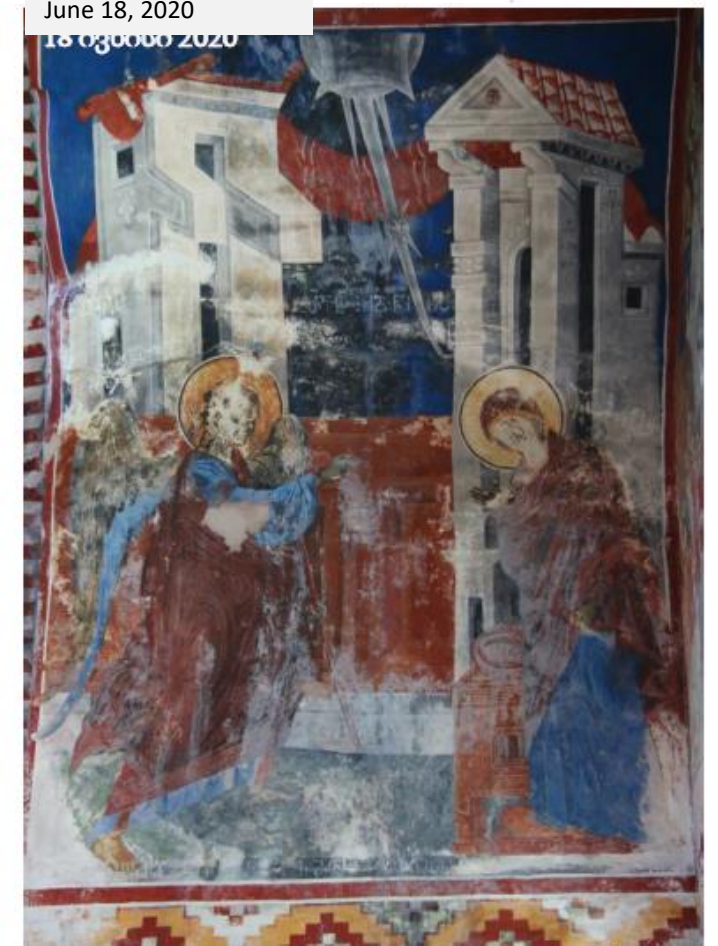
Example of wall painting condition analysis

Visible difference can't be seen based on visual observation

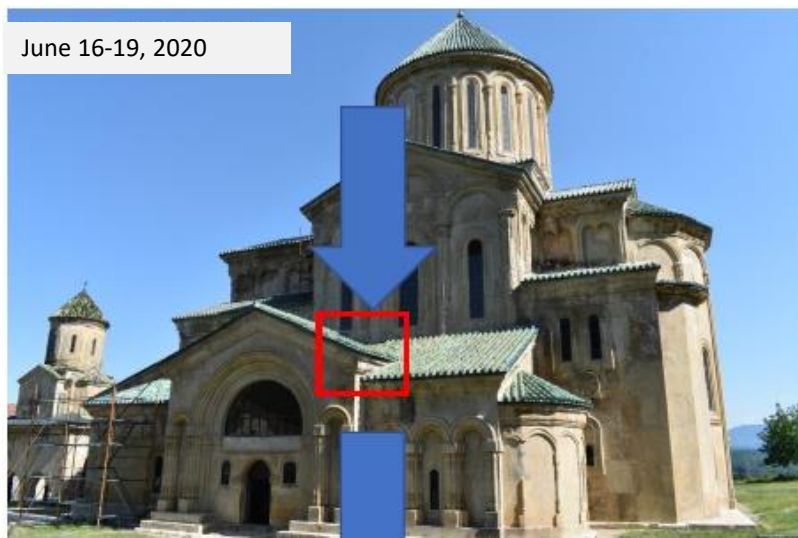
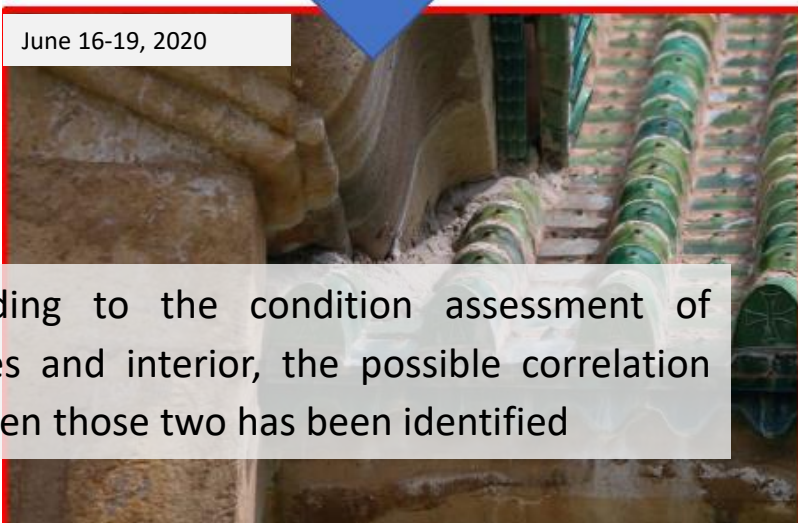
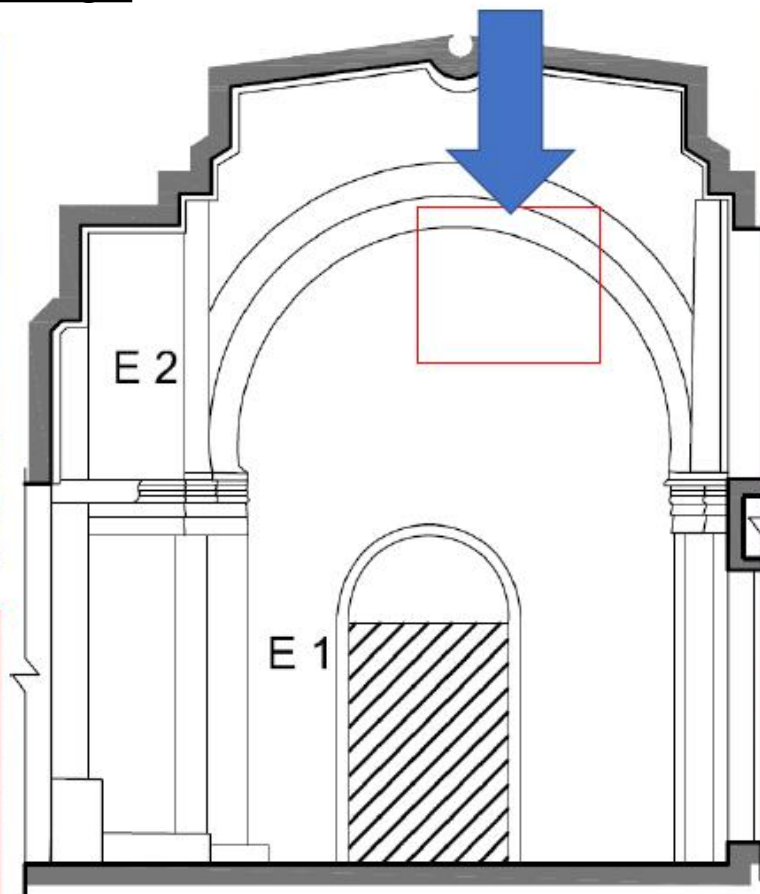
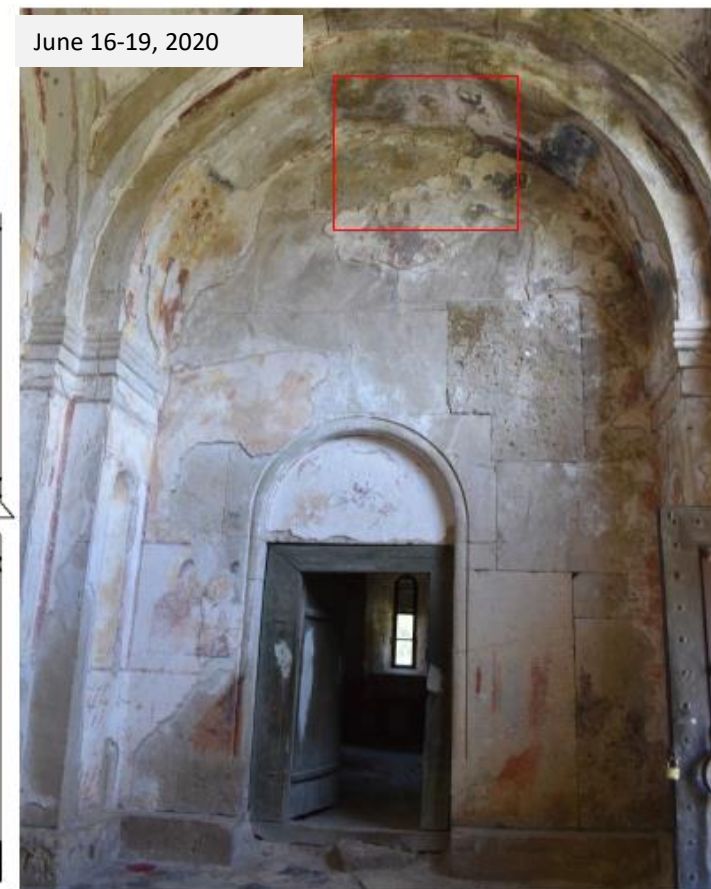
Location: the East wall, South porch, Church of Virgin

According to the condition assessment of façades and interior, the possible correlation between those two has been identified

The types of damage, identified on the roofing and façades (Salt efflorescence, color alteration/moisture) indicate to the impact of water. The damaged areas, identified on the façade were examined from interior; darkening of the stone surface (assumedly, the trace of moisture) and bio-activity between 2018-2020 was noticed in the interior, which might be related to the damages, existing in the roofing and façades (damage source and activation mechanism).

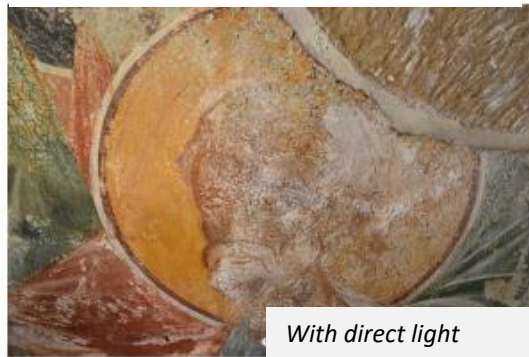
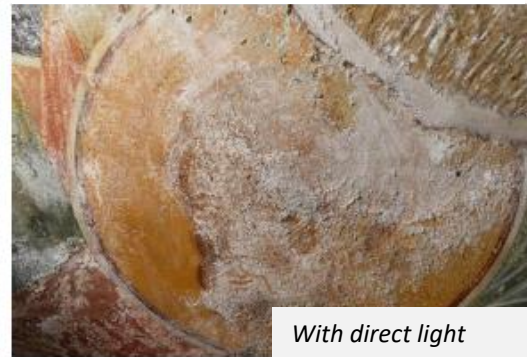
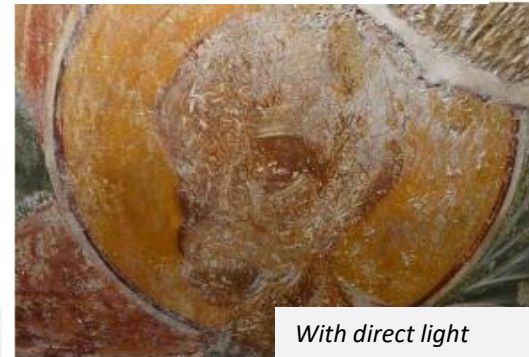
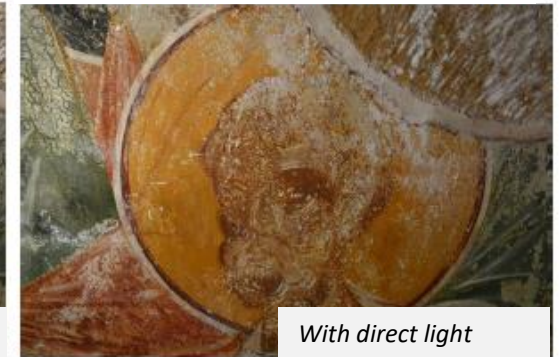
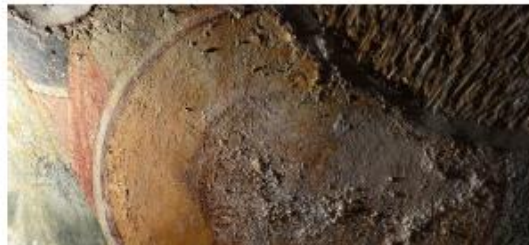
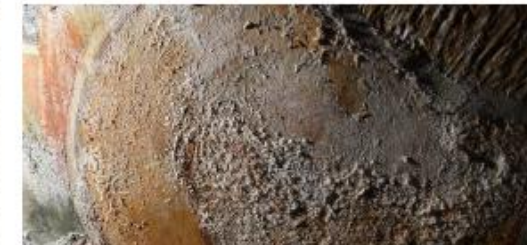
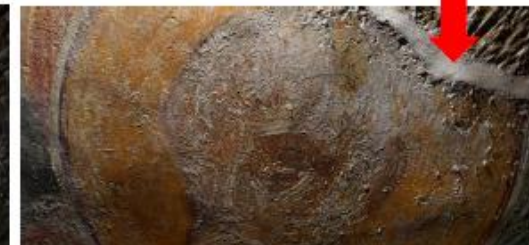
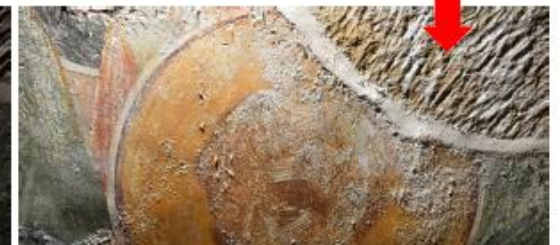
Example of the condition monitoring

According to monitoring, based on 50 days interval, activity of salt efflorescence process is observed after April 30, on June 19.

More salt efflorescence

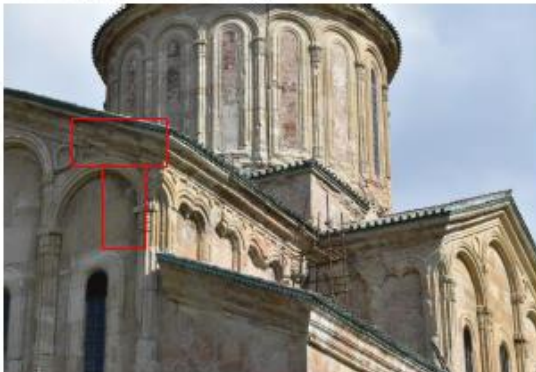
- March 11, 2020 – color alteration of the stone and repaired areas (humidity content), salt efflorescence;
- April 30, 2020 – unlike March 11, 2020, salt deposit is significantly reduced;
- May 22, 2020 – as compared with April 30, there is no salt deposit, the humidity stain is enlarged;
- June 16, 2020 – as compared with May 22, the humidity stain is preserved.

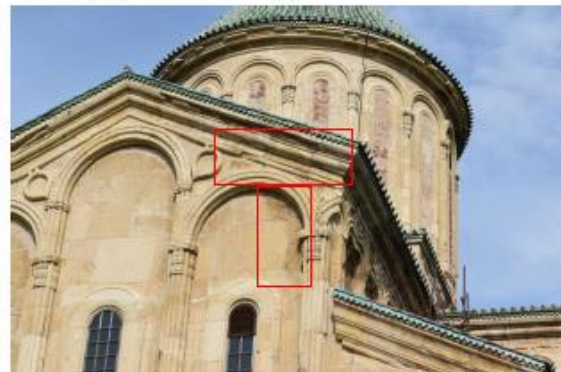
April 30, 2020

Like March 11, moisture is still noticeable, however, on April 30 **much less salt deposit** then during the previous monitoring

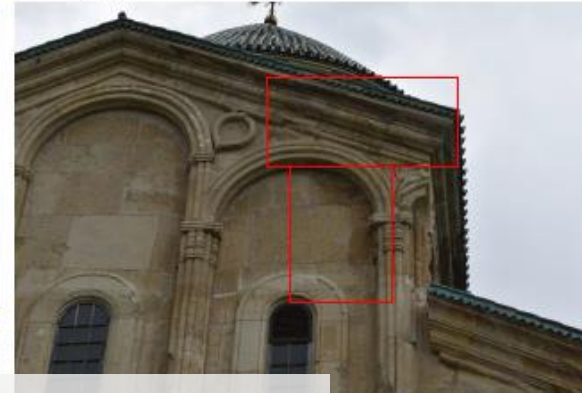
May 22, 2020

Salt crystals are not observed, only moisture is noticeable

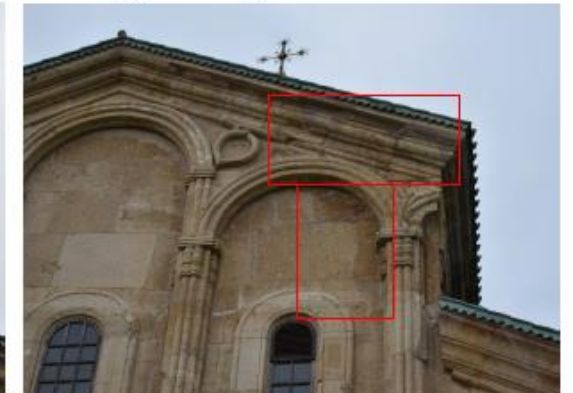
June 17, 2020

Still only moisture is noticeable
