Ref.: CLT/WHC/EUR/20/12998

**საგანი: მსოფლიო მემკვიდრეობის ძეგლის - "გელათის მონასტრის"
საკონსერვაციო მდგომარეობა**

On 8 September 2020, the World Heritage Centre transmitted to ICOMOS information submitted by the State Party on the state of conservation of the Church of the Virgin in Gelati Monastery World Heritage property, comprising a letter with two annexes: an information report on the state of conservation of the Church of the Virgin, and the implemented project documentation for the temporary scaffolding and roofing of the Church of the Virgin.

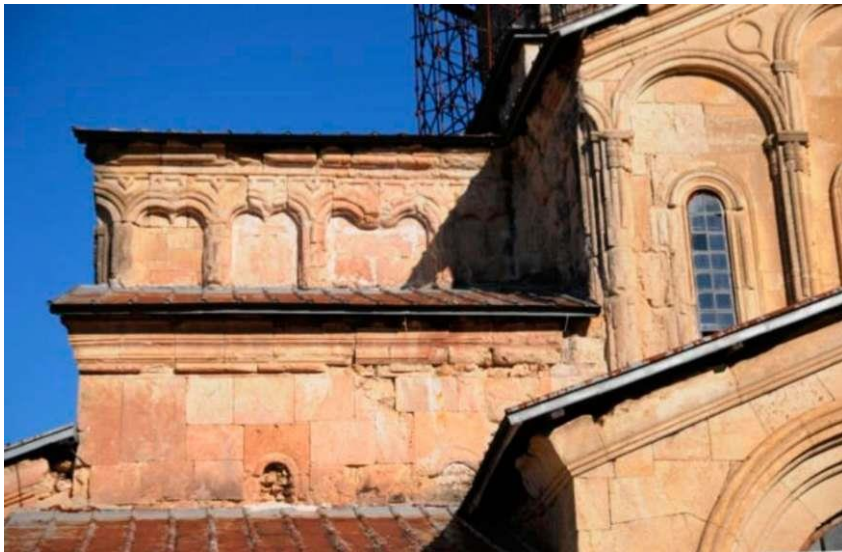
დასავლეთ ზედა ნაწილის დეტალი - ხედი სამხრეთიდან (2015 წლის მისიის ანგარიშის სურათი 11).

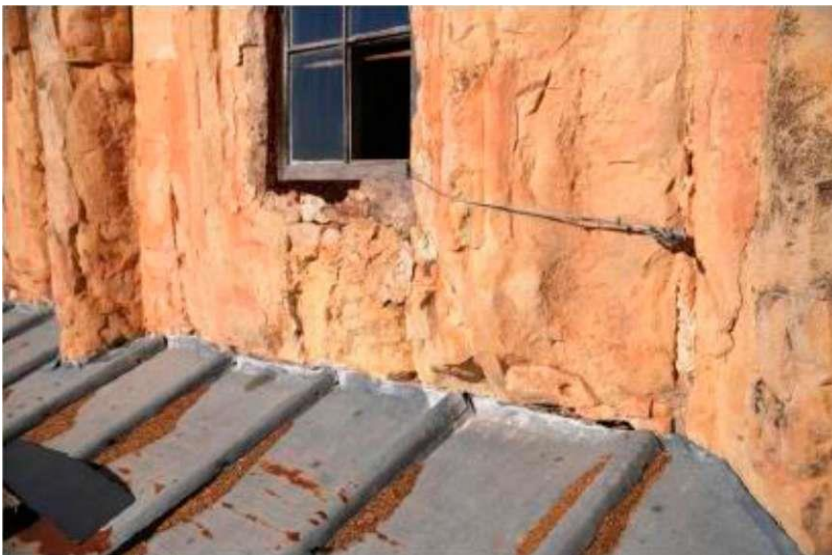
ქვის წყობა და თუნუქის გადახურვა - დღევანდელი მდგომარეობა (2015 წლის მისიის ანგარიშის სურათი. 13).

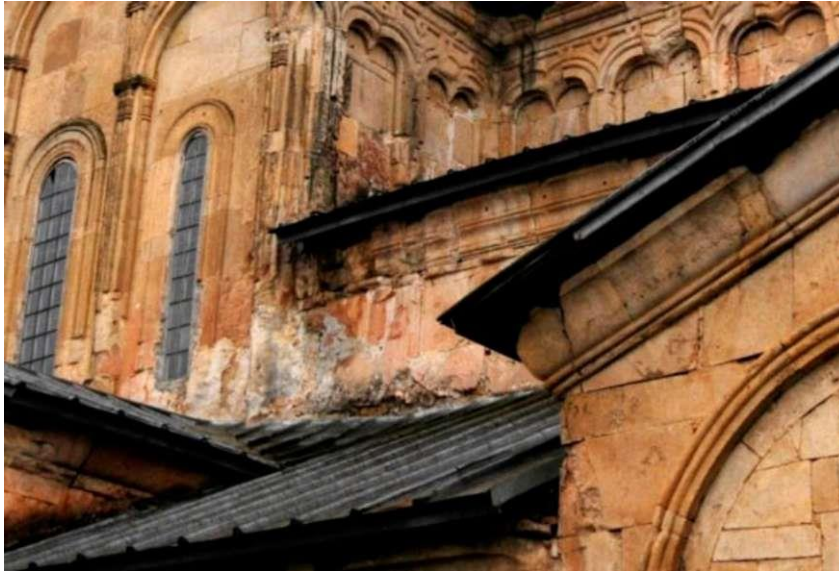
კედლის კვადრებს შორის დარღვეული კავშირი [დასავლეთი მკლავი -ჩრდილოეთი მხარე] და სტრუქტურული ქცევის შეცვლა (2015 წლის მისიის ანგარიშის 58-ე სურათი).

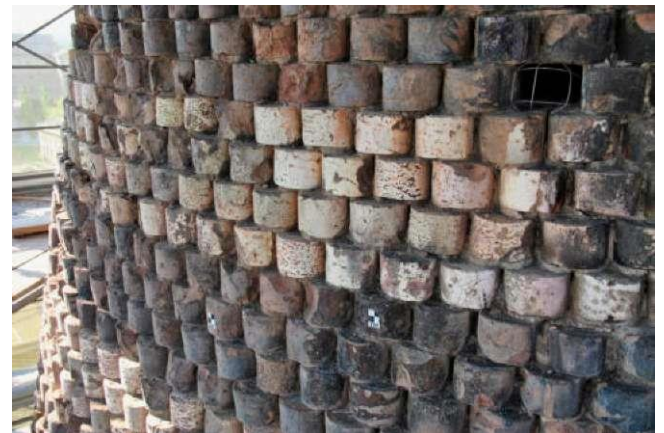
სურ. 2. კონუსური შპილის დეტალი, შესრულებული დიქრომატული მოჭიქური აგურებით: შავი და თეთრი. ქვის წყობაში შეინიშნება ზარბები და ეროზია.

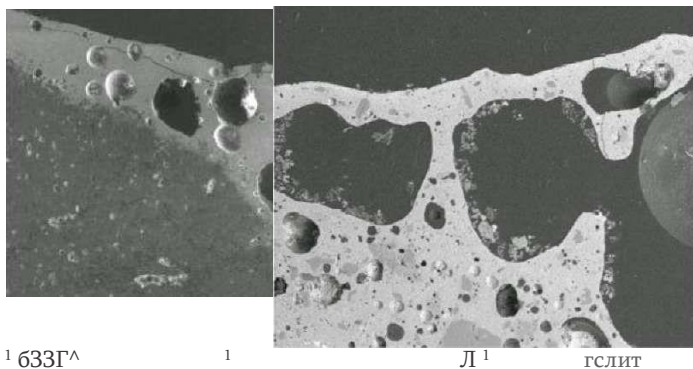
სურ. 9. ჭიქურის დაზიანება: (A) ნაპრალი ზედაპირის პარალელური ნიმუშზე CD_6; (B) ნიმუში CD_4, მინანქრის დაზიანება გამოწვევის დროს, დიდი არაერთგვაროვანი ფორმის ბუშტები და ბზარები.

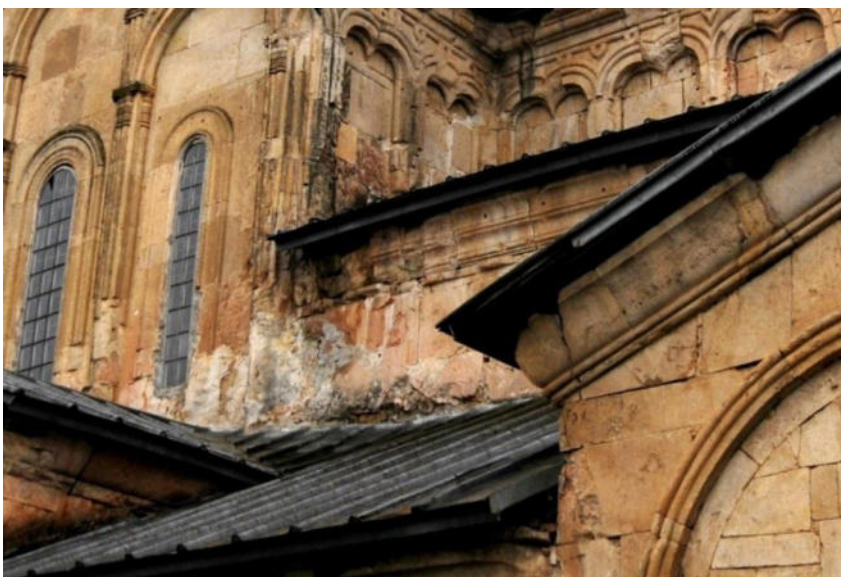
Disconnection between the blocks of a wall [west wing-north side] and alteration of the structural behaviour (Fig.58 of the 2015 mission report).

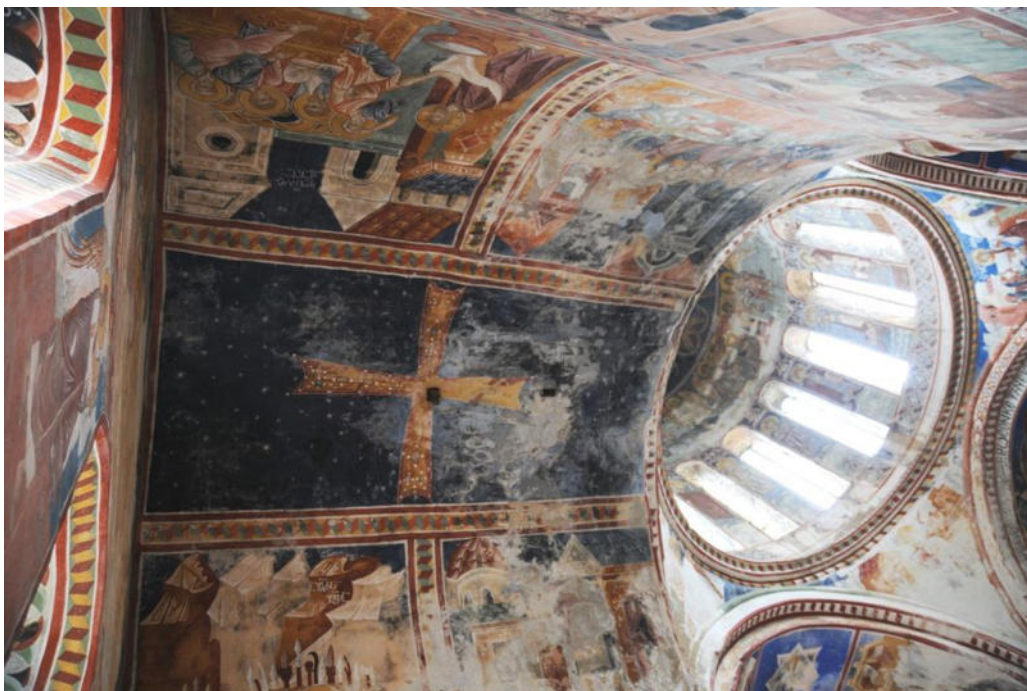
Salt efflorescence has been detected as the main cause of deterioration, which is related to water infiltration through damaged roofs and the environmental conditions of the interior. Salt crystallization cycles have caused problems with the cohesion and adhesion of paint and plaster layers, loss of repair materials applied during previous interventions in the 20th century and loss of small wall painting fragment pieces from the original technology. Bioactivity has also been observed.

The phenomena have been detected in various places, however, the most critical issues are found on the church's west arm vault.

- A certain amount of fallen fragments of plastering with original paintings was observed on the platforms of the scaffolding arranged in the west arm of the Church of the Virgin.
 - Analysis of the condition of the wall paintings in the Church of the Virgin, St. George Church and the Southern Porch was carried out; condition phenomena have been identified, documented and categorized according to:
 - Areas that have been historically damaged/deteriorated;
 - Newly damaged/deteriorated areas (occurred after roof rehabilitation).
- Apart from this, the rate and distribution of detrimental change has been determined in order to establish whether deterioration is active or not.
- According to the condition assessment of the façades and interior, a possible correlation between those two has been identified.

Church of the Virgin: Barrel-vaulted western cross arm (from the Report of the joint World Heritage Centre /ICOMOS/ICCROM Advisory Mission to Bagrati cathedral and Gelati monastery, March 2010)

The necessary time must be ensured to allow the phenomena of moisture and the formation of salts to be relieved mainly by themselves, in a natural way. The abrupt drying of the murals can cause them "shock", as a result of which salts could remain inside the pigment or create peeling conditions.

The process of moisture release can be "facilitated" by careful and periodic removal of salts from the surface of the murals, by mechanical methods. However, great care must be taken so that during these rescue operations no damage and peeling of the original material of the frescoes (either the pigment or the substrate) occurs, as it may have lost its original cohesive ability. That is why salt reduction should be probably combined accordingly with local consolidation of the wall-paintings by appropriate compresses with Japanese tissue paper.

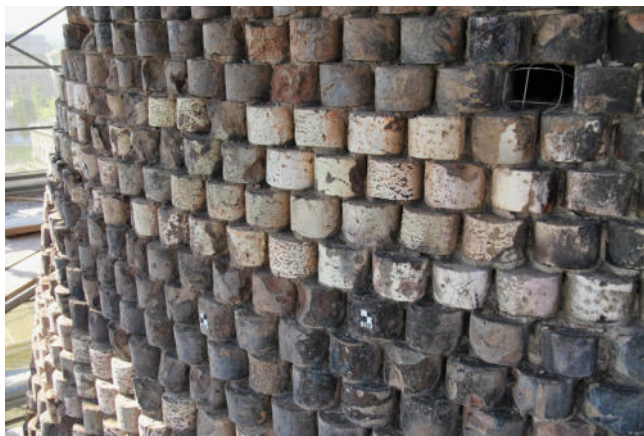
Fig. 2. Particular of the conic spire, realized with dichromatic glazed bricks: white and black. The masonry shows deterioration, cracks and erosion of the bricks.

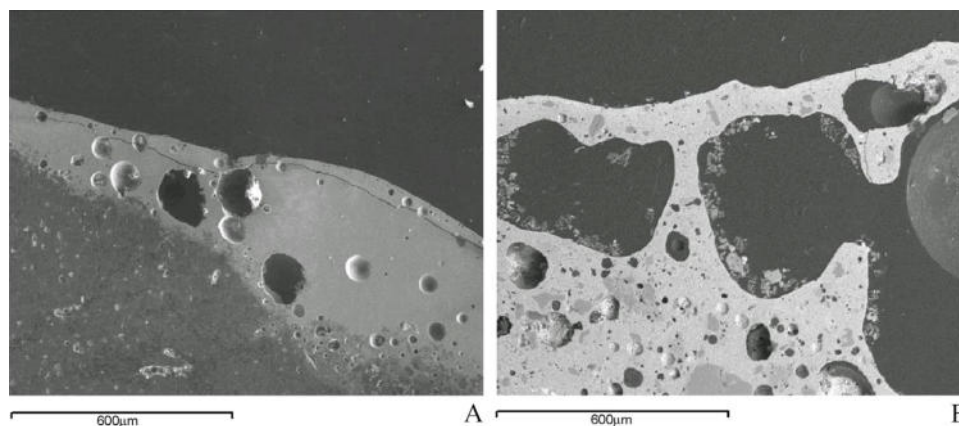
Fig. 9. Glaze damages: (A) fracture parallel to the surface in the sample CD-6; (B) sample CD-4, glaze damages during the fire, with large irregular bubbles and cracks.
