Subject: State of conservation of the World Heritage property 'Gelati Monastery'

ICOMOS Technical Review 'Temporary roofing arrangement for the Church of the Virgin and St. George's church in the World Heritage property of Gelati Monastery, Georgia'

Property	Gelati Monastery
State Party	Georgia
Property ID	710
Date of inscription	1994
Criteria	(iv)
Project	Temporary roofing arrangement for the Church of the Virgin and St. George's church in the World Heritage property of Gelati Monastery, Georgia

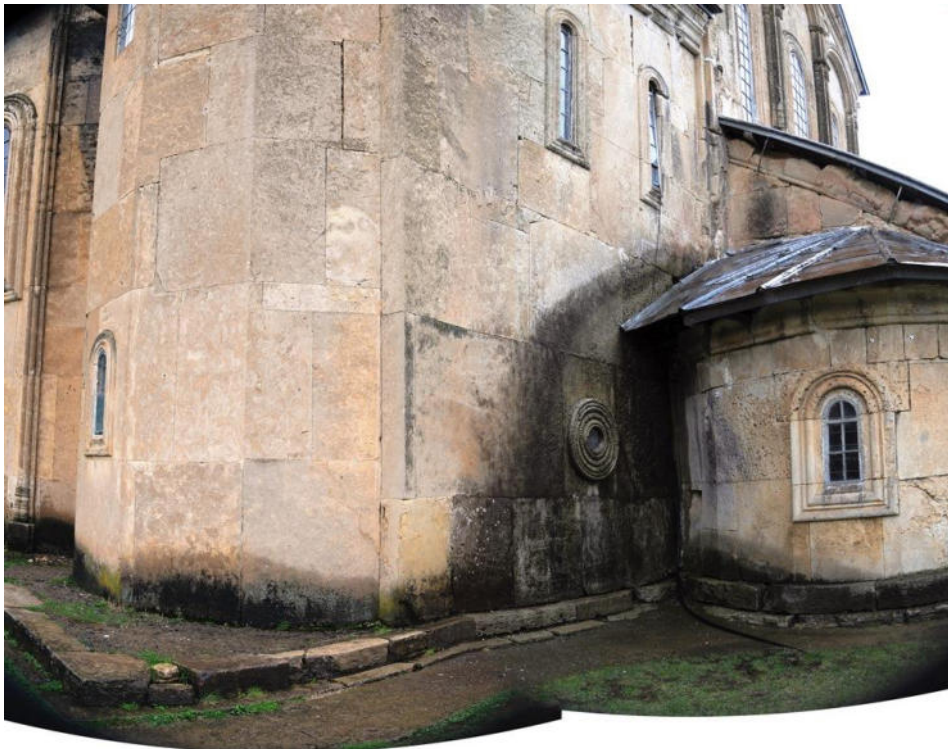
During the previous joint World Heritage Centre/ICOMOS/ICCROM Reactive Monitoring mission (11-17 March 2010), several conservation issues were identified, among them the issue of descending and rising damp on the basement of the masonry of the monuments. No information has been provided since then on the impacts of this humidity on the church interior, nor whether and how this phenomenon has been assessed, nor whether the old drainage system around the monuments has been re-used for this purpose (cf. Fig. 1, 2).

Fig.1. Descending and rising damp identified in the basement of the masonry of the Church of the Virgin (2010 World Heritage Centre/ICOMOS/ICCROM mission)

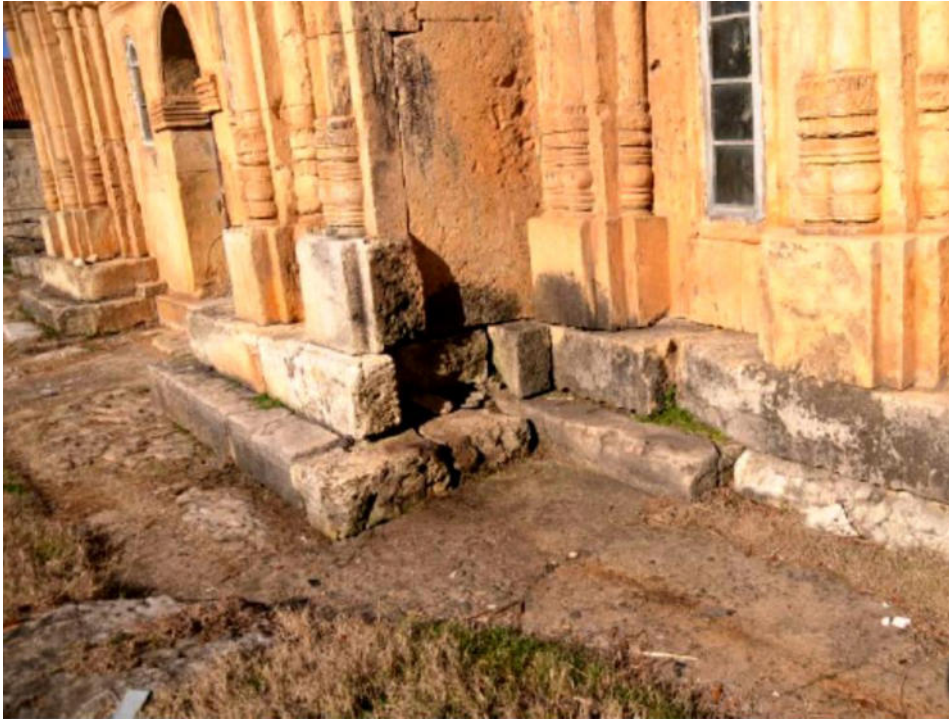
Fig.2. The *crepidoma* of the Church of the Virgin with the old drainage system around it (2015 joint ICOMOS/World Bank Advisory mission, fig.10)

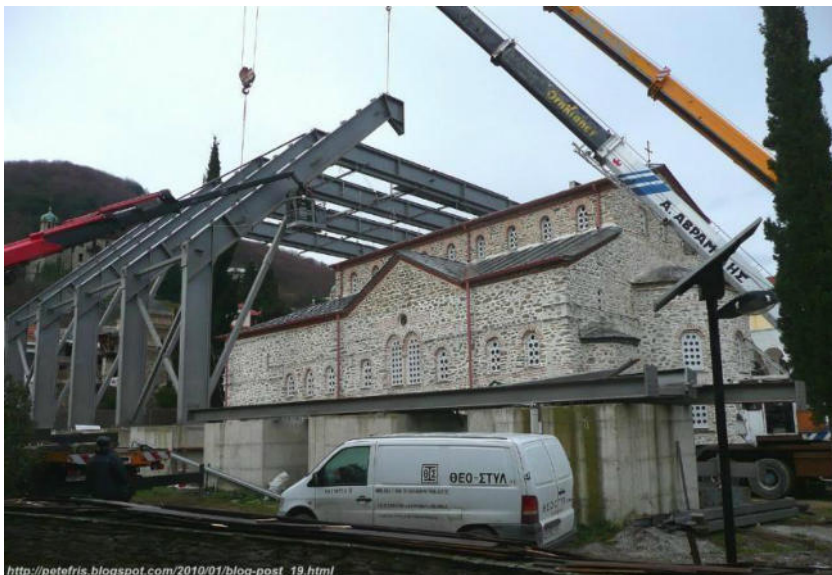
Fig.3. Protaton Church – Placement of reinforced inclined iron beams of protective metal scaffolding

In the opinion of ICOMOS, a combination of the above two versions would be preferred; that is, a lighter construction (compared to version 1) and a more solid one (compared to version 2). To this direction, it is proposed to follow the solution of a gambrel roof, which will give a sufficient slope to the roofing and practically is easier to be assembled. However, it should be constructed not of prefabricated metal scaffolding, but of reinforced inclined iron beams capable of lifting heavy loads (snow), connected to each other by cross links, and anchored to point bases of concrete. It would be necessary for vertical banners-metallic elements to be placed on the sides, in order to protect the monument and the workers from side winds and rainwater. The solution of strong plastic sheets to cover the luminaires, fixed on a suitable metal frame, is preferable. An idea of the proposed construction is provided by the photographs of the protective scaffolding that was placed over the Protaton Church¹ on the World Heritage property of Mount Athos (Greece), in order to carry out the long-term restoration work of replacing the old roof construction and tile covering (Fig. 3, 4, 5).

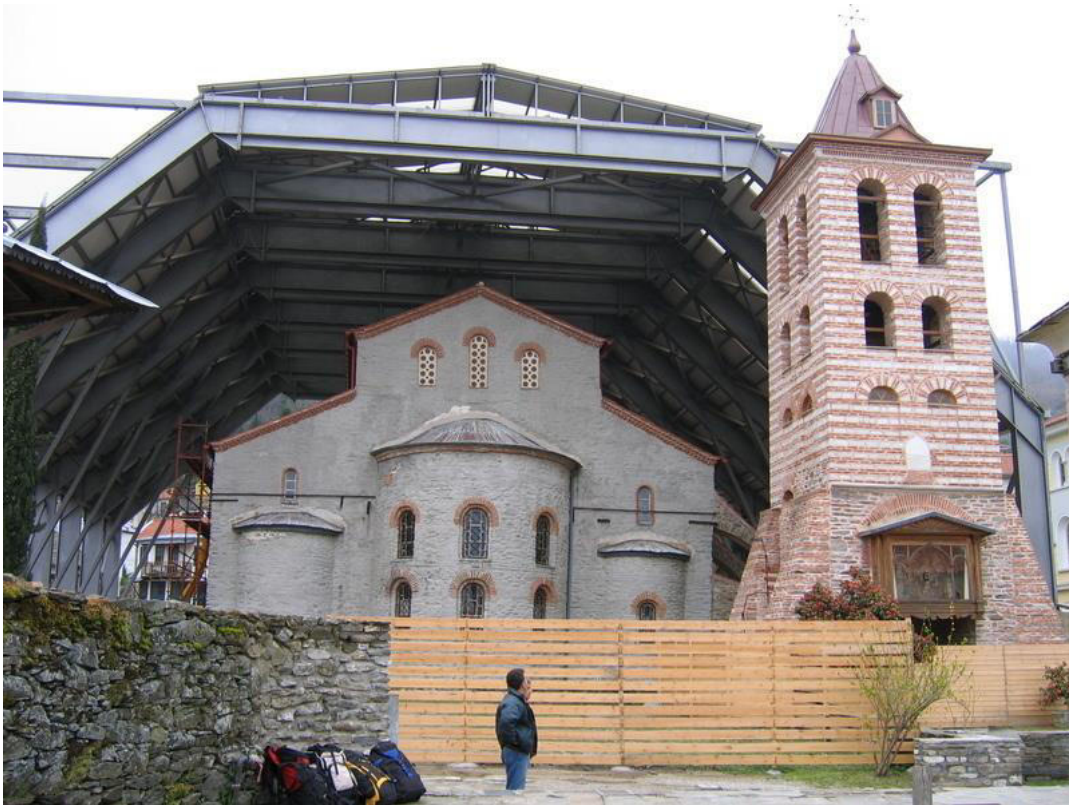
Fig.4. Protaton Church – The protective metal scaffolding.

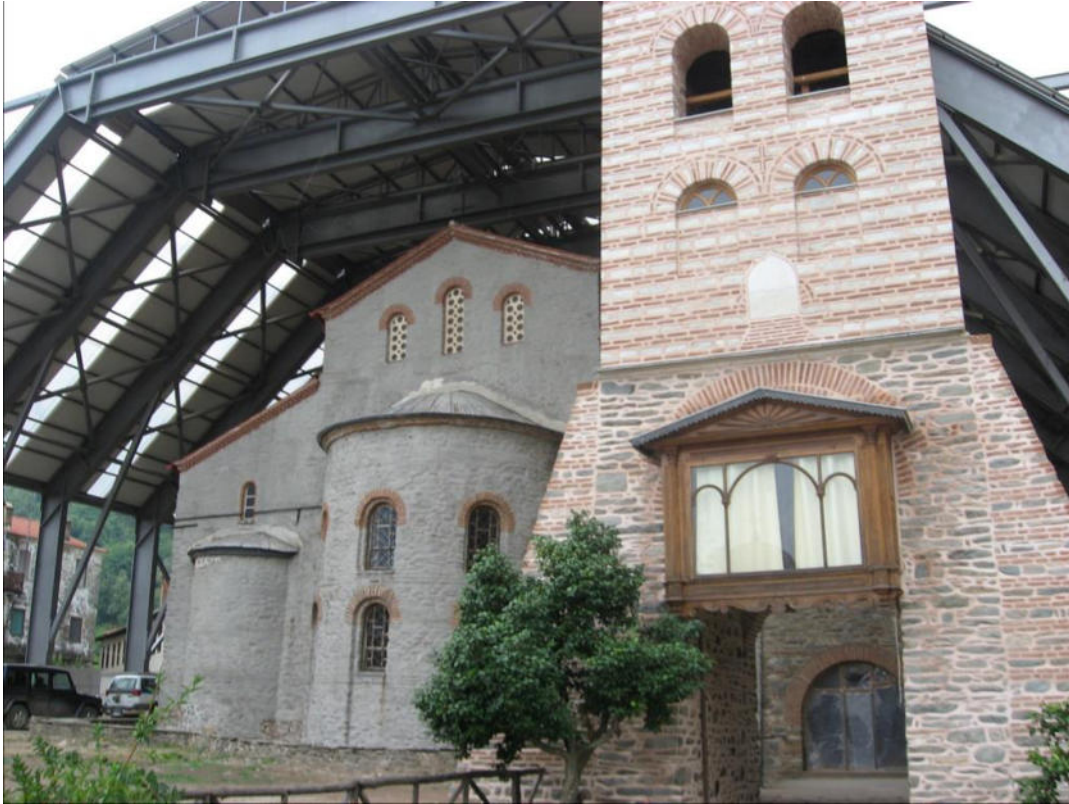
Fig.5. Protaton Church – The protective metal scaffolding.
