Information on the State of Conservation of the Gelati Monastery World Heritage Property, Georgia

May 2021

NATIONAL AGENCY FOR
CULTURAL HERITAGE
PRESERVATION OF GEORGIA

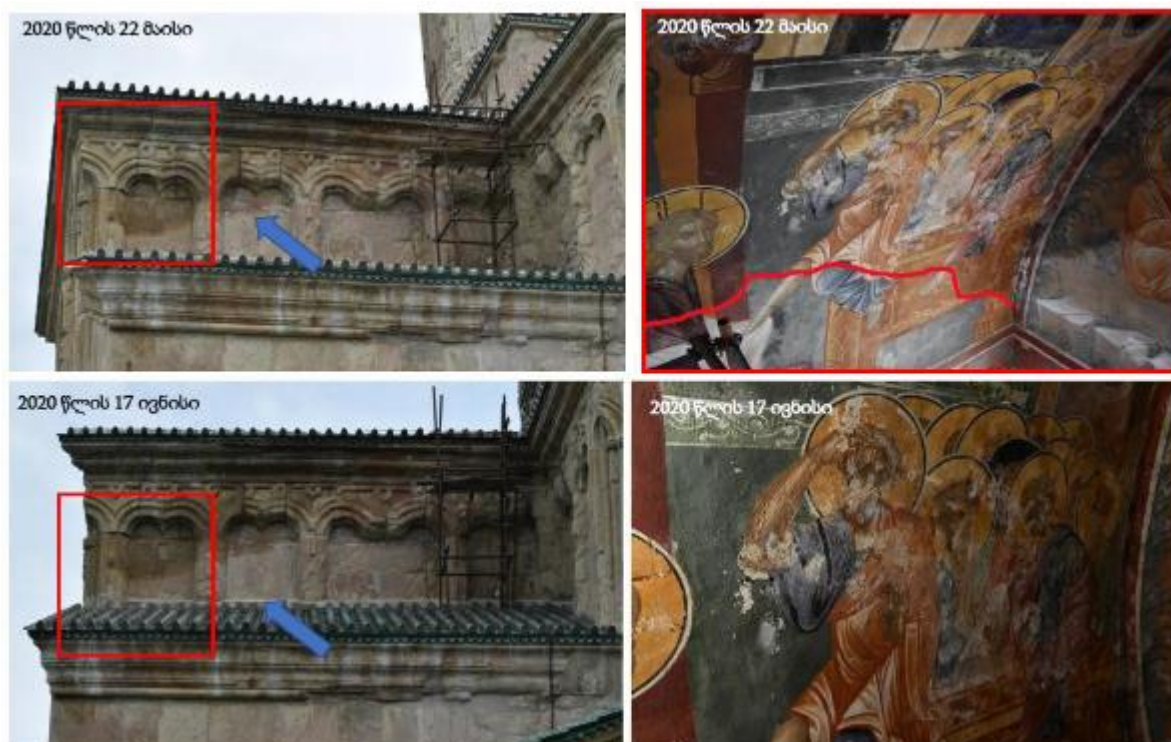
Photos: Upper part: May 22, 2020. Lower part: June 17, 2020. Exterior and interior parts of the south wall of the west arm.

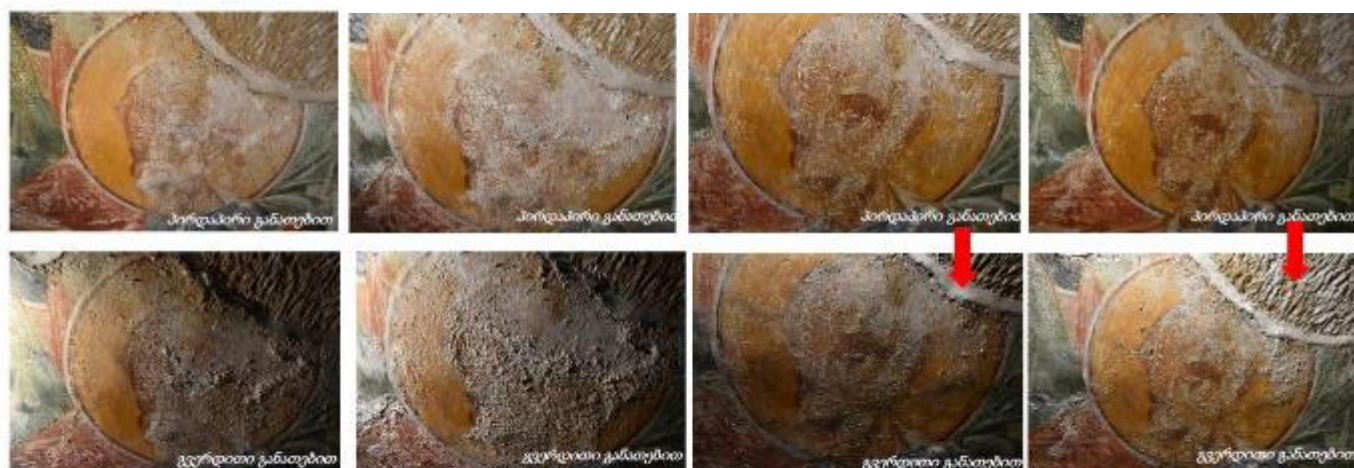
Condition as per March 11, 2020. **Condition as per April 30, 2020, before partial removal of salt** **Condition as per April 30, 2020, after partial removal of salt** **Condition as per June 19, 2020, before partial removal of salt**

An increased amount of salt efflorescence

An increased amount of salt efflorescence. A distribution pattern of the efflorescence is changed.

- Condition monitoring of the deteriorated fragments was undertaken and partial removal of salt efflorescence on the west arm was regularly conducted in 2020.

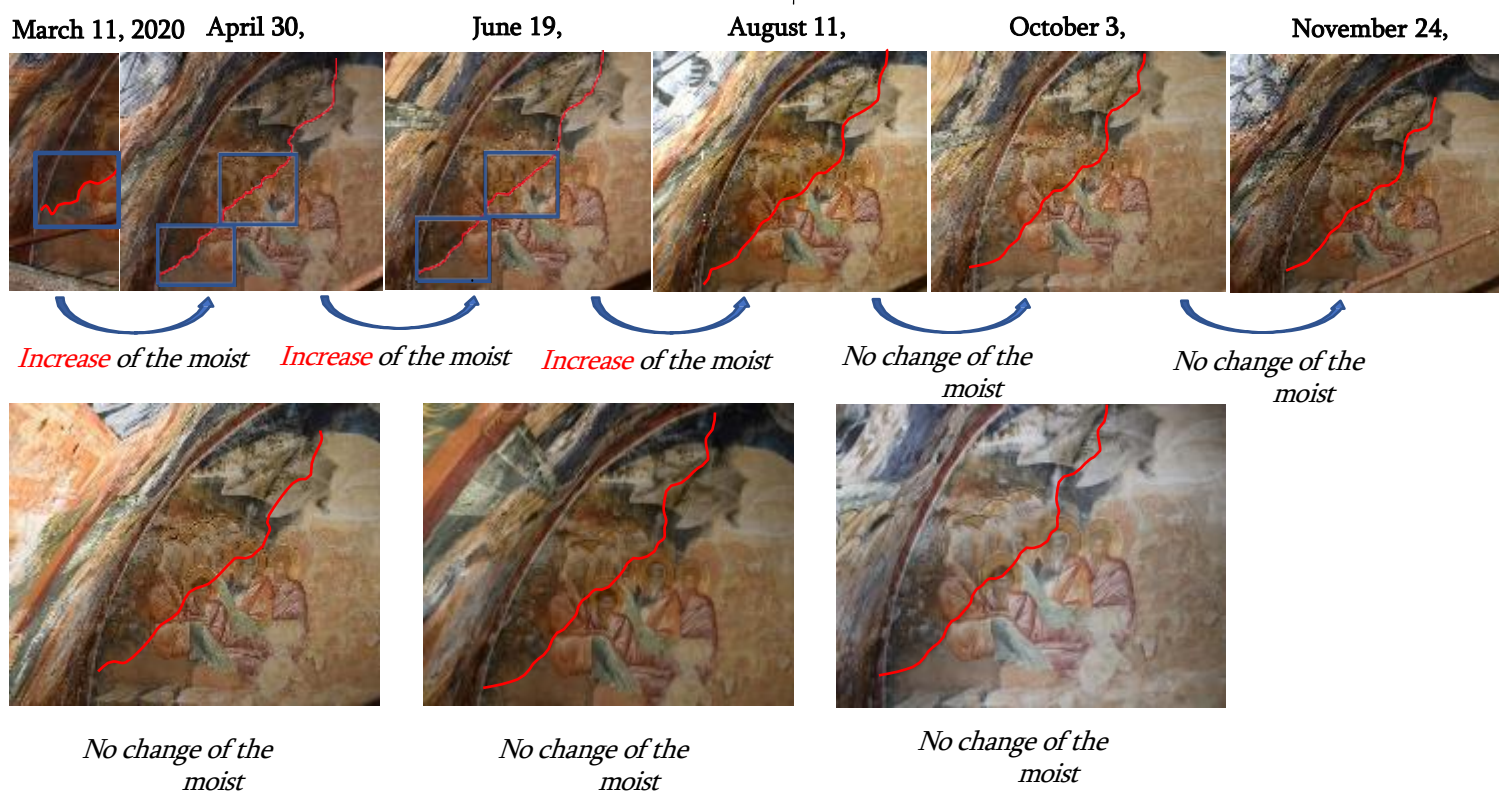
West Wall - West Arm

According to the data collected on scheduled monitoring, active source of deterioration – ongoing problem of water infiltration – in the Church of Nativity of Mary *was recorded only in the west arm*. After August 10-11, 2020, according to the data of October 2-3 and November 24, 2020 and January 10-11, March 8, April 29, 2021 the process of ‘wetting’ of walls, caused by water infiltration in the west arm, seems terminated, which should be related to the preventive measures, arranged on the roof.
