**Safeguarding and conservation of Gelati Monastery
World Heritage Property, Georgia**

Church of the Virgin

**Investigations on the structural hygrometric and micro-environmental
state aimed at safeguarding the internal wall paintings**

Mission Arch. Alessandro Massari of: 06 – 12 November 2021

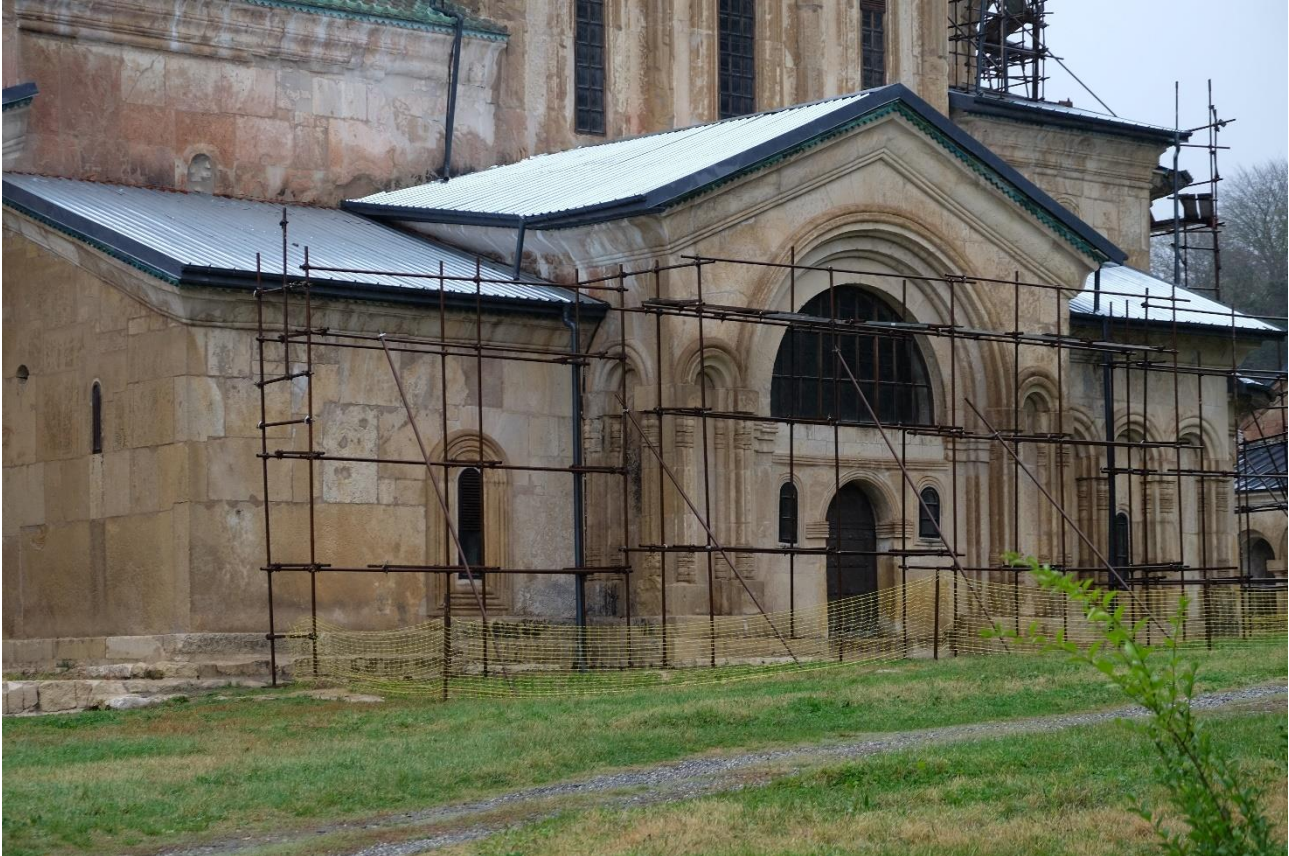
*Figure 12: Church of the Virgin Mary, view of the south front with downpipes **d4** and **d5***

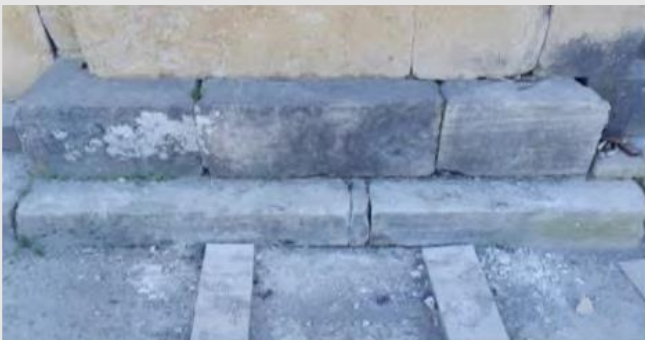
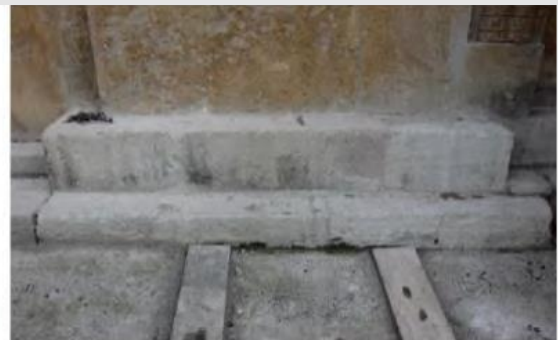
- Damaged and rehabilitated socle

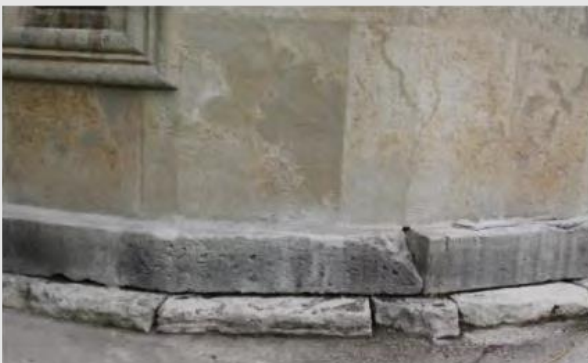
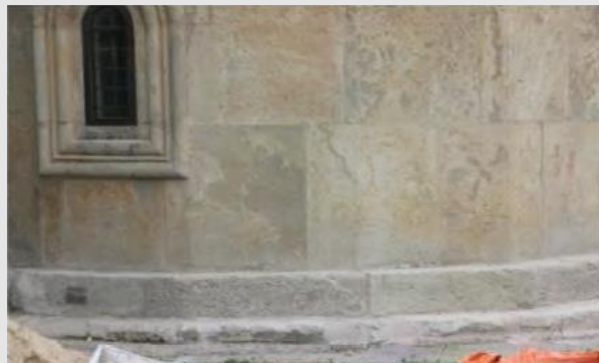
- Damaged and rehabilitated socle

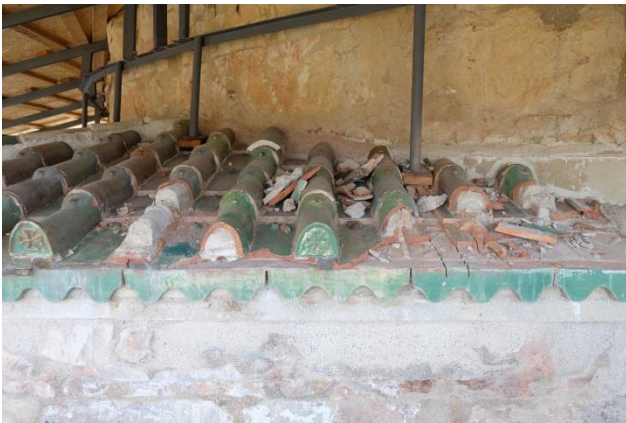
- At survey, all the temporary coverings, except for those over the "spandrels" of the drum, were built immediately above the tiled roof coverings, hence without a significant passage of air between the tiles and the overlying metal sheet (*figures 20, 21, 22 and 23*). This may result in a delay of the drying process, through evaporation, of any water that could have entered below the roof covering as a result of past infiltrations. Similarly, it could also lead to condensation on the underside of the temporary corrugated sheet coverings themselves. Ultimately, it is important to highlight that the very presence of glazed tiles (thus, not very permeable) constitutes an obstacle to the drying process of the underlying structures and can cause interstitial condensation phenomena when particularly high levels of humidity in the substrate material may occur.

Figure 20: structure of temporary roofing shelter, elevated on roofing tiles layer

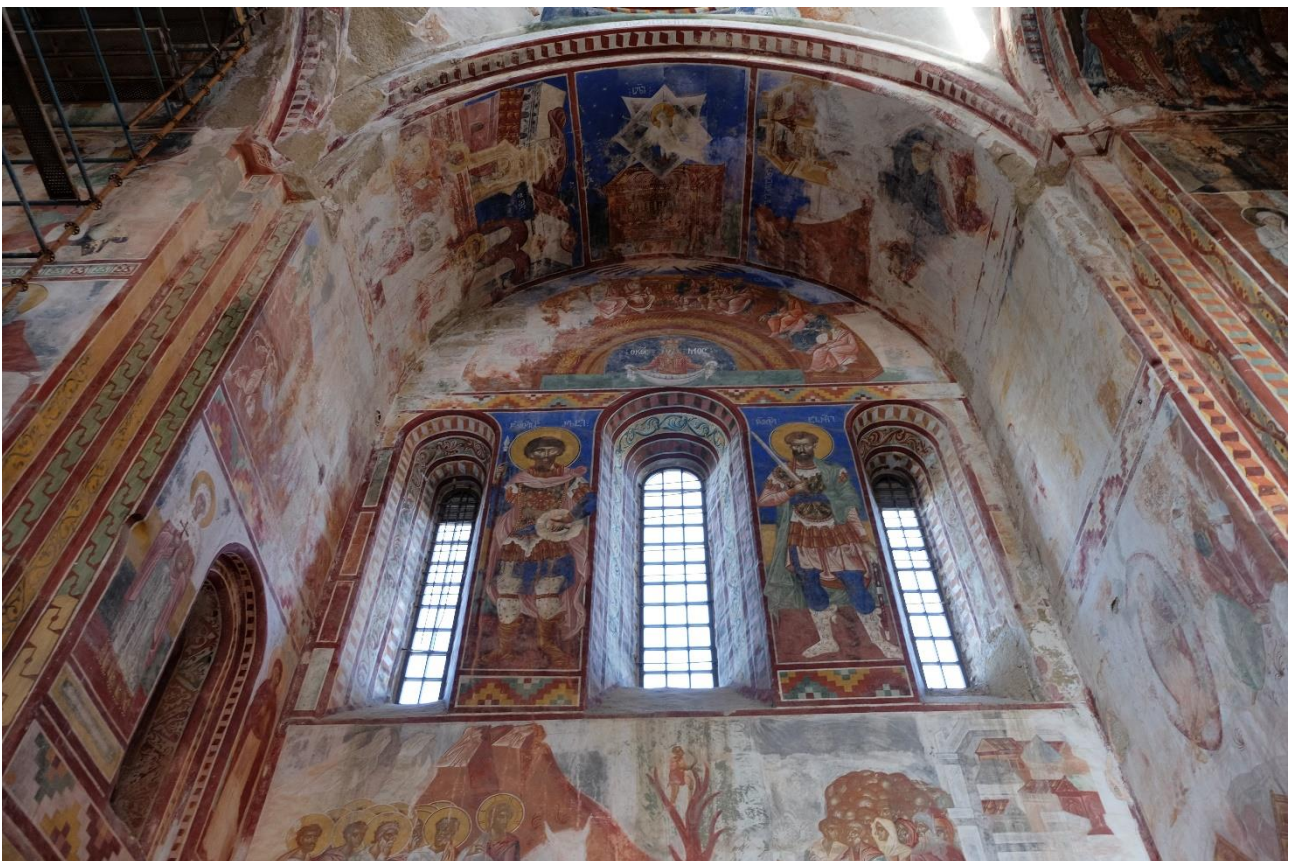
Figure 24: view of three windows overlooking the transept: the middle one only glazed, while equipped with 'anti-animal' net and a protective external shutter the side ones

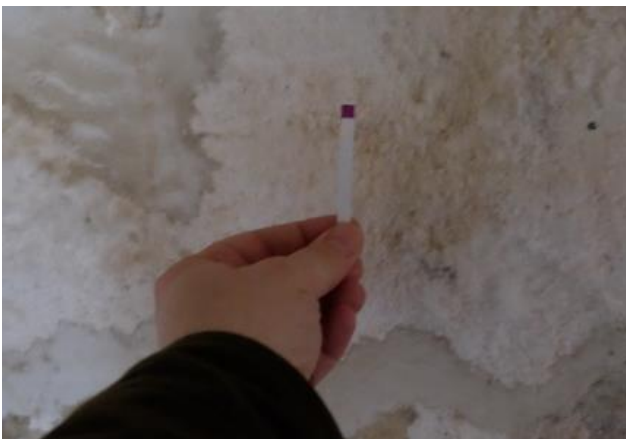
Figure 25: test N8 (env. 6)

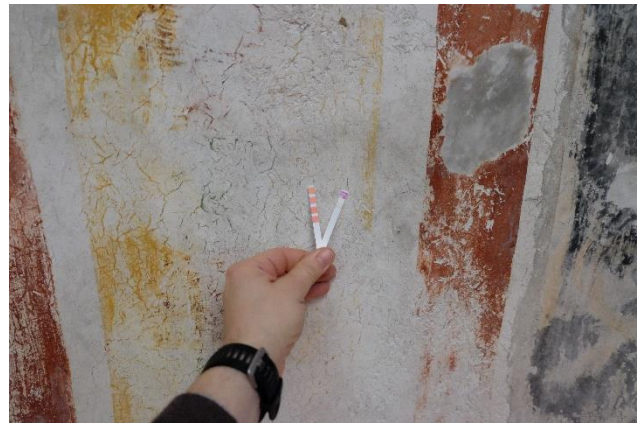
extremely differentiated results with some areas dry and others very wet. This distribution is generally indicative of localised moisture inputs caused by local and occasional events. Specifically, the north side of the vault is essentially dry with only a few spots of moderate and circumscribed humidity. The situation on the south side is much more serious, with localised very high humidity values, especially (but not only) in the area immediately above the haunch of the vault (*figure 27*). The areas found to be wet at the north side of the vault, are characterised by a varying presence, from abundant to very abundant, of both nitrates (**N19**, **N20**, **N21**, **N22** and **N23** tests), and sulphates (**S6** and **S7** tests). Conversely, sulphates are either absent or present in small quantities in 'dry' areas (**N24** and **N25** tests). On the south side of the vault, the nitrates were extremely abundant in those areas found wet (**N3**, **N14**, **N15**, **N16**, **N17** and **N18**), while, instead, have not been detected high concentrations of sulphates (*figure 28*).

Figure 28: Nitrates and Sulphates check

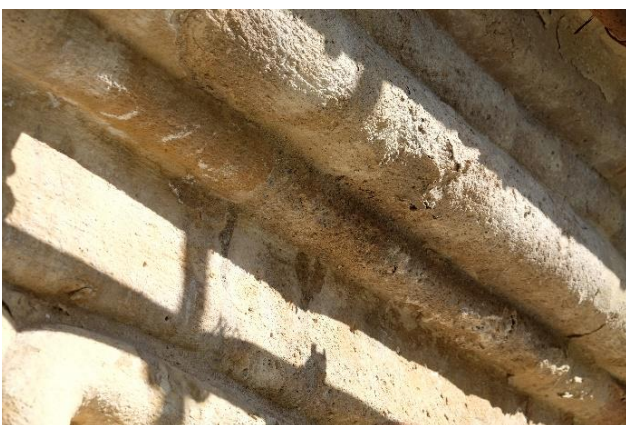
A nitrates' check has been carried out also for a portion of the exterior cornice which displayed degradation phenomena. Results showed values varying from positive to extremely positive (**N29** and **N30** tests; *figures 29 and 30*).

Figure 29: foreground of cornice

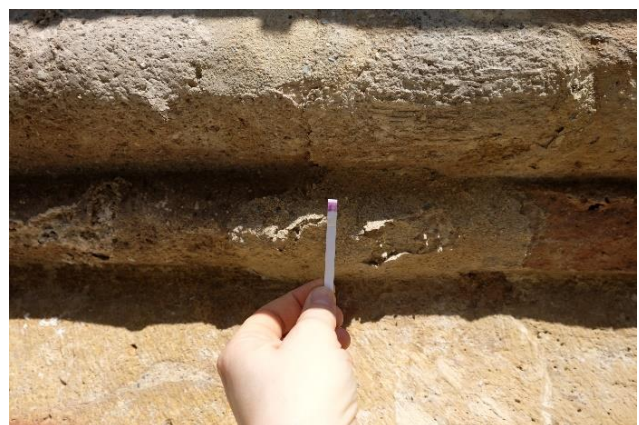
Figure 30: Nitrates check on the cornice (test N29)

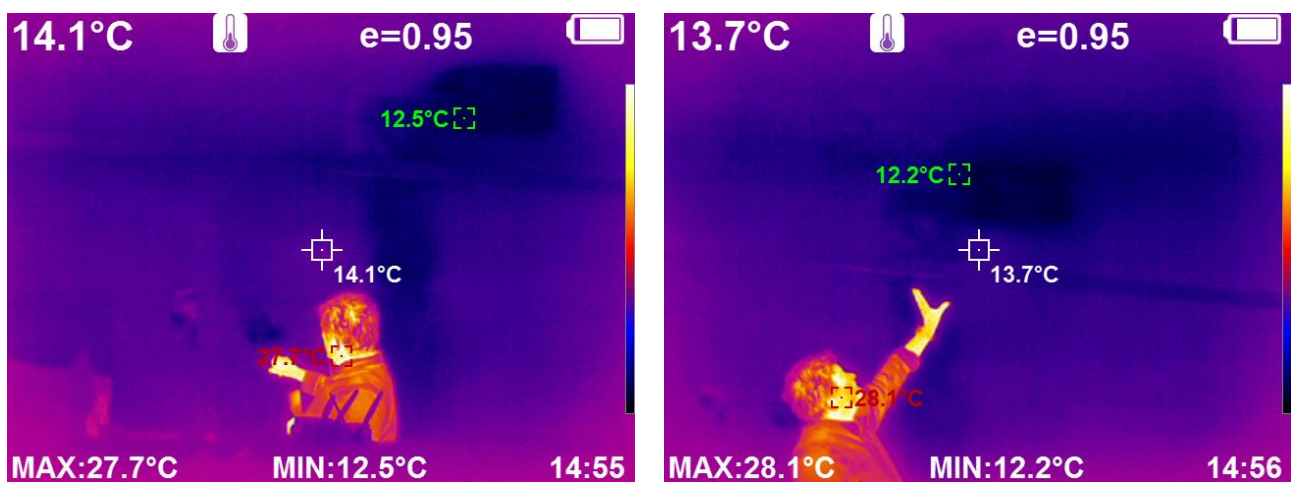
Specifically, the thermal imaging surveys did not reveal any areas subject to particularly strong evaporative flows (and therefore identifiable as colder), with the sole exception of the areas that were deliberately wetted during the work to secure the plaster on the vault of the north wing of the church, which was being carried out at the same time as the thermal imaging surveys (*figures 31, 32, 33 and 34*).

Figures 31 and 32: darker areas correspond to colder ones due the presence of water used when safeguarding the vault plasters

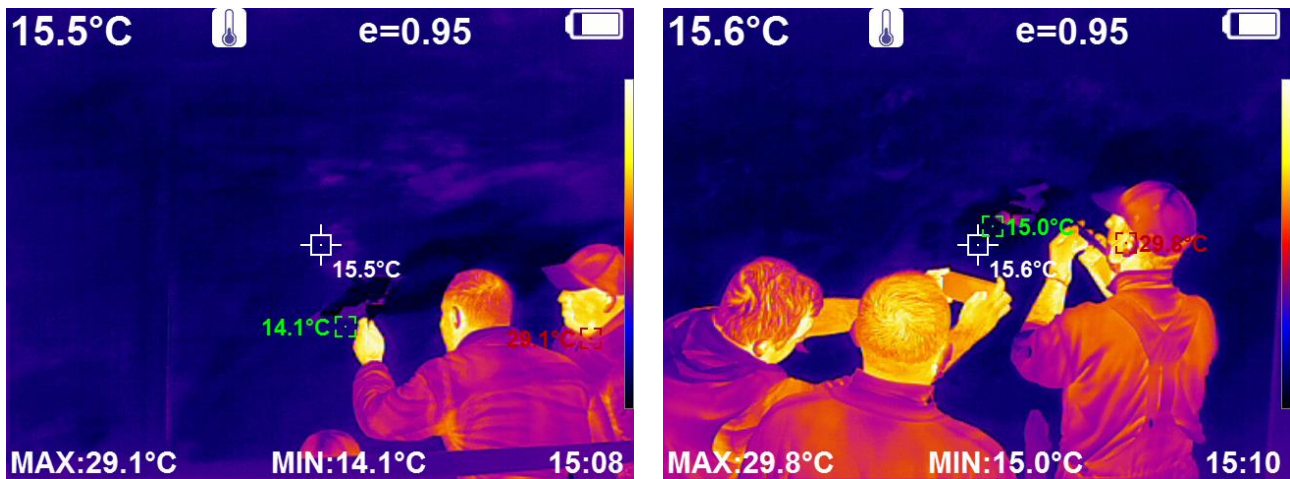
Figures 33 and 34: darker areas correspond to colder ones due the presence of water used during safeguarding operations on the vault plasters in progress

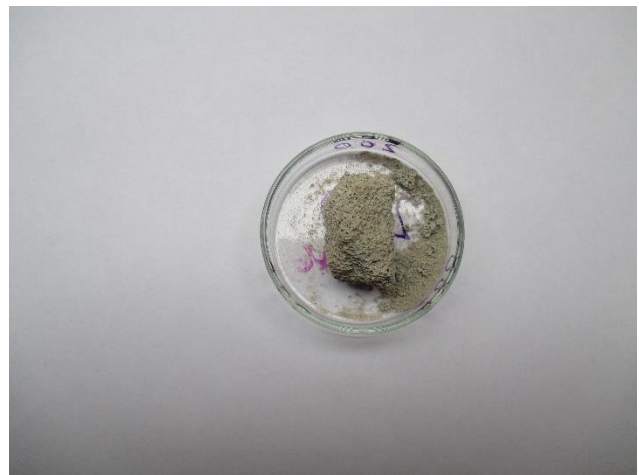
*Figure 43: Point **GB**, sample 31, layer on the back of the vault*

- For sampling points **GA**, **GB** and **GC** (namely, corresponding to samples **29**, **30** and **31** which are sampled below the roofing tiles of the south-east lunette), it was observed high values of water content, at sampling, both right beneath the tiles (**GA** and **GB**) and in the underlying light screed (**GC**); in addition, hygroscopic salts were detected.
