**Safeguarding and conservation of Gelati Monastery
World Heritage Property, Georgia**

**E.1 West Arm Emergency Uncovering:
concept, supervision of the design and implementation**

**Executive Summary on the mission carried out in Kutaisi (Georgia) at Gelati
Monastery from May 25th until May 31st 2022.**

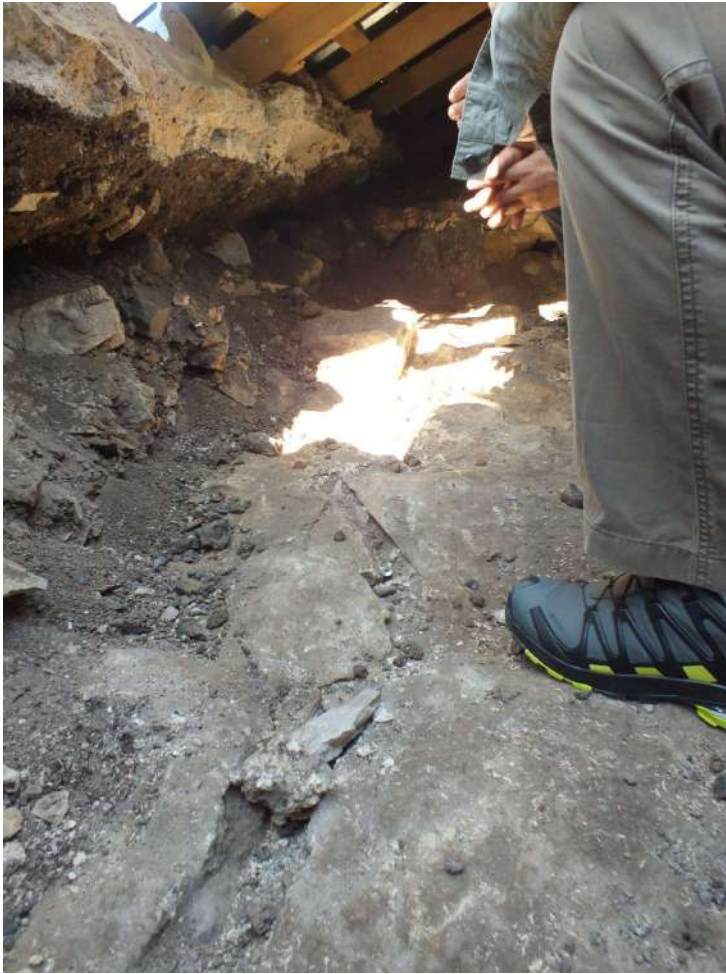
Once the covering and the filling on the South side of the West Arm had been removed, a longitudinal crack was revealed which affects the top of the wall.

Southern wall of West Arm.
Longitudinal crack on the top of the wall.

- We arrived at the decision to provisionally consolidate the crack by using "staples" on it and then, after creating a horizontal plane, to proceed to the already designed anchoring where the "core" of the ancient filling is reliable.

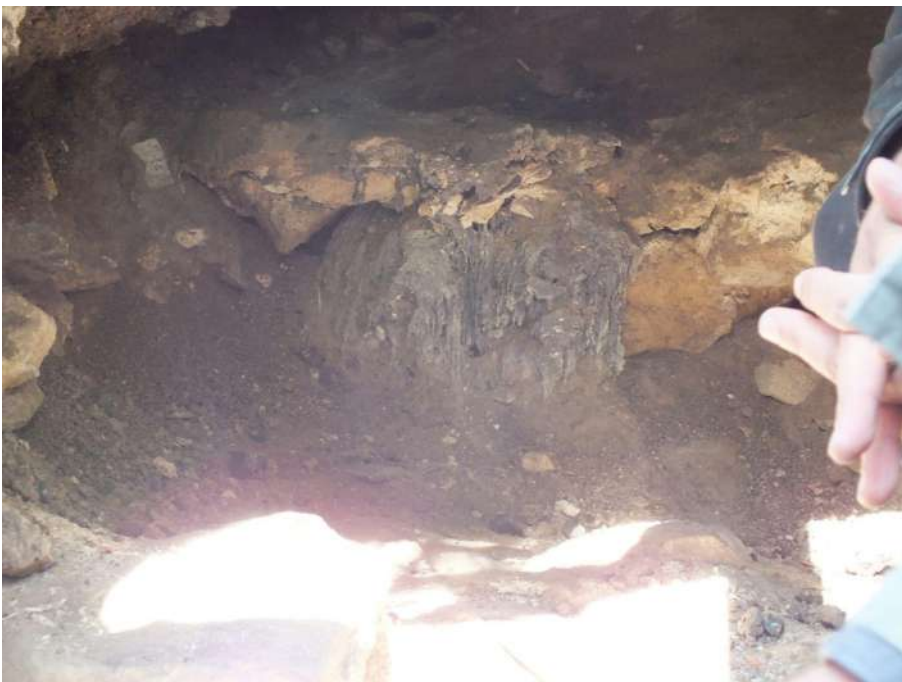
Southern wall of West Arm.
Molten lead block.

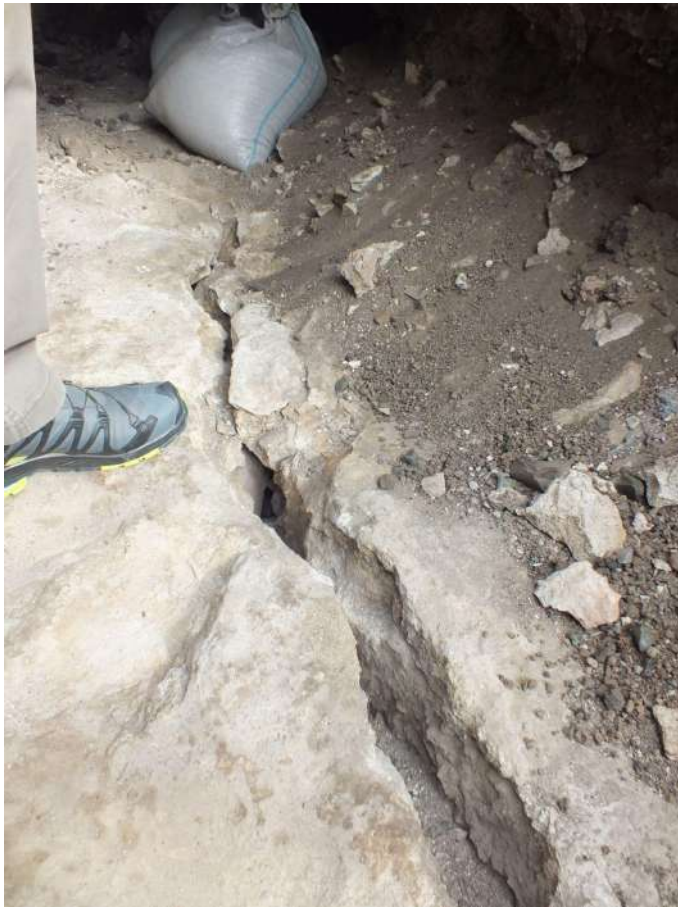
Southern wall of West Arm.
Longitudinal crack on the top of the wall.

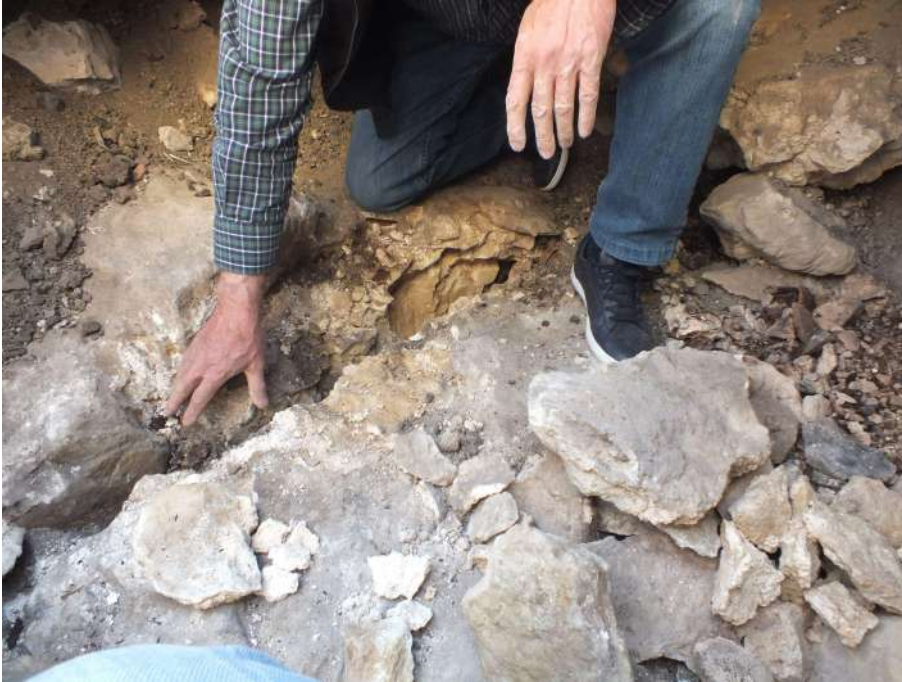
Southern wall of West Arm.
Longitudinal crack on the top of the wall.

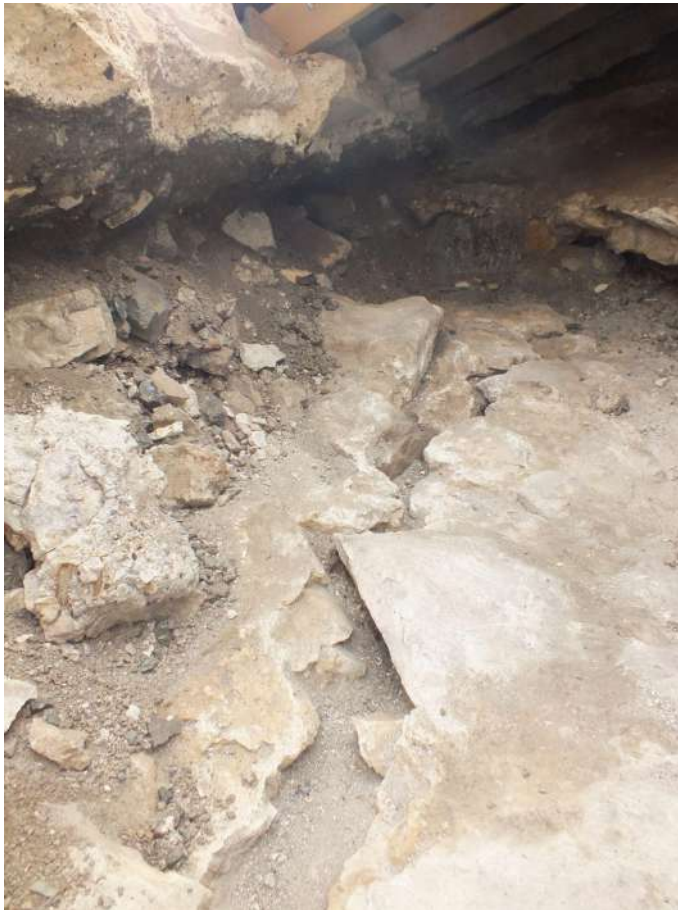
Southern wall of West Arm.
Longitudinal crack on the top of the wall.

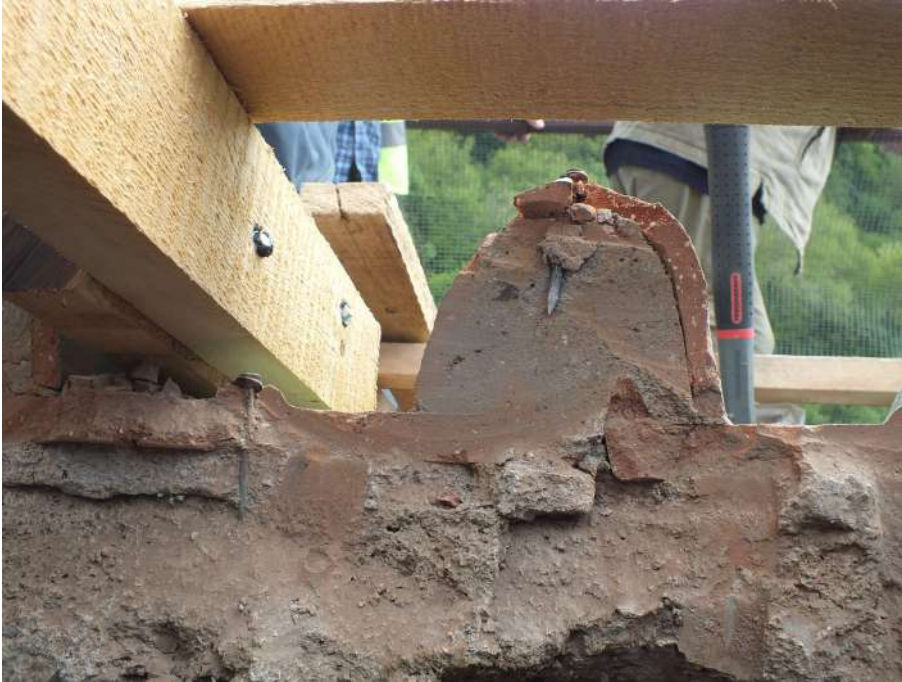
Southern wall of West Arm.
Section of the roof layers regarding the last intervention.

- **Under-roof filling removal.** Remove from the under roof only the layer of the new filling (2008-2019 intervention) and the layer of old lime made conglomerate only when it is already collapsed and incoherent and under the supervision of the archaeologist. Maintain the covering of the extrados of the vault made by such an old conglomerate when solid.

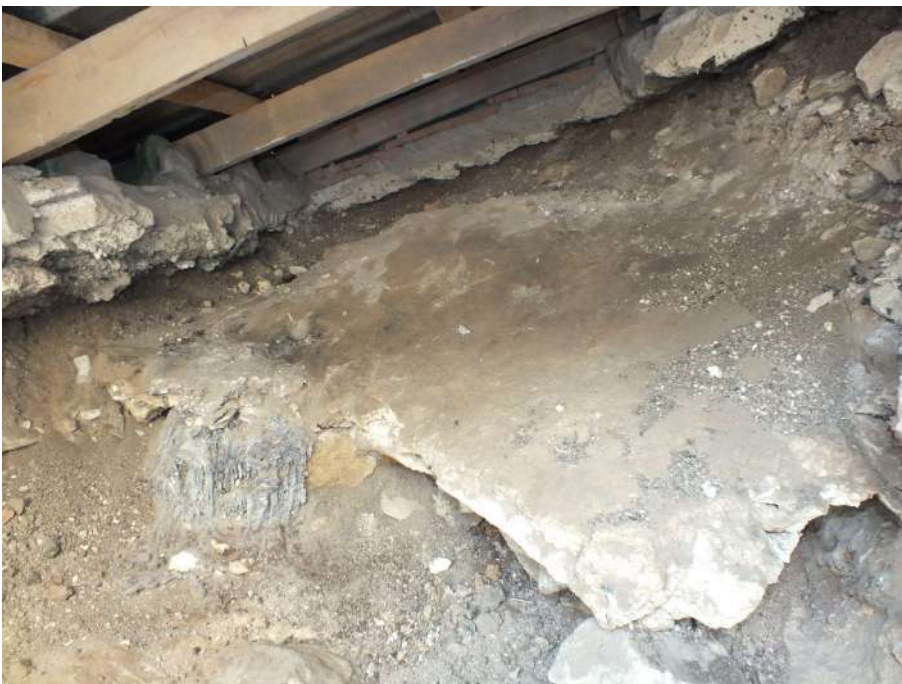
Southern wall of West Arm.
The ancient collapsed mortar filling with a molten lead block.

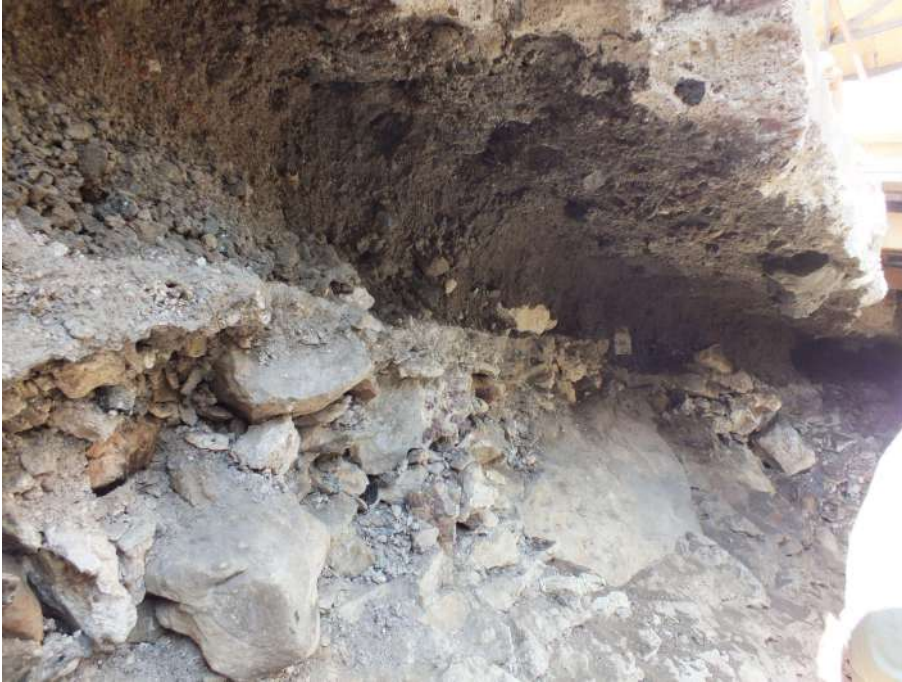
Southern wall of West Arm.
Different layers of the under-roof filling.

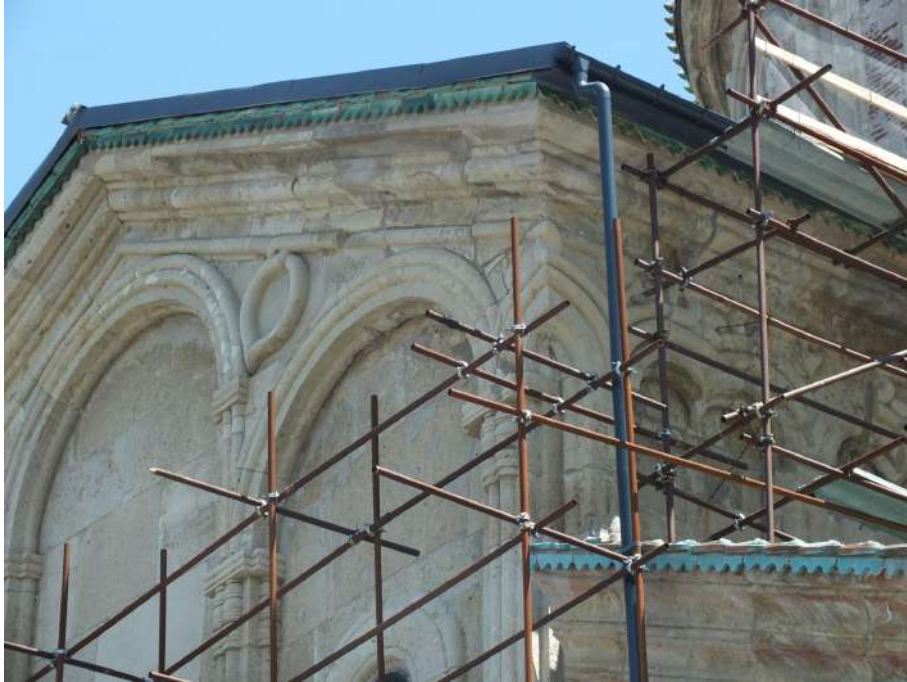
- Inspection of the crack on the South side of the West Arm;
- Inspection of the external South facade of the West Arm: findings of fractures in cornices and arches, evidence of the activation of old local mechanisms/kinematics;

Southern wall of West Arm.
Cracks on cornices and arches.

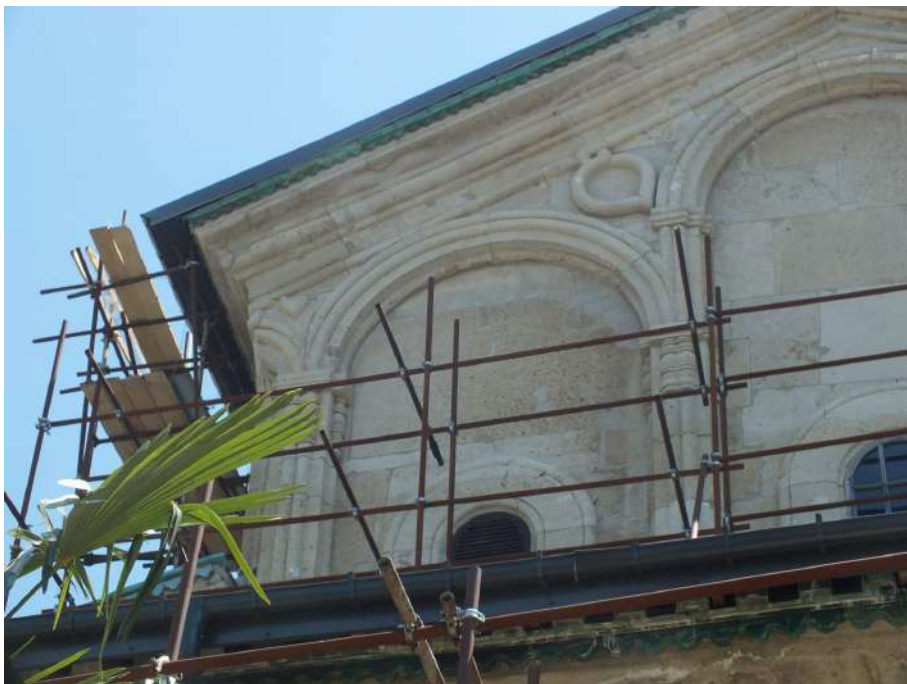
Western wall of West Arm.
Cracks on cornices.

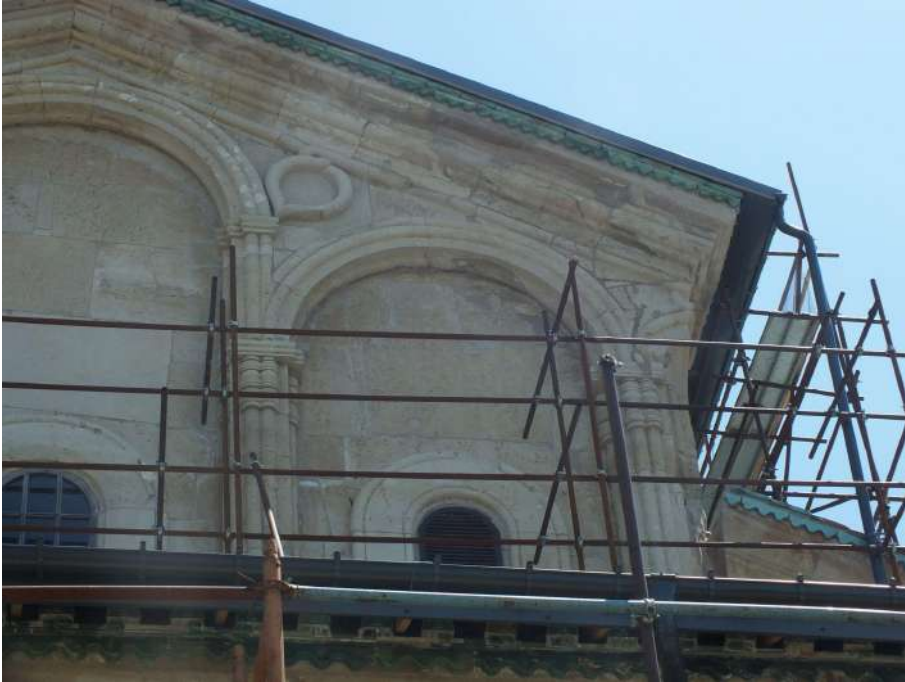
Western wall of West Arm.
Cracks on cornices.

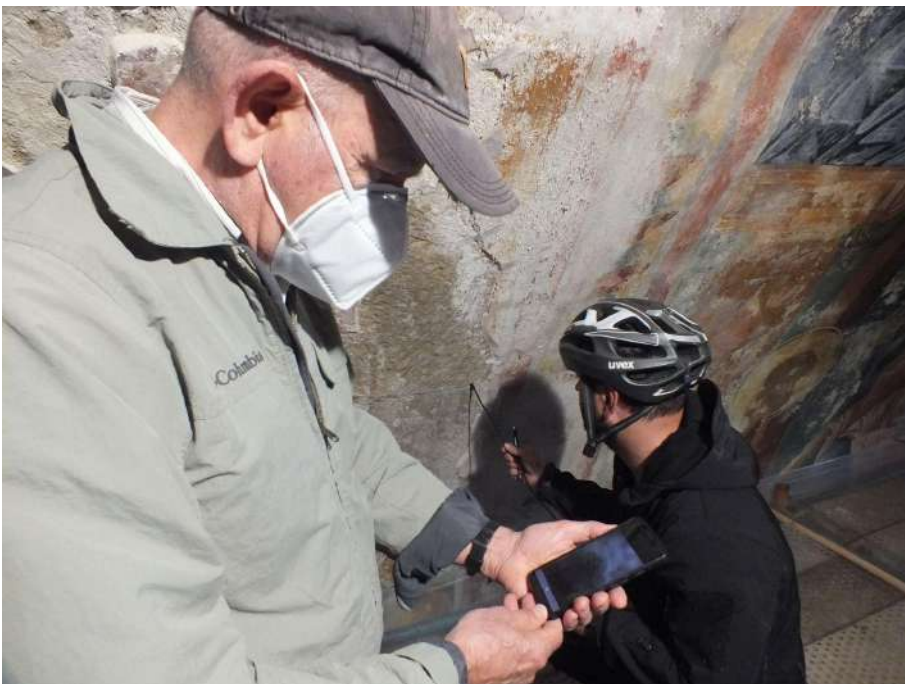
- Inspection, using an endoscope, from inside the South wall of the West arm to check the thickness of the vault;
- Discussions about the cross-section of the wall near the cornice;

Southern wall of West Arm, interior.
Inspection, using an endoscope, in order to check the thickness of the vault.

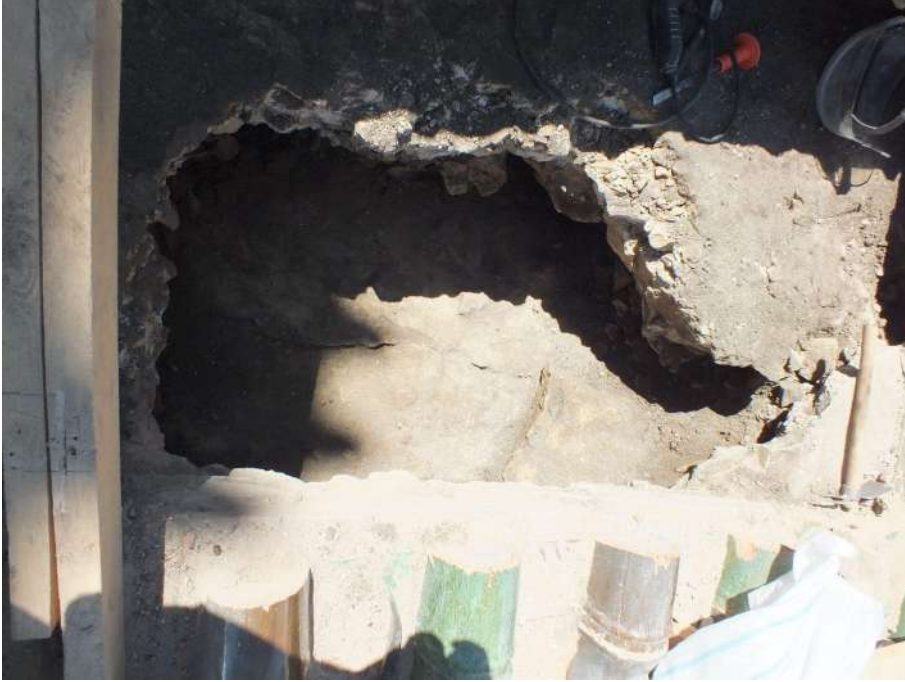
- Survey of the position of the fractures in the cross-section;
- Opening of the North side of the West Arm covering: the presence of a crack similar to that of the South side, but lesser extent, was revealed. On the North wall, the same problems found on the South wall are observed, albeit less extensive;

Northern wall of
West Arm.
Roof opening
operations: findings of
a longitudinal crack.

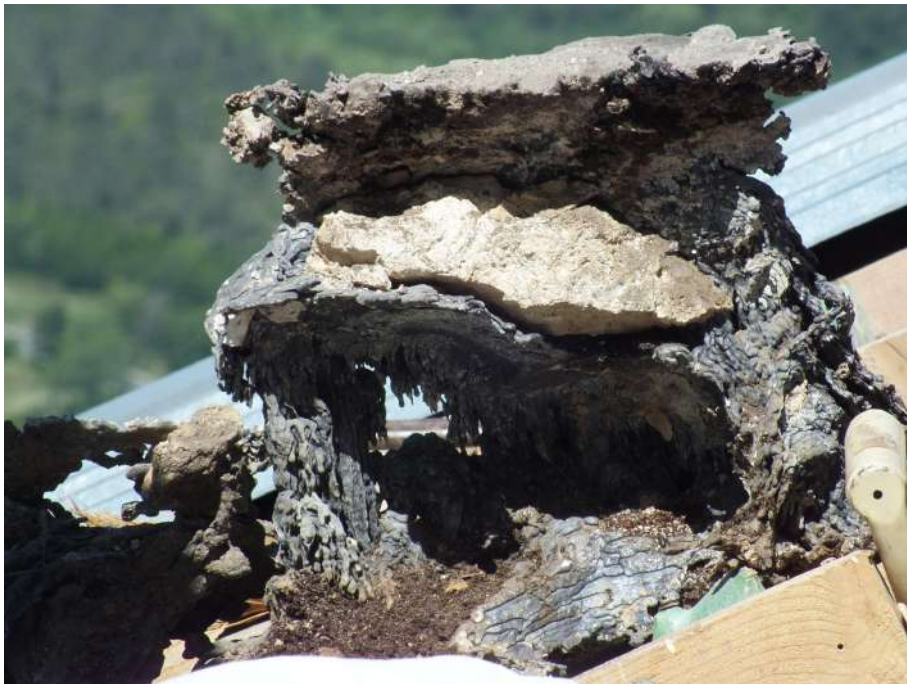
Molden lead block.

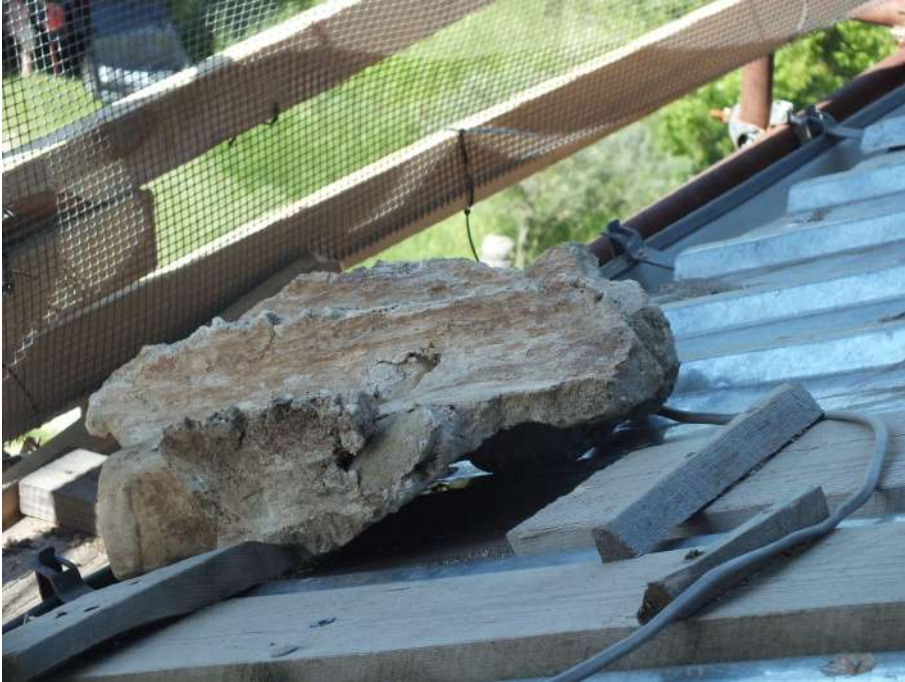
Ancient mortar filling with the imprint of timber.

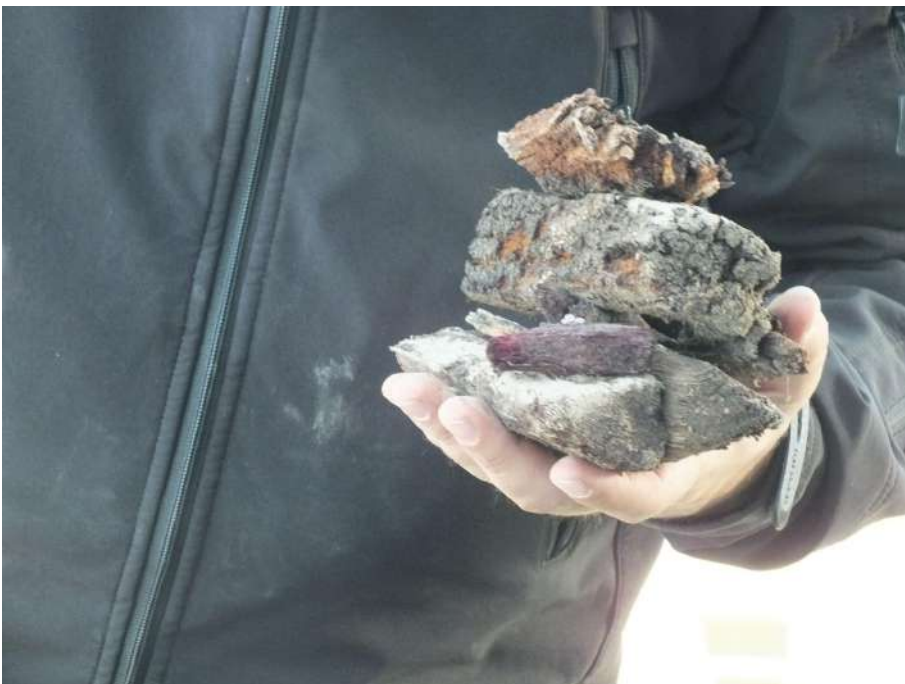
Wet burnt wood found during the opening.

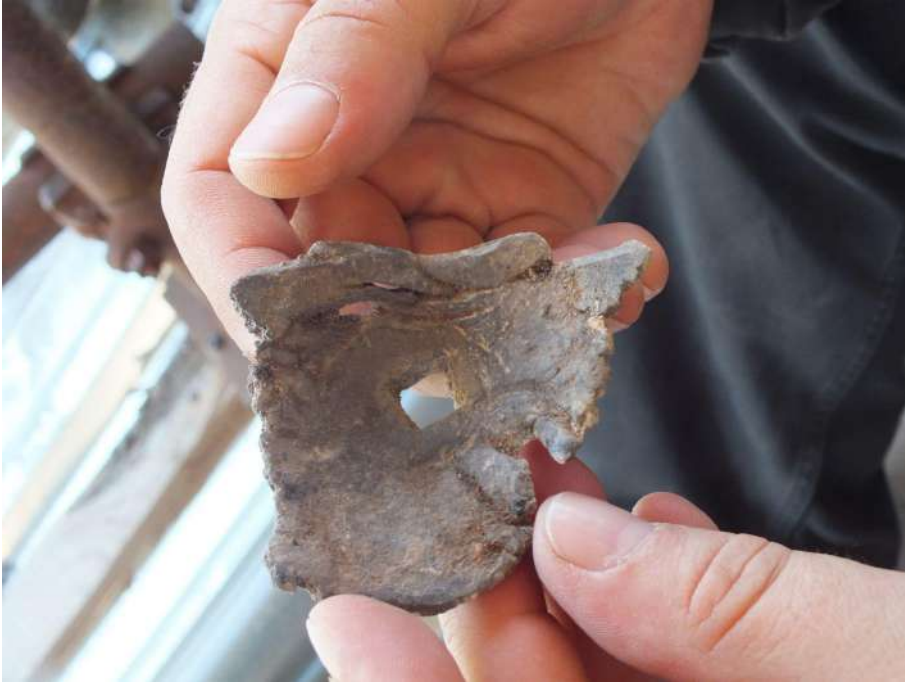
Lead with a nail hole.

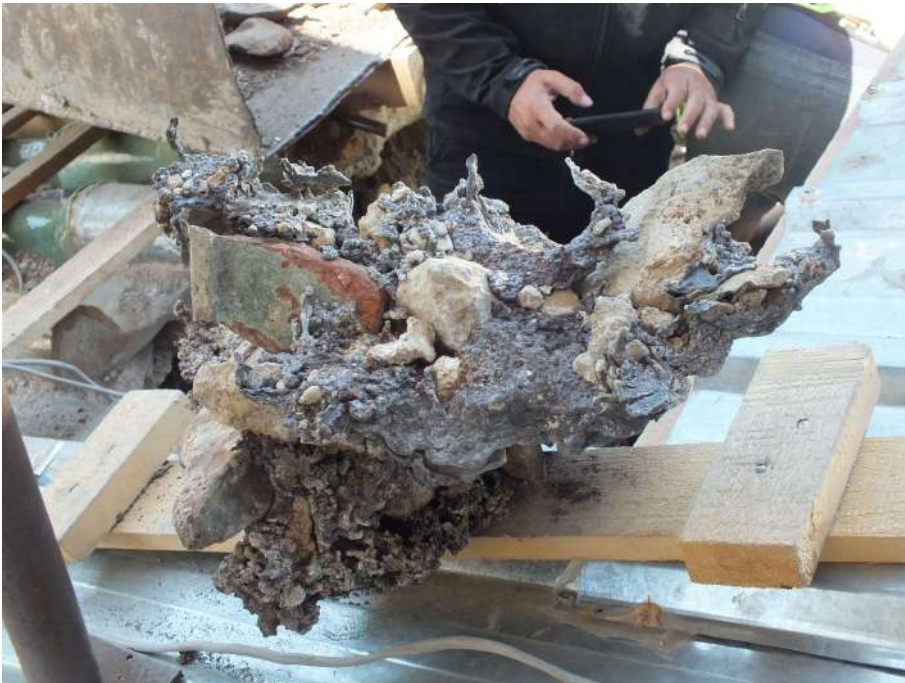
Molden lead block.

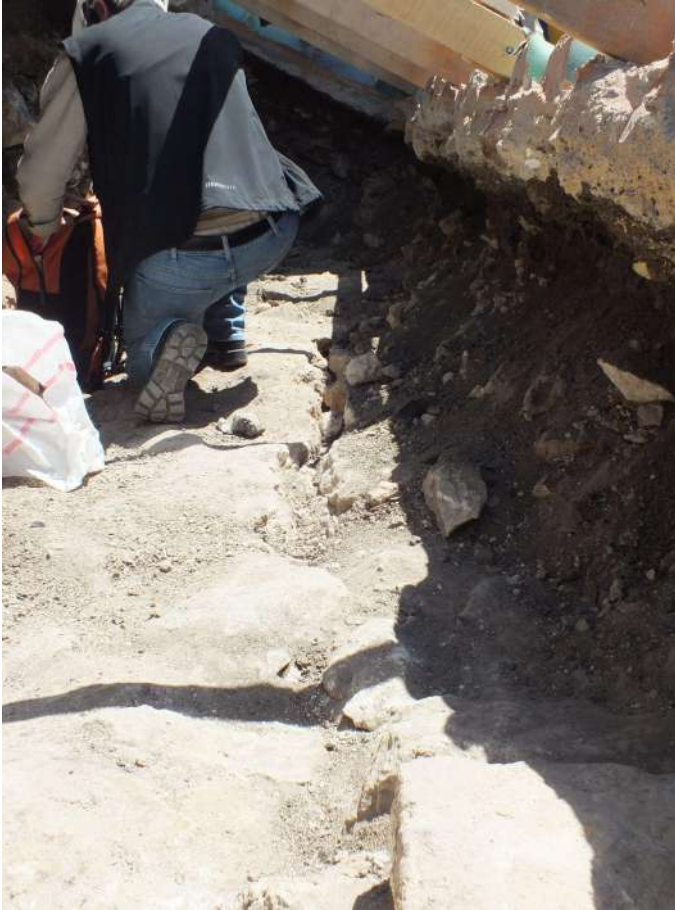
Southern wall of
West Arm.
Longitudinal crack on
the top of the wall.

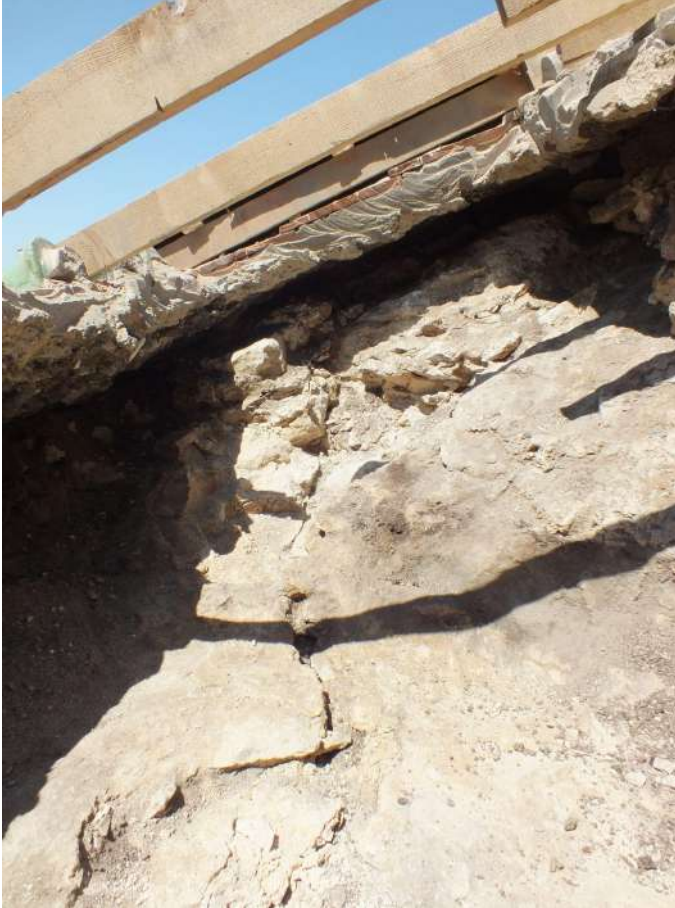
Southern wall of West Arm.
Longitudinal crack on the top of the wall.

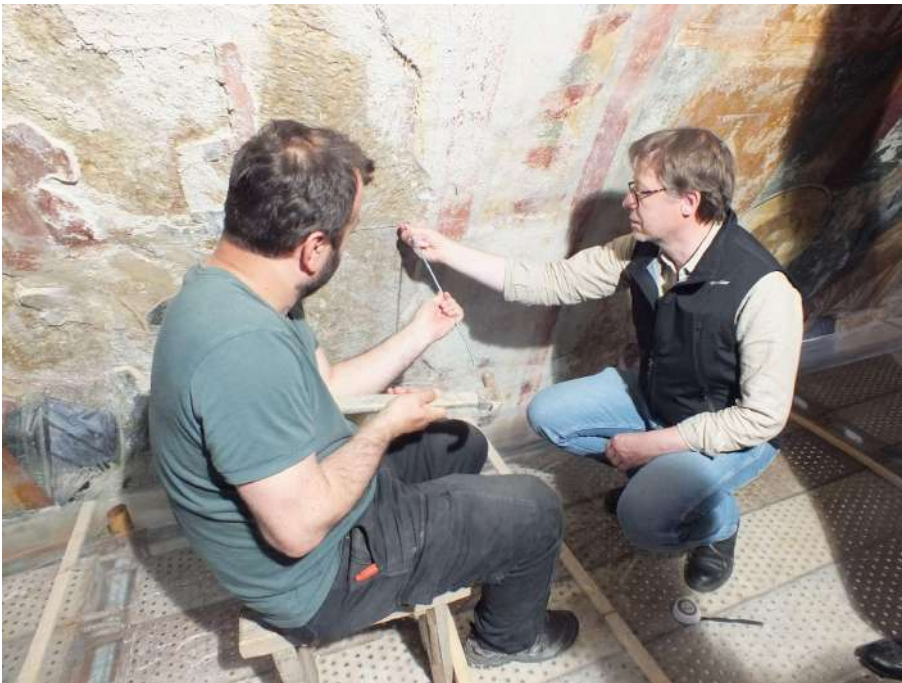
Northern wall of West Arm, interior.
Internal-external through hole in the masonry of the vault.

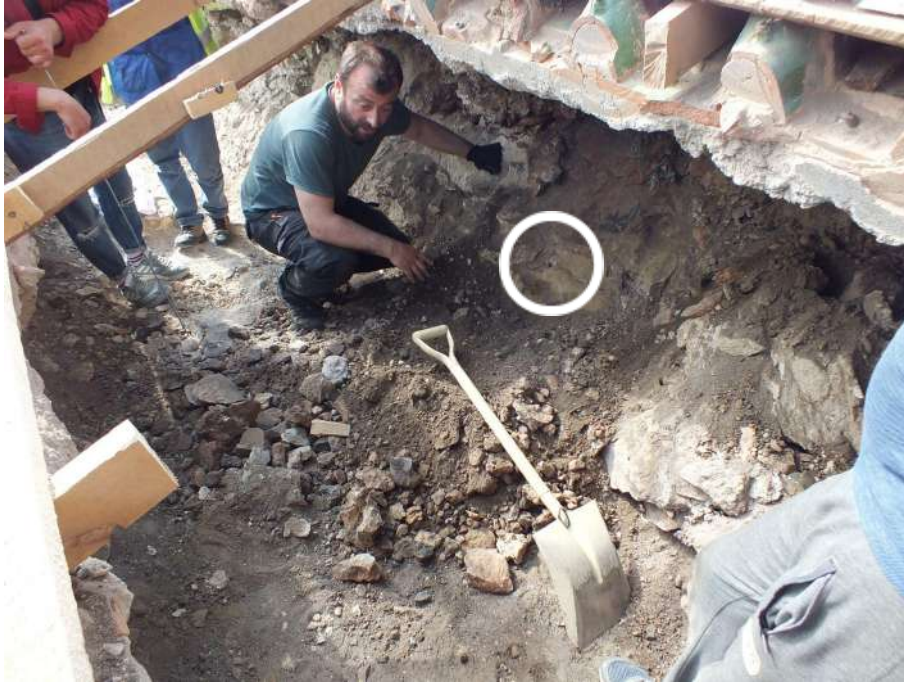
Northern wall of West Arm, extrados. Internal-external through hole in the masonry of the vault.

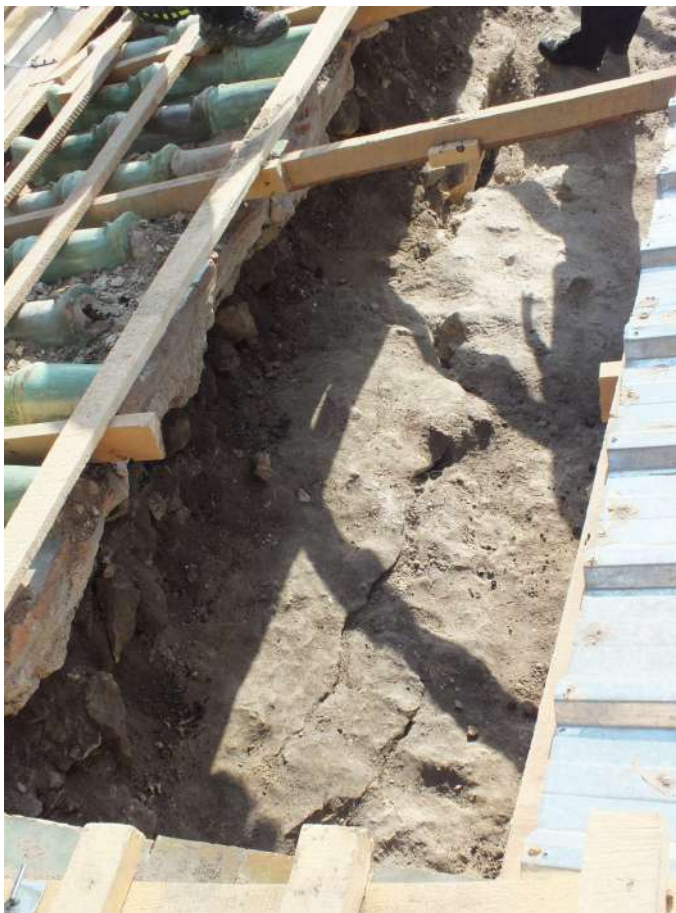
Southern wall of West Arm. Longitudinal crack on the top of the wall.

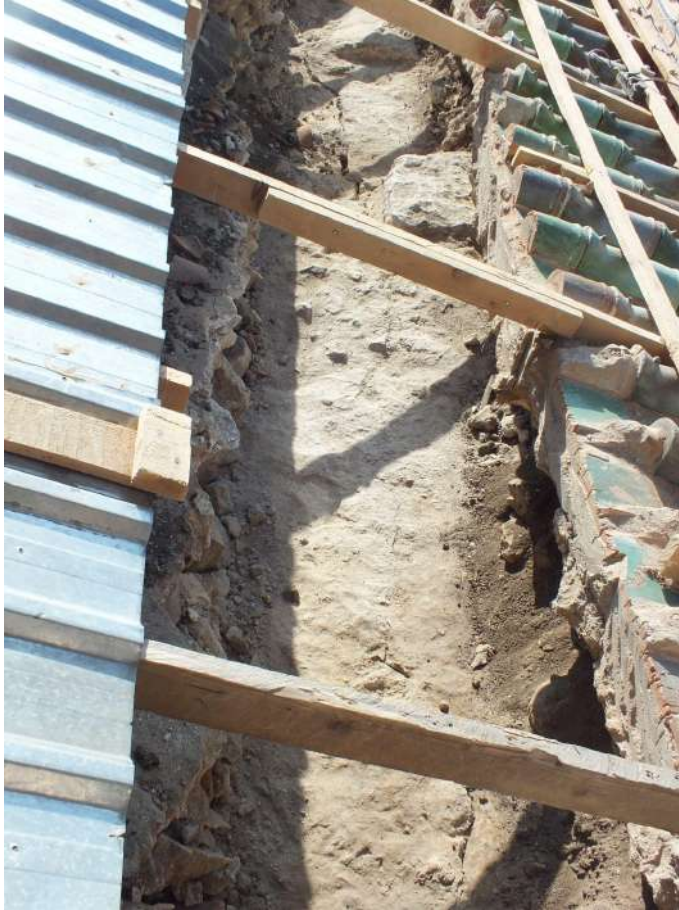
Northern wall of
West Arm.
Longitudinal crack on
the top of the wall.

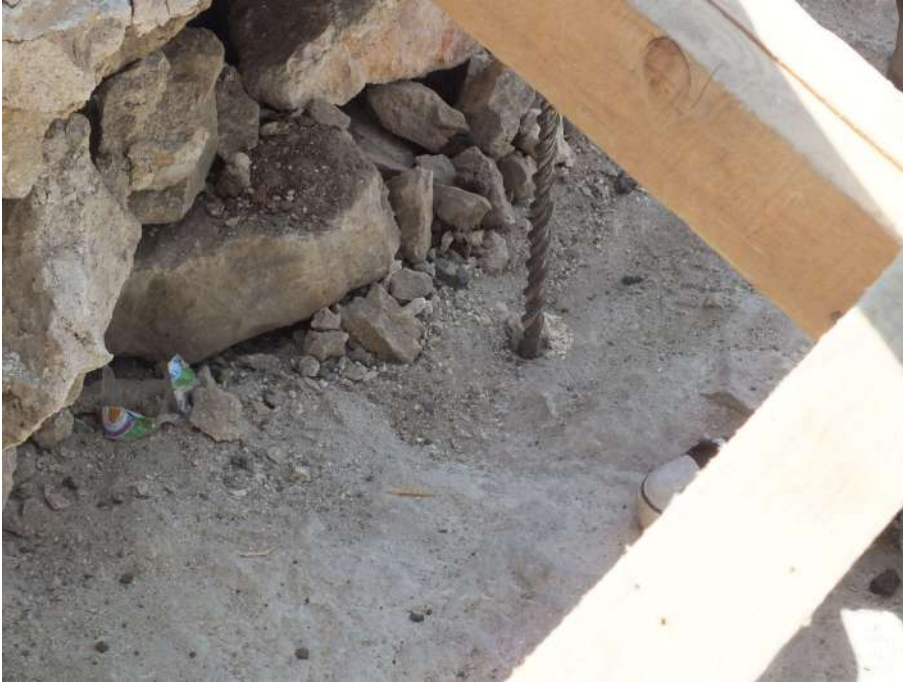
- To check the consistency of the core of the wall, holes are drilled on the North side wall of the West Arm. The consistency seems solid enough to be able to continue with the solution of the staples and to confirm the anchoring solution of the emergency temporary covering using an anchored metal beam.

Northern wall of West Arm.
Drilling a hole in the core of the wall.
