**Safeguarding and conservation of Gelati Monastery
World Heritage Property, Georgia**

***Agreement between LEPL "National Agency for Cultural Heritage Preservation of Georgia"
and "ReStruere ltd, Florence University spin-off"***

Deliverable 2

**Findings of the analysis: keynotes based on the results of the studies
conducted by RS and GET**

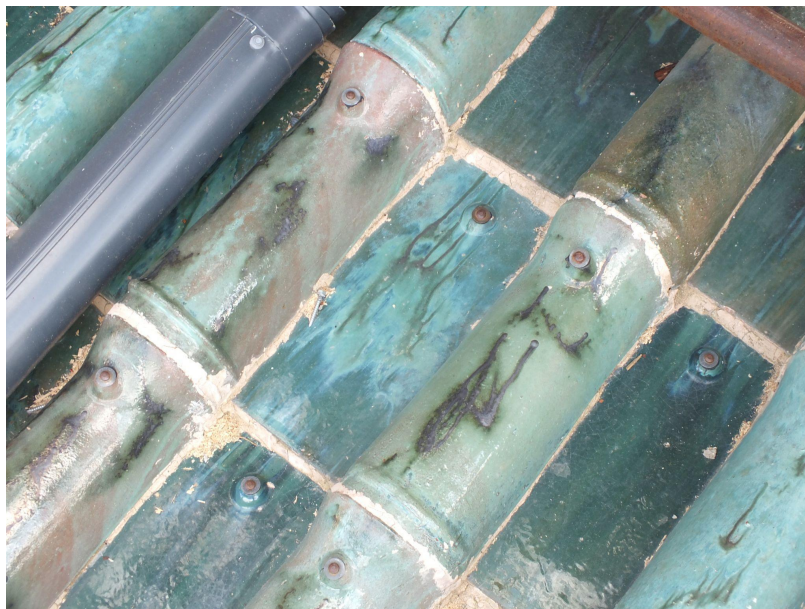
Glazed tiles (both white and red type). In addition to the obvious damage suffered by the material in a very short time (Figure 1), the tests carried out at CNR-ISPC showed how the used tiles could not guarantee effective protection from water infiltration because of their composition and inadequate cooking (see “*Test on material samples taken on-site. Scientific report explaining the results of the tests*”, December 2021).

Figure 1 - Damaged glazed tiles

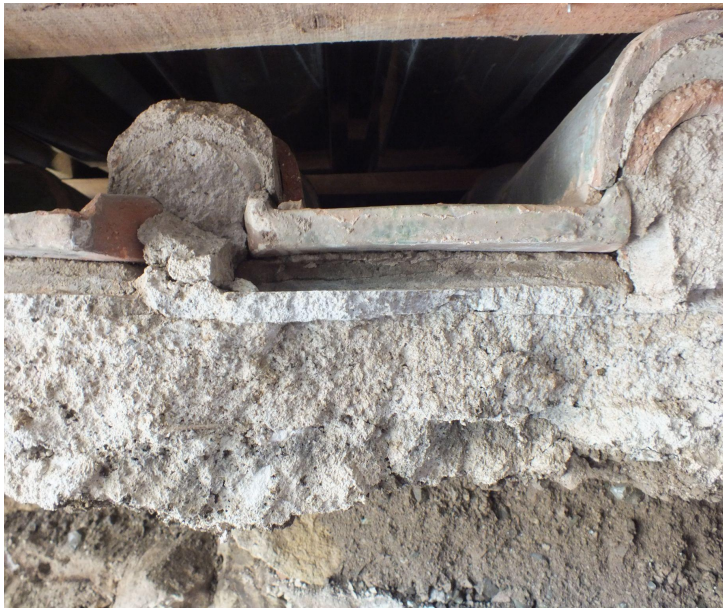
- b1. The whole tiled surface of the pitches has been placed directly on an uniform thick layer of lime mortar (Figure 2). This layer was made by a porous mortar (as lime is), capable of absorbing a lot of water. The entire tiled surface was conceived as a stiff body, unable to allow the necessary small relative movements useful under thermic exposition. In addition, the ridges follow such a technique too (Figure 3).

Figure 2 - Thick layer of mortar insert during the last intervention. It is possible to see that in this pitch (belonging to the West Arm) there is no insulation layer;

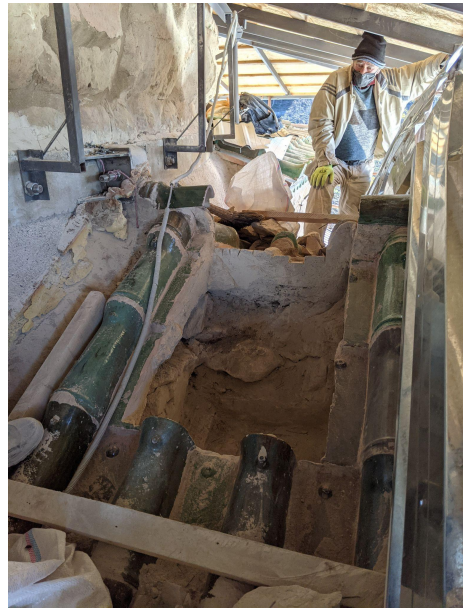
Figure 3 - Particular of the ridge: also here there is a thick layer of mortar under the glazed tiles.

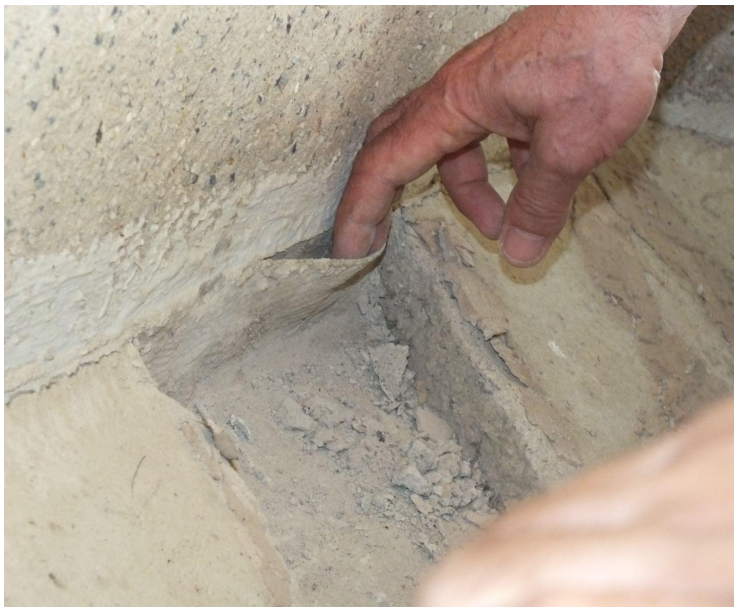
Figure 4 - Connection between the insulation layer and the vertical wall: the insulation is tucked up by just a few centimetres, insufficient for effective insulation.

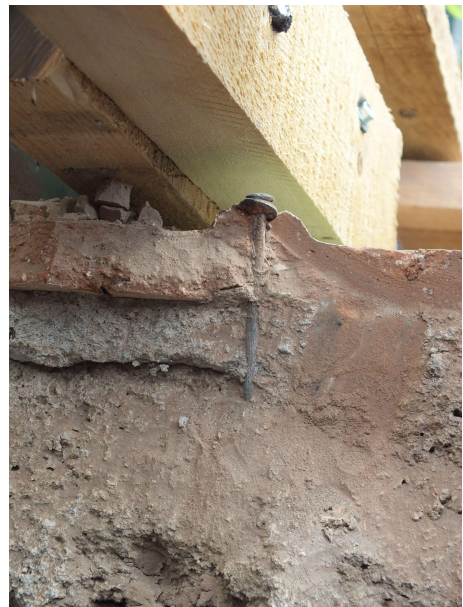
- b2. In some pitches, no insulation layer, able to protect the under-roof from the infiltration, is installed (Figure 2). However, even where some kind of insulation is present, both the material (quantity and thickness) and the installation are defective, in particular as concerns the connection line between the top of the pitches and the vertical surface of the stone-made walls on which the pitches rest (Figure 4). Furthermore, the nails, with which the tiles are anchored to the mortar layer, penetrate the isolation layer making it ineffective (Figure 5).

Figure 5 - Nail that pierces the mortar layer. In this pitch (West Arm) there is no insulating layer; if there had been, as happens in other pitches, it would have been perforated.

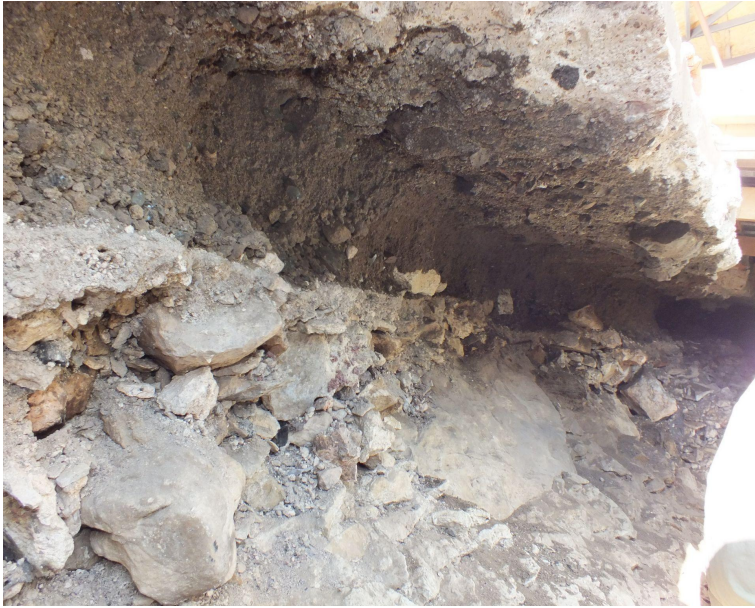
- b3. Since the tiles covering layer does not exhibit autonomous support, it is forced to lean against the filling of the under-roof making ventilation solutions essentially impractical. Furthermore, the large quantity of the (variable) filling material of the under roofs, absorbing the water transferred from the tiles layer, constituted a reservoir of humidity, with devastating consequences for the life of the frescoes below (Figures 6 and 7).

Figure 6 - Roof stratigraphy: it is possible to see the wet filling under the mortar layer.

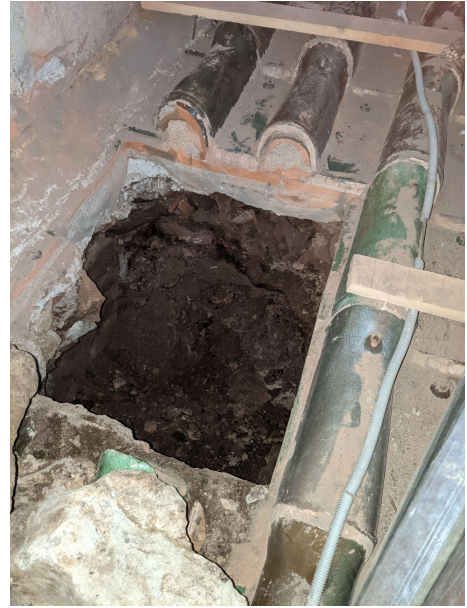
Figure 7 - Sondage carried out during autumn 2021: here also it is possible to see the wet filling.

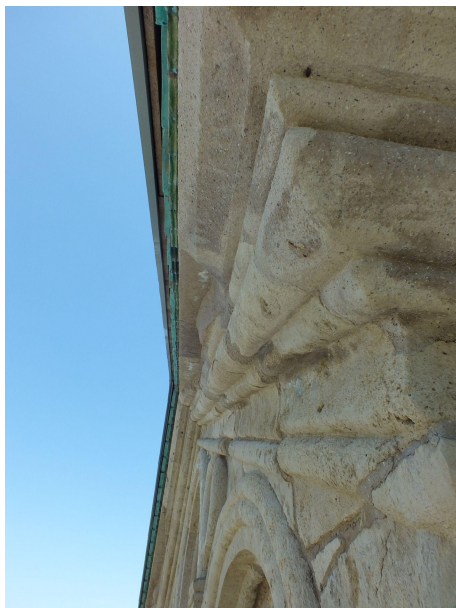
- c1. The roofing of the pitches does not have sufficient overhangs to guarantee the protection of the cornices and other parts of the stonewalls (Figures 8 and 9);
- c2. There are no specific protection devices on the intersection surfaces between the pitches and the vertical walls or in coincidence with the valley where the risk of infiltration is greater (such as flashings) (Figure 10);
- c3. The absence of devices useful for the collection and channelling of rainwater (gutter and downpipes) is assessable as a cause of the damage and deterioration to the masonry walls of the monastery (Figure 11). This item includes the broader one of the transmission system of the rain from the roof to the ground and the subsequent removal from the foot of the building. Consequences of this deficiency concern the phenomenon of rising water by capillarity at the floor level too.

Figure 8 - Insufficient overhang of the roof in the West Arm facade.

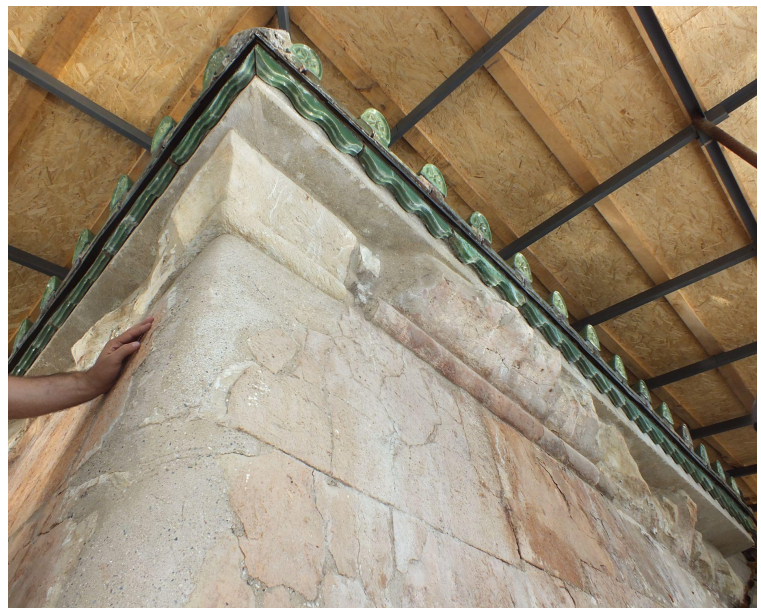
Figure 9 - Particular of the pitches at the base of the drum: here the cornice protrudes more than the pitch.

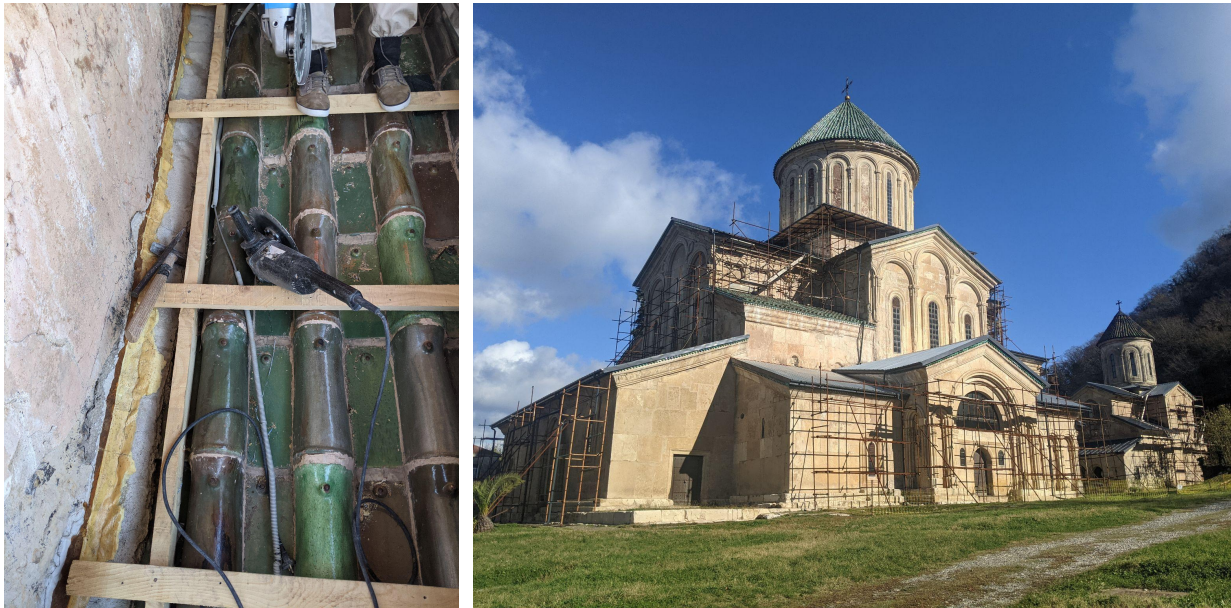
Figure 10 - Absence of flashing at the intersection between the pitch and the vertical wall;
 Figure 11 - Absence of gutter and downpipes in the Monastery.

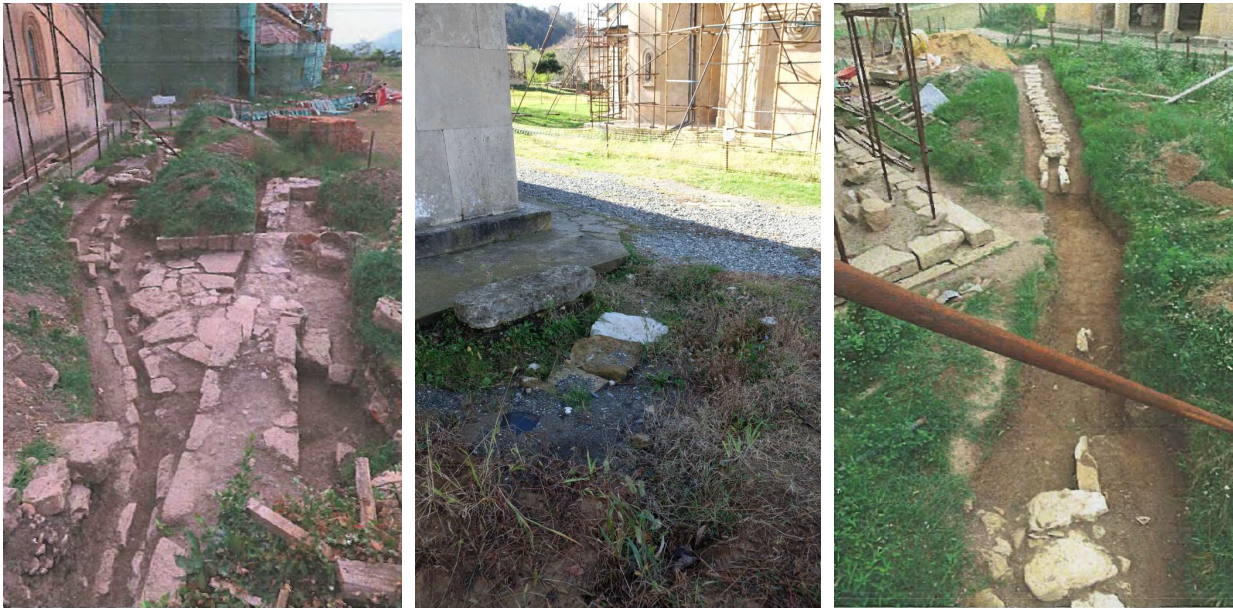
Figure 16 - The ancient water drainage system near Saint George (from DCR Ph Report);
 Figure 17 - Partially visible drainage channel on the Northside of St. George (from MCT SG report);
 Figure 18 - The ancient water drainage system near the Virgin Church apses (from DCR Ph Report).

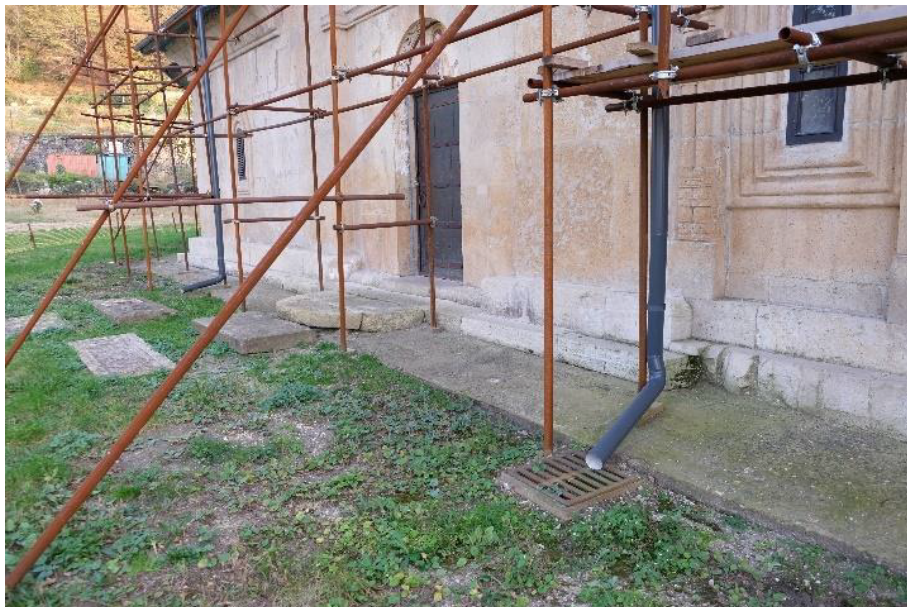
Figure 19 - Detail view of downpipe d15 with manhole sm 9 (from MCT report).

Regarding the connection between the Virgin Church and the terrain, the building rests on a stepped stone plinth. Only a modest conglomerate sidewalk protects the base of the external walls. As explained in the MCT report, regrettably, for years large amounts of water have been let run freely on structures such as the plinth and the sidewalk from the above roofs. This led to infiltration and capillary rising damp phenomena considerably more severe than the current ones. Thus, it is evident that the sidewalk surrounding the church is inadequate in the instances of copious exterior water flow (Figure 19).

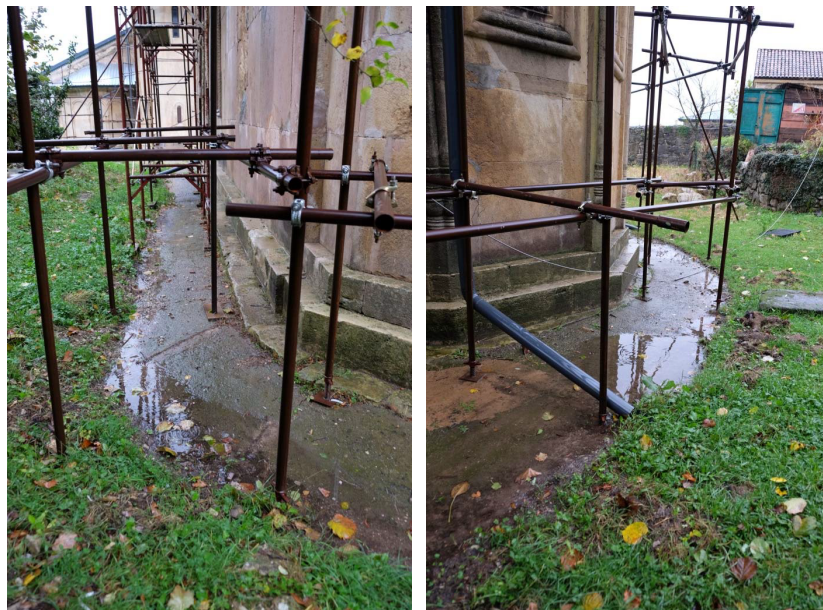
The situation appears more serious as regards St. George Church. Also here a stepped plinth connects the Church to the ground and there is a modest conglomerate sidewalk along the entire perimeter. However, here there is not a sewage network outwards with sewer manholes, but, as described in “*Church of St George - Preliminary investigations on the structural hygrometric - Missions Arch. Alessandro Massari of 06 – 12/11/2021 and 28/06 – 01/07/2022*”, June 2022 (MCT SG report), “the water is discharged, with temporary pipes, immediately beyond the conglomerate pavement surrounding the small building where, due to the slope of the surrounding ground, it accumulates, flooding the pavement itself”. The water stagnations along the outer perimeter of St. George are particularly abundant along the South and East sides (Figures 20 and 21) due to water coming in from the roofs and from higher elevations - in fact, there is terracing supported by a low stone wall along the East and South sides, but the space between the Church and the terracing has irregular slopes that are not suitable for regular water drainage. The serious situation on the ground outside affects the internal conditions. In fact, the walls exhibit moisture from the ground up to 1.5 - 2 meters with consequent damage to the paintings (Figures 22 and 23). For a detailed description refer to MCT SG report, accompanied by *Technical sheets regarding the Hygrometric Survey*’.

Figures 20 and 21 - Views of water stagnations along the outer perimeter of St. George, particularly abundant along the South and East sides due to water also coming in from the roofs (from MCT SG report).

In St. George the treatment of the water carried to the ground by the downpipes is not correct as it leads to water stagnation at the base of the Church. While awaiting the construction of the new roof and the integrated water drainage system, interventions to protect the structure are considered necessary (MCT SG report), such as:

- to shaping of the ground slopes so as to divert the dispersed surface water away from the building with the creation of small terraces where the slope of the ground towards the building is too steep and collection of surface water with gutters;
- restoration of the exterior sidewalk or resurfacing of the same.

Moreover, it is necessary to install a water drainage system similar to that that was created for the Virgin Church consisting of sewer manholes and a sewage network outward.

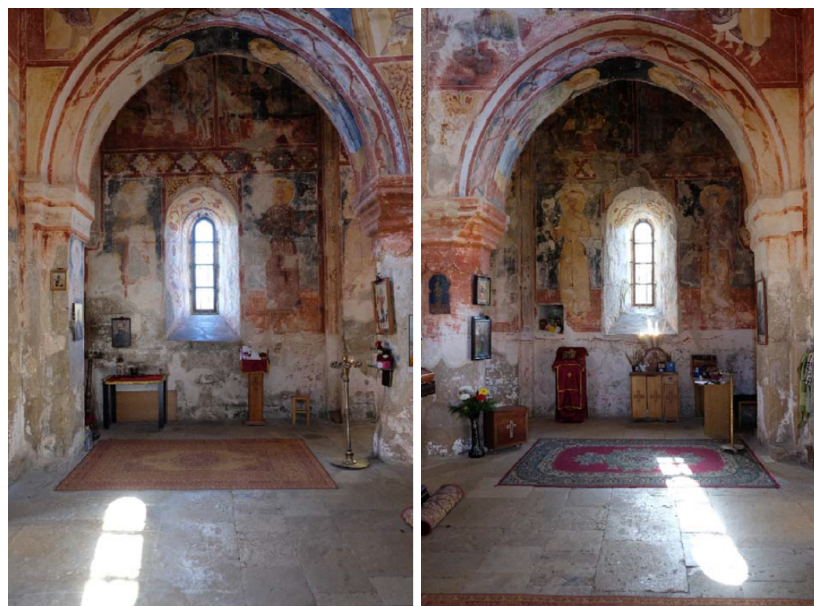
Figures 22 and 23 - Views of the interior spaces of St. George with widespread damage to the paintings which are lost, for the most part, in the lower part (from MCT SG report).
