# გელათის სამონასტრო კომპლექსი Gelati Monastery Complex

**Condition report**  
**Result of meteorological  
disaster**

2024 February 5-6

Report 13/02/2024

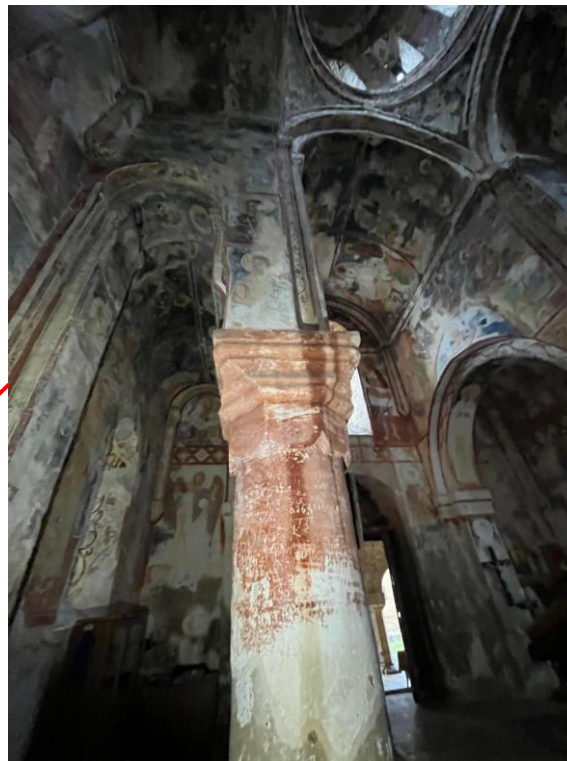
Date of image: 2024.02.06  
South-West column, stain of water

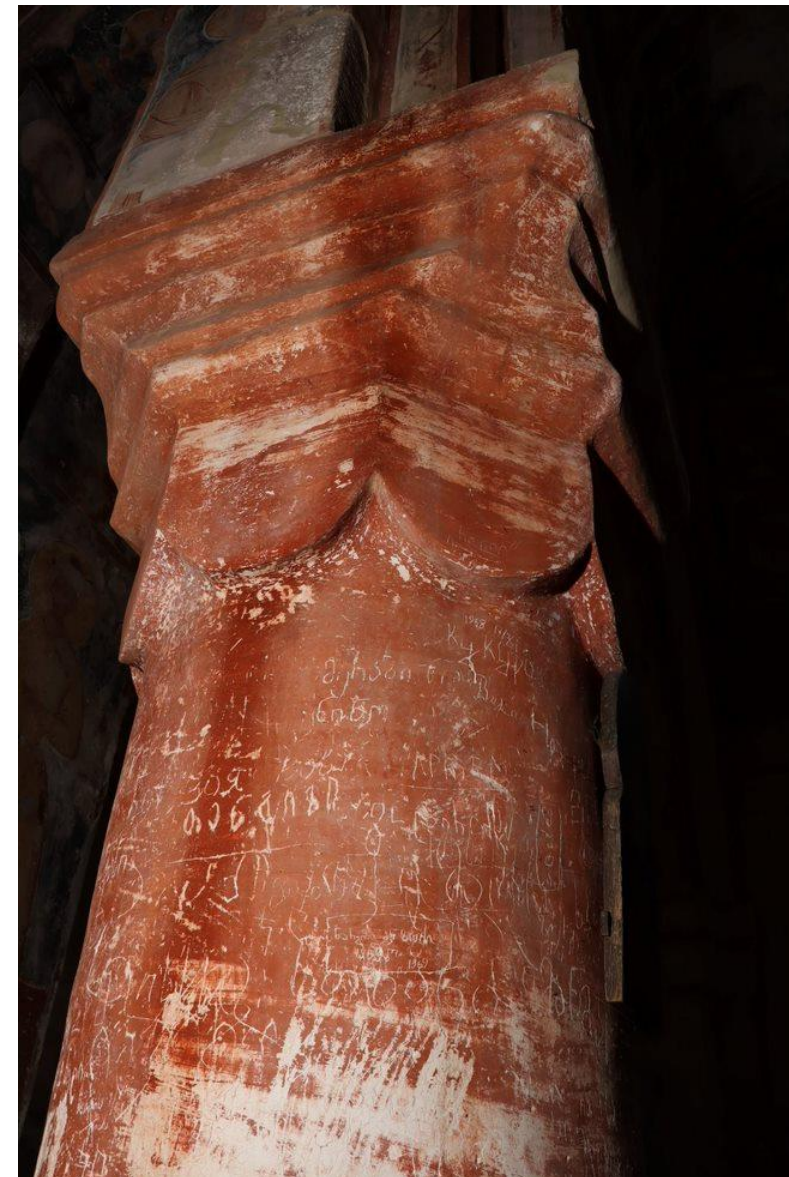
Date of image: 2024.02.08; South-West column, stain of water

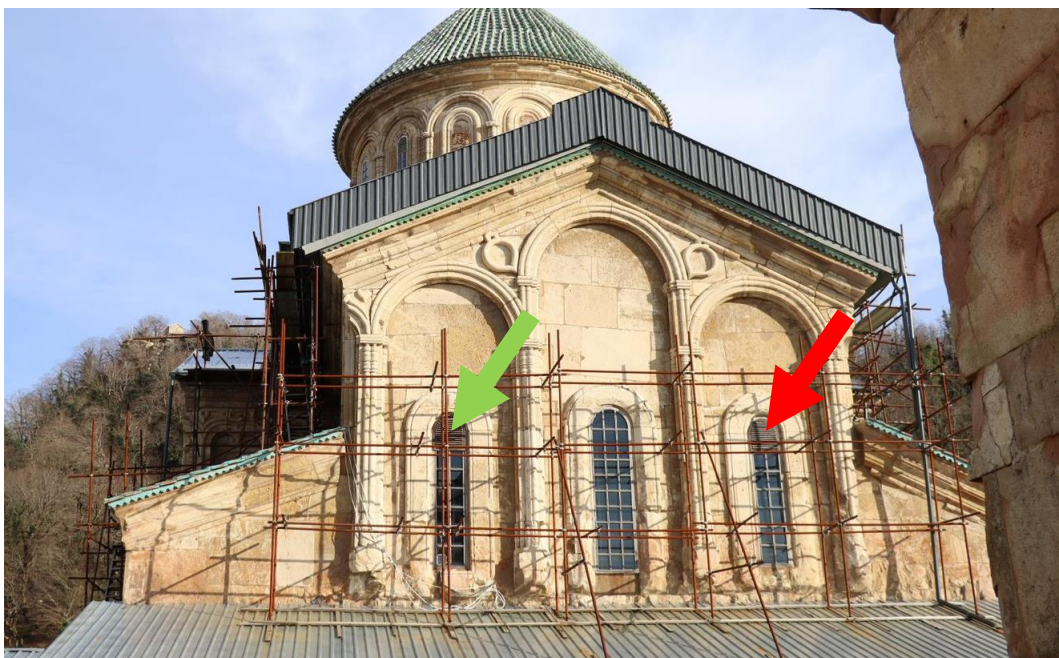
Western façade of the Church of the Nativity of the virgin Mary.

- Two of the western windows (on the south and north edges) have open wooden shutters on the upper part. Due to the strong wind and rain, open shutters have given access to the rainwater in the interior.

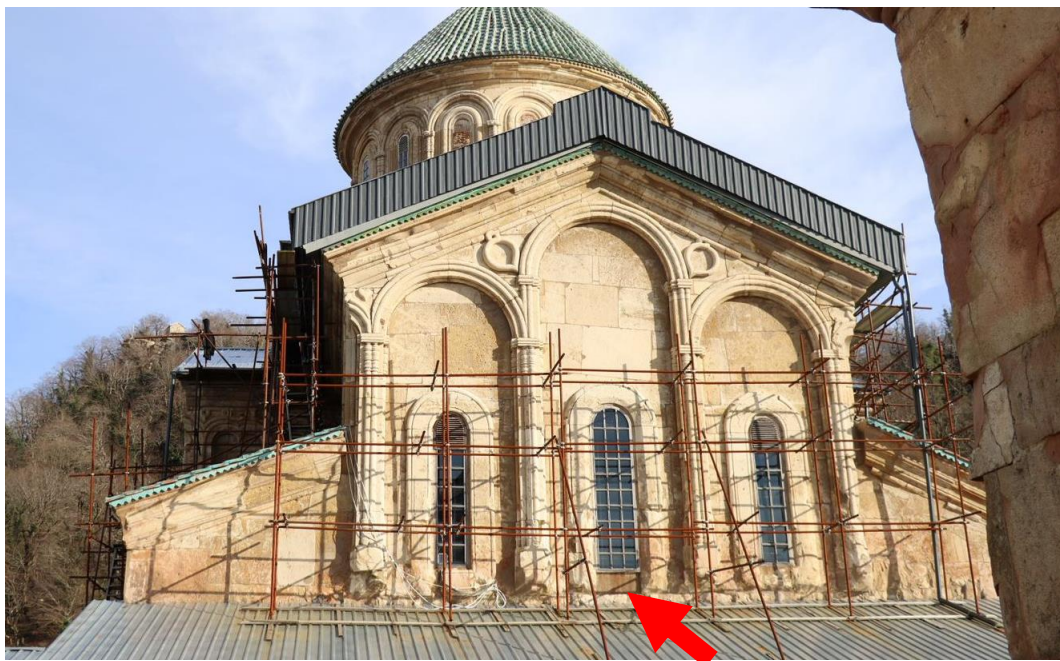
Western façade of the Church of the Nativity of the virgin Mary.

- The central western window of the main space of the west arm does not have a wooden shutter. However, there is a large lime-based fill material underneath the window on the façade. Visually similar fill material is also used in the inner part of the window. Probably, due to the hygroscopicity of the fill material, water has been absorbed from the façade and partly moisturised fill material of the window in the interior space.

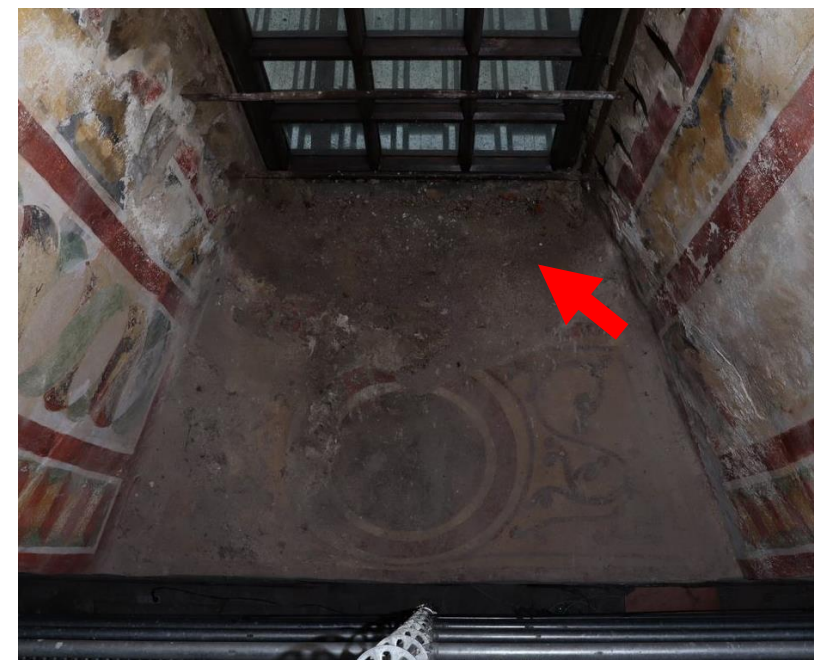
Fill material in the interior of the western window.

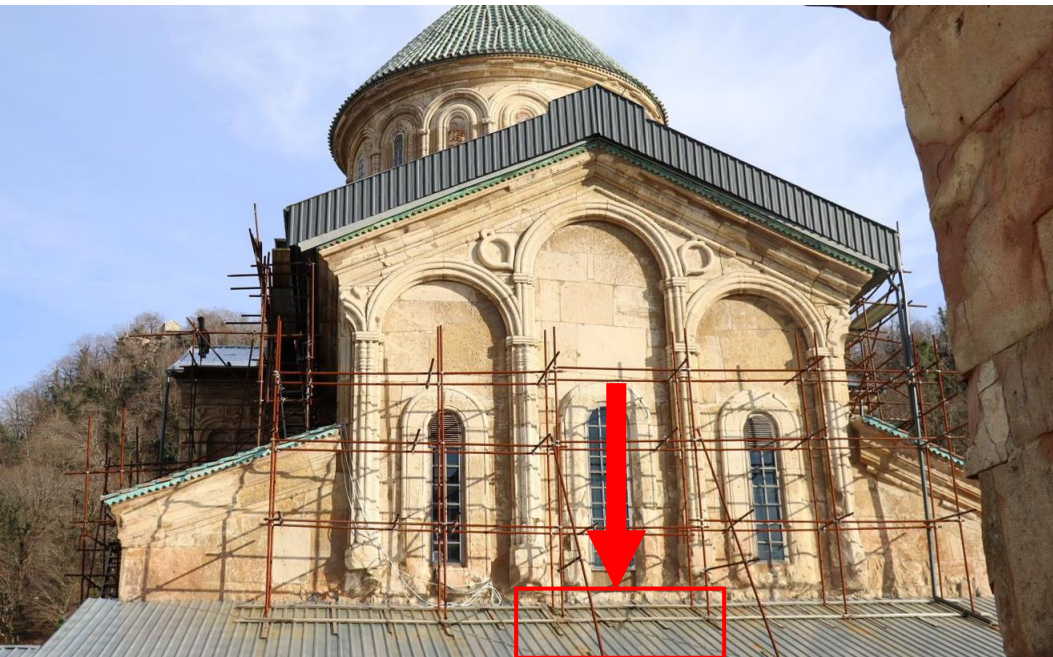
Western façade of the Church of the Nativity of the virgin Mary.

- The large amount of water has been infiltrated in the central part of the east wall of the narthex . Water has partly covered vault, walls and floor. Presumably, the water might have been infiltrated through the joint of the west arm of the main space and a roof of the narthex.

Below on left the image: The façade of the main church. The red marks mentions possible locations of the infiltration. On the right images: the wall paintings of the east wall of the narthex - the interior part of the mentioned locations.

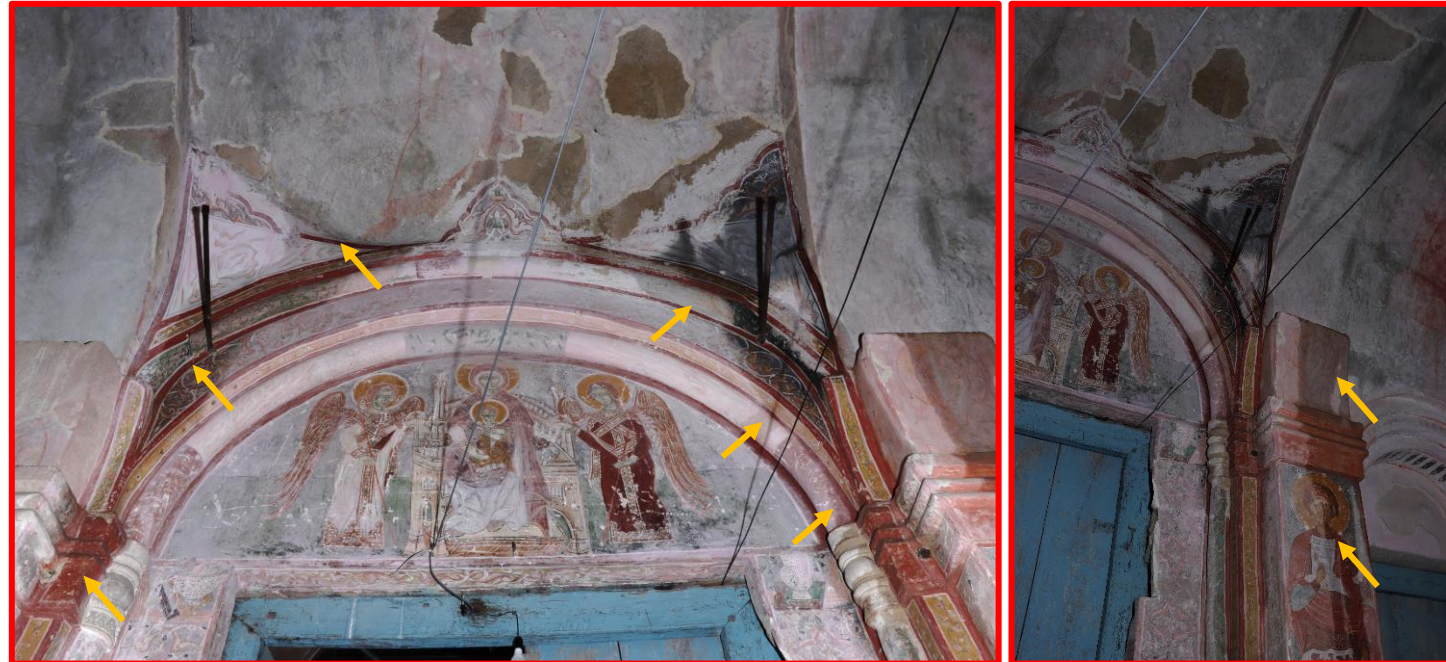
The east wall and vault of the narthex. Locations of water infiltration are marked with yellow arrows.

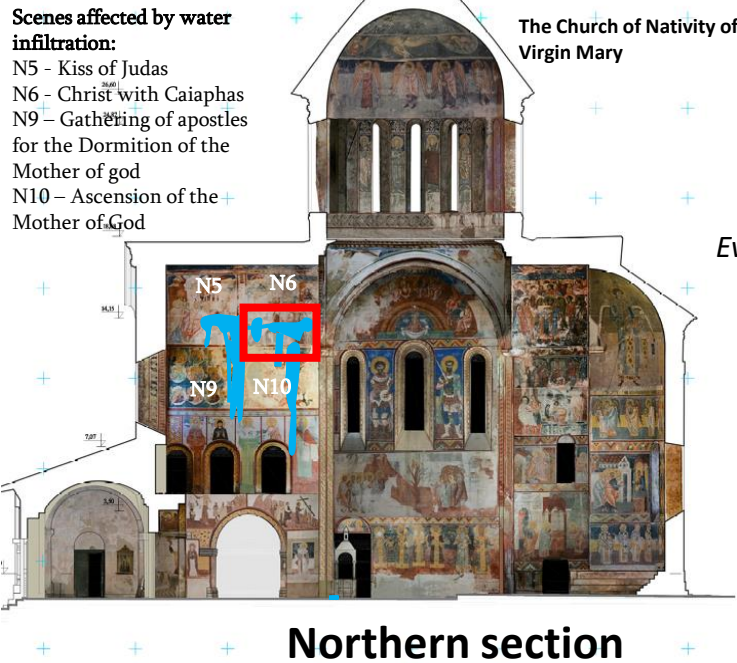
- წყლის ძლიერი ნაკადი დაფიქსირდა კამარის დონეზე (მეოთხე რეგისტრი) ქრისტე კაიფას (N6) სცენასა და დასავლეთ კამარის ჩრდილოეთ კუთხეში - ორნამენტულ თაღში. წყლის ნაკადი გრავიტაციული გზებით უმატესად ქვედა რეგისტრებზე ჩაედინა.

*On the left:  
Main space, vault of the west arm, northern part of arch.  
Evidence of the liquid water flow*

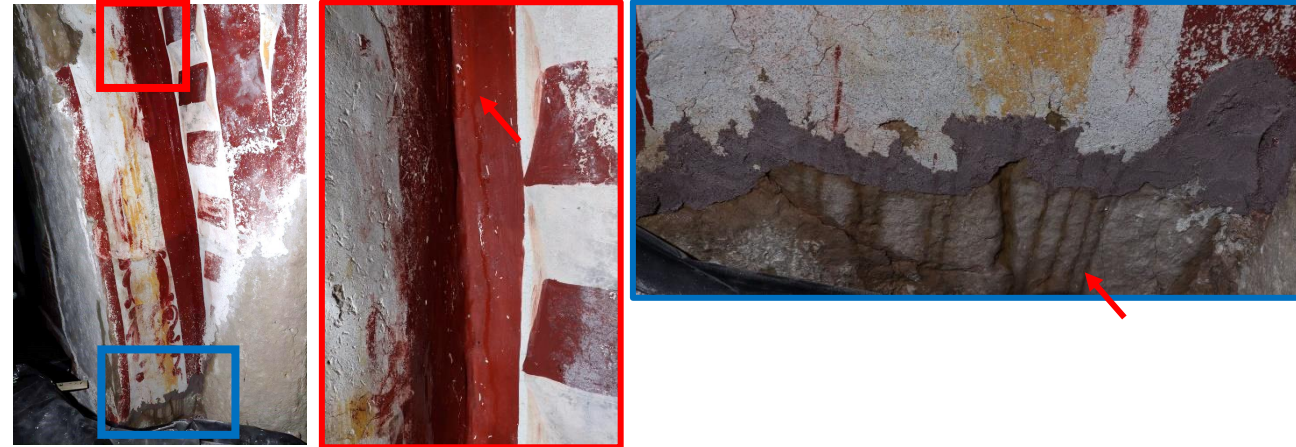
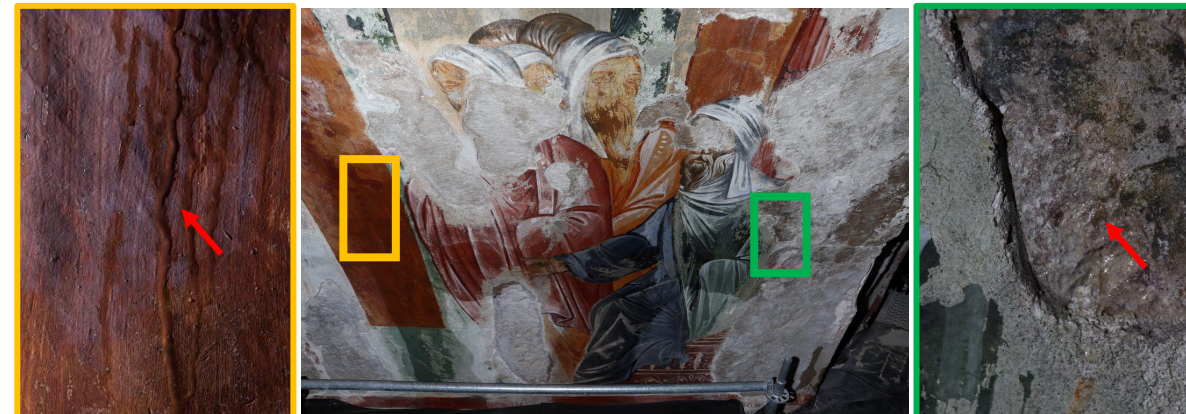
*On the left:  
Main space, vault of the west arm, northern wall, scene N6.  
Evidence of the liquid water flow on the two spots (see red arrows)*

- Water flow has been observed on the vault level (the fourth tier) on the scene of the Christ with Caiaphas (N6) and the north corner of the west arm arch. The flow went on the lower tiers though gravitation.

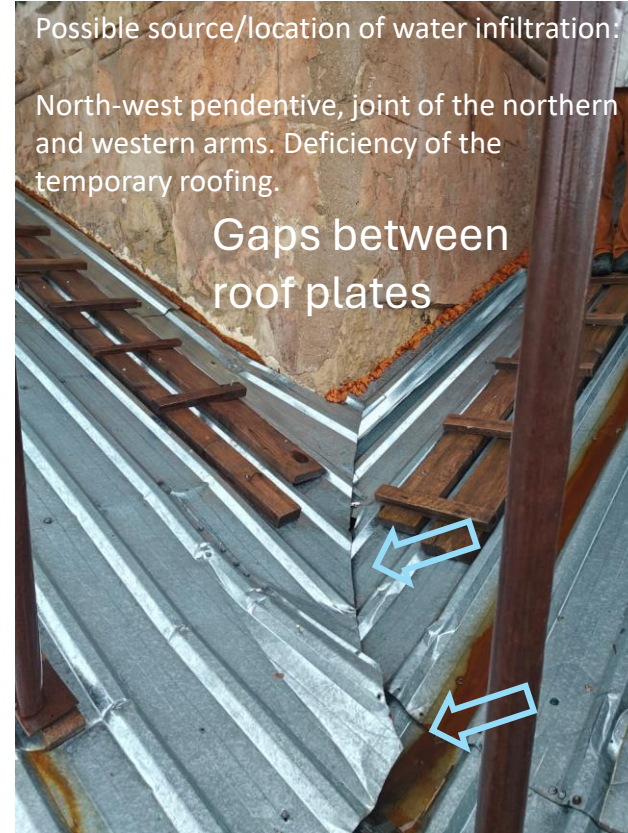
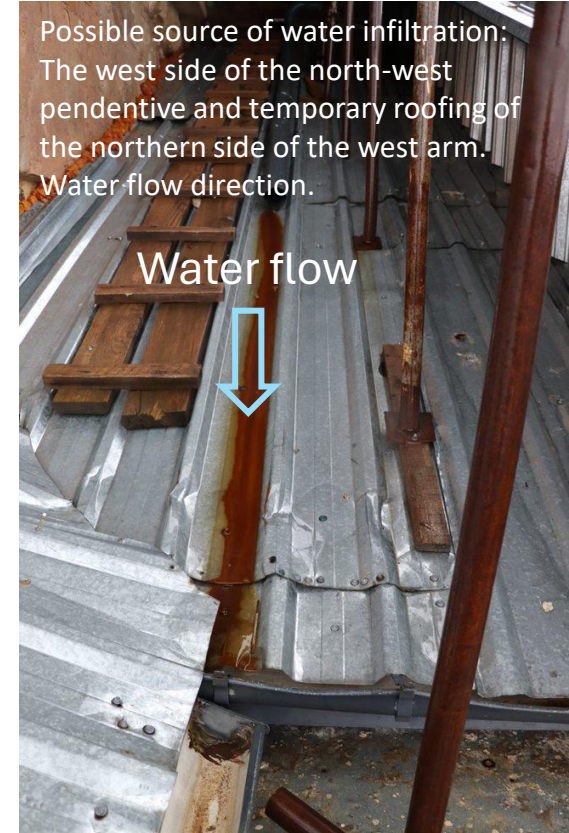
Below yellow arrows points at the location of the water flow from the interior space (scene N6). The red arrow and frame point at the location of the scene from the northern façade of the west arm. On the right, images represents the temporary roofing of the west and north arms. Blue arrows show direction of the water flow and gaps between roofings, which might be possible source of water infiltration.

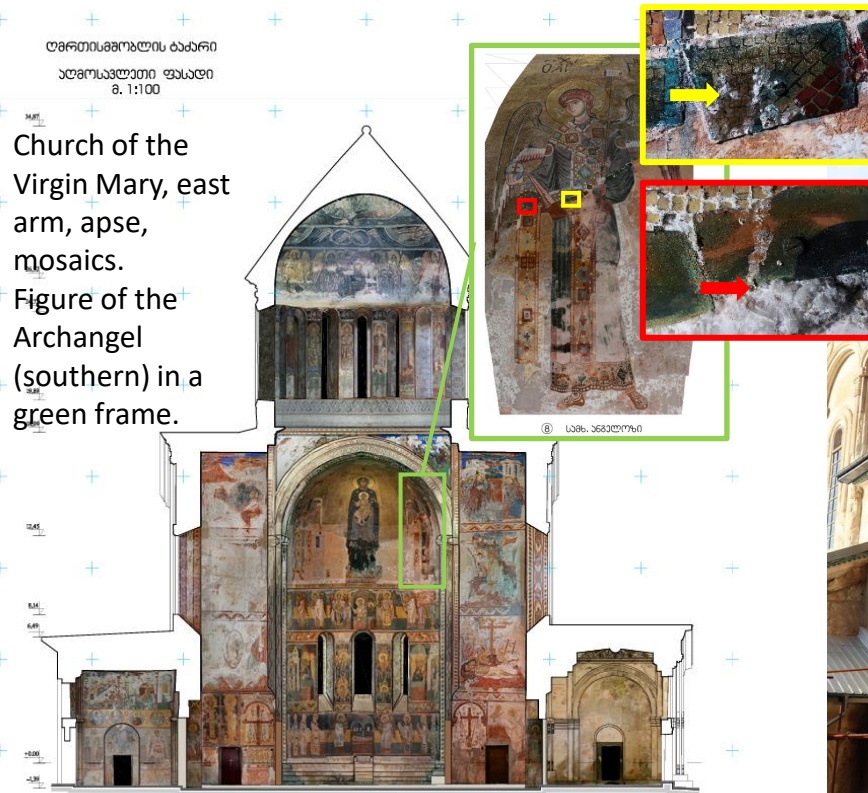
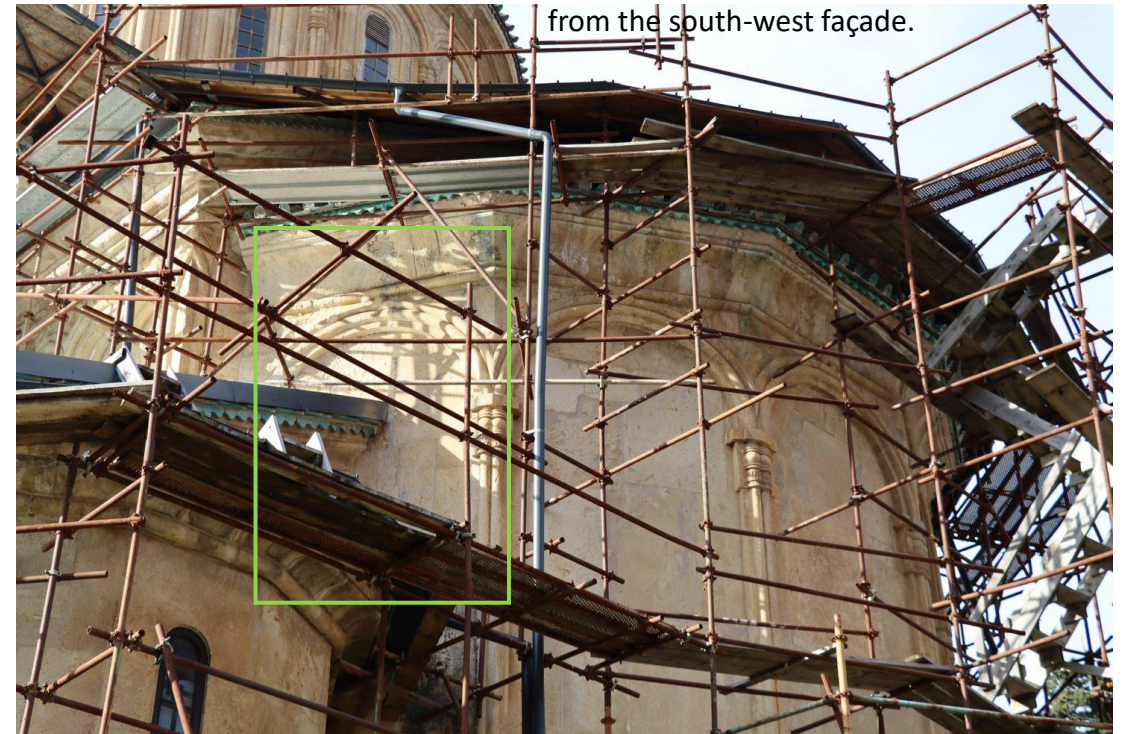
Location of southern archangel from the south-west façade.

Few droplets of the water have been observed on the metal attachments (pins) of the mosaics at the southern archangel's figure on the west arm of the main space (see yellow and red marks).

- The two droplets (one on each plate) of the water could be result of condensation or water infiltration, however, it should be noted that water infiltration has not been visually observed during the assessment,

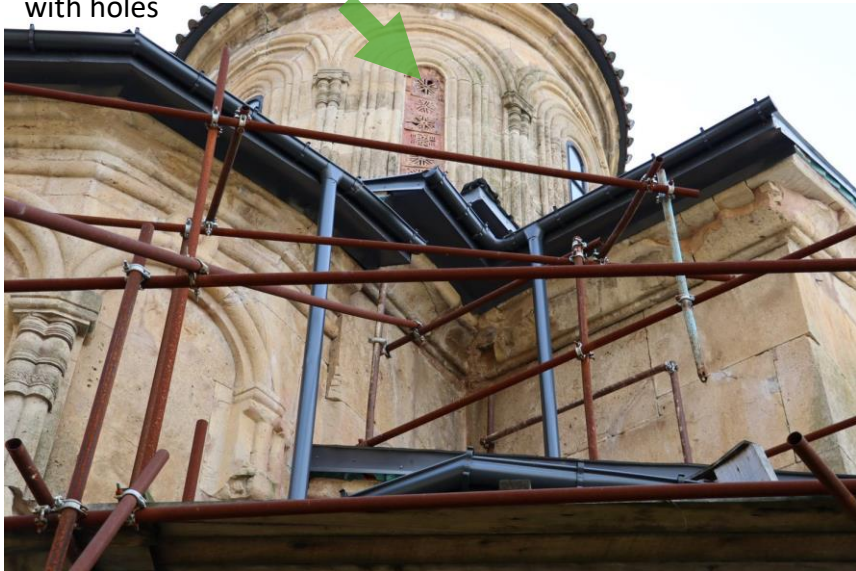
St. George,, dome north-east window made of ceramic tiles with holes

Original ceramic shutter with decorative openings

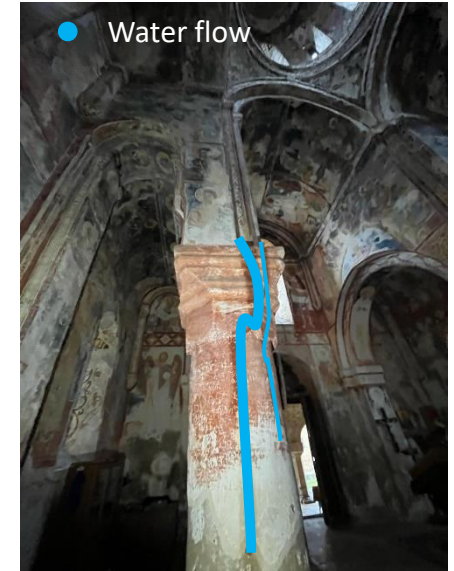
Water flow from the height of 3.4 m, from the capital of the column.

Water has been observed at the main space, on the south-west column. The water flow came from capital of the column (3.4 m height) and followed the eastern side of the shaft.

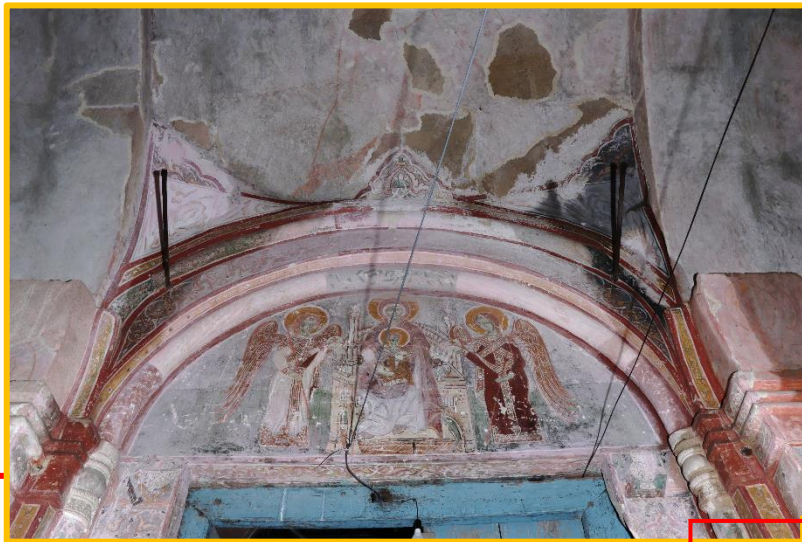
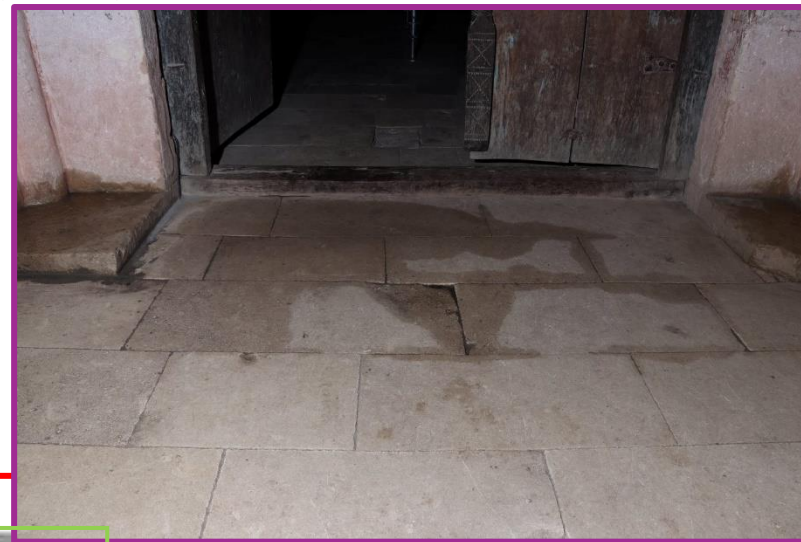
The Church of Nativity of Virgin Mary, Narthex (Western entrance), Interior wall paintings affected by rainwater.

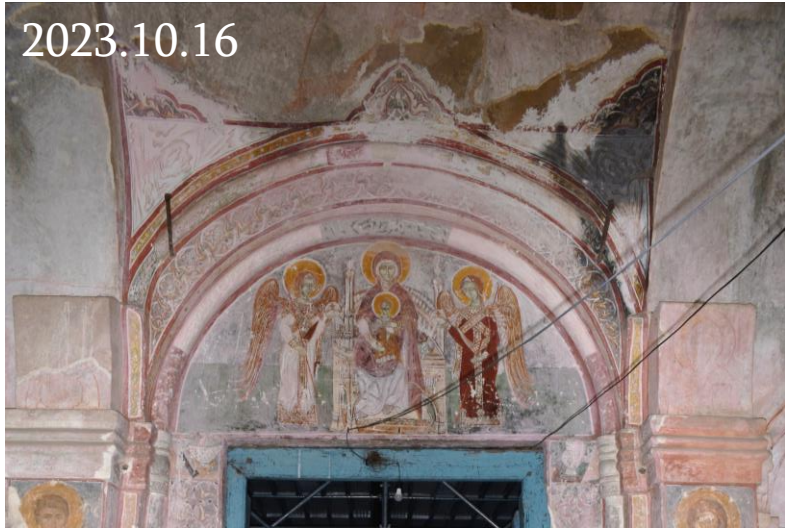
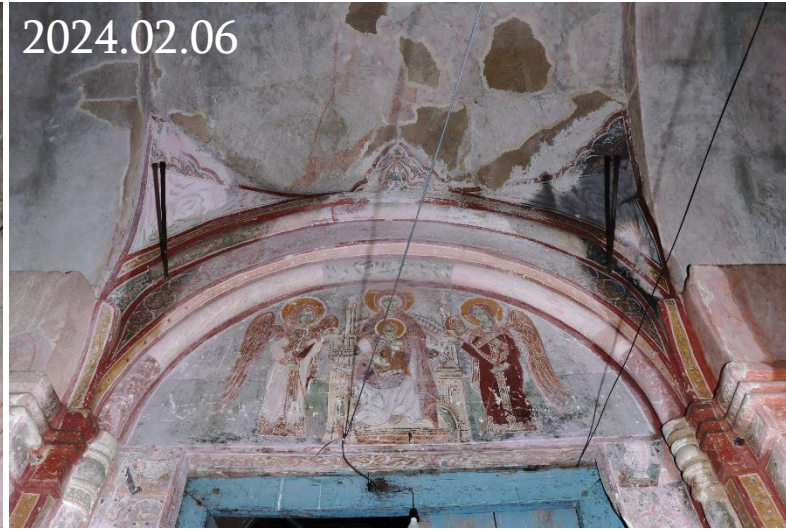
The Church of Nativity of Virgin Mary – Narthex. Images from 2023 and 2024, effect of the rainwater.

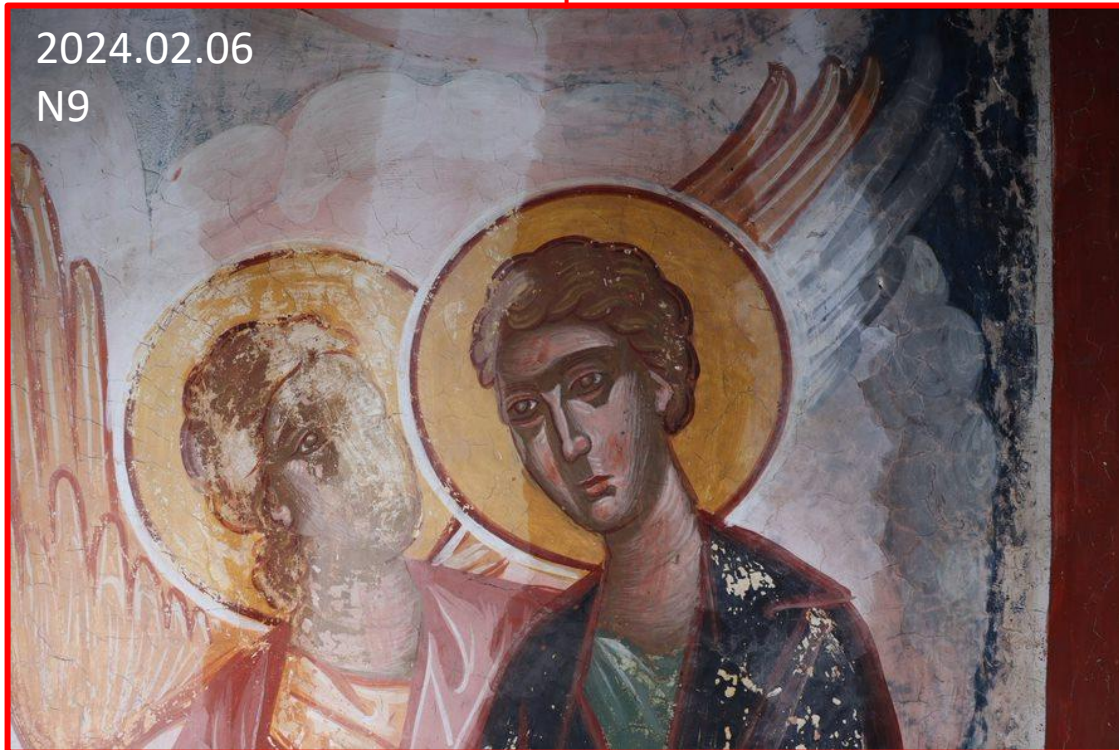
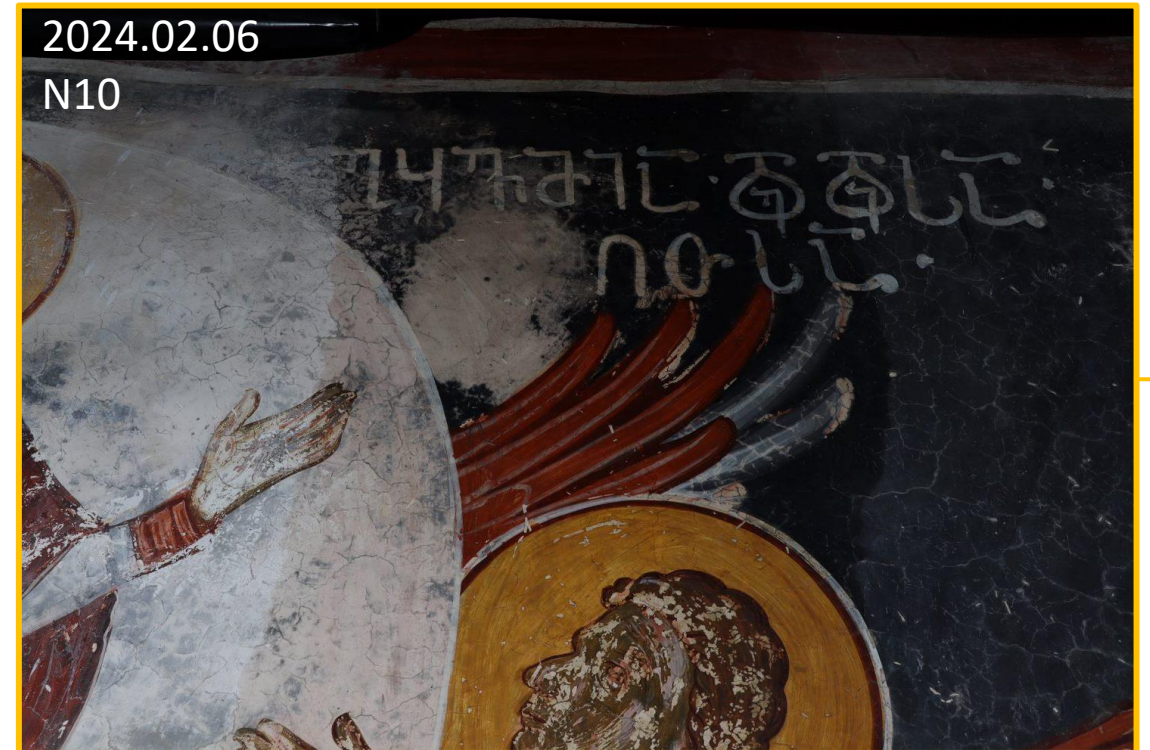
The Church of Nativity of Virgin Mary – Main space, west arm, north wall, third tier, fragments from the scenes N9 – Gathering of apostles for the Dormition of the Mother of god  
N10 – Ascension of the Mother of God.

Wall paintings with water infiltration stains.

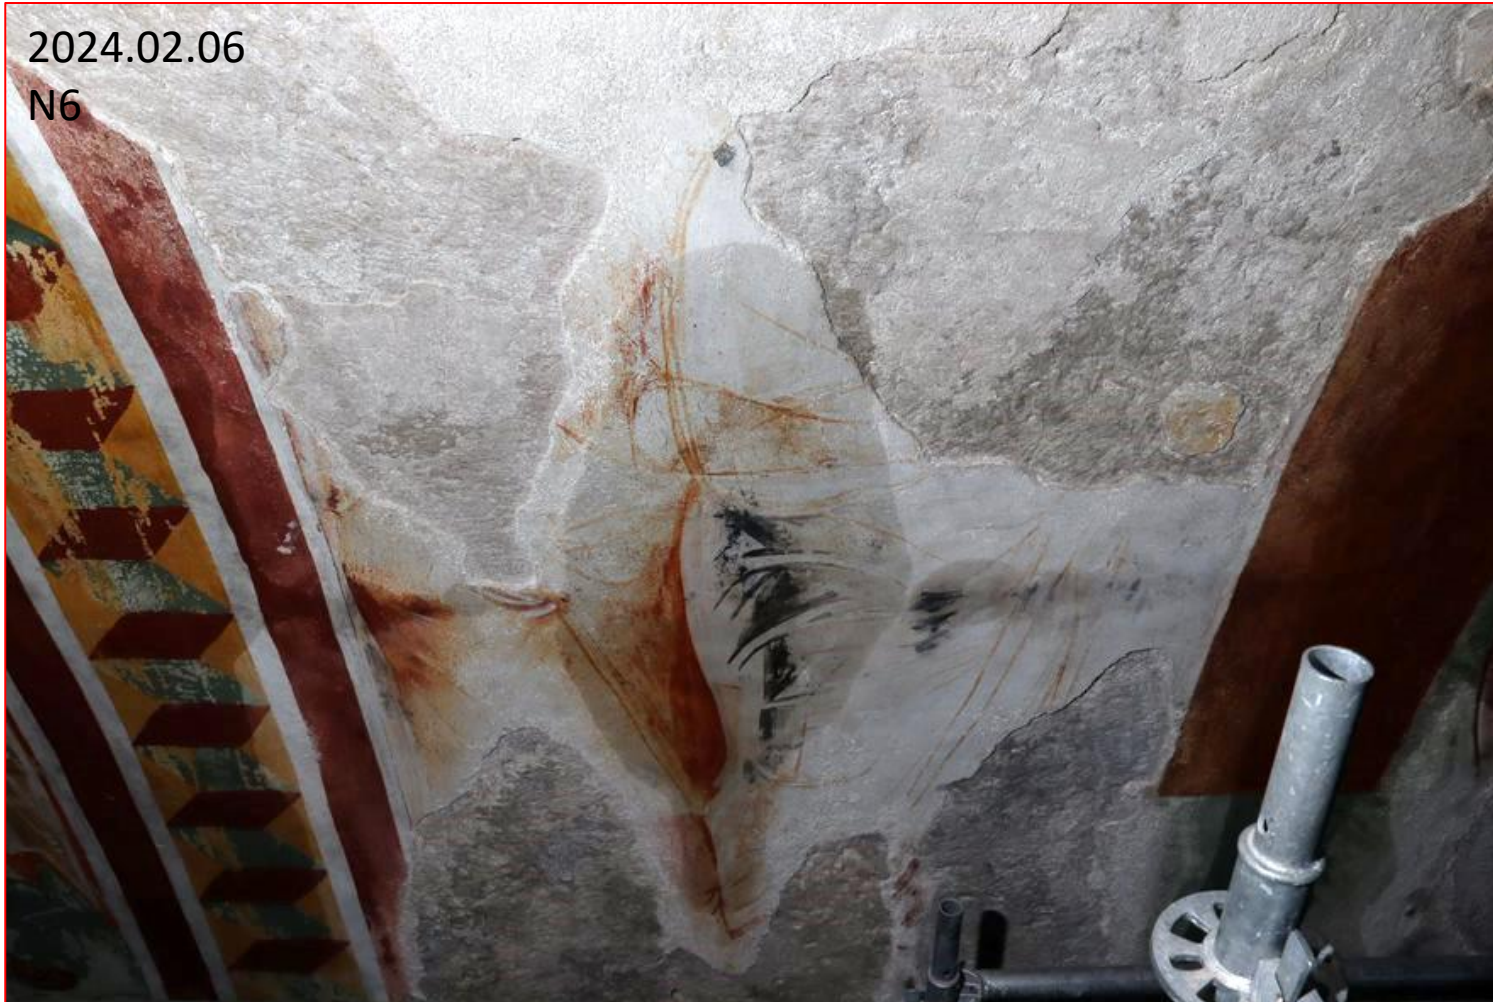
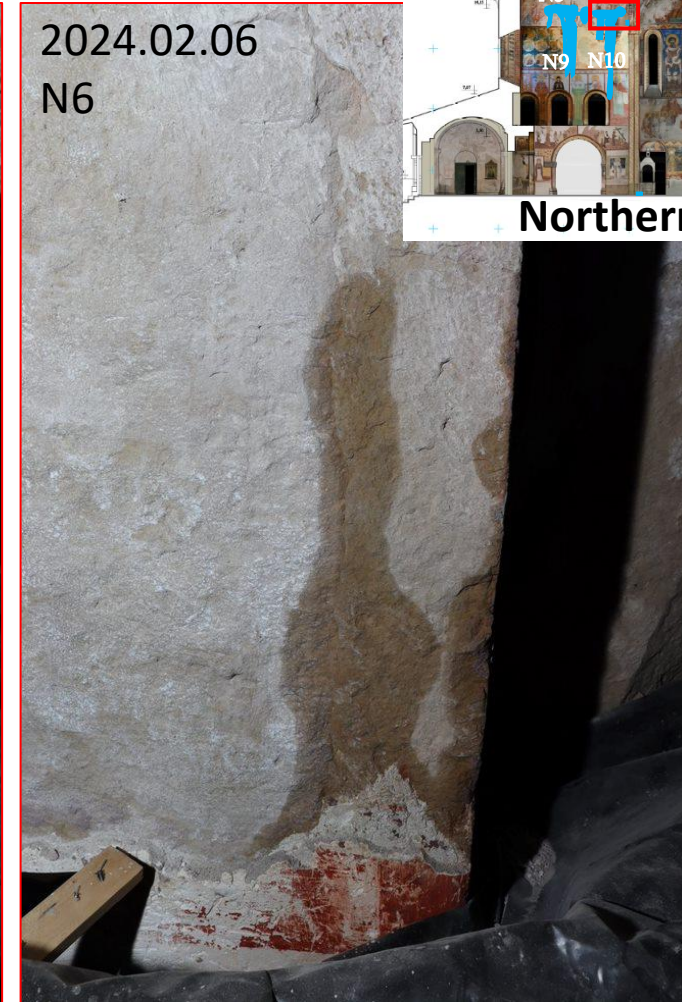
The Church of Nativity of Virgin Mary – Main space, west arm, north wall, forth tier, fragments from the scene N6 Christ with Caiaphas. Water distribution follows the masonry. Joints between the stones (through mortar) are the main/easiest sources/paths of the water coming on the surface of the wall paintings.

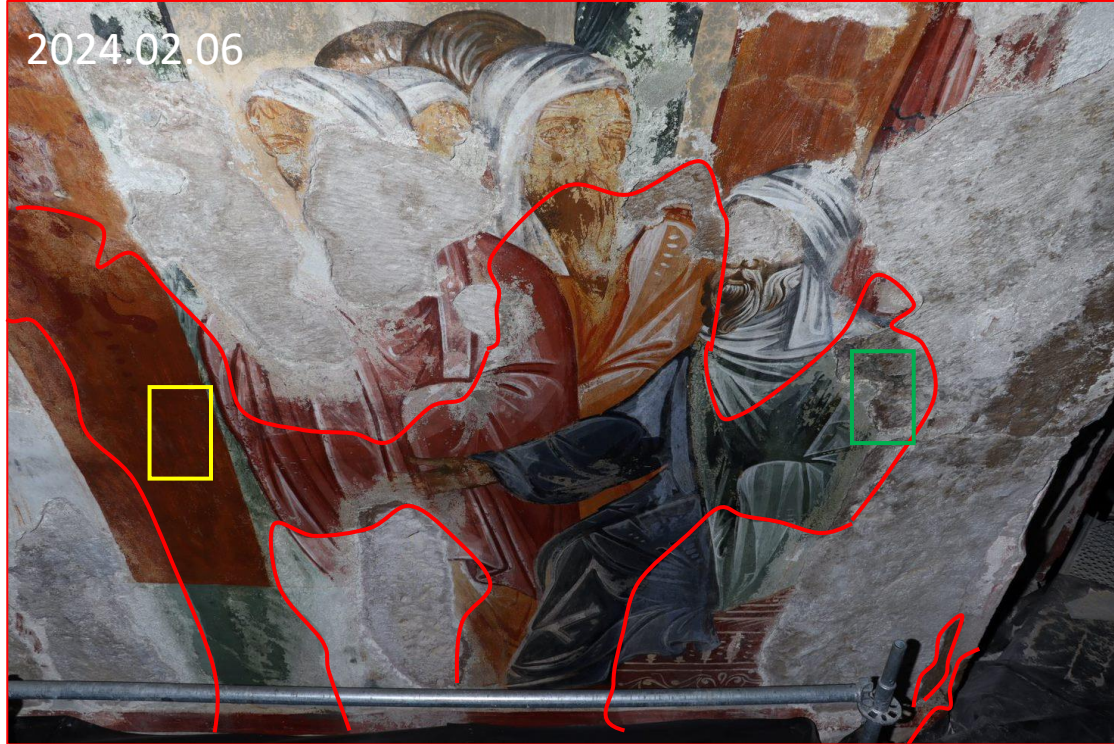
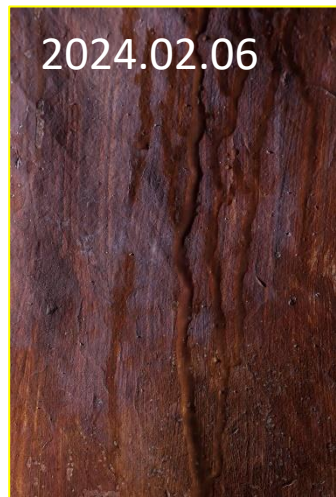
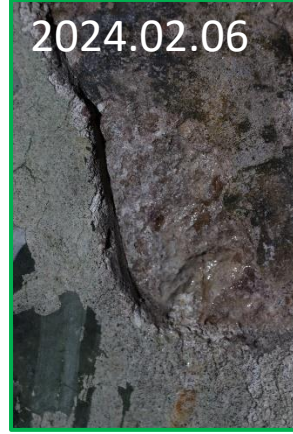
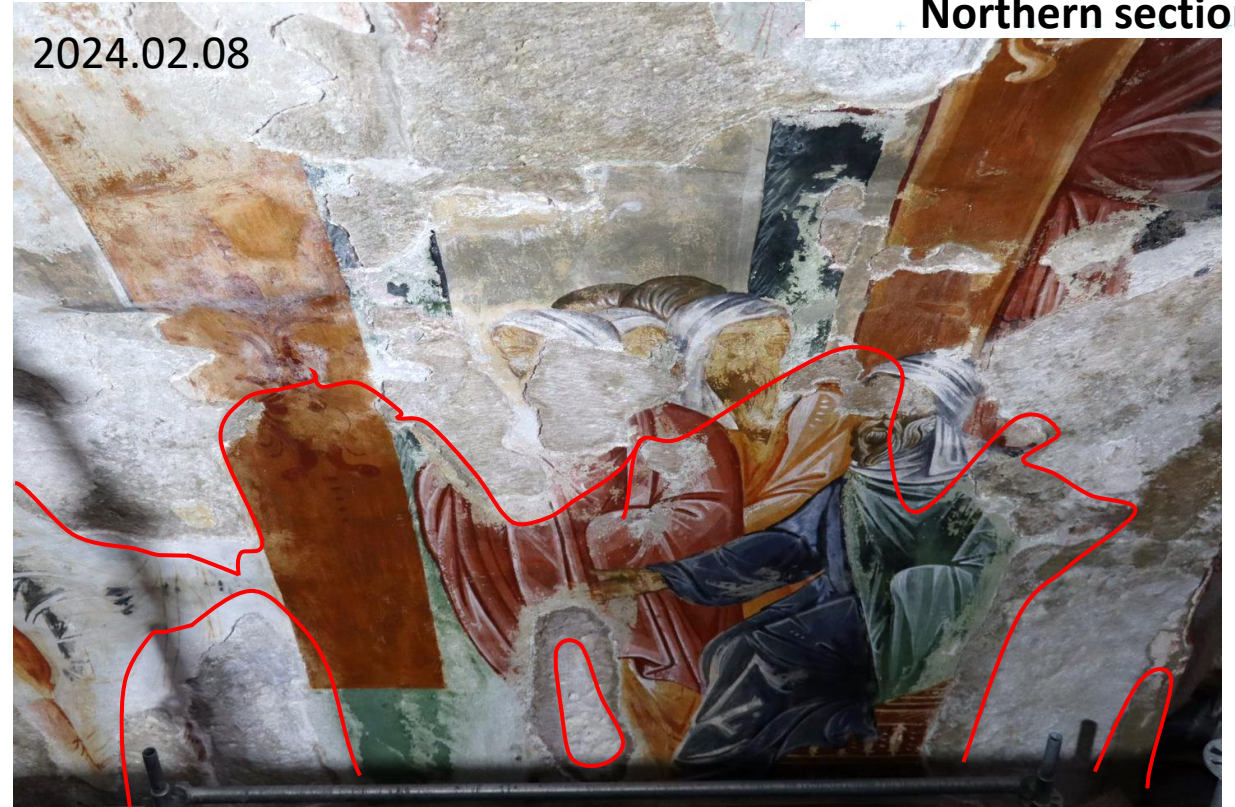
2024.02.06  
**Left:** Scene N6  
 Church of Virgin,  
 main space, west  
 arm, north wall,  
 water flow.

The boarder of the water distribution is provided in red lines. On the 8<sup>th</sup> of February (image right) compared to the condition on 6<sup>th</sup> of February (image above) water coverage has been increased.

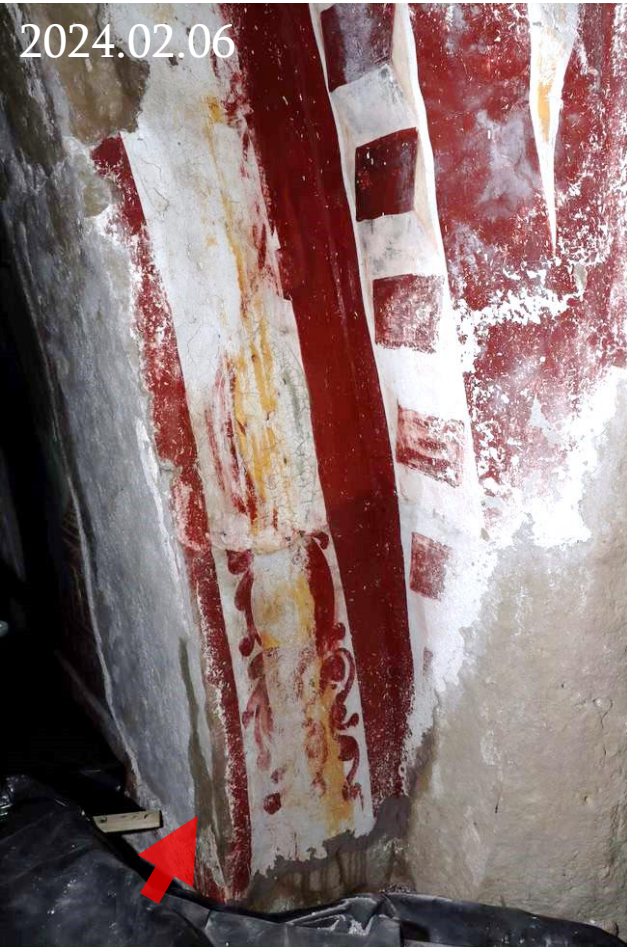
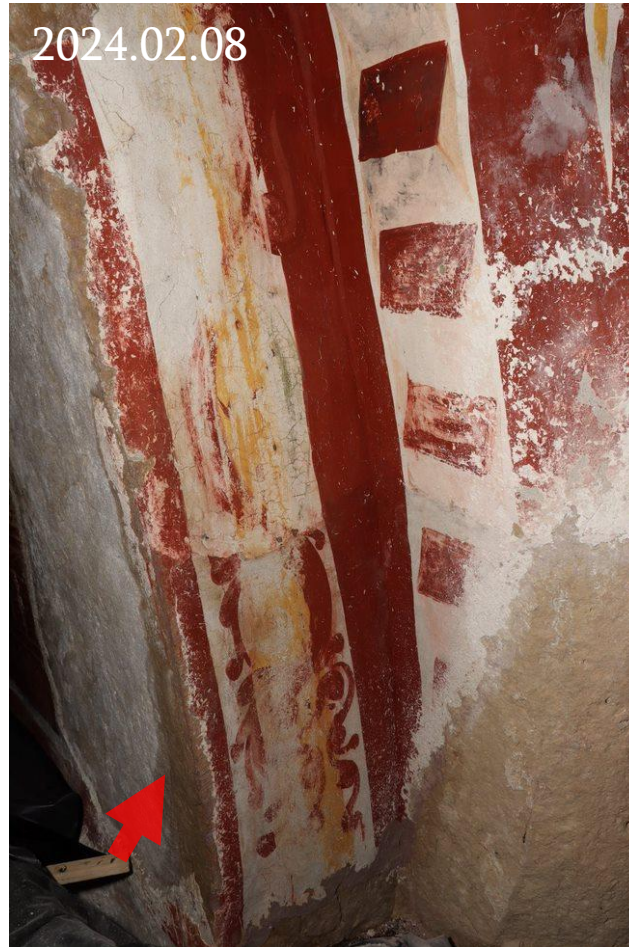
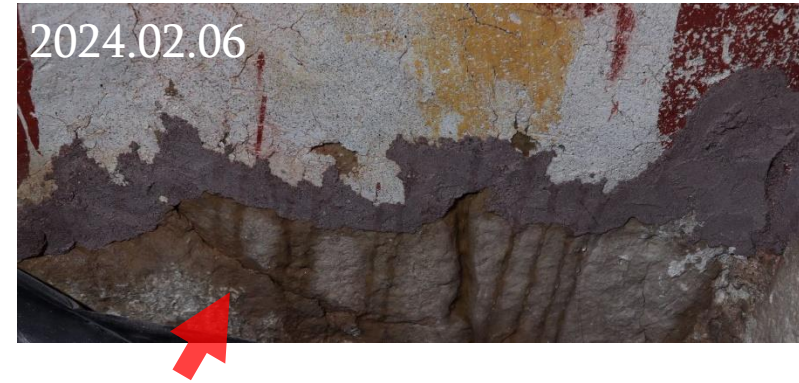
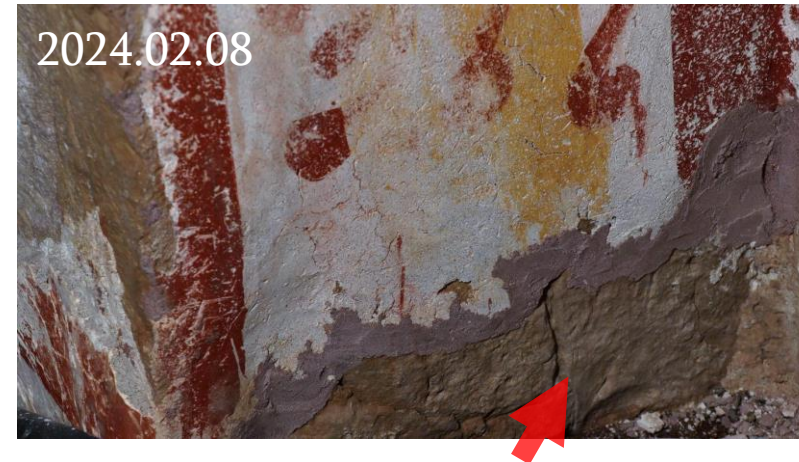
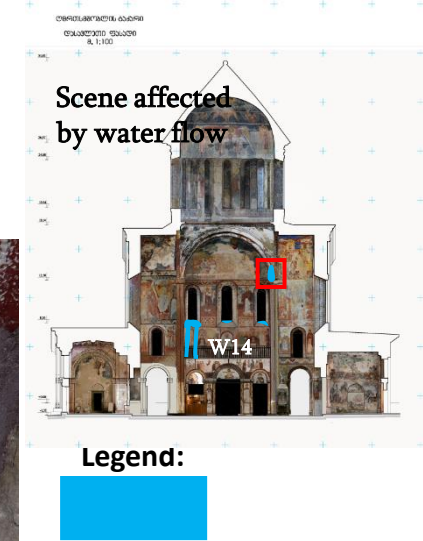
The Church of the Virgin Mary, main space, west arm, vault level, northern corner of the arch. On the 8<sup>th</sup> of February compared to the condition on 6<sup>th</sup> of February water coverage has been increased. See arrows on the below images.

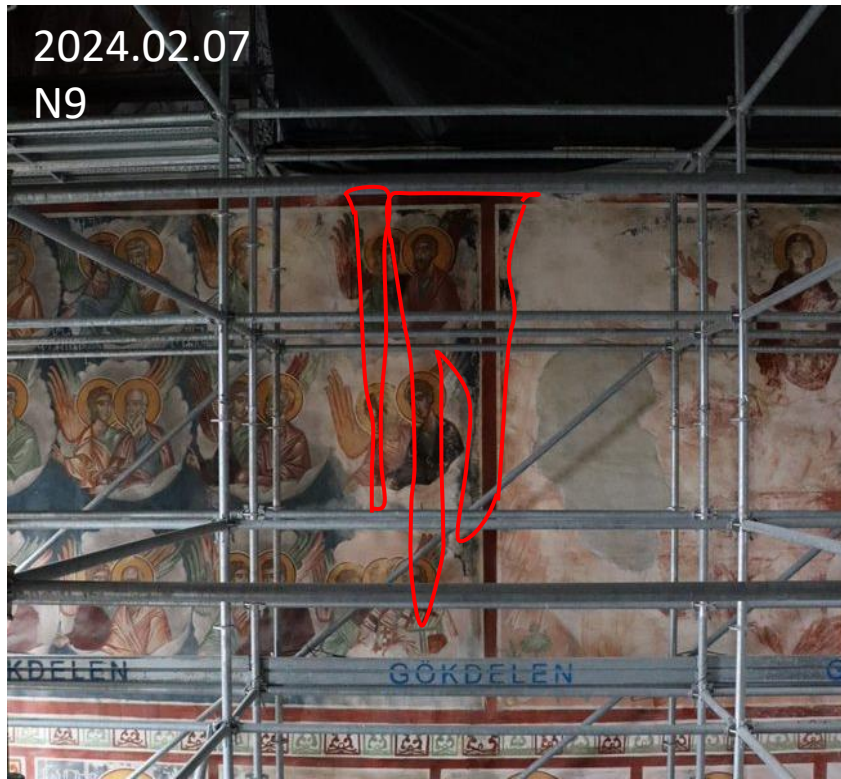
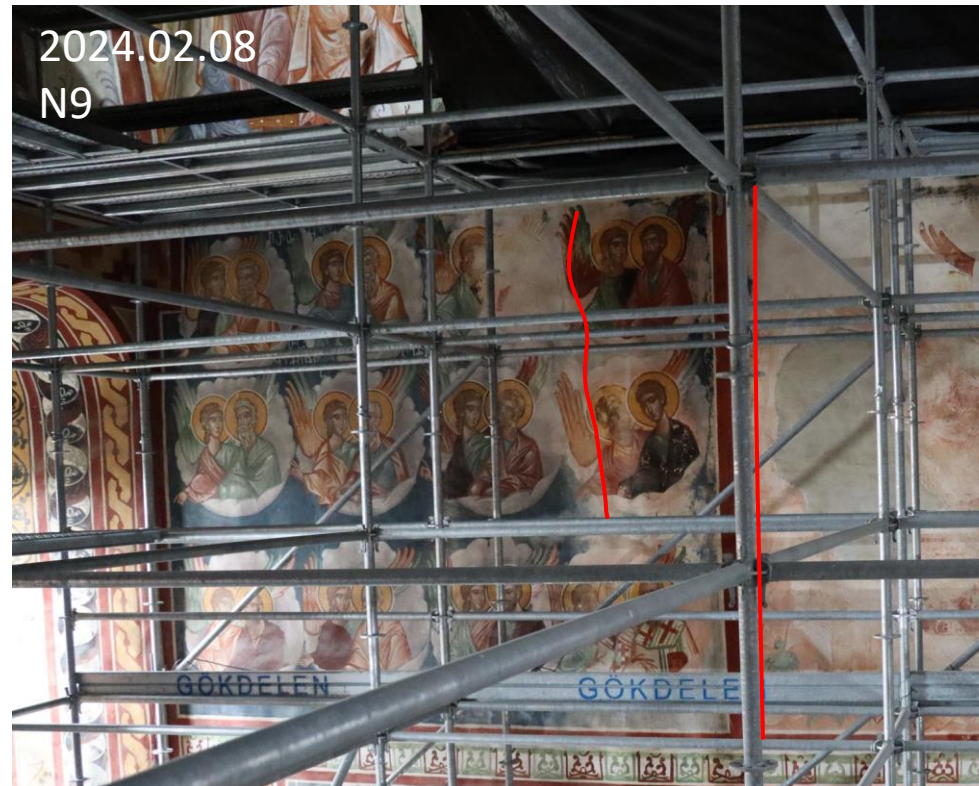
The Church of the Virgin Mary, west arm, north wall, third tier, scene of Gathering of apostles for the Dormition of the Mother of god. The boarder of the water distribution is provided in red lines. On the 8<sup>th</sup> of February (image below left) compared to the condition on 7<sup>th</sup> of February (image below right) water coverage has been increased.
