# გელათის სამონასტრო კომპლექსი Gelati Monastery Complex

**Condition report**  
**Result of meteorological  
disaster**

2024 February 5-6

Report 13/02/2024

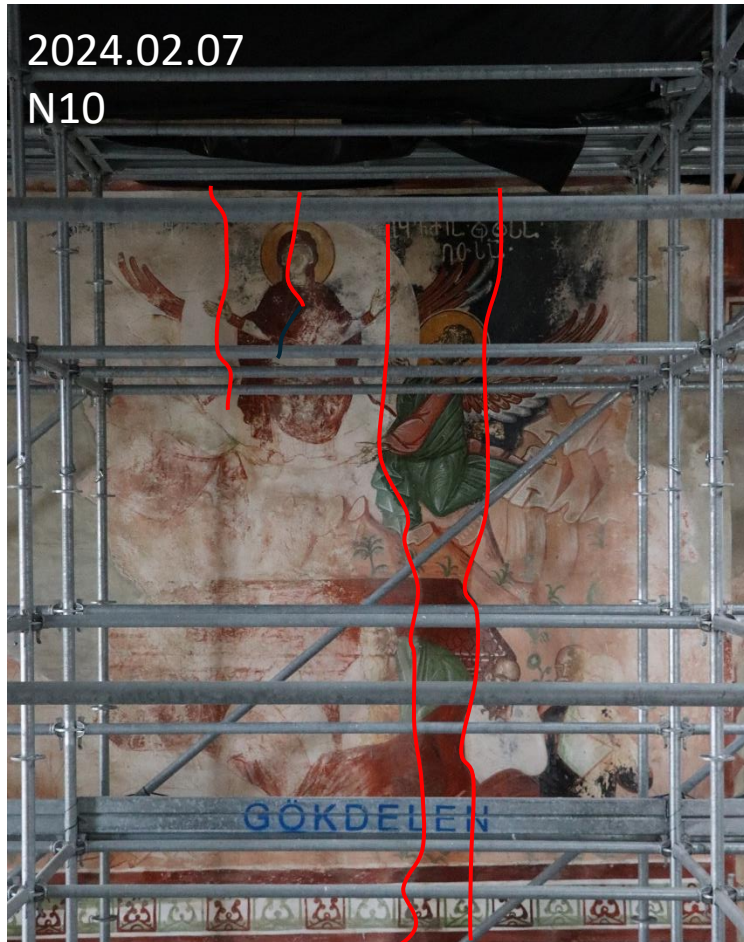
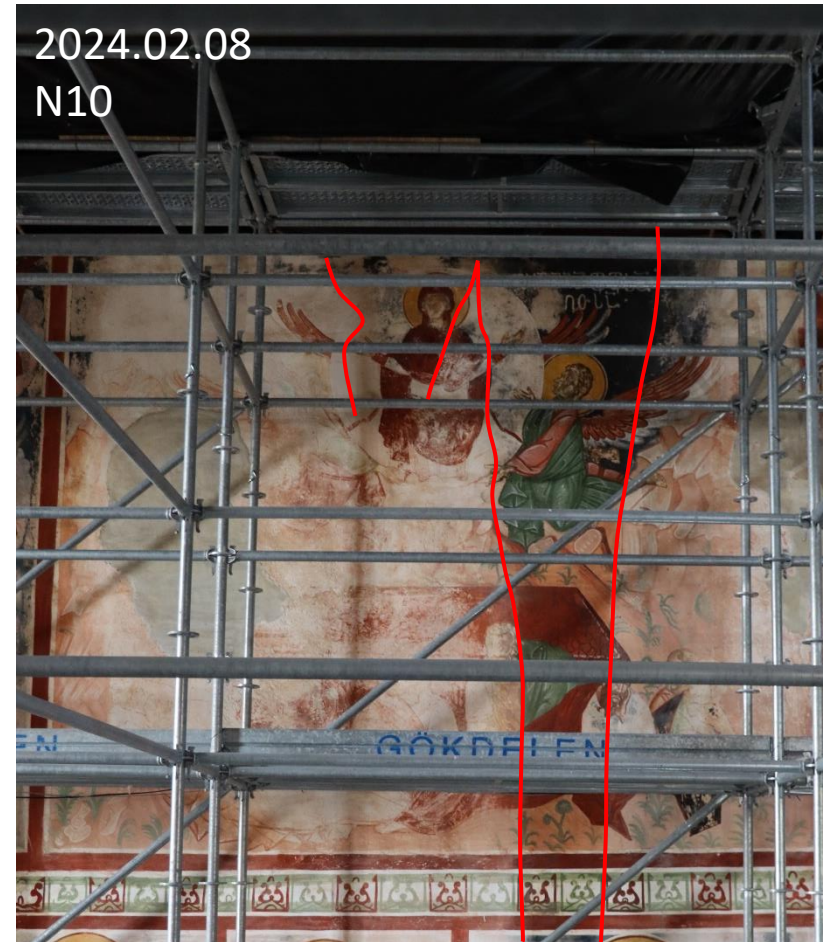
The Church of the Virgin Mary, west arm, north wall, third tier, scene of Ascension of the Mother of God. The boarder of the water distribution is provided in red lines. On the 8<sup>th</sup> of February (image below left) compared to the condition on 7<sup>th</sup> of February (image below right) water coverage has been increased.
