Gelati Monastery Complex

The Church of the Nativity of the Virgin Mary

The western window niche of the dome

Detachment of the painted wall painting fragment

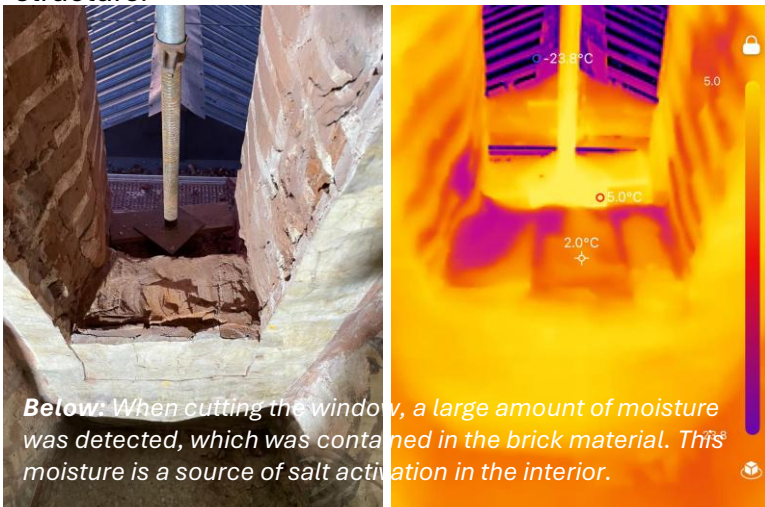
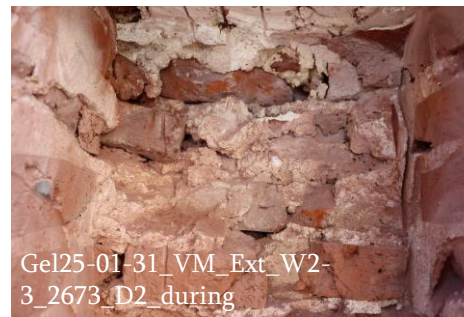
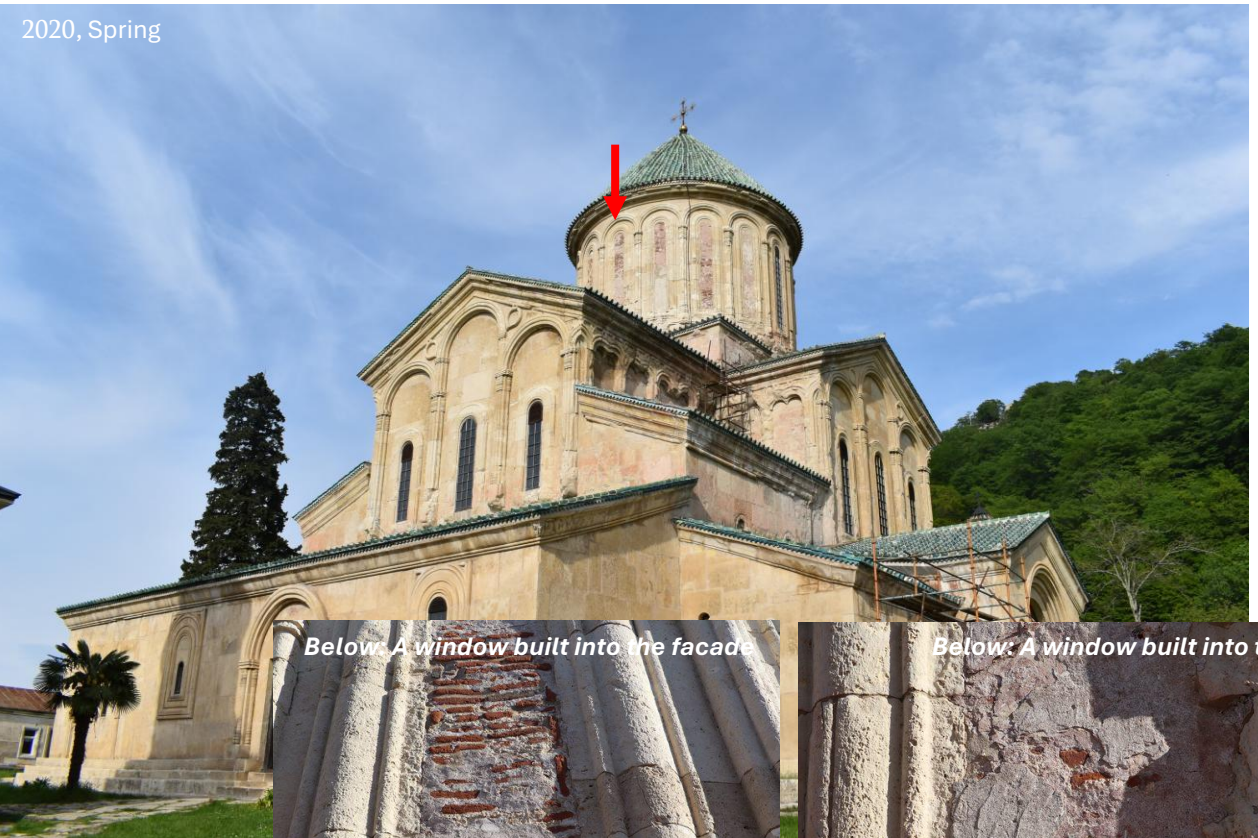
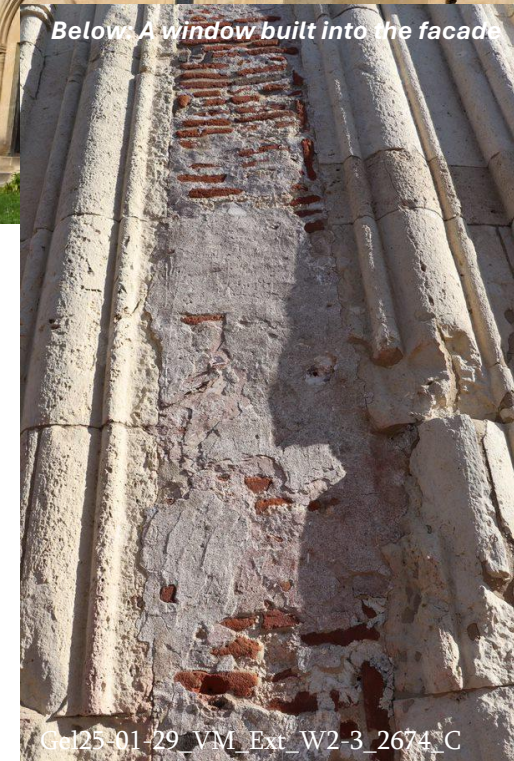
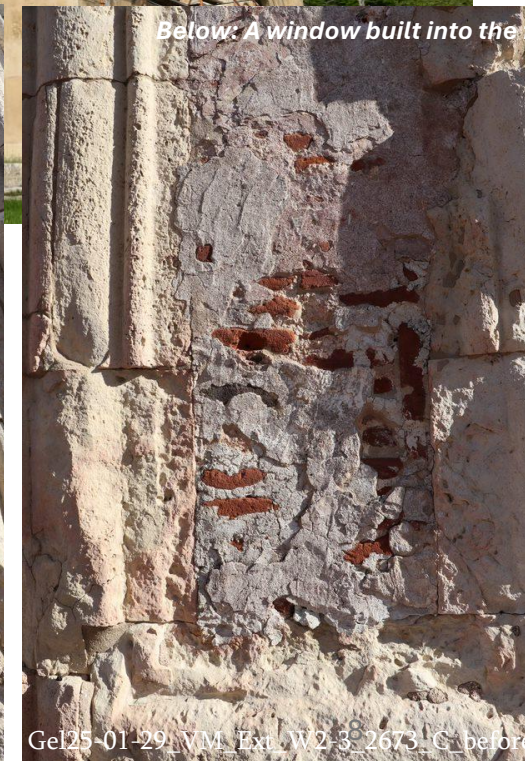
During intervention, it was noted that the bricks were moist throughout their depth, and in some areas, crumbled upon removal, highlighting the extent of deterioration and the presence of active moisture ingress in the wall structure.

Below: The bricks and mortar used in the window.

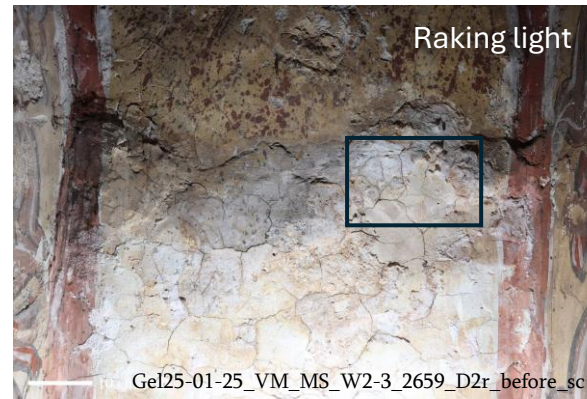
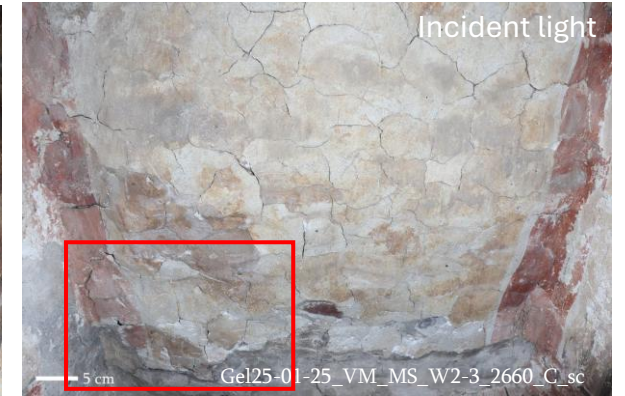
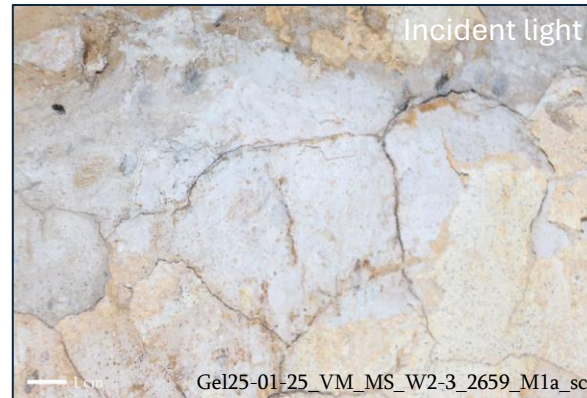
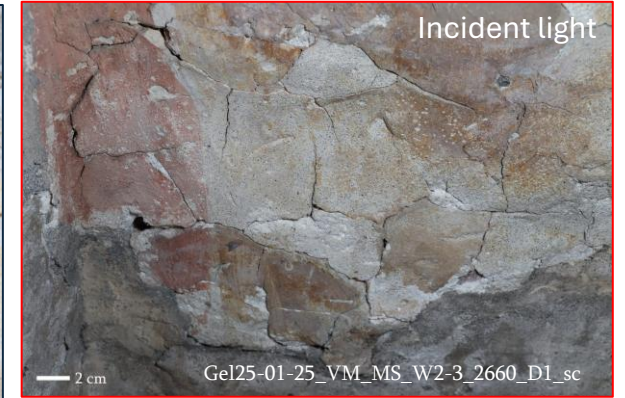
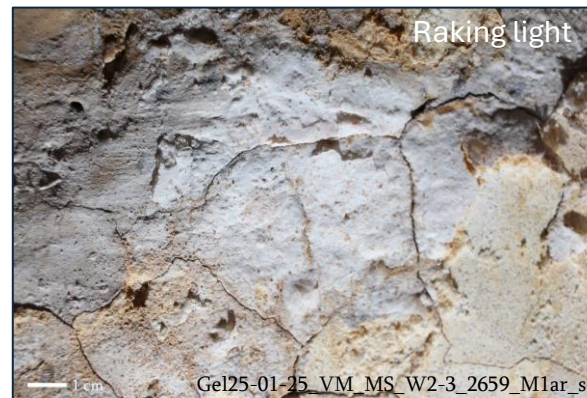
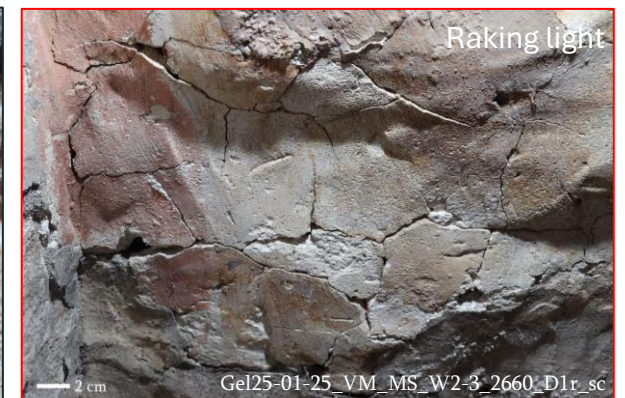
The condition assessment of the western window of the dome, particularly the fragment (to be detached), reveals that the majority of deterioration is concentrated below the plaster join. The plaster in this lower section exhibits net-like cracking, indicative of shrinkage-related stress. While some of these cracks are closed, others remain open. Importantly, the plaster remains firmly adhered to the substrate, and there is no evidence of detachment or mechanical destabilization. However, the paint layer in this area is either entirely lost or in an advanced state of disintegration.

The surface below the join is heavily affected by salt efflorescence, including both crusty and flaky deposits. Ionic analysis confirmed the presence of nitrates and sulfates, suggesting moisture infiltration and soluble salt migration as key agents of deterioration. Both the upper and lower parts of the wall painting suffer from surface contamination, including dust, dirt, spider webs, and bird droppings, along with minor plaster losses. In the surrounding areas of the removable fragment, additional deterioration phenomena are evident, such as plaster separations, fragmentation, localized loosening, micro-cracks, and material losses. These observations point to a widespread vulnerability of the wall painting system, emphasizing the urgent need for continued stabilization and conservation interventions.

Above: Cracked and disintegrated paint, partial and complete disintegration of the paint. Crusty salt.

Above: Cracked and disintegrated paint, fragmentation and blistering of the paint. 14

Following the diagnosis of the painting technology and condition, a series of conservation treatments were carried out on the fragment and its adjacent areas to stabilize the materials and mitigate further deterioration:

1. **Surface Cleaning:** A dry cleaning method was employed to remove surface contaminants. Cobwebs were carefully eliminated using cotton wool attached to a wooden stick, while dust and dirt layers were removed with soft brushes of varying sizes, selected according to the fragility of the paint and plaster layers.

2. **Salt Removal:** Crusty and flaky salt deposits were delicately removed using scalpels and soft brushes, ensuring minimal disruption to the underlying materials.

3. **Plaster Consolidation:** Fragmented and weakened plaster areas were locally consolidated with lime-based micro grout and lime, targeting only the vulnerable zones to strengthen the existing structure without over-intervention.

4. **Temporary Fixative:** To provide short-term protection and cohesion to fragile surfaces, cyclododecane was applied. This material temporarily consolidates the surface and sublimates naturally within a few weeks, leaving no residue or alteration to the original material.

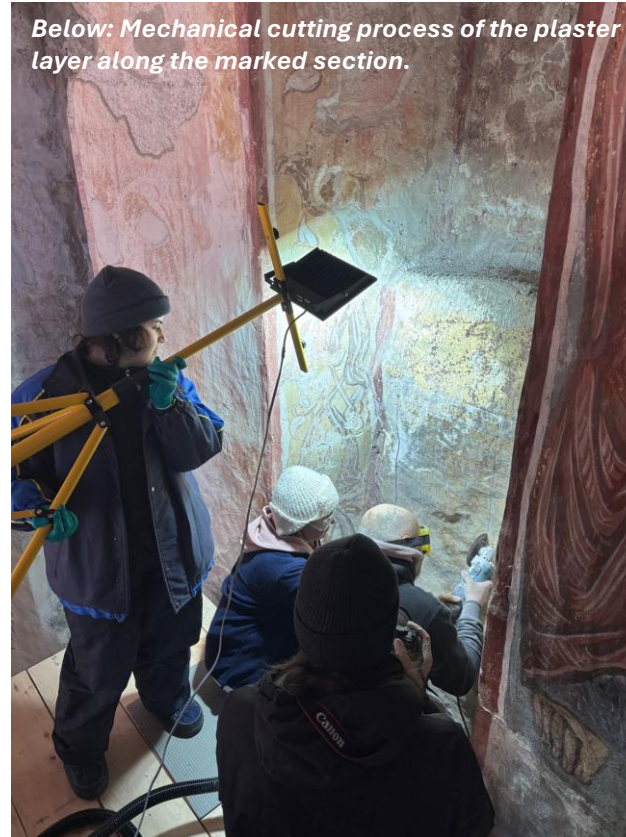
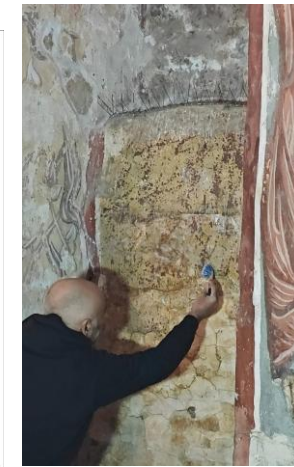
Below: Mechanical cutting process of the plaster layer along the marked section.

7. Using a **grinding machine with a thin blade** set at an angle, the **marked frame was cut**. (Dust was collected using a **powerful construction vacuum** to **prevent particle deposition** on other surfaces.) From the corners of the marked frame, **through-holes were drilled** from the **interior toward the façade**.

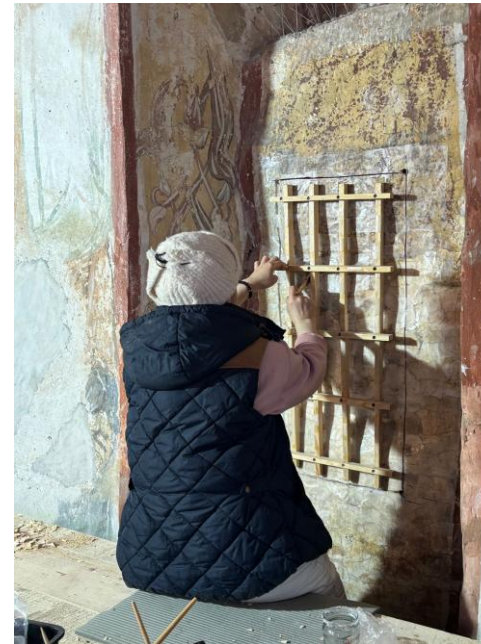
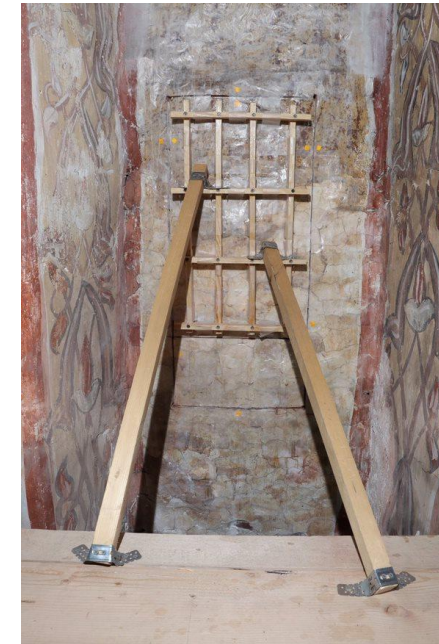
Left: Process of attaching the wooden frame to the treated painted surface.

8. Based on the dimensions of the removable fragment, a wooden support frame was prepared and mounted onto the temporarily reinforced painted surface (using Japanese paper and a solution of Paraloid B-72). The frame was temporarily secured to the scaffold with wooden braces to prevent any displacement.

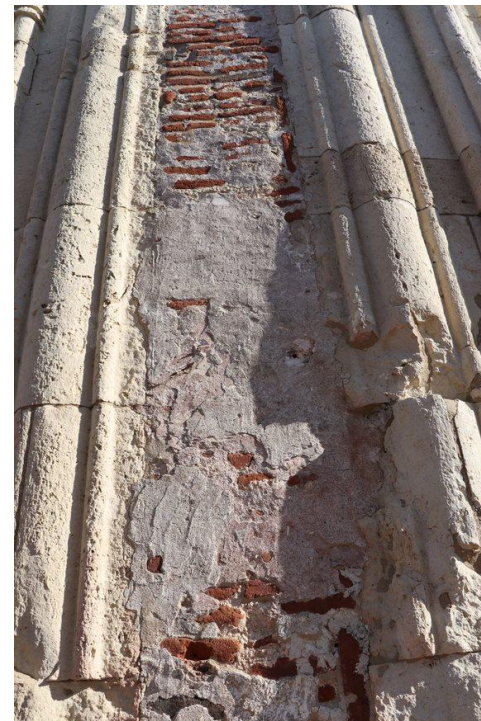
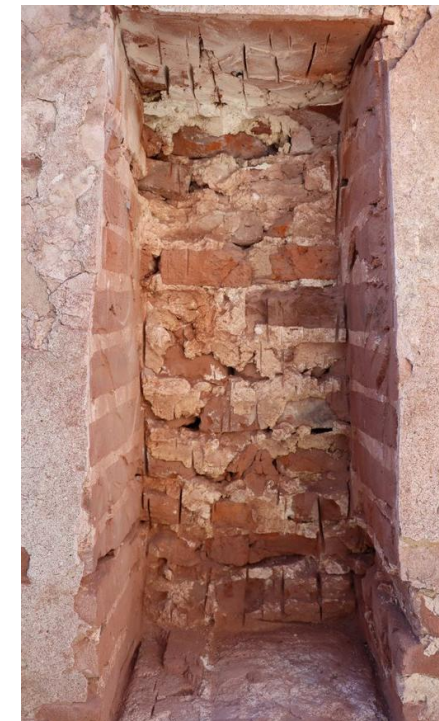
Left: Process of removing bricks from the façade side.

9. From the façade side, using a mechanical cutter with minimal vibration, the bricks of the walled-up window were removed in accordance with the marked (drilled) sections.

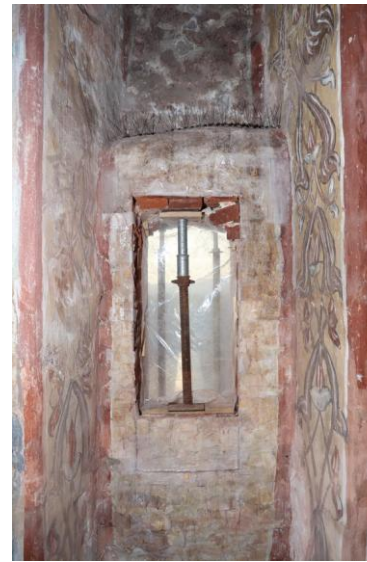
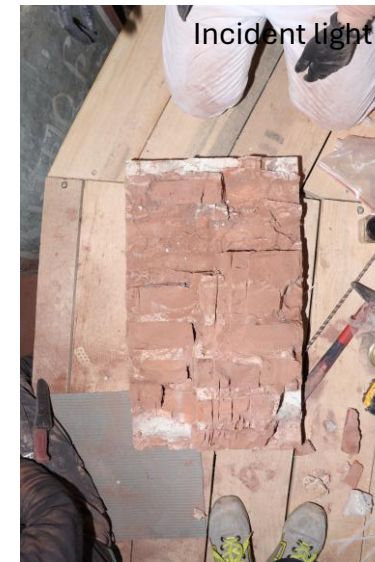
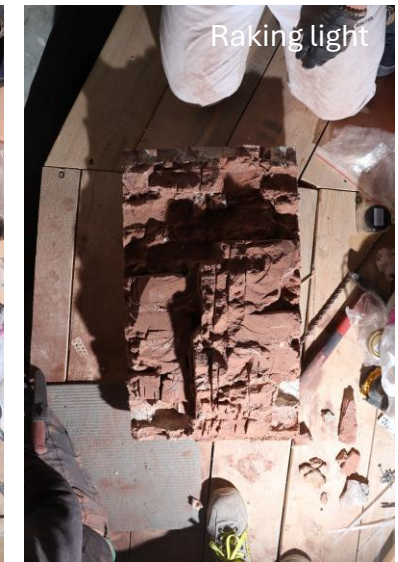
Left: A painting fragment removed using the *stacco a massello* method (removal of the painting along with its primary support).

Accordingly, it was decided to use the Stacco a Massello technique, in which the structure is dismantled from the primary support and the entire stratigraphy of the painting is removed undamaged.

10. From the façade side, the bricks were partially removed. Only those bricks remained on the surface which had direct contact with the interior painting and plaster layer. Accordingly, from the interior side, the fragment was detached along with the bricks using gentle pulling and support of the wooden frame and placed onto the scaffolding platform. The fragment was then cleared of large bricks from the back side. The bricks were mechanically detached easily from the plaster. The cleaned-back fragment was transported to the laboratory located at the Gelati Monastic Complex.

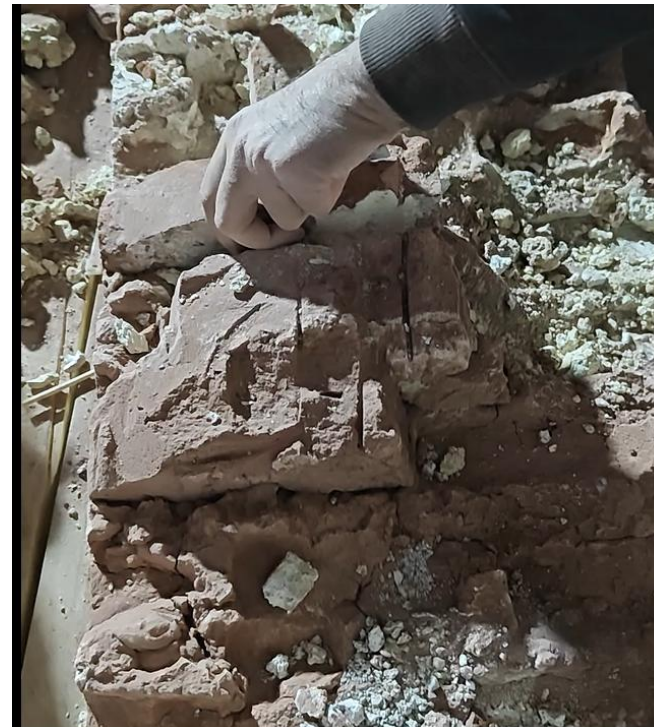
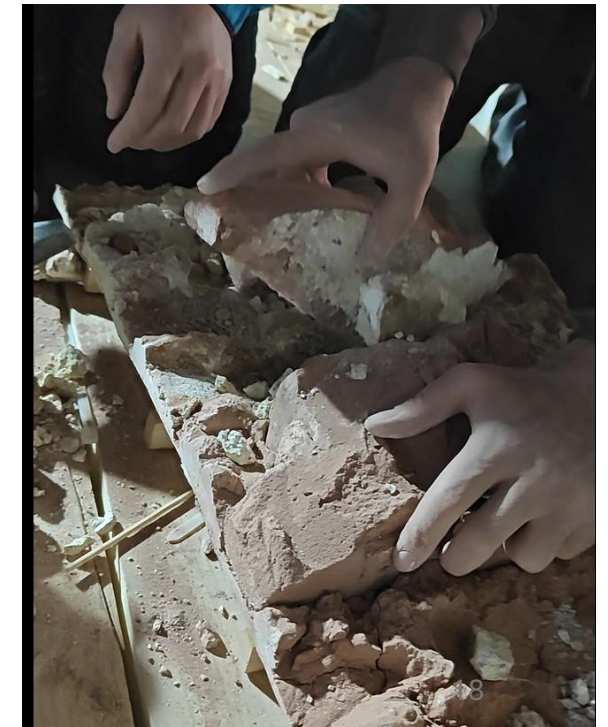
Below: The process of removing bricks from the fragment to lighten the weight of the fragment.

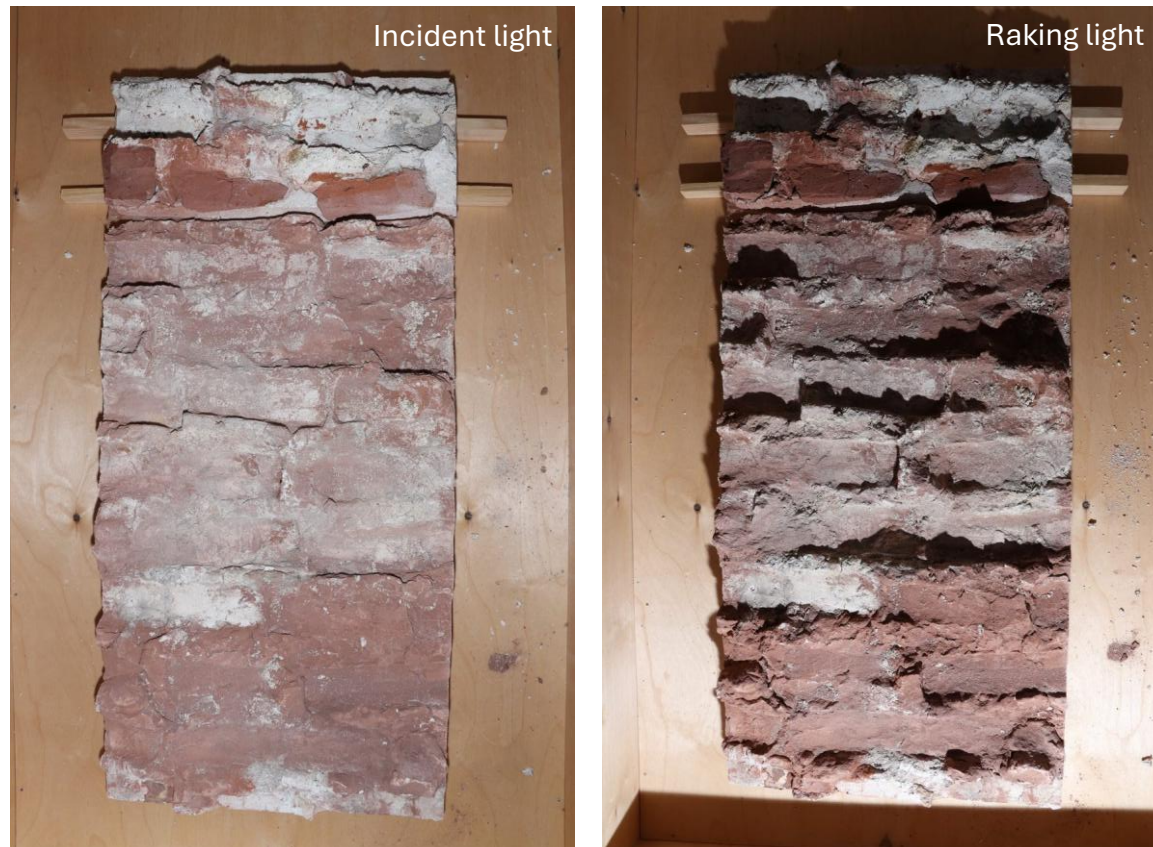
Above: The removed wall painting fragment placed in the storage box - viewed from the back side (support). Wall painting of the western built-up window of the dome of the Nativity of the Virgin Mary Cathedral.

11. The detached wall painting was placed in a suitable storage box in the laboratory and will be kept there until the completion of the rehabilitation works.

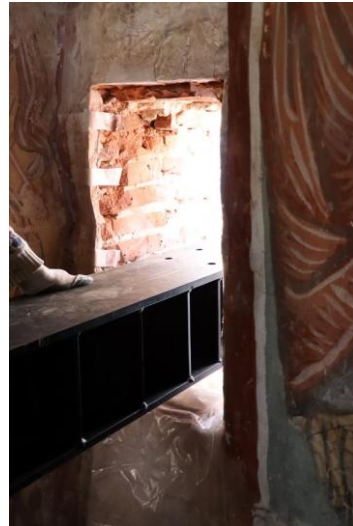
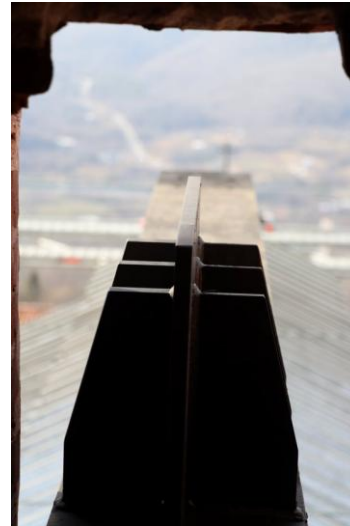
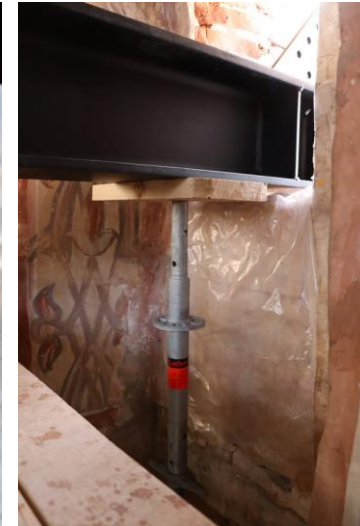
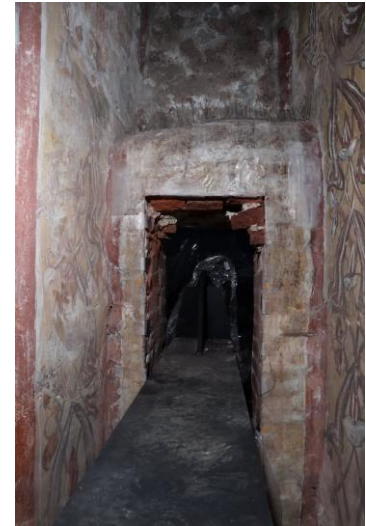
Above: Photos of the metal construction from the interior side. The openings from the facade side were temporarily covered with thick polyethylene film to prevent water ingress.
