# **Remedial Treatment Programme**

## **Table of Content**

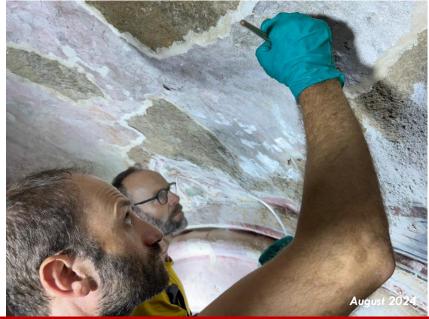
Above: In-situ lab-based analysis and testing of the conservation materials.

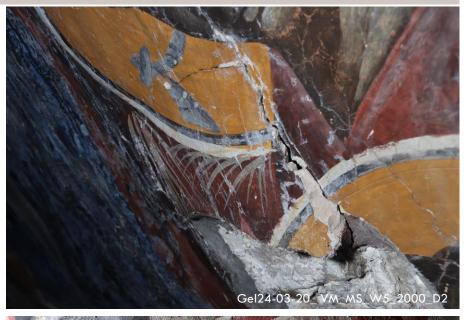
Image (Right): The Church of the Virgin, main space, west arm, vault level, south wall (S8); paint flaking and salt efflorescence. The area was consolidated in 2022.

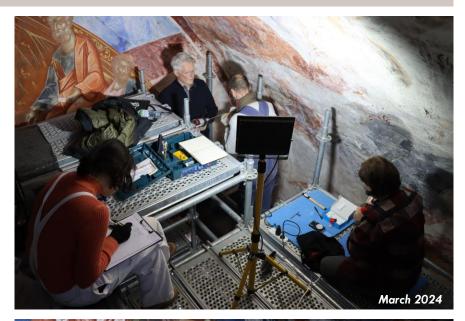
- It recognizes that irremovable and inexorable deterioration factors place considerable limitations on both the implementation and efficacy and remedial interventions;
- It limits remedial treatments to essential stabilization measures, carried out within a framework that privileges compatibility and minimal intervention; and
- It integrates the planning and implementation of remedial treatments with diagnostic, analytical and environmental investigations and outcomes.

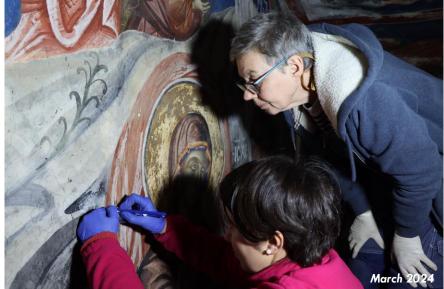
Image (Upper right): The Church of the Virgin, main space, north arm, vault level, east wall; sampling process.

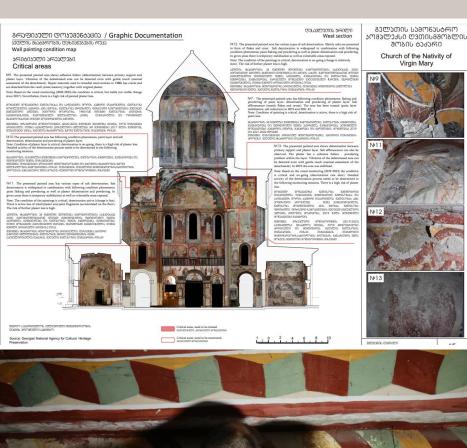
Injection grouting is being carried out on a case-by-case basis to address issues of endangering plaster separation. Injection grouting re-establishes adhesion between the separated layers of a wall painting by introducing an adhesive material with bulking properties. Building on considerable grouting research, a custom-made, light-weight, fast-setting lime-based grout is being used.

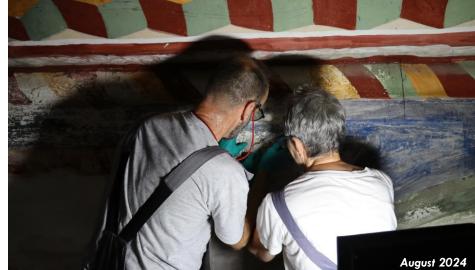
Areas of critical plaster separation are numerous and cannot be treated all at once. Areas of concern are therefore prioritized based on an assessment of various risk factors, as follows:

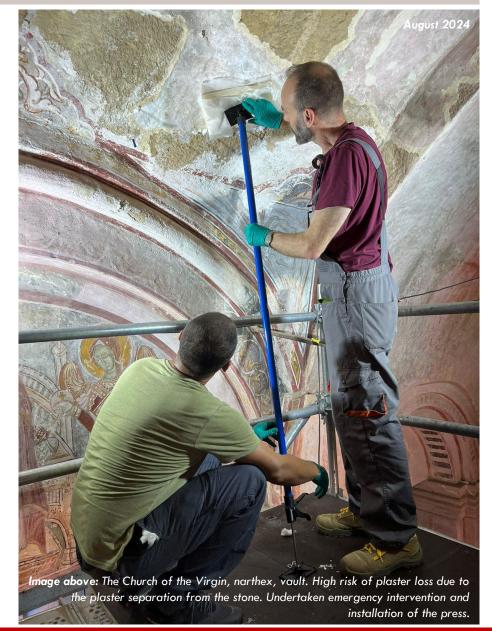
To offset the risks involved in phasing injection grouting over time, temporary stabilization measures are sometimes instigated, again depending on specific conditions and the options available.

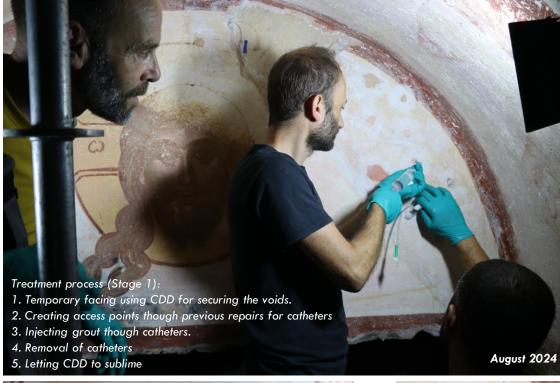
south arm, tympanum above south door: a patch of painted plaster to the right of Christ's head was at great risk of collapse and loss. Vibration from use of the door increased the jeopardy. The physical evidence suggested that the plaster patch had probably separated during its original application and setting processes, leaving it in an historically vulnerable state. Previous attempts to secure the separated patch with plaster 'plugs' had failed. Grouting was undertaken from 8th of August for several days. Gradually, 1,256 litre of grout was injected.

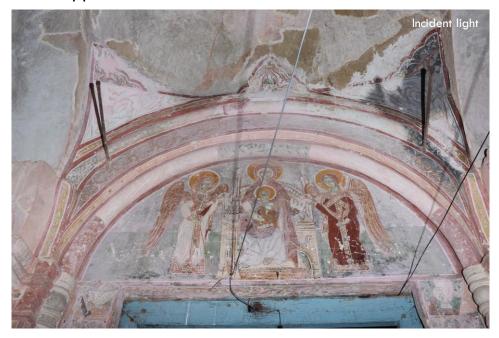
**Images above and right:** The Church of the Virgin, Narthex, vault east side, above the entrance in the main space (scene 1). High risk of plaster loss due to the plaster separation from the stone.

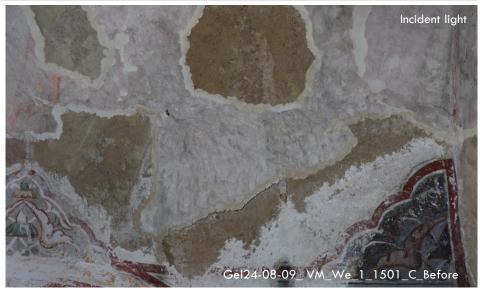
Plaster has deformation, cracks and previous repairs, which have also failed. The area has salt activity (samples has been sent for analysis).

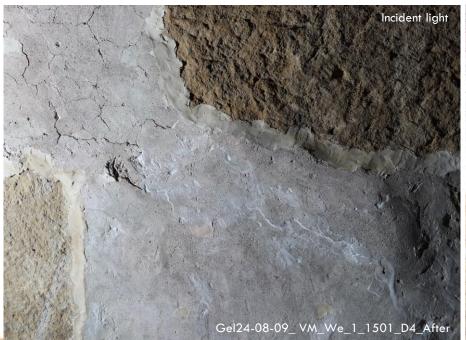
Images below: Condition after temporary stabilisation and grouting (before CDD sublimation)

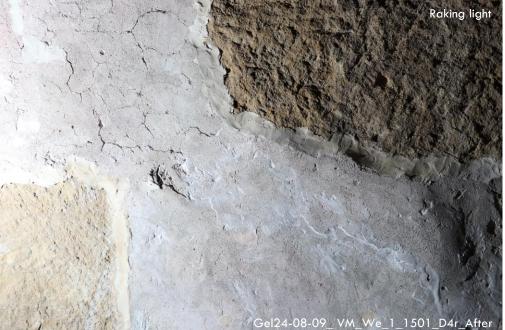
Although both areas (Narthex and Tympanum) of plaster separation were relatively small (under 1 m square), circumstances associated with their location and condition indicated that they were at high risk and required prioritised treatment. In both cases, temporary protection/support was provided by the application of cyclododecane (CDD), a wax-like material ( $C_{12}H_{24}$ ). After a brief period, this sublimes from a solid to a gaseous state, leaving no residue.

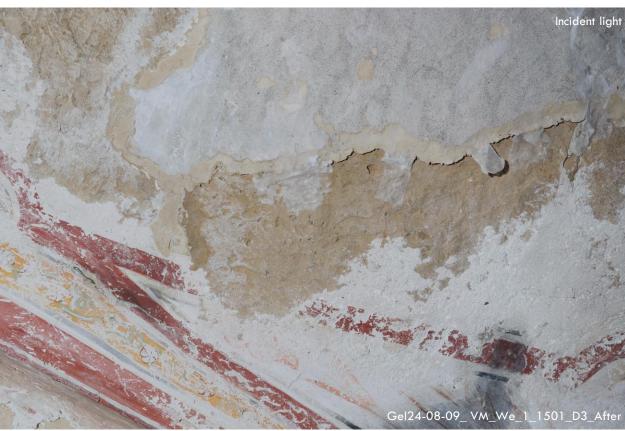
Image above and left: Prior to the grouting previous gypsum repairs and original plaster, which are detached from stone, were temporarily reinforced with cyclododecane and Japanese paper strips. After securely injection of grout, cyclododecane is left for sublimation, which will allow Japanese tissue to fell of safely without further mechanical action.

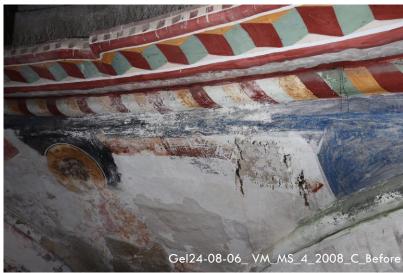
Image left and right: The Church of the Virgin, main space, north-west pendentive. The delaminated plaster has collapsed in June 2024, rest of the plaster was hanging.

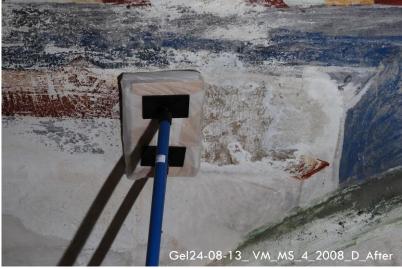
Treatment descriptions:

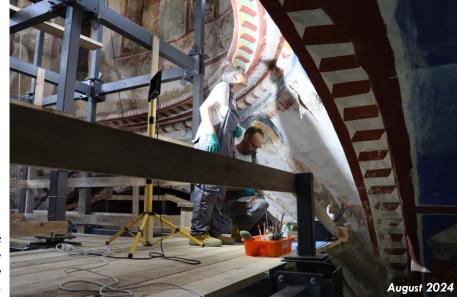
Image left: Process of the development of the treatment strategy.

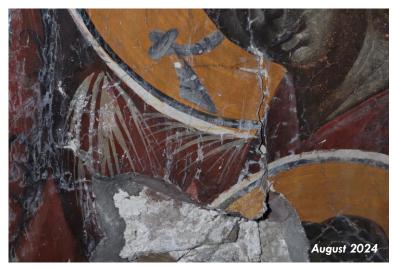
Images (Right and below): The Church of the Virgin, main space, south arm, vault level, west wall; Condition after temporary stabilisation.

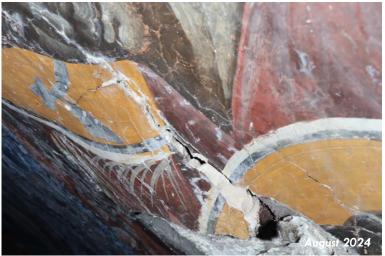
Image (Left): The Church of the Virgin, main space, south arm, vault level, west wall; Condition before after temporary stabilisation. Original plaster has delamination, cracks, salt. Previous repair also reveals cracks and salts. The area is at high risk of loss.

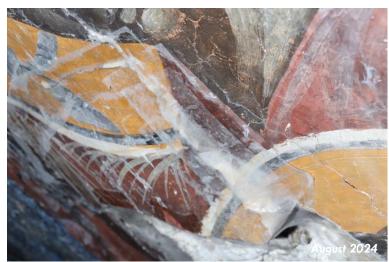
Planned treatment descriptions:

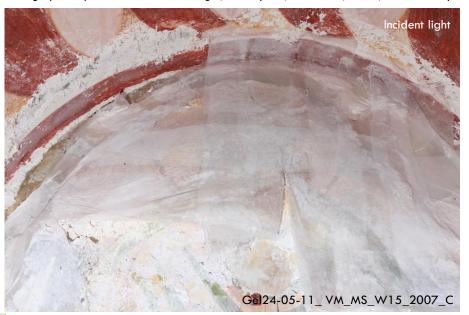
Image (below): The Church of the Virgin, main space, west niche, W15, before collapse

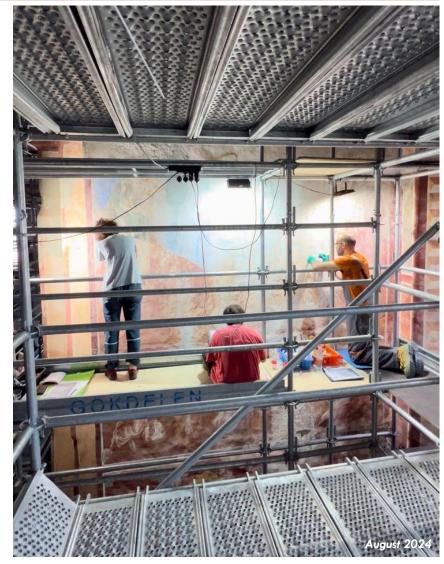
**Image (Above):** The Church of the Virgin, main space, north arm. Remedial treatment programme in progress.

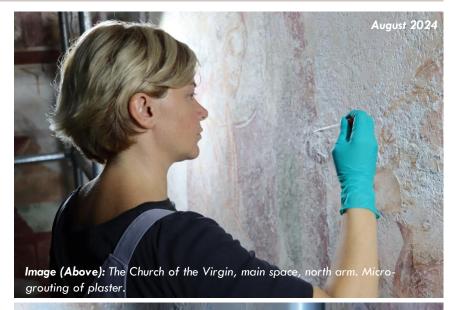
- consolidation/readhesion: use of nano-lime dispersed in alcohol (CaLoSil® NP25) to consolidate exposed and decohesive plaster;
- bridging/protection of exposed plaster edges: to protect and stabilize damaged and exposed plaster edges, introduction of a customised 'micro-grout' by pipette. An initial formulation trialed in March 2024 comprised 1 part lime, 1 part chalk, 1 part pumice (0–240 m) + added water to desired consistency for effective delivery (all parts by volume). The added water has been substituted by a 1:1 mixture of water: alcohol, both to better facilitate delivery and minimize salt risks;
- selective paint flake fixing: based on trials and surveillance of results, CaLoSil® NP25) also provides an effective means of resecuring some areas of paint flaking.

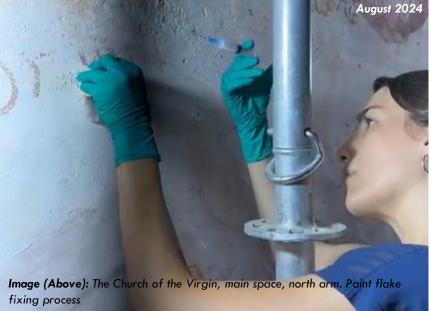
consolidation/readhesion and micro-grouting of plaster

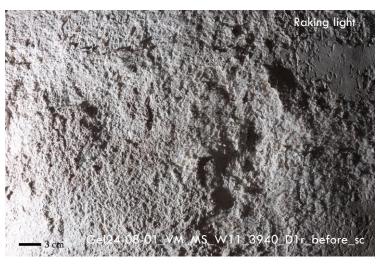
**Left:** Condition of wall paintings before intervention in August 2024. Plaster delamination, plaster powdering, exposed plaster edges; salt efflorescence

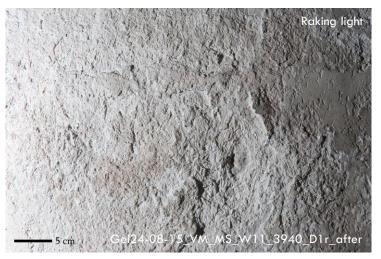
Left: In August 2024, the 2nd phase of remedial treatment programme was undertaken – development of intervention methodologies continued. Salts have been removed, plaster has been consolidated with nano lime, separated plaster fragments and exposed edges have been stabilised with micro grout.

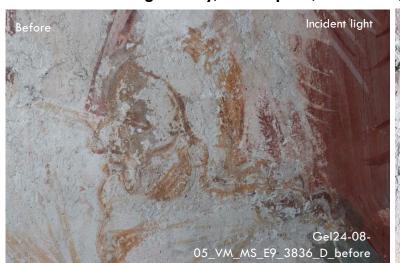
consolidation/readhesion and micro-grouting of plaster

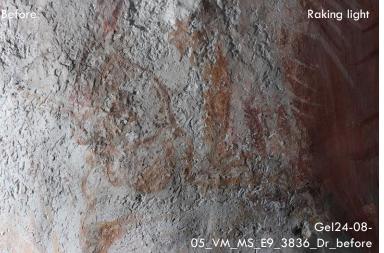
Left: Condition of wall paintings before intervention in August 2024. In March 2024 the area was treated with nano-lime to address powdering problem, however the exposed edges of the plasters remained unsecured.

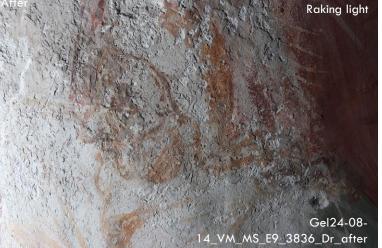
Left: In August 2024, the 2nd phase of remedial treatment programme was undertaken – development of intervention methodologies continued. Plaster losses and exposed edges were secured by microgrout. The low amount of mixture were selectively applied in small losses, which stabilised the condition of the plaster.

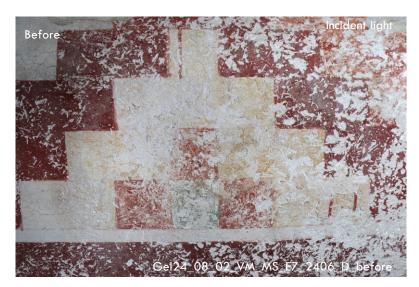
consolidation/readhesion and micro-grouting of plaster

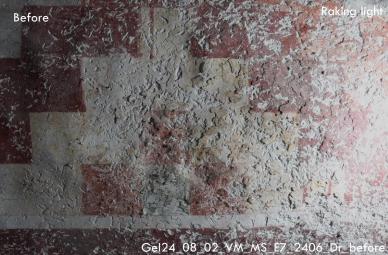
Left: Condition of wall paintings before intervention in August 2024. The painted plaster is separated from each other, plaster is also powdering and there is a high risk of loss.

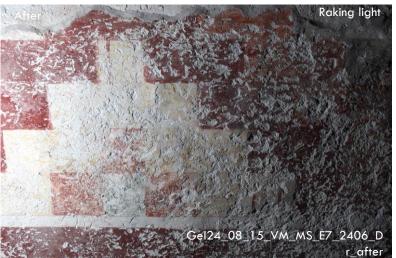
Left: In August 2024, the 2nd phase of remedial treatment programme was undertaken. Plaster has been consolidated with nano-lime, then painted loose fragments and exposed edges were secured by micro-grout. The low amount of mixture were selectively applied in small losses, which stabilised the condition of the plaster and a paint.

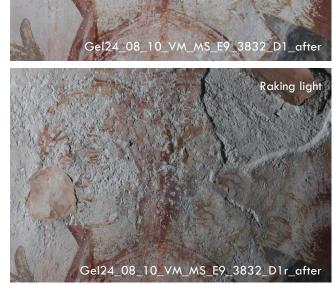
**Above:** Condition of wall paintings before intervention in March 2024. Paint flaking, plaster delamination, plaster powdering, exposed plaster edges; salt content (revealed through analysis).

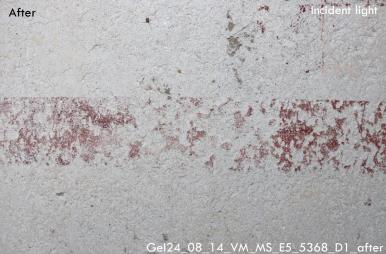
Left: Condition of wall paintings before intervention in August 2024. The painted plaster is separated from each other, plaster is also powdering and there is a high risk of loss.

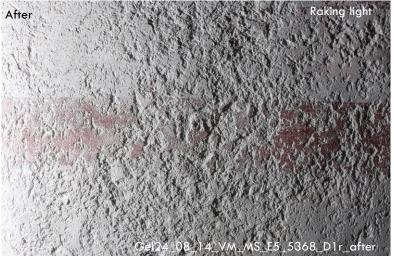
Left: In August 2024, the 2nd phase of remedial treatment programme was undertaken. Plaster has been consolidated with nano-lime, then painted loose fragments and exposed edges were secured by micro-grout. The low amount of mixture were selectively applied in small losses, which stabilised the condition of the plaster and a paint.

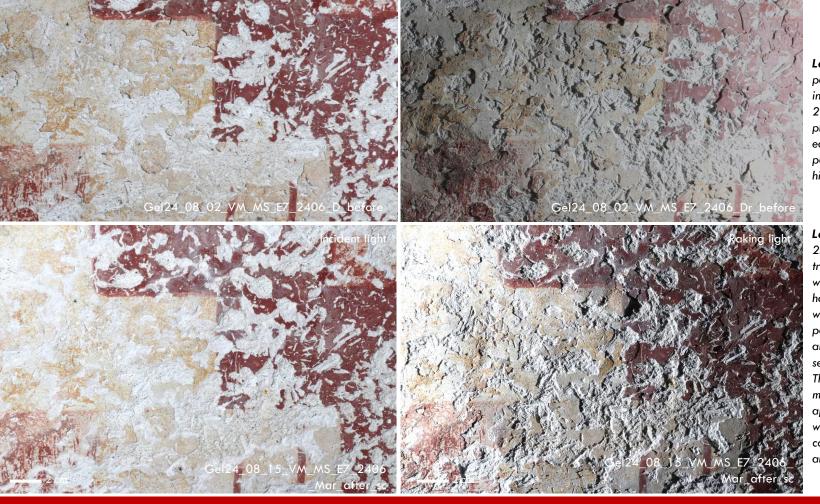
Left: Condition of wall paintings before intervention in August 2024. The painted plaster is separated from each other, plaster is also powdering and there is a high risk of loss.

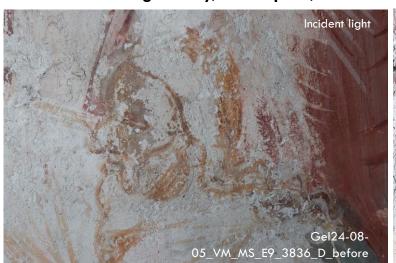
• consolidation/readhesion and micro-grouting of plaster

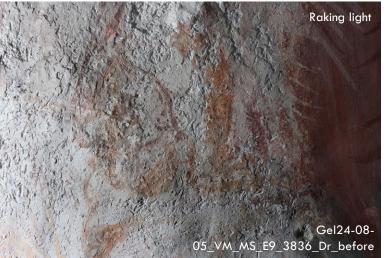
Left: Condition of wall paintings before intervention in August 2024. In March 2024 the area was treated with nano-lime to address powdering problem, however the exposed edges of the plasters remained unsecured.

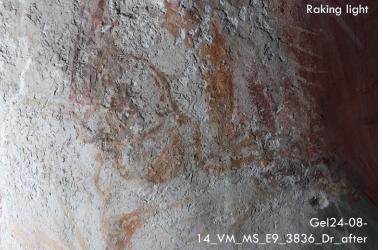
Left: In August 2024, the 2nd phase of remedial treatment programme was undertaken – development of intervention methodologies continued. Plaster losses and exposed edges were secured by microgrout. The low amount of mixture were selectively applied in small losses, which stabilised the condition of the plaster.

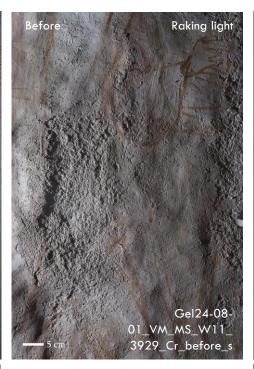
Left and right: In August 2024, the 2nd phase of remedial treatment programme was undertaken. Plaster has been consolidated with nano-lime, then loose plaster fragments and exposed edges were secured by micro-grout. The low amount of mixture were selectively applied in small losses, which stabilised the condition of the plaster.

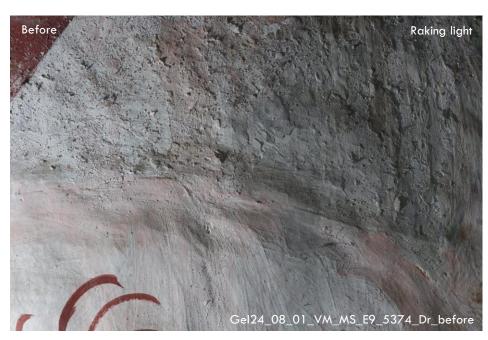
**Above** Condition of wall paintings before intervention in August 2024. The paint layer is flaking.

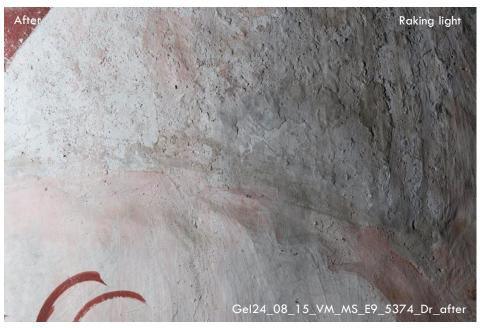
**Above:** In August 2024, the 2nd phase of remedial treatment programme was undertaken. Paint flakes have been re-adhered using nano-lime consolidant.

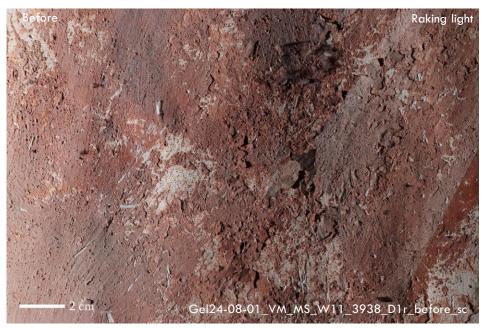
**Above** Condition of wall paintings before intervention in August 2024. The paint layer is flaking.

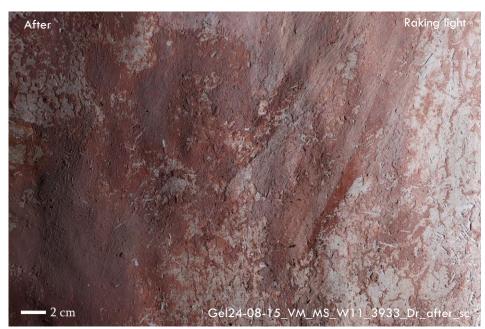
**Above:** In August 2024, the 2nd phase of remedial treatment programme was undertaken. Paint flakes have been re-adhered using nano-lime consolidant.
