The mosaic of the Virgin Mary in the Monastery of Gelati, Georgia. Conservation Program – Phase 1

Documentation, Diagnostics, Study and Executive Conservation Plan
Interim Report, July 24th, 2024

Roberto Nardi, Centro di Conservazione Archeologica – Roma

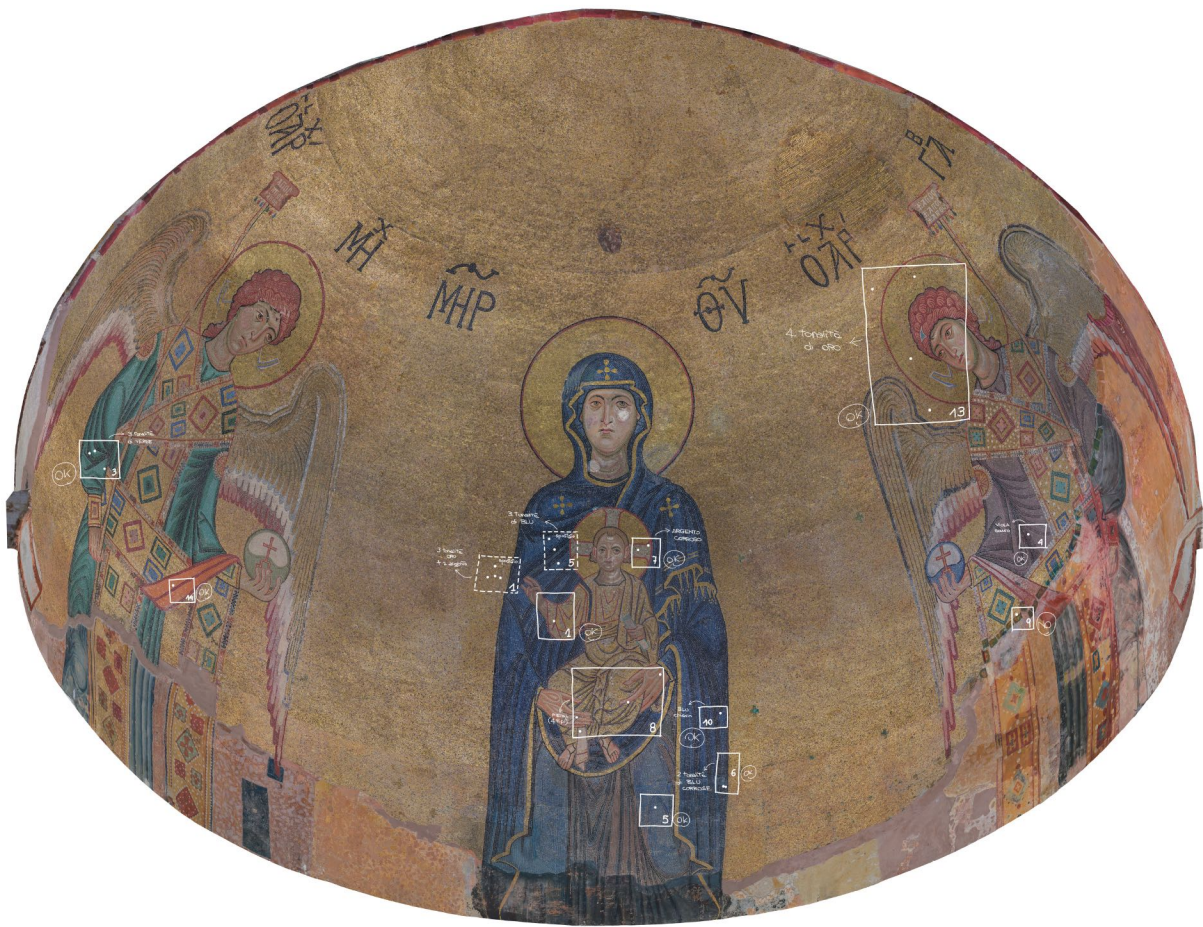
Map of sampling

A group of 21 tesserae withdrawals was prepared for export in Italy where at the moment the study is in progress. Some of the tesserae also include portions of mortar setting bed and pigment. The collection was carried out according to the most cautious conservative procedures and no damage occurred to the original material. It was performed by using a surgical scalpel and specillum. The tesserae were documented and transferred in laboratory containers by areas of interest. All the original material will be traced to Gelati and relocated in the original position by using lime mortar made according to the original components.

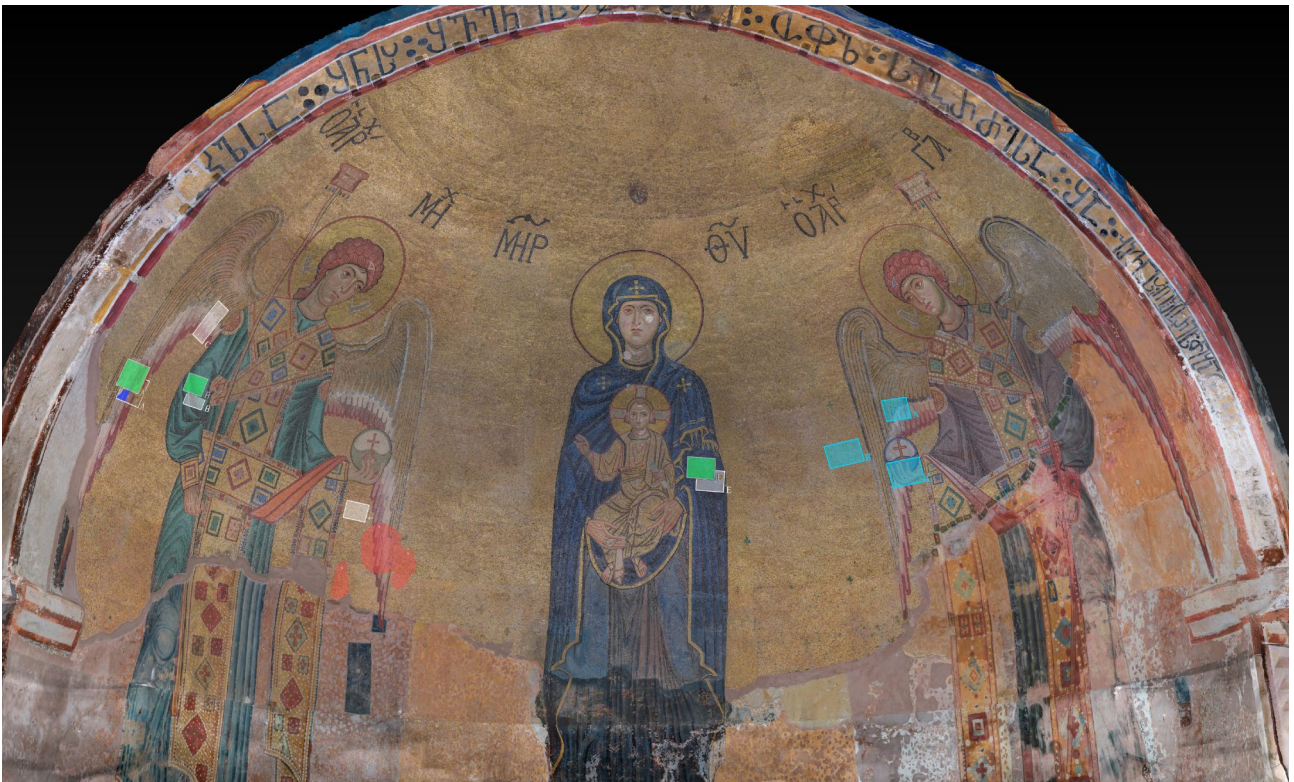
Map of the treatment tests

Cleaning: removal of soot deposits and coherent deposits

TEST 1 (Area A, in white): from pink and white stone tesserae, black schistose tesserae, gold tesserae and red glass pastes;

TEST 2 (Area B, in white): from glass pastes in shades of green;

TEST 3 (Area C, in white): from pink and white limestones, black schistose tesserae and red glass pastes;

TEST 4 (Area D, in white): from gold tiles.

TEST 5 (Piece E, in white): from glass pastes in shades of blue of the Virgin Mary's mantle.

TEST 6 (Area A-B in red), from pink and white limestones, red glass pastes and gold tesserae;

TEST 7 (Area A, in blue), from pink and white limestones and black stone;

TEST 8-10 (Area A-C in light blue): Right side of the apse, Archangel Gabriel;

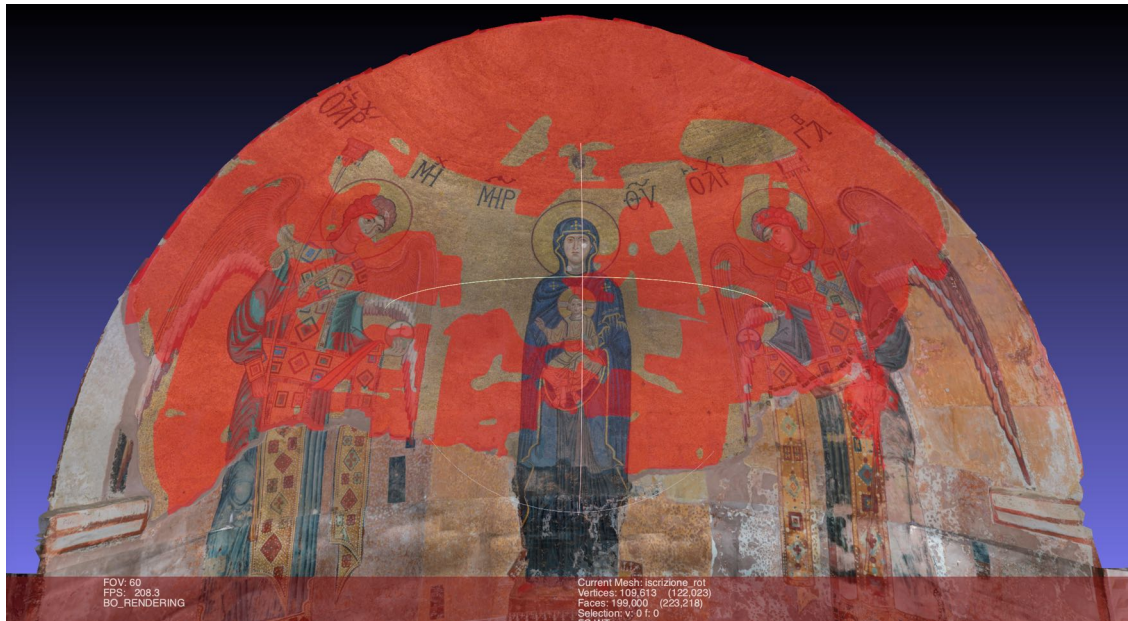
Map of detachments

After the first two survey campaigns in Gelati we had a hard time believing the verdict of the engineers who quantified the mosaic surfaces detached from the wall support at 89% of the entire surface. According to the engineers' belief, numbers are numbers and therefore they are not up for discussion. But it was not this that convinced us of the validity of the estimate, but rather what Karlo Bakuradze reported in his technical report in which he quantifies the surfaces detached in 1985 at 84%. Therefore a coincidence that erases any doubts about the current evaluation.

Despite these numbers, those who deal with mosaic conservation know well that it is not only the extent of a detachment that qualifies the seriousness of the problem, it is also the type of damage and the position of the detachments. In the case of Gelati, the panorama is the worst that can be imagined under all the aspects just mentioned. In more than 35% of that 89% of detached areas, the volume between the mosaic and the wall structure is practically empty for more than 22 millimeters of thickness. To the point that it was possible to investigate the interior of the structure with an endoscopic probe 5.5 mm thick and 2 meters long and identify, inside the mosaic, areas of strong air circulation, water passage and the presence of animals and biological attacks. Another 35% of detached areas is located in the upper section of the vault which means in the area of maximum physical stress. The picture is even more dangerous due to the presence of longitudinal fractures that did not exist at the time of Karlo Bakuradze.

Since these observations are preliminary and do not yet take into account all the information we are gathering, we are faced with a situation serious enough to suggest some cautionary measures. This is also in anticipation of the fact that further knowledge about the state of the mosaic will probably not only confirm the current assessment, but may even make it worse.

Above all, the recommendation is not to take any risks regarding the stresses to which the mosaic may be subjected. To be clear, the structure of the apse and the mosaic should not receive any static or vibrational stresses until an integrated mosaic-structure safeguarding system independent of the scaffold is put in place. This system will have to be the result of a preventive conservation program to be implemented as soon as possible and will be preparatory to the actual conservation intervention, which will follow immediately afterwards. It will consist of direct protection interventions on the mosaic surfaces that will ensure the stability of the mosaic and the creation of an external exoskeleton independent of the scaffolding, specially made according to the critical points of the mosaic.

Until this **preventive conservation intervention** is complete, it is recommended to exclude any action on the structures of the apse, both internal and external, and any intervention on the mosaic itself. Only when the entire mosaic surface will be secured, conservation activities and intervention on the roof of the apse will start in condition of security.
