Georgian Arts and Culture Center
7, Niko Nikoladze str.,
0108, Tbilisi, Georgia

**PROJECT FOR CONSERVATION INTERVENTION OF THE DOME DRUM
OF THE MAIN CHURCH IN GELATI, GEORGIA.**

1. STATE OF CONSERVATION

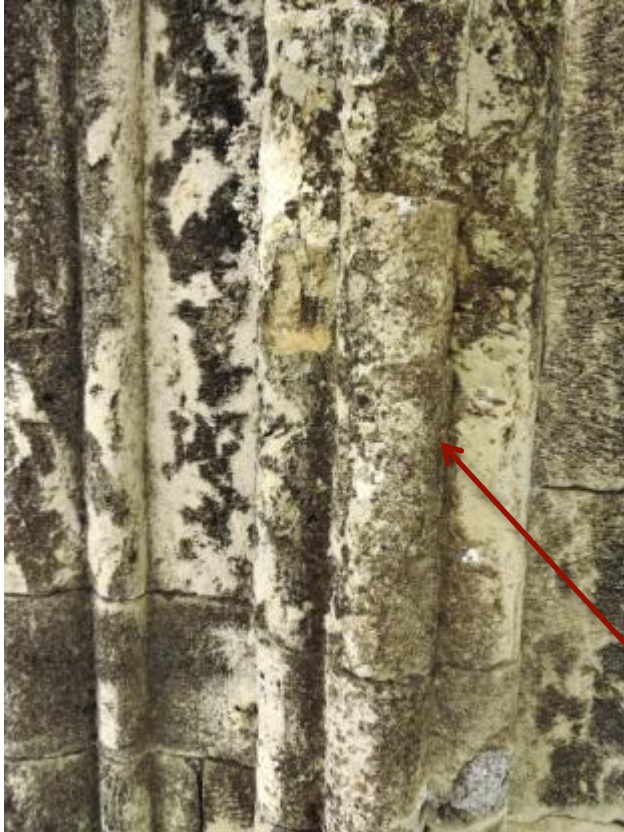
A profuse green/brownish-blackish layer of biological growth, clinging into the stone alveoli and spreading also inside cracks and fissures, can be observed over the surfaces (mostly foliose and crustose lichens and algae; sometimes weeds like *Parietaria*): microflora causes not only aesthetic decay but also physical/chemical deterioration of stone substratum, connected to growth and metabolism of vegetation (development of roots over the surfaces and inside the micro-fissures, mechanical stress, excretion of acid substance over the substratum which leads to chemical degradation of stone surface, etc)

This form of biodeterioration is particularly evident in areas facing north (more stable favorable microclimate)

An example of biological patina over the stone surface

- To treat microflora, a specific biocide (4% solution of Benzalkonium Chloride in demineralized water) will be sprayed over the surfaces. After 20 days, the time needed to complete the biocide action, devitalized vegetation will be removed by a delicate washing of the surface with the aid of soft nylon and/or sorghum brushes. Treated surfaces should not be washed away by rain for at least three days after application of biocide; in case of rain the application should be repeated.

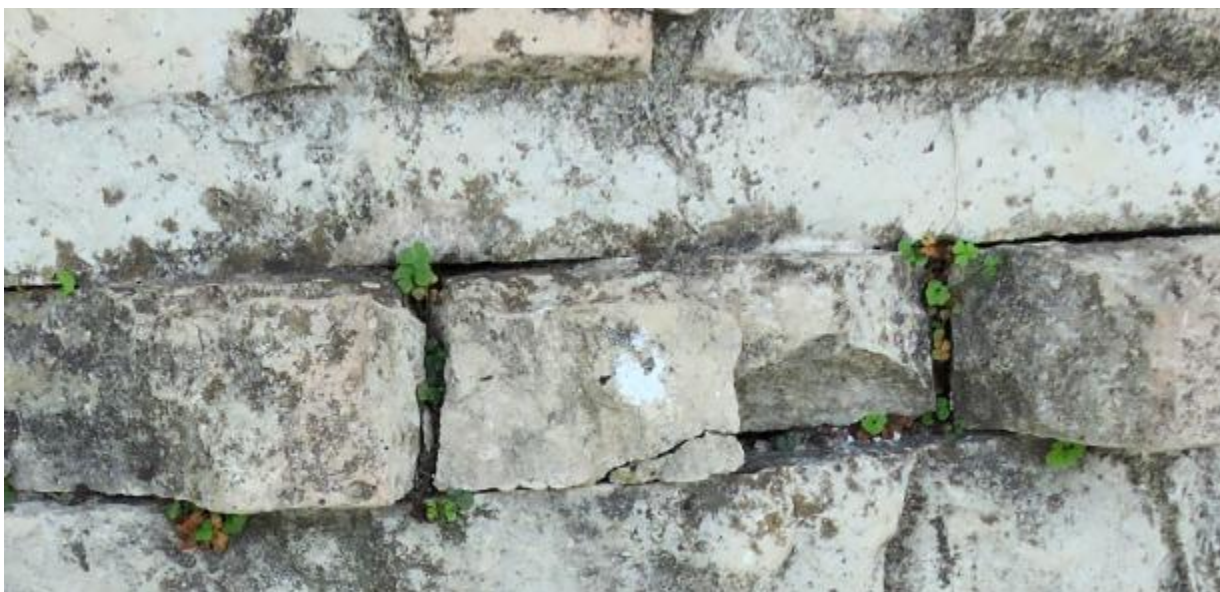
Weeds rooted in joints lacking bedding mortar.

A general reduction and/or total lack of bedding mortar among the stones can be observed: this facilitates the formation of preferential ways for seepage of rain water, causes washing away and formation of physical decay (for instance the disruptive action of water in seasonal cycles of frost and thaw) and chemical deterioration caused by natural and artificial “pollutants” carried by water...but this is not the only problem!

- Devitalization of weeds (such as *Parietara*) by a specific glifosate based herbicide (such as “Rodeo Gold” Monsanto). After 20 days, the time needed to complete the biocide action, devitalized weeds will be removed.

- Replacement of bedding lime mortar with suitable color and granulometry mortar (lime putty, river sand, suitable aggregates, 1: 3) after deep injection of natural hydraulic lime grout NHL5 + ventilated aggregates, such as cocciopesto or pozzolana 1: 1)

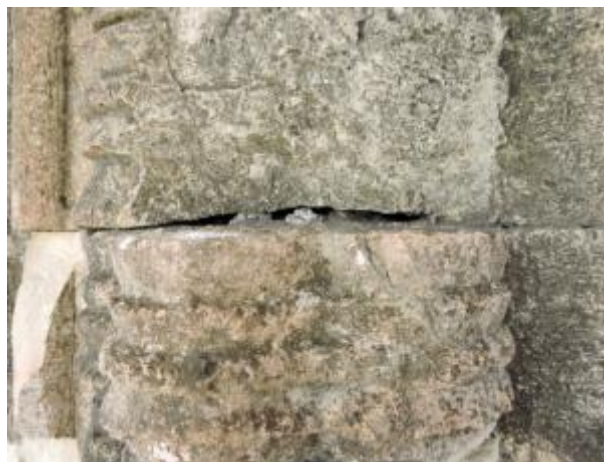
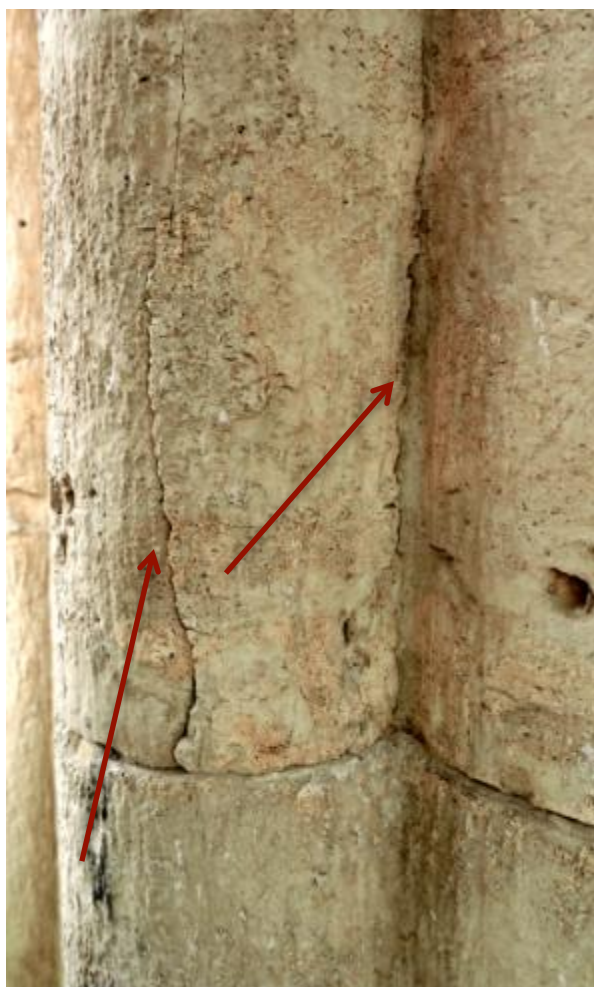
The partial or total loss of this bedding mortar, occurring over the centuries, puts the surfaces of the overlapping ashlars into direct contact; the mortar is no more there to absorb the compression and bending forces; the stress concentrated in points of contact causes

crackles, cracks and fissures that fracture the stone, then causing detachment and fall of stone parts.

Crackles and fissures caused by contact among ashlars.

- Refurbishment of lack of adhesion between plaster and bricks by injections of natural hydraulic lime with aggregates (NHL5 + ventilated aggregates, water and alcohol 1: 1)
- In places where ashlar are in direct contact, separation, by means of a thin diamond disk, between two elements to create a suitable mortar joint (it is important to get a suitable space into the joints without altering the building technique) 2 mm.

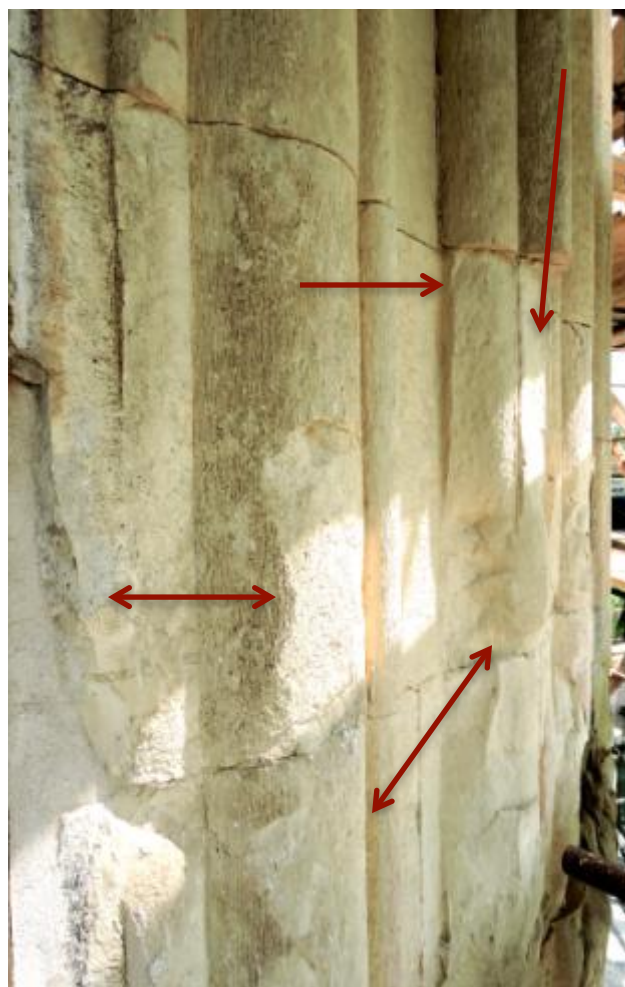
Loss of large stone parts

Many areas of the dome drum are affected by this pathology and are characterized by a typical web of crackles and fissures, by parts still *in situ* though unsafe and by a diffuse loss of original material either in wall surfaces or in decorated parts (typical lacunas at the corners of ashlars and delaminations of the modillion mouldings can be seen, etc.).

- Reconstruction in reinforced mortar of parts where ashlar that are fundamental for wall stability are missing (for instance if they are a support for the upper ashlar)

In the corners or in the parts to be reconstructed a sort of reinforced support with a fiberglass net G.F.R.P. ("FIBMESH 33x33t96ar" Fibre Net) will be anchored with stainless reinforced steel micro-pivots (4 mm), to support mortar.

The mortar used for reconstruction should have a mechanical resistance similar to the stone (in this case a "bastard" mortar should be used, that is 30% of binder made of white cement and 70% natural hydraulic lime NHL5)

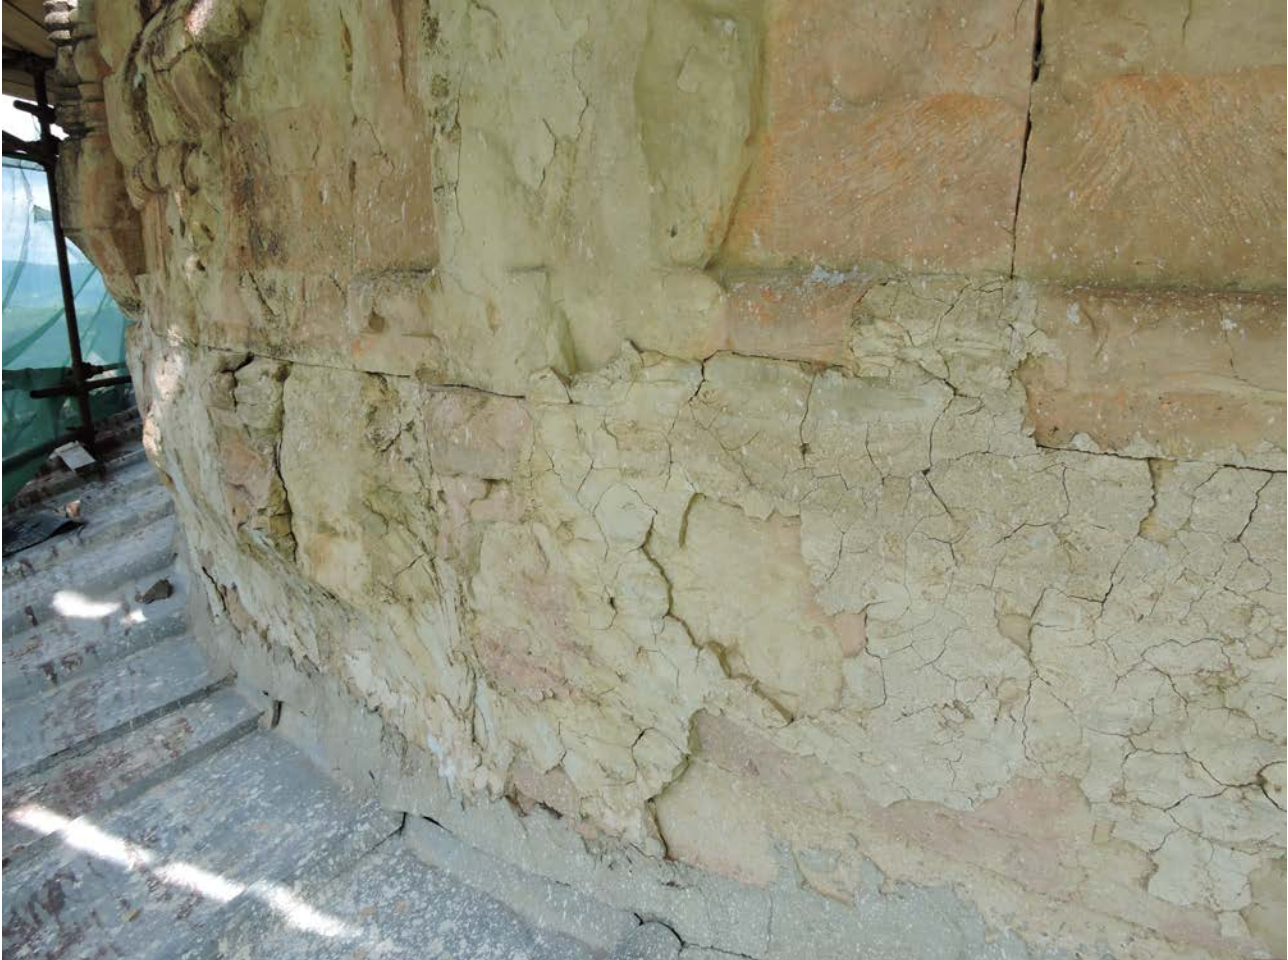
The lower part of the dome drum, just above the roofs of the lower building, shows a severe decay, likely caused by a specific event that affected this architectural part in the past centuries (fire of shelters?): for the time being no archive documents have been found. Stone surfaces are widely covered by a concrete mortar; under this layer the stone is cracked and fragmented, sometimes lacking cohesion.

- Mechanical removal of concrete fillings which are not suitable for an appropriate conservation.
- Refurbishment of lack of cohesion of stone (lower part of the dome drum) and of bricks by an inorganic consolidant (Ethylsilicate Wacker OH 100), injected with a syringe into all crackles, cracks and fissures and applied with a brush until saturation of the stone. Thirty days are needed to Ethylsilicate to complete consolidation; it is also important to avoid that, during the first 15 days after application, the surfaces are exposed to rain and control that the temperature are within 15° and 30 ° Celsius.

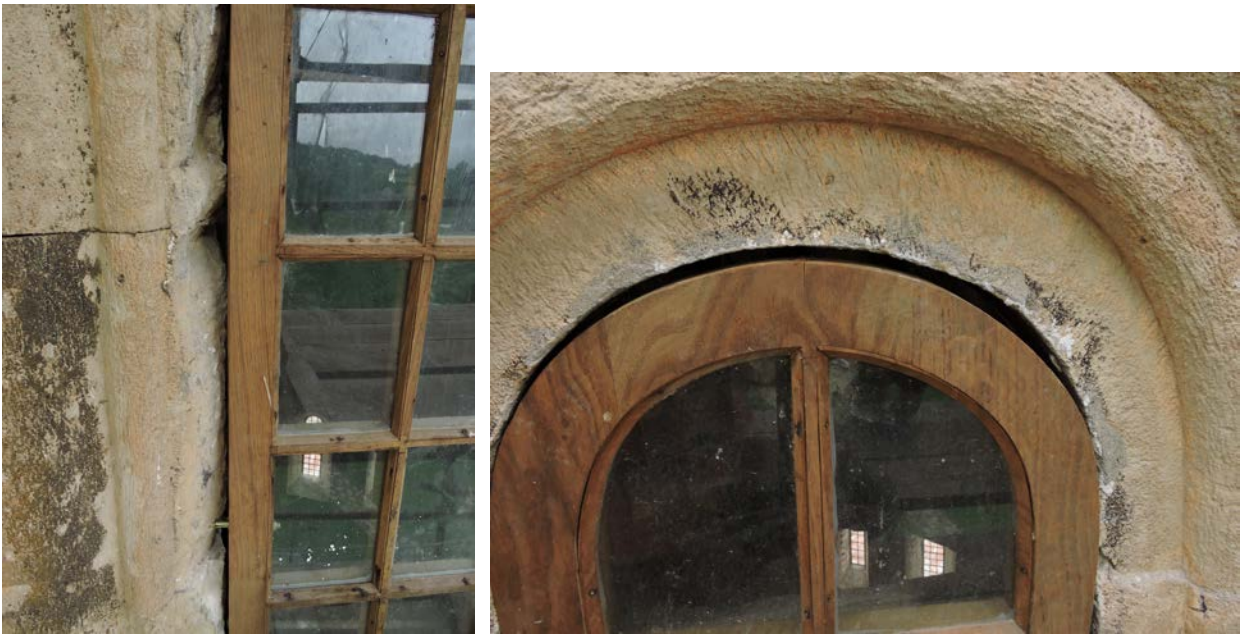
The concrete mortar, laid in the past with the aim to preserve the decayed ashlar, contributed, on the contrary, to worsen conservation: the migration of soluble salts contained in concrete and its elastic modulus which differs from the original stone, greatly increased disintegration over and beneath the surface and fragmentation of ashlar.

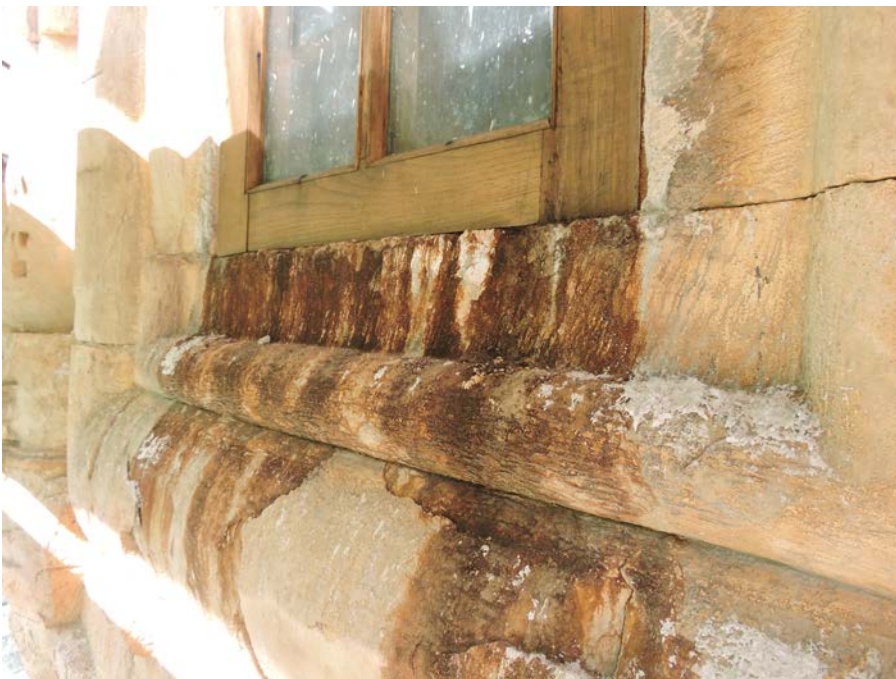
Two specific problems connected with the recent placing of oak frames can be observed. Due to the lack of a framework in the wooden frames a deleterious disjointment between wood and stone allows seepage of rain water. Moreover, since the time in which the window frames were put in place, one year ago, the insufficiently seasoned wood caused a very widespread leakage of tannin over the stone surfaces.

- Sealing the gap between stone and window frames 5 mm below the stone level with "Sikaflex 11FC" Sika, to allow space for a mimetic filling with lime mortar.

The only areas that need to be cleaned are those stained by tannin leaks. Preliminary tests of cleaning will be carried out with suitable supports (cellulose paste Arbocel 1000 and/or ventilated sepiolite) and suitable buffered solvents and/or surfactants (Ammonium Carbonate, contrad 2000, Hydrogen Peroxide).

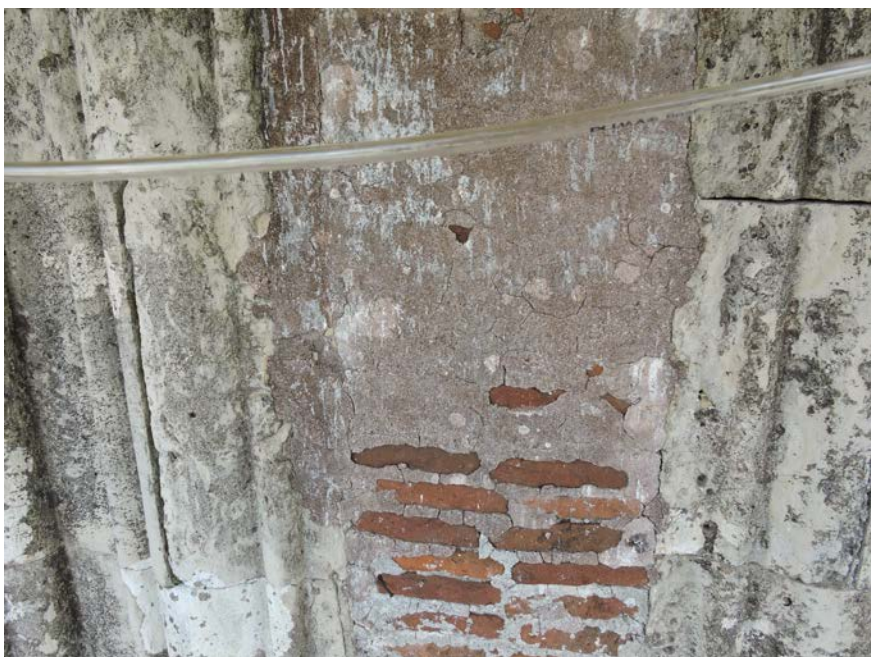
Some windows were in-filled in ancient times (inner wall paintings) with bricks covered by a layer of mortar. Plaster shows decay: biological growth, crackles and fissures, lack of adhesion to the wall, detachments, loss of material and lacunas. The visible bricks show weak cohesion, pulverization, erosion and loss of material.

- Filling of fissures, fractures, plaster borders of in-filled windows, lacunas, with a suitable color and granulometry mortar (lime putty, river sand, suitable aggregates, 1: 3)
