ICOMOS Technical Review

Property	Gelati Monastery
State Party	Georgia
Property ID	710bis
Date inscription	1994
Criteria	(iv)
Project	Proposal on the Arrangement of the Temporary Roofing over the Church of the Virgin

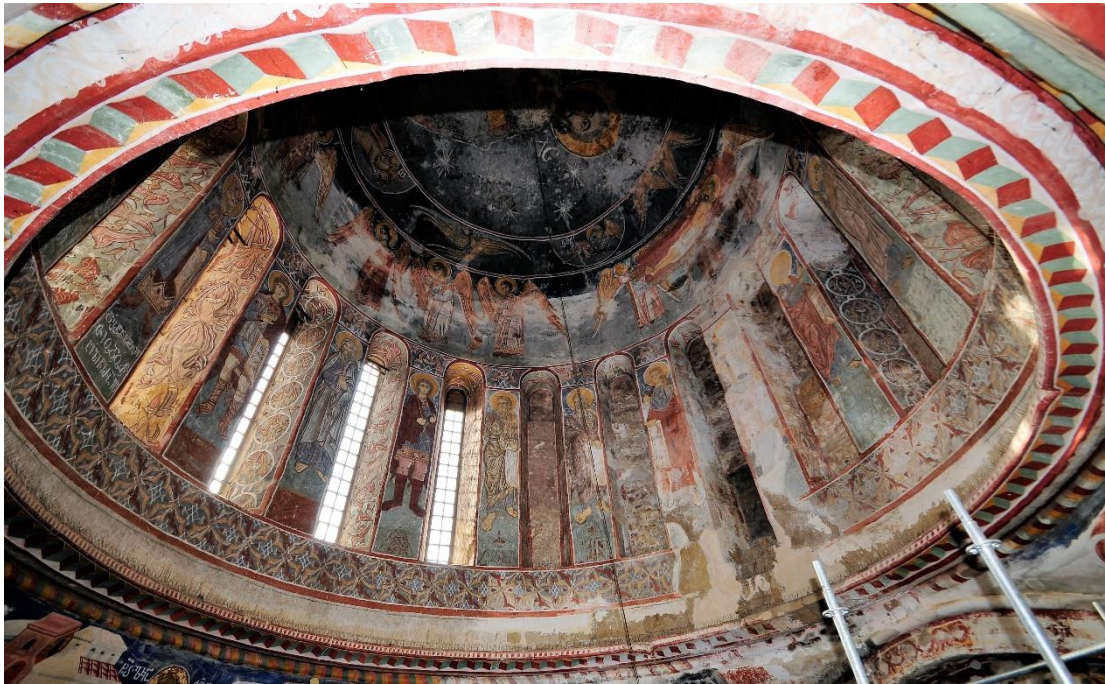
- ii. Visible effects of long-term water infiltration accompanied with salt crystallization and moisture action on the church cupola's interior building blocks and its wall-paintings are assessed at the tholobate level of the dome. Moisture on the pillars between the window openings on the west side of the tholobate has caused serious damage to the representations of prophets, as well as to the building blocks of the ring base of the drum. It should be noted that these window openings have been walled in the distant past, either for reasons of strengthening the bearing capacity of the extremely tall dome, or to block the inflow of rainwater, or for both reasons. In fact, due to this fact, the only internal exit to the outside of the cathedral has also been blocked. In the western dome area, the effects of moisture (recent and older) are evident and are in fact within the masonry areas that have been repeatedly repaired with the use of cement even in the recent past, long after the walling of the window openings (Figs. No. 1, 2, 3, 4).

Fig. 1. The drum with visible results of active moisture. The walled window openings on the west side of the tholobate.

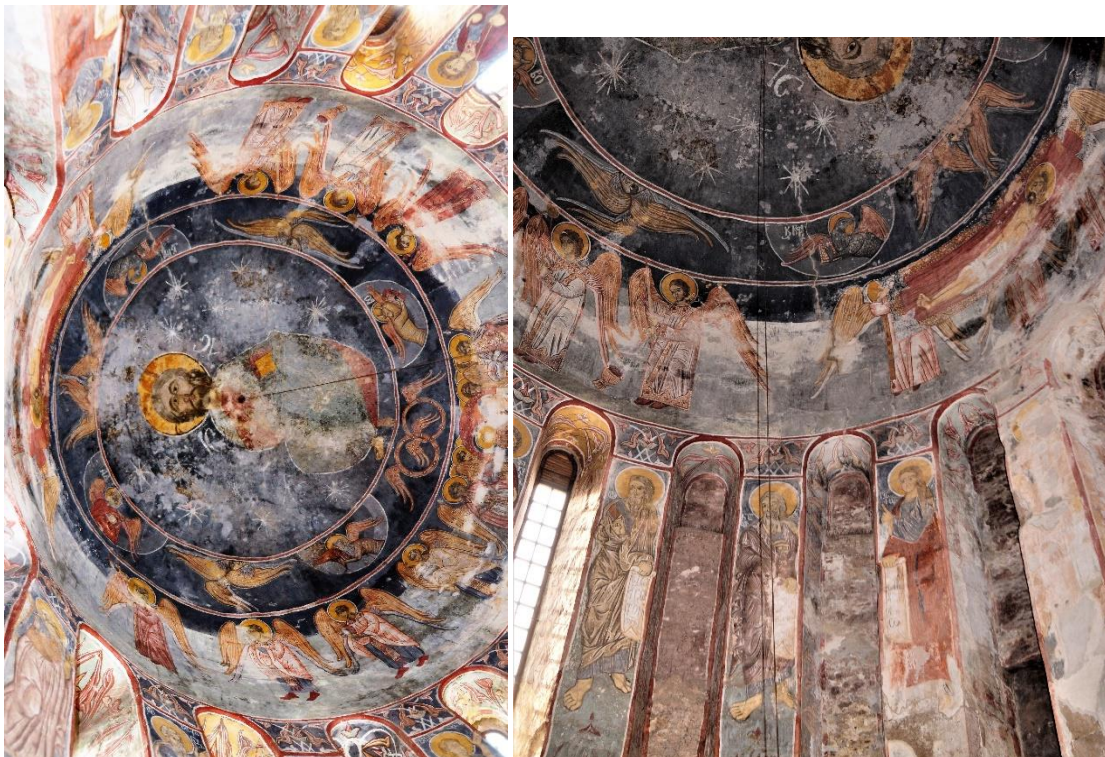
- i. During the Joint Advisory mission, it was not possible to closely inspect the uppermost part of the dome from the inside, as there was no interior scaffolding with such height present. The visual inspection, therefore, was made from the distance of the ring at the base of the tholobate, and with the help of telephoto lenses. Thus, it was not possible to assess with certainty the condition of the fresco of the Pantocrator. Nevertheless, in the photographs, there are many blurred spots in the depiction of the Pantocrator, which may very possibly be damages to the fresco due to moisture.

Fig. 2. The cupola with the representation of Pantocrator with evidence of moisture results.

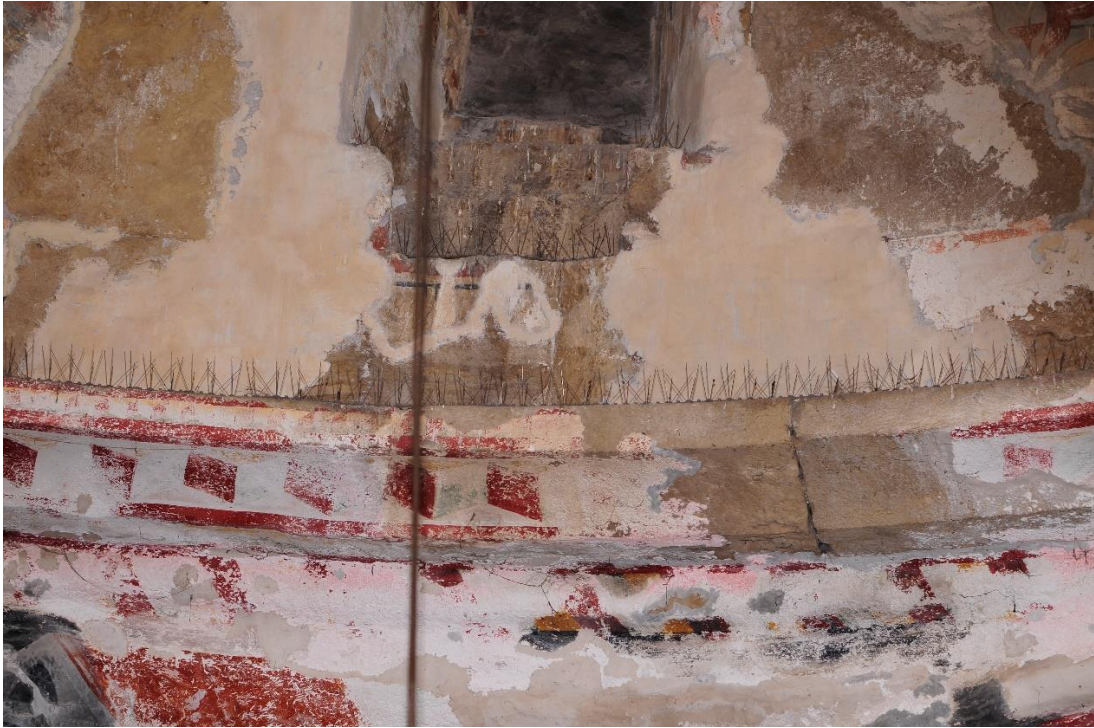
Fig. 4. Drum base west side - the walled exit to outside of the cathedral: old and recent moisture results

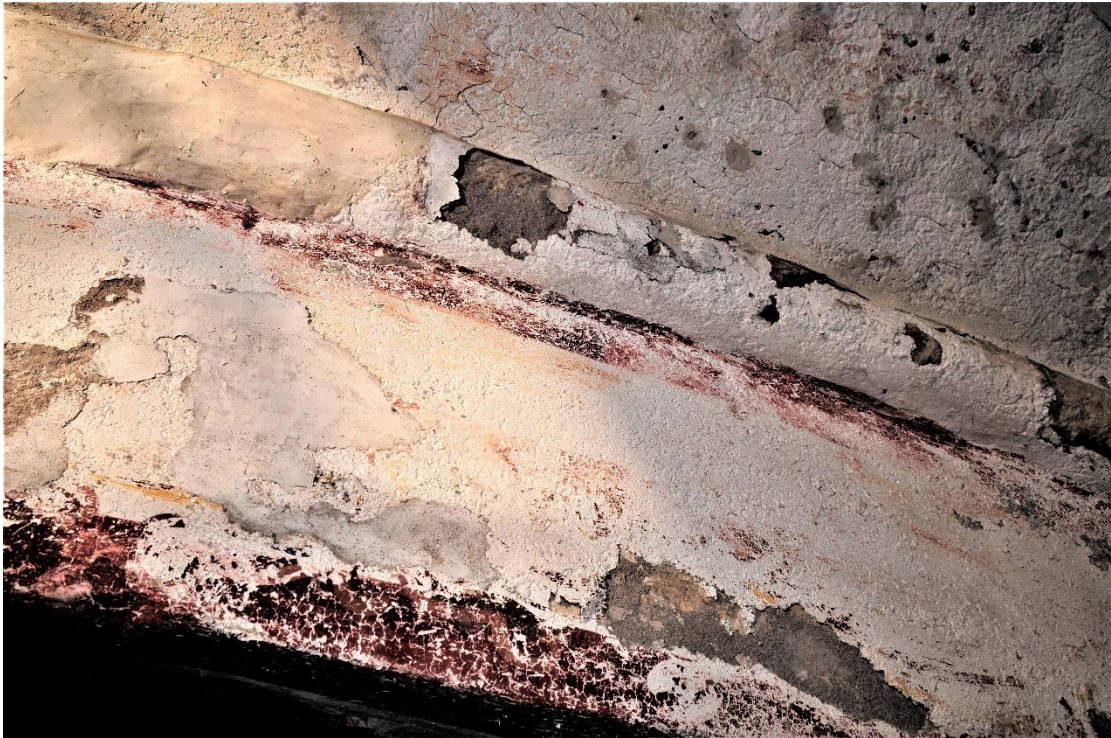
- iii. The Technical Report acknowledges that "*The water infiltration problem arises at the meeting point of the temporary roof and the tholobate of the dome*" (Annex 01, p.7). The Joint Advisory mission found recent moisture phenomena still in progress at the ring of the tholobate, which have long-since progressed to the pendentives that support the dome, with devastating consequences for their frescoes. These findings of severely decayed areas were identified by the Joint Advisory mission report (p. 17 and photos 32, 33). In fact, the damaged pendentives are visible from the ground level of the cathedral. Only the South East pendentive retains its fresco (which may have been painted over in the past) (Figs. 5, 6, 7, 8, 9, 10, 11).

Fig. 5. The ring at the base of drum - west side: moisture effects.

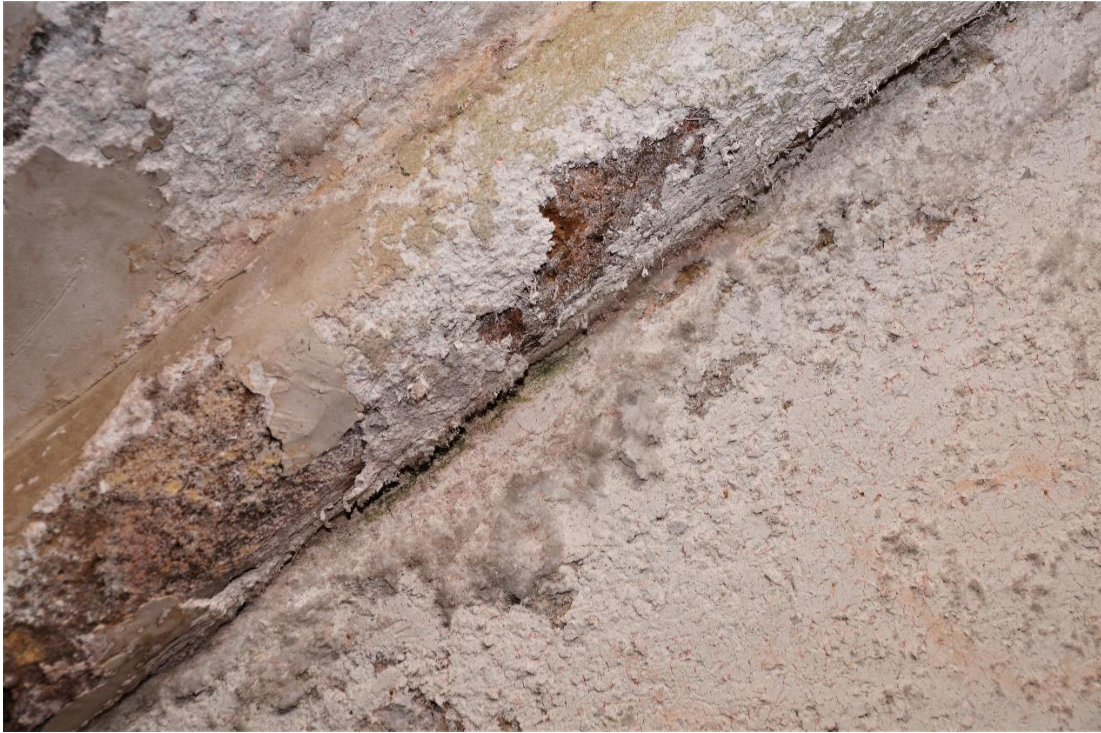
Fig. 6. N-W pendentive: moisture effects.

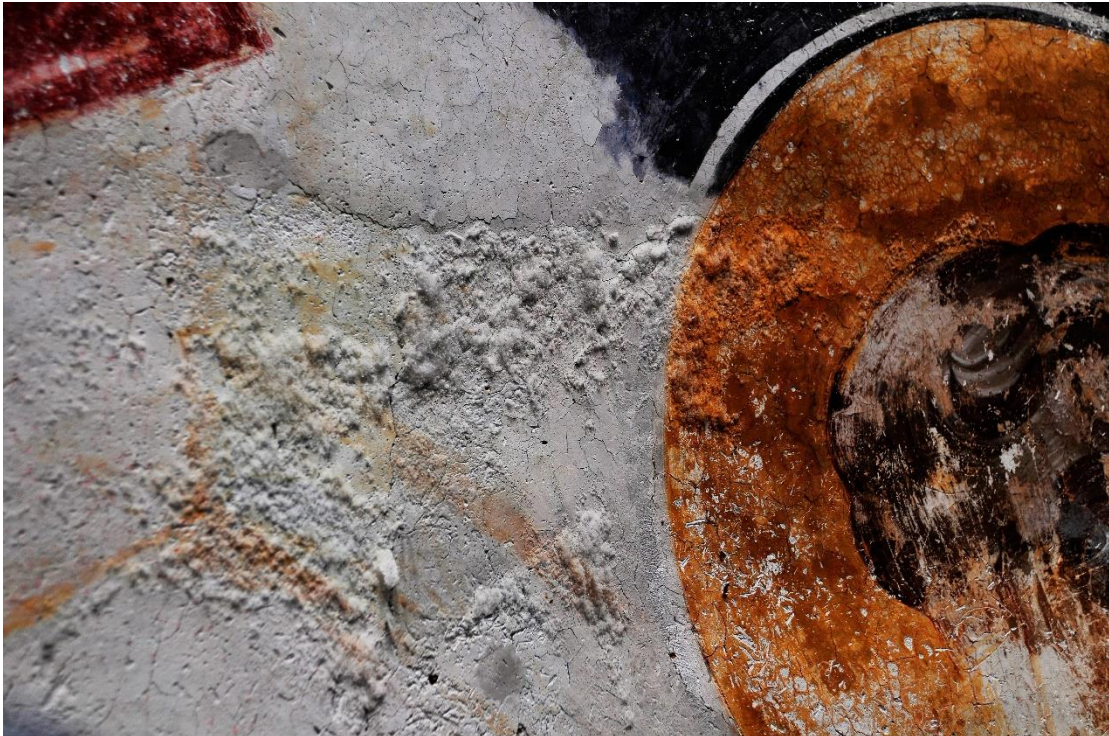
Fig. 7. N-W pendentive: moisture effects.

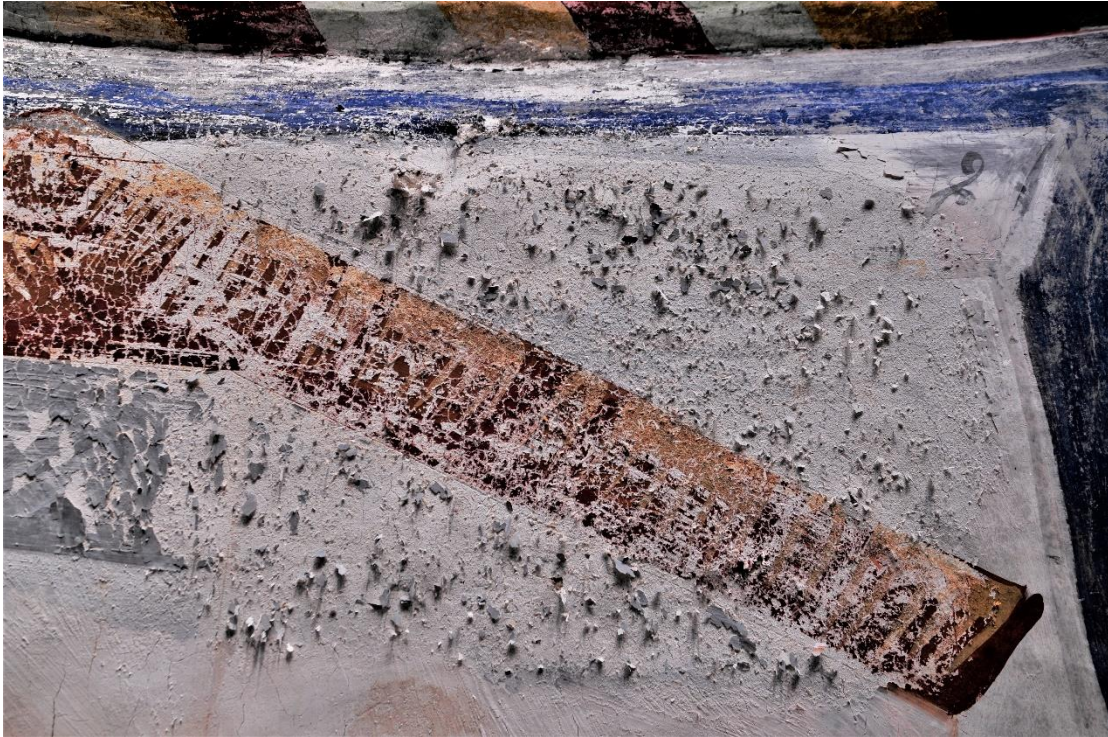
Fig. 8. N-W pendentive: moisture effects.

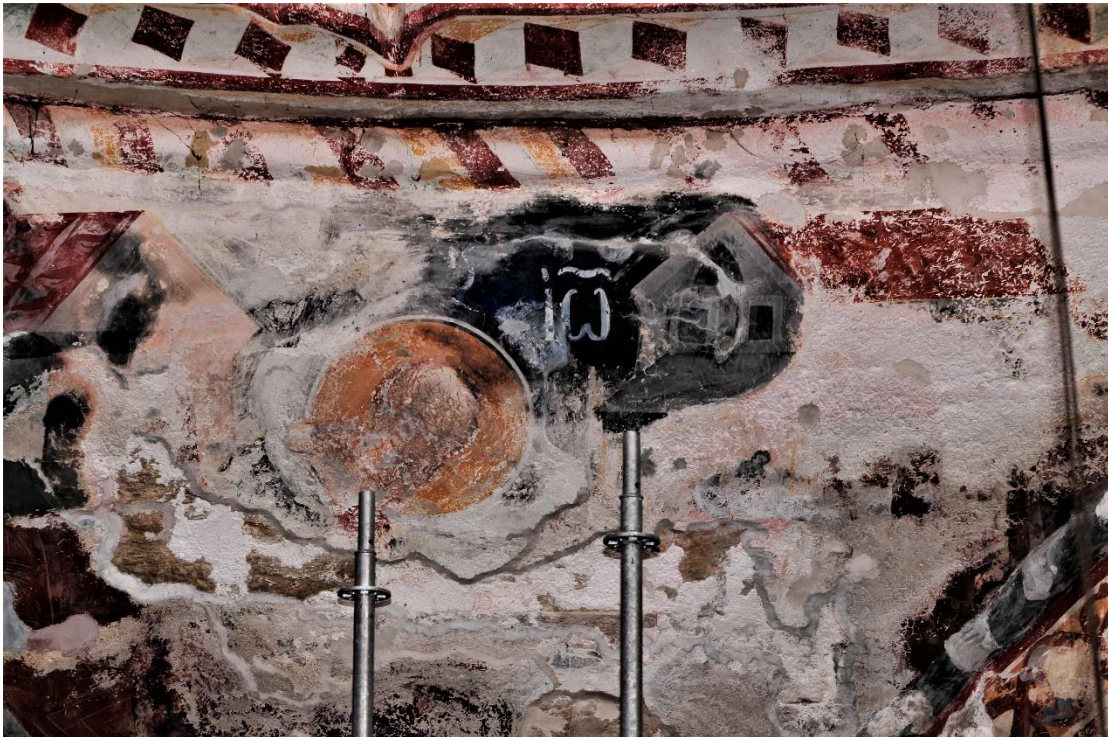
Fig. 9. S-W pendentive: moisture effects.

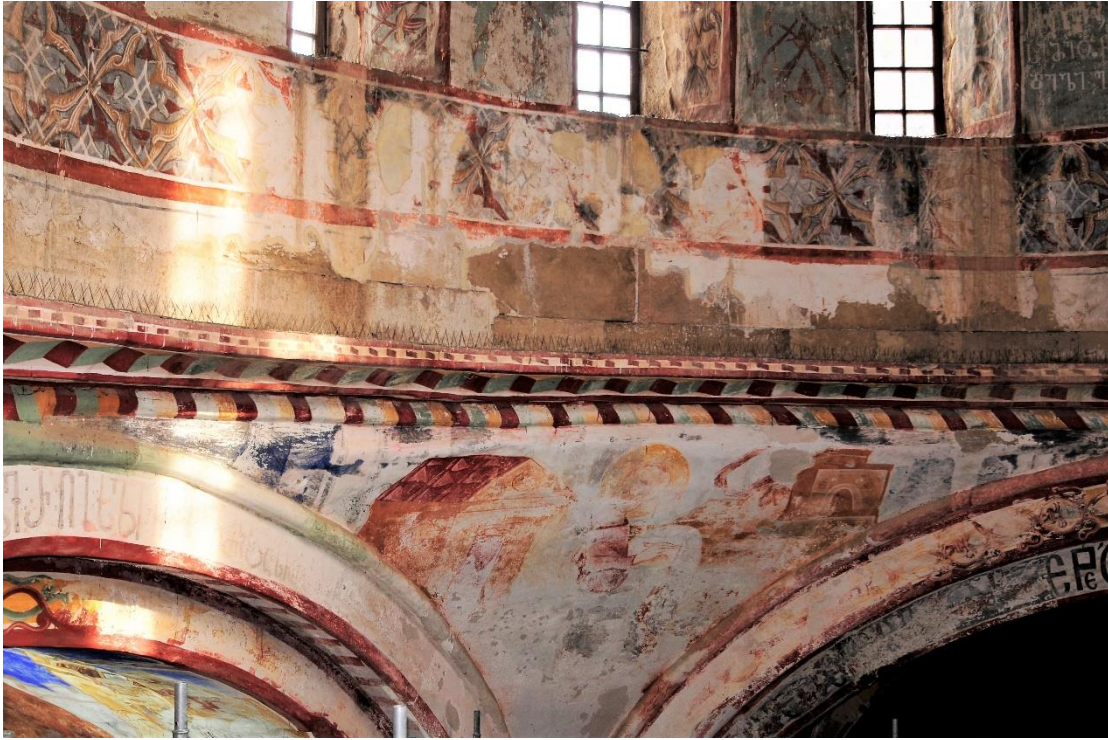
Fig. 10. N-E pendentive: moisture effects.

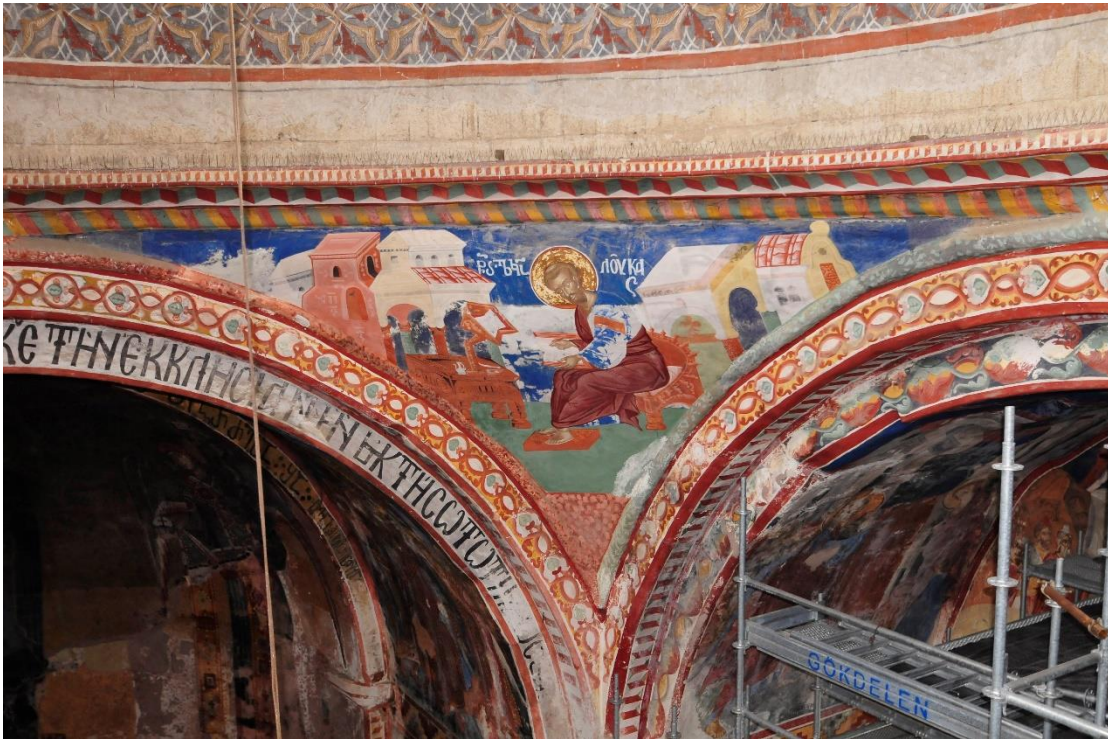
Fig. 11. S-E pendentive: existing condition.

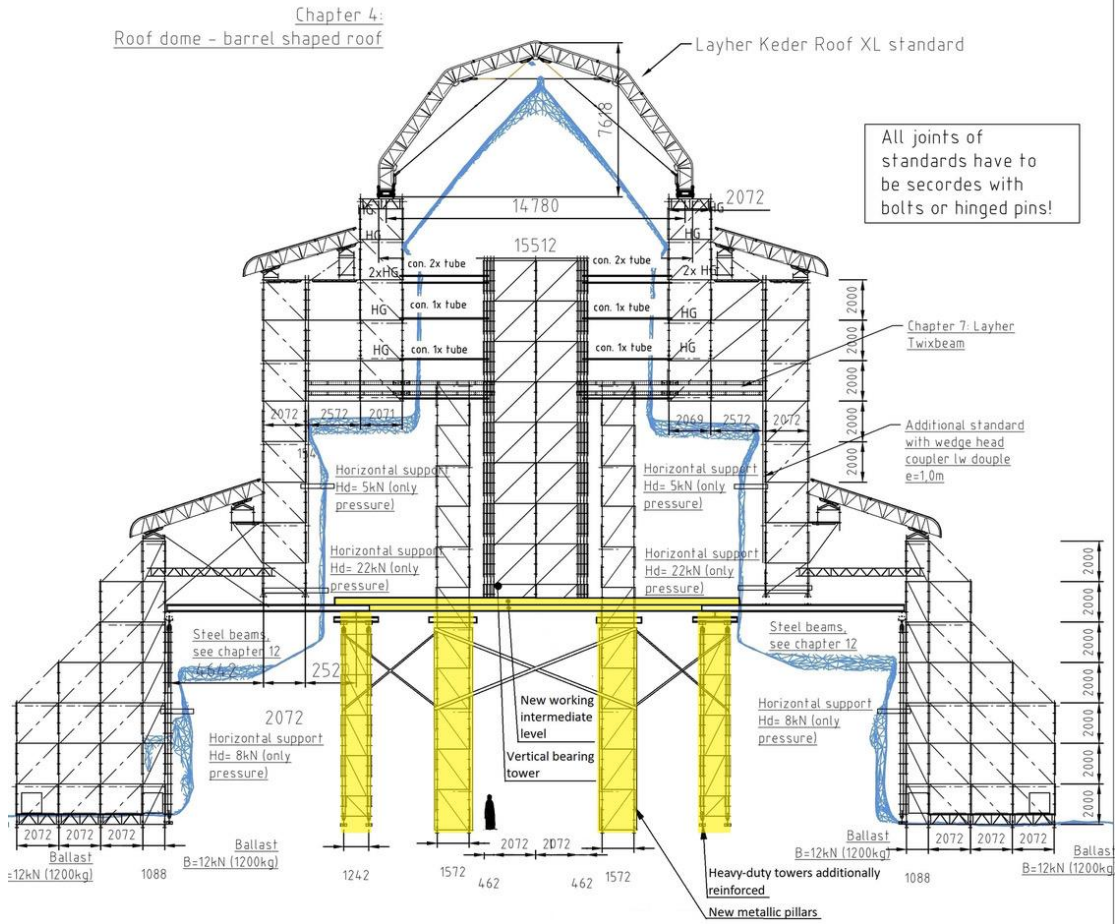
Fig. 12. Schematic alternative proposal for supporting the vertical bearing tower with full covering of the cupola.

Considering that the dome will be completely covered, and in view of the requirement of a central pillar (vertical bearing tower) in order to stabilize the dome structure against horizontal loads such as wind and earthquakes, it is not inevitable that this structure should reach to and rest on the ground level of the cathedral. The central pillar can rest at an intermediate horizontal plane, constructed at a suitable height from the ground level of the cathedral, with sufficient strength to receive the loads from the overlying structure. Judging from the provided scaffolding structure cross section plan (Annex 3, p.2), the intermediate plane could be constructed at the height of the foreseen first horizontal support (ca. 10,10 m.). Ultimately, this intermediate plane could be supported on the ground level by 4 metallic pillars at the four eagle points of the inscribed square inside the projection of the dome base circle, being cross connected to each other at a reasonable height. Alternatively, the working intermediate level could rely on the predicted heavy-duty towers beside the centre of the cathedral – those being additionally reinforced - or on a combination of both supporting systems (pillars and towers). Thus, this alternative solution will free up sufficient space in the central part of the cathedral (ca. 6,80 m. between the 4 metallic pillars), so that the performance of liturgical services would not be restricted, neither would the free access of pilgrims and visitors be hindered throughout the time frame of the restoration work.

An explanatory-schematic construction plan is attached, based on the modification of the proposed construction plans by the State Party (Fig. 12).

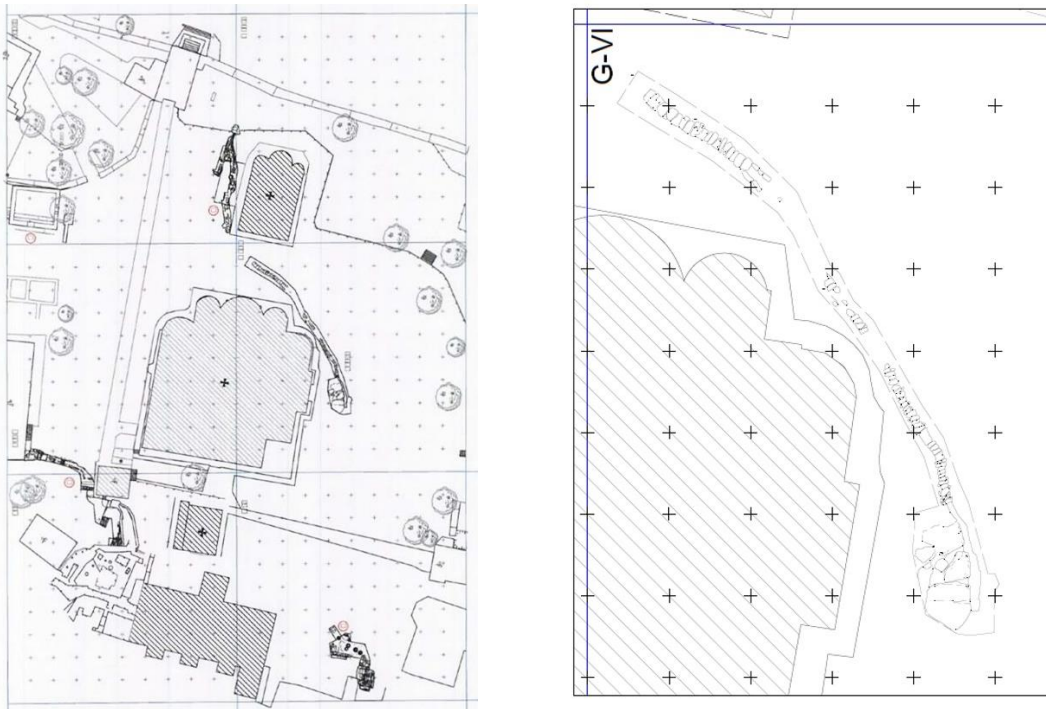
On this matter ICOMOS notes that during archaeological excavations, ancient drainage channels have been found around the churches of the Monastery. The ancient water drainage system is out of order for a long time and, moreover, it is not visible as it is covered by the ground (cf. Photo Report on Drainage Collector restoration-rehabilitation (2018-2019) shared by Georgian Expert Team; Annex 2_State of conservation report Gelati Monastery, 2020, p. 234, Drawing N4 – see here attached: figs. 13, 14, 15, 16).

Fig. 13. Ancient drainage channels found around the churches of the Monastery.

The ancient system is placed differently from the recent system (2019-2020) for the collection and passage of water, consisting of downpipes, sewer manholes and a sewage network outward from the Church of the Virgin. Consequently, particular attention should be paid to the substructures of the South East main pillar and of the external southern secondary pillar of the proposed design for the scaffolding structure.

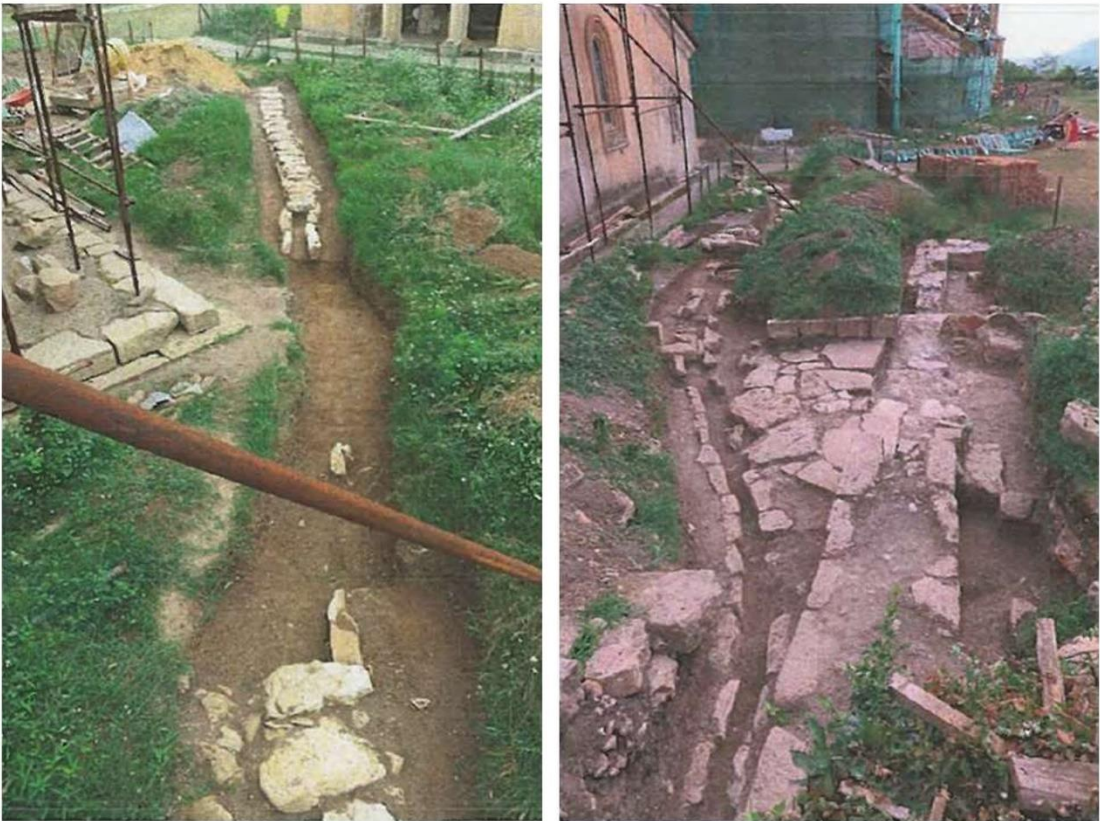
Fig. 15. Photo documentation of drainage collector in the Monastery grounds near the churches.

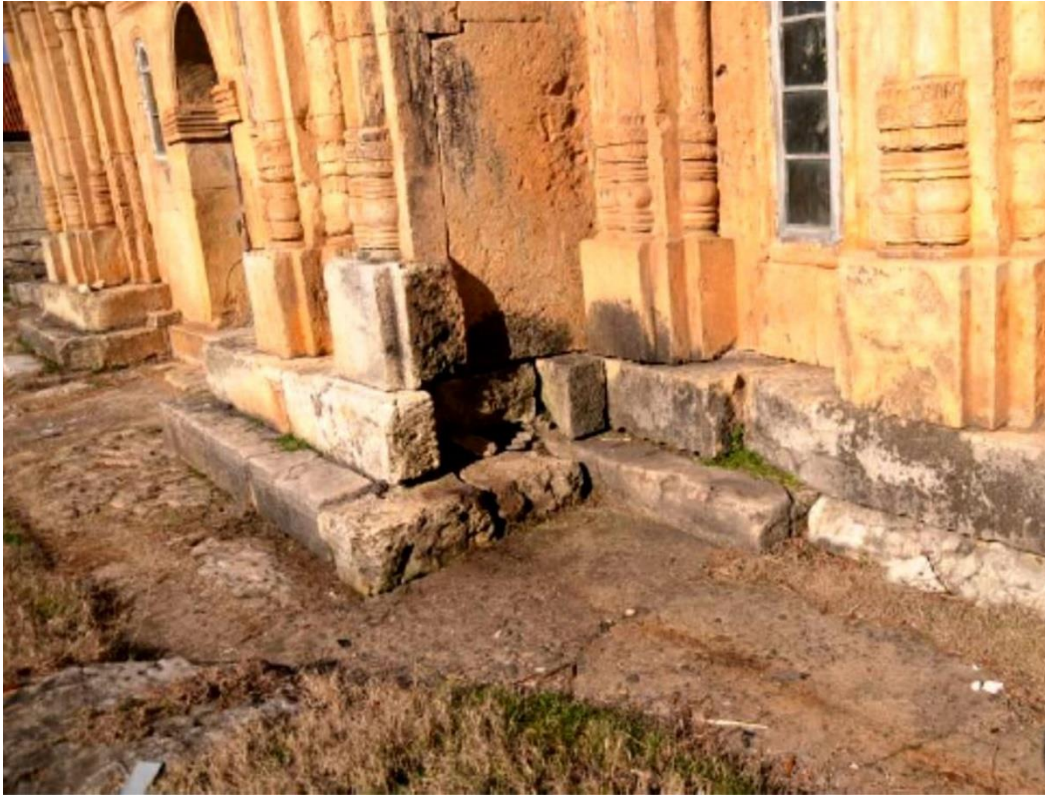
Fig. 16. S-E side: The crepidoma of the Church of the Virgin with the old drainage system around it (2015 joint ICOMOS/World Bank Advisory mission report, fig.10)
