Industry & Facilities Division
Third Party Inspection Report

INSPECTION REPORT No.CA15092401		Revision No. 1
<input type="checkbox"/> Initial <input checked="" type="checkbox"/> Interim <input type="checkbox"/> Final <input type="checkbox"/> Resident <input type="checkbox"/> Remote		
Inspection requested by: Foundation of Gelati Rehabilitation Temporary Committee		
Inspection performed as Recognised Authority:		<input type="checkbox"/> Yes, :(Recognition) <input checked="" type="checkbox"/> No
BV Job Nr: GE.9235725

Project: Gelati Monastery Rehabilitation Project	IPO Ref (If applicable): N/A (BV internal P/O)
BV Client: Foundation Of Gelati Rehabilitation Temporary Committee	P/o nr: N/A (client to BV)
Manufacturer/Vendor: Quadrex Gerüstbau GMBH	P/o nr: N/A (client to Manufacturer)
Sub-Vendor (If applicable): N/A	
Inspection Location (Address): Tkibuli Municipality, Village Gelati, Gelati Monastery, Kutaisi, Georgia	Previous Inspection (If applicable): N/A
Inspection Location (GPS Coordinates): 42.29482, 42.76813	Next Inspection (If applicable): October, 2024
Inspection performed on: 10/11/12/13.09.2024	Total No. of Inspection Days: 4 Days

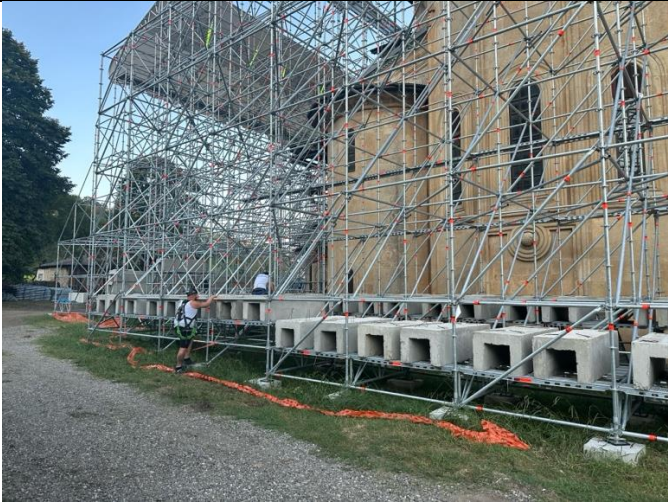
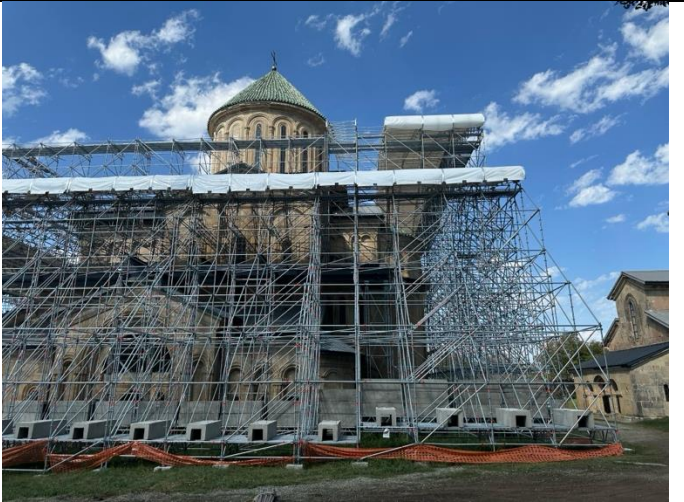
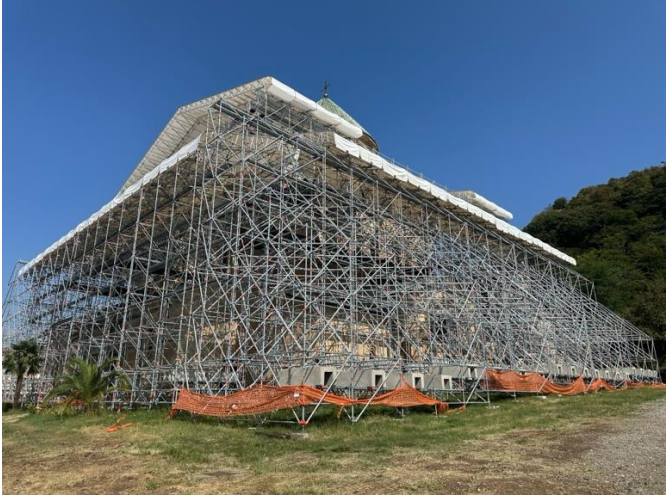
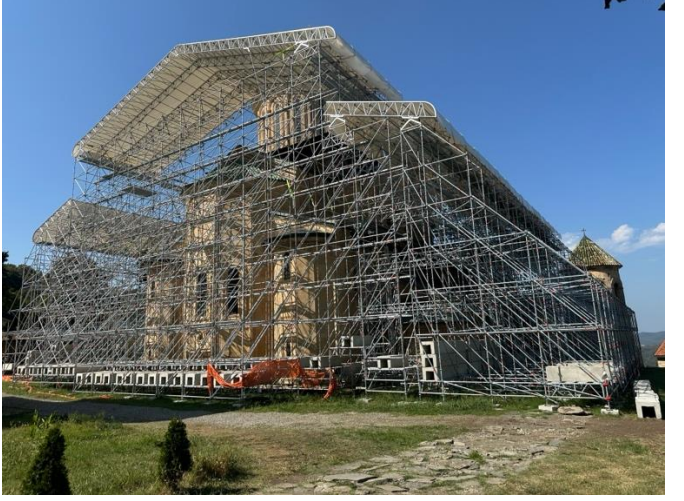
<p><i>Description: General View Scaffolding</i></p>

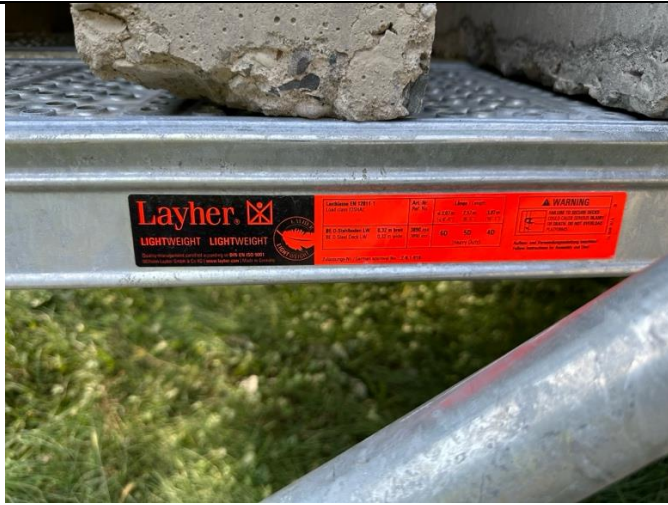
Description: Scaffolding Name LAYHER

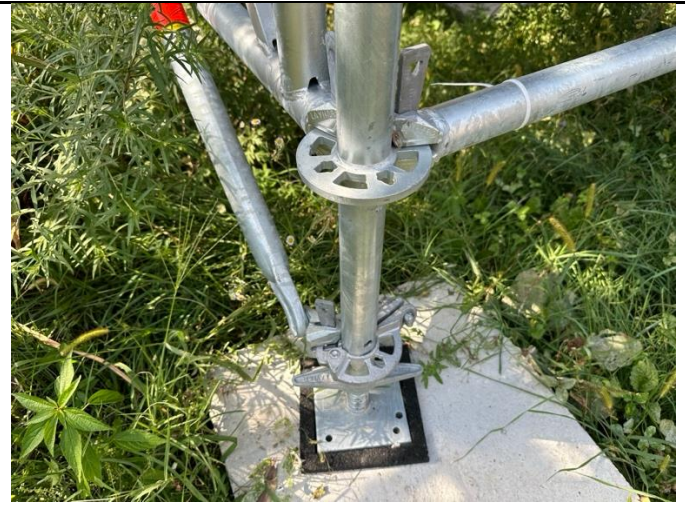
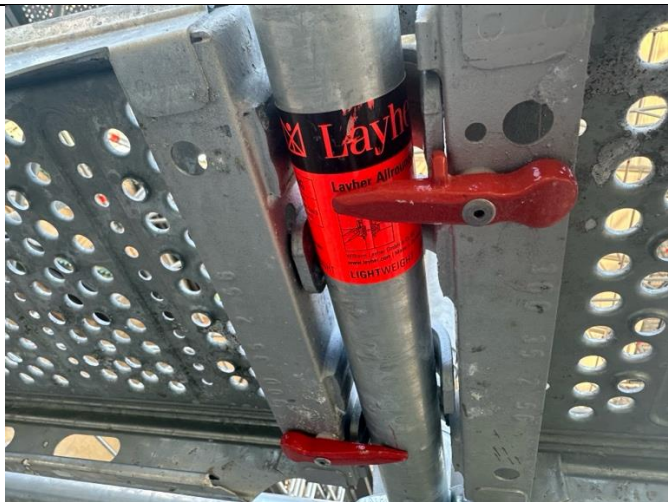
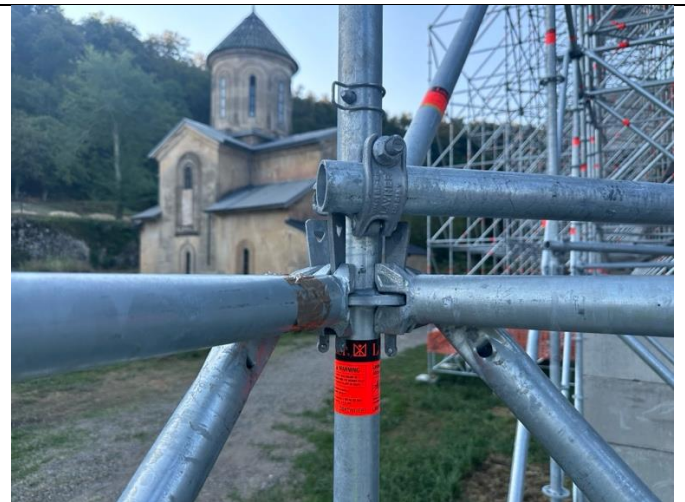
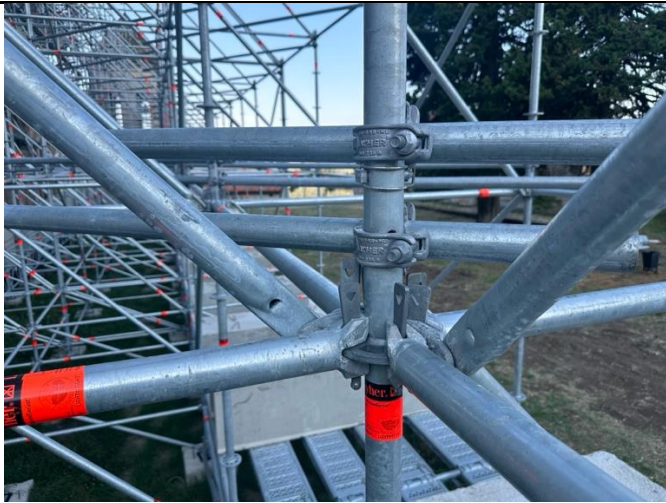
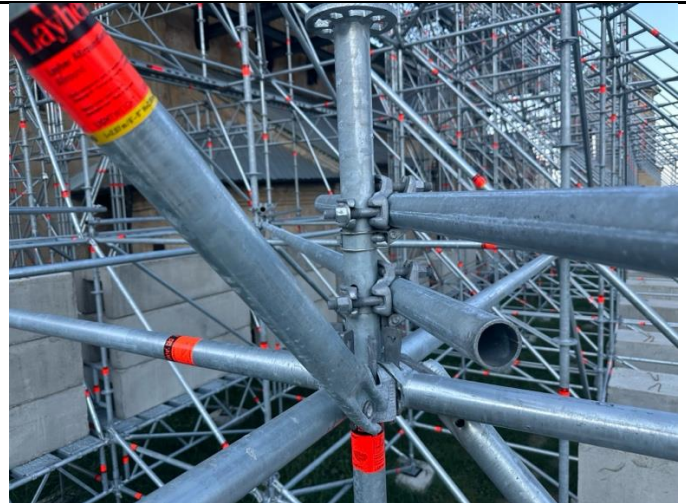
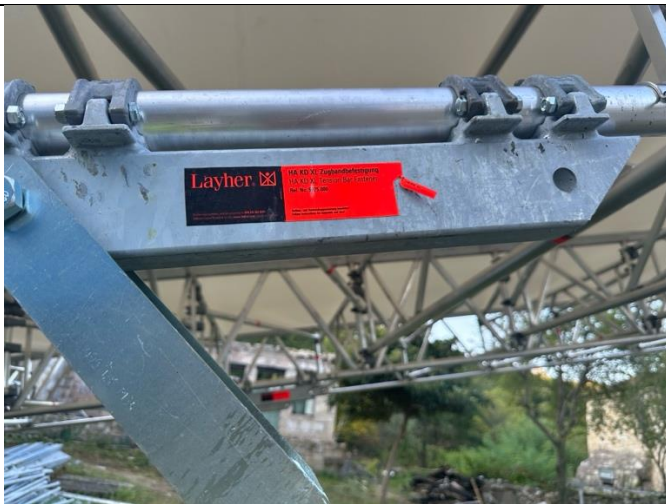
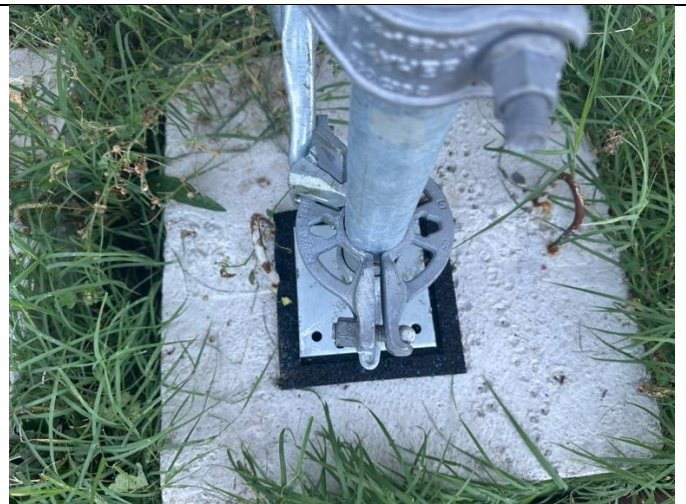
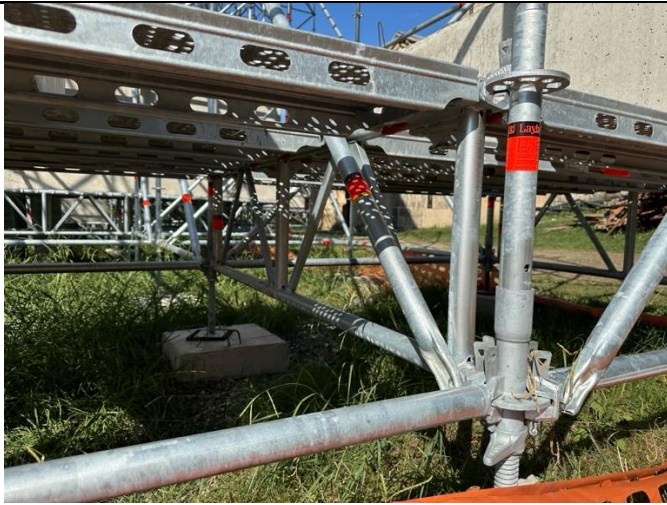
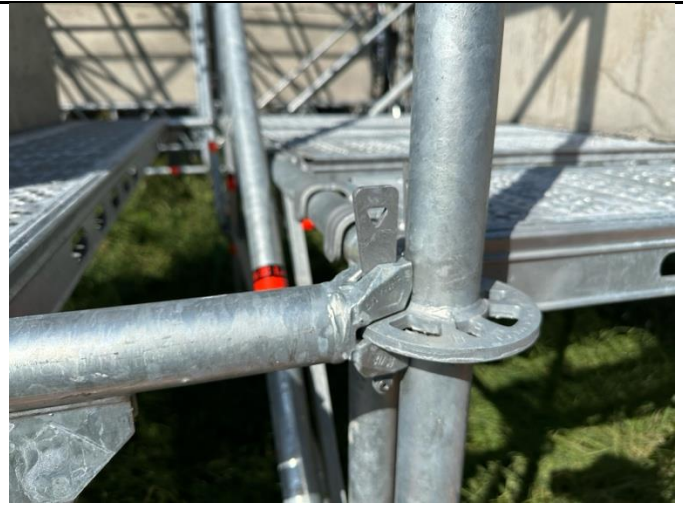
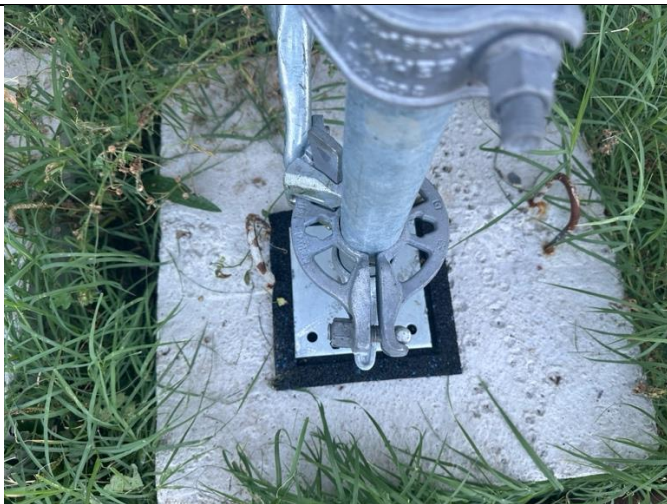
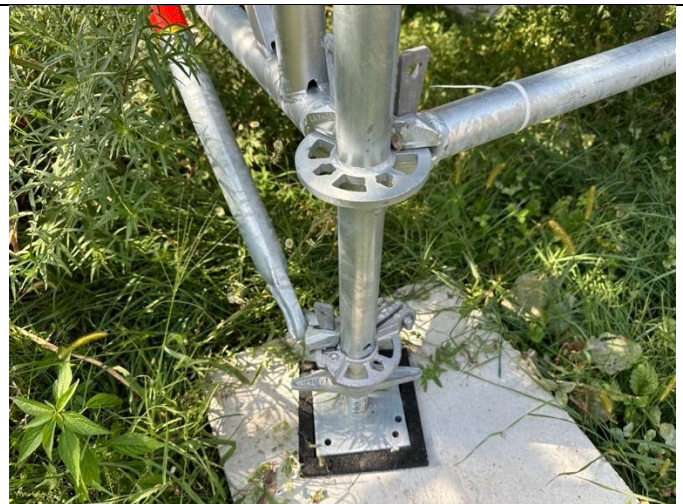
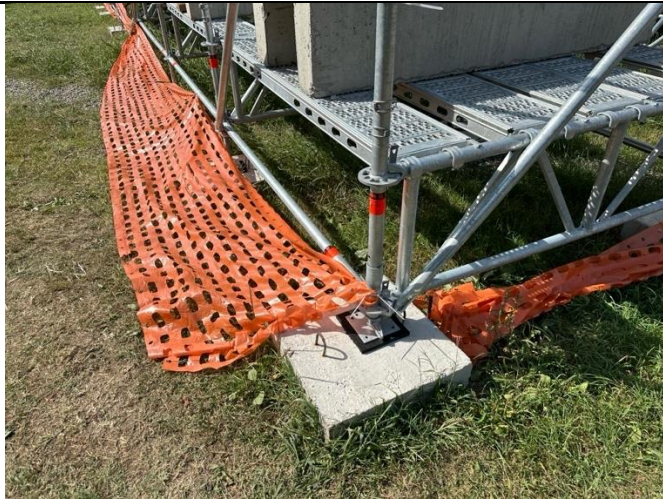
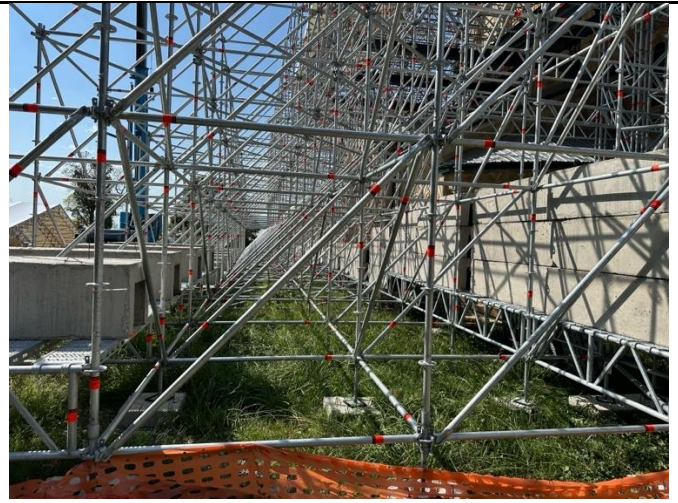
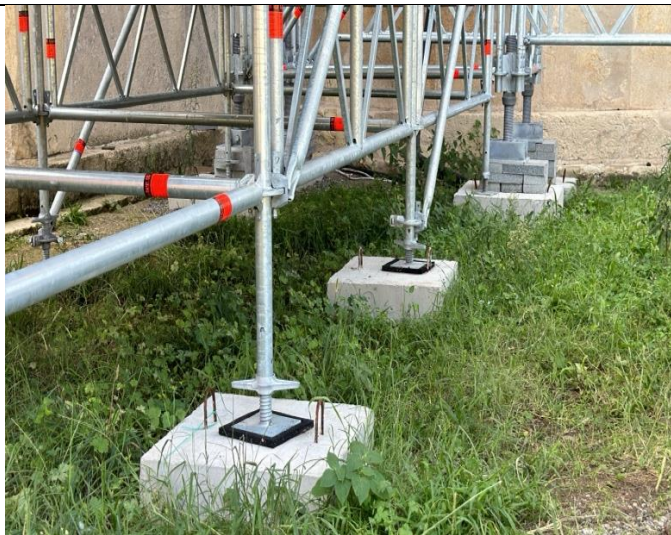
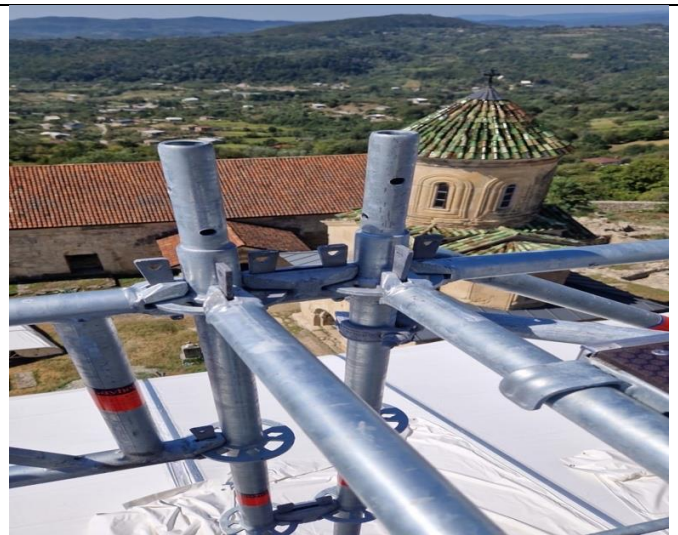
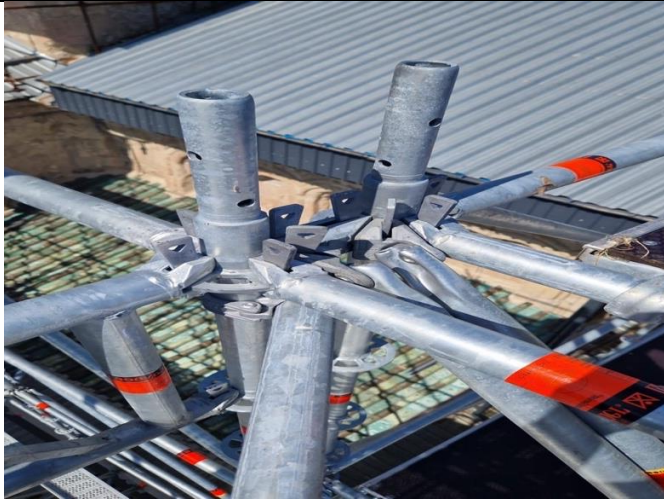
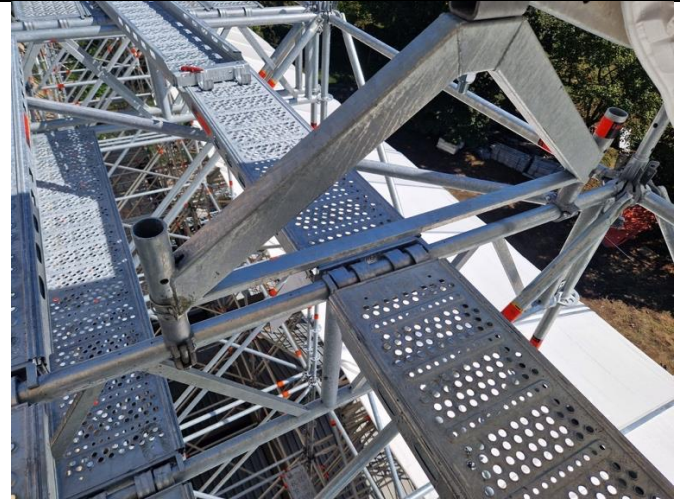
Description: Technical Control of Scaffolding

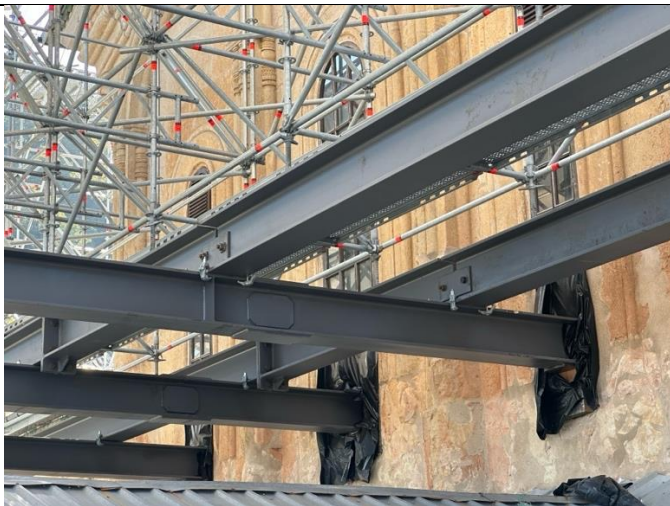
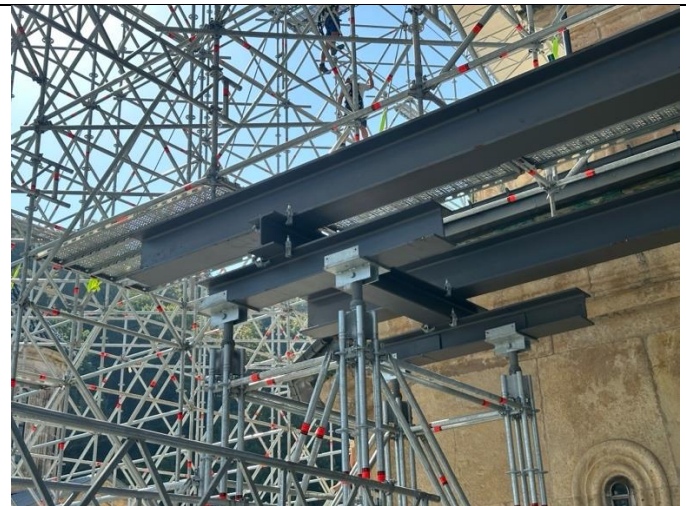
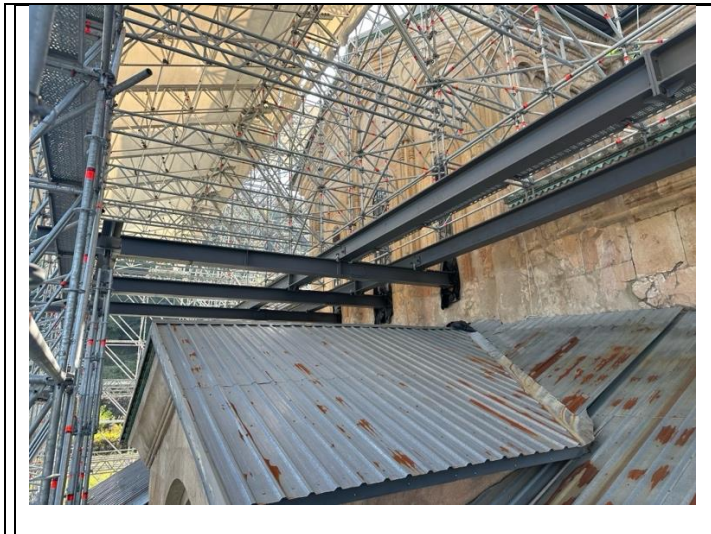
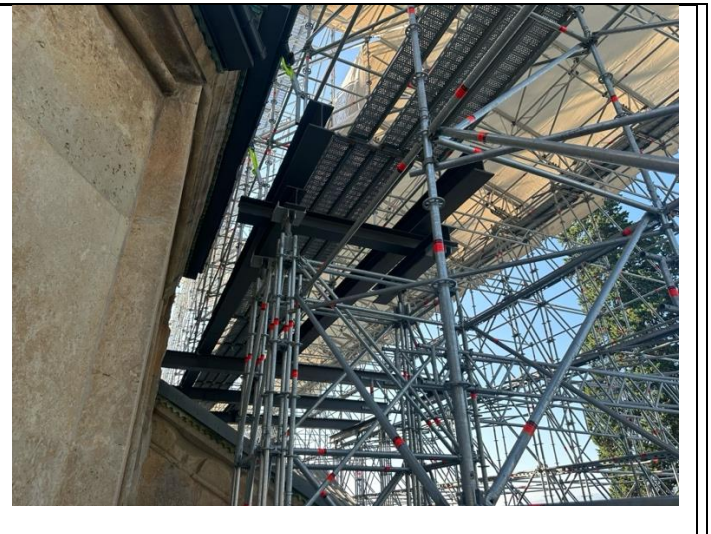
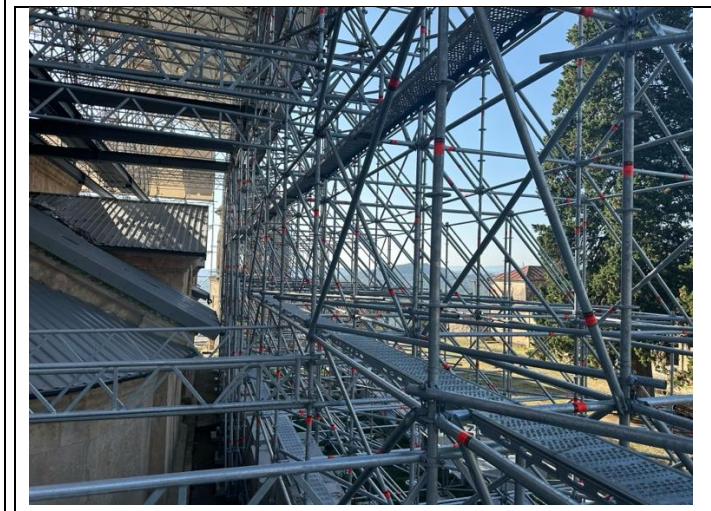
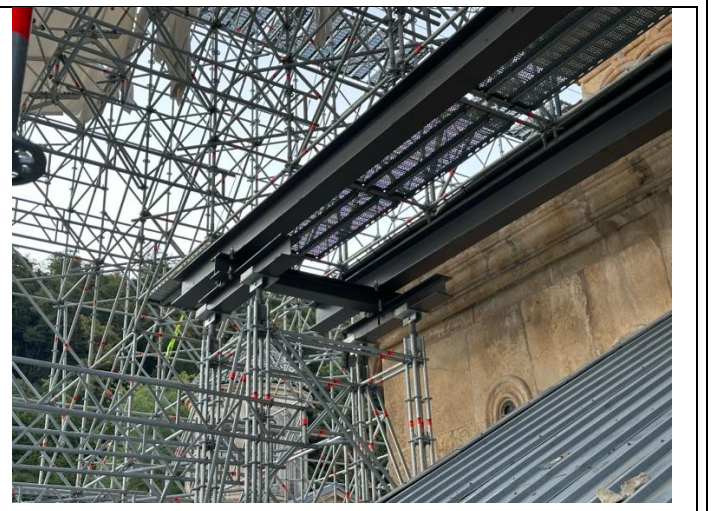
Description: Connection control

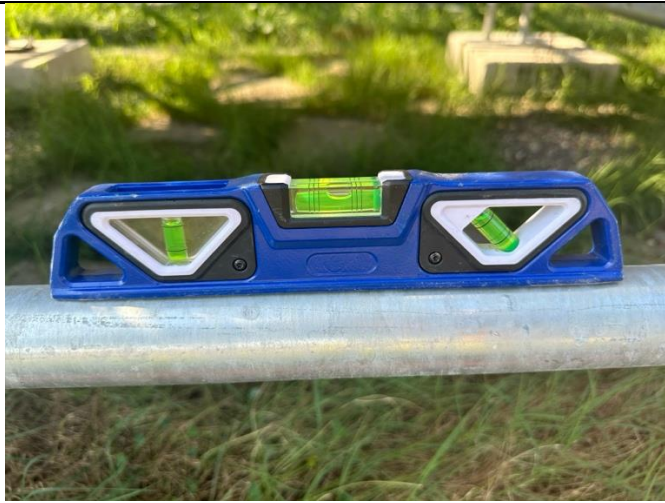
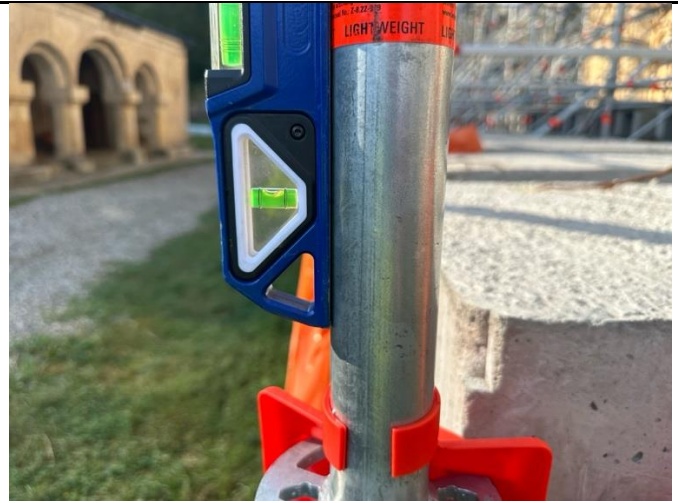
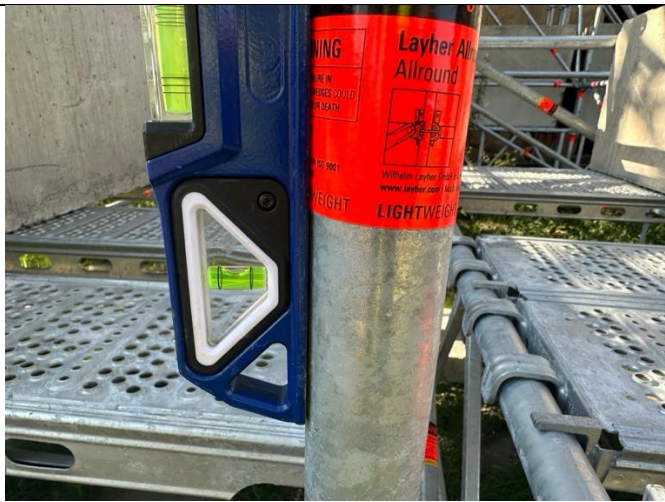
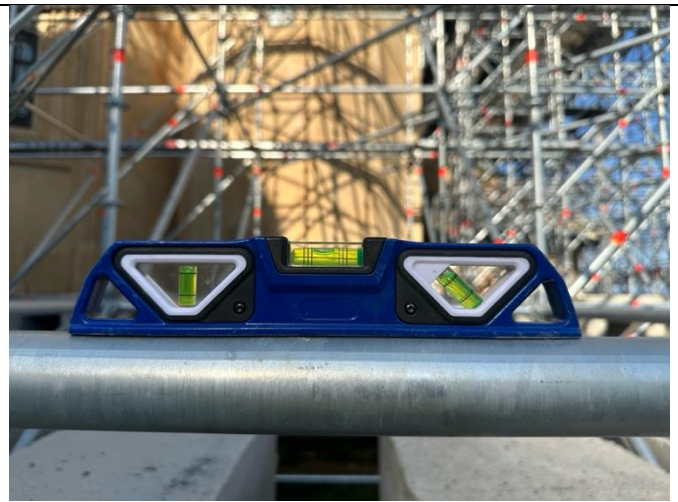
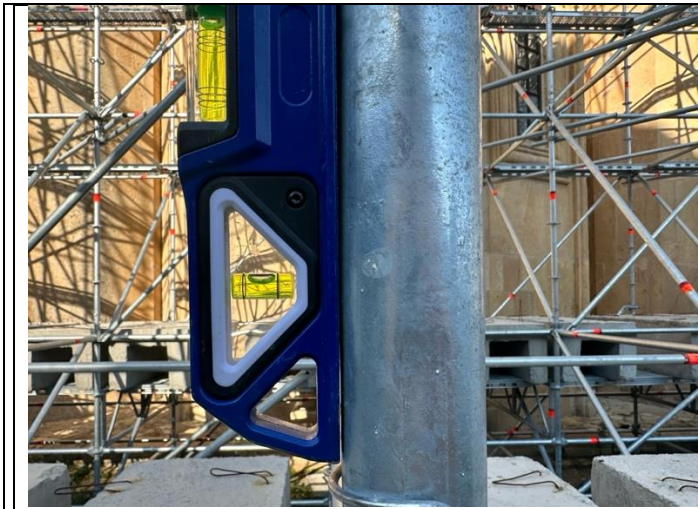
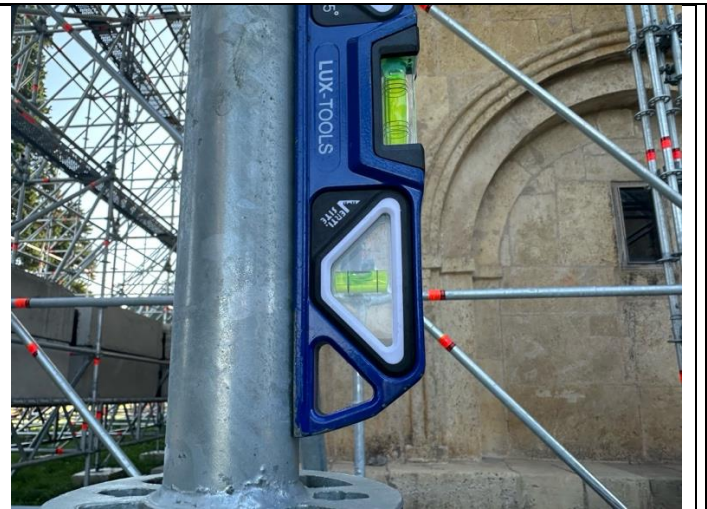
Description: Level Control
