Gelati monastery complex

Report on the urgent monitoring mission implemented on February 7, 2024

Prepared by arch. Vakhtang Zesashvili

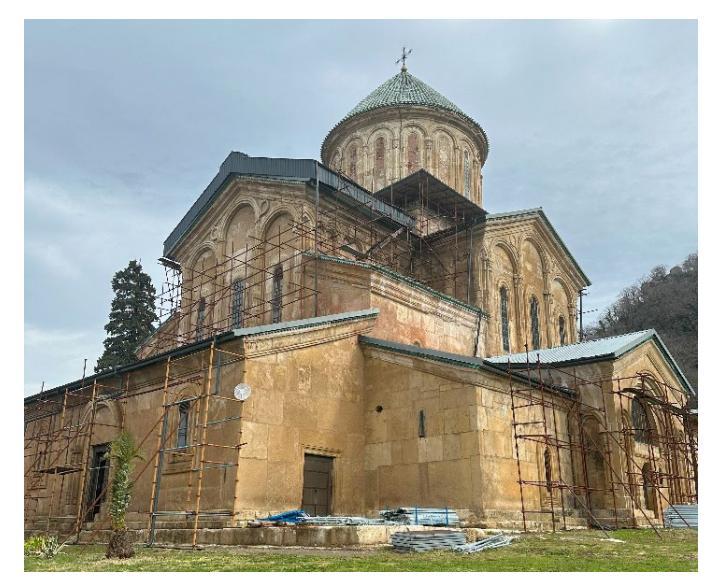
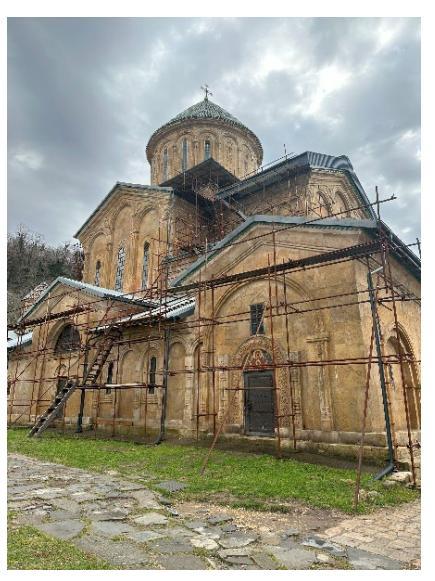
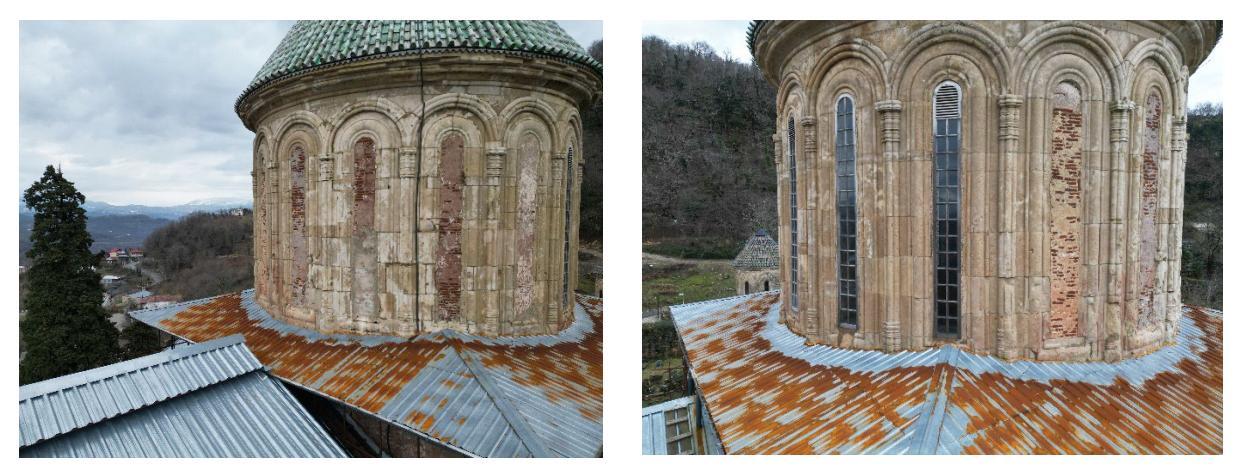
As a result of the immediate monitoring mission of 7th February, 2024, it was revealed, that the all walls of the facades of the churches of Virgin and St George were completely wet. Due to the combination of the strong wind and a heavy rain, and a large amount of water ended up on the walls, causing infiltration inside.

In certain instances, identifying infiltration points is straightforward, while in others, it becomes challenging due to the limitations of inspecting the roof, given that the roof is shielded by protective layers composed of corrugated sheet metal. We can deduce potential paths that water may take, but we cannot assert them with absolute certainty.

Water infiltrated into the main church of Virgin and into the church of St. George. Both churches are covered by temporary roofs arranged in recent years. The temporary roofs are made of corrugated sheet metal and rests directly on the ceramic glazed tiles.

The issue concerning the joint between the temporary roof sheets and the stone walls must be addressed promptly in both churches. The challenge arises from the irregularity of the masonry. Soft materials like lead can be utilized to conform to the irregular shape, or alternatively, the shapes can be scanned using a 3D laser and 3D printed details with a counter shape, ensuring maximum protection of the buildings.

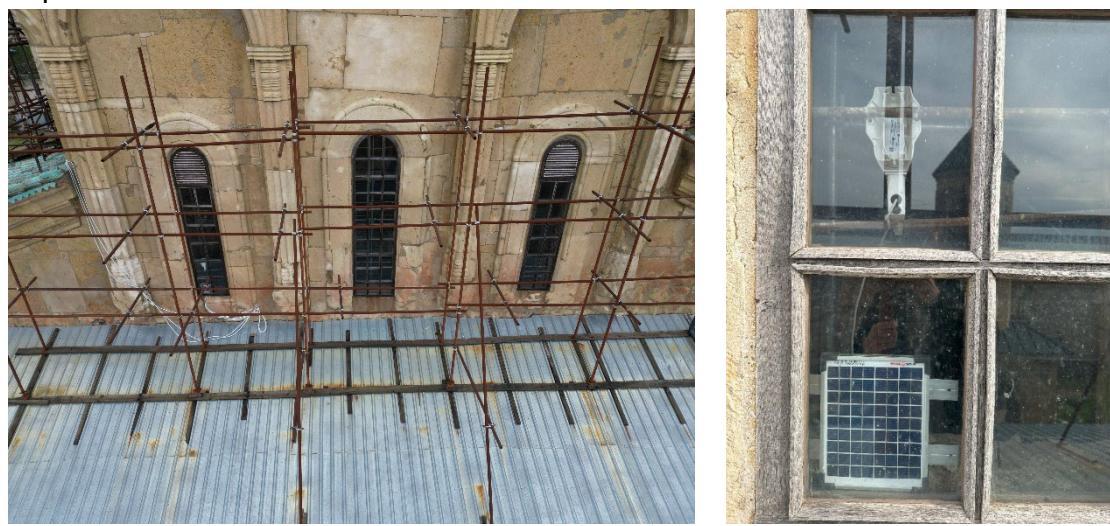
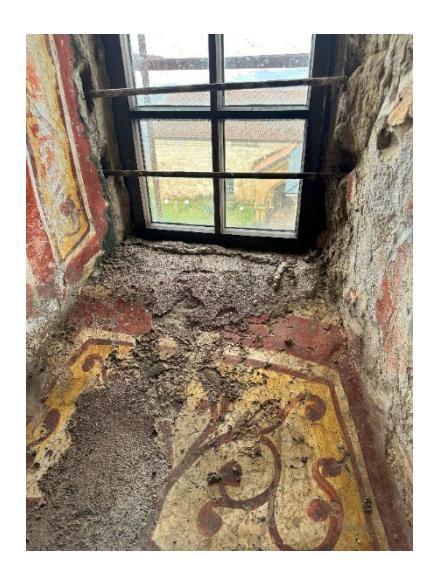
• The water infiltration is clearly identified from all 3 windows on the west façade of the main temple. While the southernmost one is the most impacted

It should be underlined, that the frames of the wooden windows on the west façade are deteriorated and have small cracks in the recess. The joining of window frames with wall is also lightly deteriorated, from which the water infiltration had a place. In addition, the windows have upper shutters for ventilation, contributing to the entry of water during a strong storm.

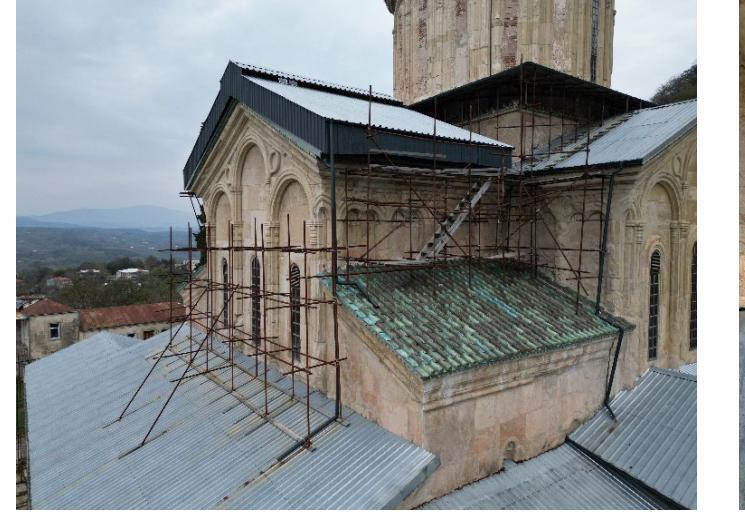
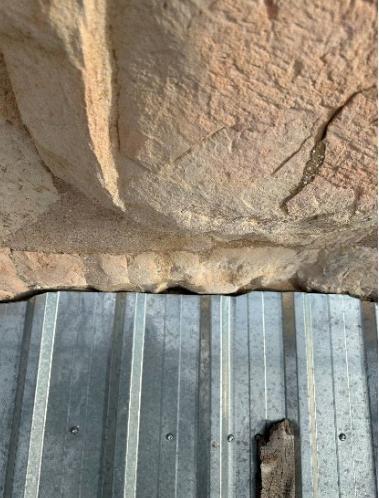
• Another water infiltrations were identified in the narthex. Specifically, above the main doors of the church.

The connection between the main body of church and the narthex presents inherent vulnerability. It lacks a unified structure with main body, rendering it particularly fragile during rainfall that saturates the wall. The connection between the wall and corrugated sheet metal features holes of various sizes spanning its entire length, as we can see on the photos above.

The underside of the narthex roof comprises two types of structures: one made of pumice blocks and the other consisting of wooden beams. Upon careful inspection of the accessible portion, significant amounts of water were discovered. It is important to note that no damp stains were observed inside the narthex beneath the wooden structure; rather, the infiltrations were found beneath the pumice block structure.

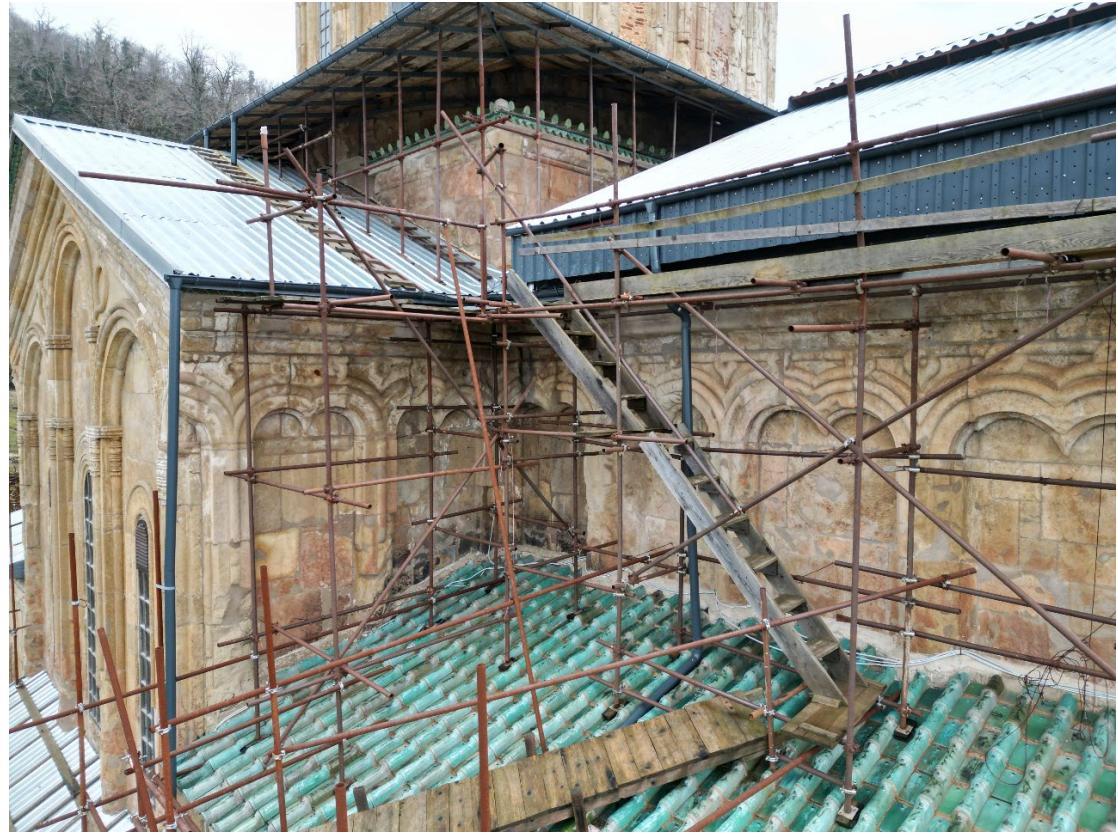
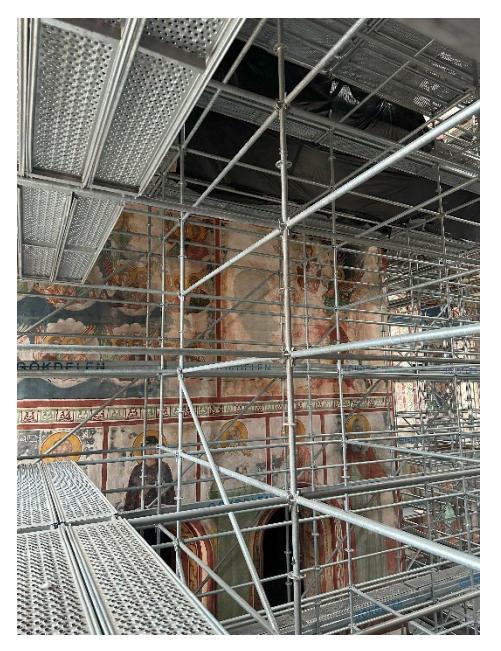
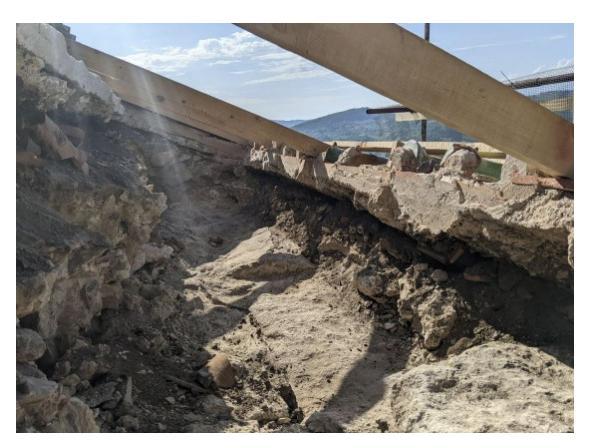
• Infiltrations were discovered along the northern wall of the southern wing. It is impossible to understand and fix the particular point/s of water infiltration in this part of the structure, due to that it is covered by metal protective roofing.

From the inside the infiltration point is located at a height of 15 meters and coincides with the existing crack detected and documented in the Mission Report of June, 9, 2022, elaborated by Ugo Tonietti. The crack certainly favored the water to reach the interior in such a short time.

The crack is currently covered by a lime mortar pad which supports the temporary ventilated roof, we have no opportunity to inspect. the depth of the crack and the infiltration point on the internal wall are very similar. For this reason, we can consider, that the water path was facilitated by the crack.

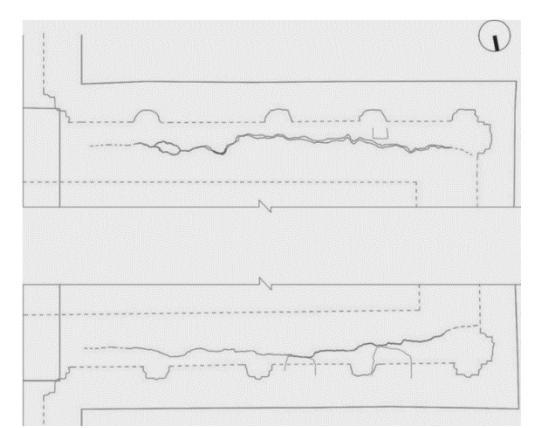
Plan of the course of the longitudinal cracks of the South (top) and North (bottom) wall, (drawing by Architect Lasha Shartava, 2022)

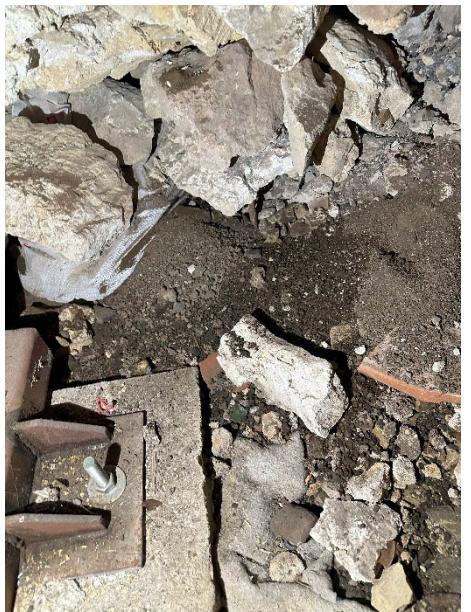
Investigation under the temporary roof revealed water infiltrations, as depicted in the photo. The change in color of the pumice grain indicates dampness, particularly near the lime mortar pad. It is evident that the temporary roof failed to withstand the magnitude of the storm, resulting in water infiltration into the interior.

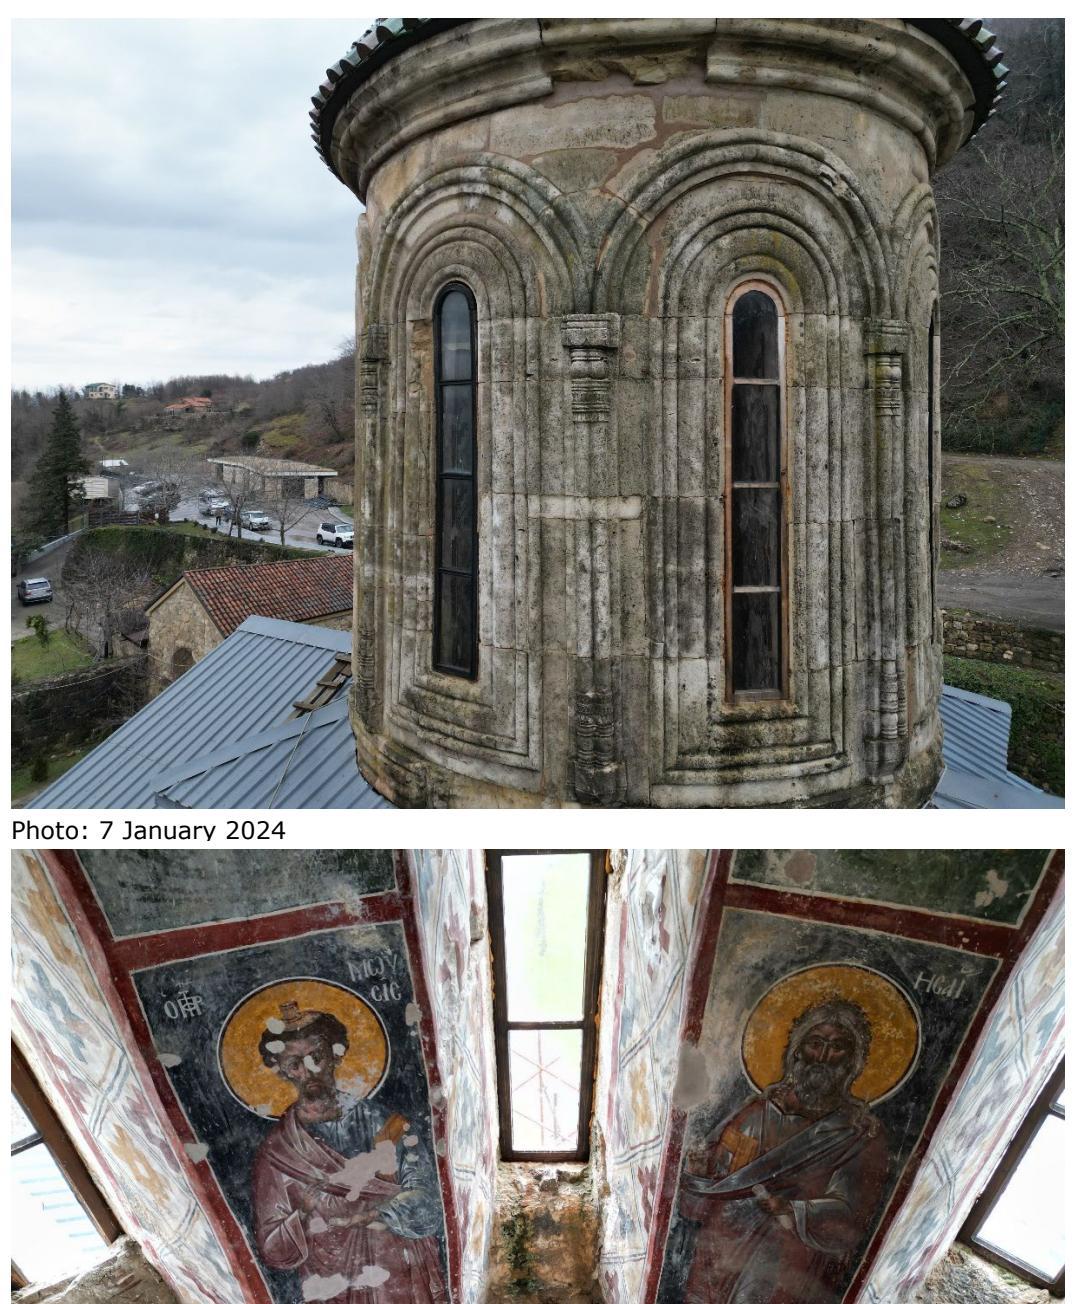
In the church of St George, water infiltration is evident only from the window of the dome drum. The south-west window, particularly exposed to wind and rain, facilitated the infiltration. The wooden windows are not of high quality. One of the two appears to have been previously replaced and fixed with foam.

In the past, these windows were bricked up, as seen in the church of Virgin, to protect against storms of this nature.

Since the temporary roof resembles the one on the church of Virgin, where the junction between the sheet metal and stone permitted infiltration, we can infer that here, too, there may be additional infiltrations not visible on the surface inside.

The protection for the dome drum windows can be constructed using transparent materials such as plexiglass from the outside, allowing light to enter the church while utilizing the window frame for attachment.
