**REPORT ON THE STATE OF CONSERVATION OF THE GELATI  
MONASTERY WORLD HERITAGE PROPERTY, GEORGIA**

Mission of 05-12 November 2021

## COLOR CONSOLIDATION

## **PLASTER CONSOLIDATION**

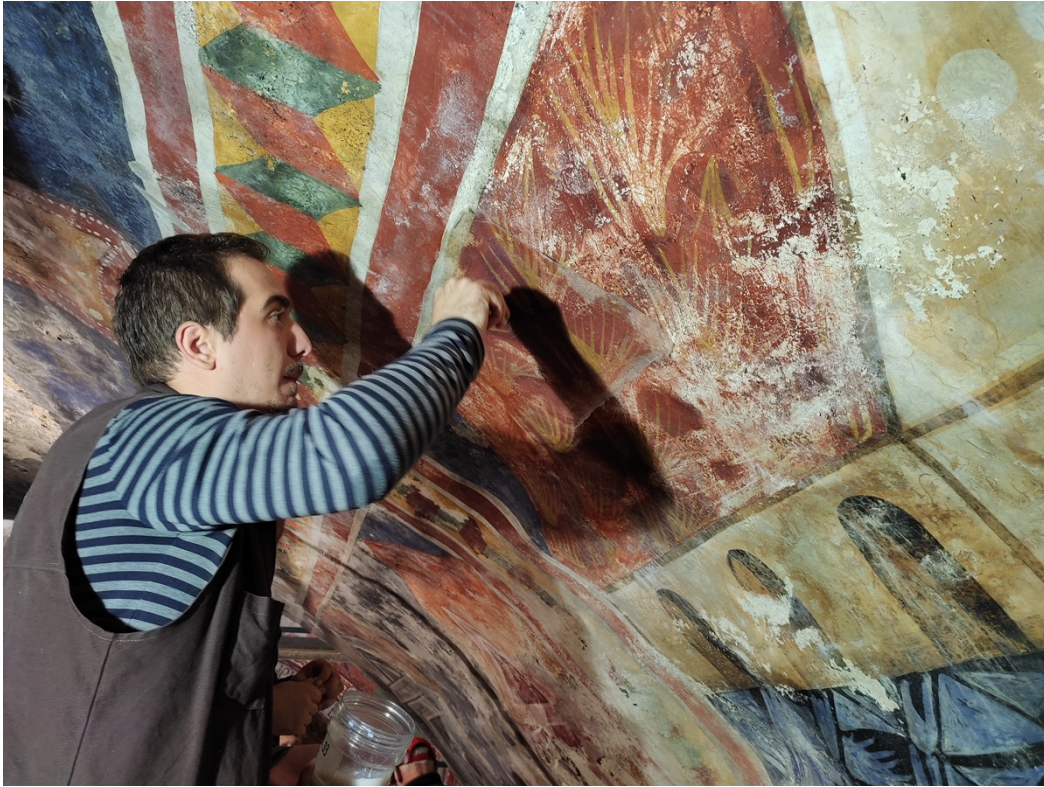
*Georgian Conservator during fixing the color*

With regard to the first, we therefore began to proceed extensively on the entire pictorial surface with the method developed which preliminarily provides for the dry removal of the soluble salts that have surfaced and then the application with distilled water of the Japanese paper tissue on which it was spread the acrylic resin. After keeping it in contact with the color for about 1 minute and following the crushing of the same through a light pressure with a cotton swab on the paper itself, the Japanese paper was removed. In this way the saline efflorescences present were also removed.

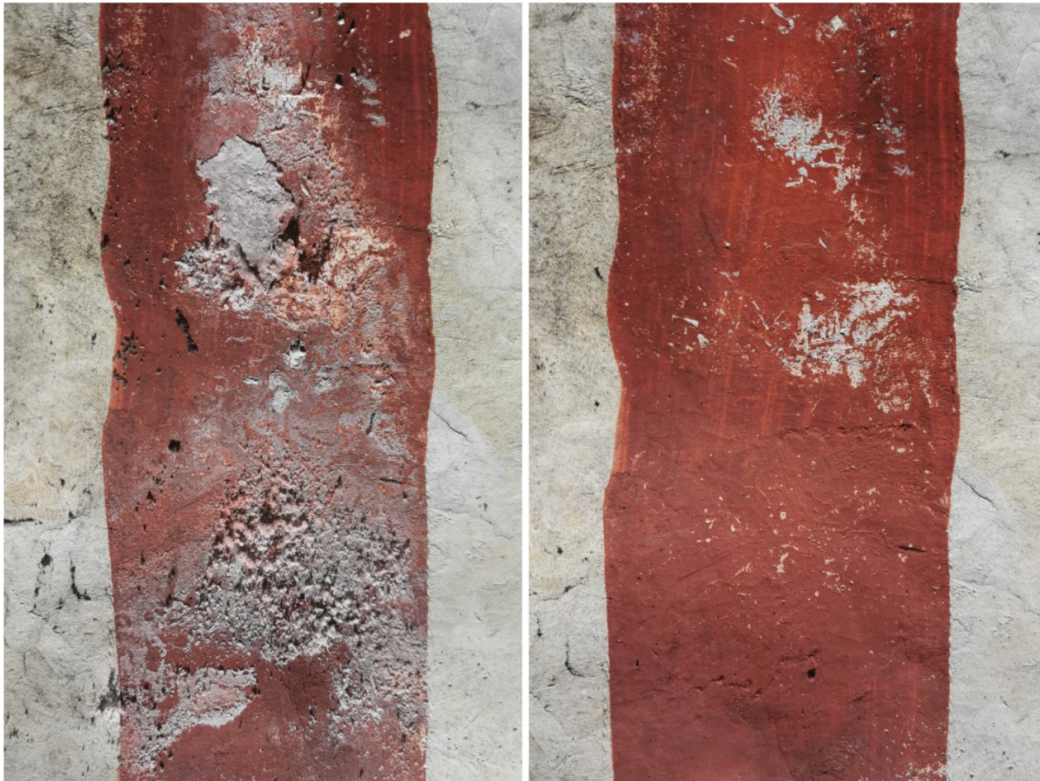
*Before consolidation*

*After consolidation*

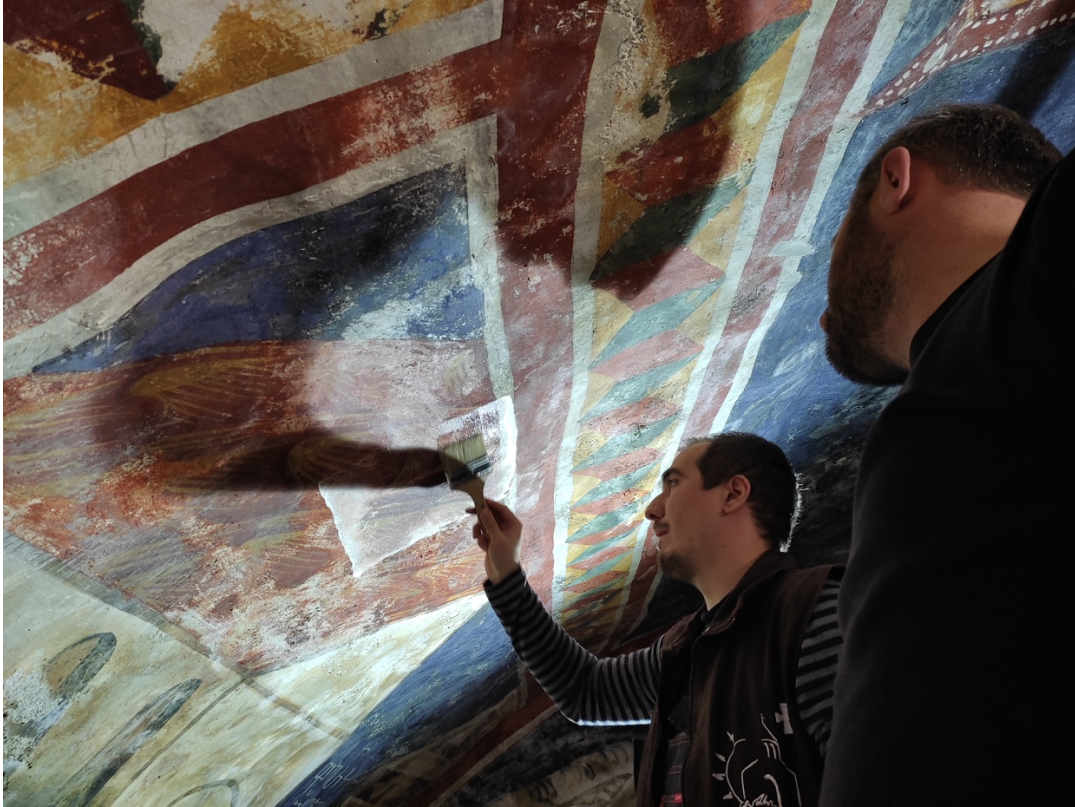
*Georgian Conservator during fixing the color*

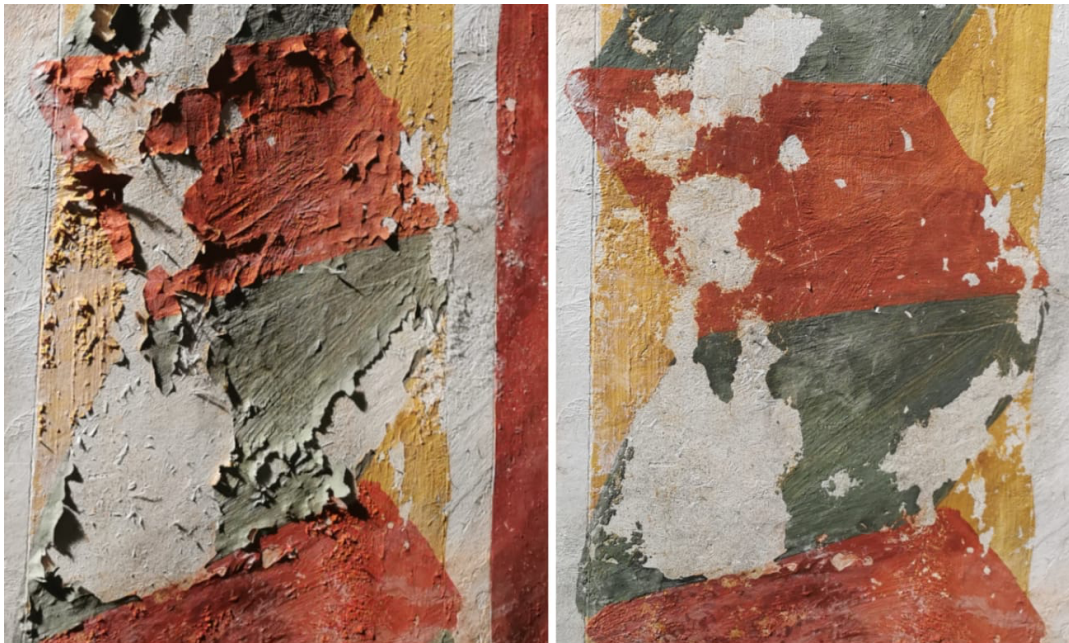
*Before consolidation*

*After consolidation*

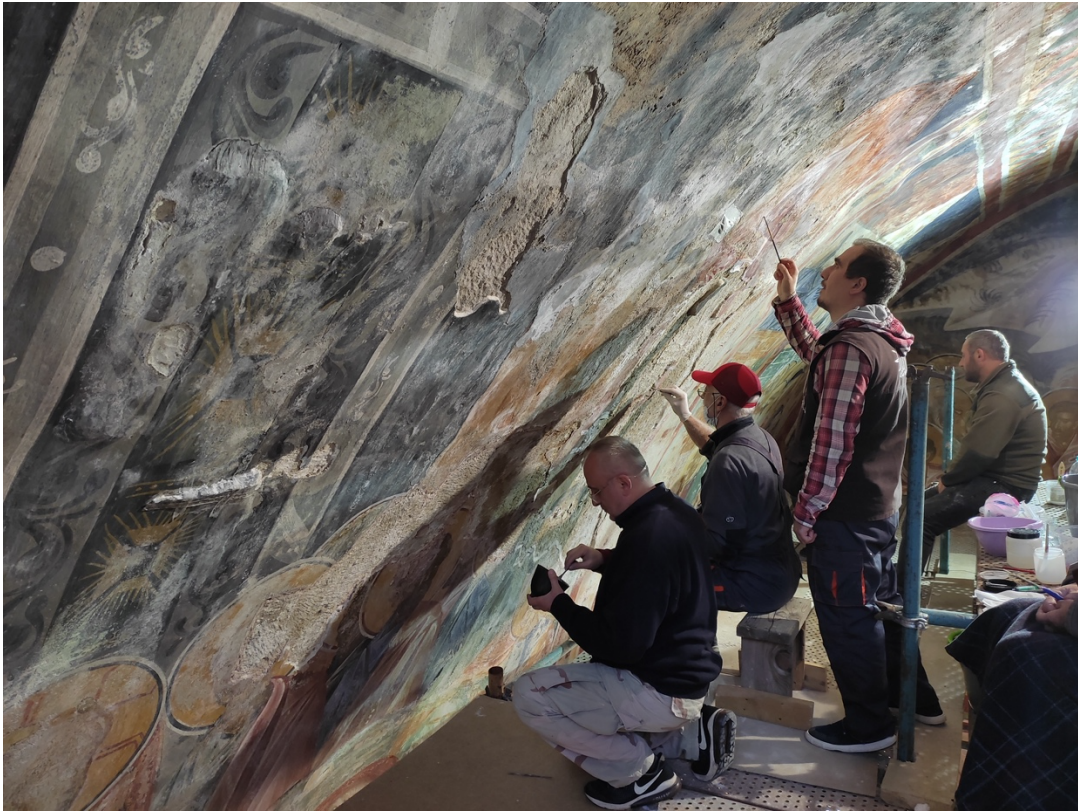
*Georgian Conservator during fixing the color*

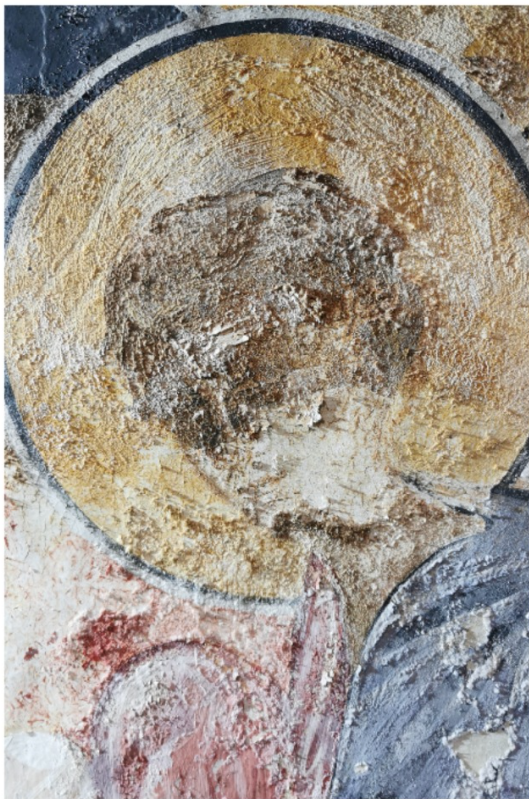
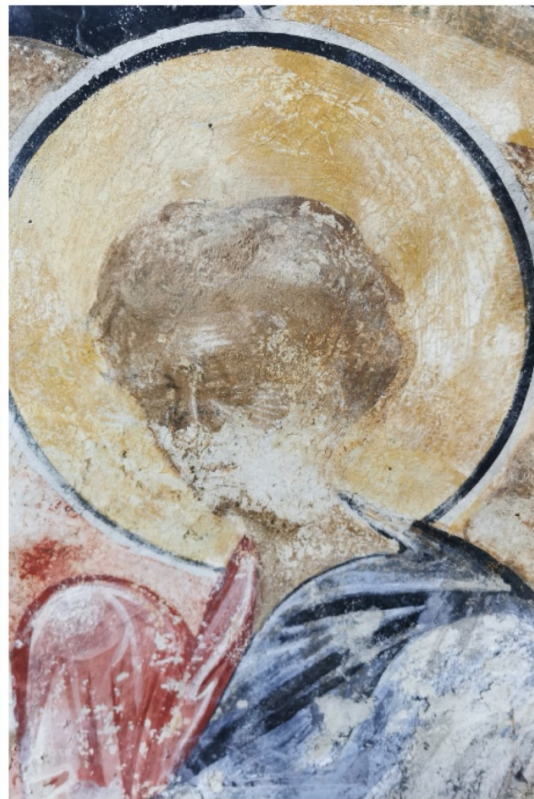
*Before consolidation*

*After consolidation*

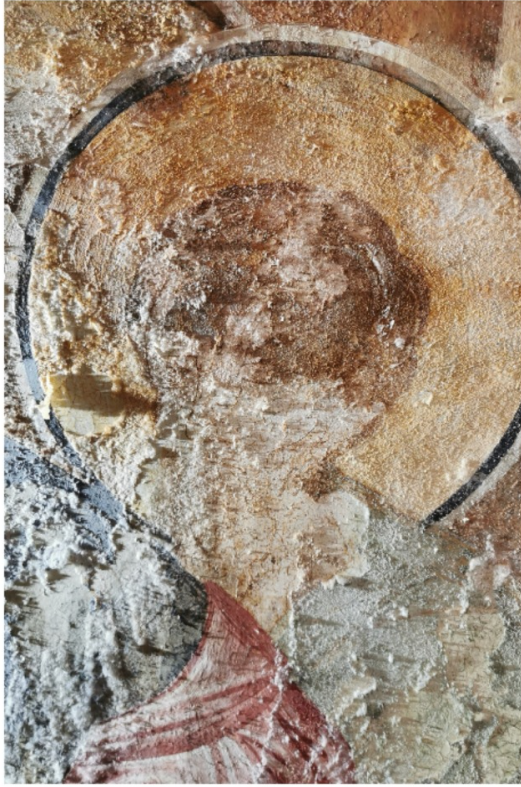
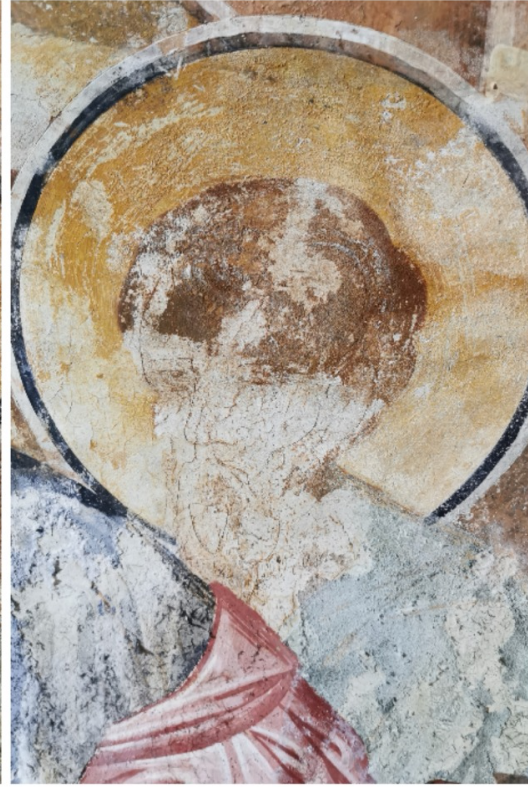
*Before consolidation*

*After consolidation*

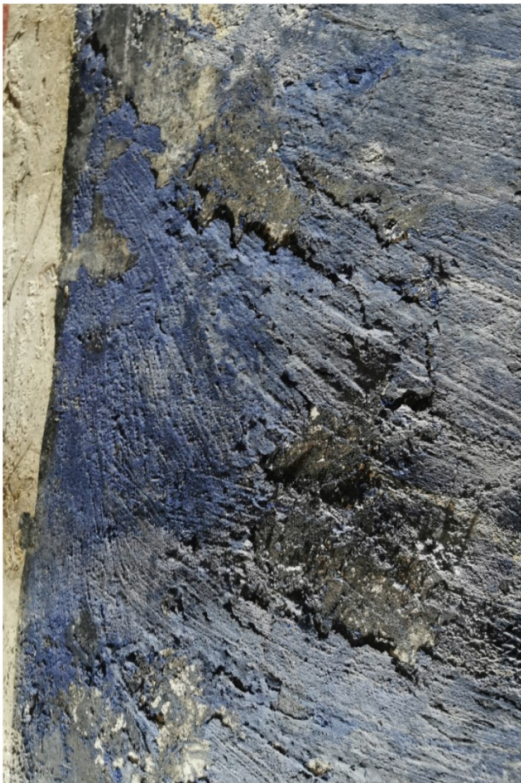
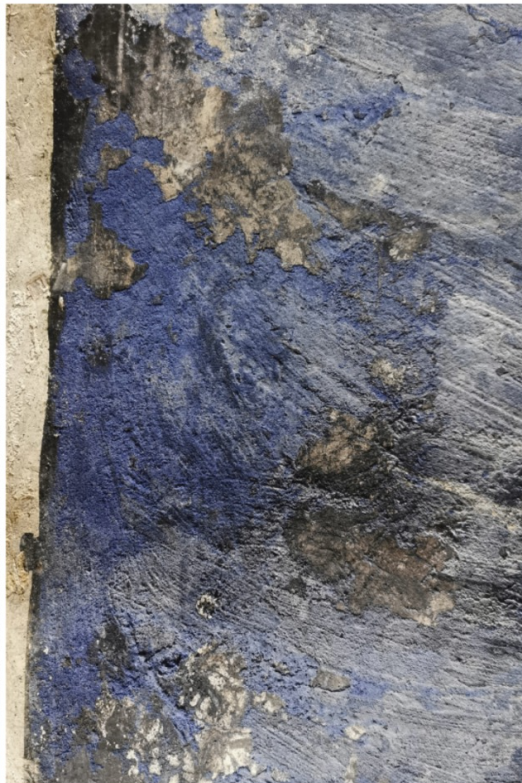
*Before consolidation*

*After consolidation*

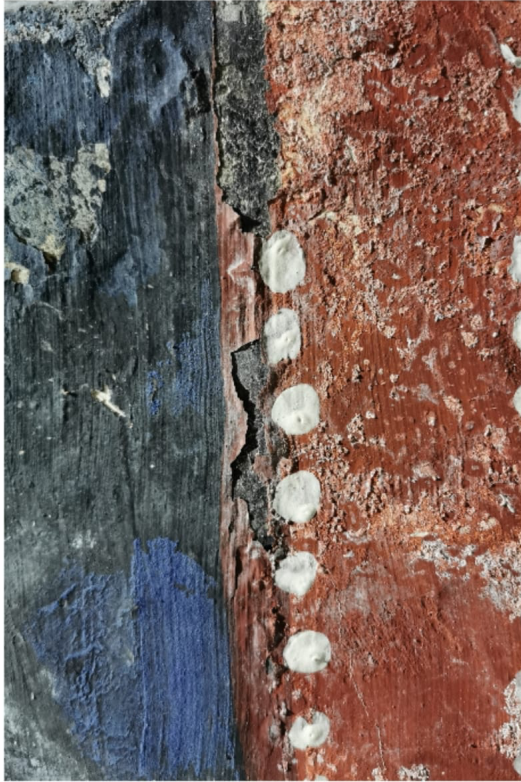
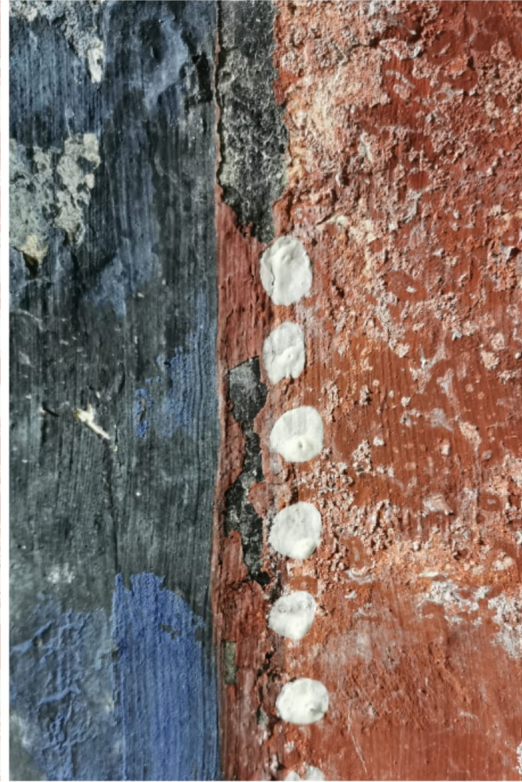
*Before consolidation*

*After consolidation*

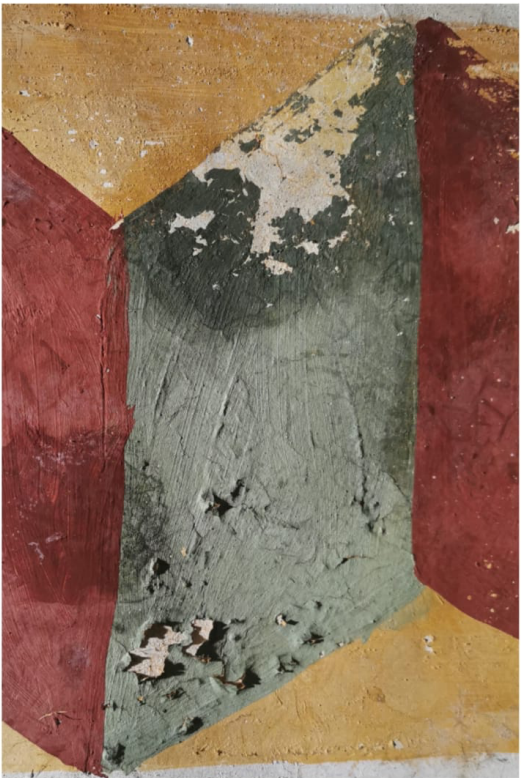
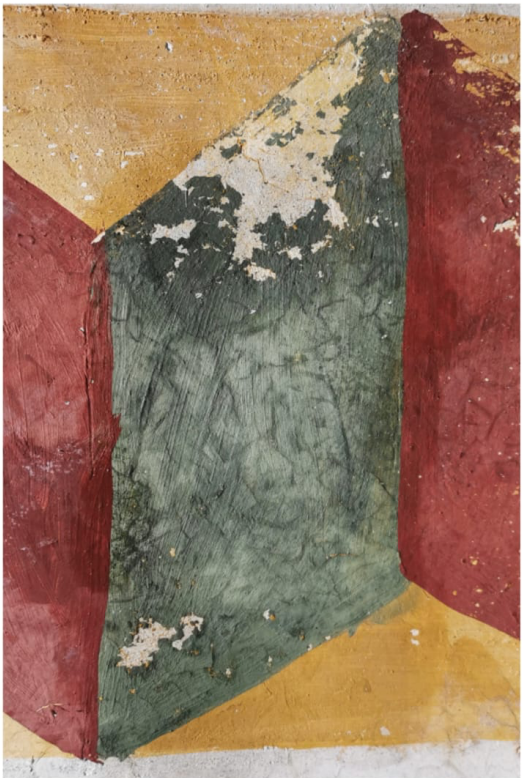
*Before consolidation*

*After consolidation*

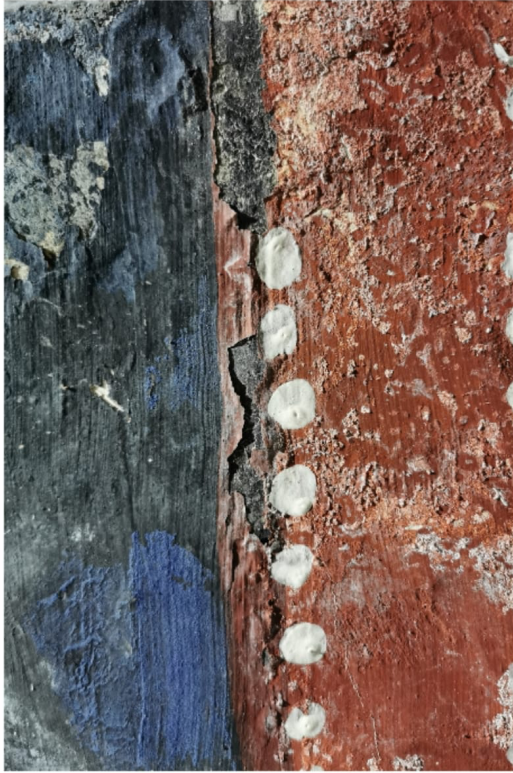
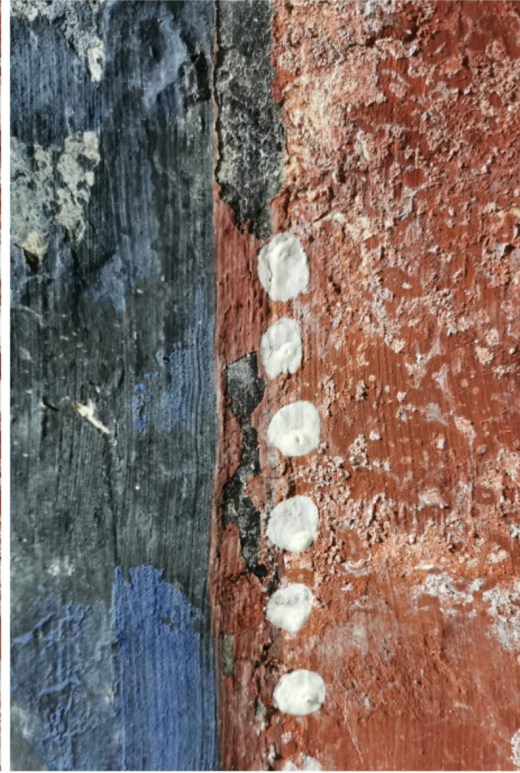
*Before consolidation*

*After consolidation*

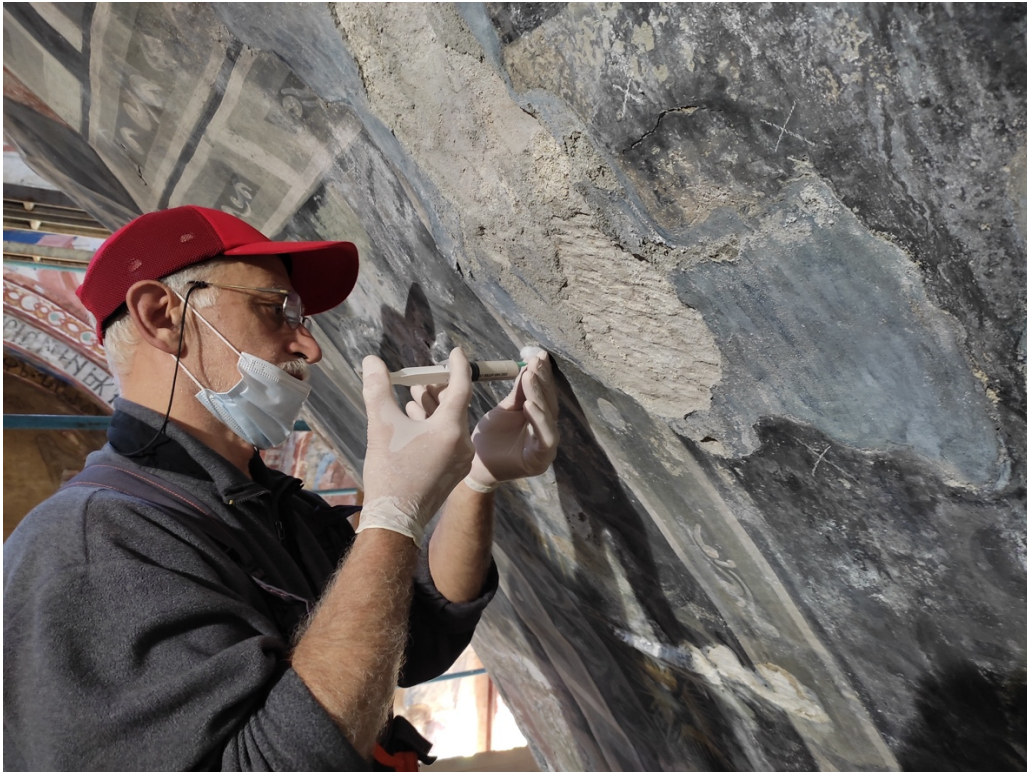
*Georgian Conservator while consolidating the plaster*

Previously, the Italian restorer Marco Pulieri had identified on the south wall of the west arm a series of points where the plaster was strongly detached which required an urgent consolidation intervention.

It was then explained that very often, prior to the injection of PLM consolidating mortar, a series of precautionary measures had to be prepared in the areas of plaster in danger of falling, aimed at making them safe.

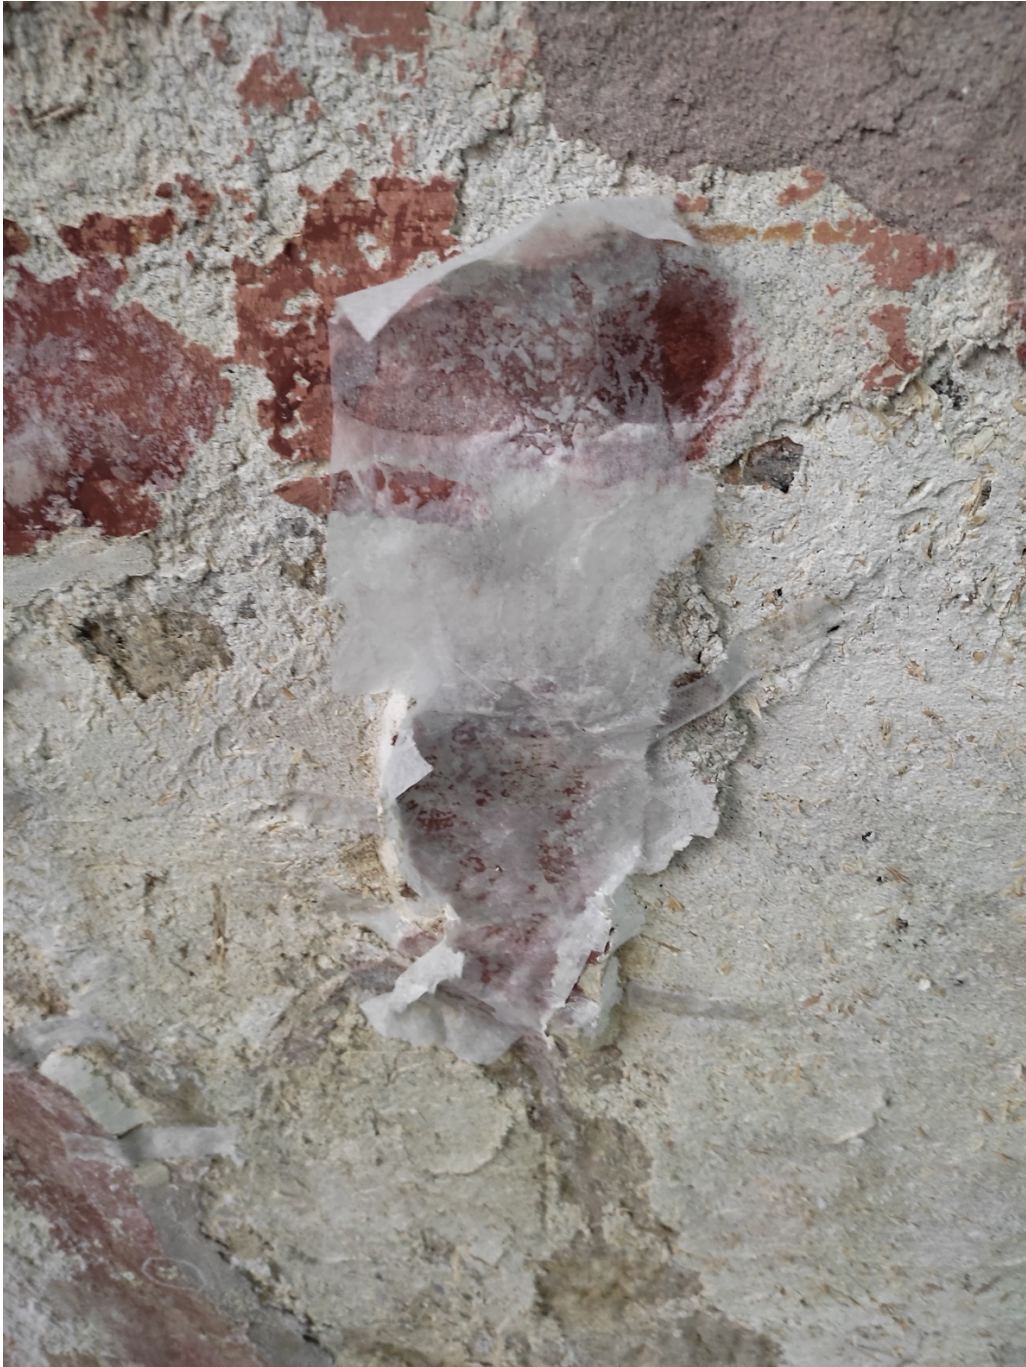
*application of velinatura with Paraloid B72 to consolidate the plaster*

Another preliminary operation to the depth consolidation that was illustrated to the Georgian team was the temporary protection of the unsafe portions of plaster with the application of Japanese paper soaked in Paraloid B72 acrylic resin.

This expedient allows you to perform mortar injections with syringes in complete tranquility, having anchored the part in danger of falling to the nearest solid part with the bandage.

Once the consolidation of these parts was completed, the process of removing the protective bandage was also illustrated, which took place by means of acetone compresses which removed, dissolving it, the acrylic resin Paraloid B72, subsequently allowing easy removal of the Japanese paper tissue.

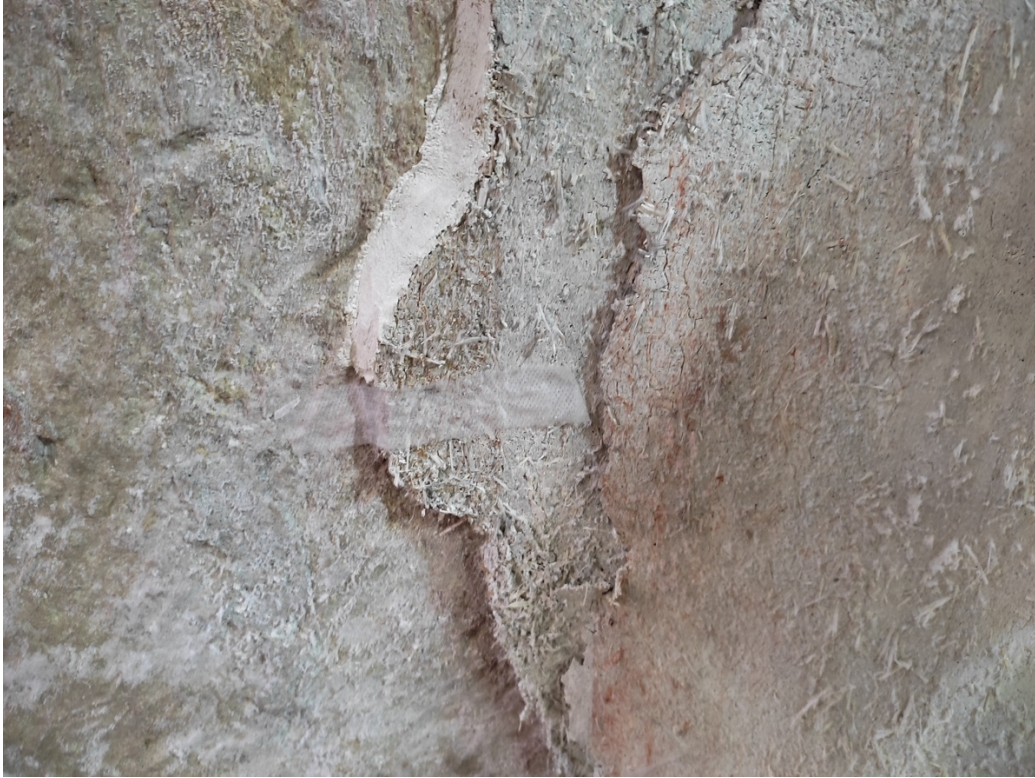
*temporary anchoring grouting for consolidation of plaster*

Some temporary "support" grouting was then carried out with mortar based on slaked lime and sand in a ratio of 1: 3 along the edges of the plaster gaps, blocking its imminent fall. Holes have been left along the grouting for the subsequent injection of the consolidating product.
