Preservation Measures for Gelati Monastery Cultural Heritage Site

**Restoration of Architectural Structure of the
Church of the Virgin at Gelati Monastery**

Monthly Progress Report #5

Reporting Period: October 24, 2015- November 30, 2015

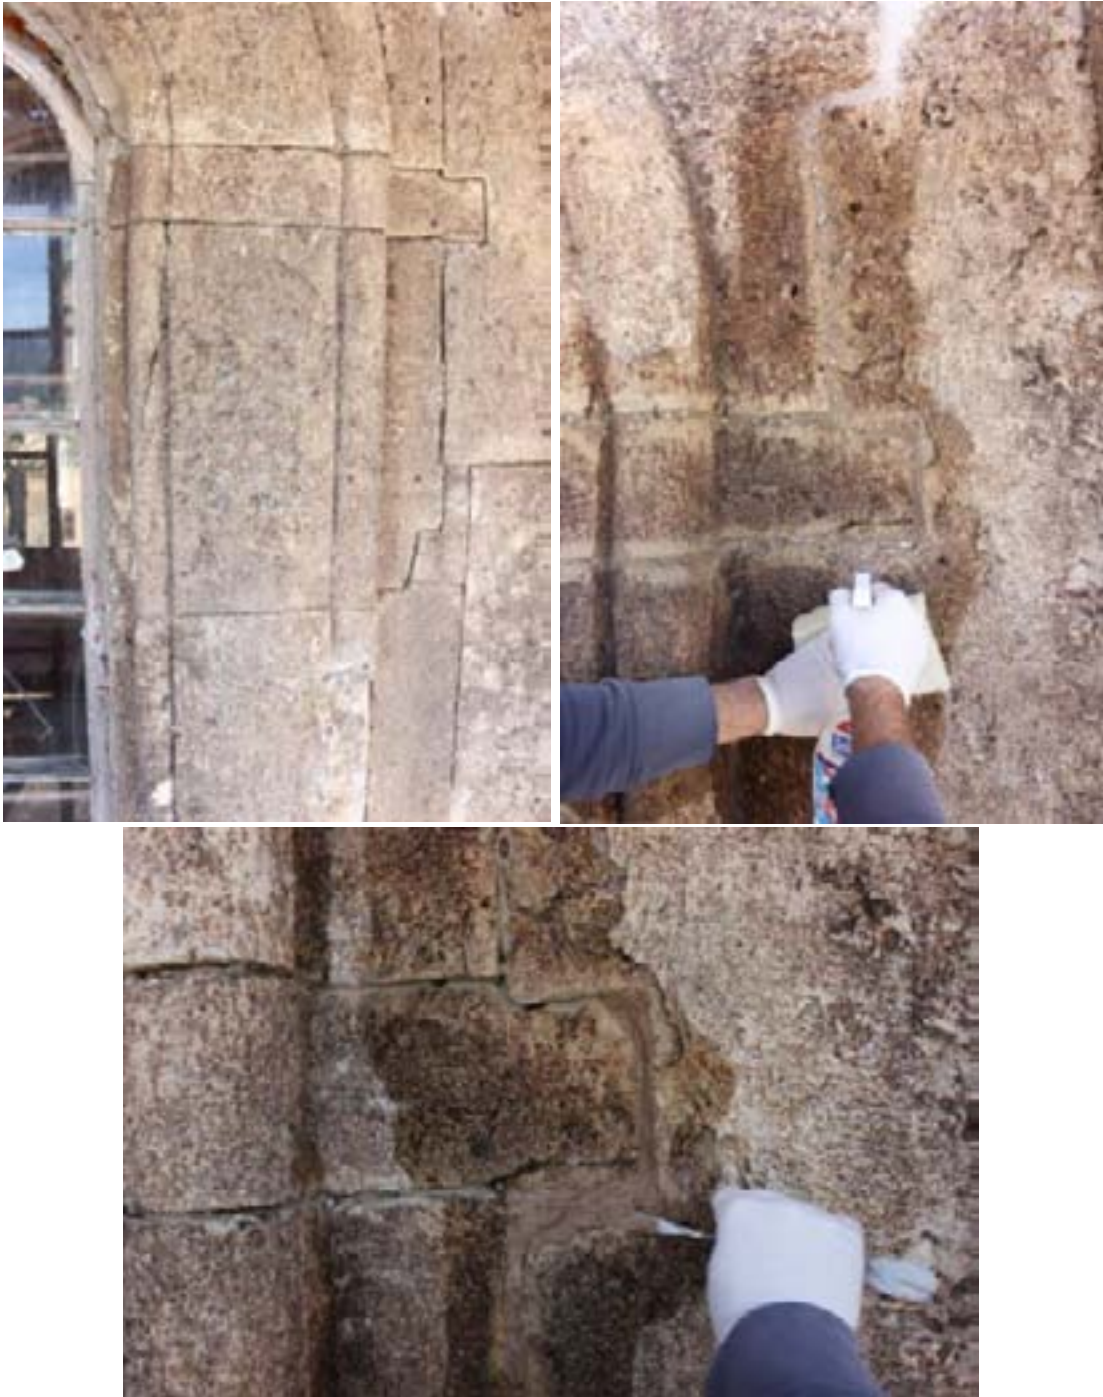
Western façade, Church of the Virgin at Gelati Monastery

Filling the joints

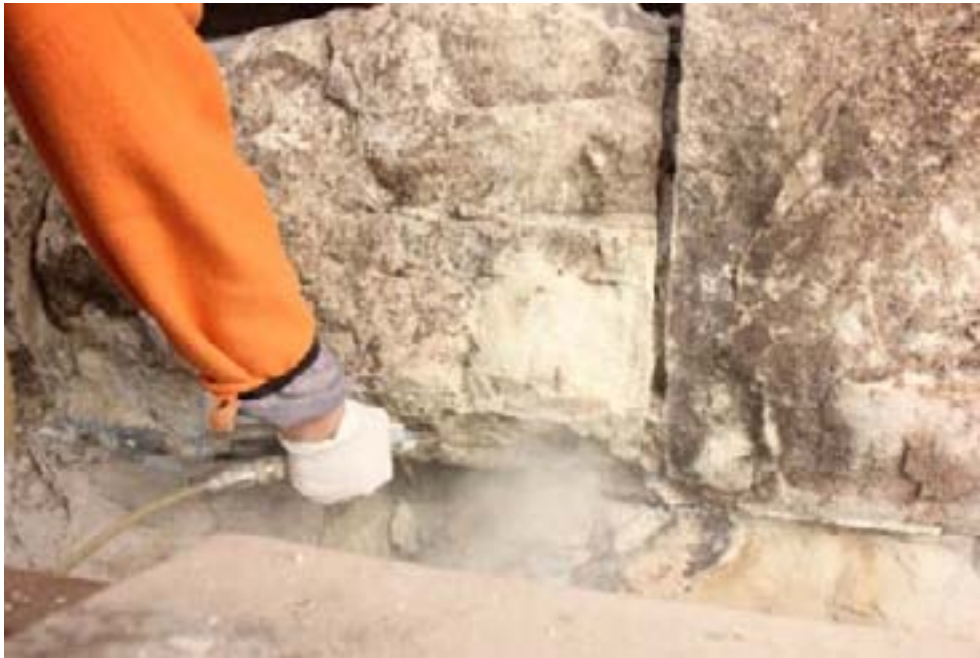
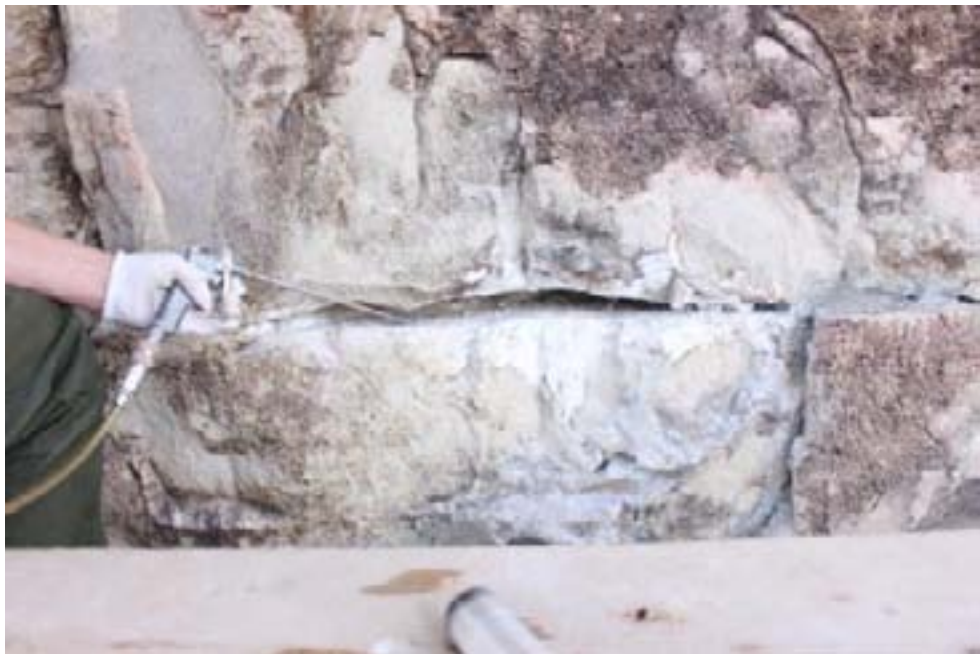
Western facade Church of the Virgin at Gelati Monastery

Cleaning of spaces between the stones

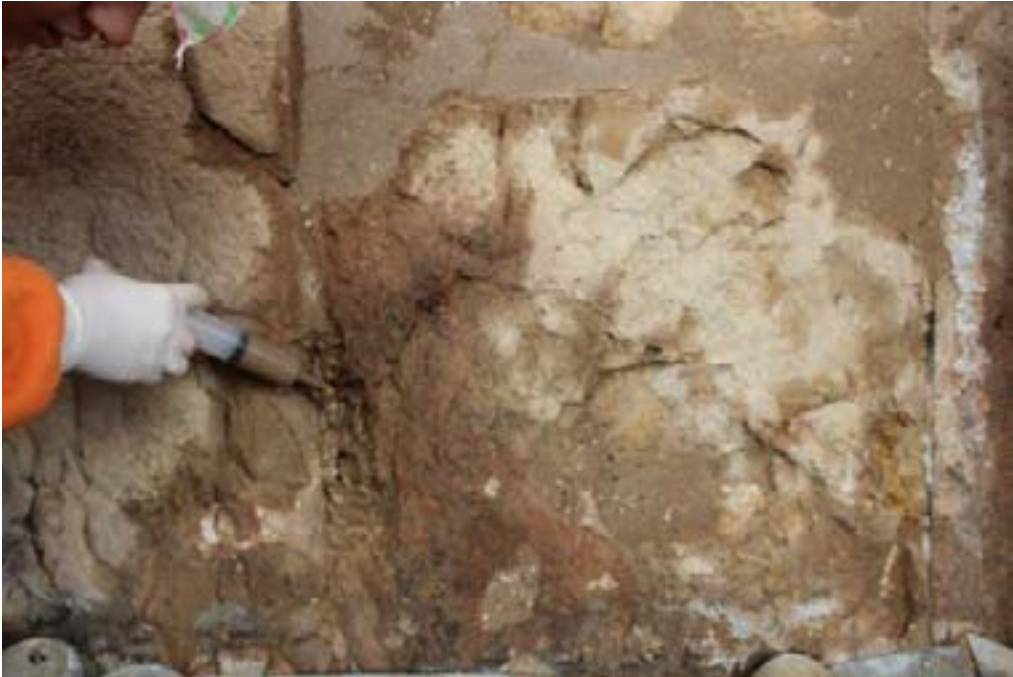
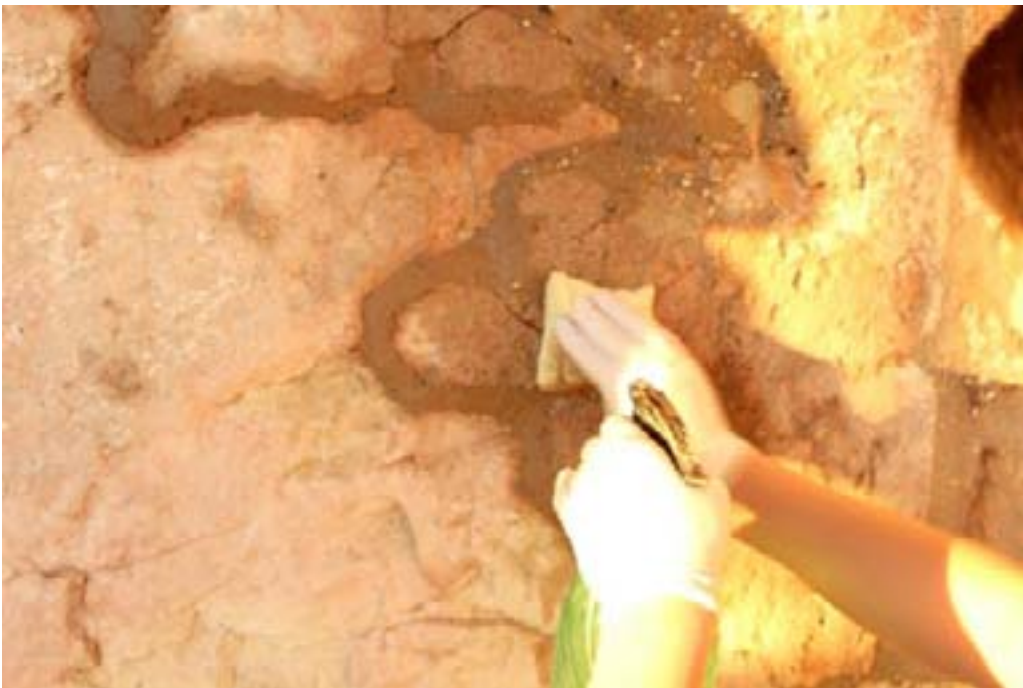
Western facade Church of the Virgin at Gelati Monastery

Consolidation of cracks

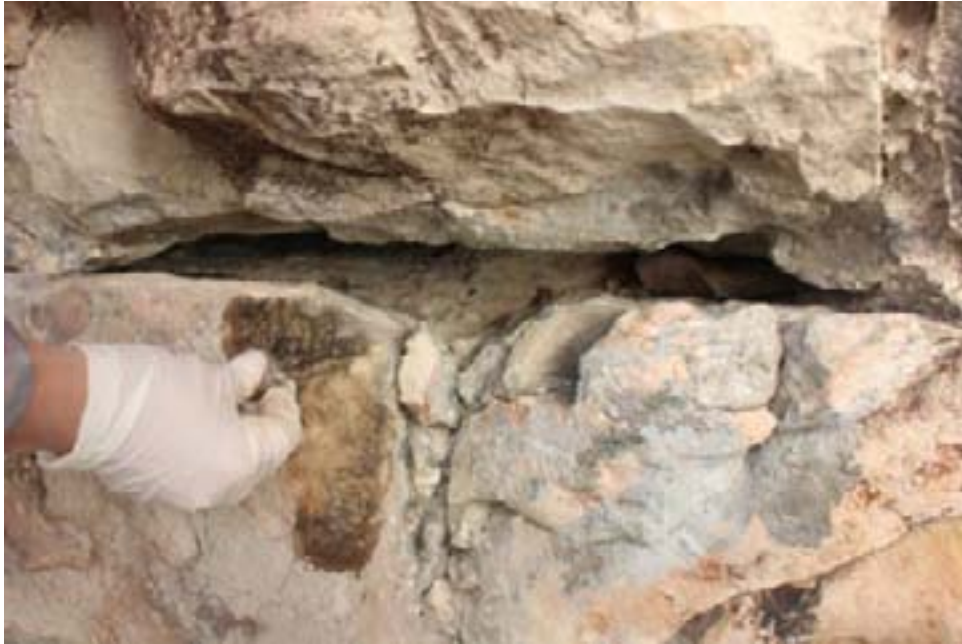
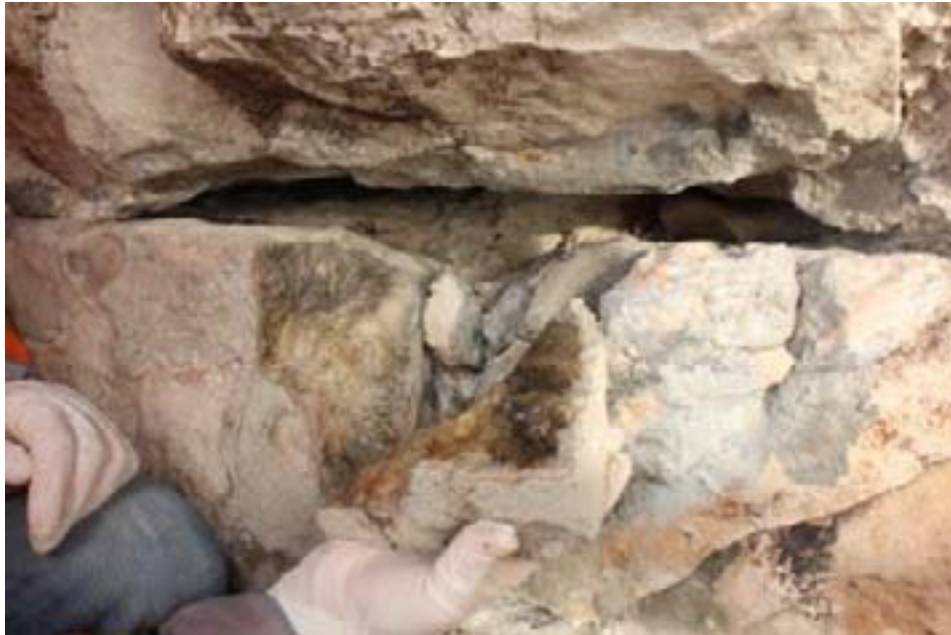
Western facade Church of the Virgin at Gelati Monastery

Reassembling the fragmented parts of the stone

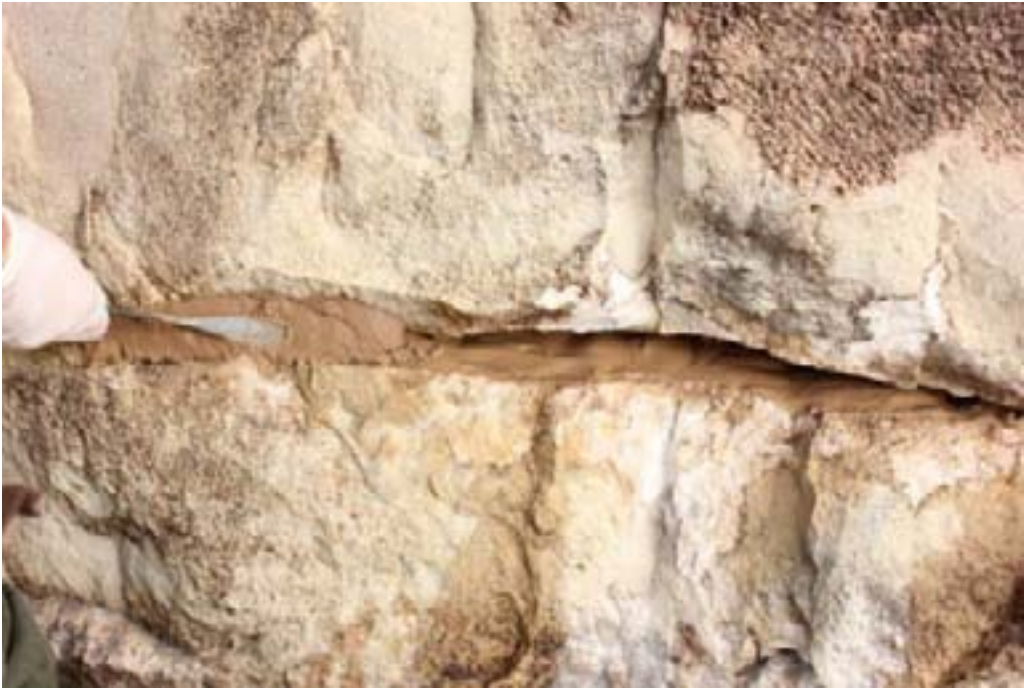
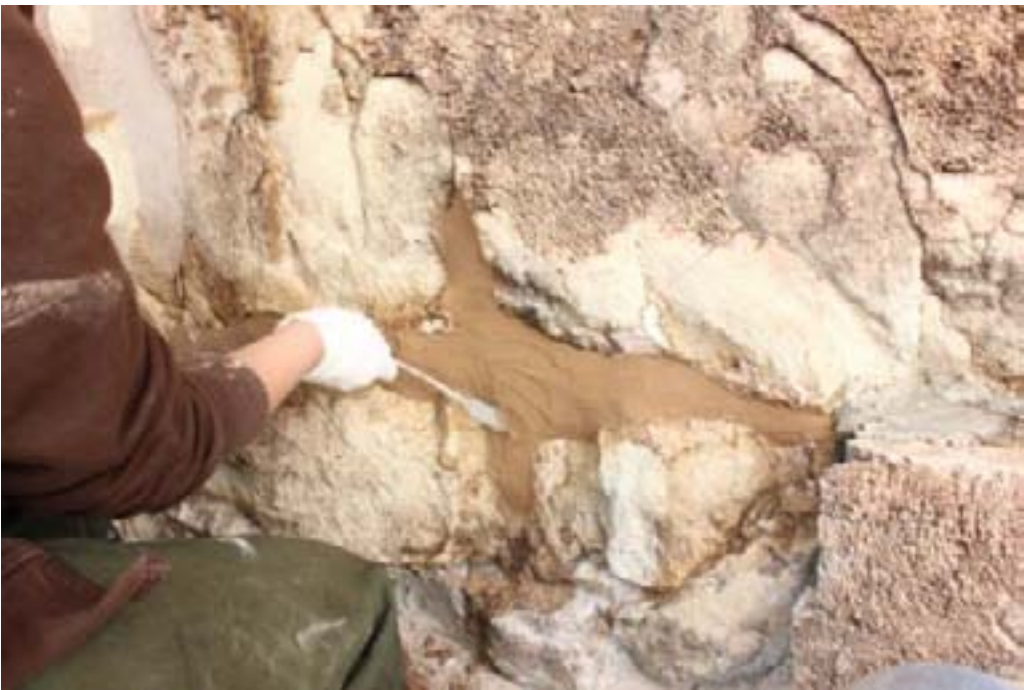
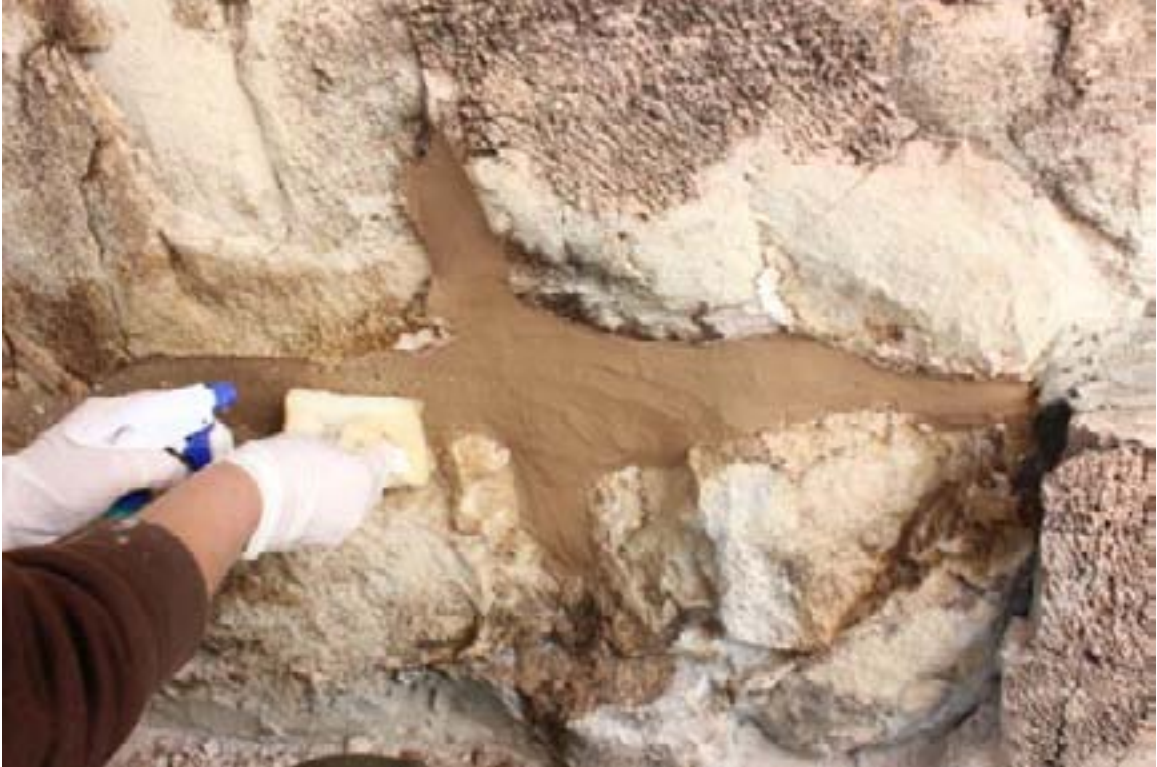
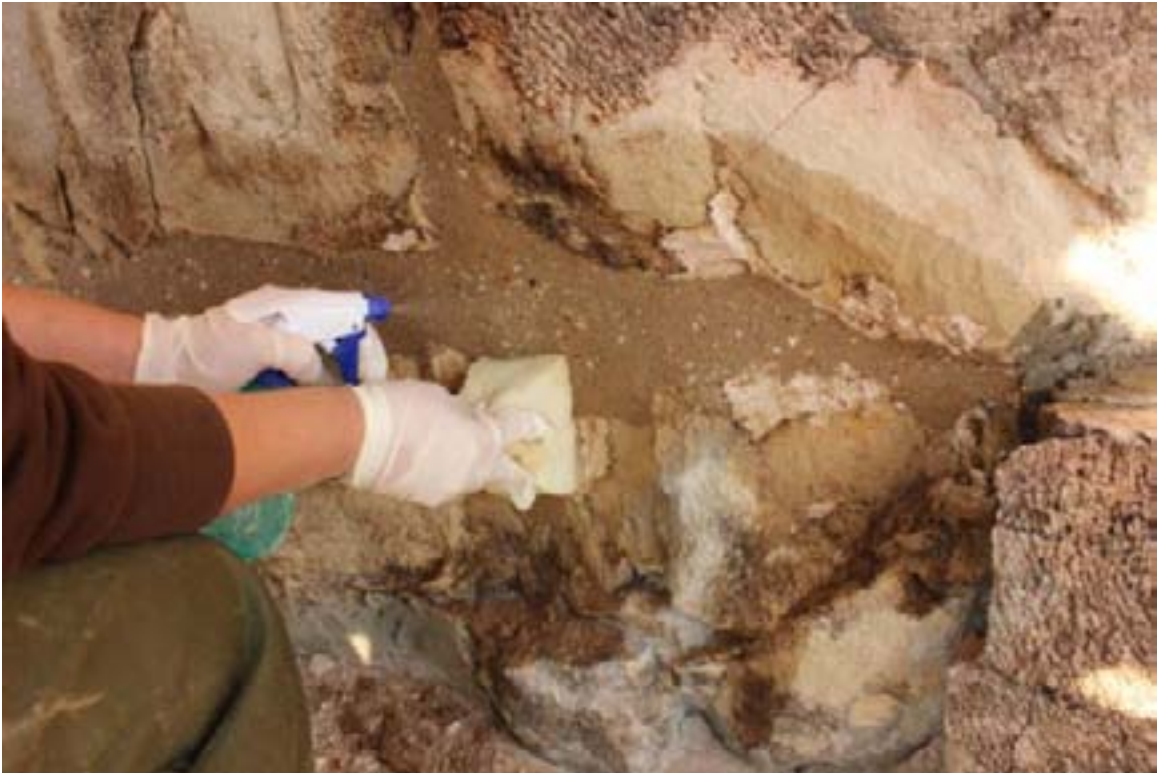
Western facade Church of the Virgin at Gelati Monastery

Reconstruction of missing parts of the masonry with lime mortar

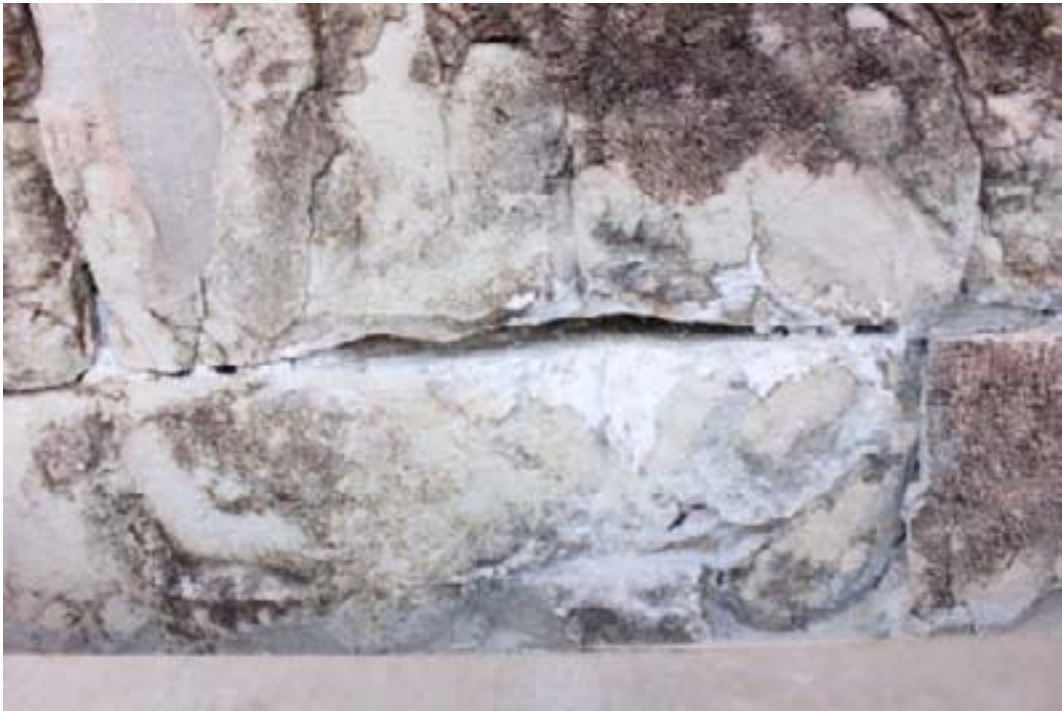
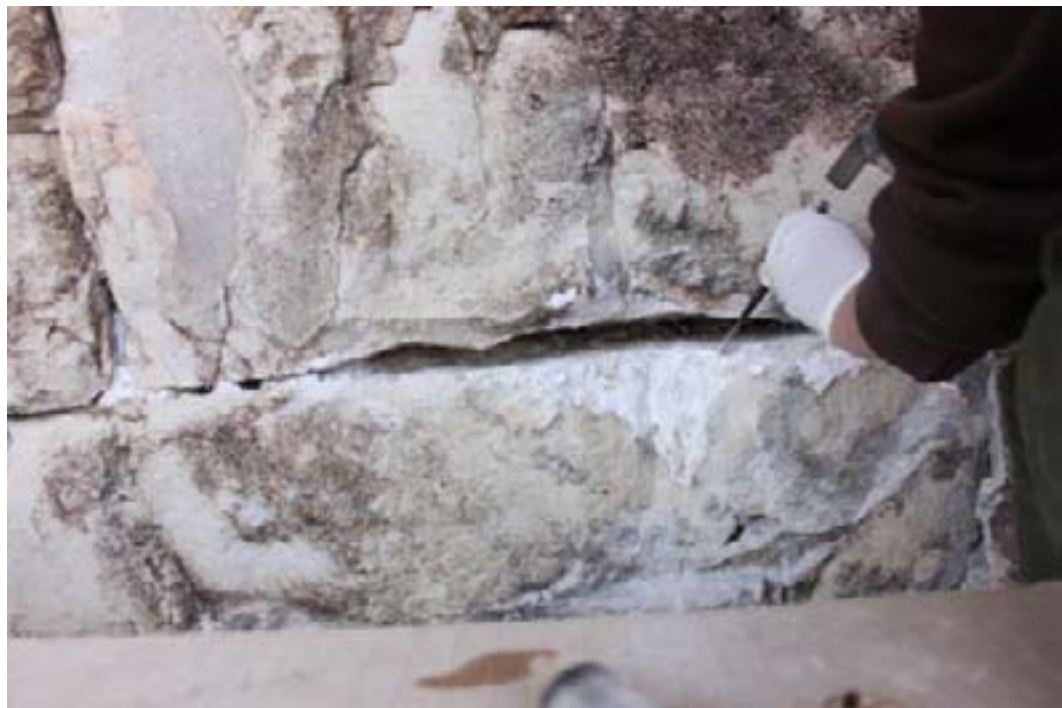
Western facade Church of the Virgin at Gelati Monastery

Cleaning of the old fillings

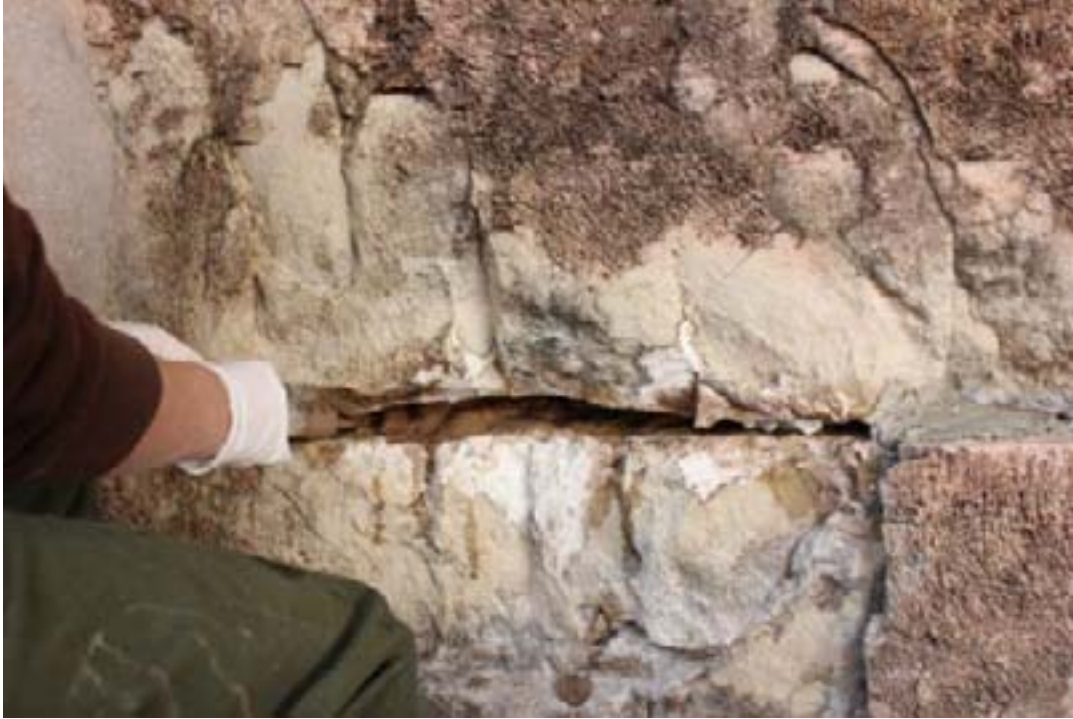
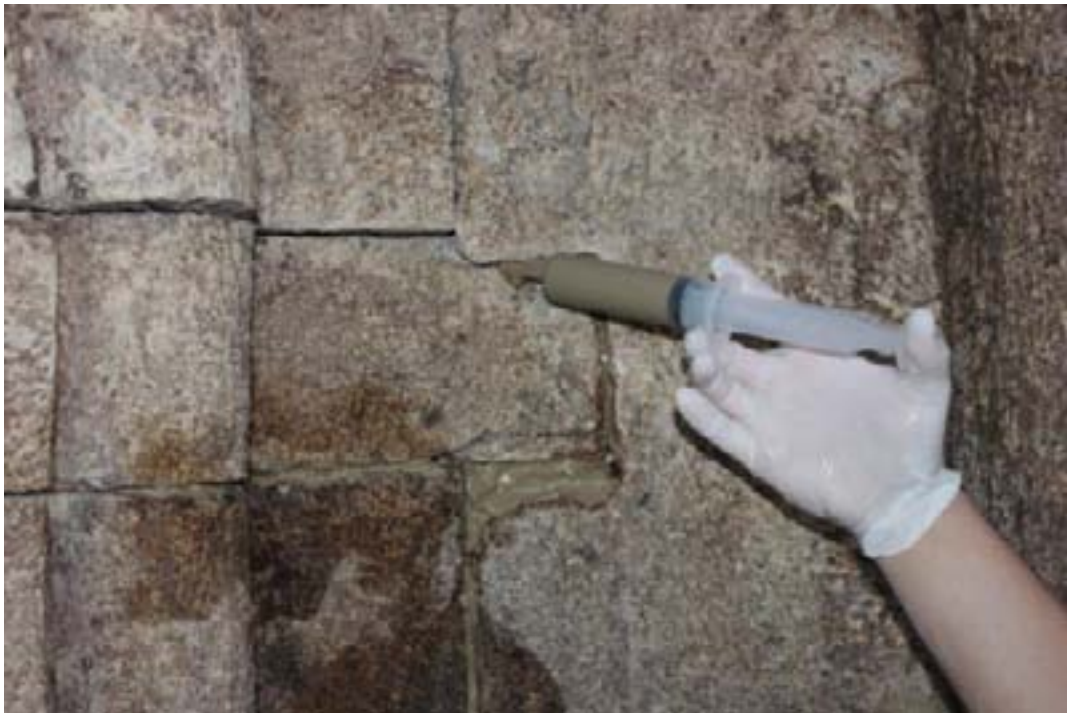
Western facade Church of the Virgin at Gelati Monastery

Injection

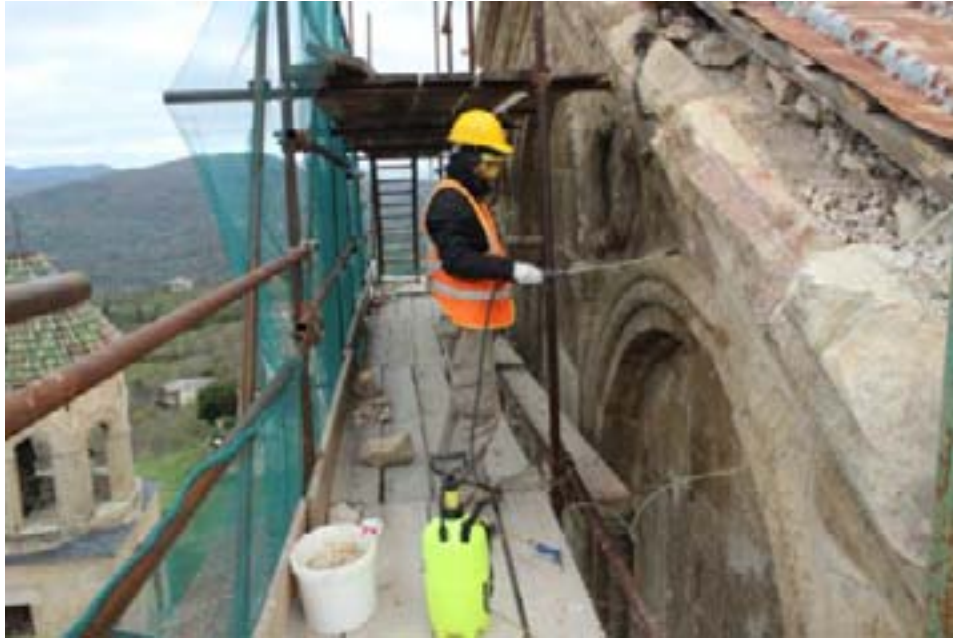
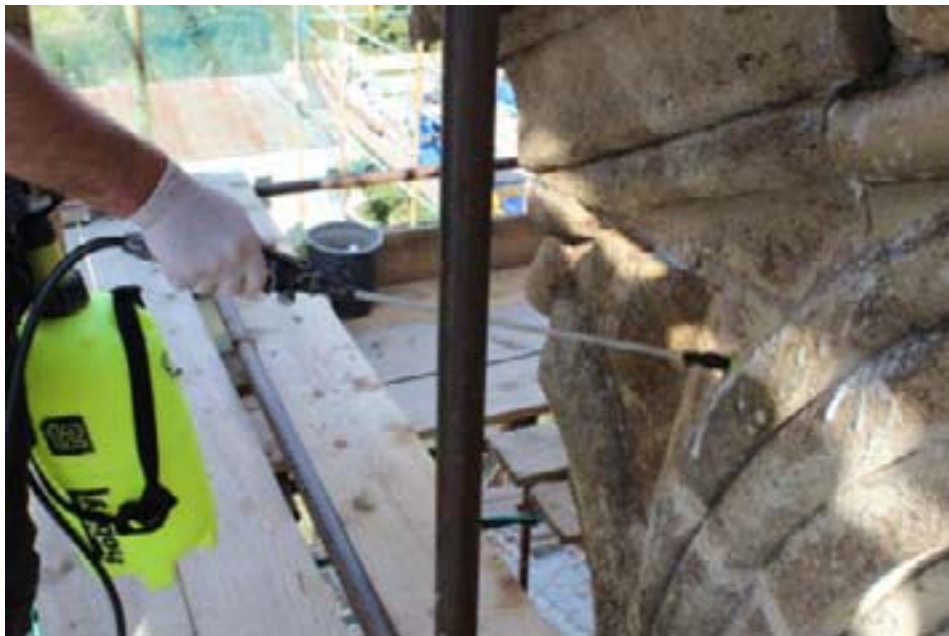
Western facade Church of the Virgin at Gelati Monastery

Treatment with Biocide
