Church of the Nativity of the Virgin - Gelati Monastery

Article on the emergency conservation-restoration intervention of the Frescoes

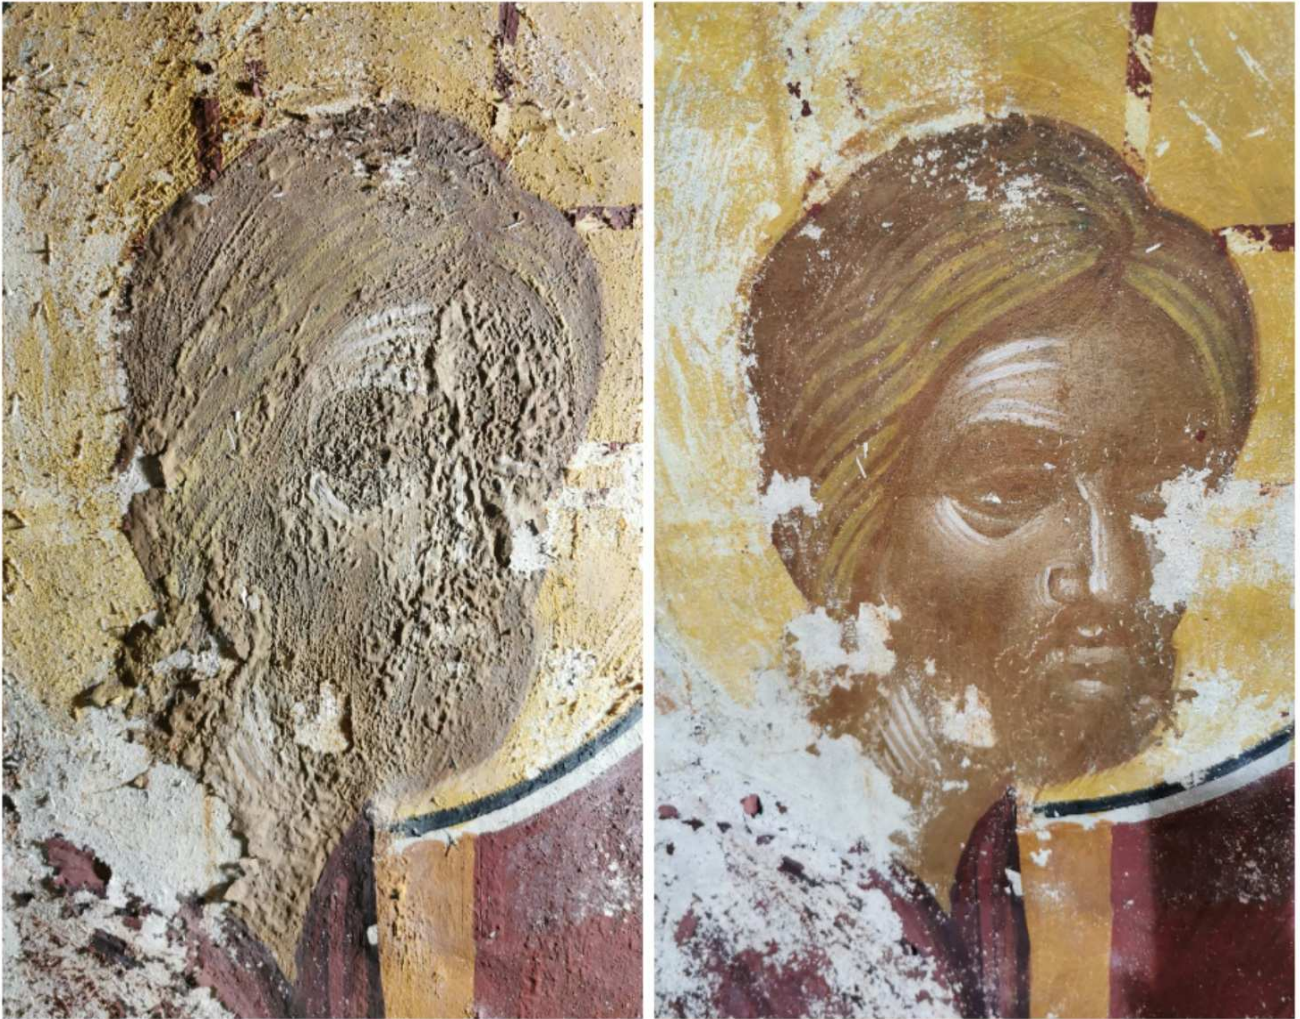
Fixing of the raised paint film

The exfoliation of the pictorial film was consolidated to the underlying layer of plaster by applying on the painted surface a folio of Japanese paper, adhered by the use of deionized water and exerting pressure with soft pads in order to re-stick the lifted portions of pictorial film. Subsequently, again through the paper layer (filter), a solution of deionized water and acrylic resin in aqueous emulsion (3%) (Acrill 33 / EA-MMA) was applied.

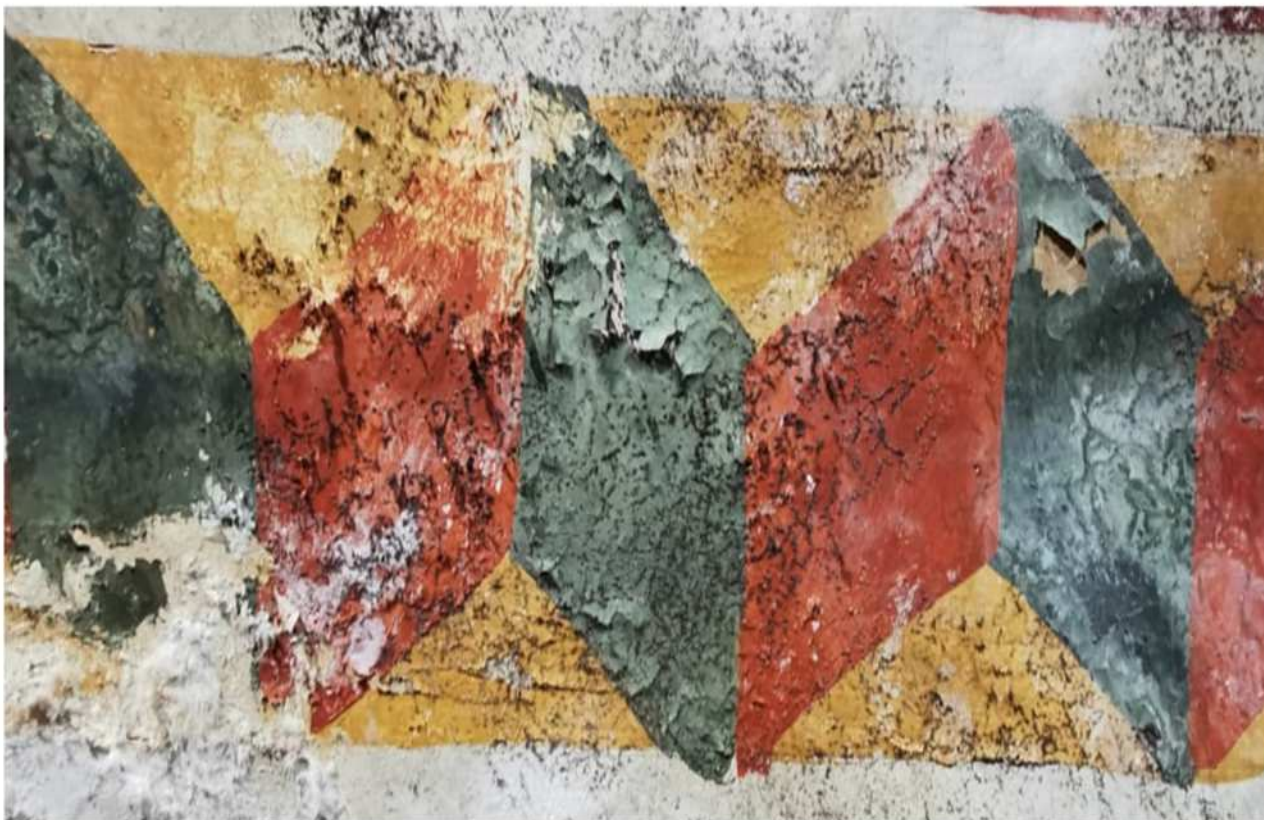
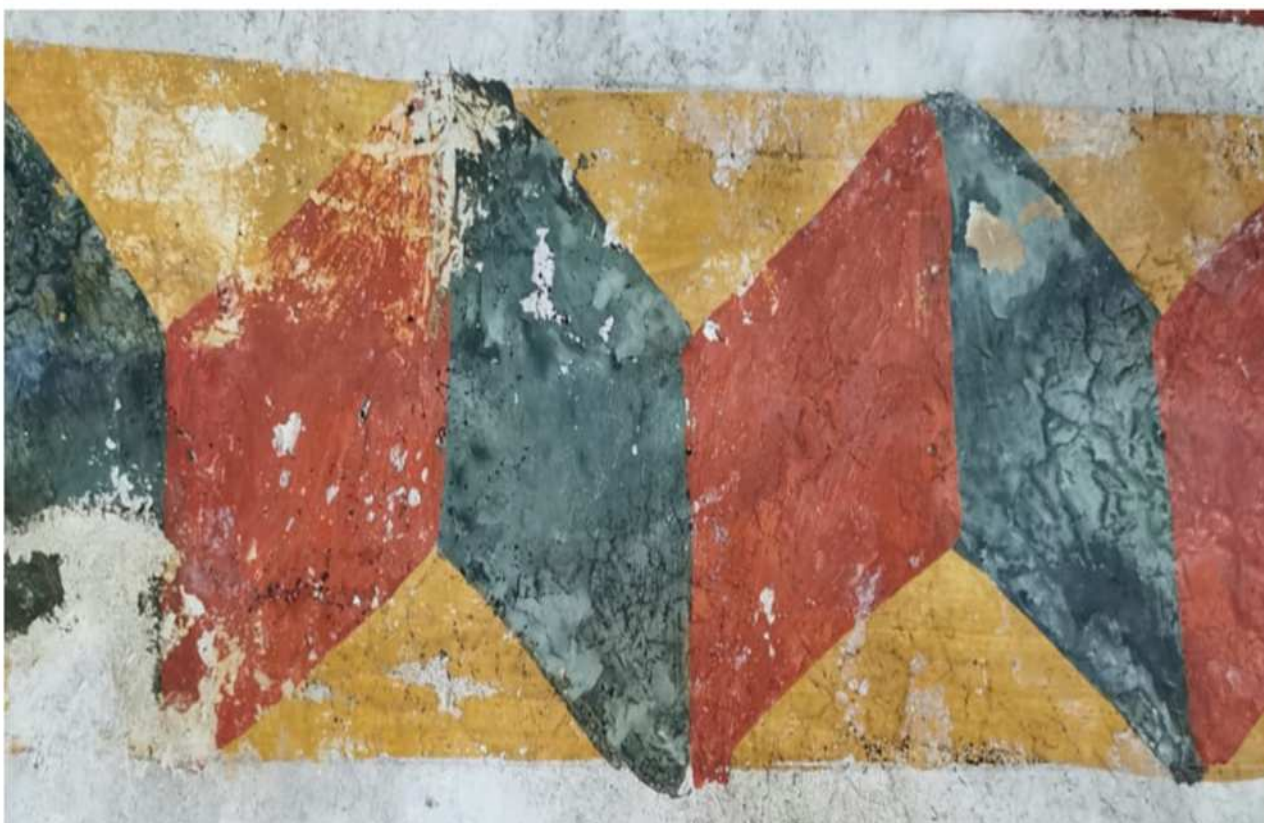
Fixing of the paint film and removal of saline efflorescence

Before fixing the color, in the areas where saline efflorescences were evident, the latter were removed with meticulous attention, first dry by using soft bristle brushes and then by compresses of

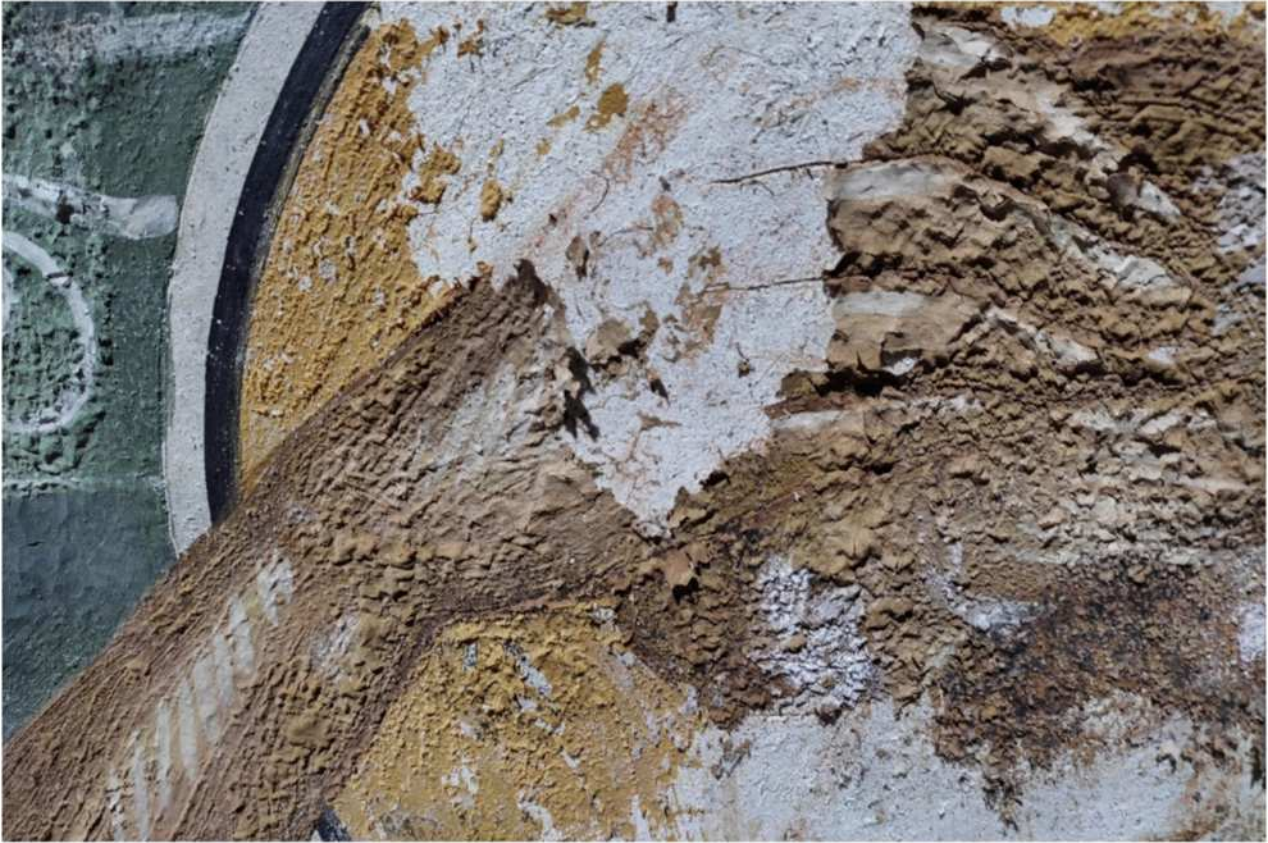
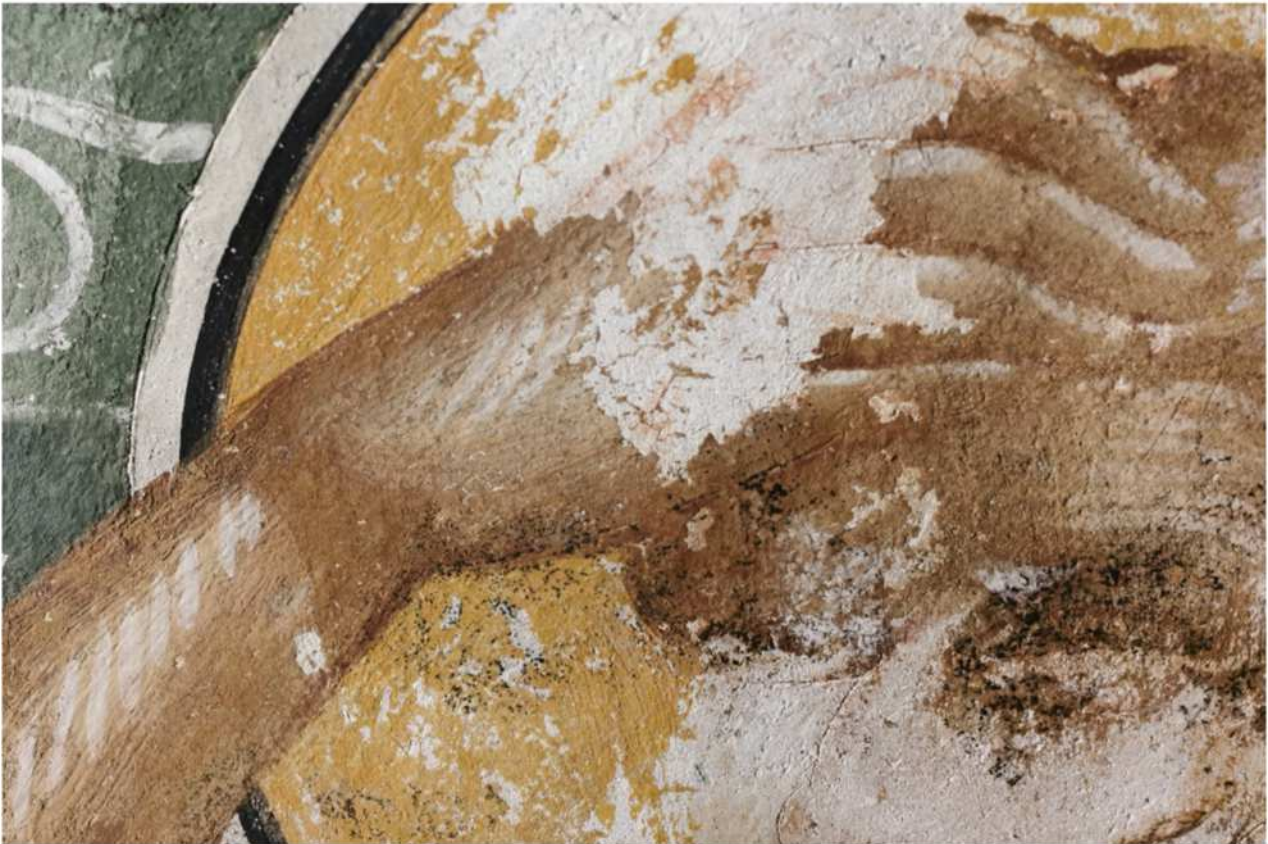
Fixing of the raised paint film

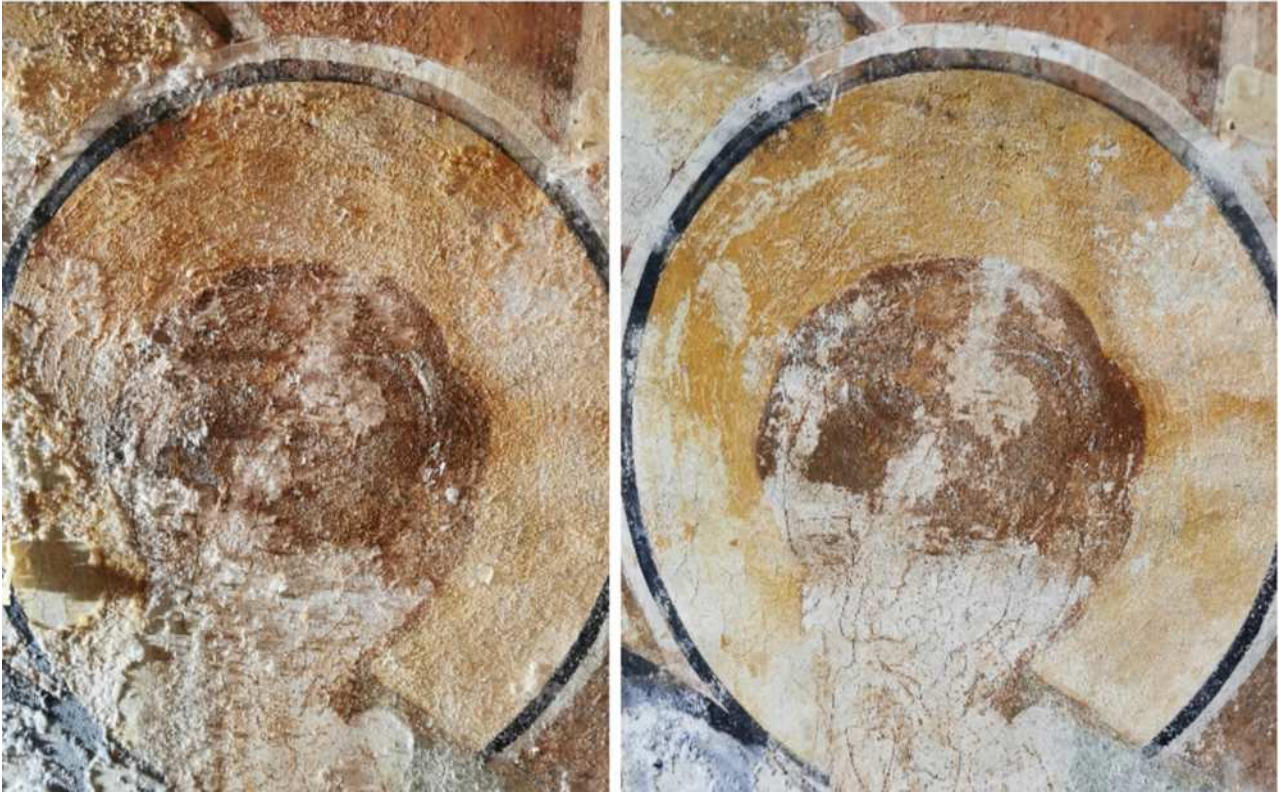
Fixing of the paint film and removal of saline efflorescence

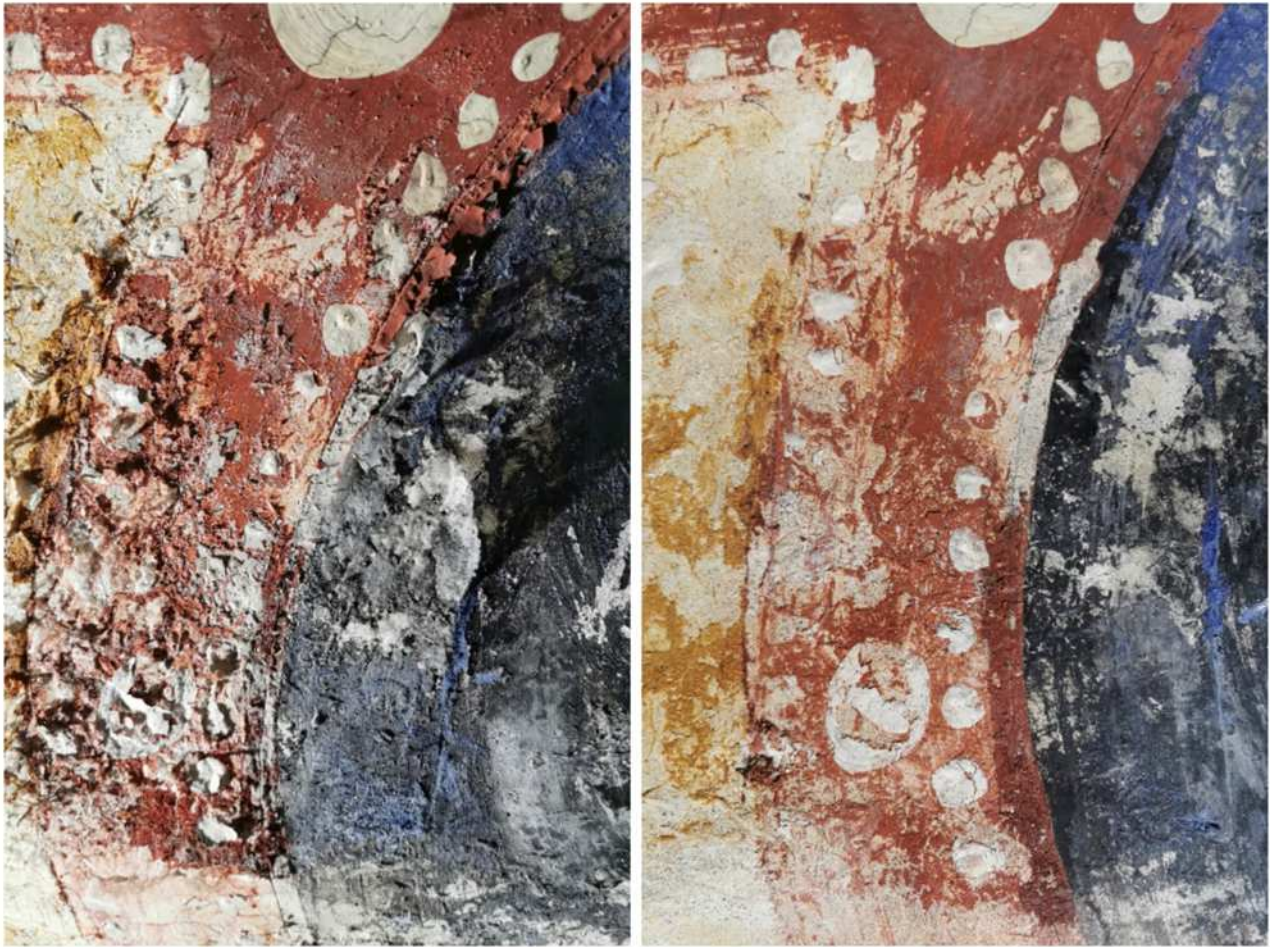
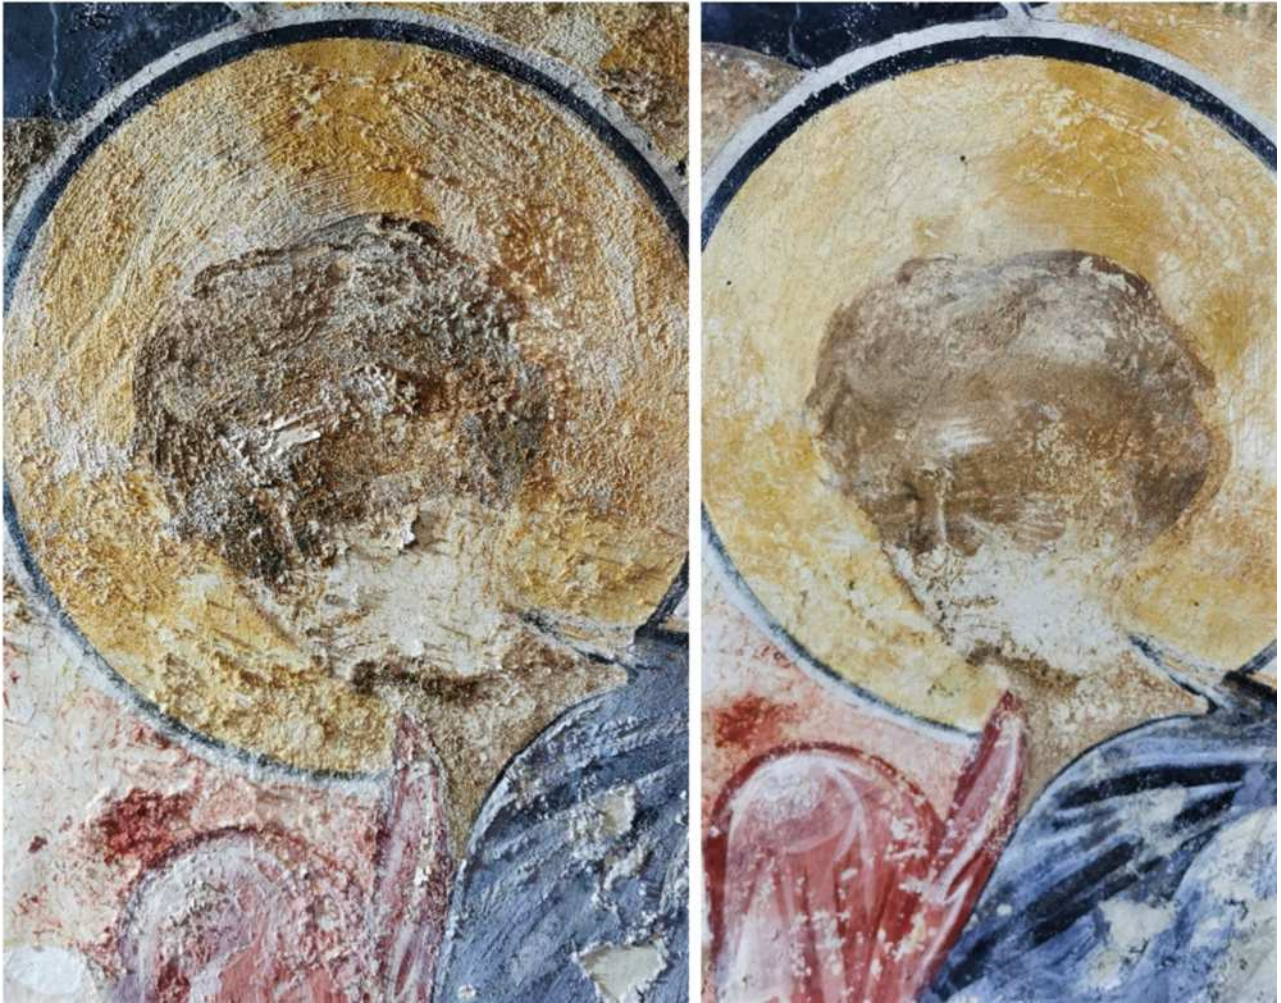
Fixing of the paint film and removal of saline efflorescence
