Annex 1: State of Conservation Report, Historical Monuments of Mtskheta

Annex 2: State of Conservation Report, Bagrati Cathedral and Gelati Monastery

Bagrati Cathedral and Gelati Monastery (Georgia) (710)

1. STATE OF CONSERVATION

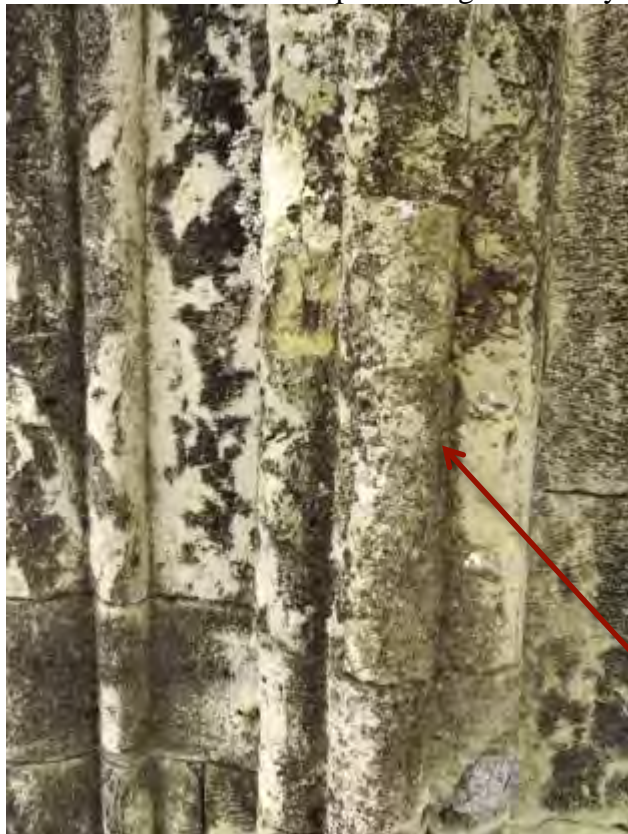
Stones of the dome drum present a great variety of forms of decay.

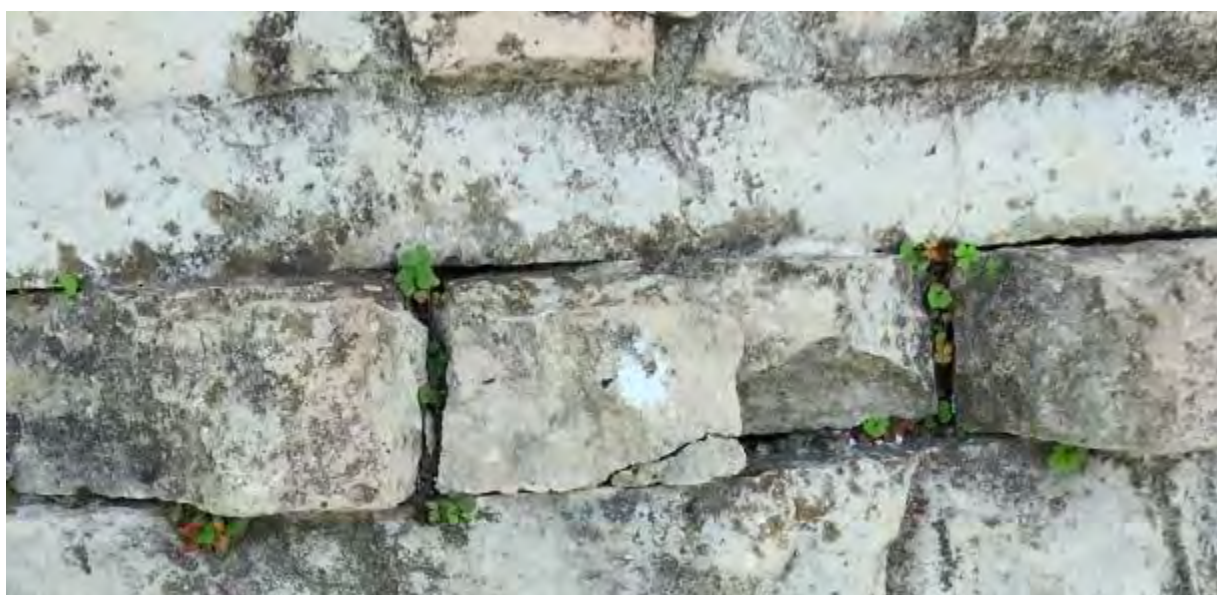
A profuse green/brownish-blackish layer of biological growth, clinging into the stone alveoli and spreading also inside cracks and fissures, can be observed over the surfaces (mostly foliose and crustose lichens and algae; sometimes weeds like *Parietaria*): microflora causes not only aesthetic decay but also physical/chemical deterioration of stone substratum, connected to growth and metabolism of vegetation (development of roots over the surfaces and inside the micro-fissures, mechanical stress, excretion of acid substance over the substratum which leads to chemical degradation of stone surface, etc)

This form of biodeterioration is particularly evident in areas facing north (more stable favorable microclimate)

An example of biological patina over the stone surface

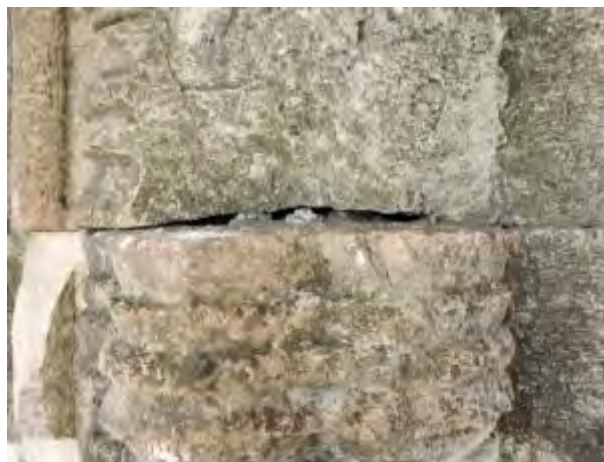
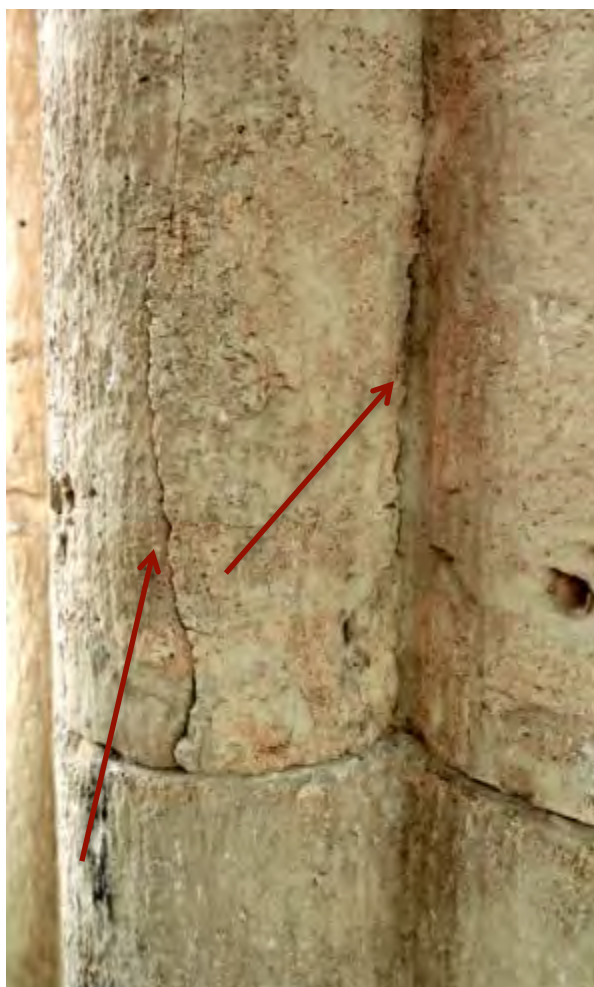
Weeds rooted in joints lacking bedding mortar.

A general reduction and/or total lack of bedding mortar among the stones can be observed: this facilitates the formation of preferential ways for seepage of rain water, causes washing away and formation of physical decay (for instance the disruptive action of water in seasonal cycles of frost and thaw) and chemical deterioration caused by natural and artificial “pollutants” carried by water...but this is not the only problem!

The partial or total loss of this bedding mortar, occurring over the centuries, puts the surfaces of the overlapping ashlars into direct contact; the mortar is no more there to absorb the compression and bending forces; the stress concentrated in points of contact causes

crackles, cracks and fissures that fracture the stone, then causing detachment and fall of stone parts.

- Replacement of bedding lime mortar with suitable color and granulometry mortar (lime putty, river sand, suitable aggregates, 1: 3) after deep injection of natural hydraulic lime grout NHL5 + ventilated aggregates, such as cocciopesto or pozzolana 1: 1)

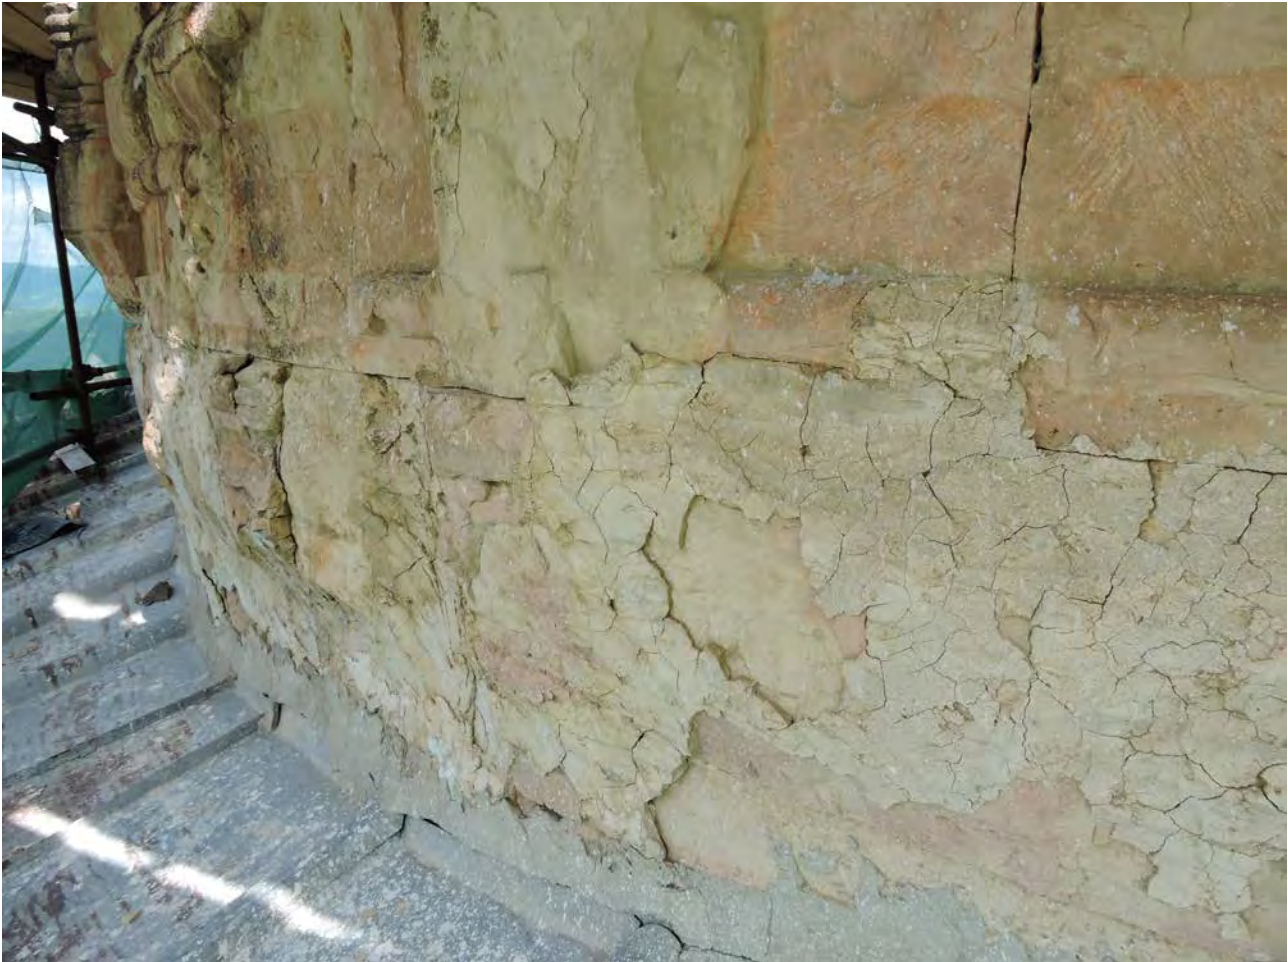
Loss of large stone parts

The lower part of the dome drum, just above the roofs of the lower building, shows a severe decay, likely caused by a specific event that affected this architectural part in the past centuries (fire of shelters?): for the time being no archive documents have been found. Stone surfaces are widely covered by a concrete mortar; under this layer the stone is cracked and fragmented, sometimes lacking cohesion.

- Refurbishment of lack of cohesion of stone (lower part of the dome drum) and of bricks by an inorganic consolidant (Ethylsilicate Wacker OH 100), injected with a syringe into all crackles, cracks and fissures and applied with a brush until saturation of the stone. Thirty days are needed to Ethylsilicate to complete consolidation; it is also important to avoid that, during the first 15 days after application, the surfaces are exposed to rain and control that the temperature are within 15° and 30 ° Celsius.

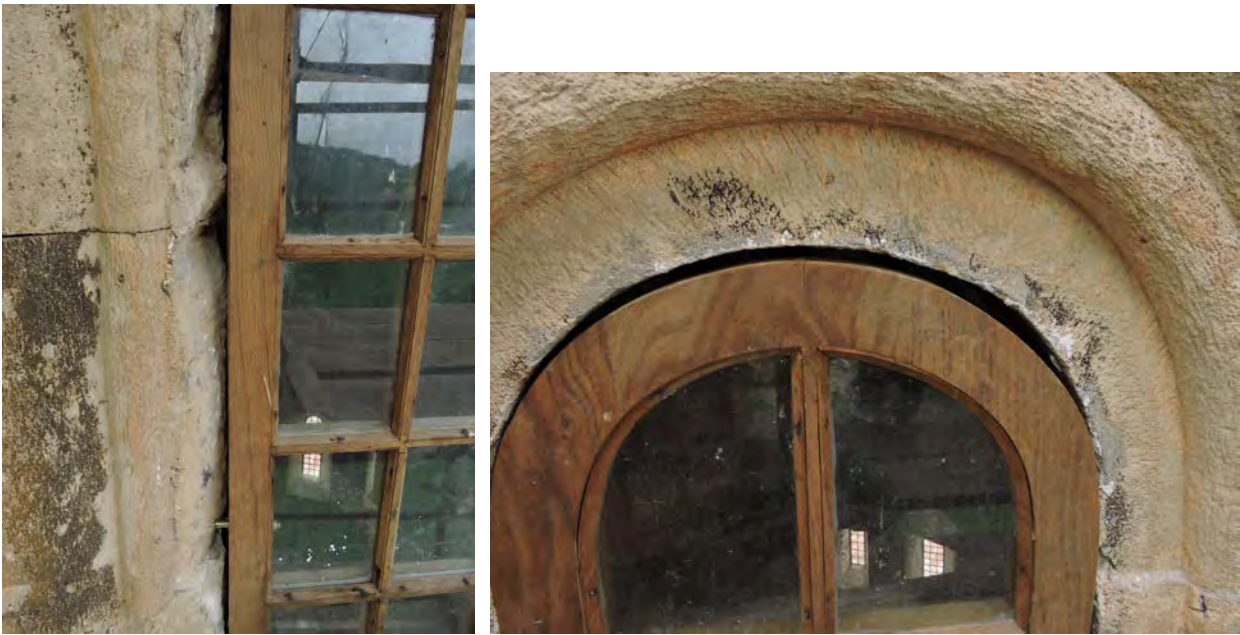
The concrete mortar, laid in the past with the aim to preserve the decayed ashlar, contributed, on the contrary, to worsen conservation: the migration of soluble salts contained in concrete and its elastic modulus which differs from the original stone, greatly increased disintegration over and beneath the surface and fragmentation of ashlar.

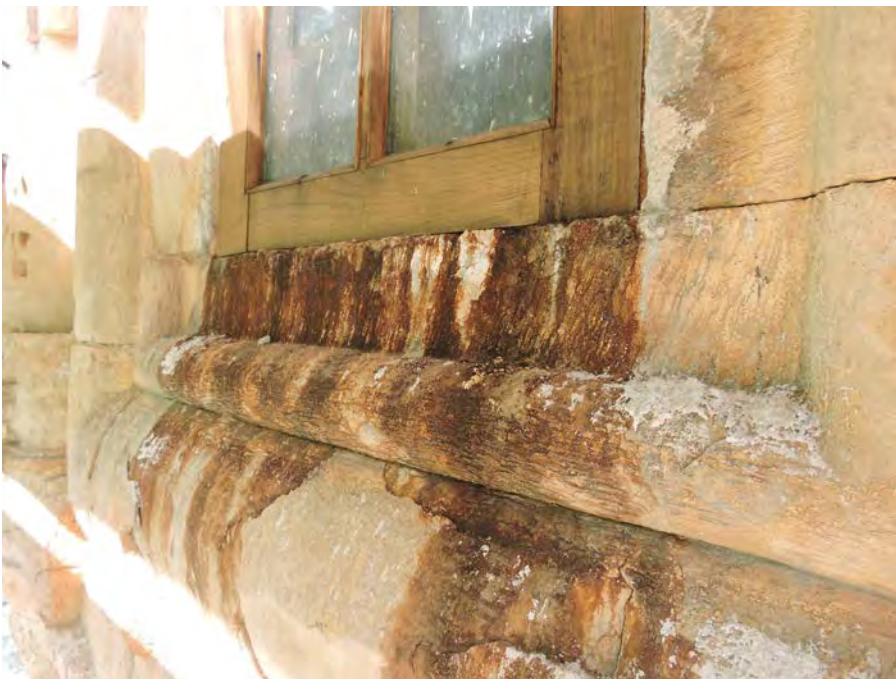
Two specific problems connected with the recent placing of oak frames can be observed. Due to the lack of a framework in the wooden frames a deleterious disjuncting between wood and stone allows seepage of rain water. Moreover, since the time in which the window frames were put in place, one year ago, the insufficiently seasoned wood caused a very widespread leakage of tannin over the stone surfaces.

The only areas that need to be cleaned are those stained by tannin leaks. Preliminary tests of cleaning will be carried out with suitable supports (cellulose paste Arbocel 1000 and/or ventilated sepiolite) and suitable buffered solvents and/or surfactants (Ammonium Carbonate, contrad 2000, Hydrogen Peroxide).

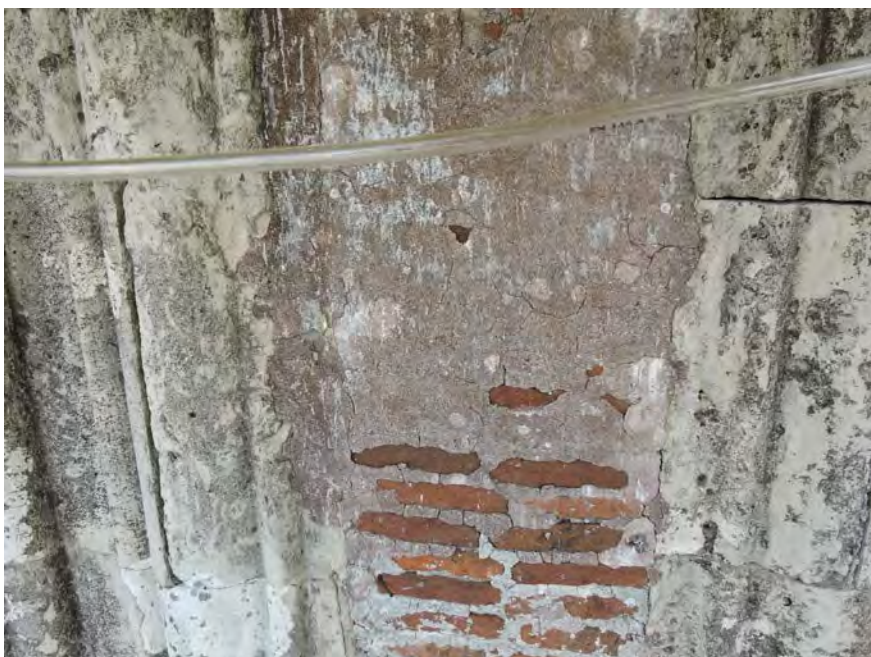
Some windows were in-filled in ancient times (inner wall paintings) with bricks covered by a layer of mortar. Plaster shows decay: biological growth, crackles and fissures, lack of adhesion to the wall, detachments, loss of material and lacunas. The visible bricks show weak cohesion, pulverization, erosion and loss of material.

- Filling of fissures, fractures, plaster borders of in-filled windows, lacunas, with a suitable color and granulometry mortar (lime putty, river sand, suitable aggregates, 1: 3)

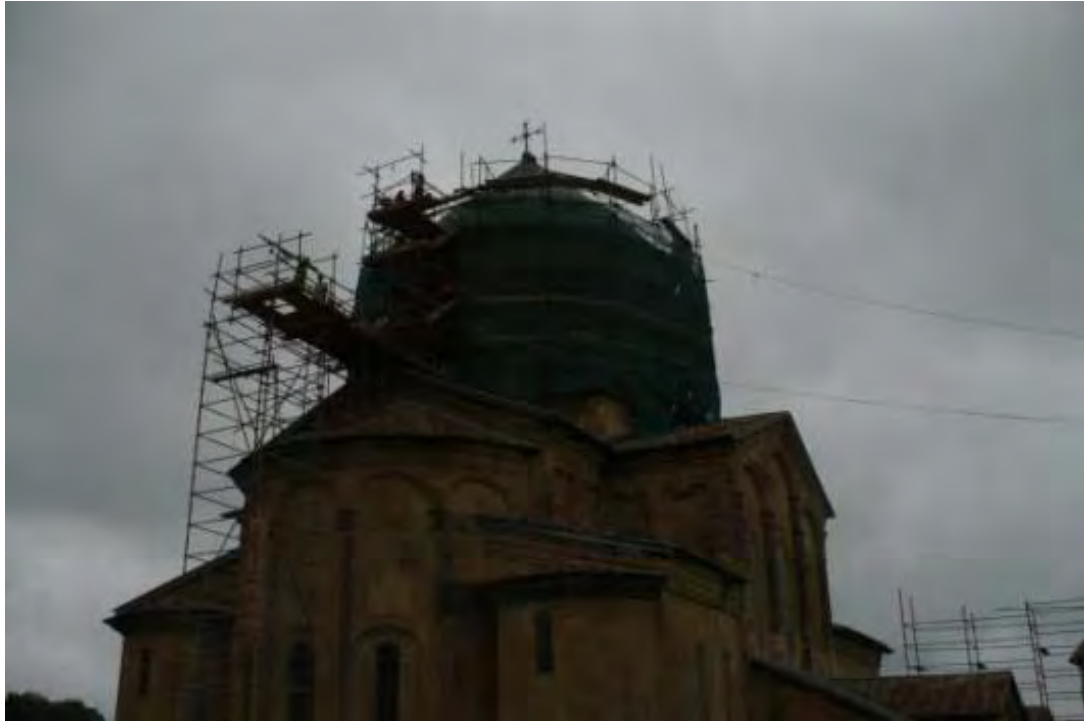
3-4. Improvement of existing scaffolding on the Dome

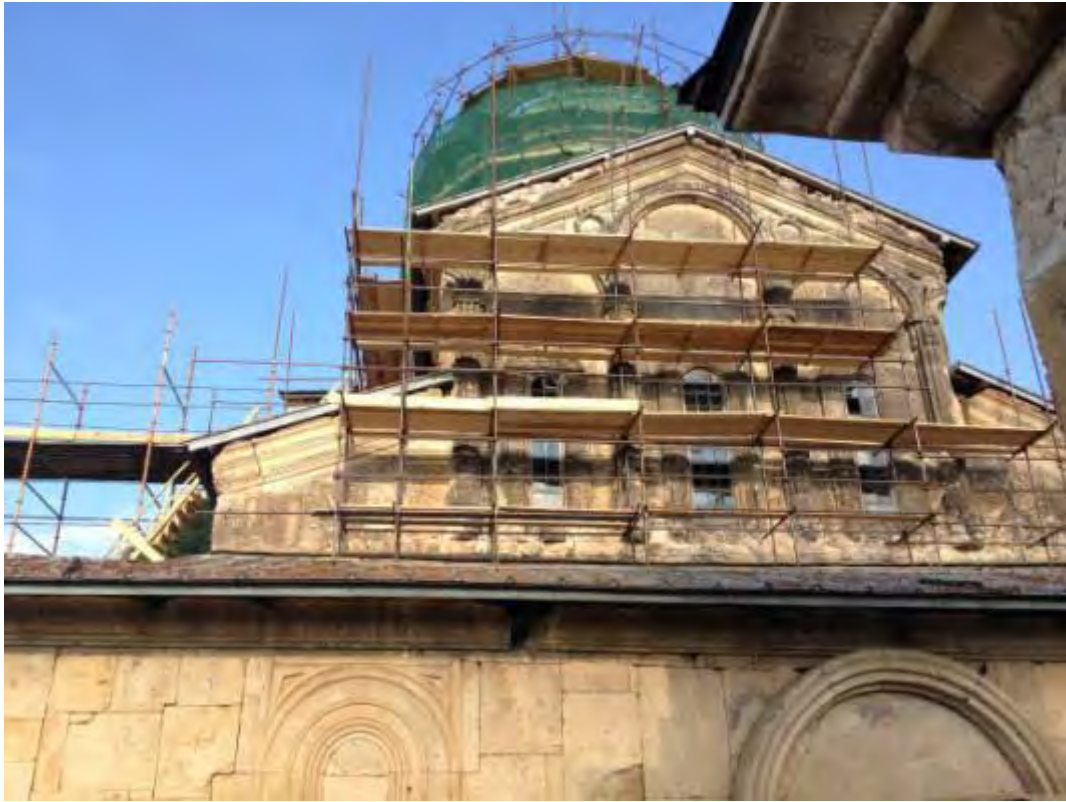
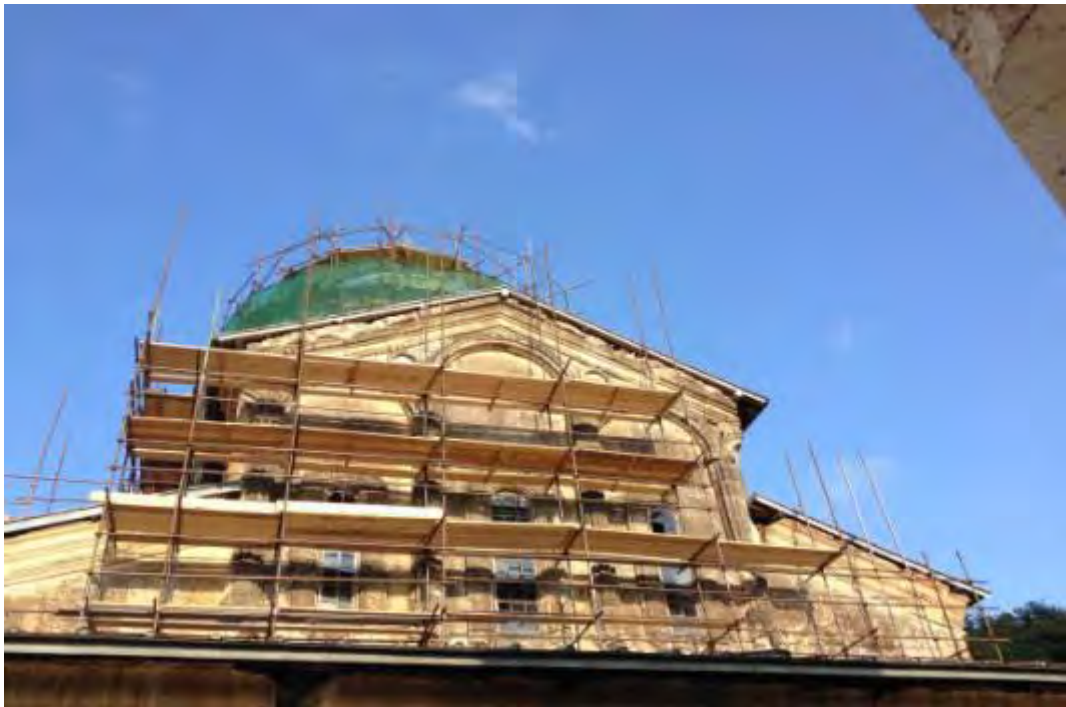
7-8. Construction of Scaffolding on the Western facade

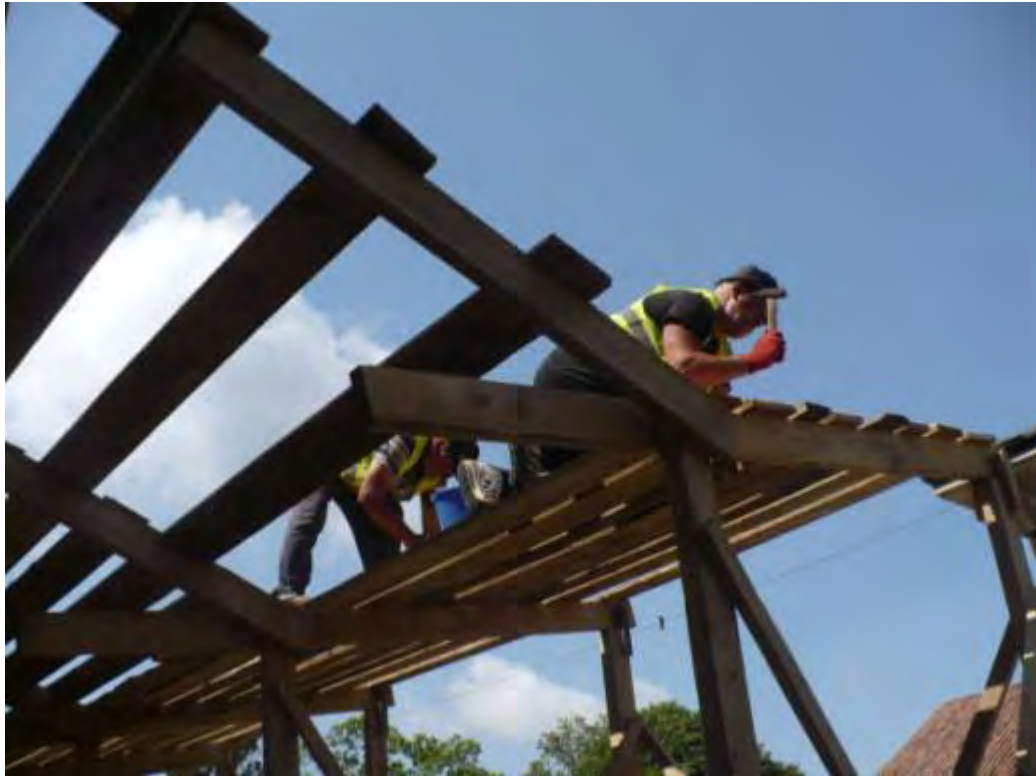
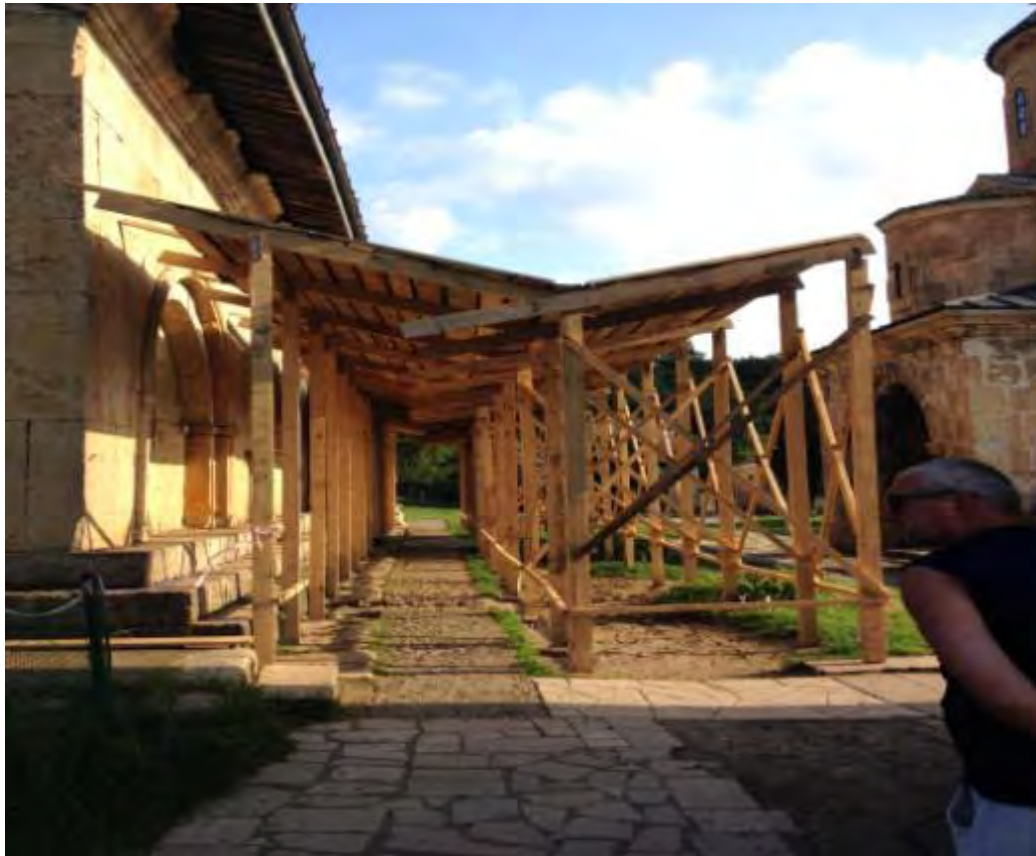
9-10. Construction of Scaffolding on the Western facade

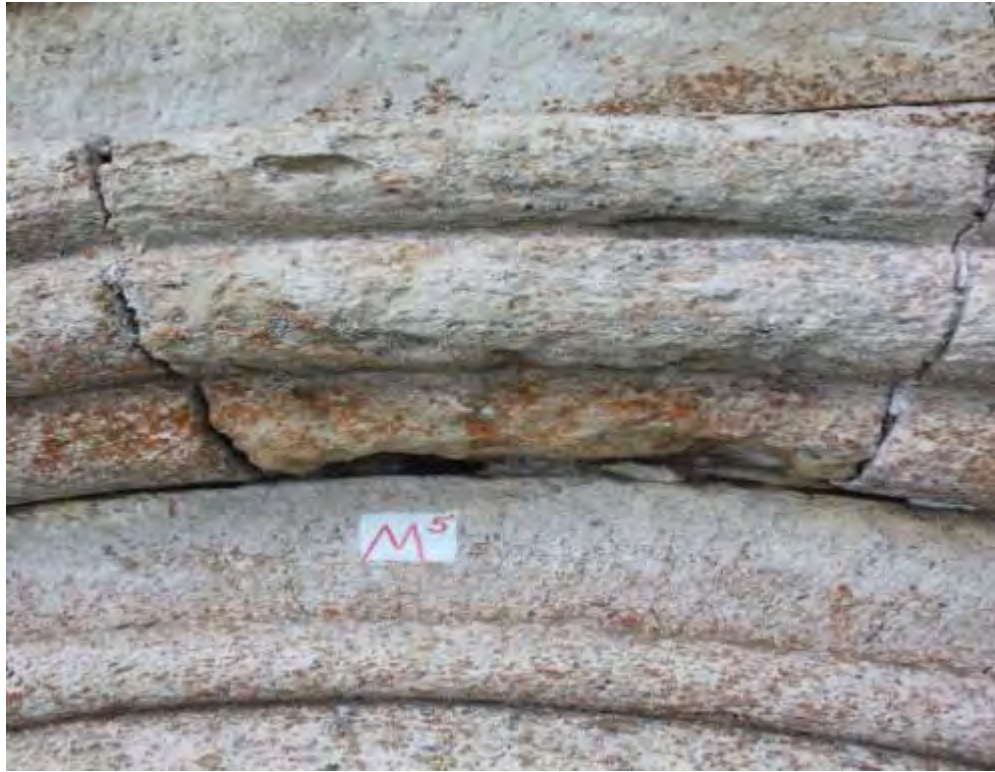
21-22. Filling of Joints, Drum Upper level, Northern side

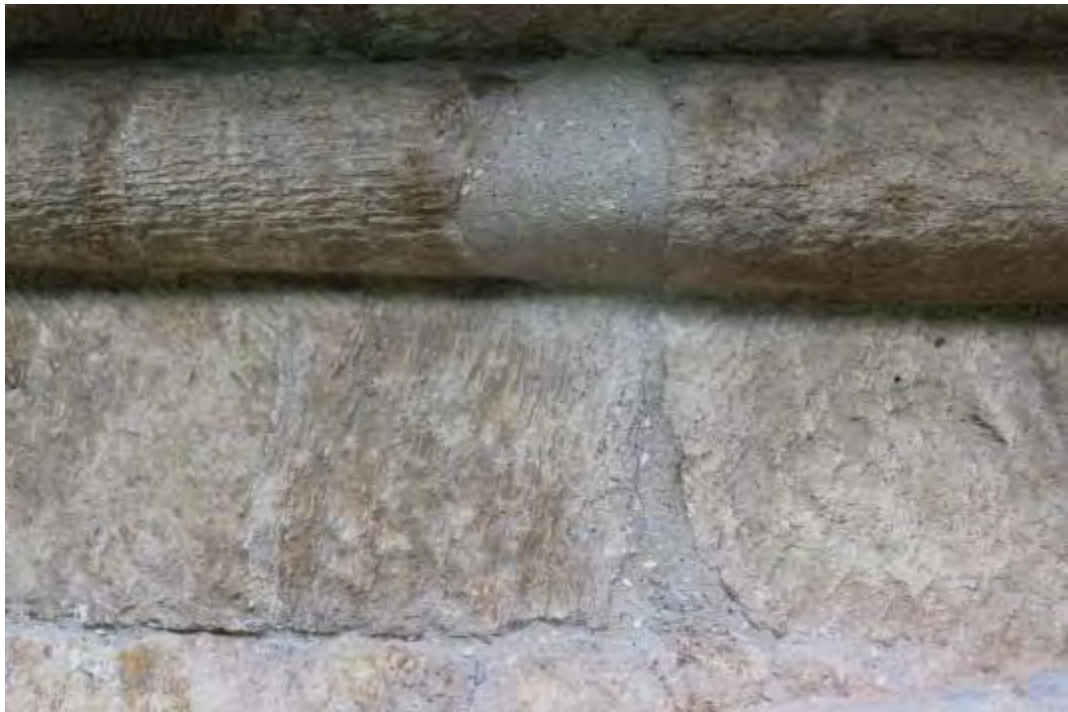
25-26. Filling of Joints, Drum Upper level, Eastern side

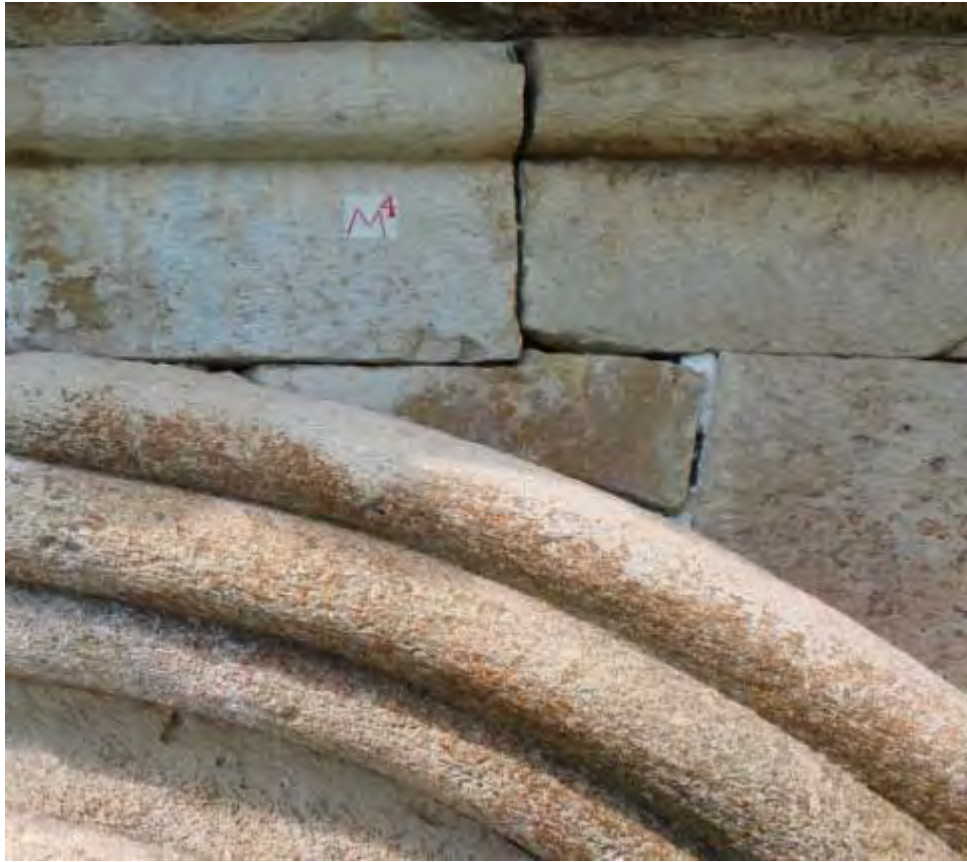
30-31. Filling of Joints, Drum Upper level, Northern side

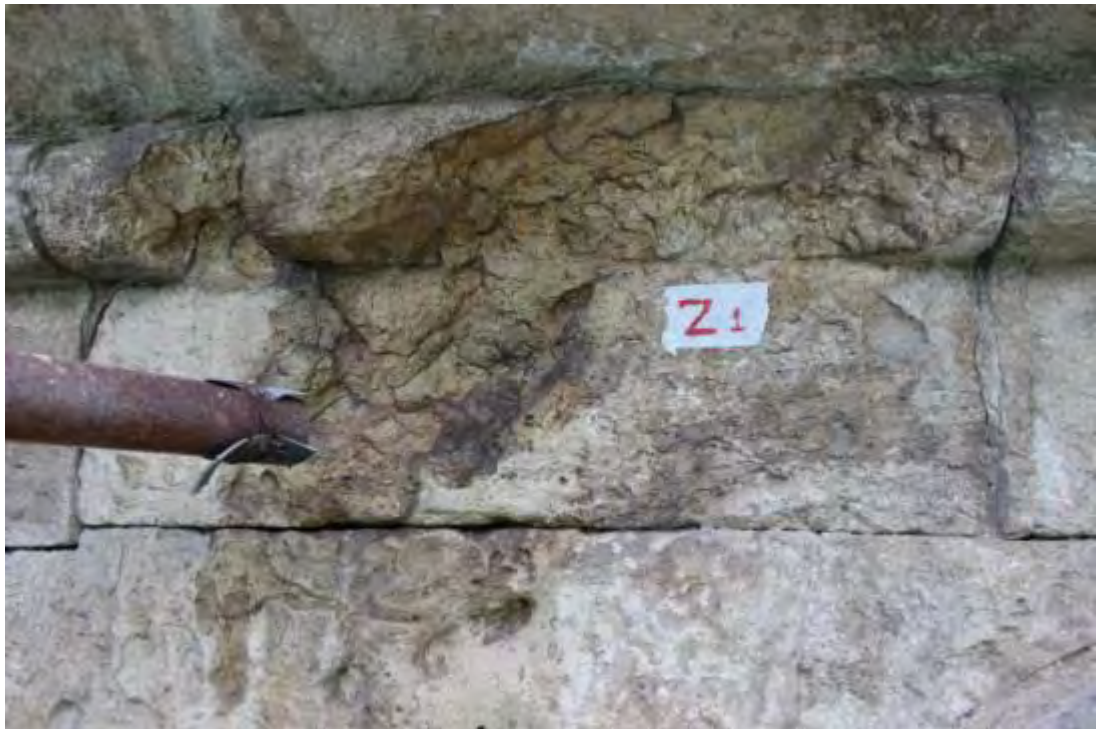
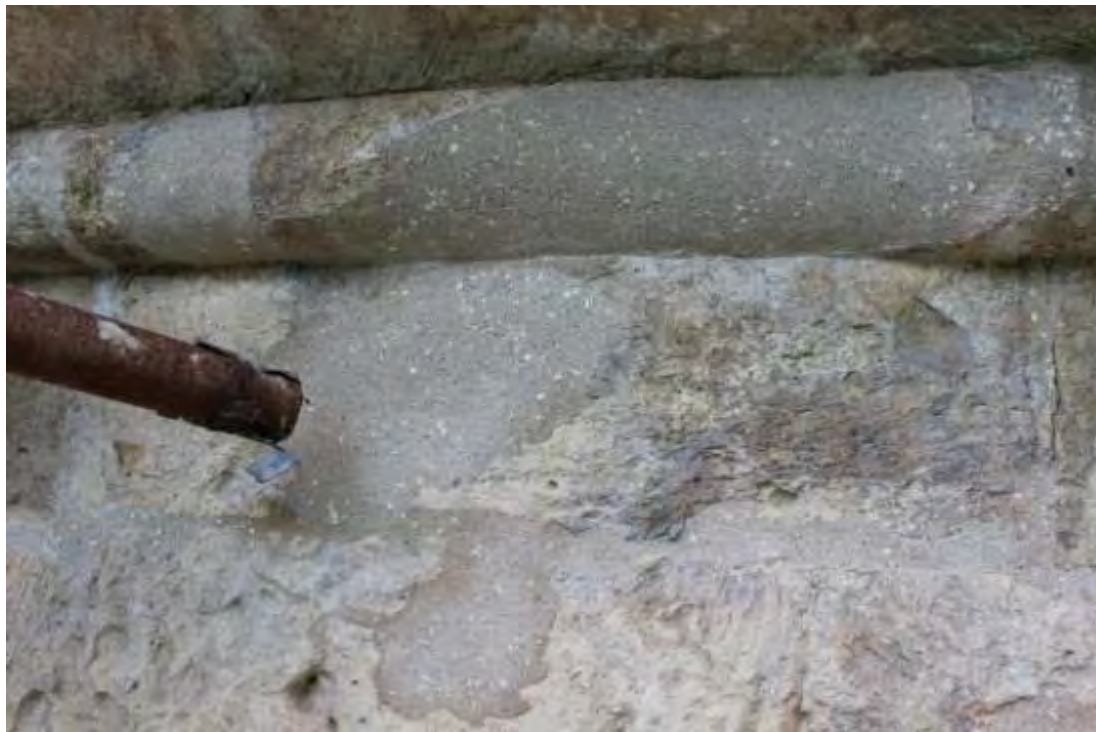
32-33. Filling of Joints & Consolidation of missed parts of masonry by lime and pozzolana, Drum Upper level, North-Western side

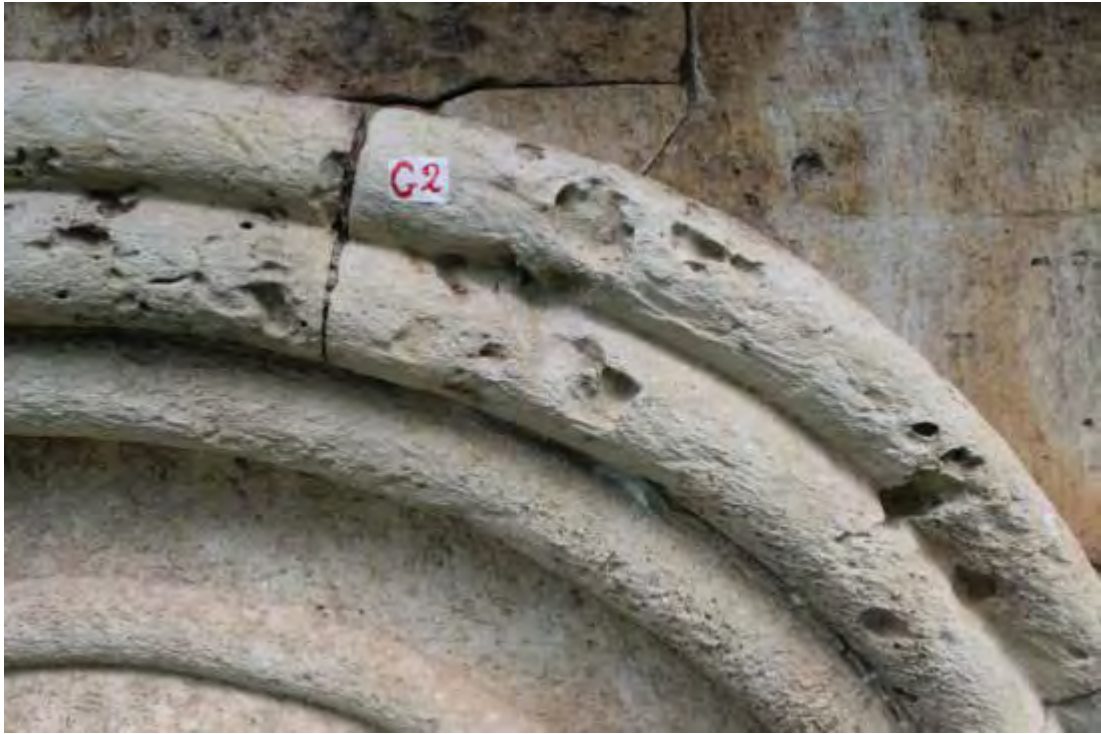
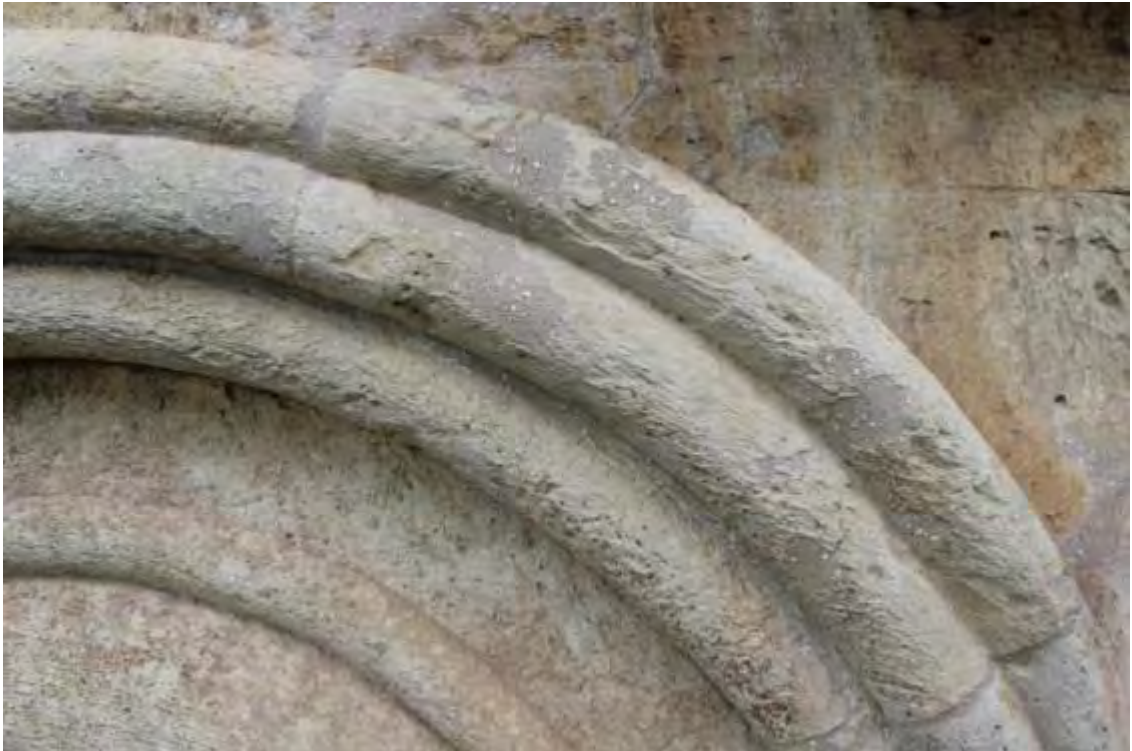
34-35. Filling of Joints & Consolidation of missed parts of masonry by lime and pozzolana

Drum Upper level, Southern side

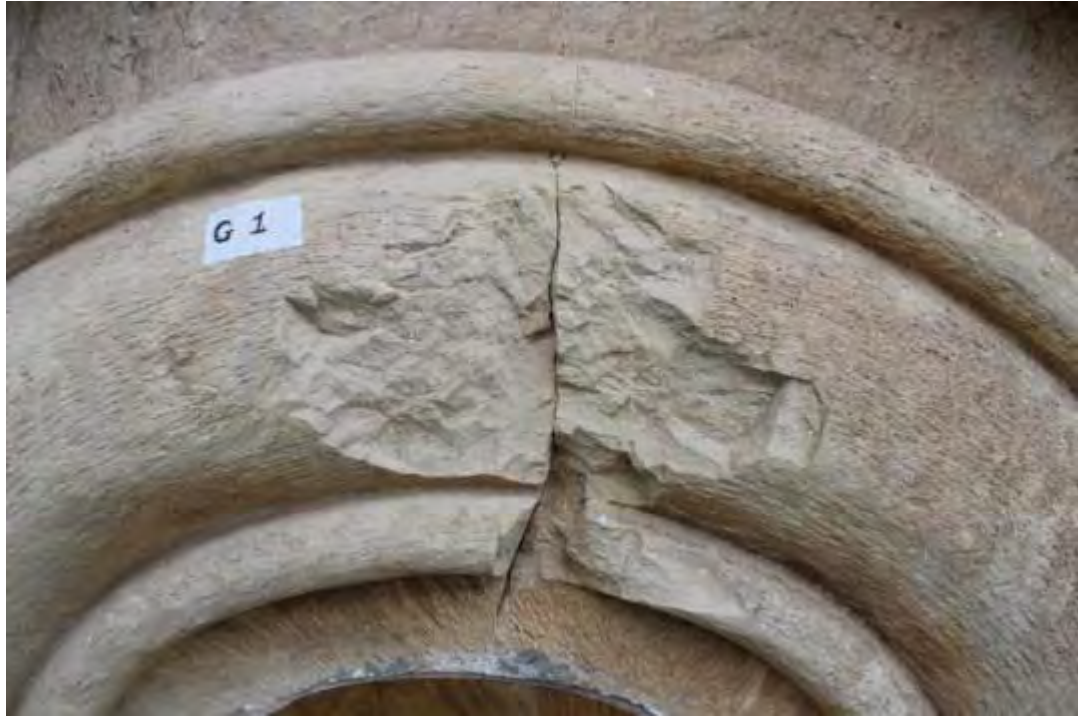
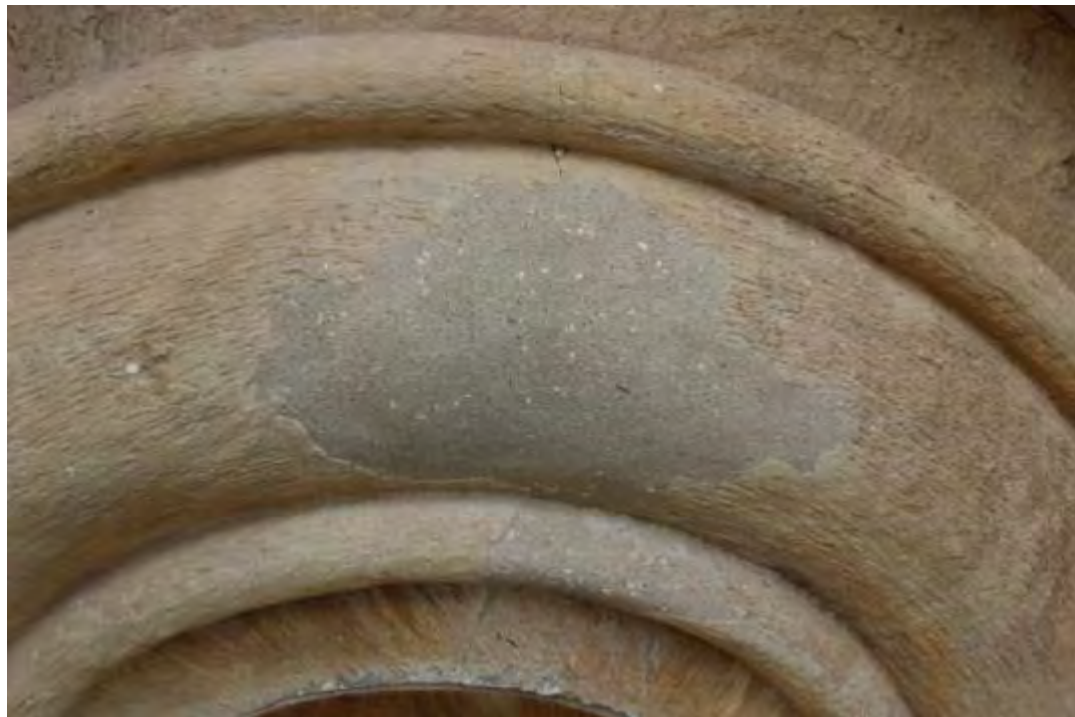
36-37. Consolidation of missed parts of masonry by lime and pozzolana, Drum Upper level

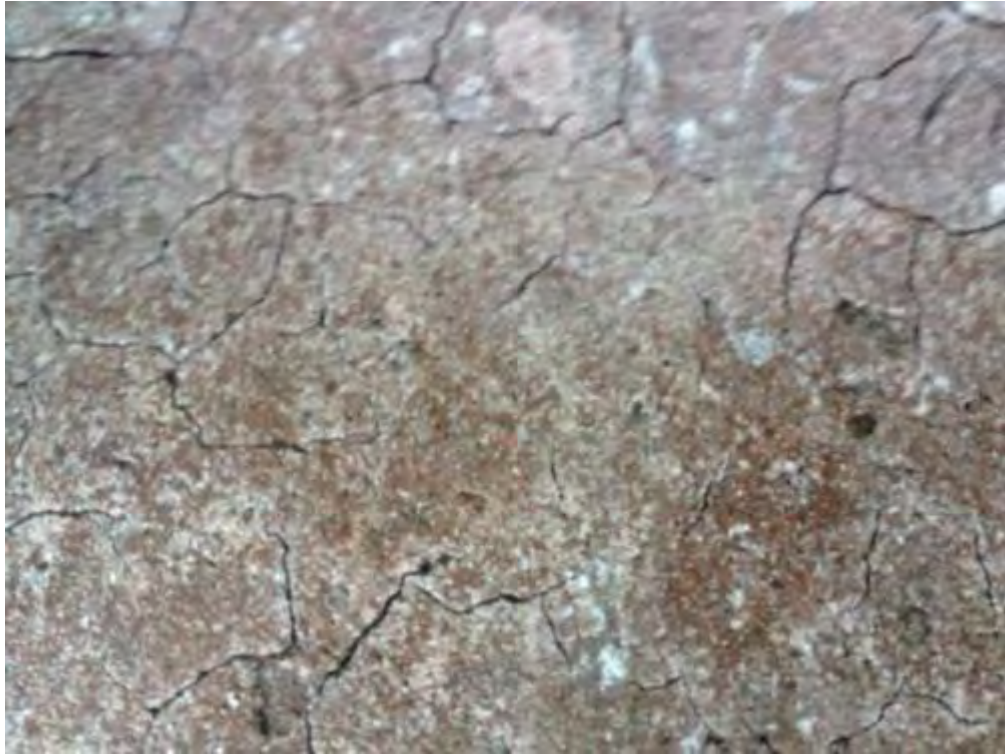
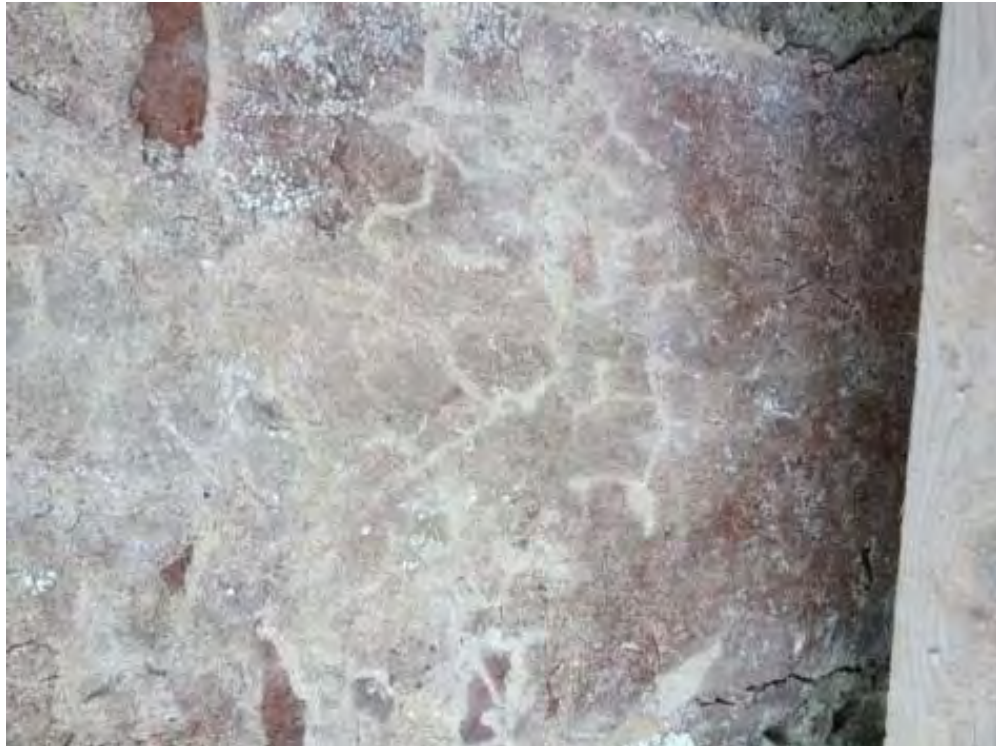
38-39. Consolidation of micro-cracks, Drum Upper level, South-west side

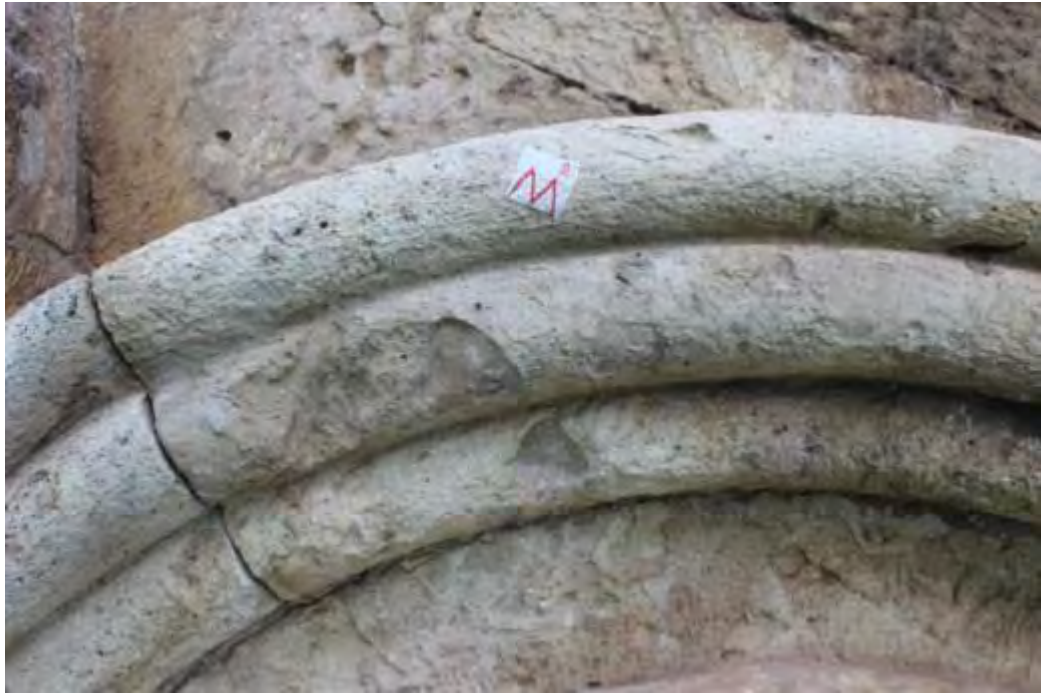
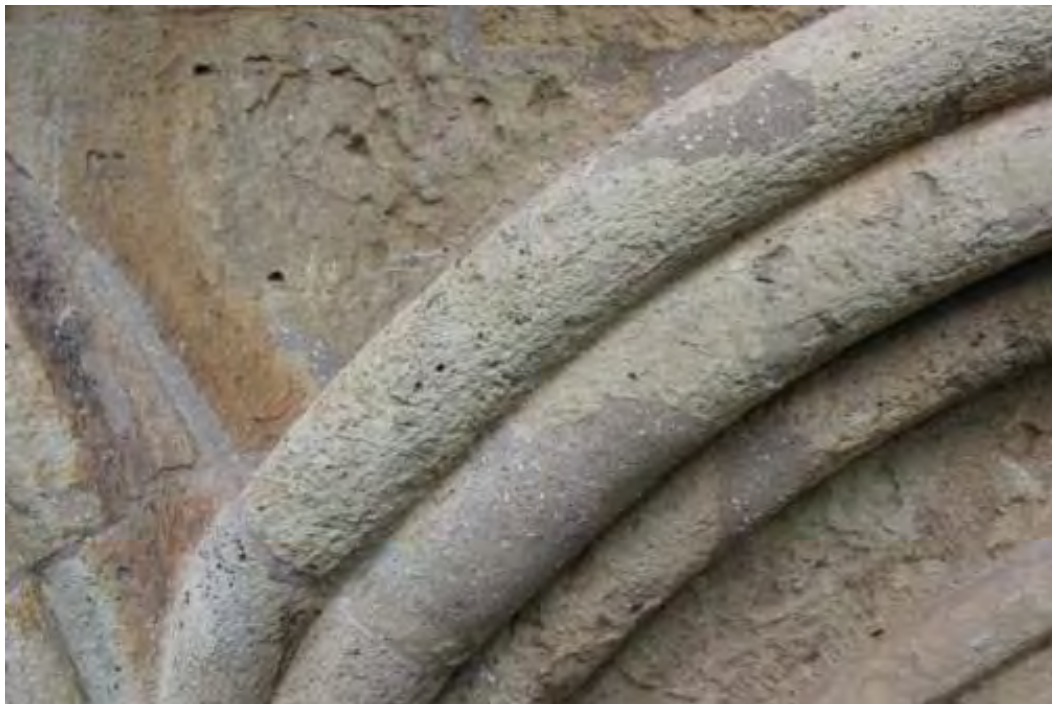
40-41. Consolidation of missed parts of masonry by lime and pozzolana. Northern side

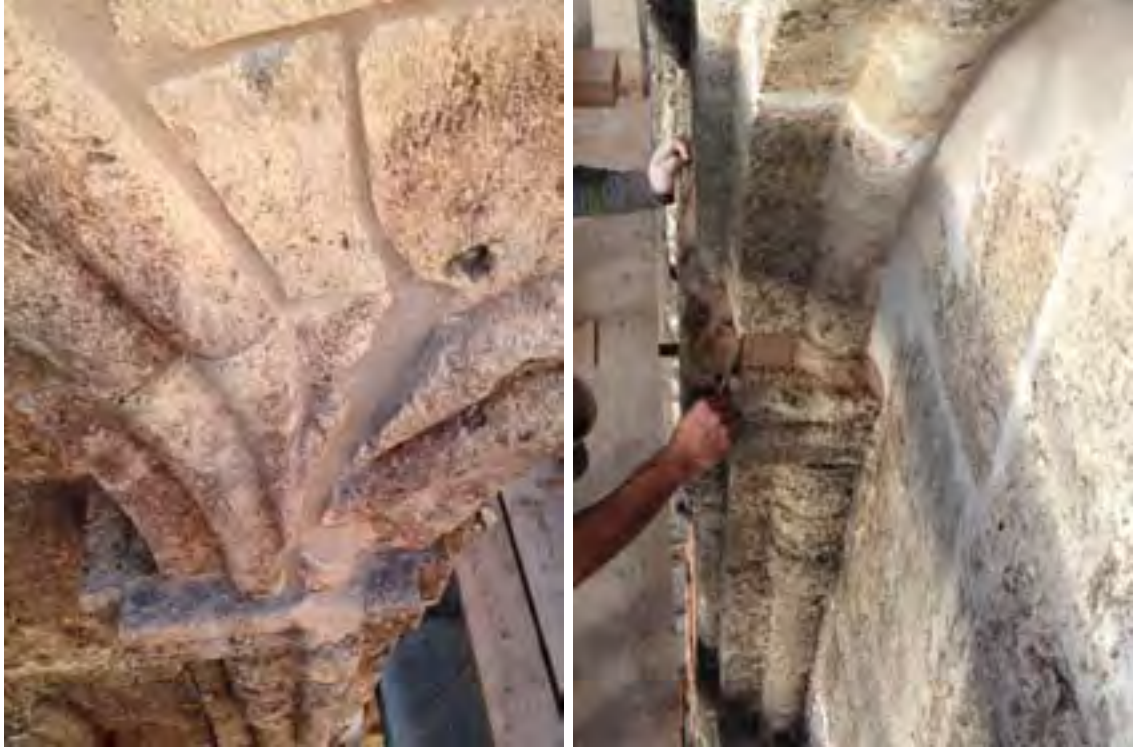
Filling the joints

Western facade of the Church of the Virgin at Gelati Monastery
