Annex 1: State of Conservation Report, Historical Monuments of Mtskheta

Annex 2: State of Conservation Report, Bagrati Cathedral and Gelati Monastery

Bagrati Cathedral and Gelati Monastery (Georgia) (710)

1. STATE OF CONSERVATION

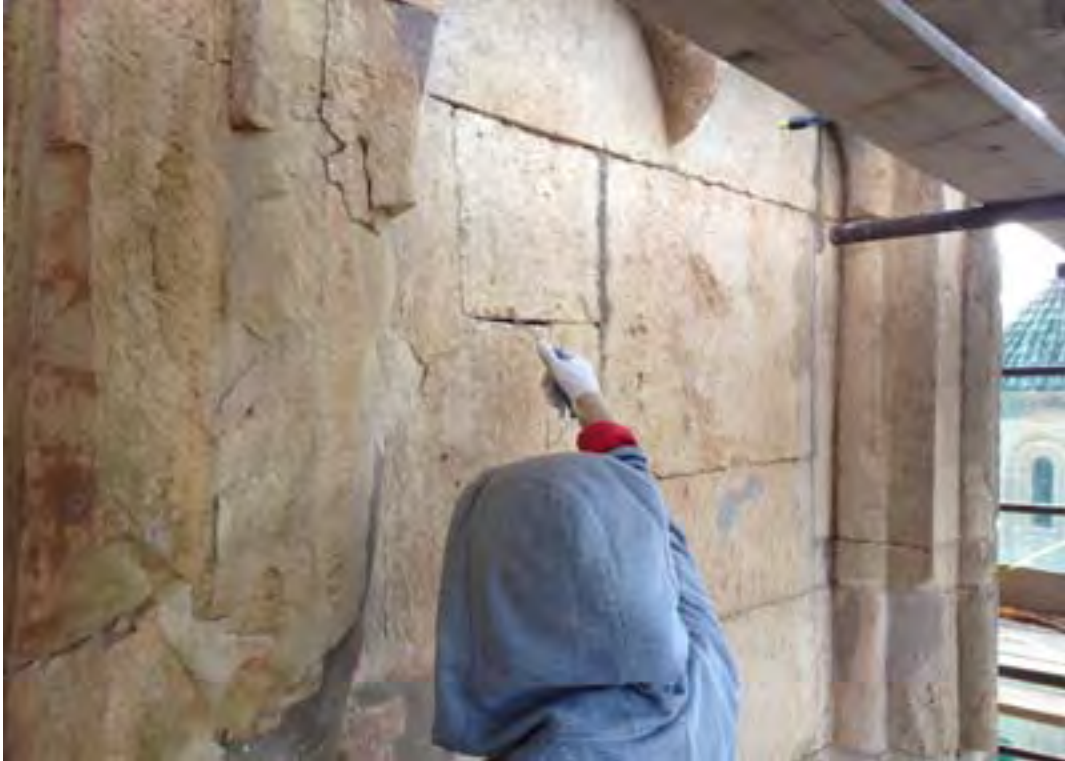
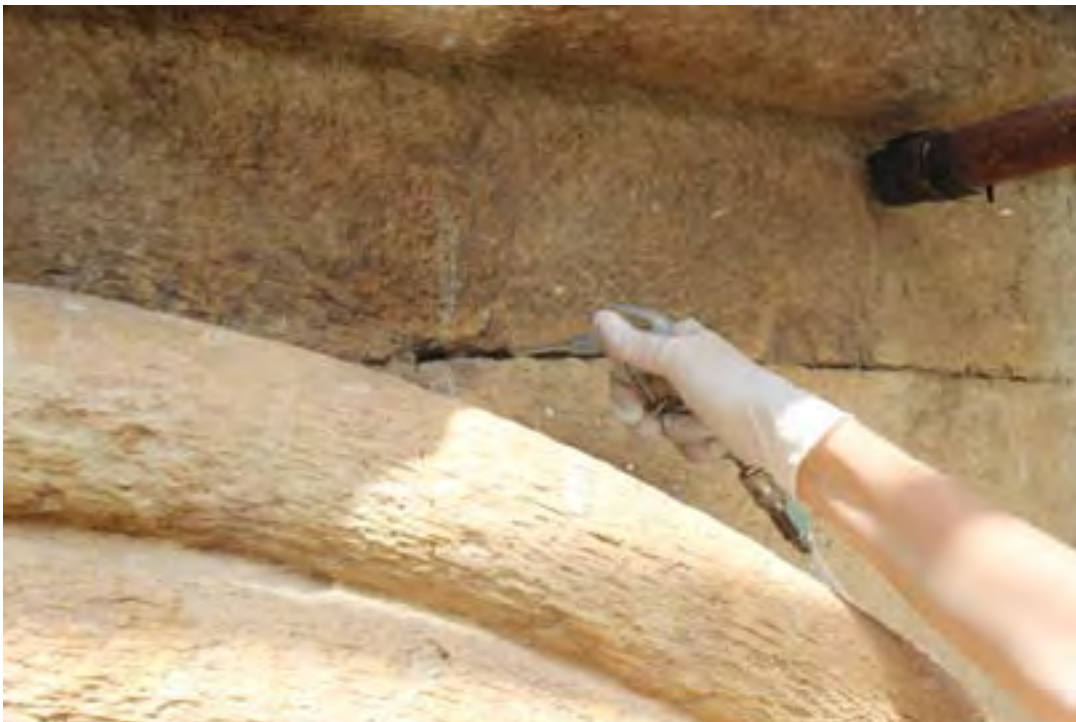
Cleaning of spaces between the stones

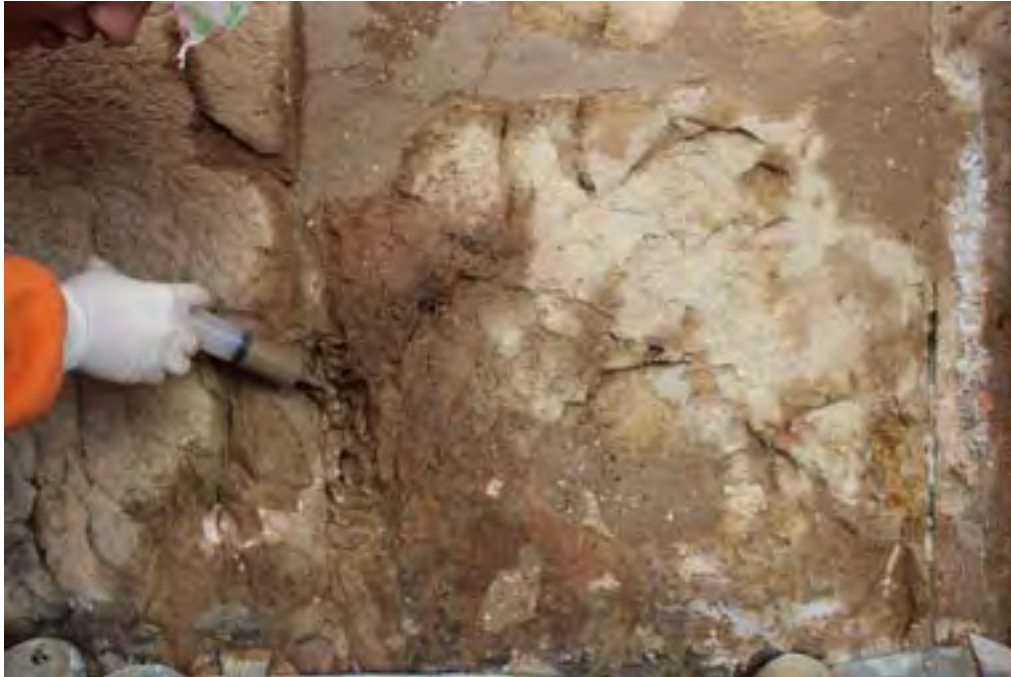
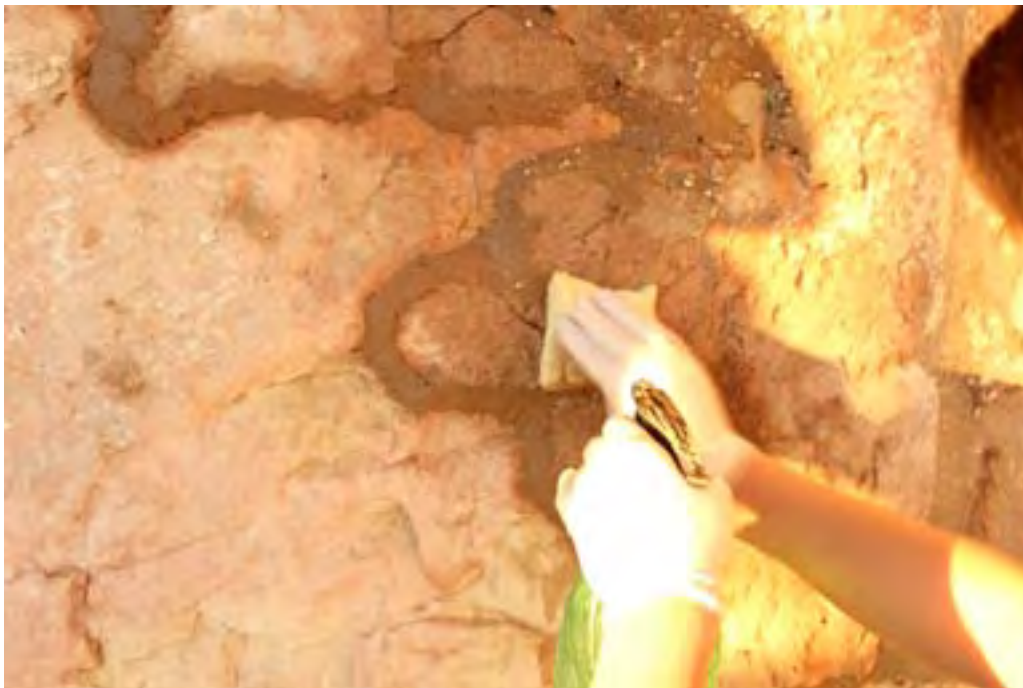
Consolidation of cracks

North facade of the Church of the Virgin at Gelati Monastery

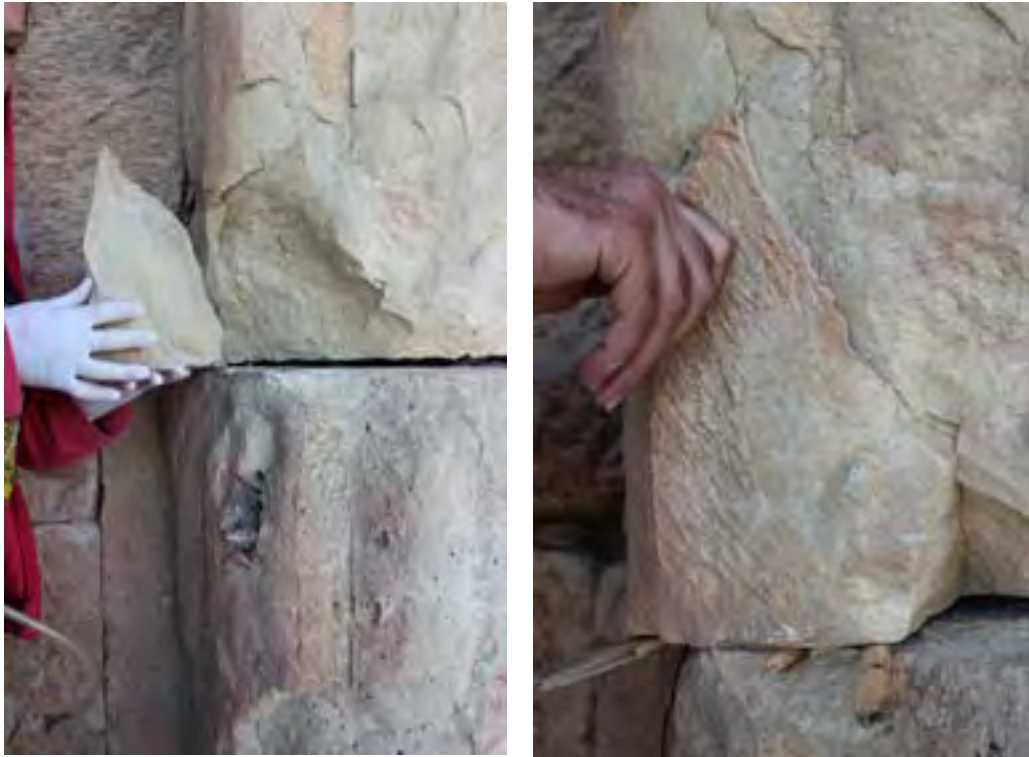
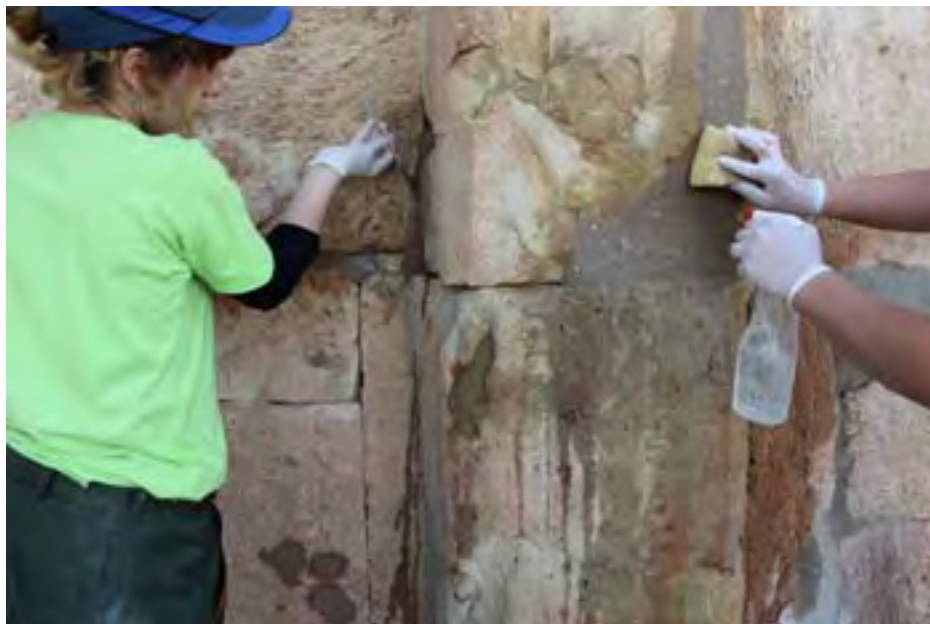
Reassembling the fragmented parts of the stone

South of the Church of the Virgin at Gelati Monastery

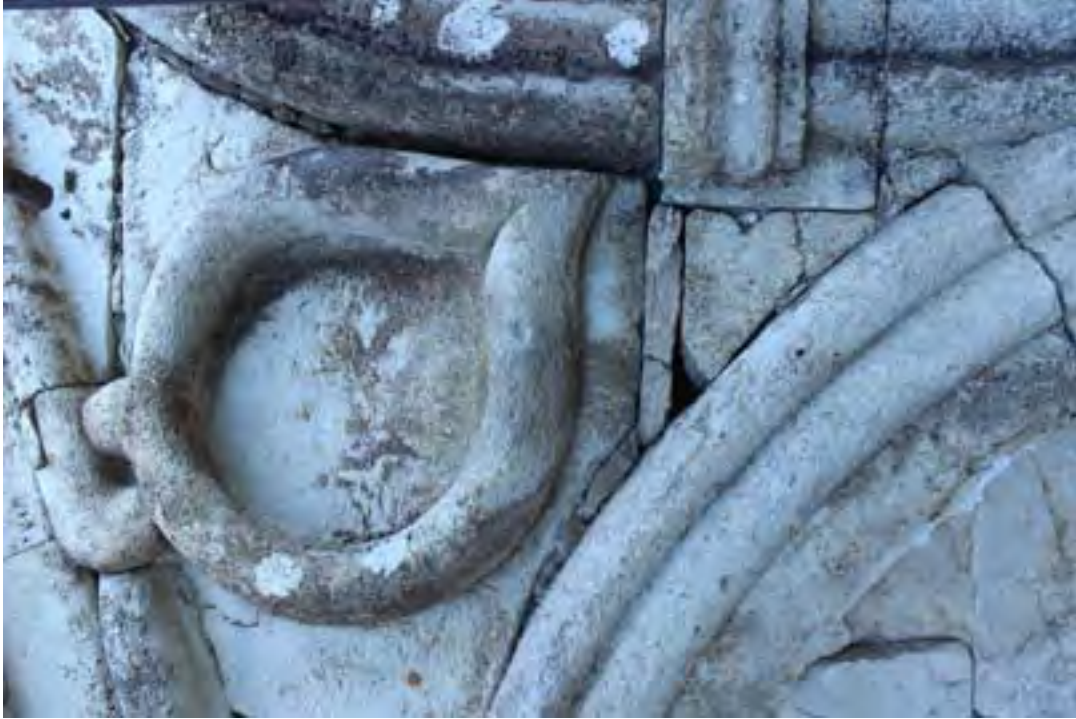
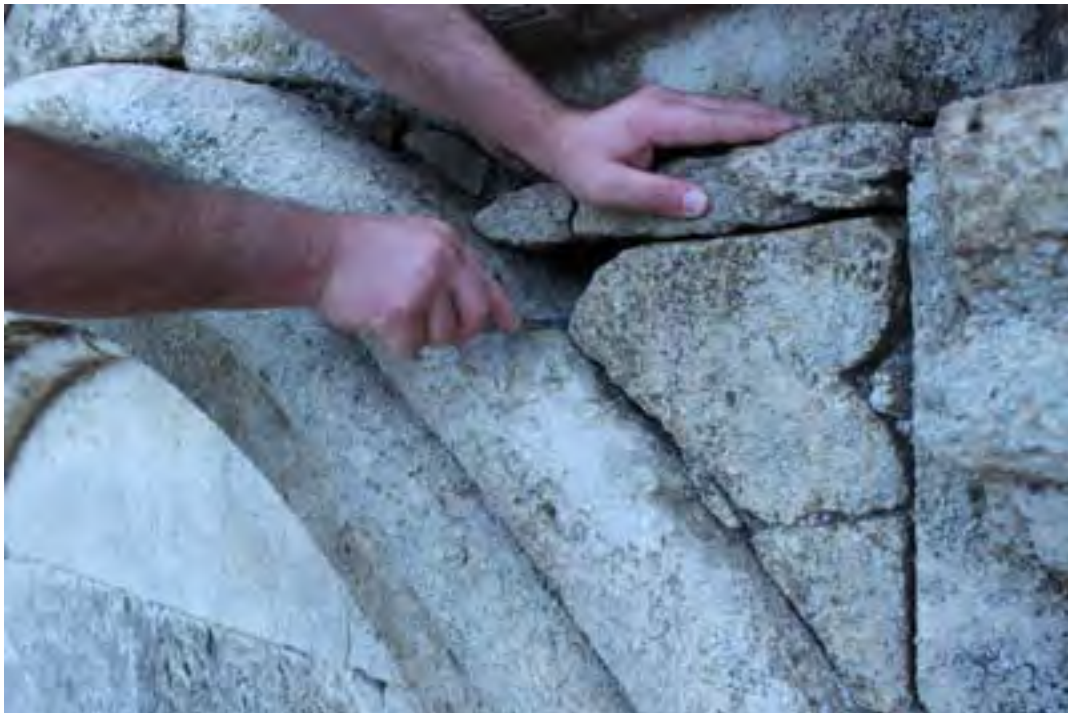
Reconstruction of missing parts of the masonry with lime mortar

North façade of the Church of the Virgin at Gelati Monastery

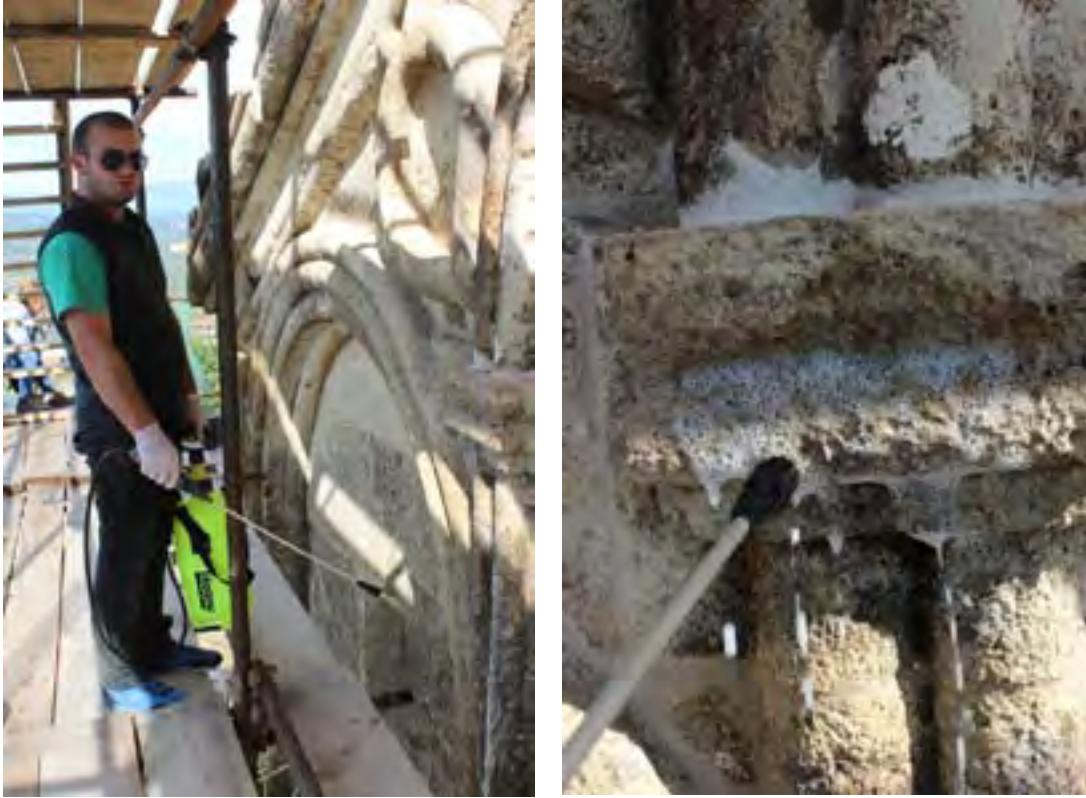
Treatment with Biocide

West façade of the Church of the Virgin at Gelati Monastery

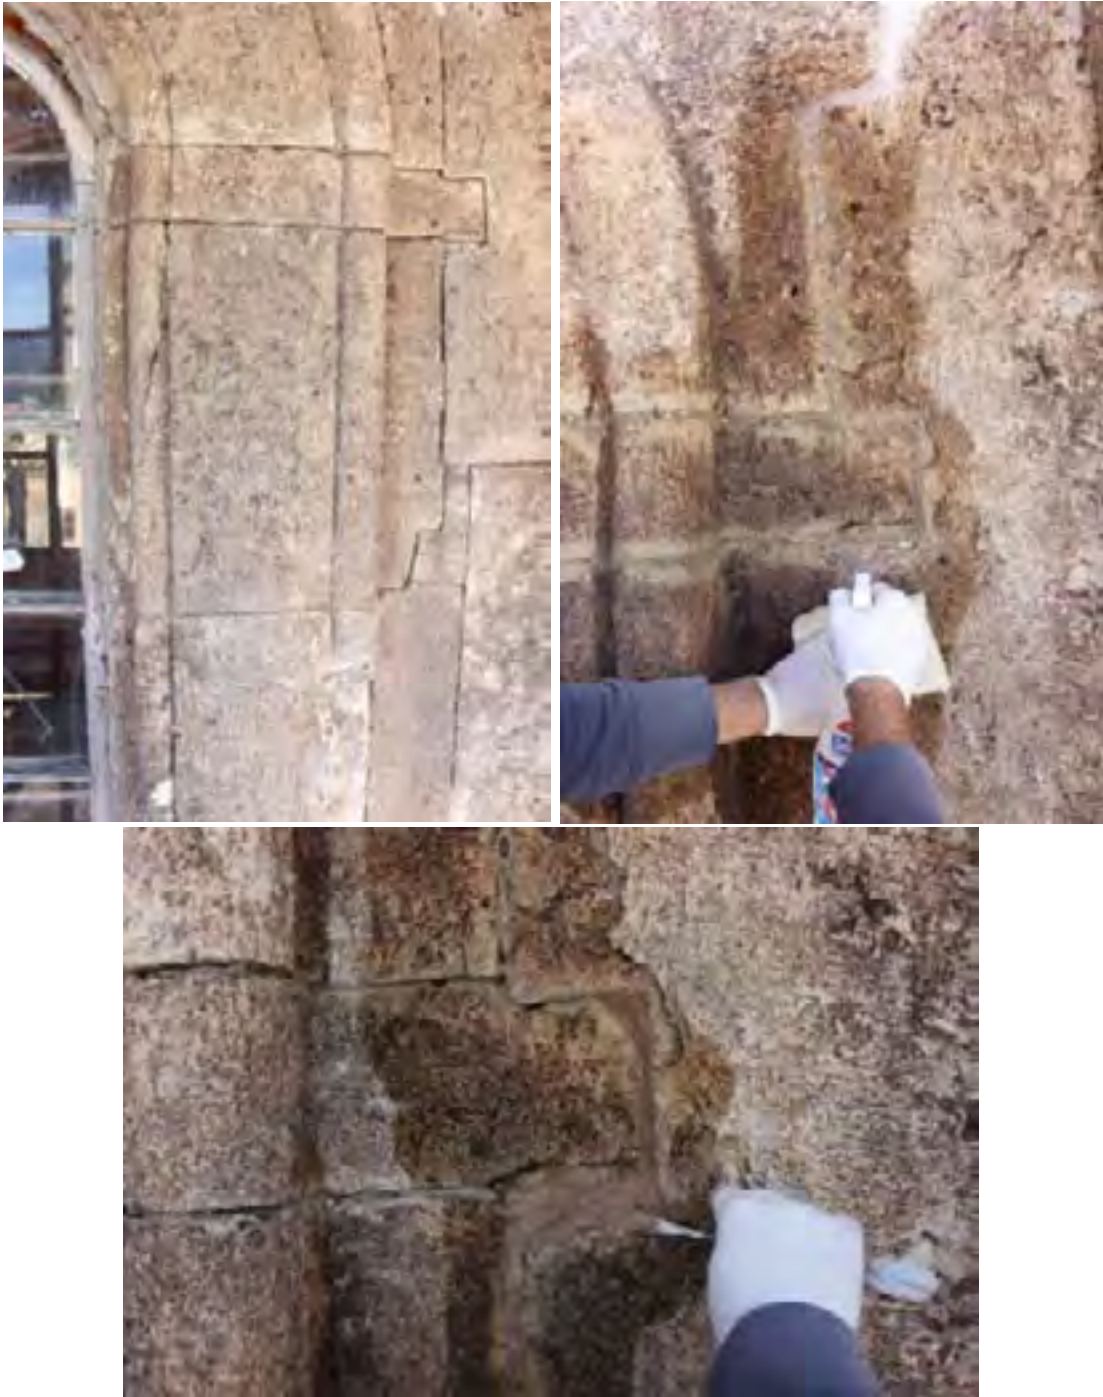
Filling the joints

Western façade, Church of the Virgin at Gelati Monastery

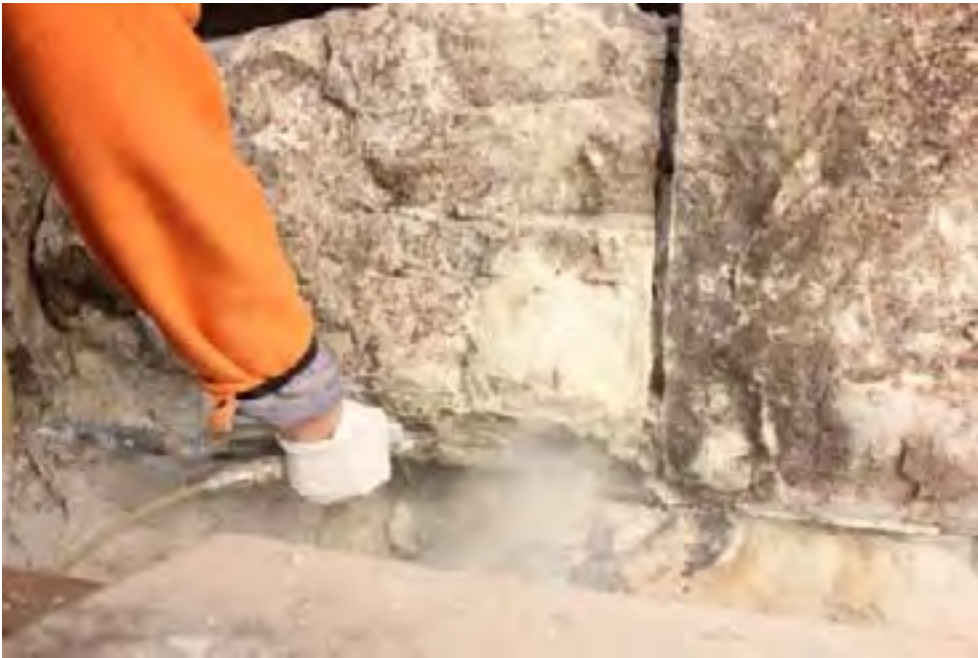
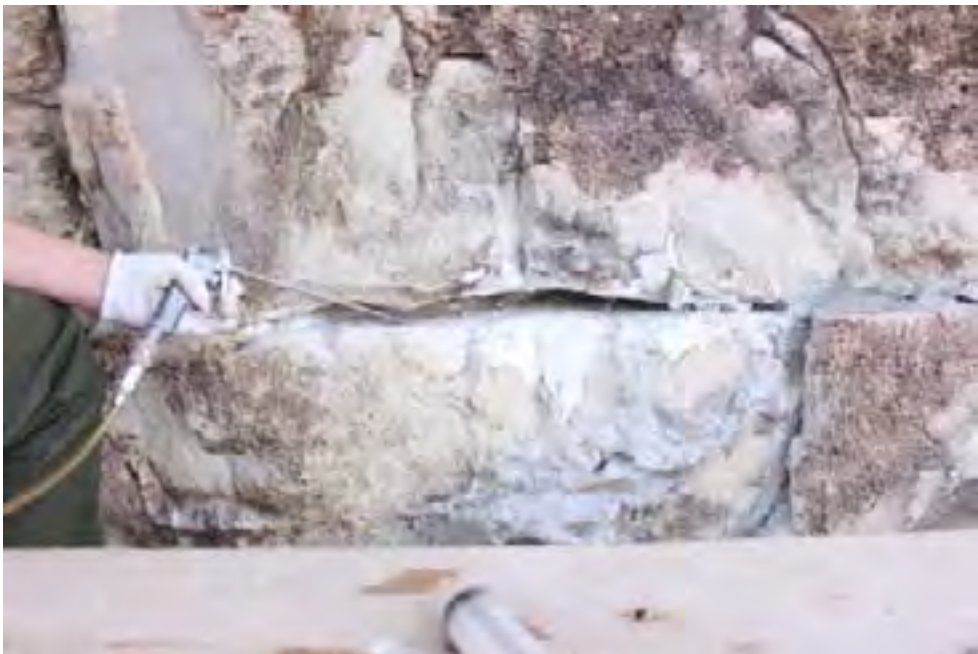
Cleaning of spaces between the stones

Western facade Church of the Virgin at Gelati Monastery

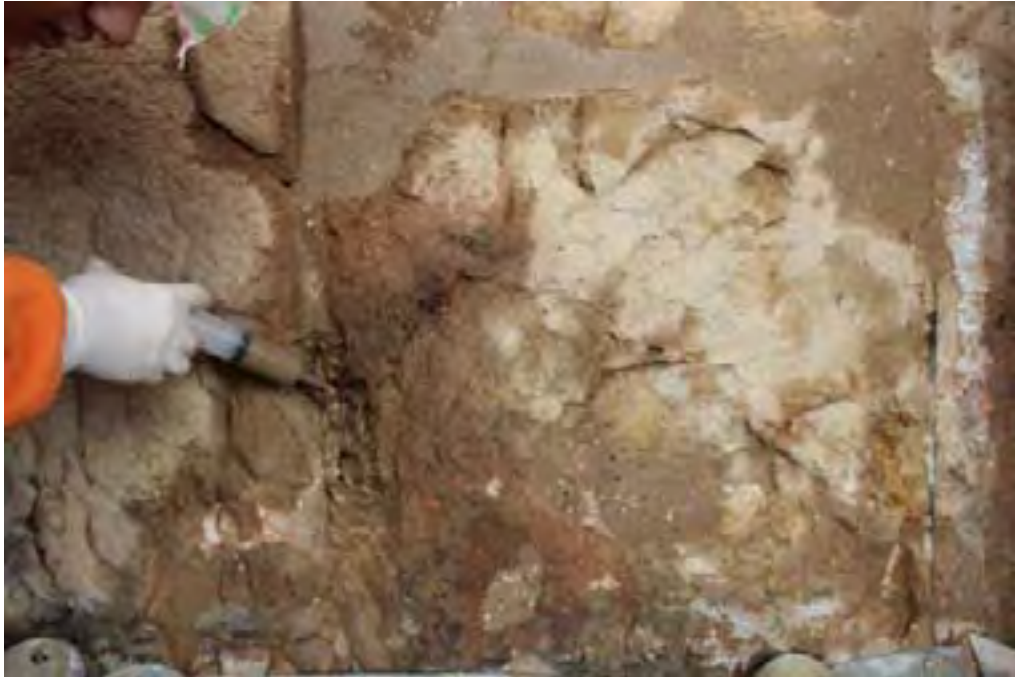
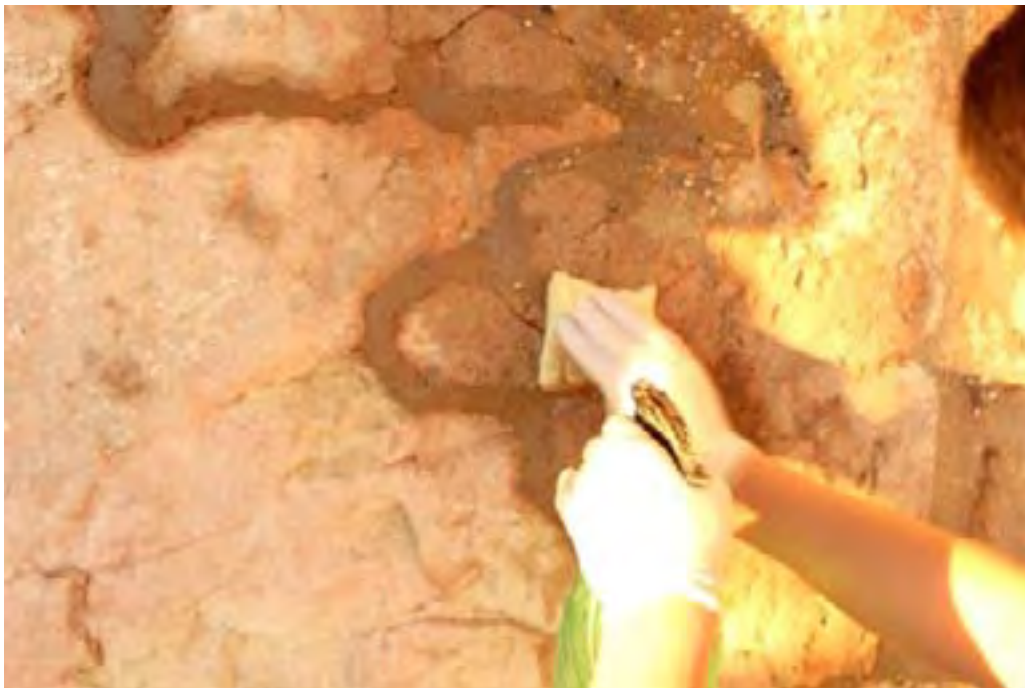
Consolidation of cracks

Western facade Church of the Virgin at Gelati Monastery

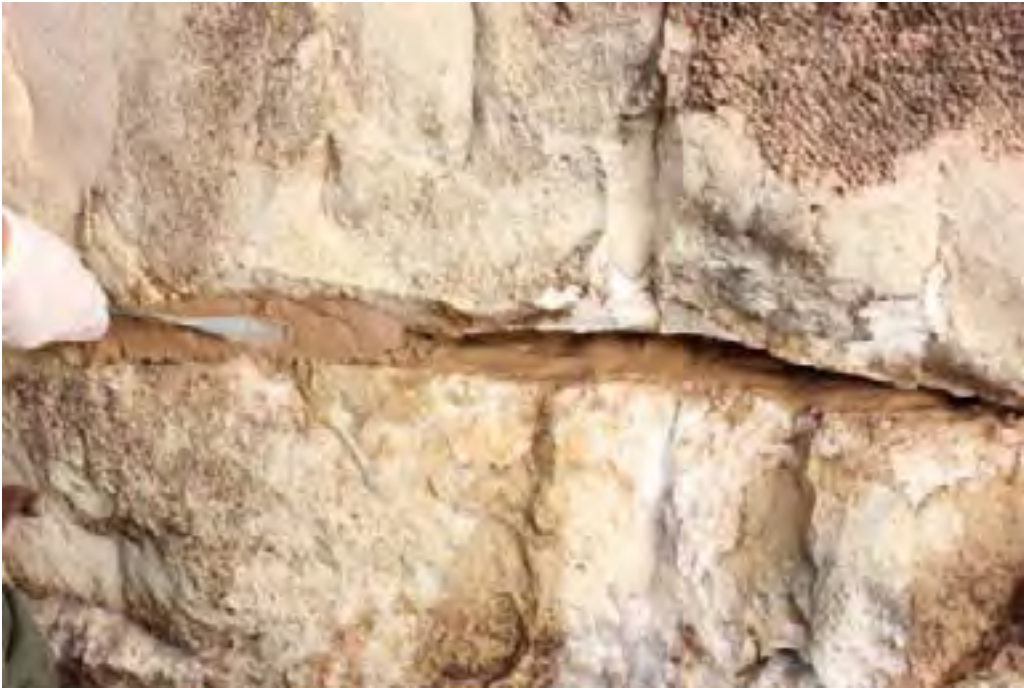
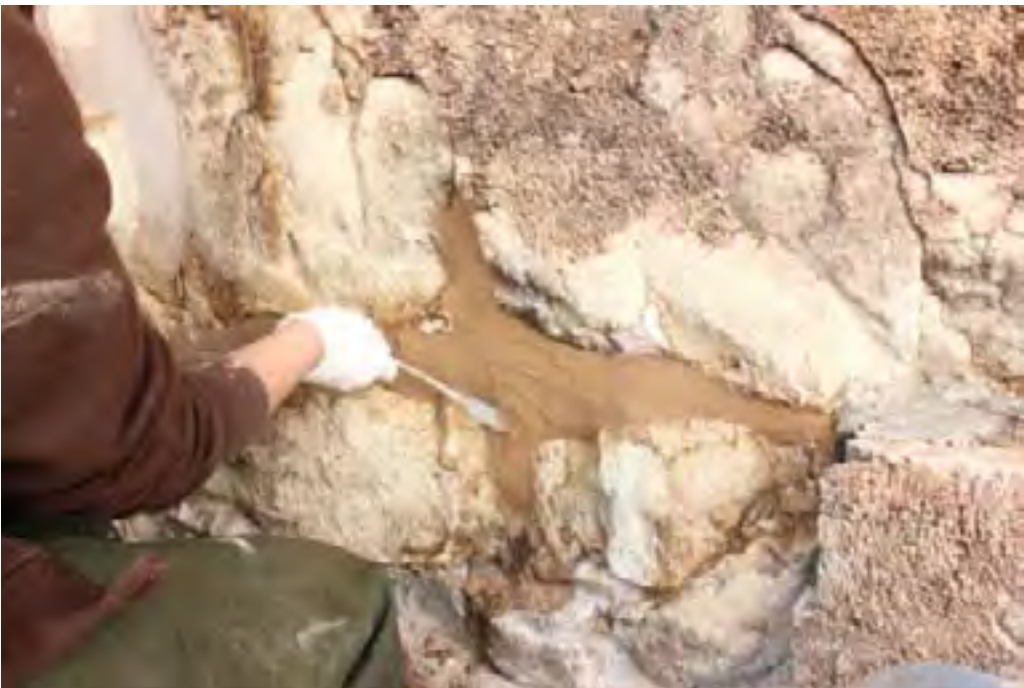
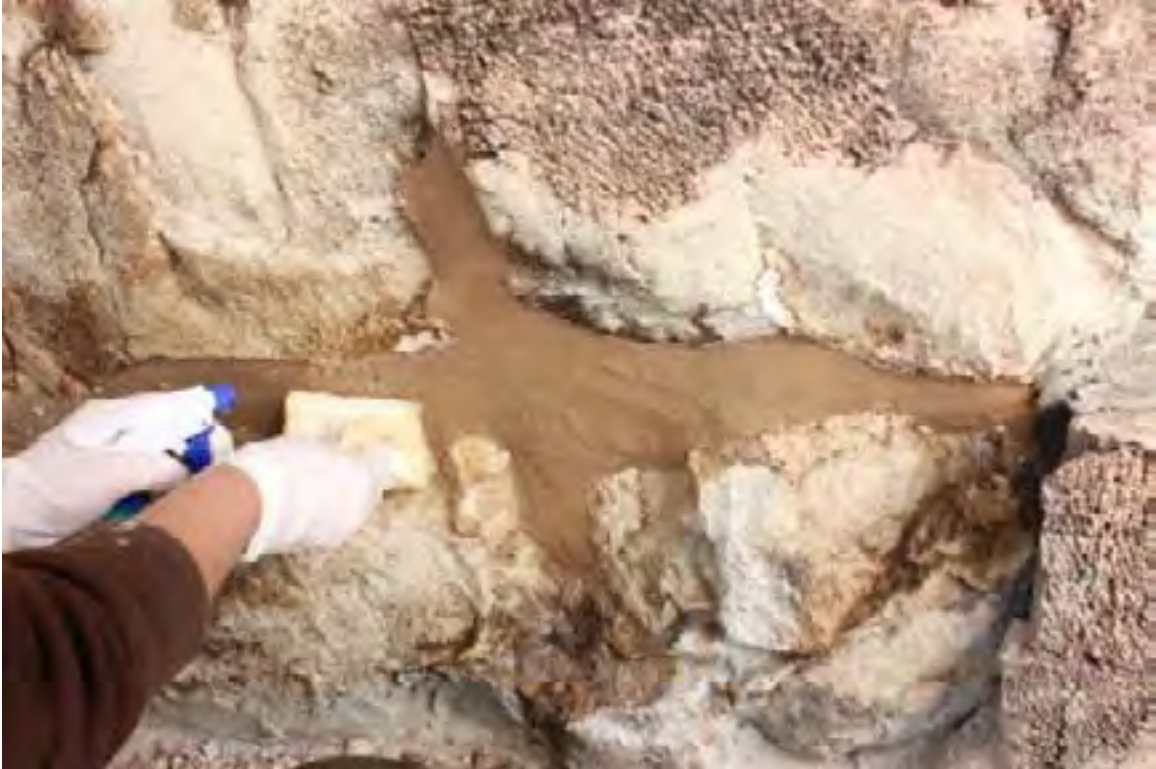
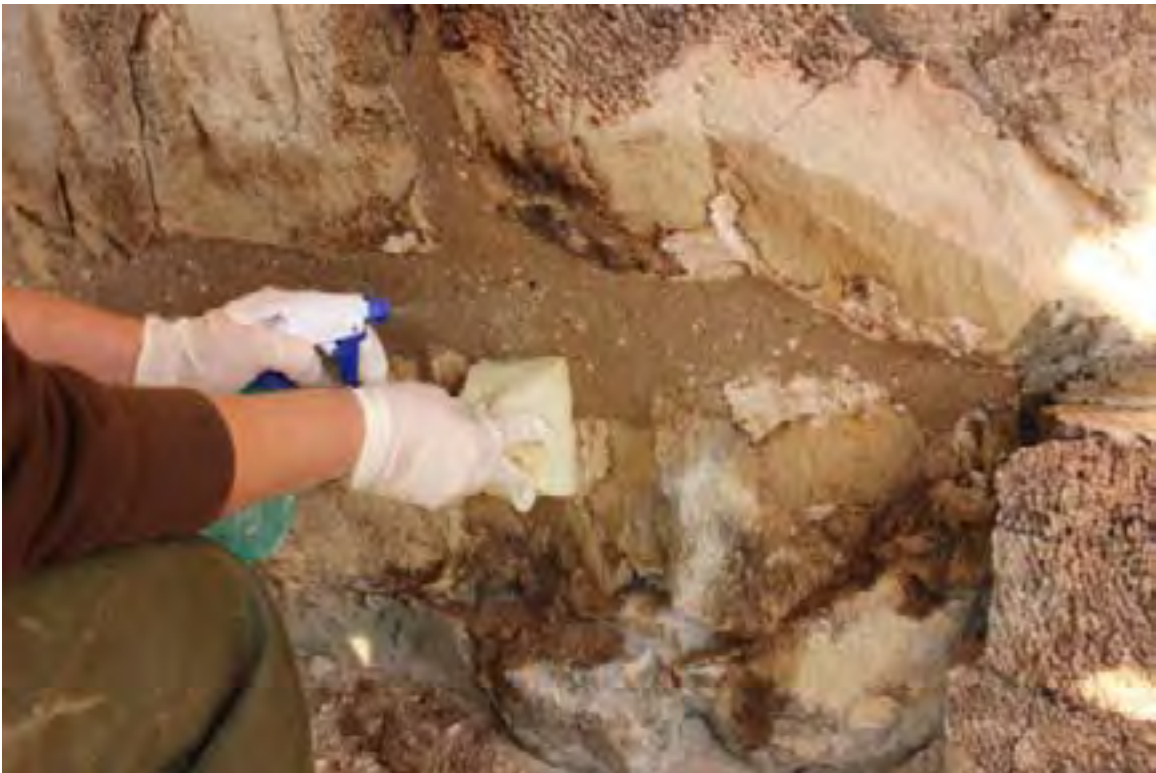
Reconstruction of missing parts of the masonry with lime mortar

Western facade Church of the Virgin at Gelati Monastery

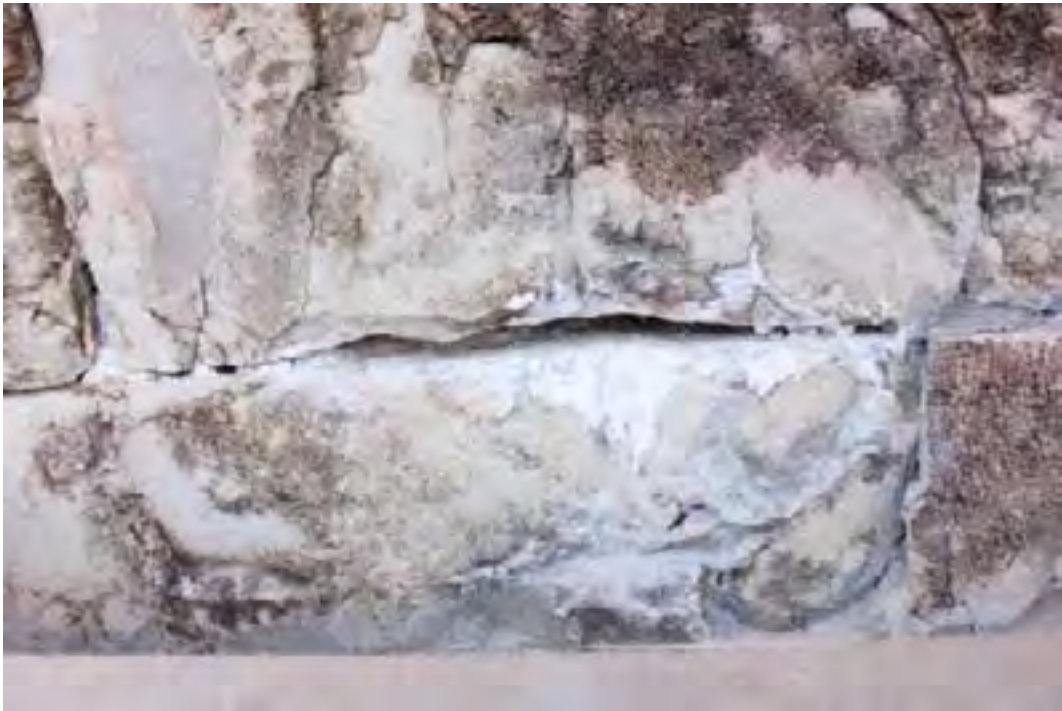
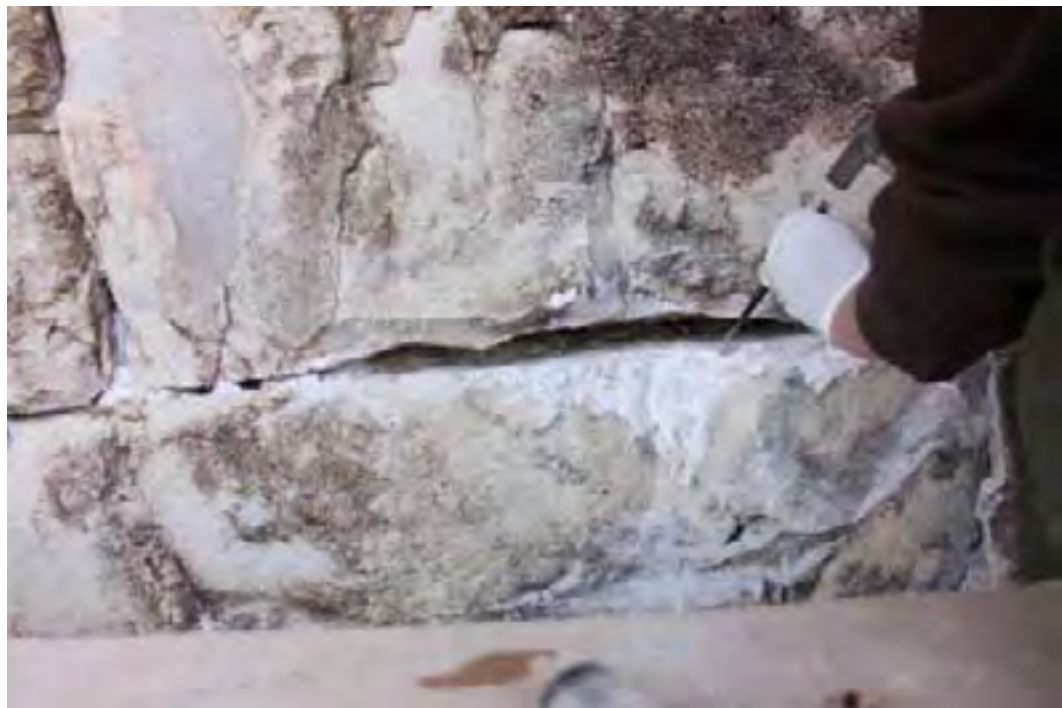
Cleaning of the old fillings

Western facade Church of the Virgin at Gelati Monastery

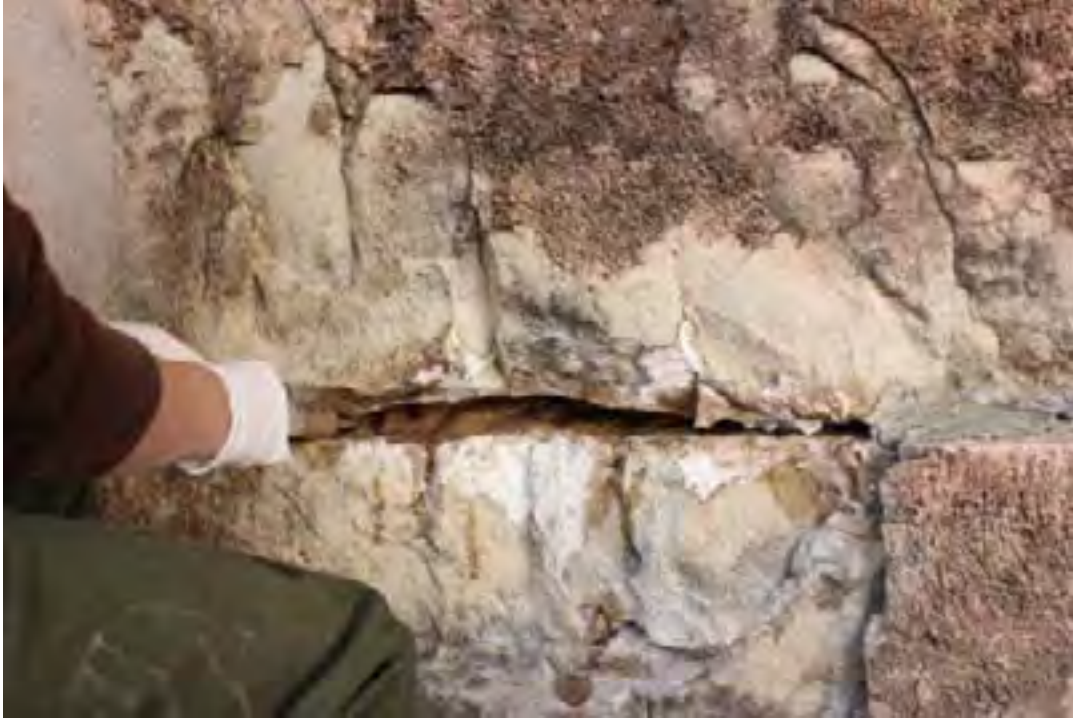
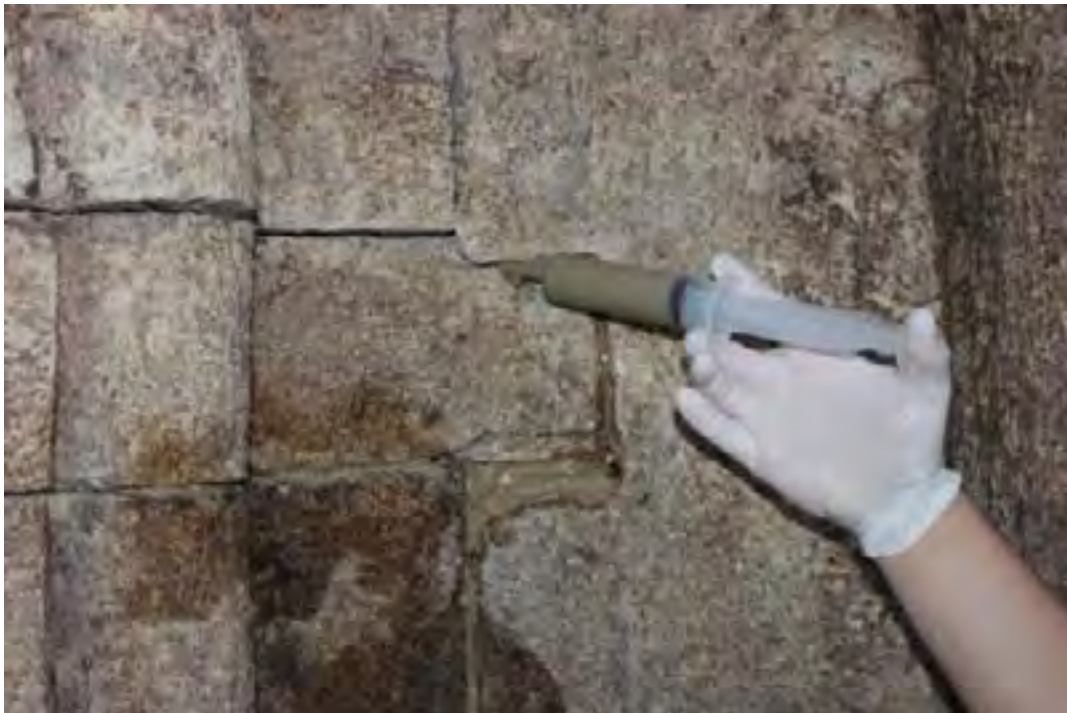
Injection

Western facade Church of the Virgin at Gelati Monastery
