REHABILITATION PROJECT OF THE ROAD AND THE SUPPORT STRUCTURE GELATI MONASTERY WHS

Rehabilitation Project of the Road to the Gelati Monastery WHS and the Support Structure

Explanatory Note

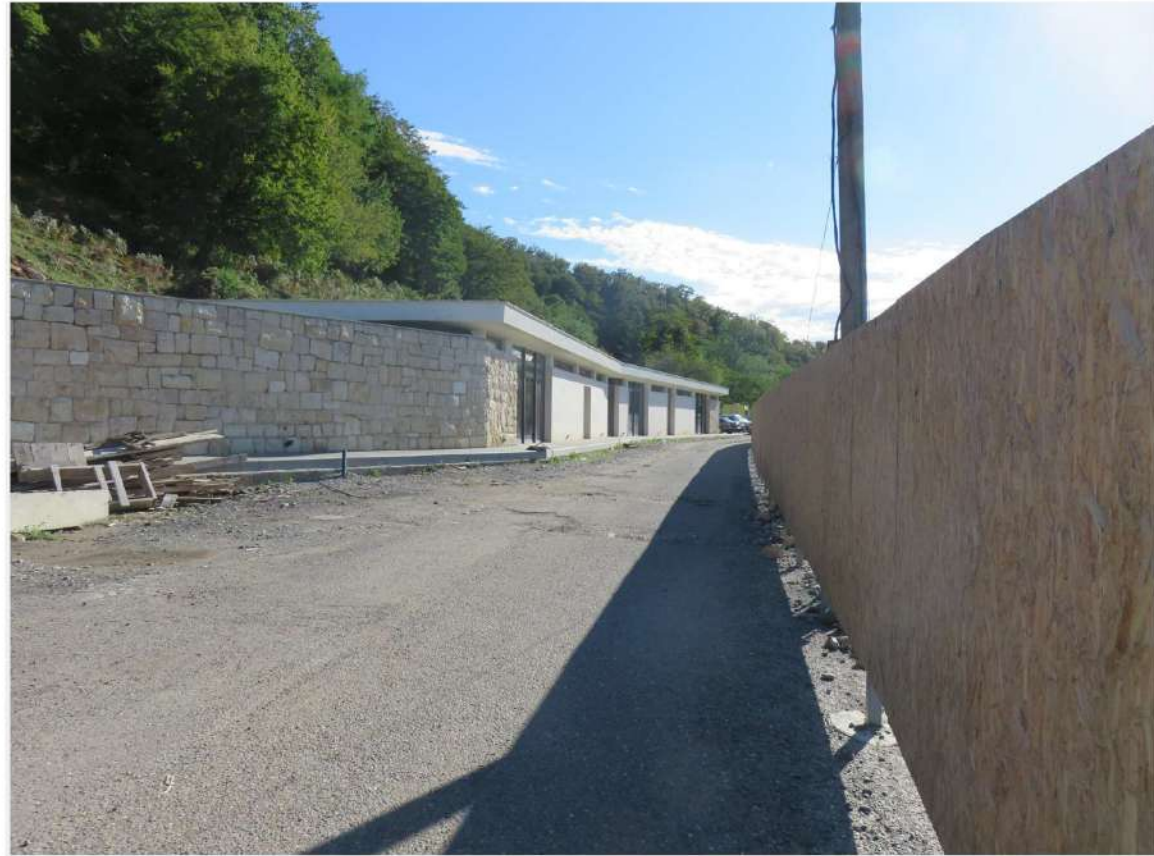
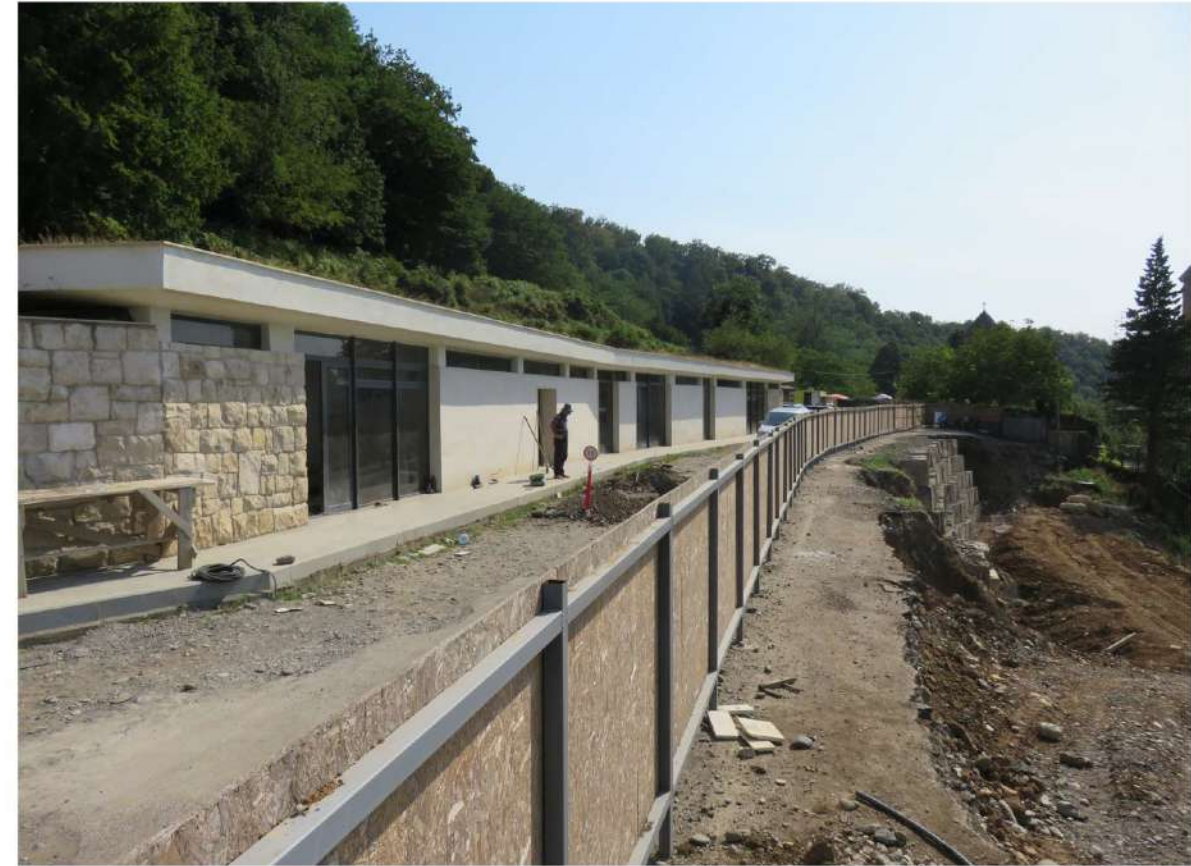
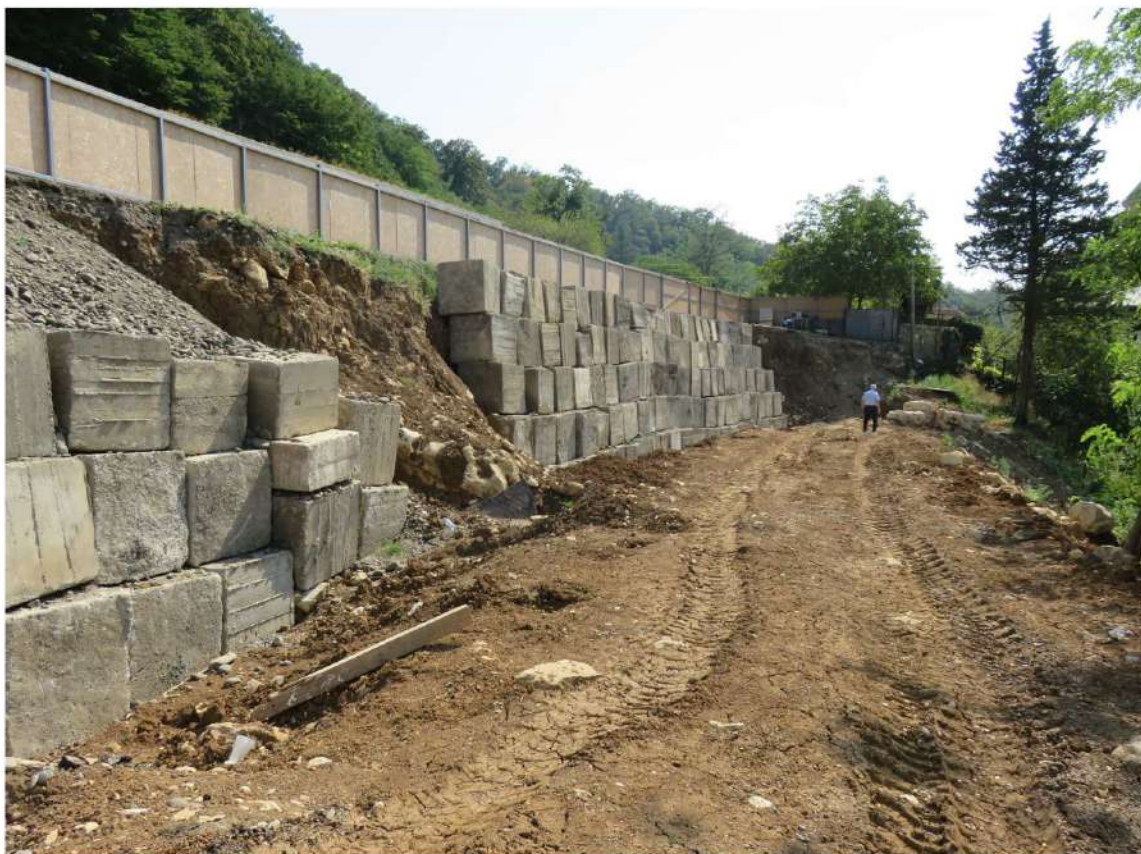
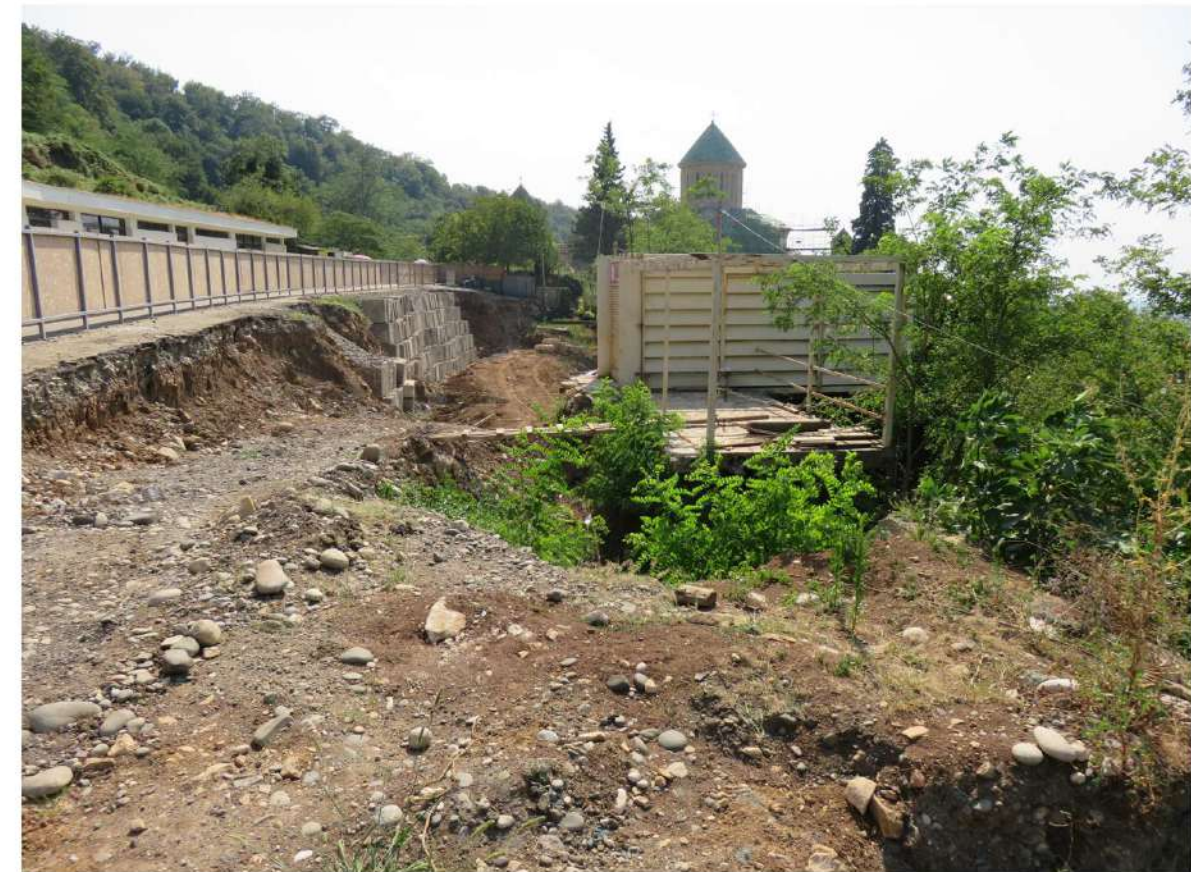
Current condition of the road to Gelati Monastery

In winter 2016, landslide caused a partial collapse of the middle part of a road to the monastery (approx. 90-100 m). It caused the demolition of an existing road support wall. Quite large part: 70-80m in length and 7-8m in width, of road was broke down. In result, from existing wide road, which leads to the monastery, only a narrow path (4-5m width) remains. Before this, the damage of the support wall was observed and geological investigations started. Performed surveys showed that the reason of the collapse was that the existing support wall was based in fragile soil. With this, area is in landslide sensitive zone.

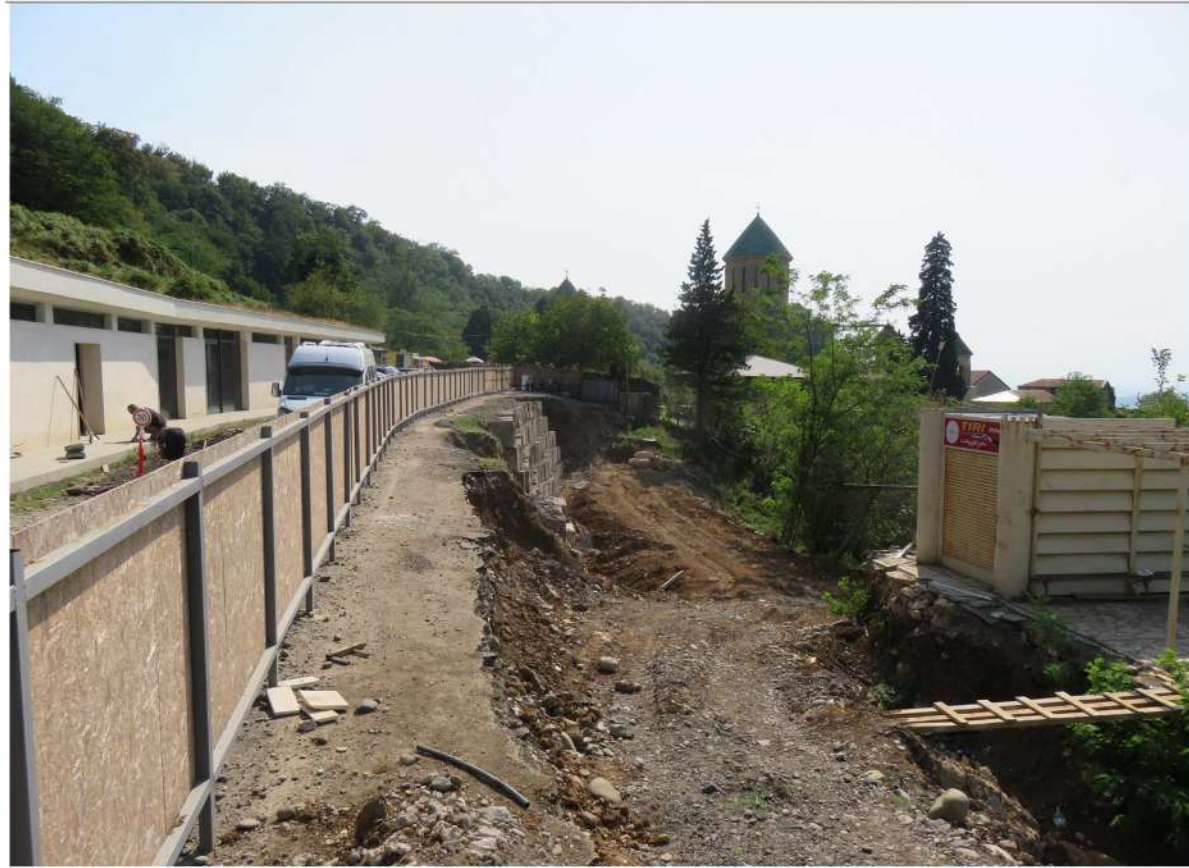
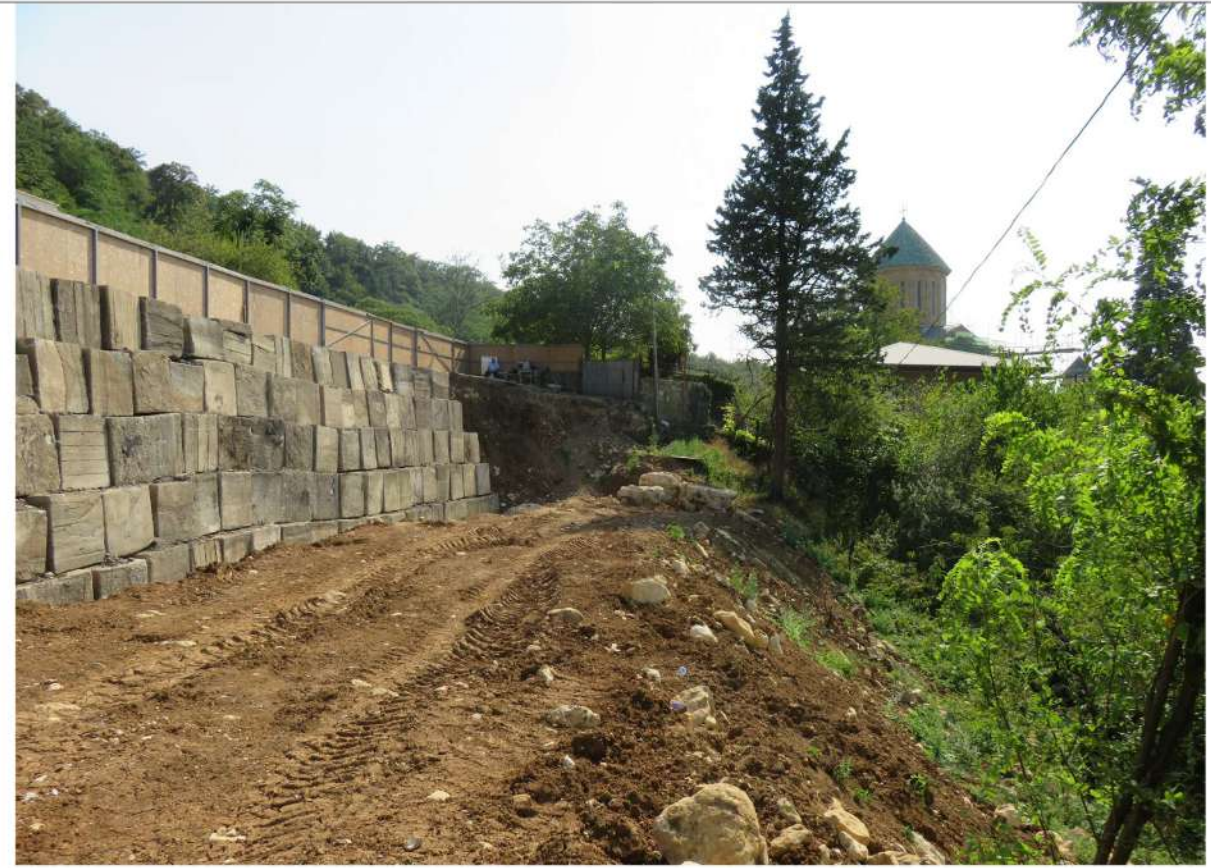
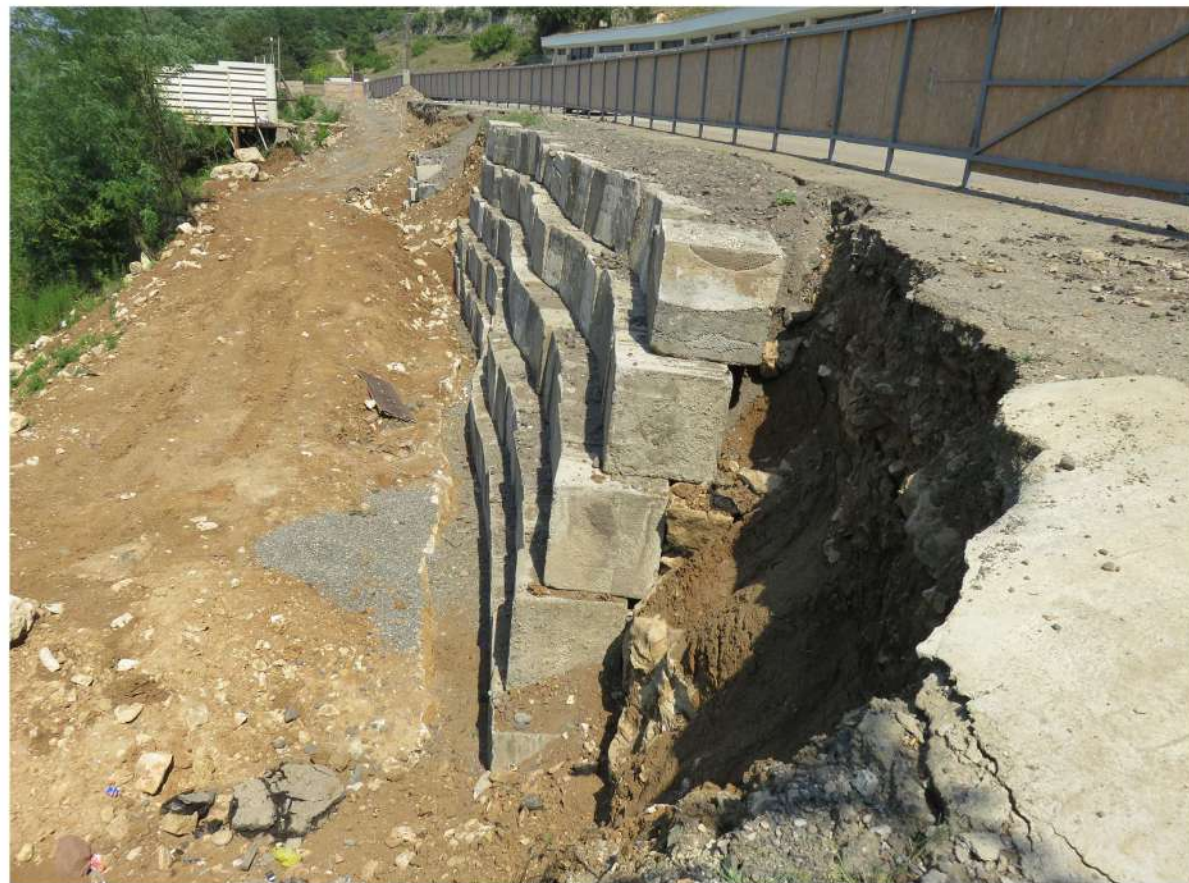
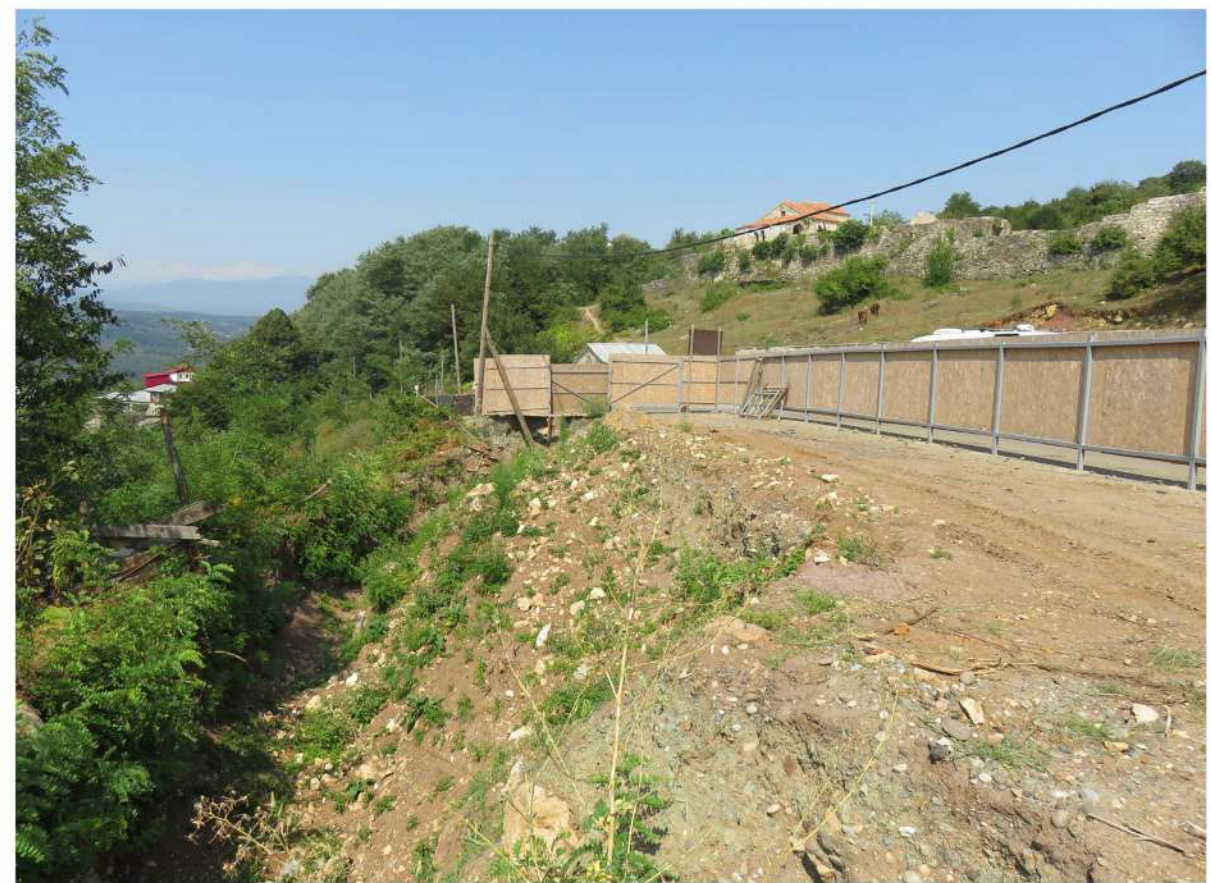
Current condition of the road to Gelati Monastery

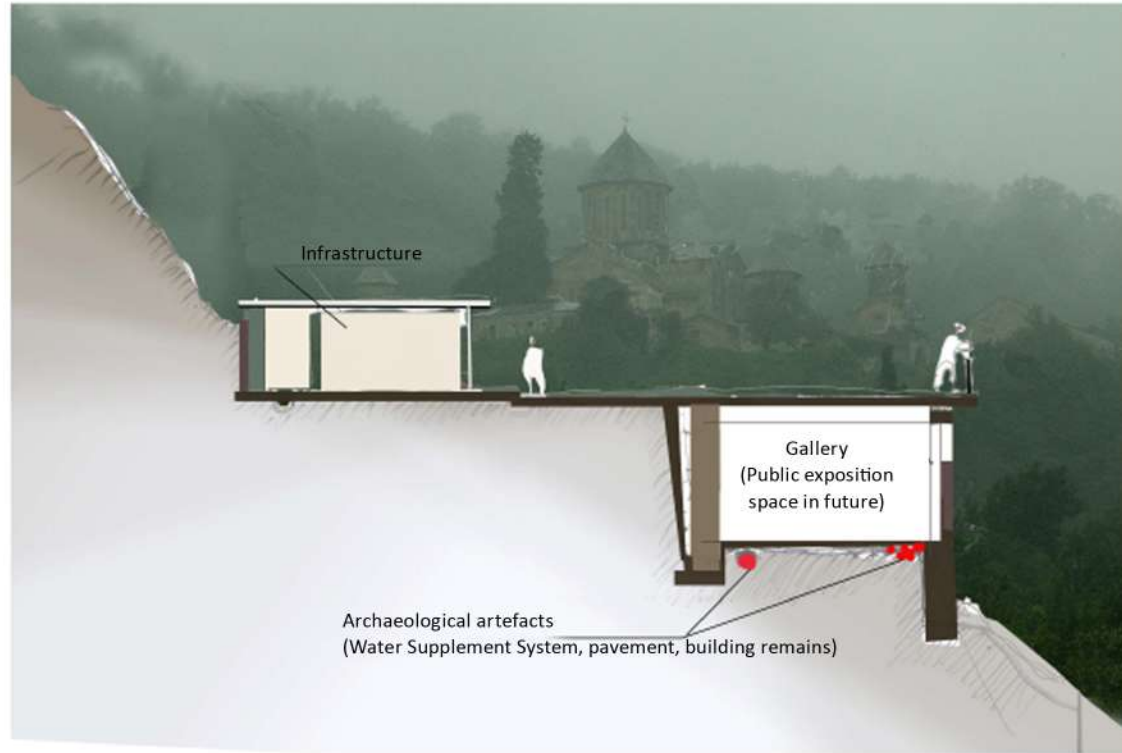
Project proposal of support wall for the underground museum arrangement

Because of these findings, it has been decided to build up a gallery type supporting structure instead of a simple wall; this would let further archaeological surveys. The upper surface of the structure would be used as a road for transport and pedestrians, while the lower part of it would be dedicated to archaeological on-field investigation and in future it could transform to the exposition space of those remains. For this phase of project, it does not include an elaboration of detailed interior; this will be the work to be complete within the framework of next phase.

The proposed structure is composed with two supporting walls, located in parallel of the slope and connected with horizontal, caisson slab of steeled reinforced concrete. The main support wall (on the axis A) would be constructed in place of the collapsed one. In parallel (in distance of 7m) of the main support wall another wall (on the axis B) would be placed. Height of the main support wall would be 9.0-9.5m, while the inner wall would be 8-8.5 meters height. The exact heights are depended on the base rock slope. According to the geological surveys as basing point are identified the clay-limestone rocks, located to the 401.0 absolute levels, with resistance of 4.0-5.0 M Pa.

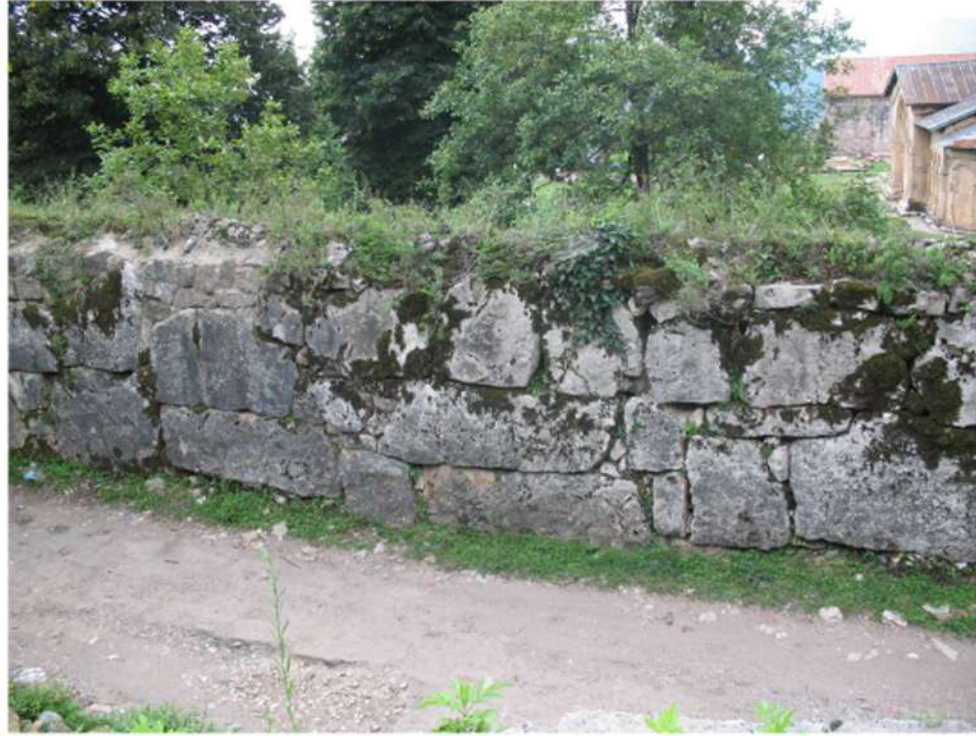
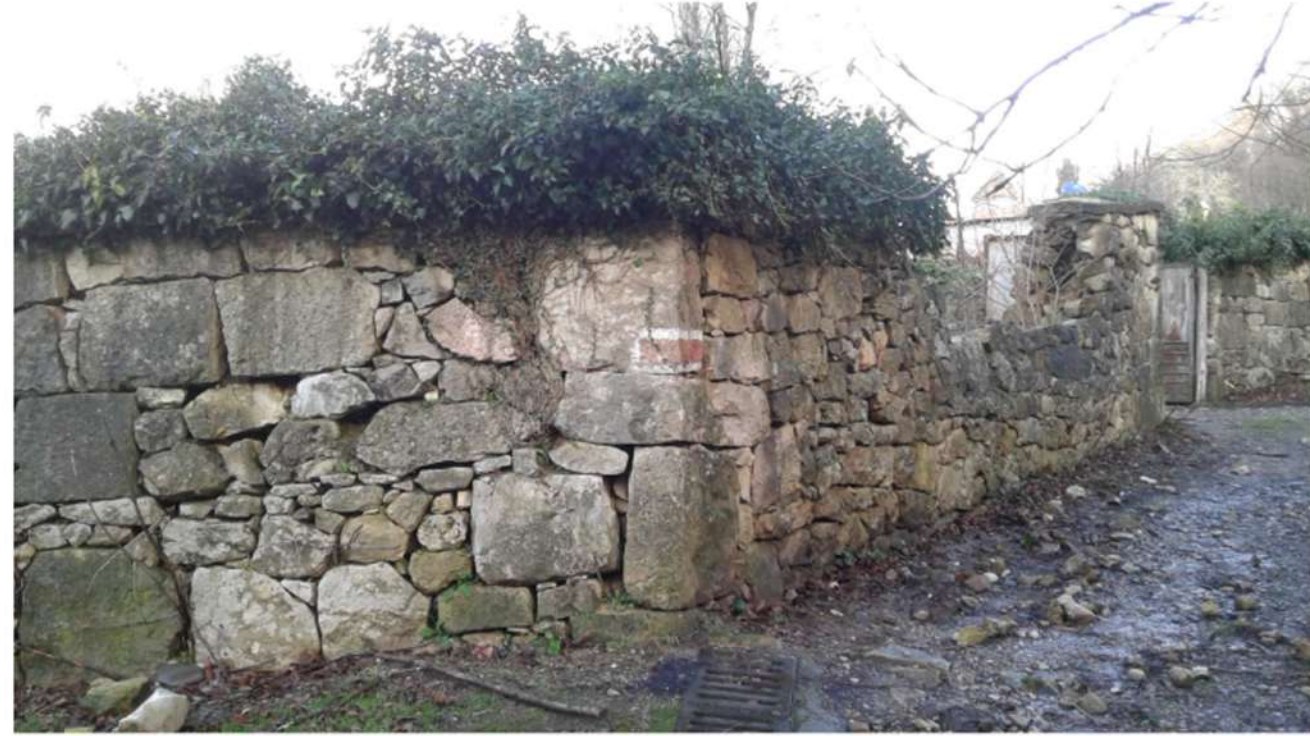
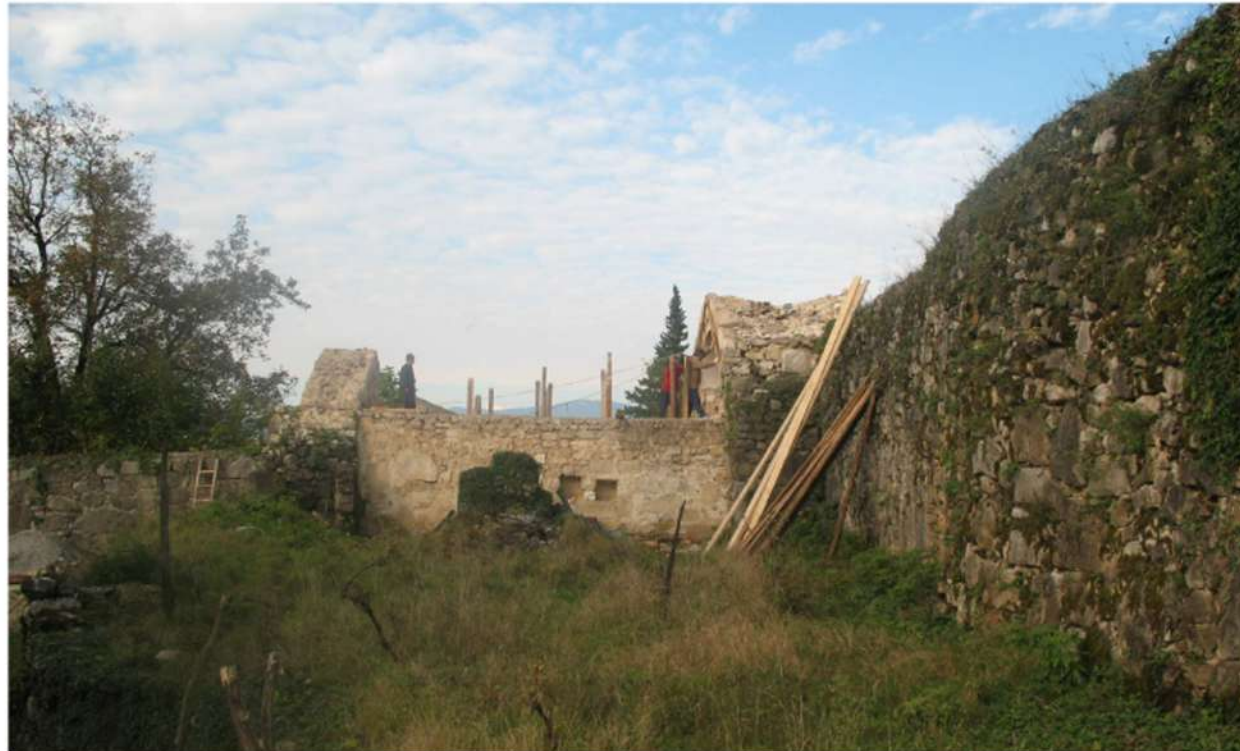
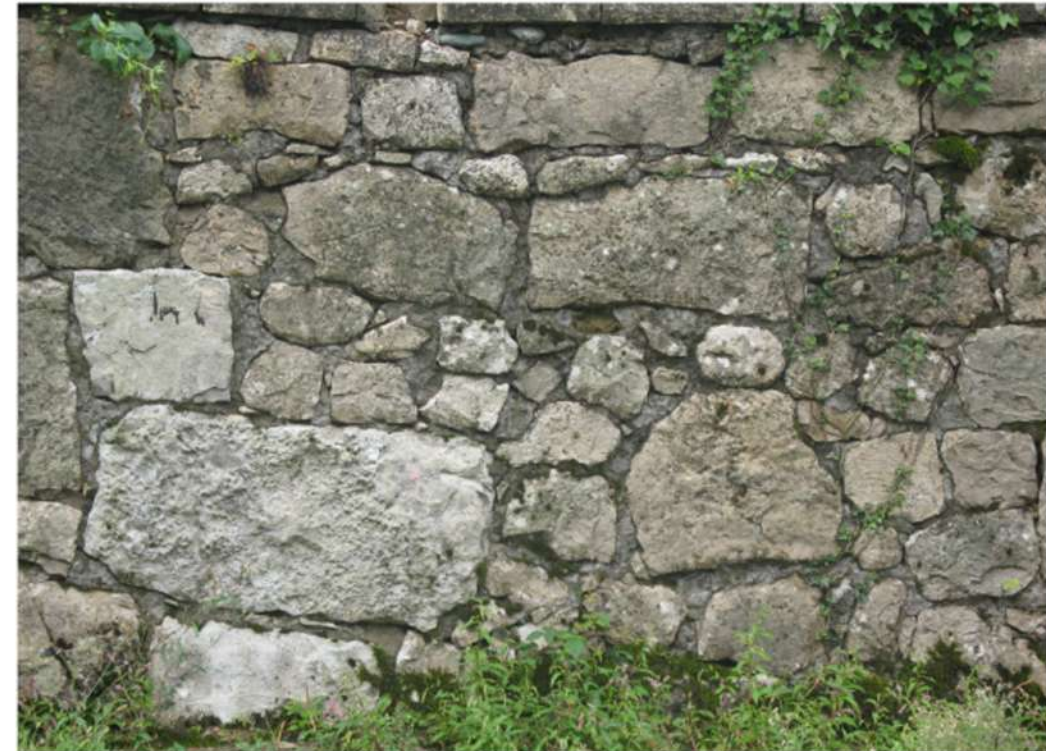
Examples for support wall facing

Proposed structure’s façade, and partially within the gallery would be covered with a local stone. The structure would not be actively visible from the long distance views to the Monastery, as intensive green vegetation is covering a surrounding area, in opposite, the visible parts would be perceived as a continuation of monastery protective wall.

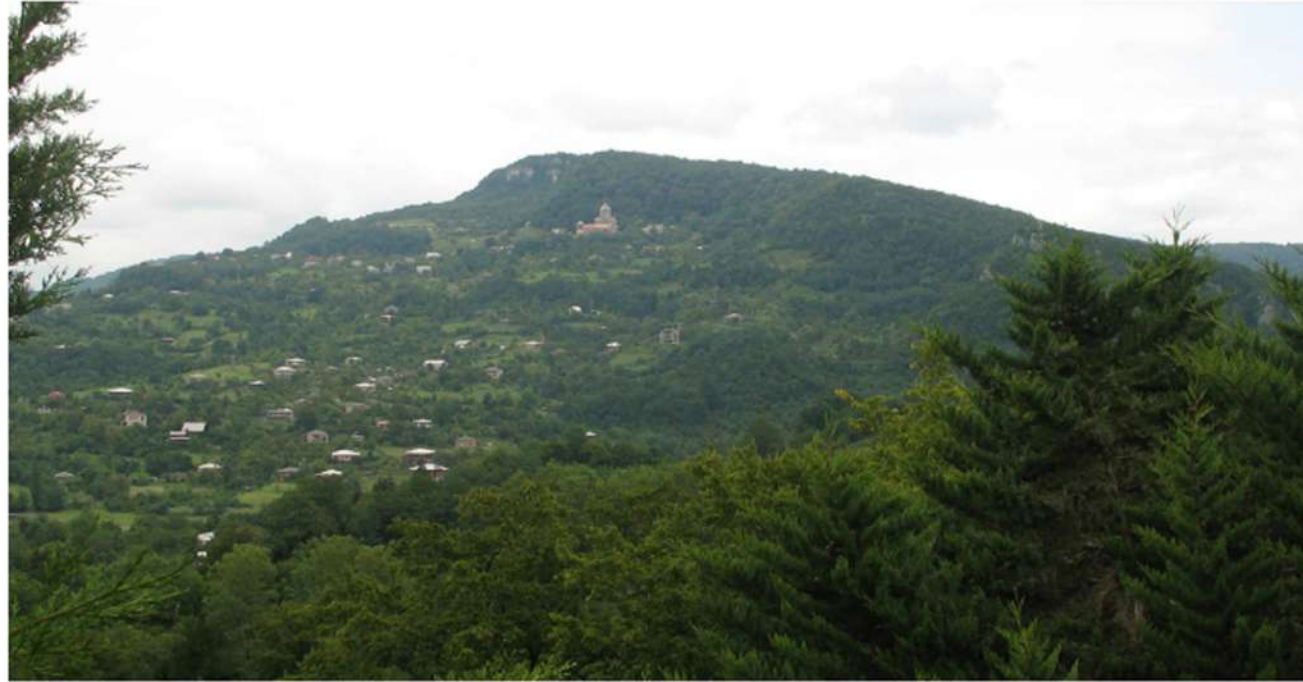
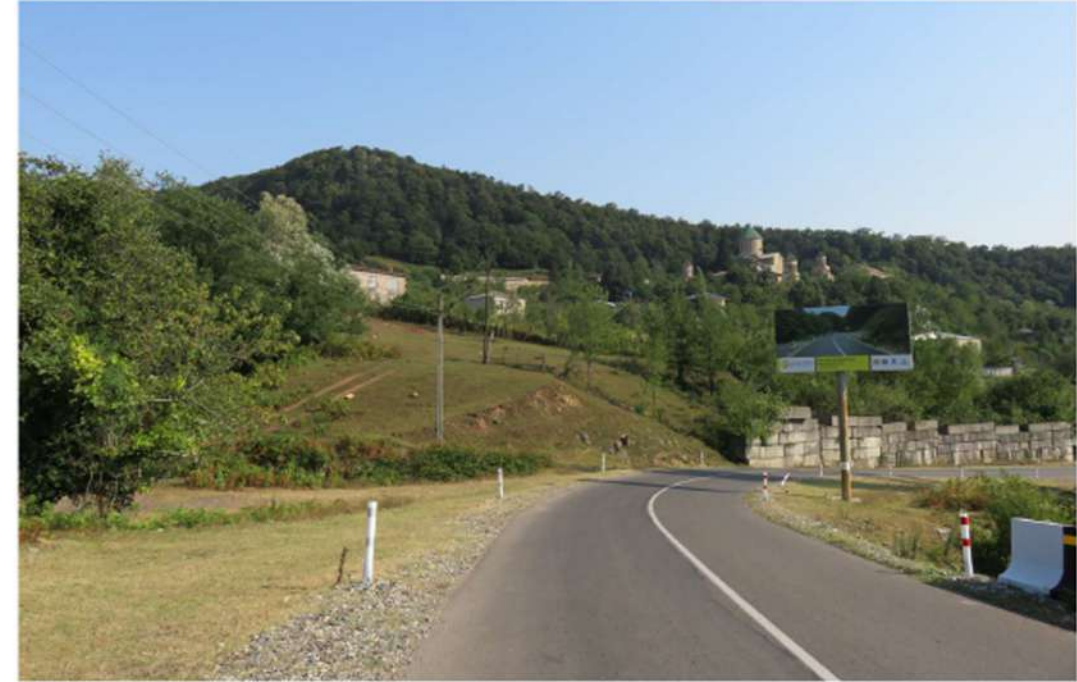
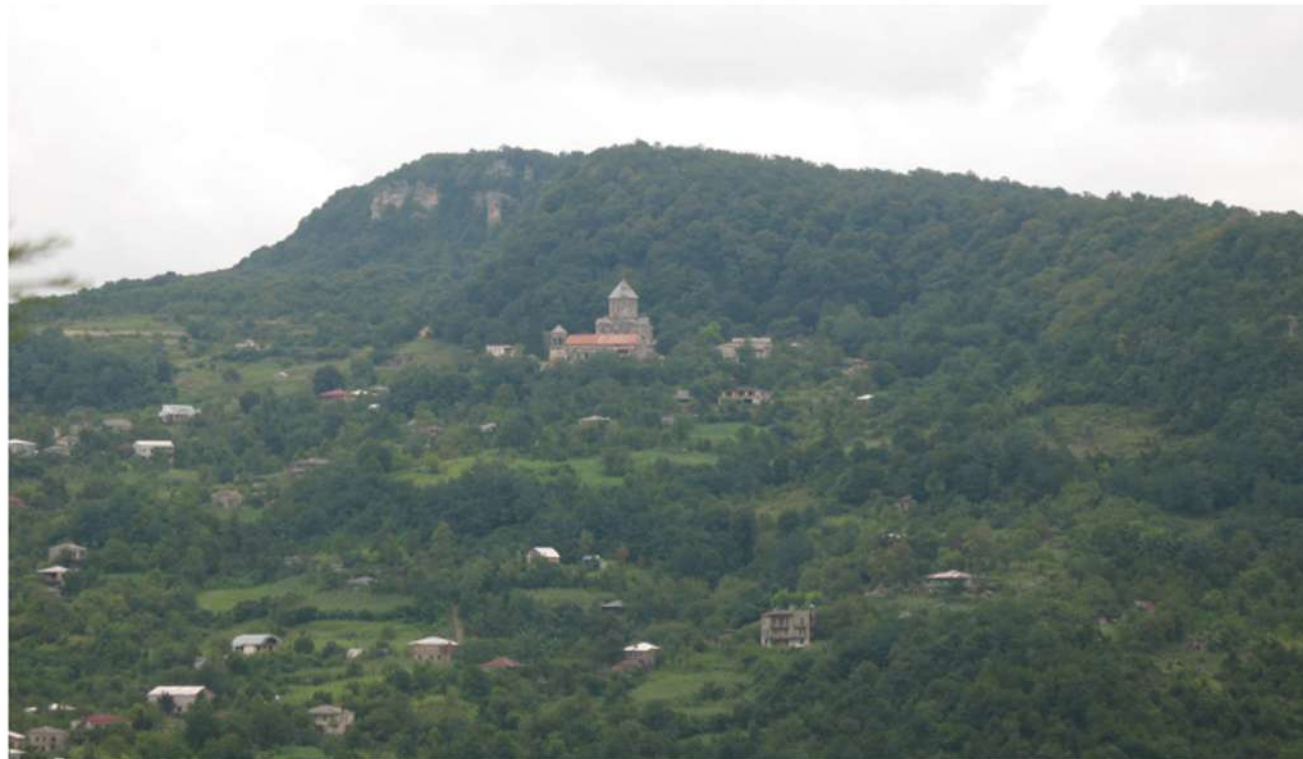
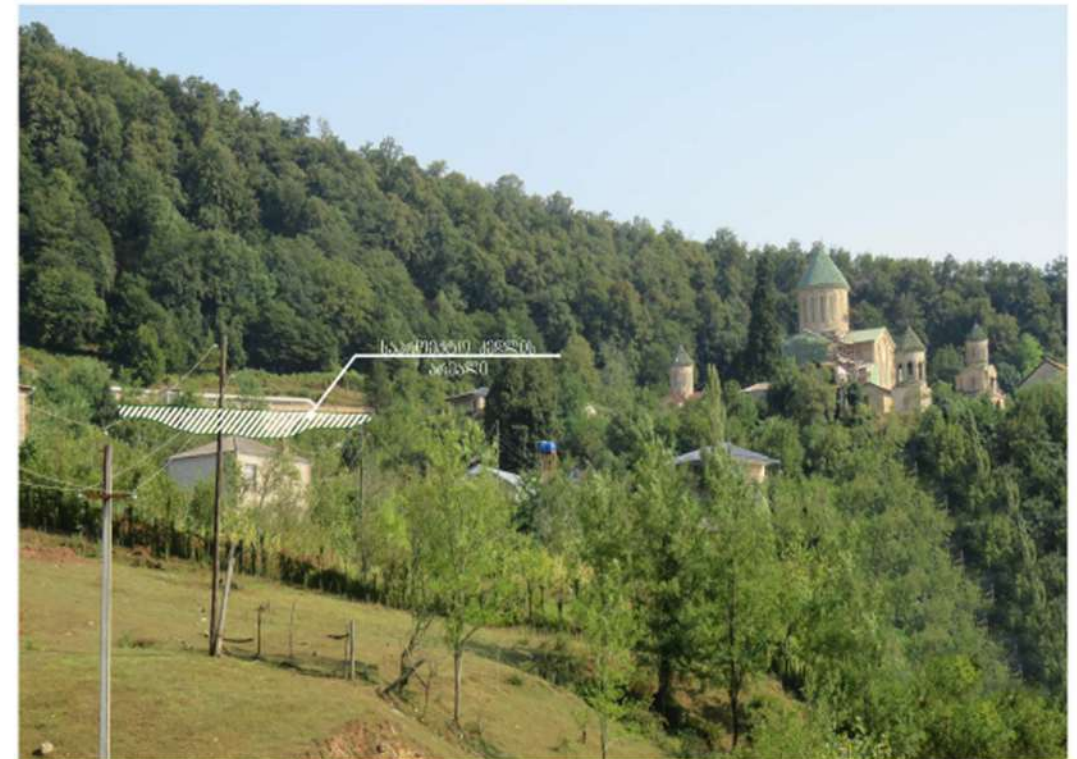
Views on Gelati Monastery WHS

Supporting Wall would be viewable neither from short nor from the long distances.
