Monastery of Gelati- Church of the Nativity of the Virgin

Report on the second mission for the conservation of the paintings

Mission of emergency conservation intervention of the Frescoes

Settembre 16/21

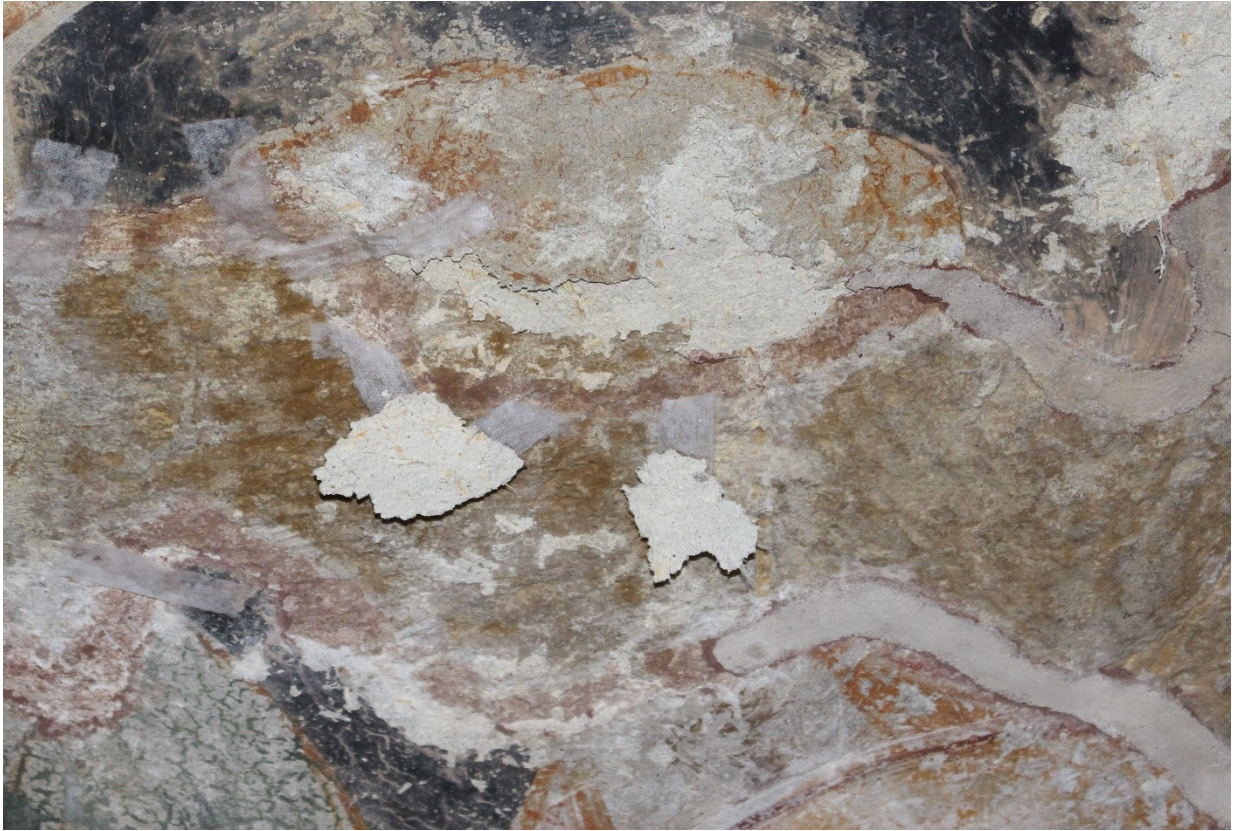
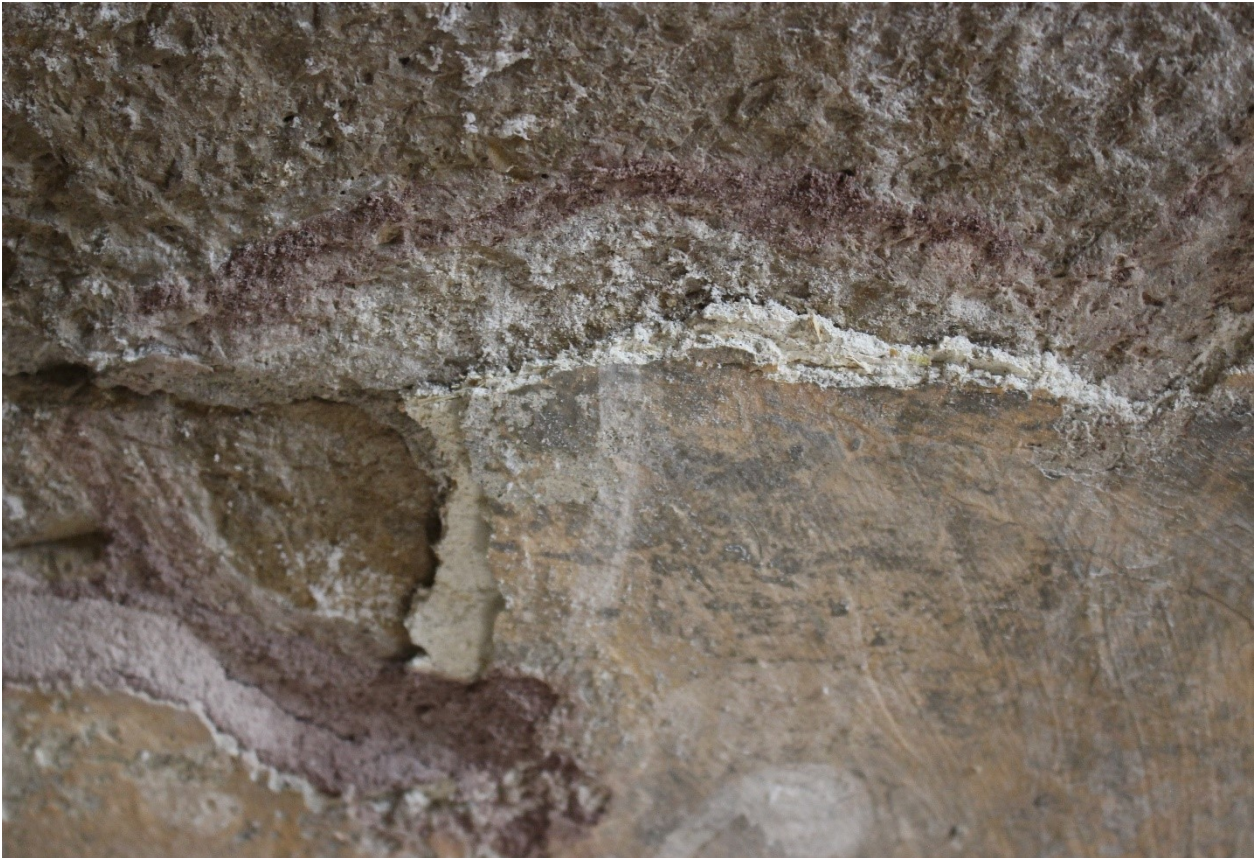
Detachment of portions of plaster due to the failure of the protections (tissues and stucco curbs)

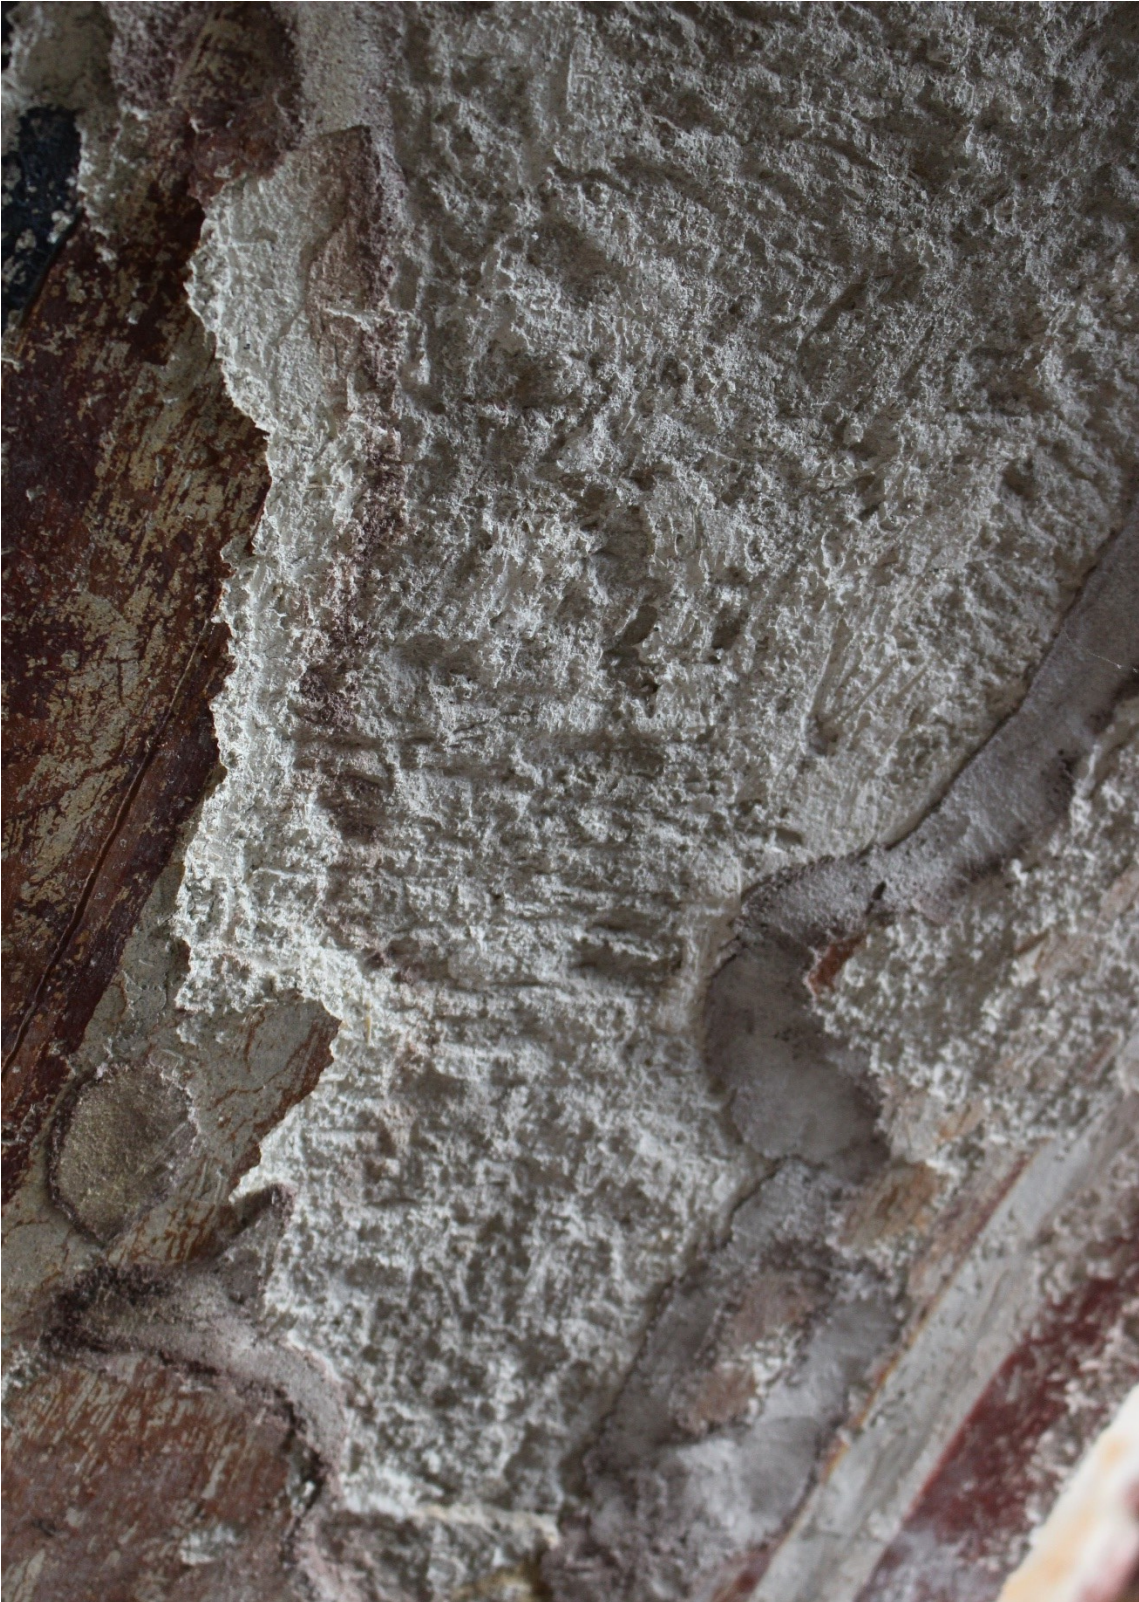
Detachment of portions of plaster due to the failure of the protections (stucco curbs)

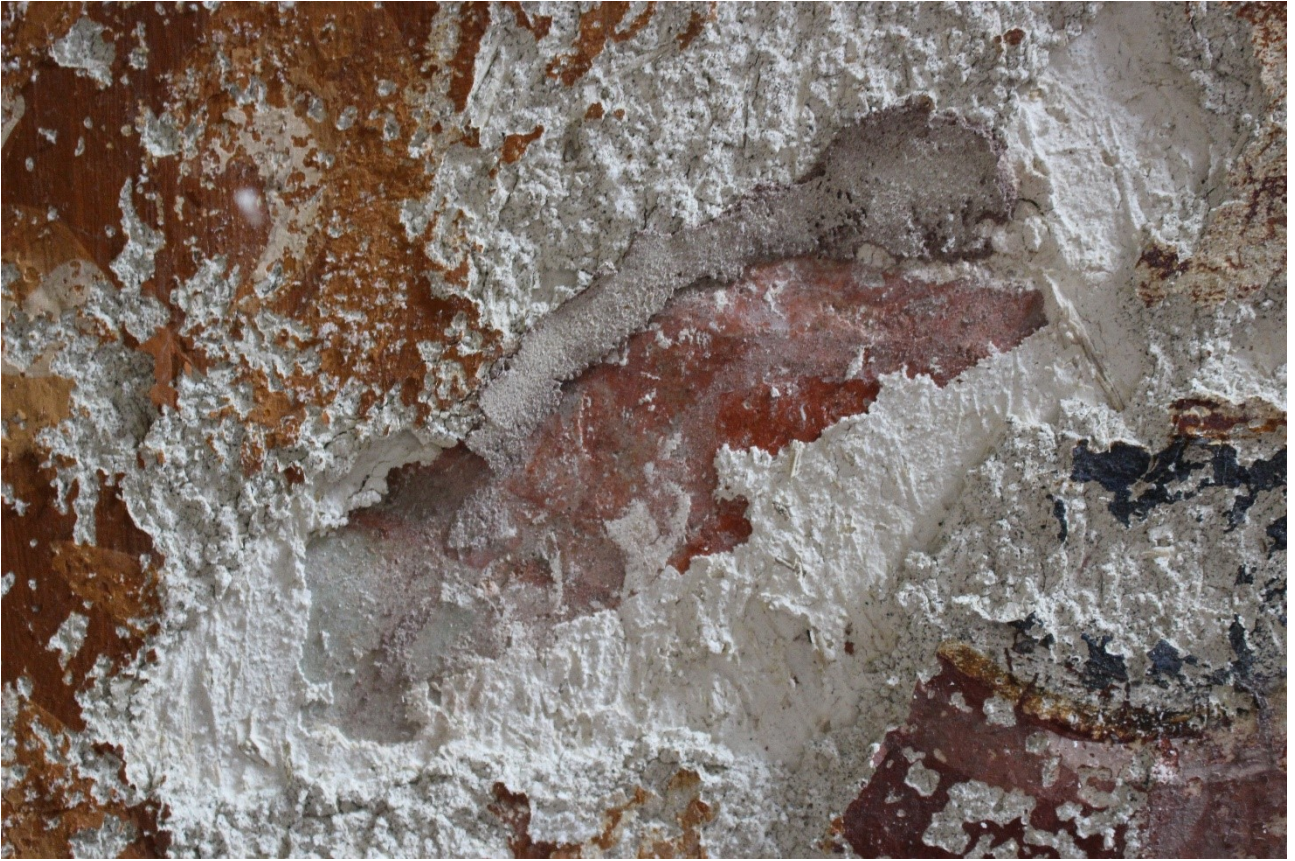
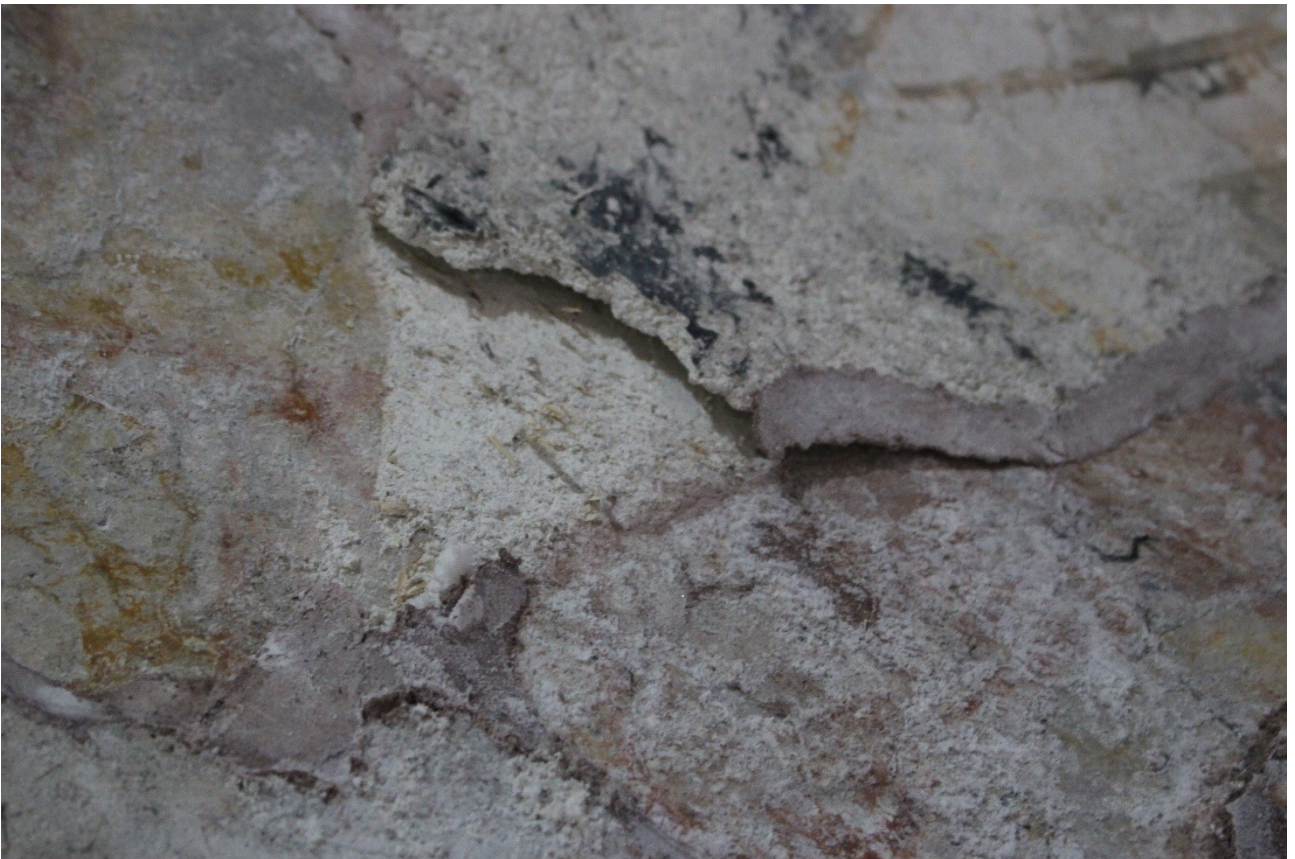
Detachment of portions of plaster due to the failure of the protections (stucco curbs)

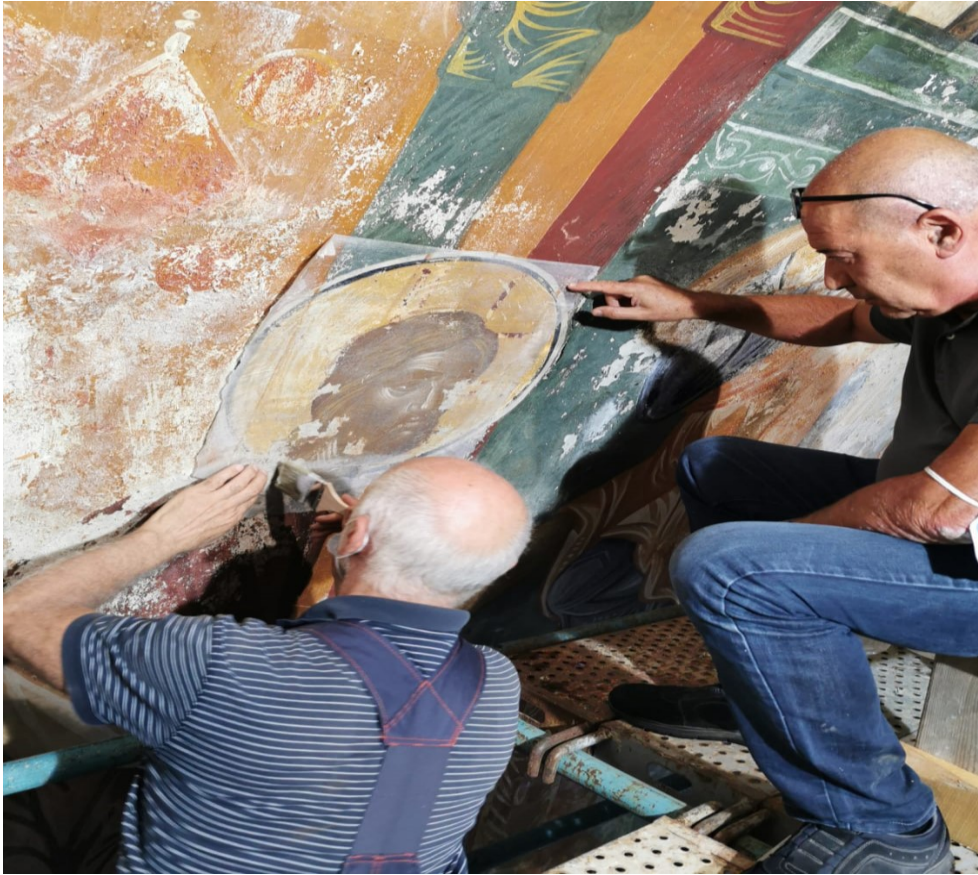
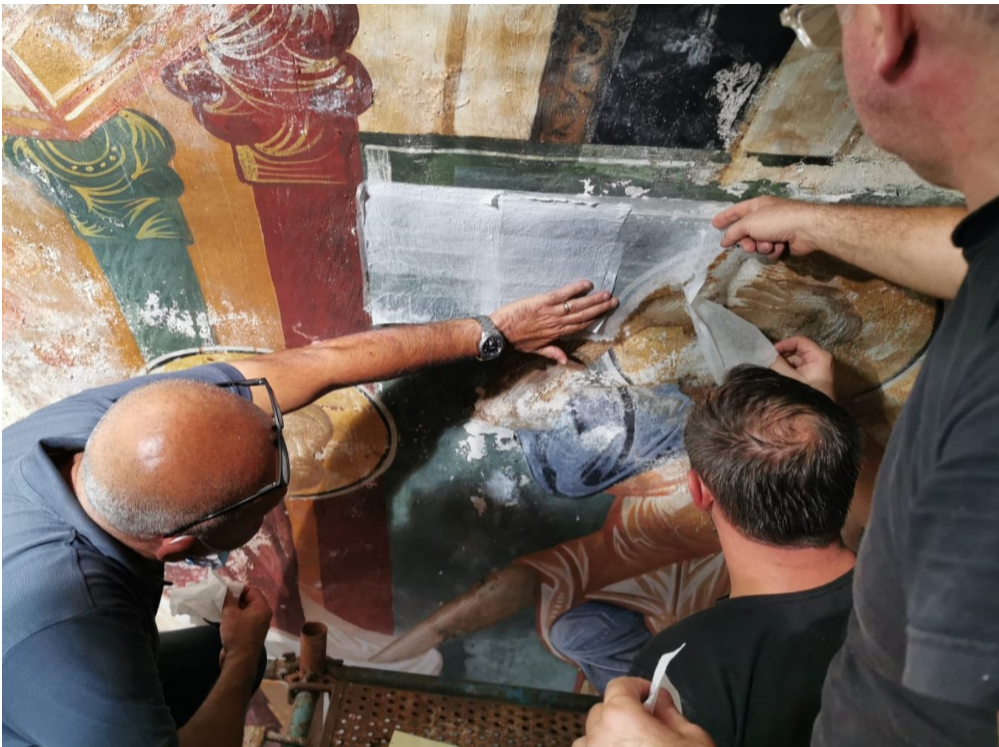
Fixing of the raised paint film

The exfoliation of the pictorial film was consolidated to the underlying layer of plaster by applying on the painted surface a sheet of Japanese paper adhered by the use of deionized water and exerting pressure with soft pads in order to re-stick the portions of the pictorial film lifted up. Subsequently, again through the paper layer (filter), a solution of deionized water and acrylic resin in aqueous emulsion (3%) (Acrill 33 / EA-MMA) was applied.

Pressure was exerted again on the previously treated parts by using soft pads to improve adhesion to the support of the previously raised paint film.

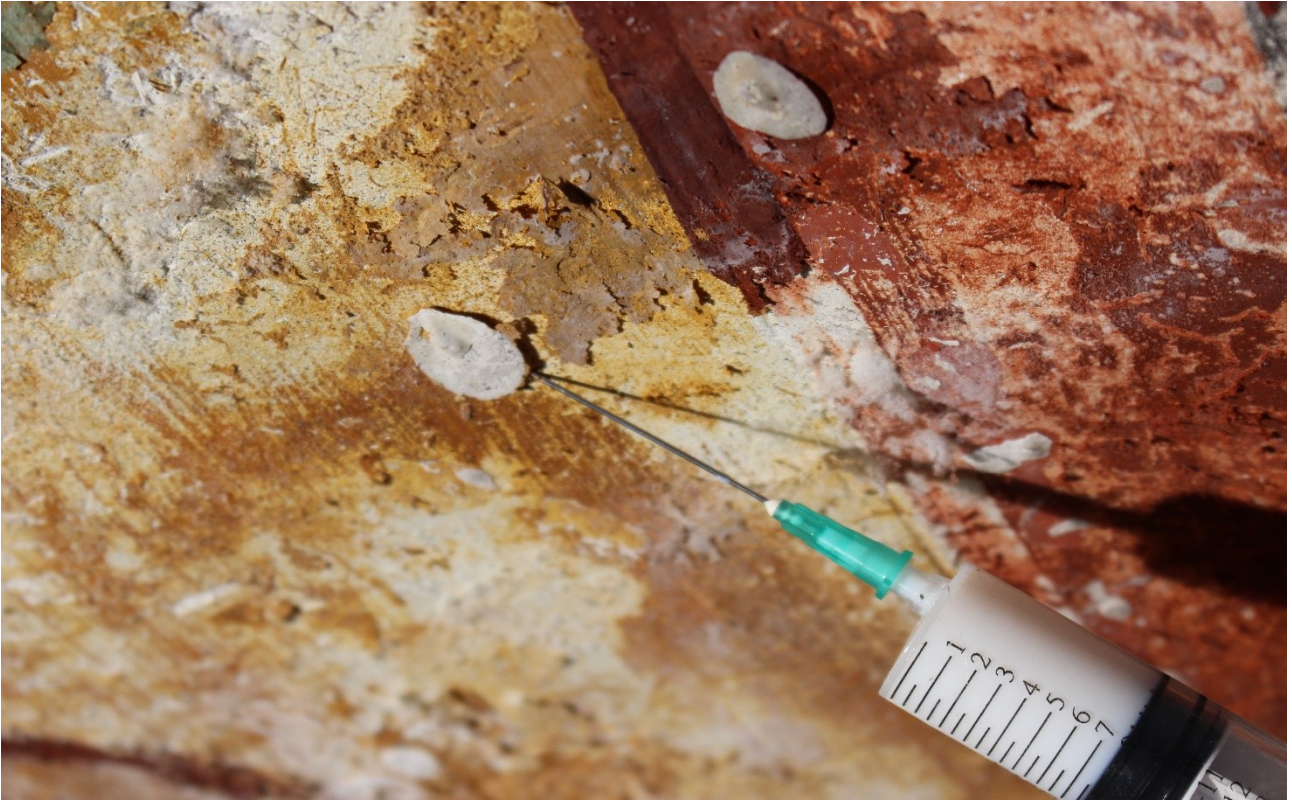
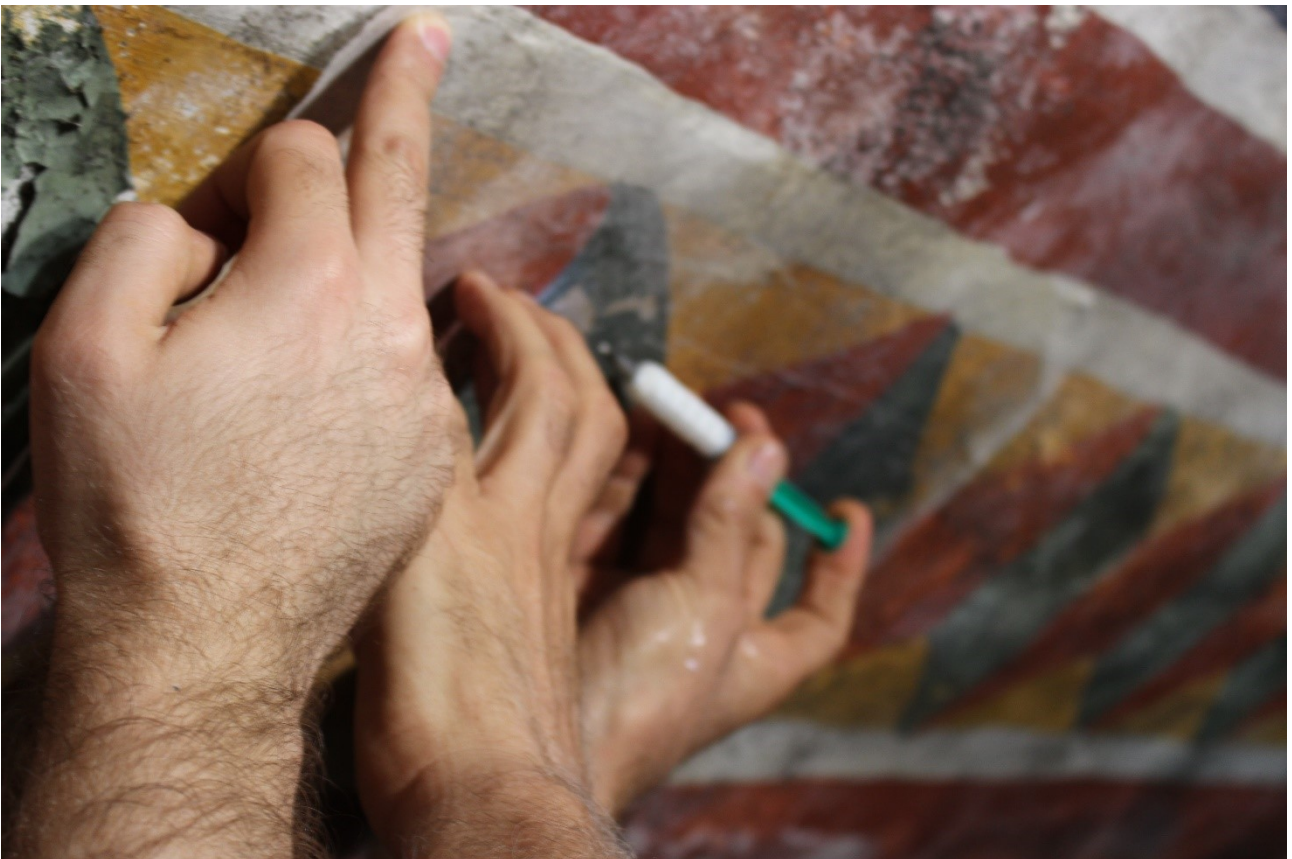
Fixing of the raised paint film with injections

In the case of thicker color exfoliation, always through the Japanese paper filter, under the raised color layer, a solution of the same consolidant with a higher percentage of resin (5/6%) was injected. Before fixing the color, in the areas where there were evident saline efflorescences, the latter were removed with meticulous attention, first dry by using soft bristle brushes and then by compresses of deionized water kept in contact with the surface with a first layer of Japanese paper to which 3 layers of soft absorbent pure cellulose paper have been superimposed.

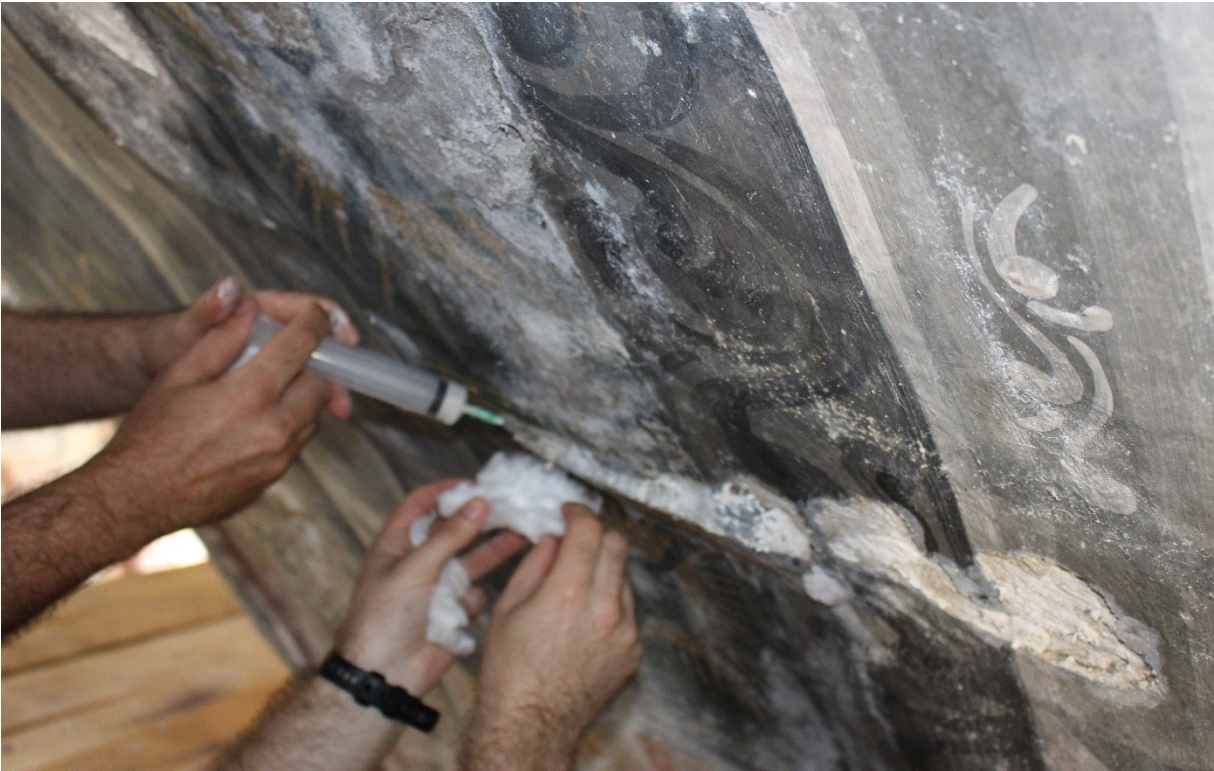
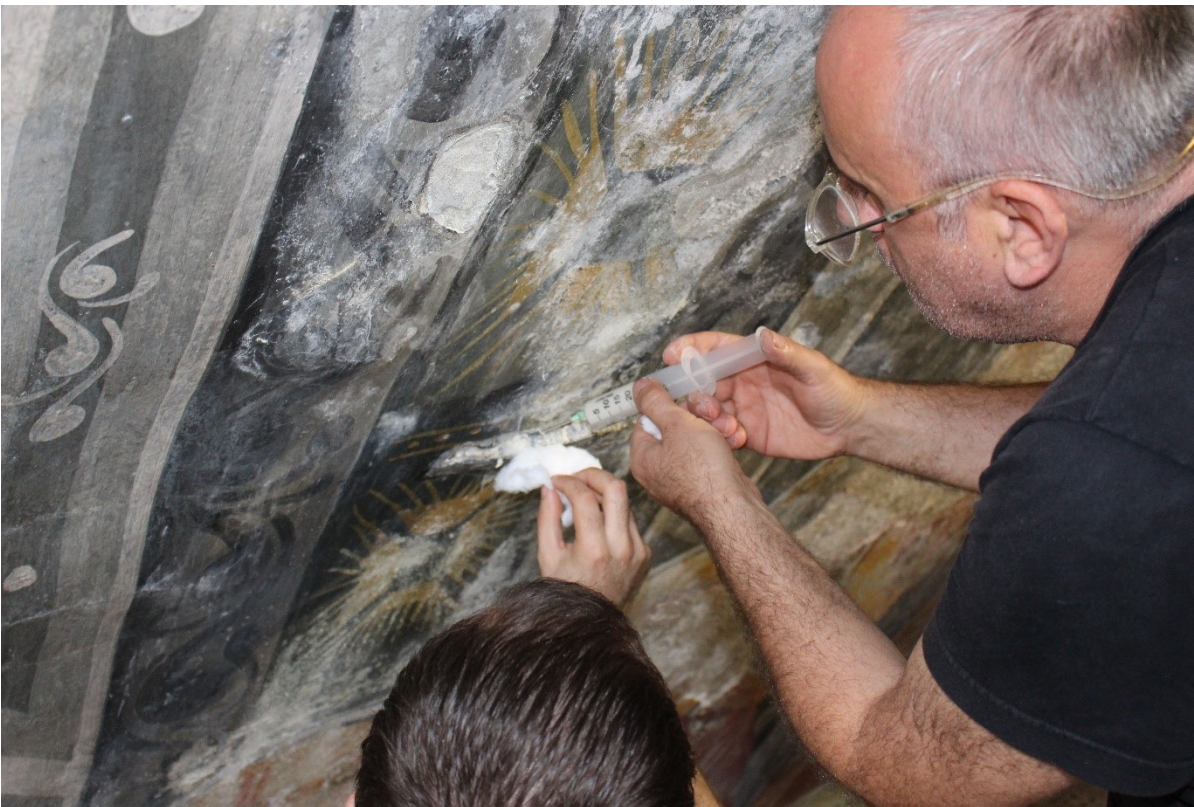
Consolidation of plaster detachments

The gaps present between the various layers of plaster have been consolidated by injections of two types of premixed mortar suitably studied, tested and composed for the targeted and specific use in the conservation and restoration of decorated surfaces of the architecture of historical and artistic value. The injected mortars are mainly based on natural hydrated lime free from efflorescing salts and inert selected also according to the characteristics of use (PLM A - Plaster of masonry / PLM AI - with low specific weight ideal for plaster of vaults or for large detachments thickness).

The portions of plaster to be consolidated that showed very thick detachments were previously coated with a sheet of Japanese paper applied with a 10% resin solution (Methylacrylate-Ethylmethacrylate / Paraloid b72) dissolved in acetone, while the detached edges of the plaster were sealed with a temporary mortar based on slaked lime (natural airborne binder based on lime hydroxide) and siliceous aggregates. The consolidations by means of mortar injections continued until the adhesion between the various layers of plaster and between these and the load-bearing masonry was fully restored.

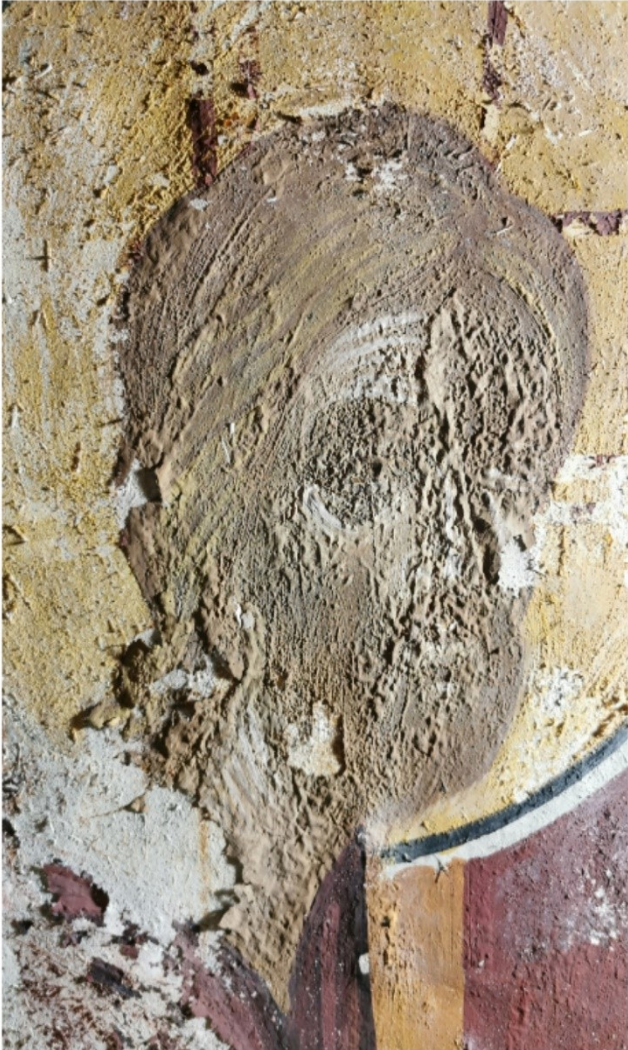
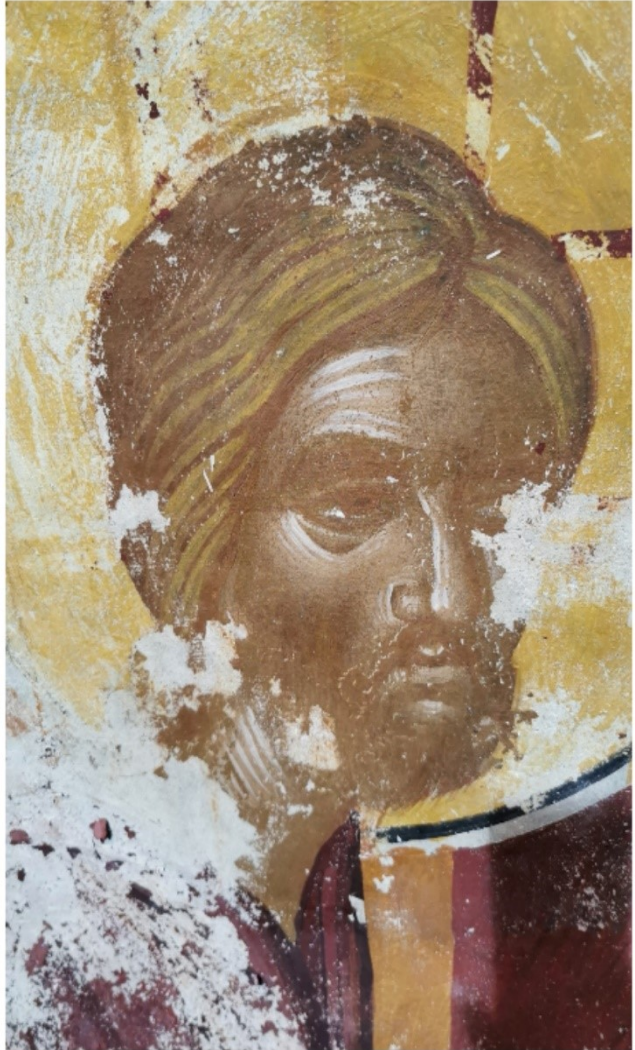
Fixing of the raised paint film

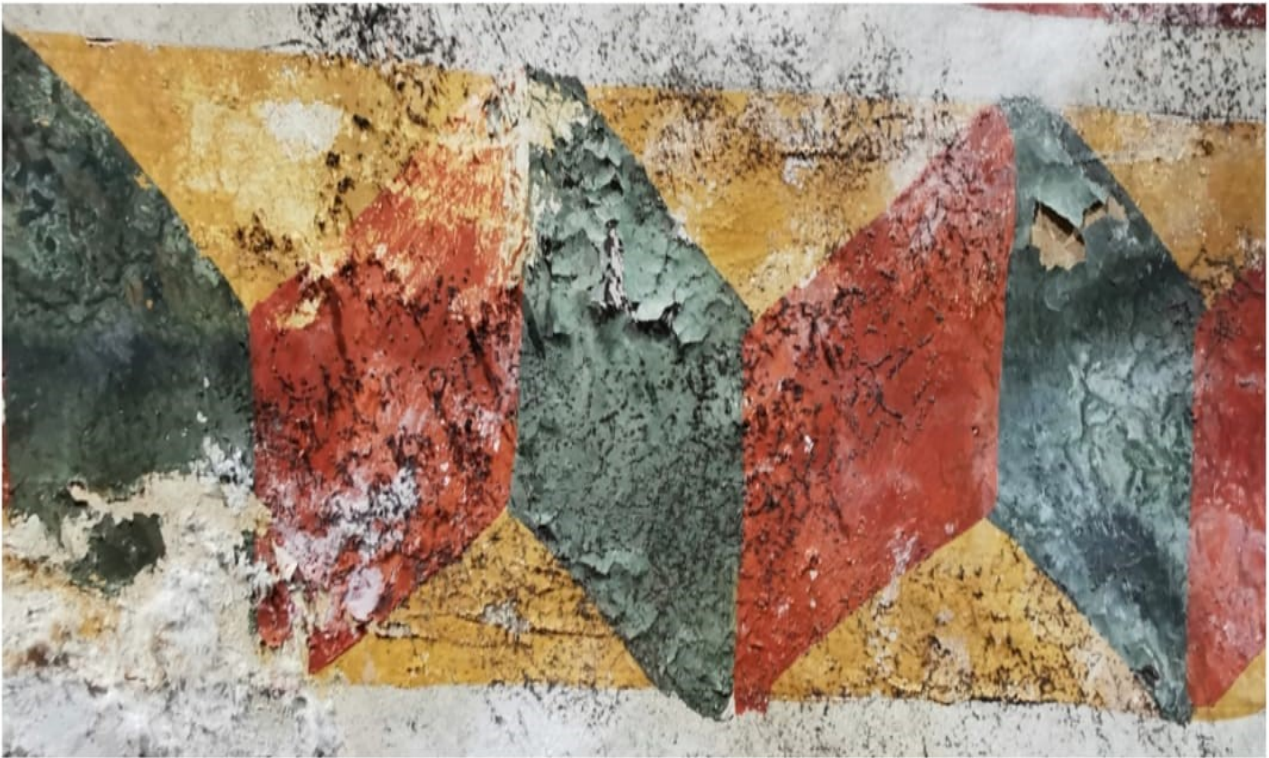
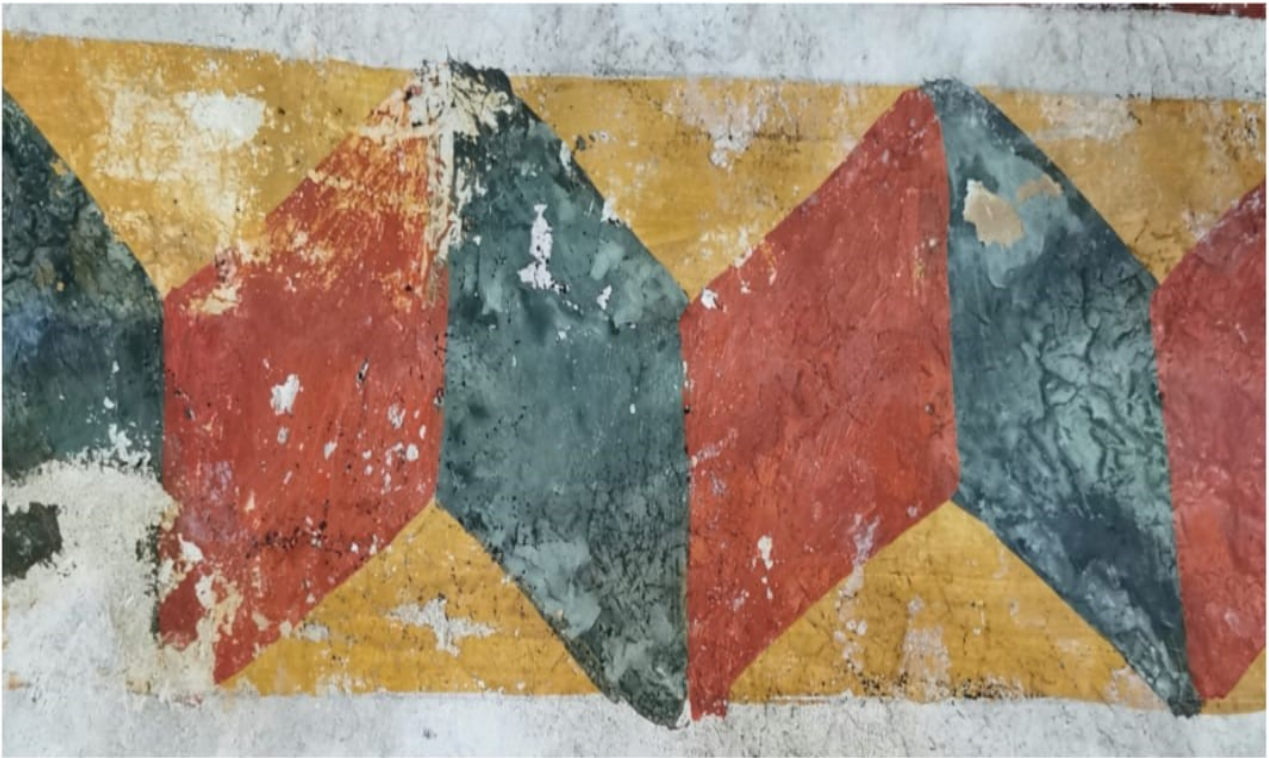
Fixing of the raised paint film

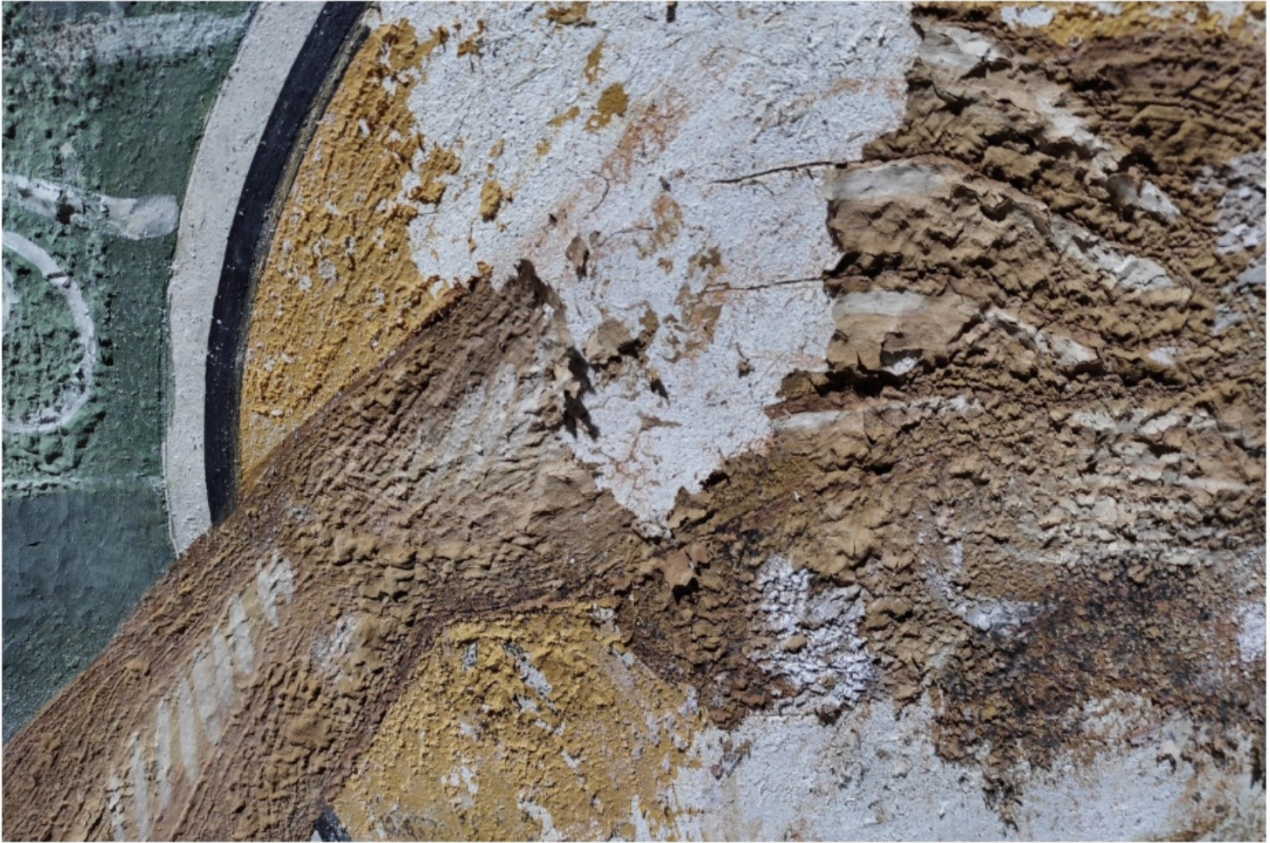
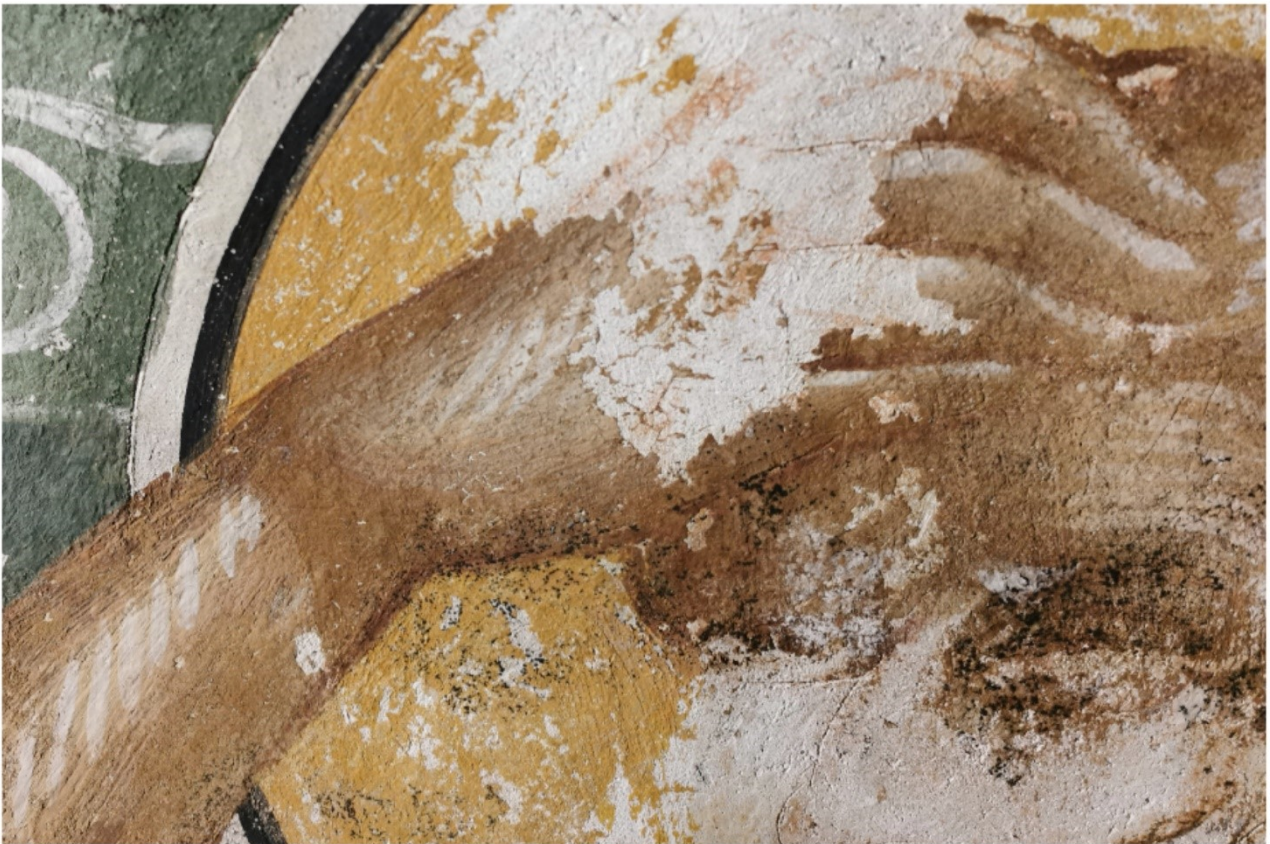
Fixing of the raised paint film

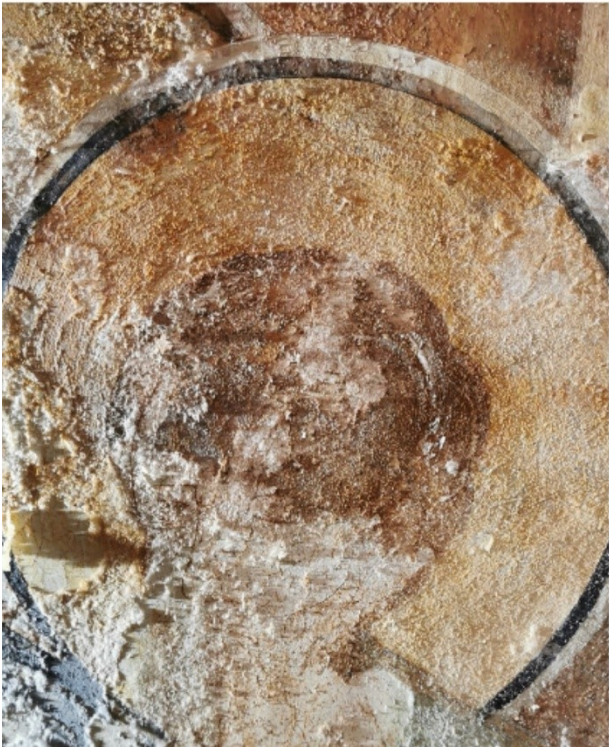
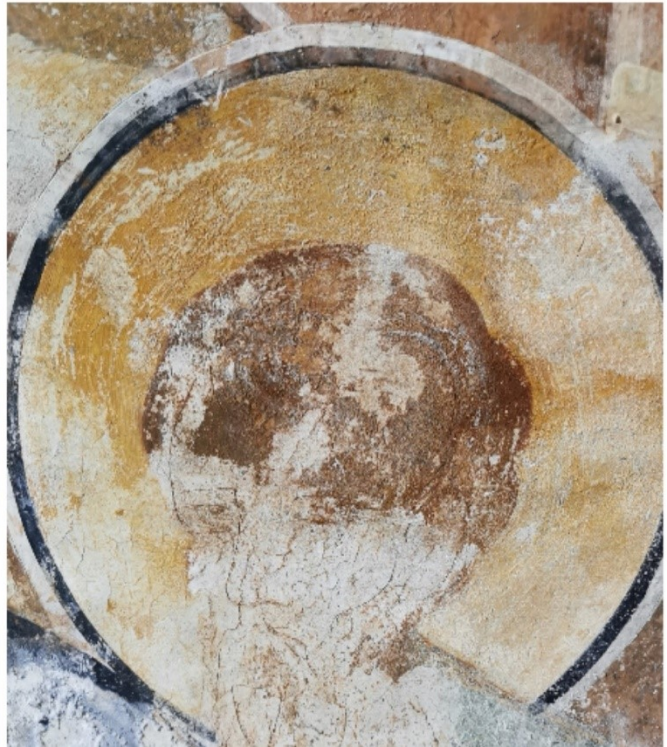
Fixing of the raised paint film and removal of saline efflorescence

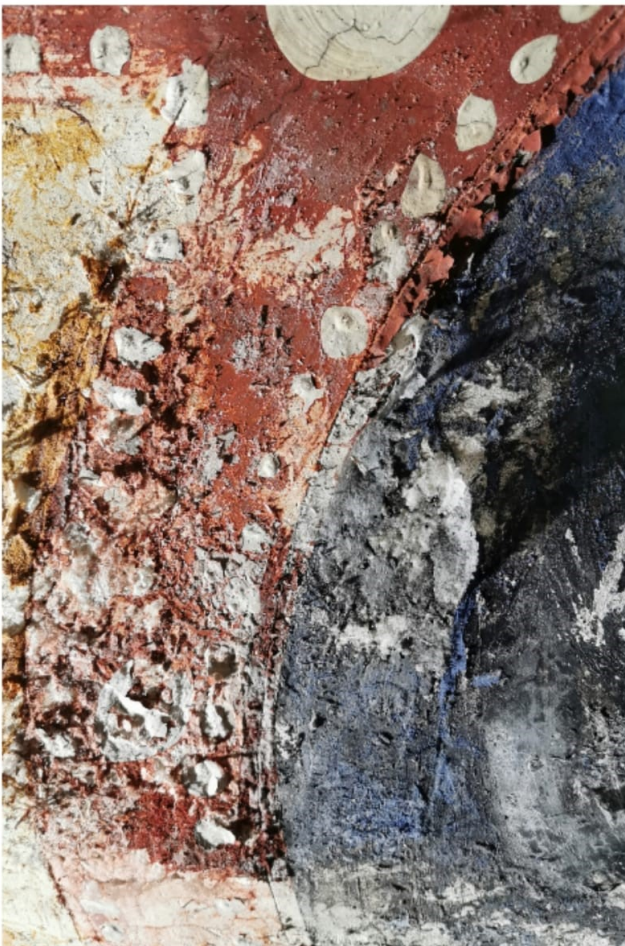
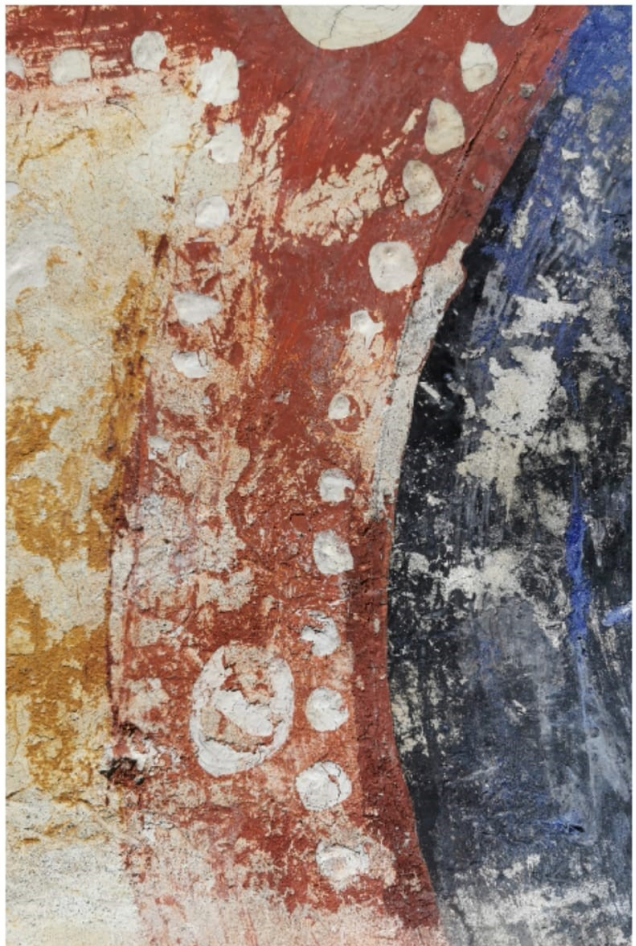
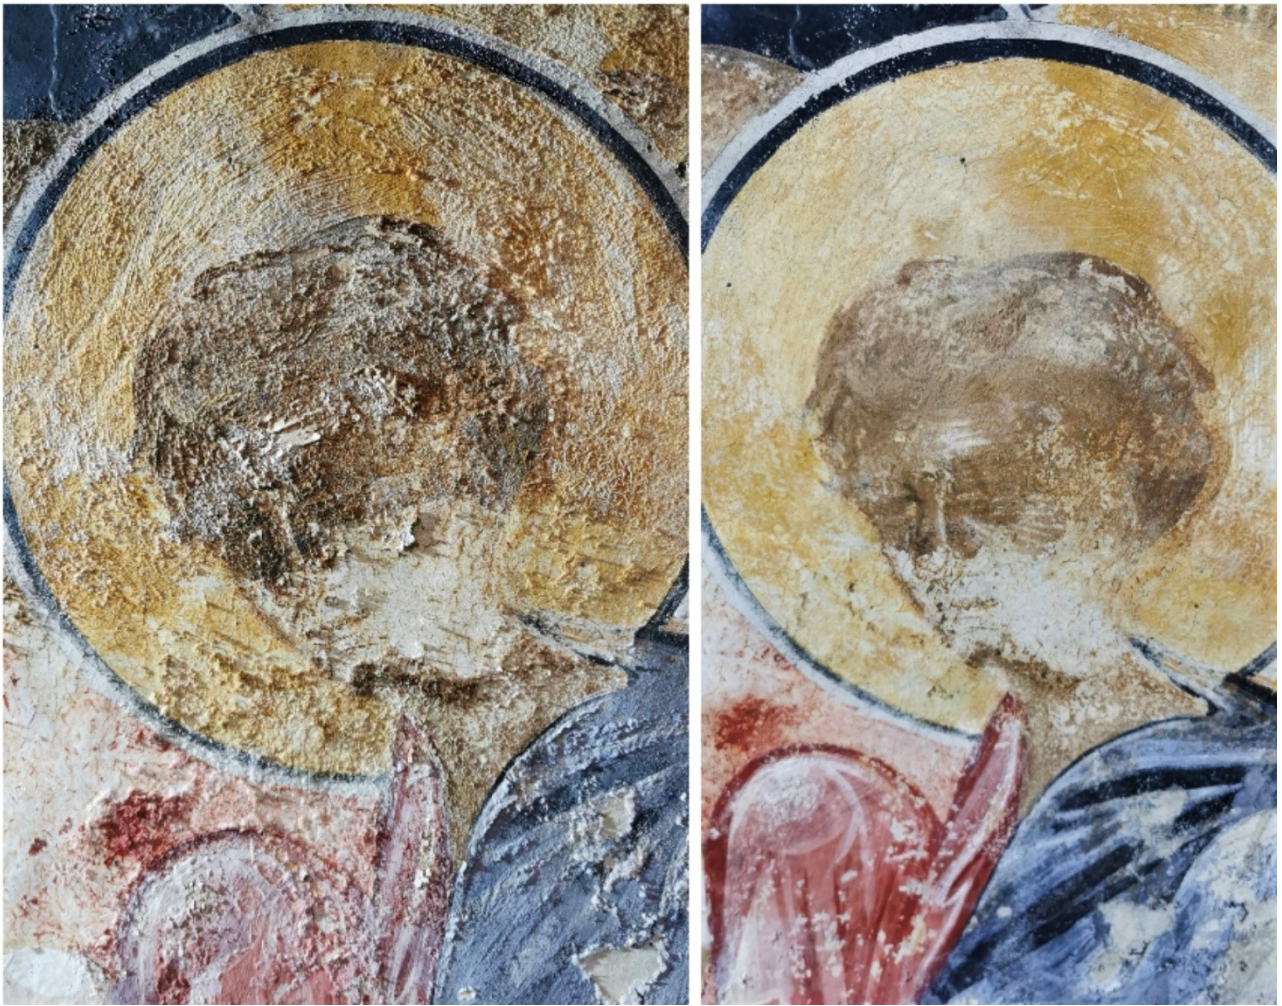
Fixing of the raised paint film and removal of saline efflorescence
