Safeguarding and conservation of Gelati Monastery World Heritage Property, Georgia

**Tests on material samples taken on-site
Scientific report explaining the results of the tests**

Deliverable 1.1

**MINERALOGICAL-PETROGRAPHIC
CHARACTERIZATION OF MORTARS, STONES
AND TILES AND CHEMICAL
CHARACTERIZATION OF INSULATING
MATERIALS FROM GELATI MONASTERY
(GEORGIA)**

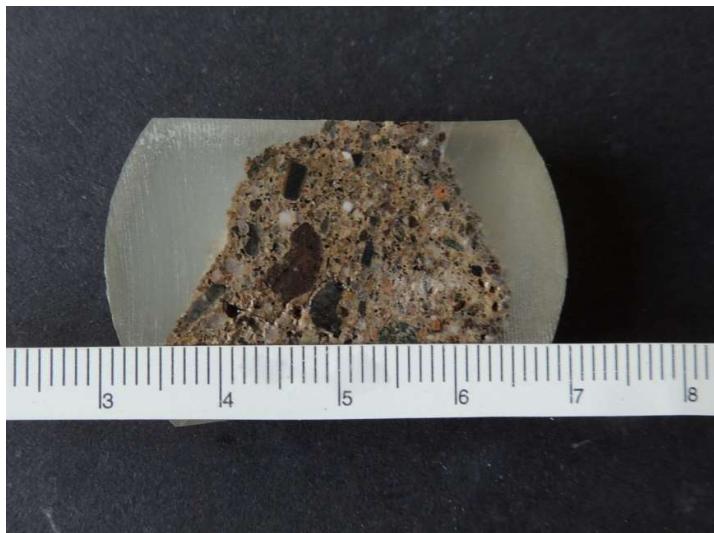
R1 a - Cross section image

R1 a Saggio RI Tile filling mortar

The mortar is made of calcite, quartz, micas (muscovite), feldspars (andesine).

The mortar shows a scarce binder (Binder/Aggregate ~ 1/3) with a micritic texture and a pure aspect of possible hydraulic nature. The aggregate is made of quartz, feldspars, micas, fragments of porphyric and granitic rocks. The grains are subrounded in shape with a bimodal grain-size distribution (400-500 µm and 1.5-2 mm). The macropores are subrounded in shape.

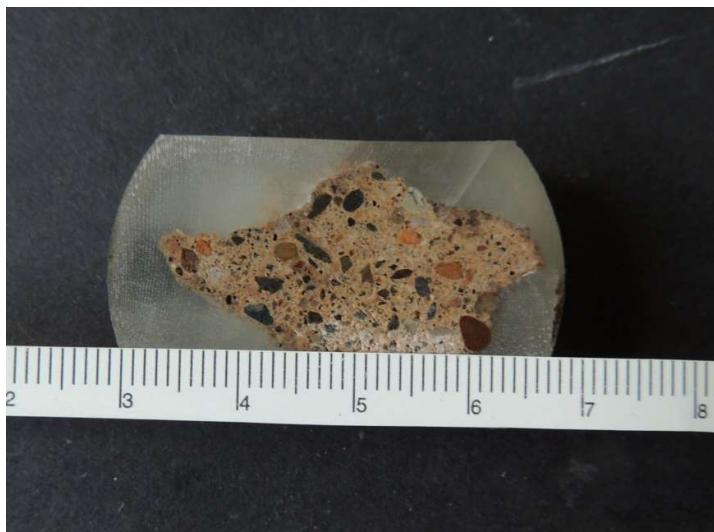
R2 a - Cross section image

R2 a Saggio R2 Mortar, connection between roof tile and wall

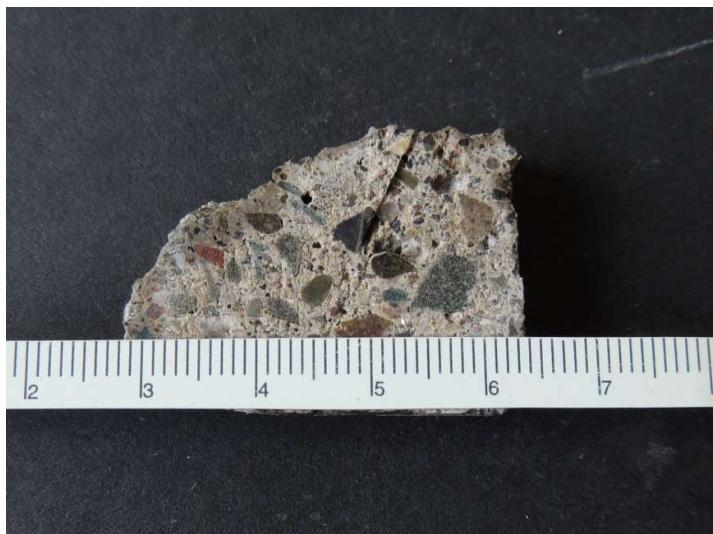
R3 a - Cross section image

R3 a Saggio R3 Mortar

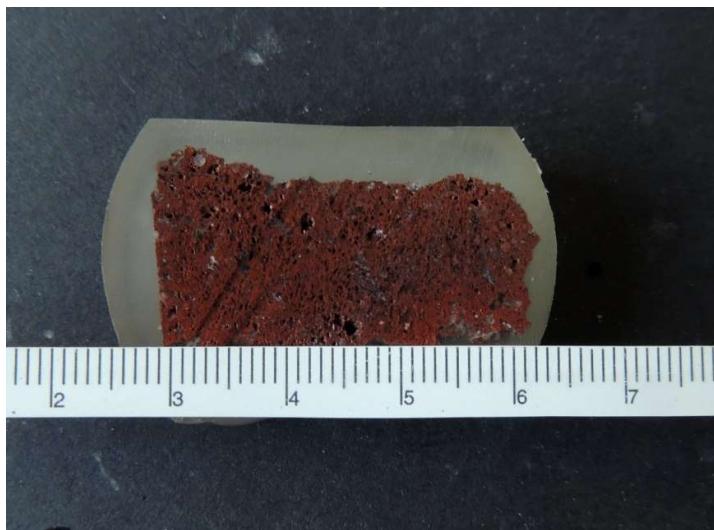
F 1 - Cross section image

F1 Sottotetto Falda 22 Pumice, filling of the Roof #22

The F1 sample, taken from the filling material of the under roof of pitch n. 22, is an effusive rock too, known as pumice, which is characterized by the presence of many closed pores into which water does not enter, making it waterproof. Anyway, it should be noted that the mortar, with which these stones have been put in place, is not a waterproof material.

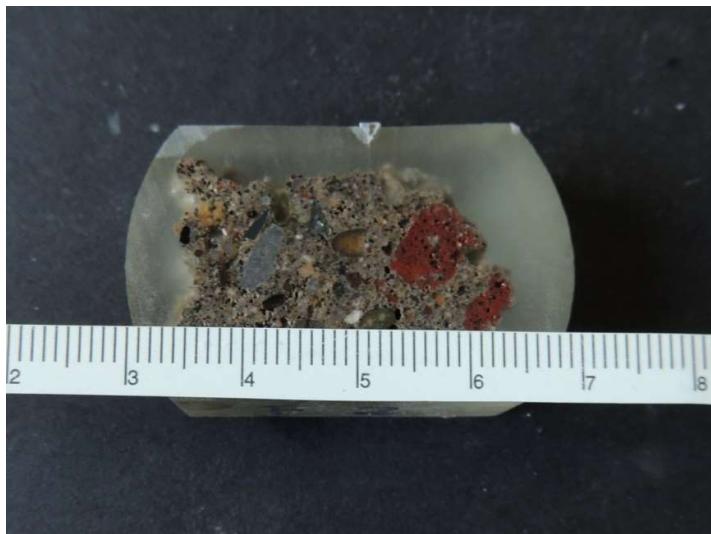
F 2 - Cross section image

F2 Sottotetto Falda 22

Mortar (*cement*), filling of the Roof #22

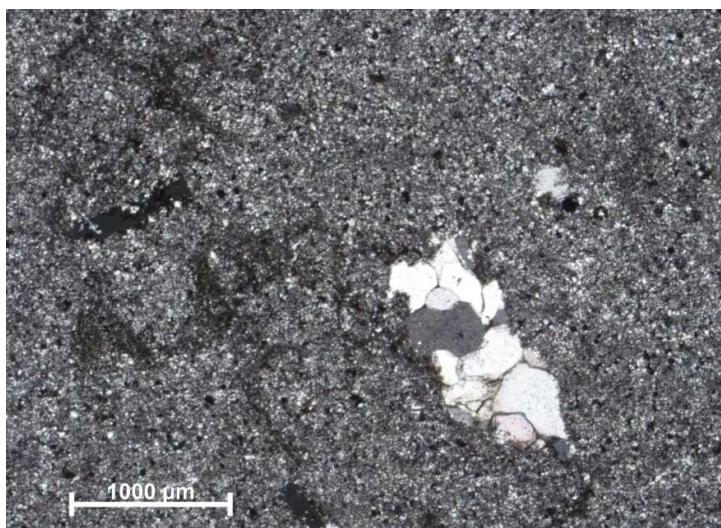
S 3 - Thin section image, transmitted light, crossed nicols

The stone shows a microsparitic texture with rare intraclasts constituted by sparitic calcite with dimension of 400-600 µm. Calcite veins are present. Macropores are scarce. According to the petrographic aspect the rock can be classified as “intraclasts bearing micrite” (Dunham 1962) and mudstone (Folk 1959).

According to the mineralogical composition it can be classified as a dolomite rock

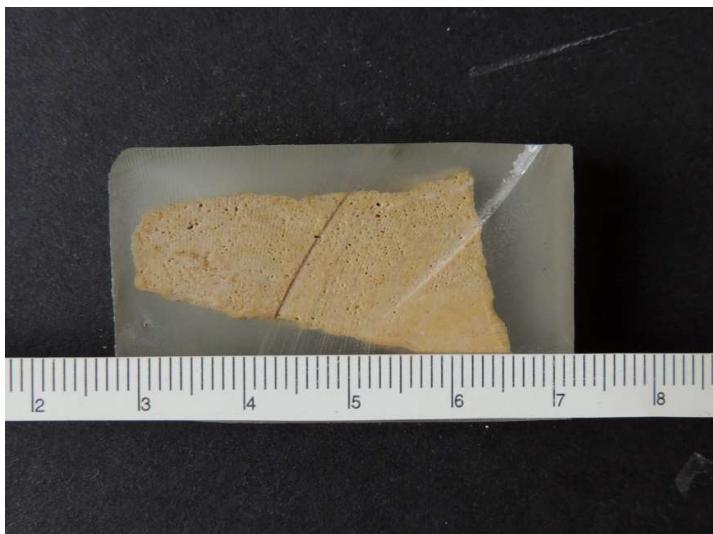
S 4 - Cross section image

S4 *Interior Wall* Stone

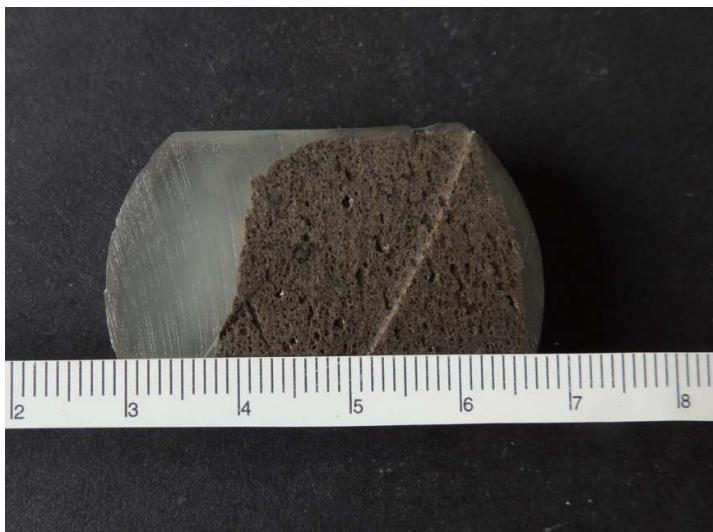
S 5 - Cross section image

S5 *Provided Stone slab* *roof stone*

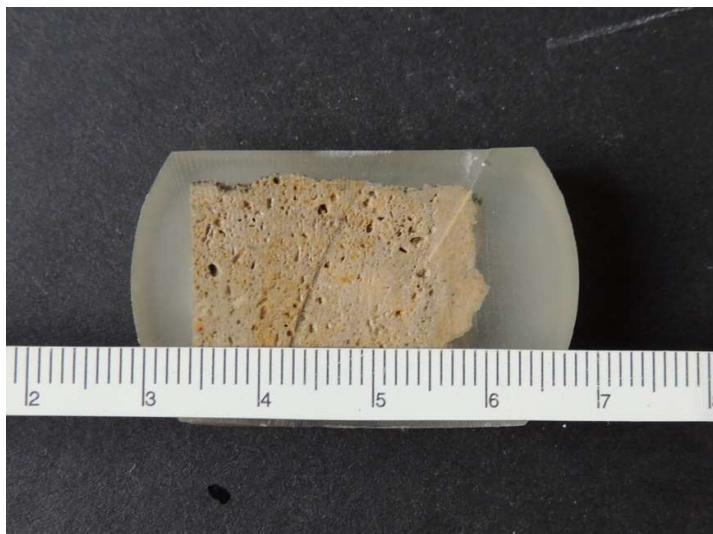
S 6 - Cross section image

S6 Apse South-East side Wall stone

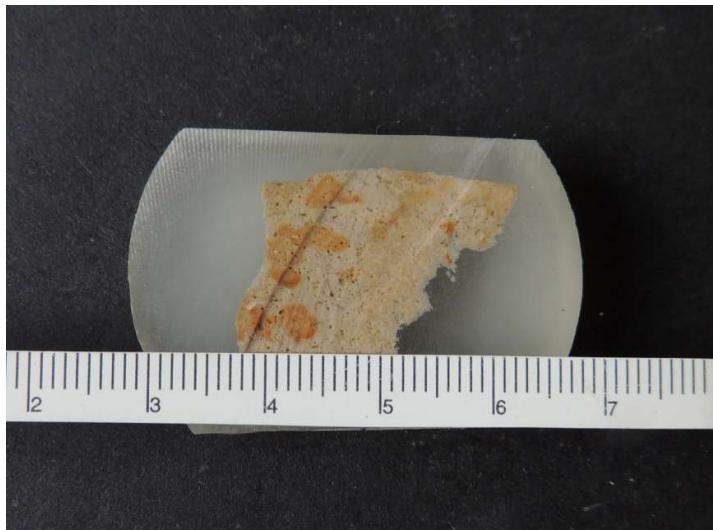
S 7 - Cross section image

S7 Cornice North side Cornice stone

The stone is made of ankerite, with traces of feldspars (orthoclase) and gypsum. Ankerite [$\text{Ca(Fe,Mg)}(\text{CO}_3)_2$] is a dolomite where part of magnesium has been replaced by iron ferroan dolomite). According to this composition it can be still classified as dolomitic rock.

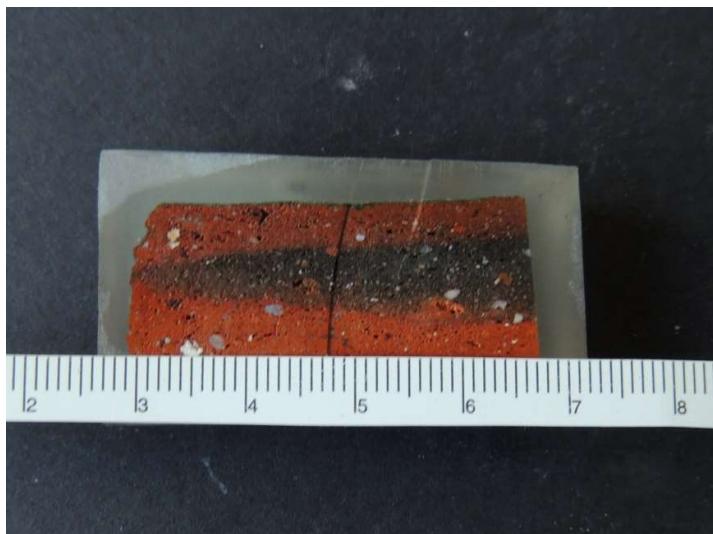
T (red) 2 - Cross section image

T (red) 2 *Interior old tile - XVI sec*

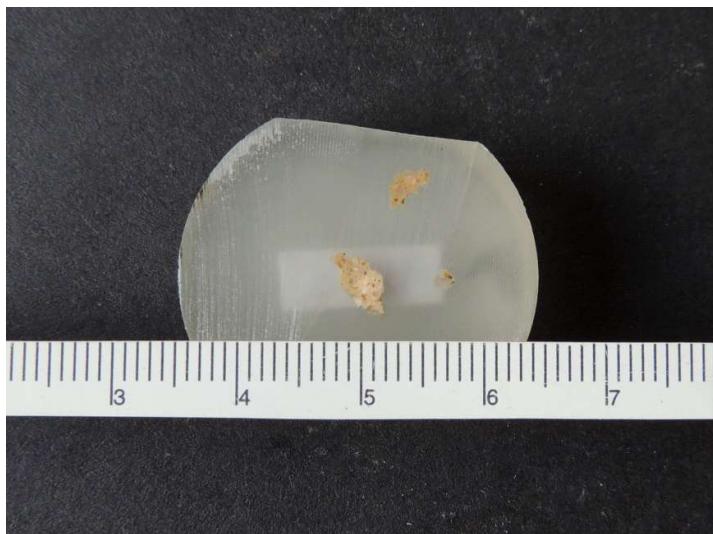
M XII a - Cross section image

M.XII-a *Provided, from XII tile mortar XII sec*

Samples M XII a, MXII b, M XVI show an abundant binder (Binder/Aggregate ~ 1/2) constituted by air hardening lime. The aggregate is made of quartz, feldspars, micas, and carbonate rock fragments. The grains are angular in shape with a unimodal grain-size distribution (400-800 µm). Lime lumps are present. The macropores are constituted mostly by shrinkage fractures.

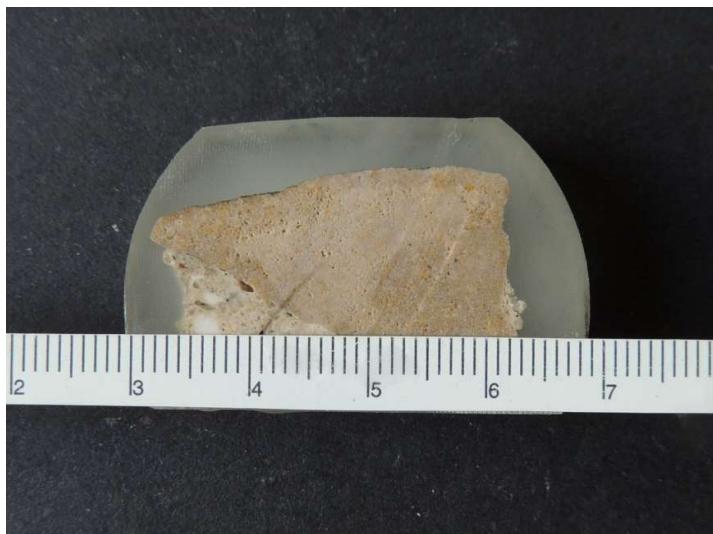
M XVI - Cross section image: the mortar is in the left side

M.XVI *Provided mortar XVI sec*

The mortar shows an abundant binder (Binder/Aggregate ~ 1/2) constituted by an air hardening lime with a micritic texture. The aggregate is made of quartz, feldspars, micas, and carbonate rock fragments. The grains are angular in shape with a unimodal grain-size distribution (400-800 µm). Lime lumps are present. The macropores are constituted by shrinkage fractures

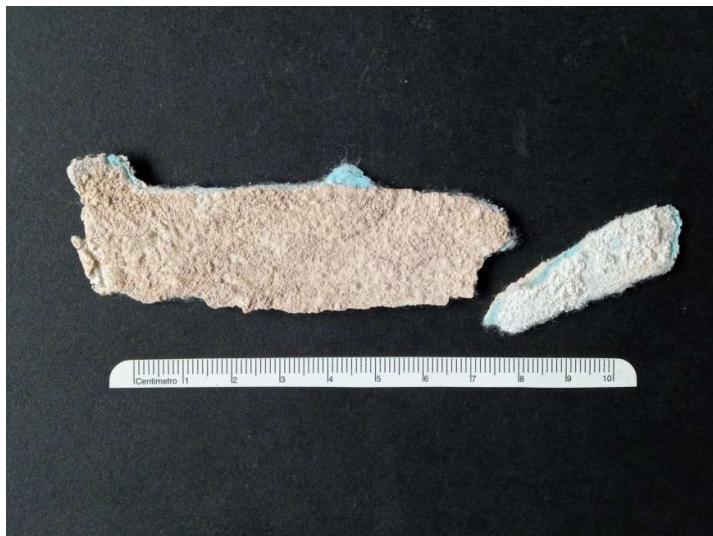
Sample R2 b

R2 b Saggio R2 Insulating, connection between roof and wall

The sample appears as a thin, non-brittle, elastic fragment. Macroscopically it is possible to distinguish an external light brown layer, a blue layer and an internal non-continuous layer of adhesion with the material underlying the fragment.

The outer layer (spectrum 1) is basically composed of calcite and silicates. The blue layer (spectrum 2) shows typical C-H stretching and C-H bending signals of aliphatic compounds, which could indicate the presence of a paraffin wax.

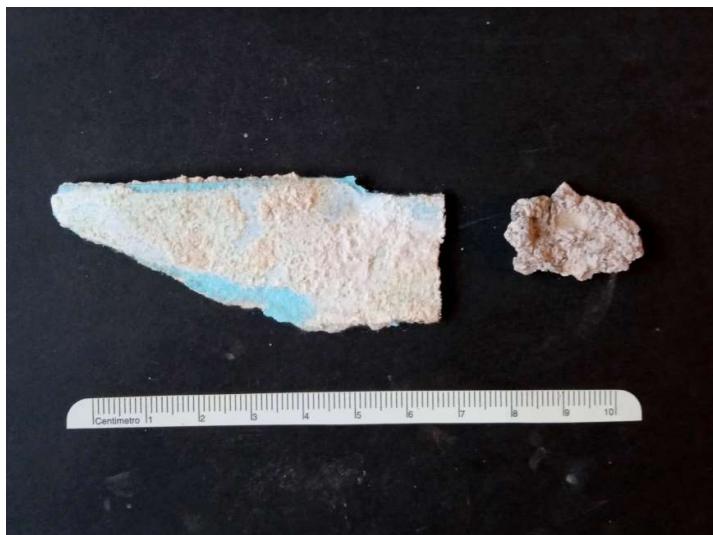
Sample R3 b

R3 b Saggio R3 Insulating, connection between roof and wall

The sample appears as a thin, non-brittle, elastic fragment, similar to R2b. It is possible to distinguish an external light brown layer, a whitish layer, a blue layer and an internal non-continuous layer of adhesion with the material underlying the fragment.

The outer layer (spectrum 3) is basically composed of calcite and silicates. The intermediate whitish layer (spectrum 4) shows a peak at 1733 cm⁻¹ (carbonyl C = O), which could indicate the presence of a wax other than paraffinic, probably partially saponified. The blue layer (spectrum 5) shows typical C-H stretching and C-H bending signals of aliphatic compounds, which could indicate the presence of a paraffin wax.

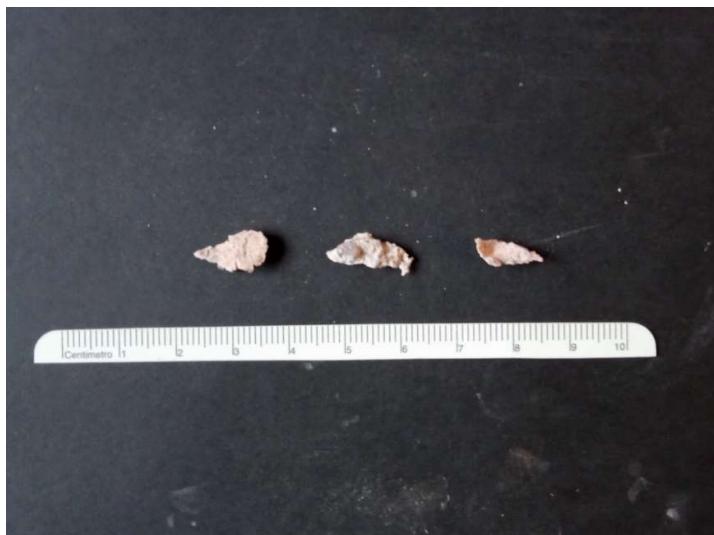
Sample R3 c

R3 c Saggio R3 Insulating, liquid (mortar + organic portion)

The sample consists of 3 irregularly shaped fragments, in which layers are not macroscopically distinguished as in the previously analysed samples. The fragments subjected to analysis are less elastic, and indeed tend to shatter under pressure from the measuring head of the instrument.

The outer layer (Spectrum 6) exhibits the signals of calcite and silicates, but also the signals of what could be a saponified wax. The inner layer (Spectrum 7) is basically calcite and silicates.

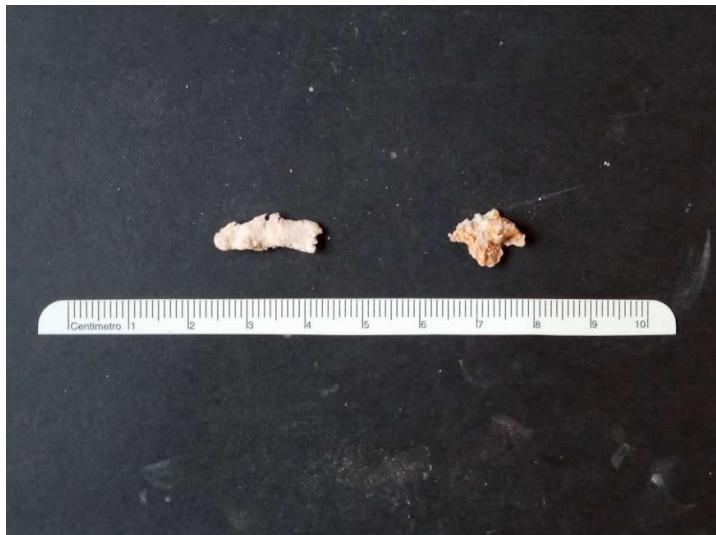
Sample R3 d

R3 d Saggio R3 Glue

The sample consists of 2 irregularly shaped fragments, in which layers are not macroscopically distinguished.

The fragments subjected to analysis are less friable than the R3c sample, but the FT-IR spectrum of the outer layer (Spectrum 8) shows the presence of what could be traces of wax.

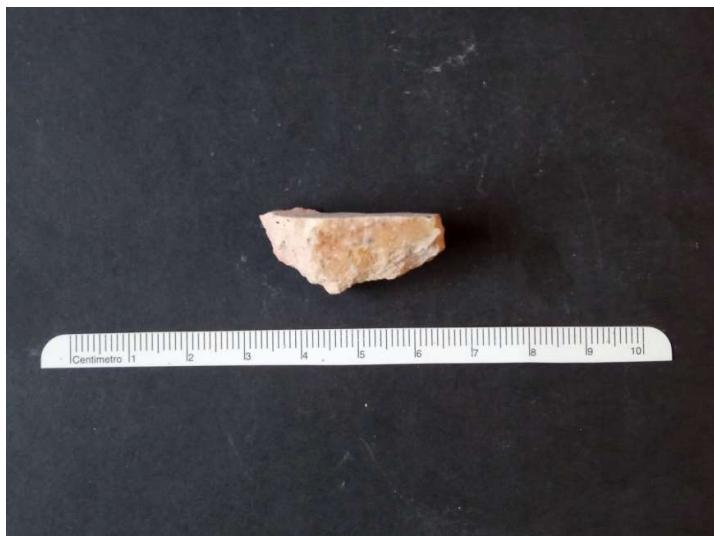
Sample S2

S2 Drum near R3 Wall

The sample, previously analysed from a mineralogical-petrographic point of view, has a translucent brown surface treatment

The sample is not easy to analyse with the ATR accessory, and the resulting spectra are very noisy and therefore difficult to read. Nevertheless, some peaks attributable to organic compounds are visible, even if not better identifiable (Spectrum 9).

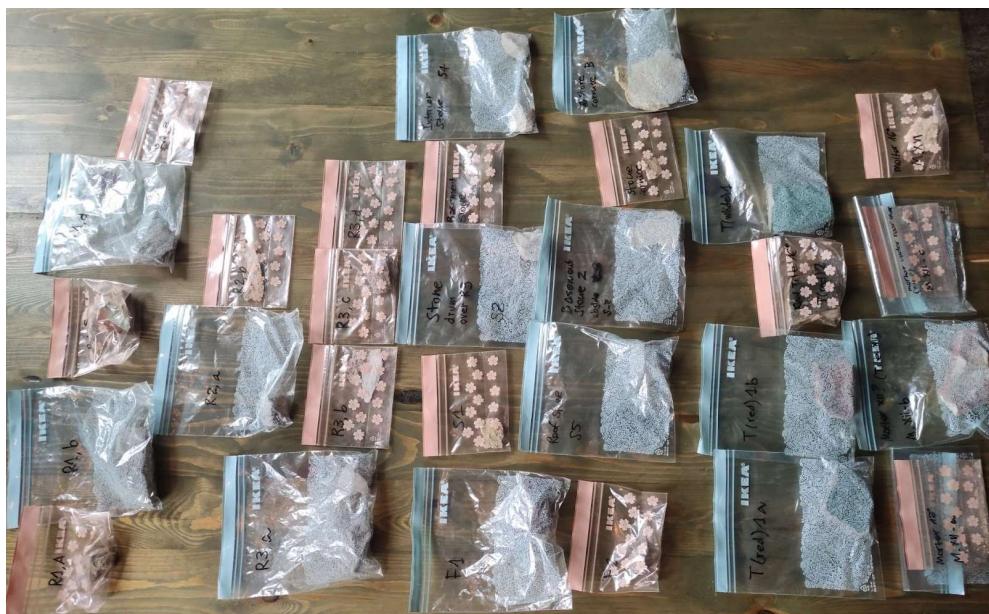
Figure 2 - Samples taken on-site during the June 2021 mission.
