**CONSERVATION-RESTORATION CAMPAIGN OF THE VAULT AND
WALLS OF THE WEST ARM OF THE GELATI MONASTERY –
GEORGIA**

Report of the mission of the conservation-restoration expert Marco Pulieri

May 27 - June 3 2022
Contract N° 1-124-22

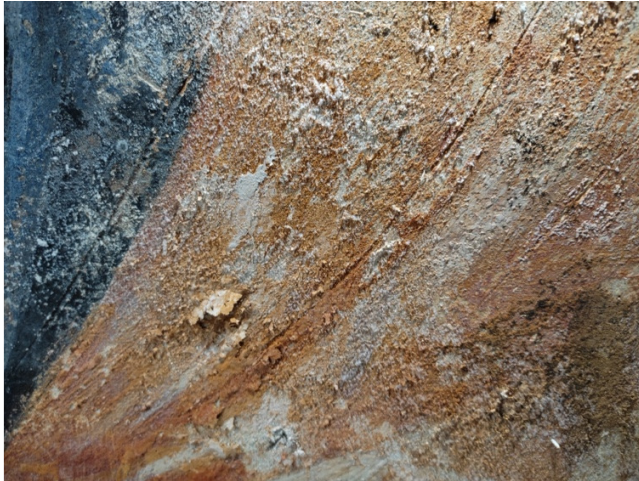
1- new saline efflorescence on the South wall

The new saline efflorescence was also removed with an extractive compress made with the application of double Japanese paper poultice and distilled water which solubilized the salts and absorbed them on the Japanese paper.

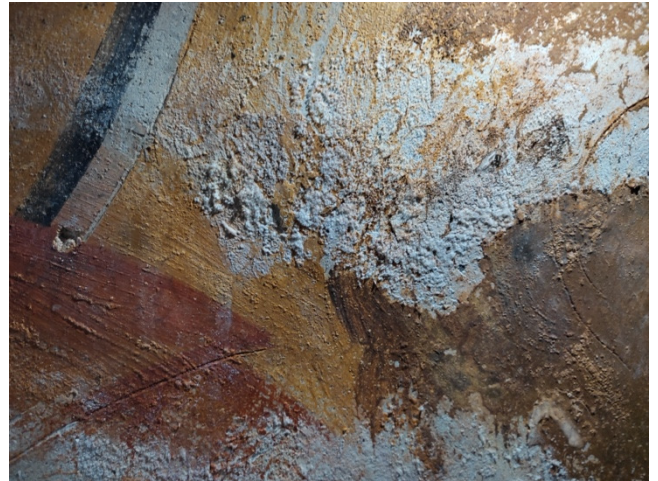
new saline efflorescence on the South wall

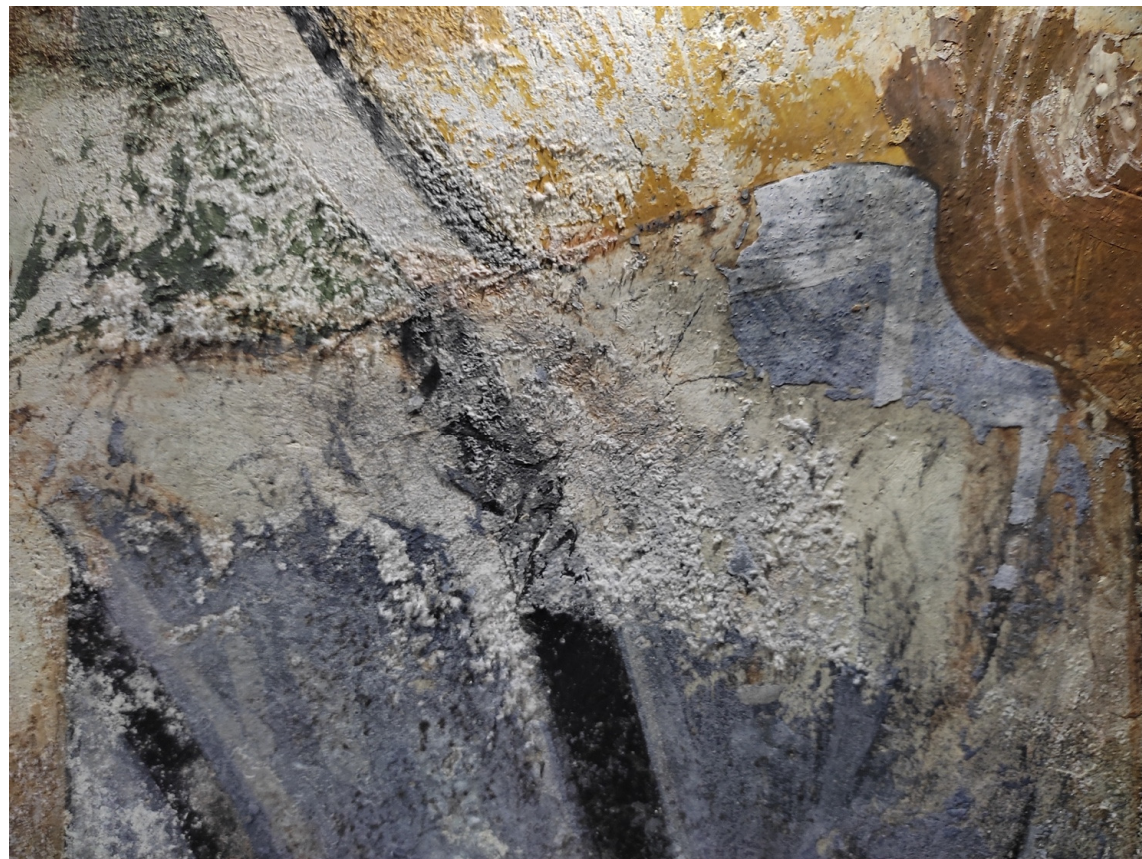
new saline efflorescence on the South wall

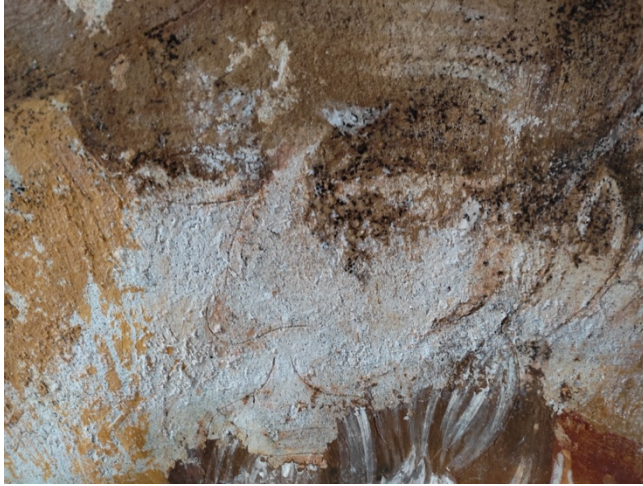
new saline efflorescence on the South wall

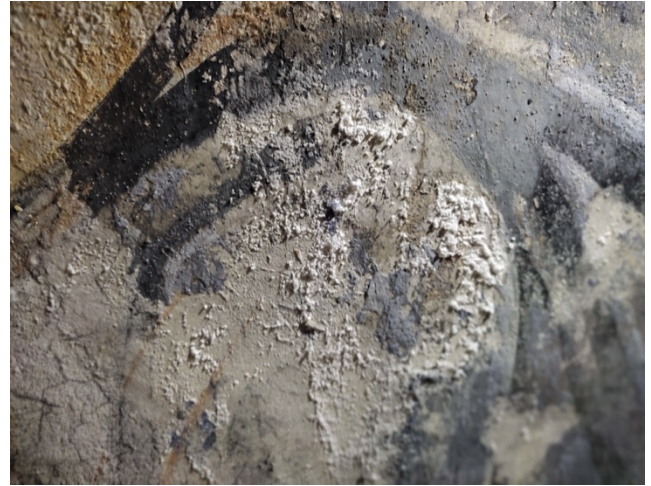
new saline efflorescence on the South wall

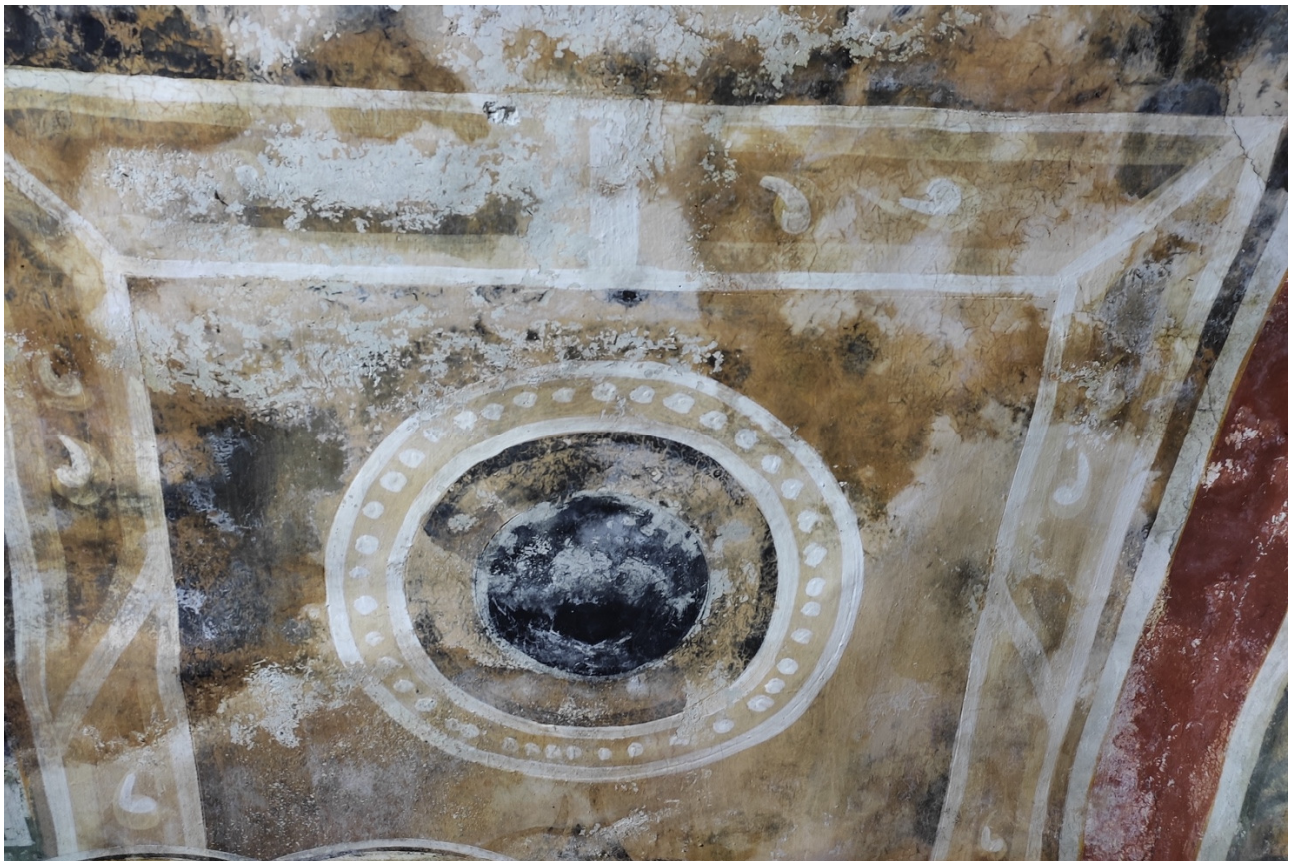
Compared to the possible mechanical dangers that were supposed to have repercussions on the paintings following the removal of the roof structures (which fortunately turned out to be unfounded due to the accuracy and attention with which the works were conducted and which represented the reason why constant monitoring of this delicate operation was foreseen as the main target of the mission), unfortunately it was found that the dangers were actually coming from the roof but not due to the mechanical vibrations of the opening processes of the pitches, but from the copious amount of water still present inside the walls caused by the meteoric infiltrations that occurred in the winter 2019 - 2020. In fact, the presence on the painted surface of numerous new saline efflorescences in different areas than those in which they had been recorded in the past. The portions of color that had been made to re-stick in previous missions were still in good condition. In addition, the painted surface showed much more water stains of humidity than in November 2021.

Water stains of humidity much more pronounced

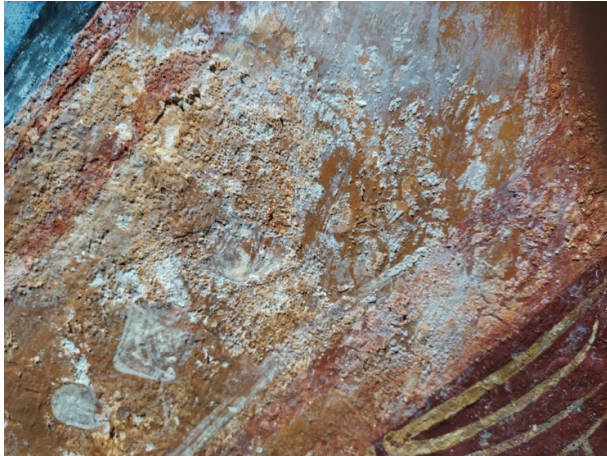
In light of this verification, the architect Massari then proceeded to monitor the hygrometric situation on the surface of the masonry of the entire vault of the West arm, comparing it with the data obtained from the previous monitoring, recording a significant increase in the quantity of water and soluble salts both in the wall support and on the painted surface. This phenomenon has caused the new crystallization of saline efflorescences, composed of both nitrates and sulphates (see report by the architect Alessandro Massari) with the consequent aggression of the pictorial film which is pulverized and raised in several new points.

color disintegration by attack of salt crystals

The intervention methodology therefore followed that of the previous missions, with the only difference that in the area surrounding the lower part of the central geometric partition of the South wall where the color support was swollen by the very high percentage of humidity and the latter instead stiffened and lifted up due to the consequent loss of adhesion, it was decided to proceed through the preliminary and accurate softening of the pictorial film by infiltrating with a syringe of denatured alcohol and subsequently with infiltration on the back of the pictorial film of acrylic emulsion Acril 33, made to penetrate through the microcracks and existing micro holes.

Then we proceeded to the usual system of applying the double Japanese paper tissue with distilled water on which a light pressure was then exerted with a pad to reactivate the adhesion of the color to its support.

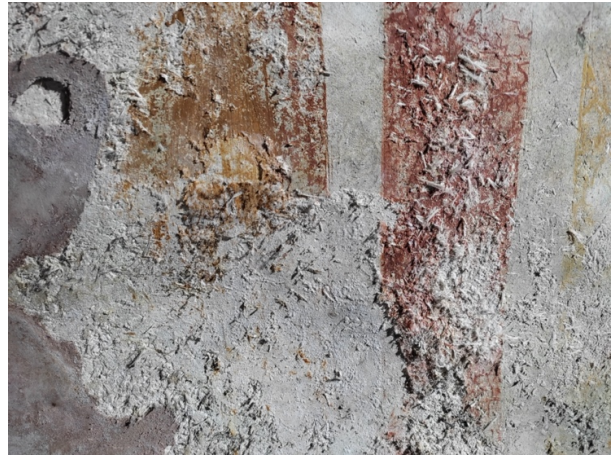
color disintegration by attack of salt crystals

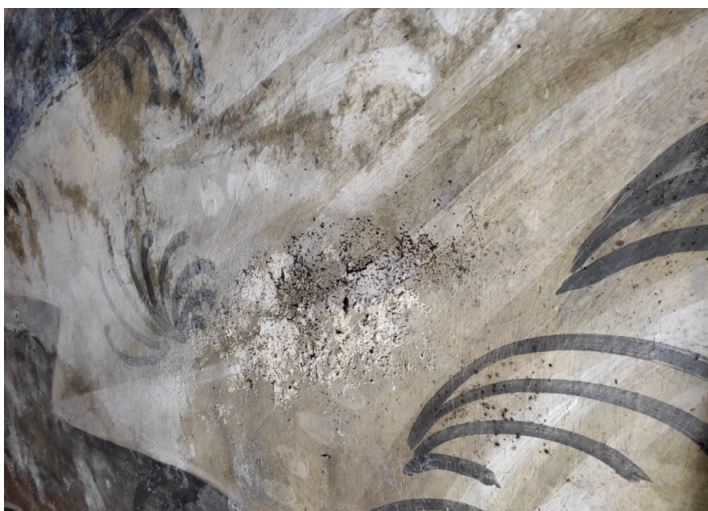
Therefore, alongside the monitoring operation on the interference that could arise from the disassembly operations of the roof structure, it was decided to proceed with an immediate safety intervention - on the basis of those carried out in the previous missions - of the portions of color that were been compromised by the new saline and microbiological attack, which in the meantime appeared very copiously on the scene of the Garden of Gethsemane.

microbiological attack on the west wall

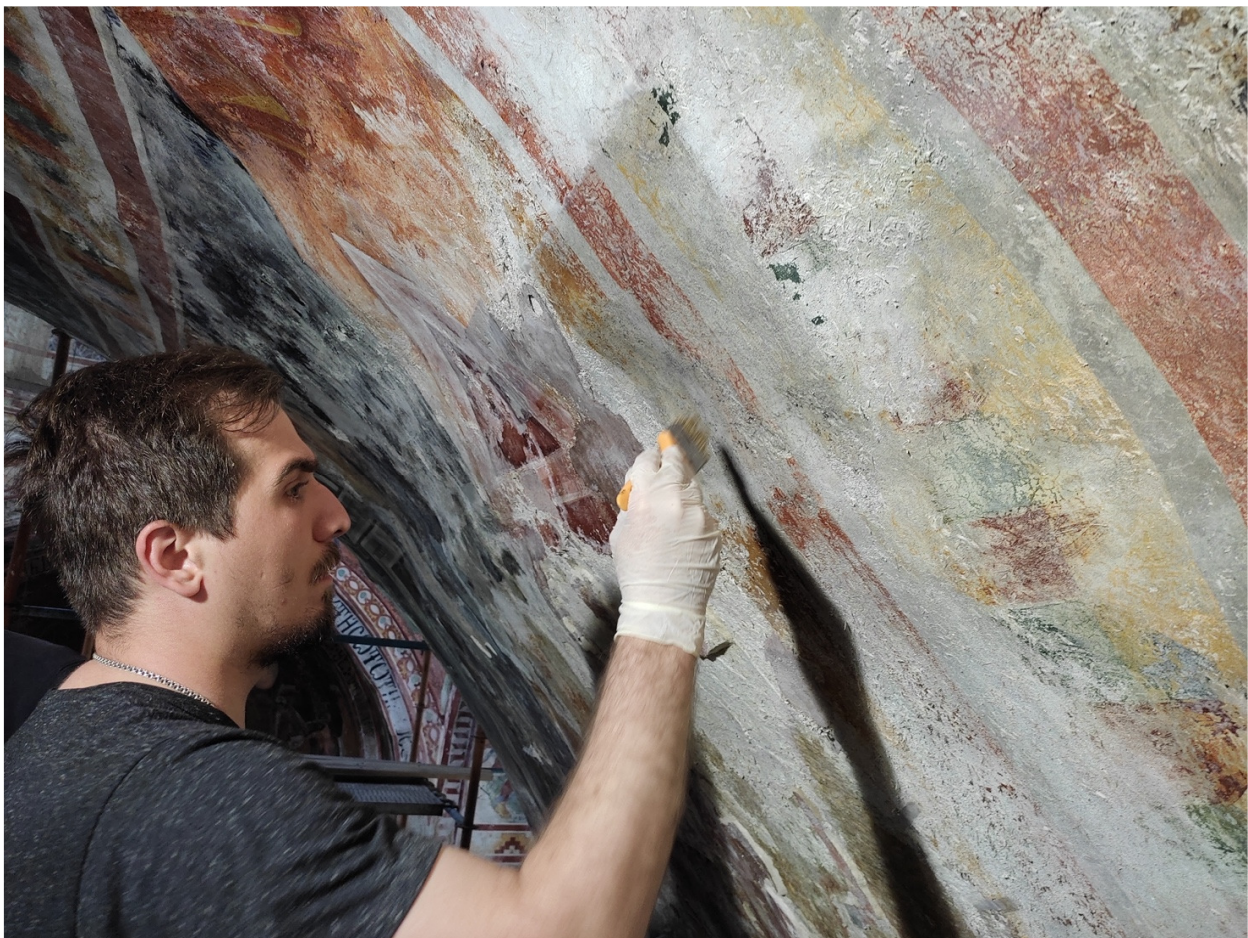
It was therefore decided to continue the intervention at the conclusion of the mission on June 3, 2022, identifying each point of the pictorial cycle that still presented critical issues on the state of conservation. It was therefore decided to continue the intervention at the conclusion of the mission on June 3, 2022, identifying each point of the pictorial cycle that still presented critical issues on the state of conservation. The continuation was commissioned to the Georgian conservative team who pledged to complete the color consolidation before restart the global restoration global expected around mid-July 2022.

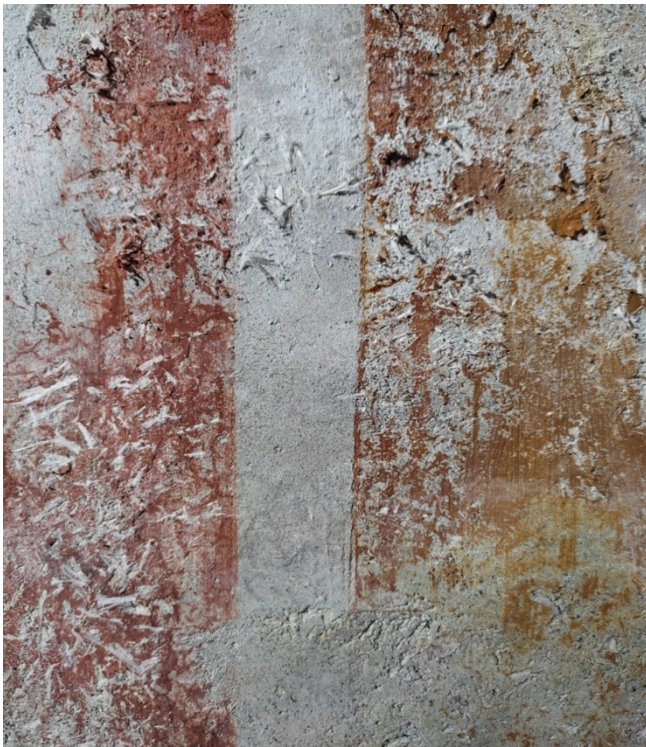
plaster consolidation test with ammonium oxalate

Following the recommendations contained in the latest report drawn up by ICOMOS with which the intervention methodologies carried out in the previous missions were approved, we also proceeded to deepen the experimentation of the consolidation of the original plaster by preparing some sample areas on which both ammonium oxalate and ammonium diphosphate are applied.

In these samples, diagnostic investigations will be carried out aimed at verifying the effectiveness of the deep penetration and the consolidating property of the two products, in order to establish which is more suitable for the treatment of highly uneven surfaces of the original plaster to be adopted in the subsequent intervention of conservation-restoration.

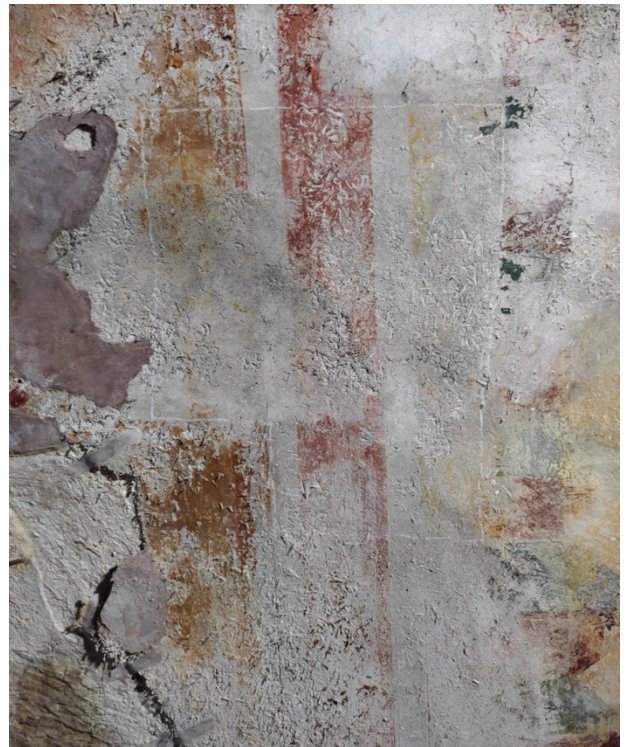
plaster consolidation test with ammonium oxalate

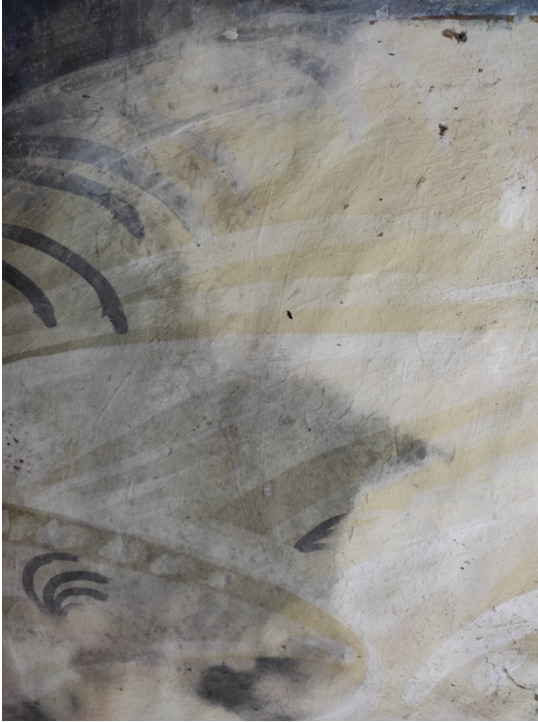
The study of the executive technique has however revealed the presence of extensive dry washes on the landscapes of the Christ scene in the Garden of Gethsemane, of which it will have to be taken into careful consideration in the cleaning phase of the pictorial surface which seems, at first glance, to have undergone a rather drastic cleaning operation which compromised the finishes of the hilly landscape that forms the background and some parts of the sky and in the lower part of the mantle of Christ on the right side of the scene.

Landscape of the hill before cleaning: note the clear transition between the dirty and the light area that already looks clean

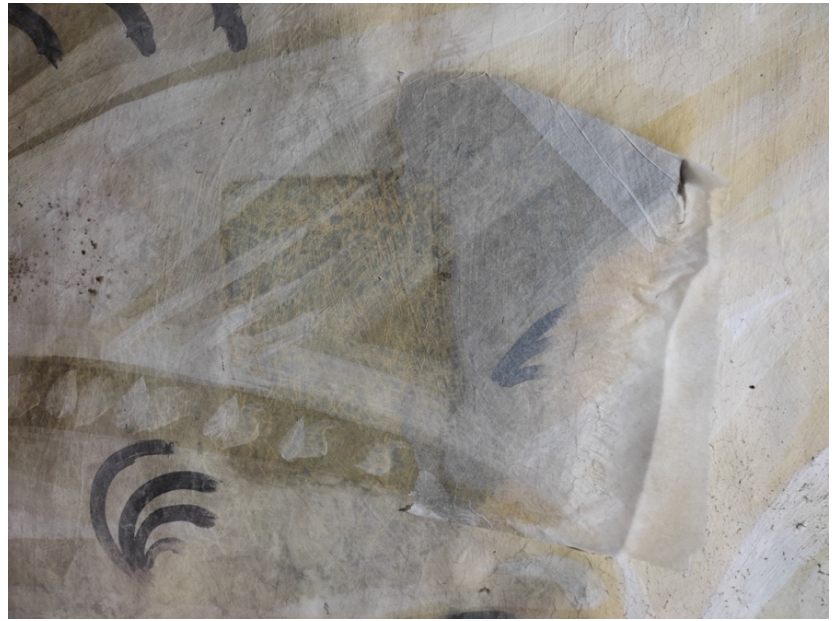
During the cleaning test

Two small cleaning samples of the pictorial film were carried out which confirmed the *mezzo fresco* technique. Both tests were carried out with a preliminary dry cleaning with soft Wishab and latex sponges.

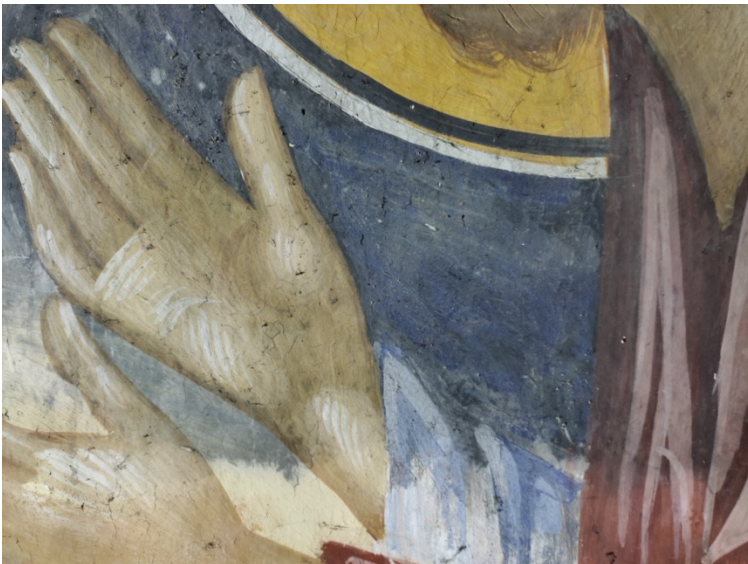
Before cleaning with distilled water

Subsequently, a final cleaning was carried out in one of the two samples with the use of distilled water only, with the addition of a weak surfactant with a biocidal action, applied to Japanese paper tissue and kept in contact for 20 minutes.

The cleaning was then finished after removing the Japanese paper with a rinsing performed with the soft latex sponges.

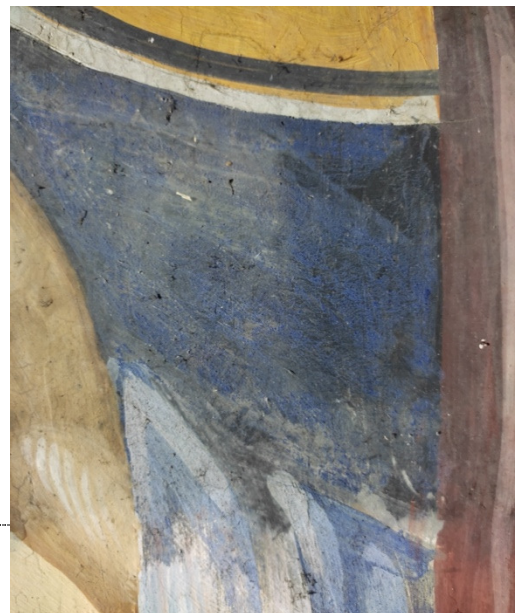
After the cleaning
