Safeguarding and conservation of Gelati Monastery World Heritage Property, Georgia

PHASE 2 - Analysis and development of the acquired documentation

Deliverable 2

**Findings of the analysis:
keynotes based on the results of the studies
conducted by RS and GET**

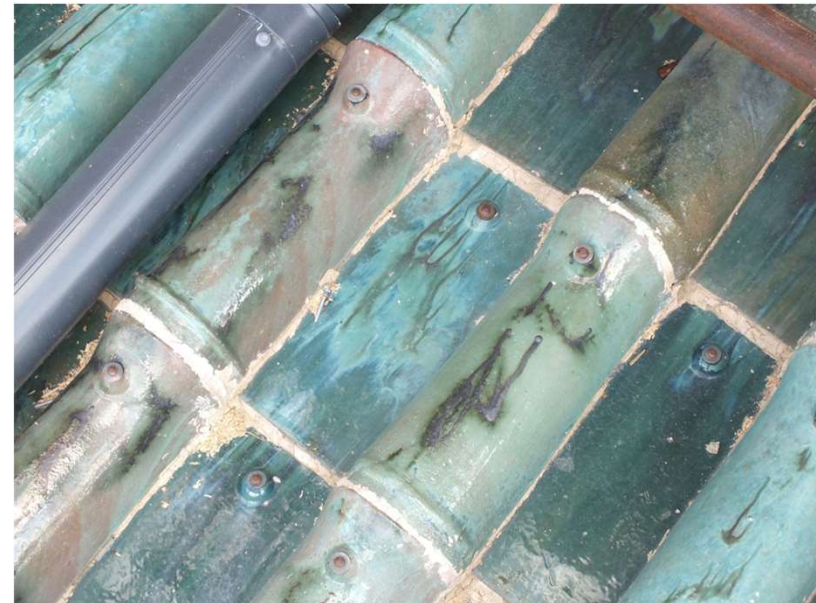
Glazed tiles (both white and red type)

The tests carried out at CNR-ISPC showed how the used tiles could not guarantee effective protection from water infiltration because of their composition and inadequate cooking.

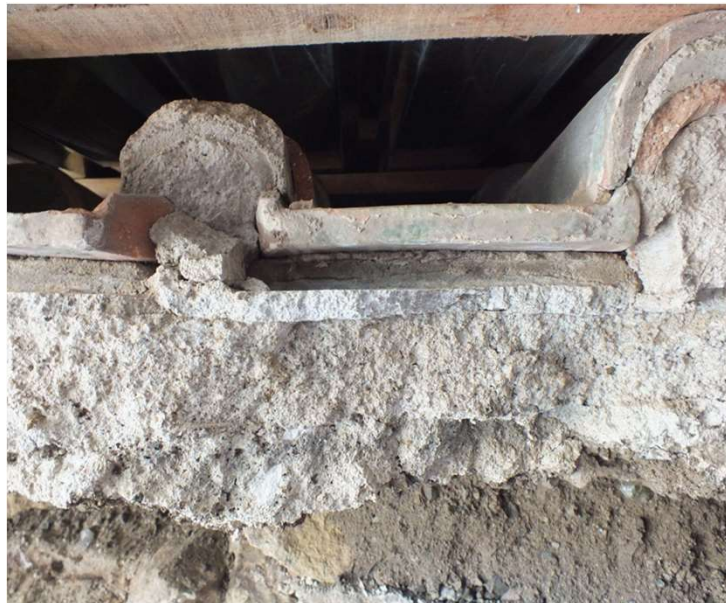
B1. Thick layer of porous lime mortar, capable of absorbing a lot of water.

Unable to allow the necessary small relative movements useful under thermic exposition. The ridges follow such a technique.

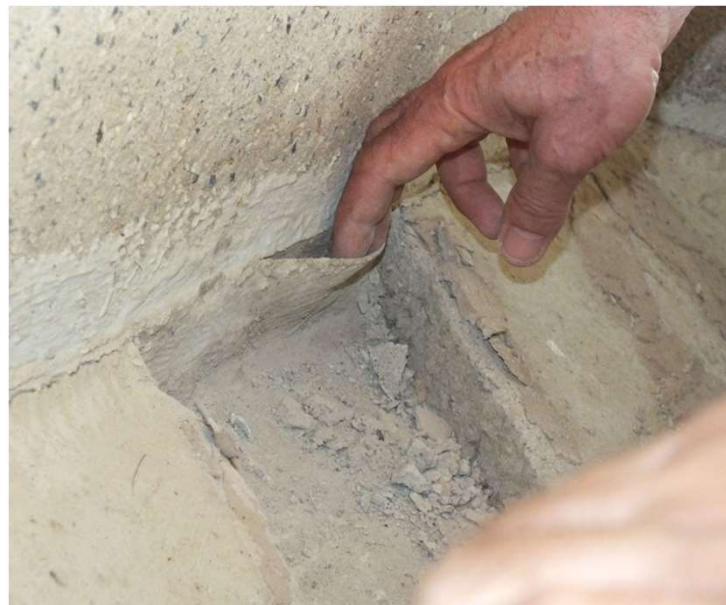
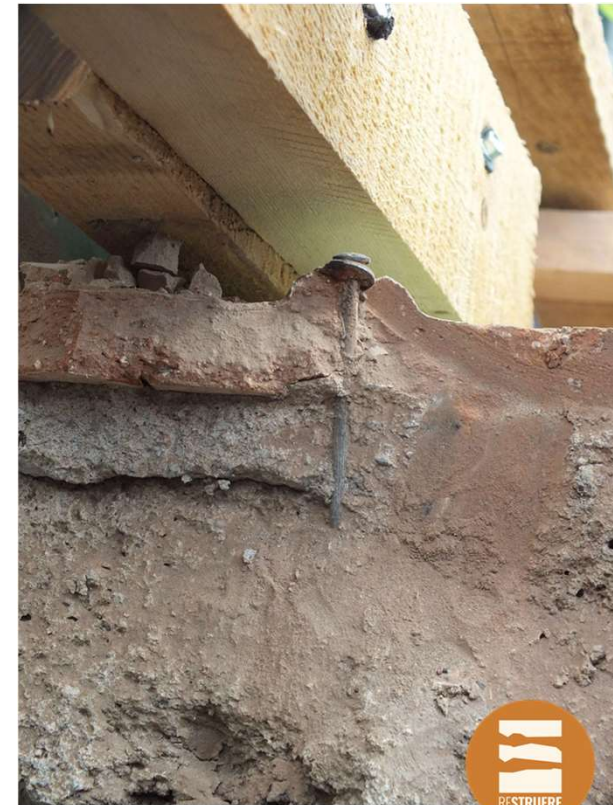
B2. In some pitches no insulation layer is installed. Even where some kind of insulation is present, both the material (quantity and thickness) and the installation are defective

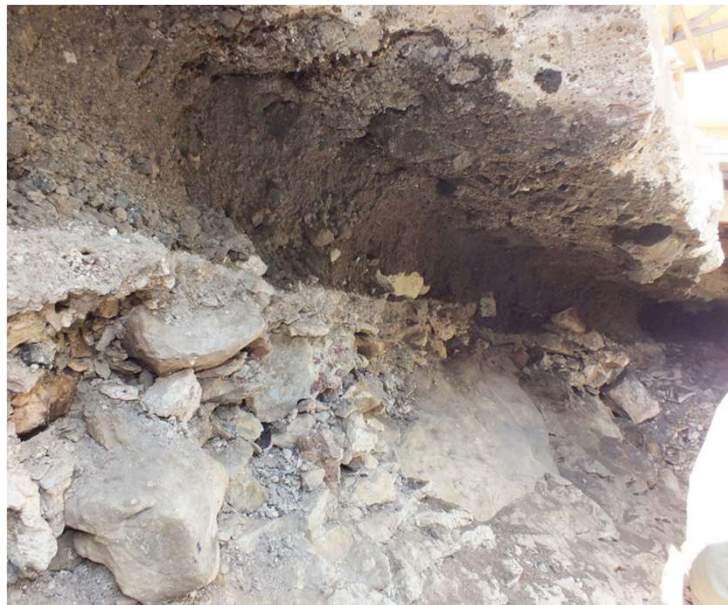
B3. The large quantity of the filling material of the under roofs, absorbing the water transferred from the tiles layer, constituted a reservoir of humidity.

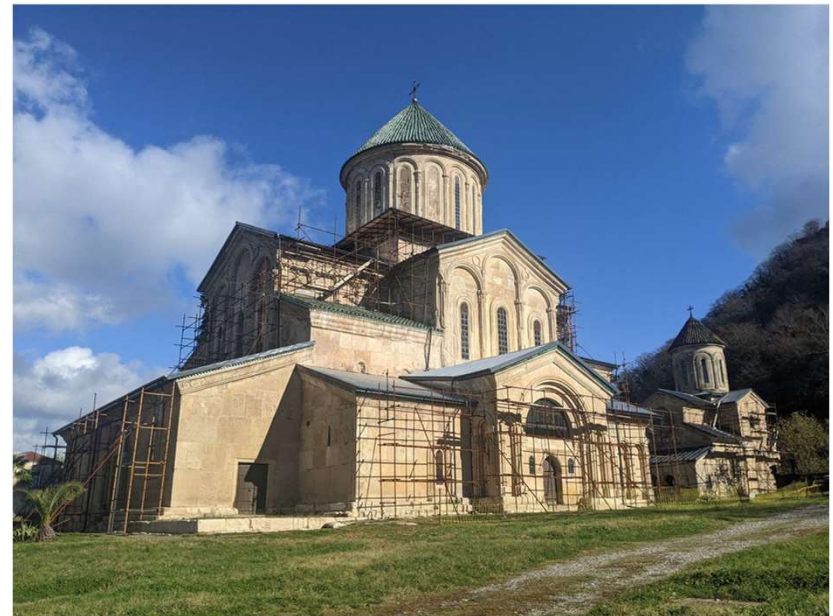
C3. Absence of devices useful for the collection and channelling of rainwater (gutter and downpipes)

This item includes the broader one of the transmission system of the rain from the roof to the ground and the subsequent removal from the foot of the building. Consequences of this deficiency concern the phenomenon of rising water by capillarity at the floor level too.

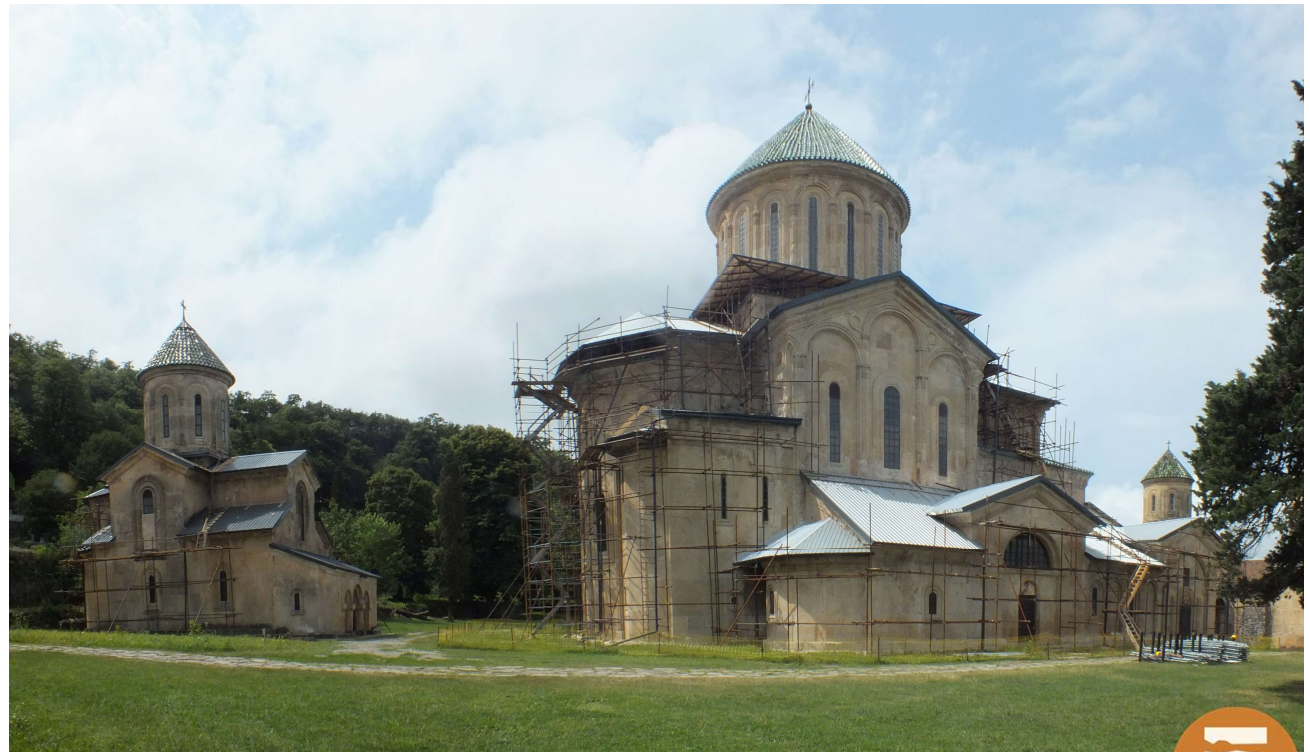
At present, the drainage system corresponds to the morphology of the land.

The choice to use only the grass covering as a drainage system dates back to the last interventions that interested the Monastery (2008-2019).

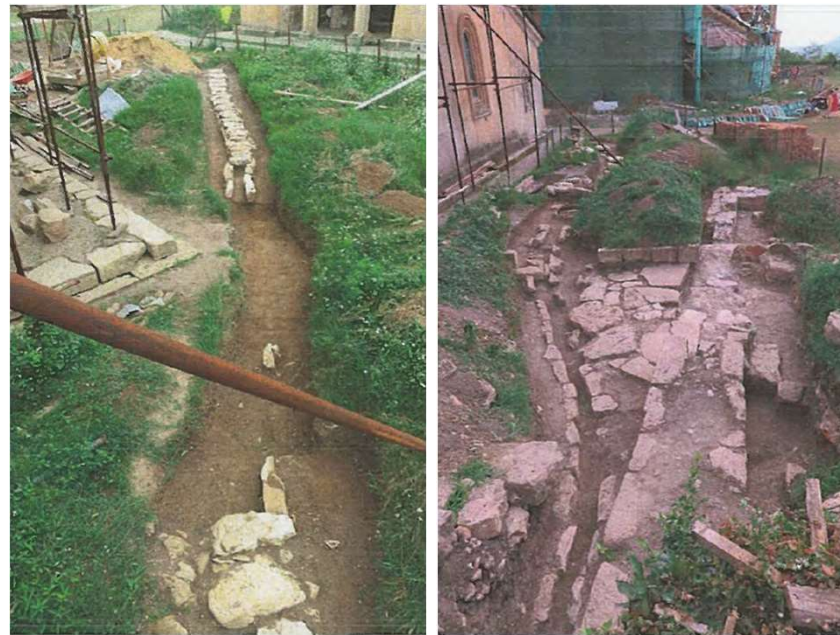
Photos from Photo Report on *Drainage Collector restoration-rehabilitation (2018-2019)* shared by GET

During archaeological excavations, ancient drainage channels have been found around the Churches of the Monastery.

The ancient water drainage system is out of order for a long time and, moreover, it is not visible as it is covered by the ground.

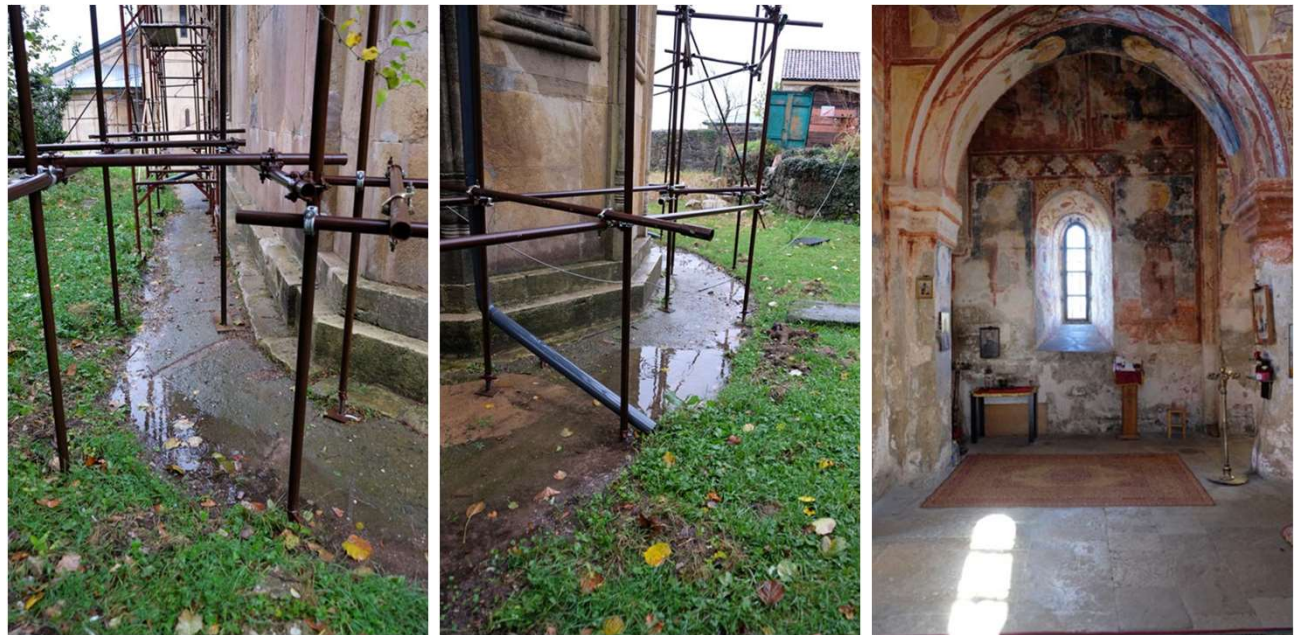
Church of St George - Preliminary investigations on the structural hygrometric - Missions Arch. Alessandro Massari of 06 – 12/11/2021 and 28/06 – 01/07/2022 – with Technical Sheets

In St. George there is not a sewage network outwards with sewer manholes and the water floods the pavements.

The serious situation on outside affects the internal conditions, where the walls exhibit moisture from the ground up to 1.5–2m with consequent damage to the paintings.

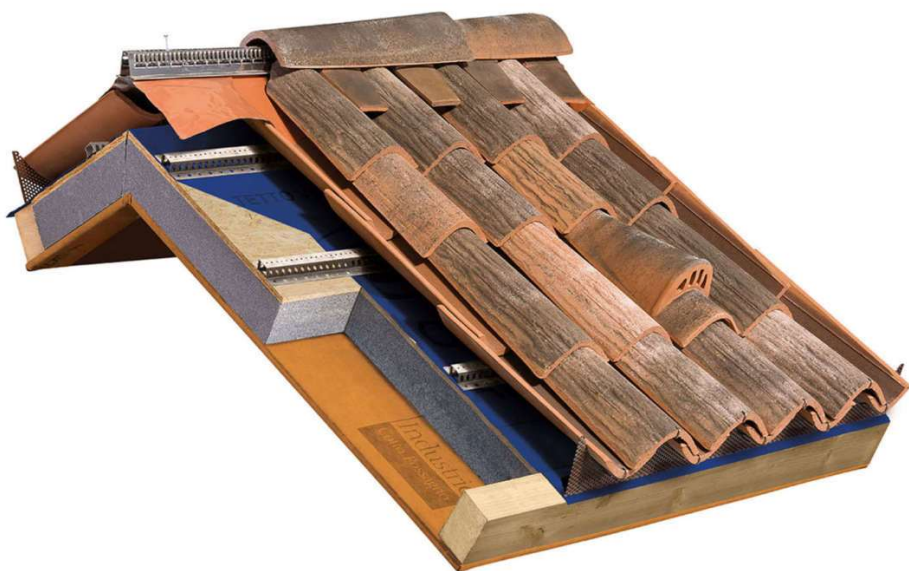
Example for the ventilation system 1.
In this case, the covering mantle is made of tiles
(from a technical publication).
