**REPORT ON THE STATE OF CONSERVATION OF THE GELATI  
MONASTERY WORLD HERITAGE PROPERTY, GEORGIA**

Mission from 15 July to 23 September 2022

Conservation specialists of wall paintings  
*Mario Pulieri (Italy)* –TECNI.CO.R. s.n.c.

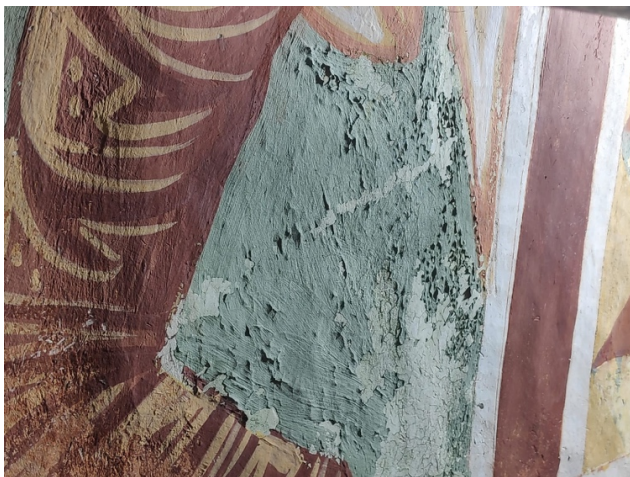
*Rising of color - North Wall - scene "The Kiss of Judas"  
Before consolidation*

to integrate the methodology implemented in the previous missions which consisted in the application of the acrylic emulsion Acril 33 at 3% in water, we proceeded to consolidate the pictorial film, where it was not very thick and about to fall, with the brush application of a solution of 5% polyvinyl alcohol in water through Japanese tissue paper.

The decision to use a product with different characteristics for the consolidation of the pictorial film derives from the fact that the emergency phase of the previous missions was considered concluded in which the state of conservation of the color was characterized by pronounced and widespread detaching about to fall, which required the use of an acrylic consolidating product with strong and immediate adhesive properties and stable in the presence of soluble salts.

In this second phase, for the consolidation of the color which was instead affected by decohesion and pulverization or by minor lifting, it was decided to proceed with the use of polyvinyl alcohol which, compared to the acrylic resin, has the character of complete reversibility and has a lower risk of creating films on the surface having an excellent water vapor permeability coefficient.

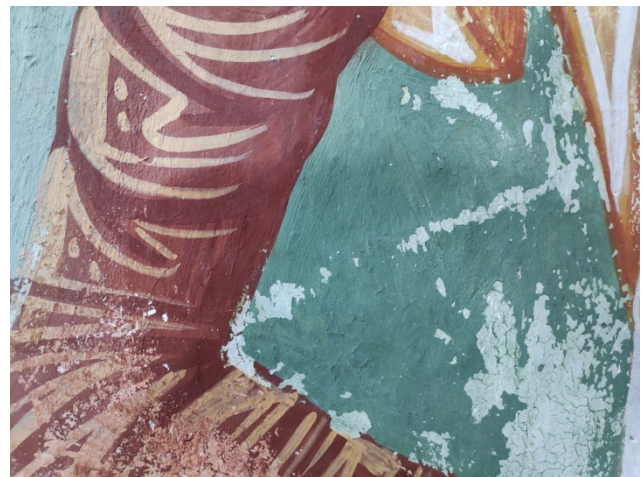
*After the consolidation*

The results obtained were very satisfactory.

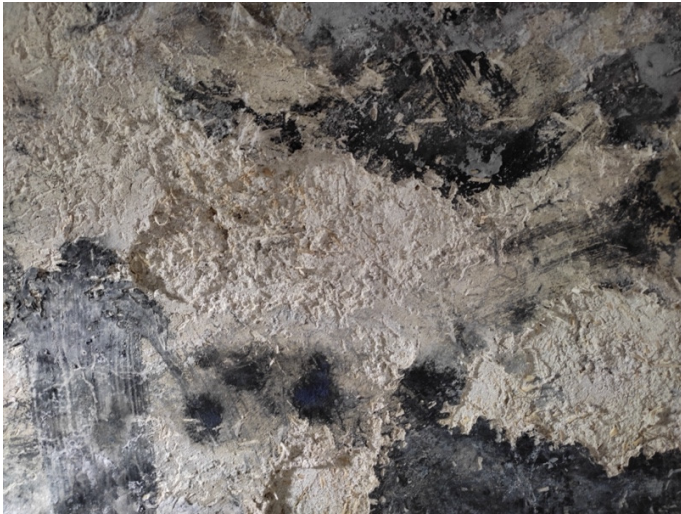
*Disintegrated plaster (intonachino) consolidation*

On the scene of the "Washing of the feet" on the South wall and on the vault, consolidation tests were also carried out on the very de-cohesived and disintegrated fine plaster (*intonachino*) and in many cases completely pulverized, with the application of both Ammonium Oxalate and Ammonium Diphosphate, alternative products to consolidants based on acrylic resins normally used in these cases of bad conservation state.

In light of this, we proceeded to systematically consolidate all the portions of *intonachino* which were highly disintegrated and unsafe, applying the Ammonium Oxalate with an abundant impregnation (*impregnazione a rifiuto*) which, compared to the Diphosphate, has a greater superficial reagggregating power.

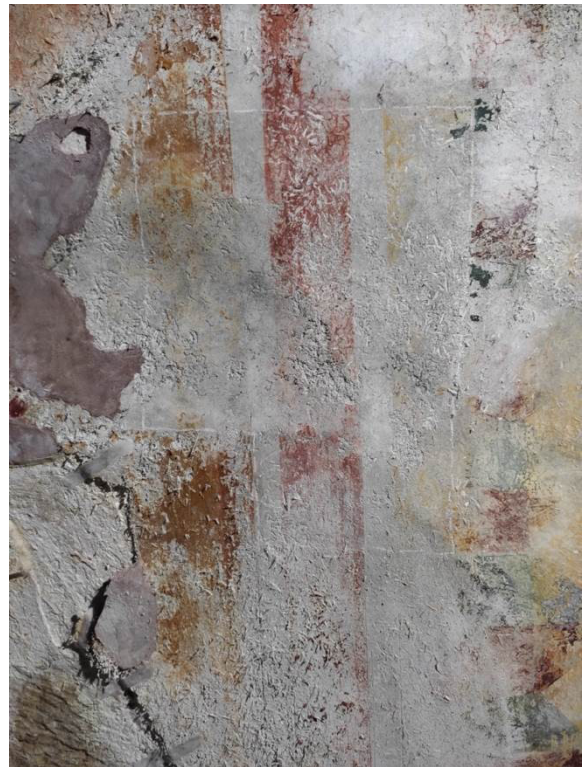
*Consolidation plaster (intonachino) with Ammonium Oxalate*

The consolidation obtained with this methodology went well beyond expectations and thus responded to the encouragement received from ICOMOS in the report dated February 2022 regarding the intent to experiment with these methodologies, alternative to the resin.

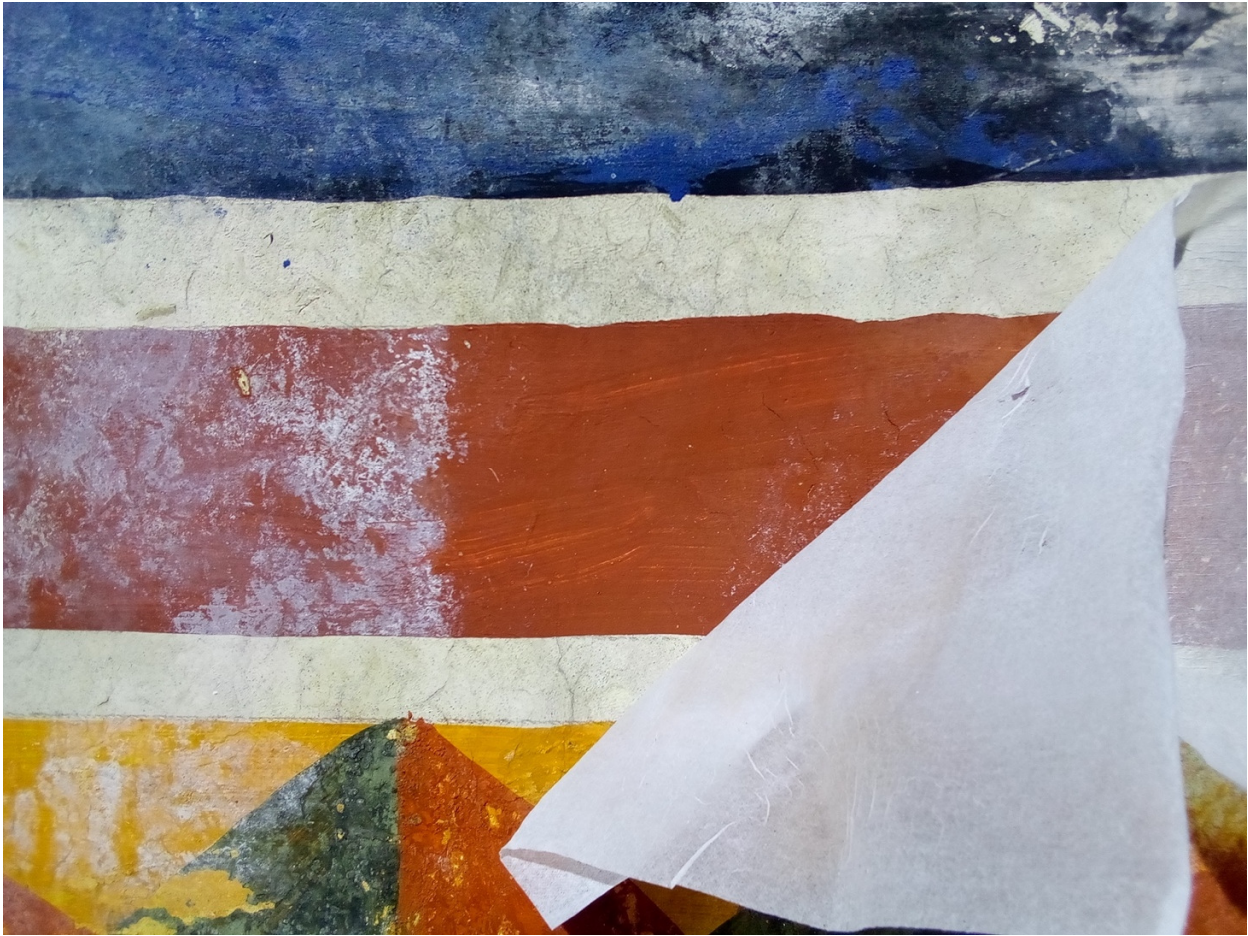
*North wall - Carbonation cleaning*

The pictorial surface of the North wall, even if not affected by thick layers of generalized dirt or altered fixatives, nevertheless had a fair layer of incoherent deposits which were removed with soft flat brushes and soft rubber sponges such as Wishab or latex. However, there were also numerous carbonations created by deposits of extremely tenacious carbonate salts which gave the pictorial film a milky-white appearance in many points; these carbonations were removed with poultice of cellulose pulp - often repeated - applied with a double layer of Japanese paper, soaked in a solution of ammonium salts with a very slight percentage of EDTA (2% disodium salt) and kept in contact for about 15 minutes which disrupted the compactness of the carbonates, subsequently allowing to finish the cleaning with the mechanical scalpel removal of the residues.

Once the poultice was removed, the surface was then rinsed with deionized water. It should be noted that large areas of the vault are affected by heavy repainting of the background blue, dating back to unspecified old restoration interventions which, however, it was decided to keep them totally because their removal, would have highlighted the abraded plaster in which the color it was lost with the consequence of creating a chromatic imbalance which should have been remedied with a new chromatic compensation very similar to the one already present.

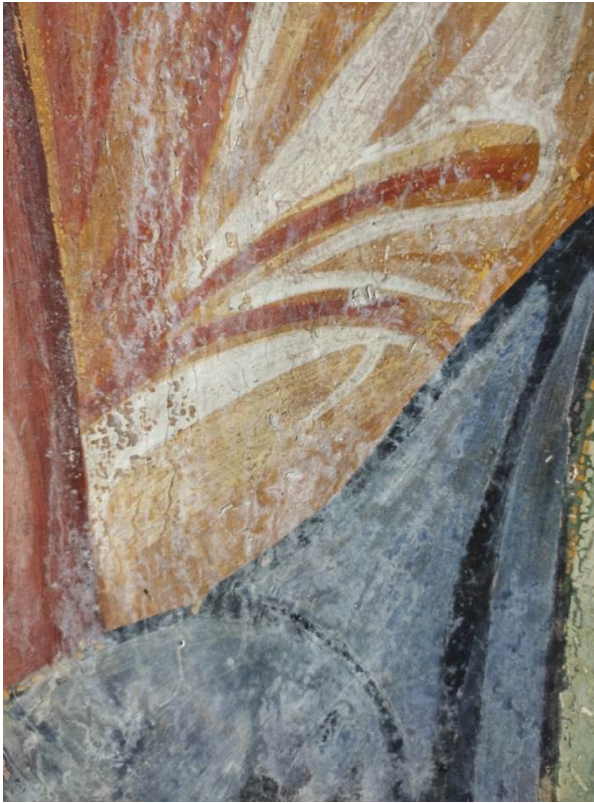
While monitoring the state of conservation of the pictorial film on the scene of the "Kiss of Judas", a uniform coat was found on the entire surface of a glossy film which seemed to find a similar response both in the scene of "Jesus in the presence of Caiaphas" and on the opposite wall, the southern one, within the scene of the "Wedding at Cana".

The results of the analyzes carried out for its determination indicate the presence of calcium and magnesium oxalates in the surface layer which could be the result of the lime paint execution technique performed with the addition of organic binders such as lipids which have mineralized over time altered transforming itself into the transparent and satin film that covers the entire pictorial surface.

*North Face - Carbonation cleaning - Before the intervention*

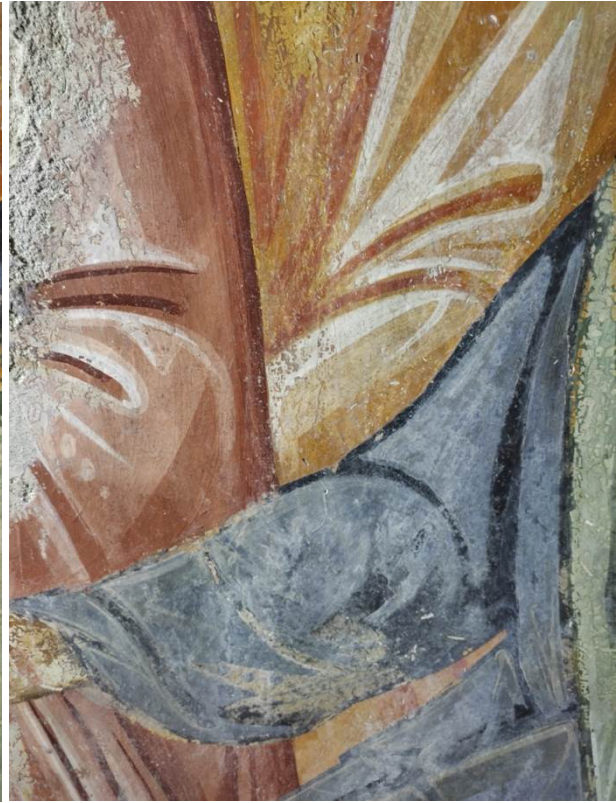
*North Face - Carbonation cleaning - After the intervention*

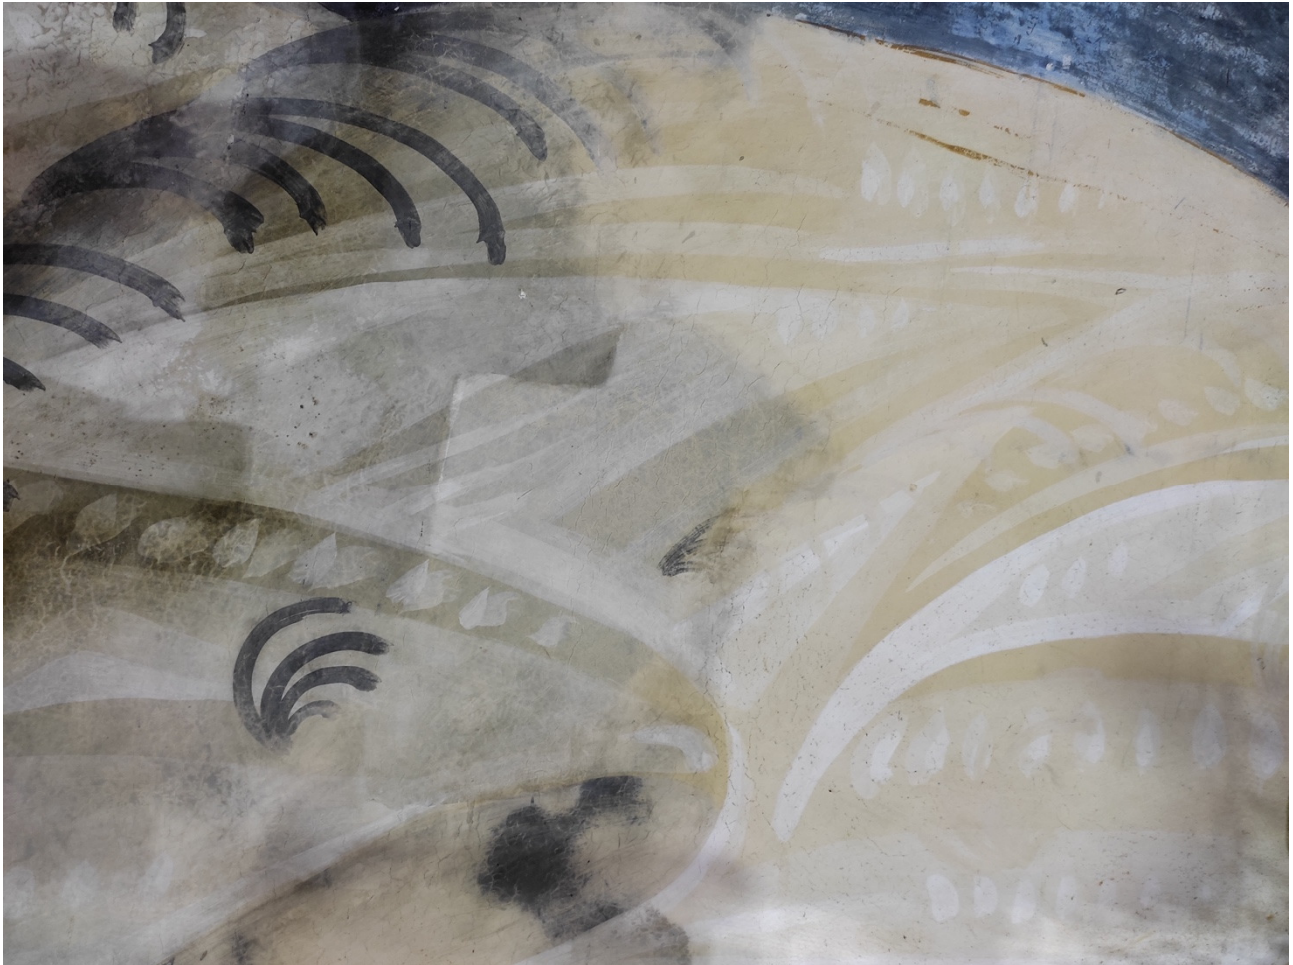
Some signs of cleaning of the layer of superficial carbonaceous deposit of the scene have been identified, during which, however, the layer of color immediately below was also completely removed, corresponding to a greyish glaze, very probably original (see analysis), which was present on the whole pattern of the hilly background is still clearly visible in the extreme right and left parts of the scene which, for reasons not yet highlighted, were not then affected by the cleaning operation.

This pattern (*campitura*), underlying the lampblack (*nerofumo*) layer, appear in its original tonality, in the small cleaning test performed during this mission, which highlighted how it was completely removed in most of the central area of the scene.

*West wall - cleaning sample - recovery of the original greenish-grey dry finishing which is totally missing in the central part of the scene*

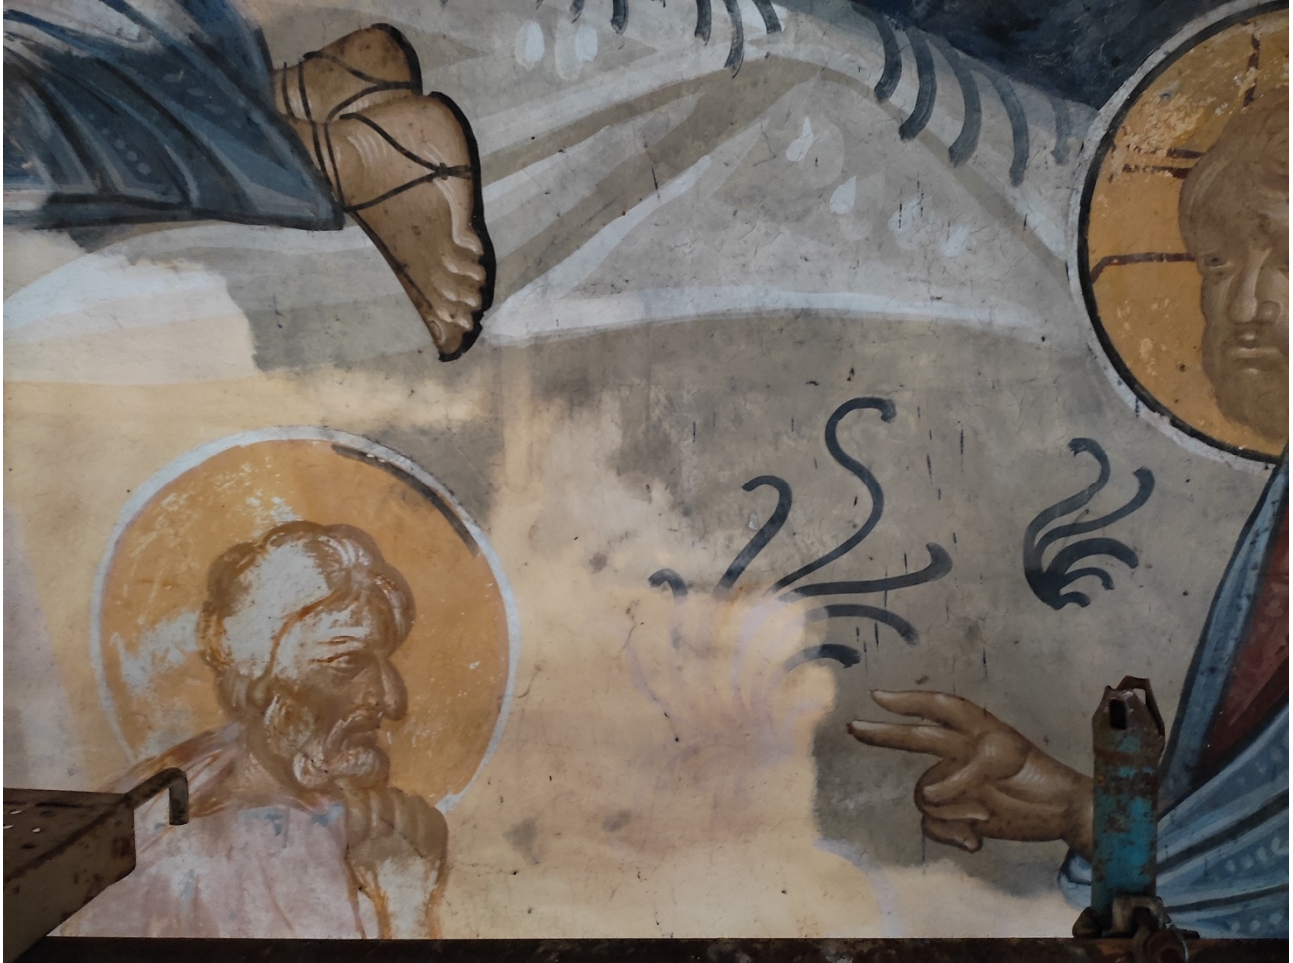
This old intervention has also completely removed the dry finishing of the black decorative plant elements of which only the pattern base remains.

In the light of these observations it would seem that this restoration intervention has generally altered the original vision of the scene.

*West wall - detail of the cleaning carried out in a previous restoration which removed the dry finishing of the blades of grass*

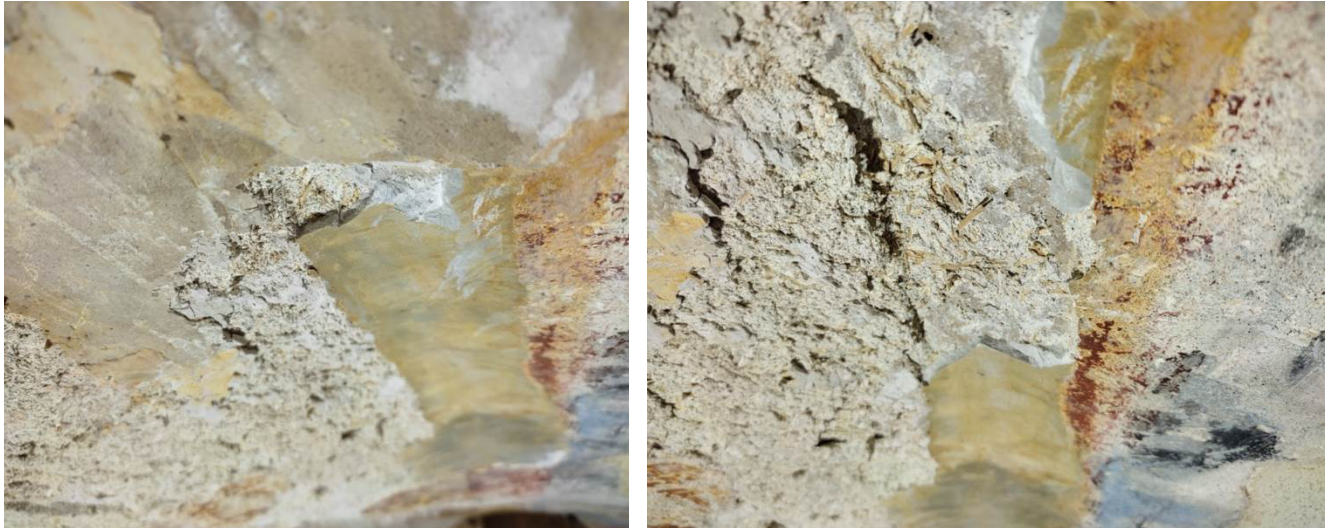
It should be pointed out that some very extensive stucco filling resulted to be composed of gypsum (*gesso*), especially some of those carried out for the chromatic restoration of the cross in the center of the vault, which is notoriously an absolutely unsuitable and inadvisable material

to be used in the presence of environments with high humidity due to its characteristic hygroscopicity which in these conditions involves a strong increase in the volume of the sulphate salts that compose it, with consequent pressure and lifting of the color.

*Removing the old stucco fillings around the vault cross*

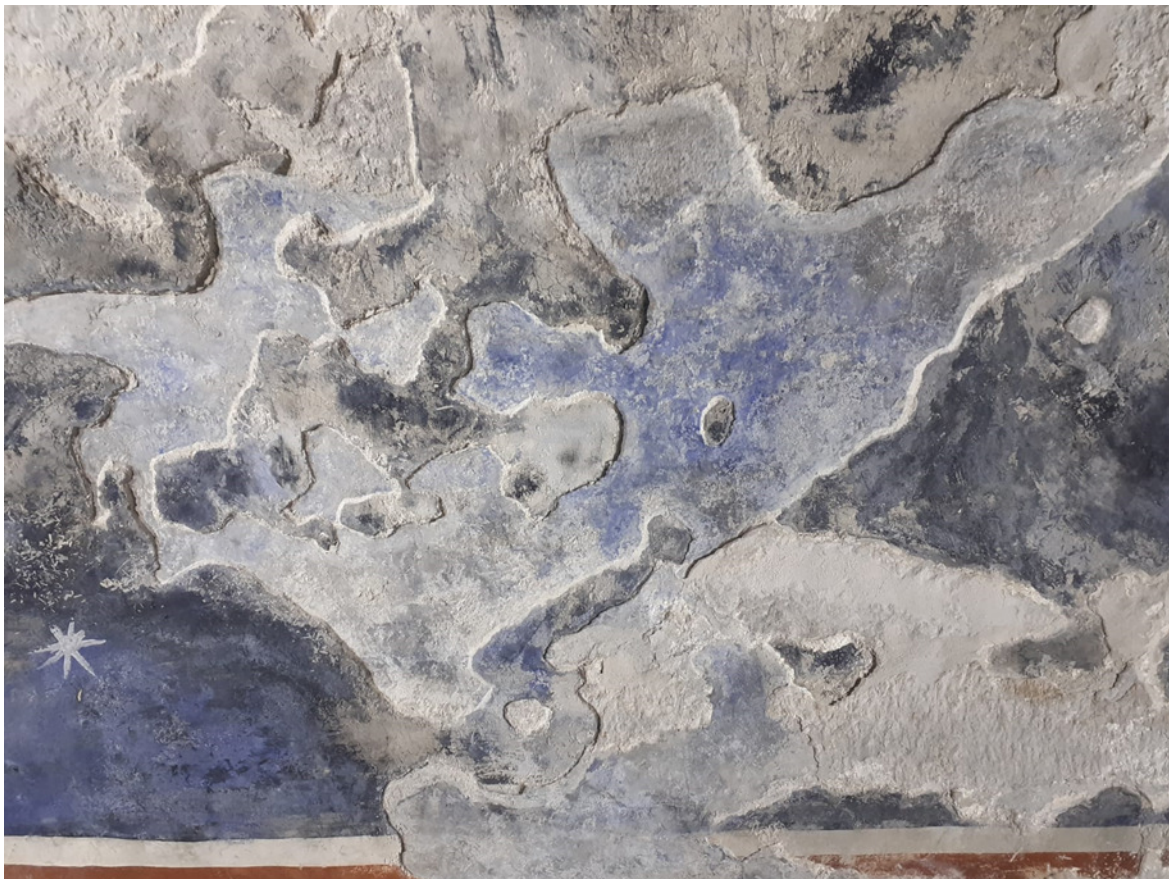
Without considering that they did not have a chromatic intonation compatible with the adjacent original colour. Numerous old stuccos were also removed which, in addition to being no longer suitable, they completely concealed various fragments of the ancient first coat of the fresco below the level of the seventeenth-century paintings visible very clearly in the scene of "Jesus in the presence of Caiaphas" and also in the area of the apex of the vault. In the latter, various areas of the ancient blue color were thus recovered.

*Removal of old grouting and cleaning of the underlying fresco layer*

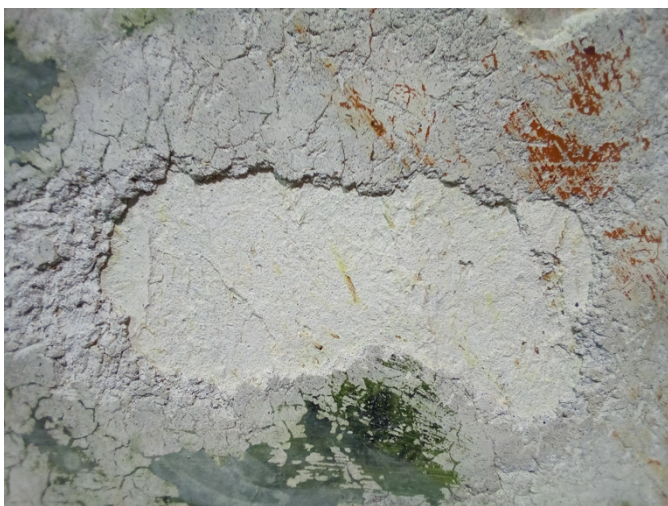
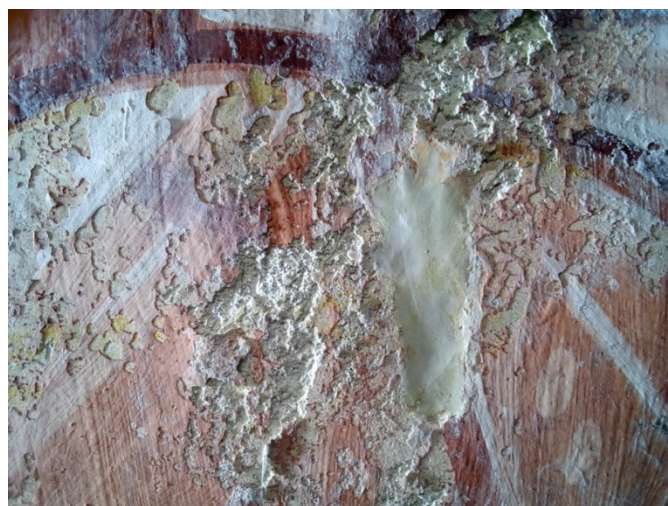
The loss (*lacune*) in the *intonachino* that keep the original rough-casting plaster (*arriccio*) undercut (*sottosquadro*), which in many cases is in perfect condition and represent a precious testimony of the preparatory executive technique, have been left in view and it is considered appropriate for this reason not to compensate for them with a new stucco filling.

*Rough-casting plaster (arriccio) in good state of conservation left in view* *Old unsuitable gypsum stucco filling (stuccature)*

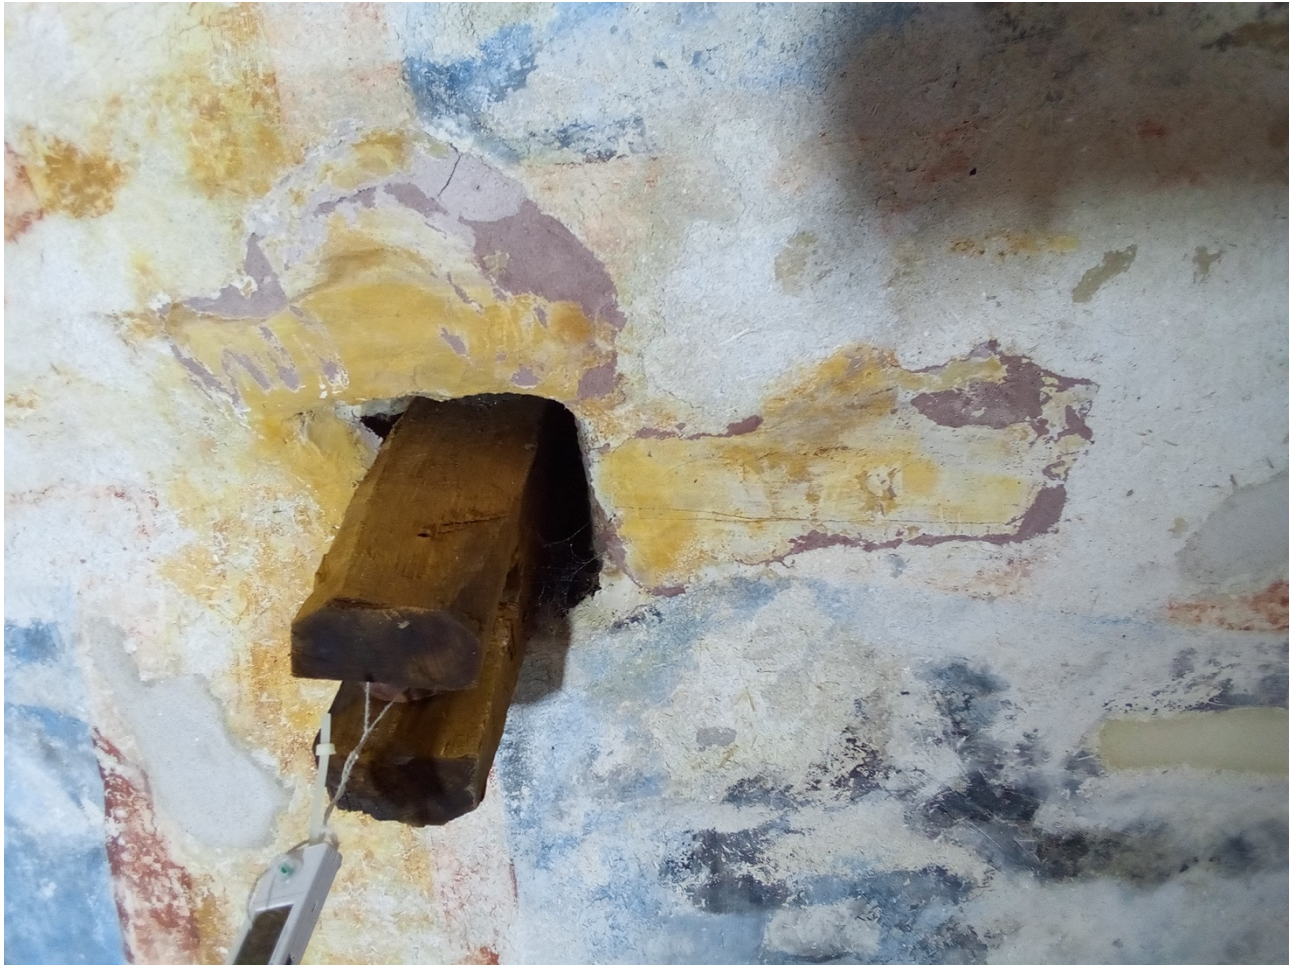
Both on either the two scenes of the North wall that on a vast surface of the vault a considerable quantity of old stucco fillings filled with colors have been recorded, with a blue-blackish tone in the case of the vault or reddish in imitation of a pozzolanic surface in the case of the scenes, completely out of tone toward the adjacent original colors.

Furthermore, the adhesion of the stucco filling to the edges of the pictorial surface appeared very precarious and, in many cases, completely non-existent. The edges of these gaps had been filled in the past with temporary mortars which were often applied in an unsuitable way and above all overlapping the original color and therefore were removed.

*Old unsuitable stucco fillings (stuccature) near the cross*

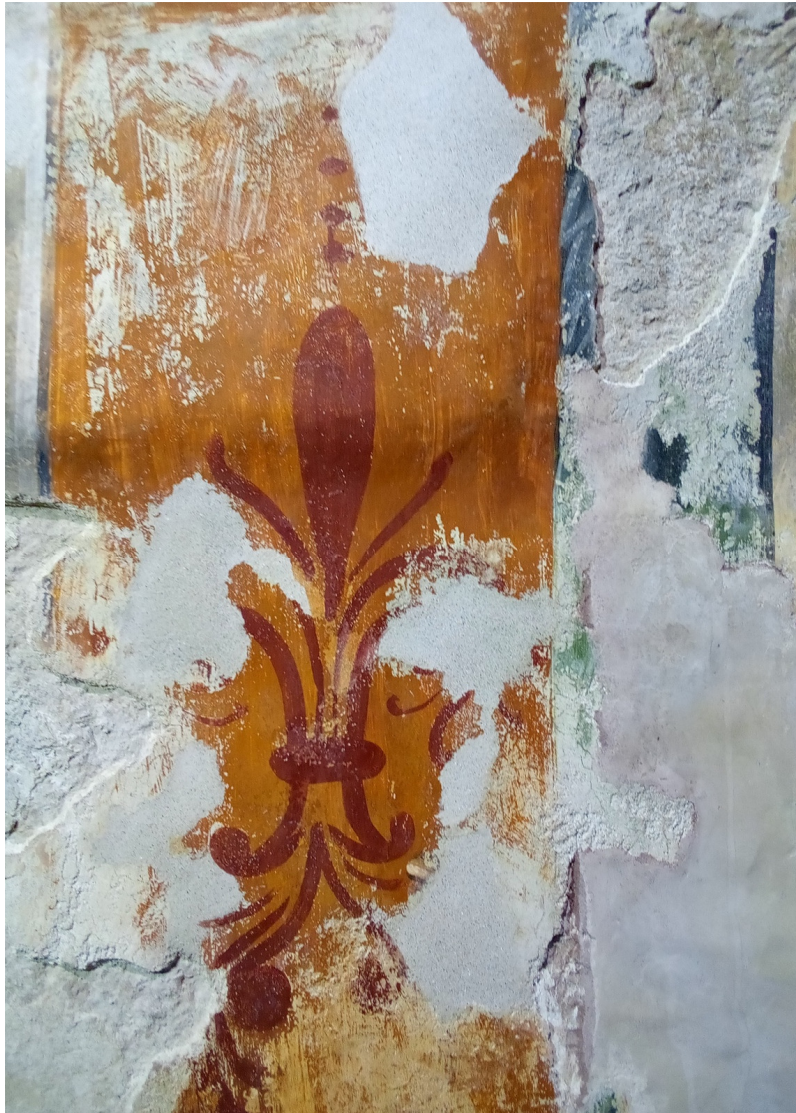
*North wall - new stucco filling (stuccature) grouting with lime paste (grassello di calce) mortar and river sand*

We began to treat the loss in the plaster that resulted from the removal of the old stucco fillings, especially in the central area of the vault, following an aesthetic principle different from that used in the past.

It was considered appropriate not to compensate (*risarcire*) all of them entirely with a new mortar more suitable than the previous ones, composed of a mixture of lime paste (*grassello di calce*) and local river sand in the ratio 1:3, but to restrict to treating exclusively those which, due to their size or location, created a visual interference with the homogeneity of the pattern of the ceiling of the vault, thus leaving all the rest visible, compensated undercut (*sottosquadro*) with a neutral colored mortar.
