**Safeguarding and conservation of Gelati Monastery  
World Heritage Property, Georgia**

**EMERGENCY PHASE E.1**

**West Arm Emergency Uncovering: supervision of the implementation**

**Executive summary of activities and report of the phase E.1.1**

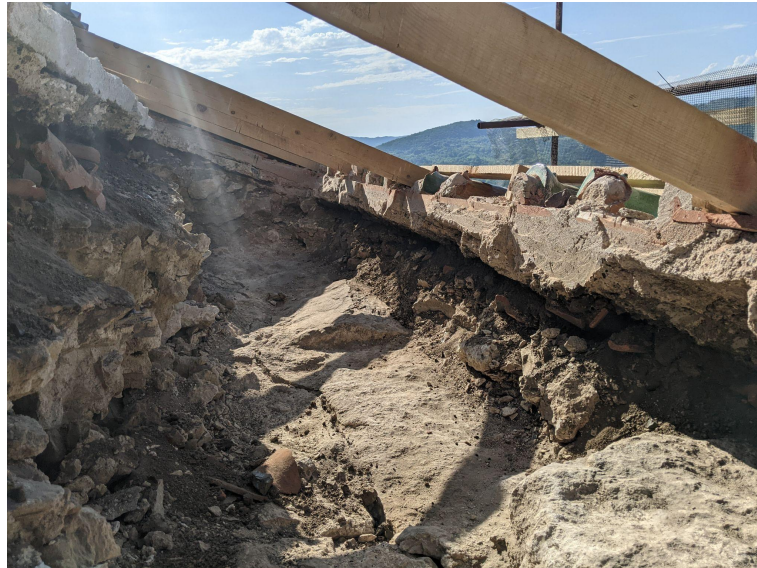
During the activities of removing the roofing layers, two longitudinal cracks were observed on the top of the Southern and Northern walls of WA. The cracks are likely due to an earthquake that occurred in ancient times. This discovery obliged the involved teams to delay the work schedule to face the unforeseen situation modifying the planned activities for the temporary covering. Moreover, the cracks highlighted the necessity to open a new research and investigation path regarding the structural consolidation of the Arms.

Figure 1. Northern wall of West Arm, clean view of the opening. The longitudinal crack is visible.

During the RS mission, it was decided to stitch the cracks before continuing the operation of removal of the roofing layer in order to consolidate the top of the walls. The walls were drilled using a non-vibrating, electric drill (150-200mm deep) and anchors were placed perpendicular to the cracks, every 500-600mm, at a distance of 250-300mm from the cracks. An anchoring solution was used to

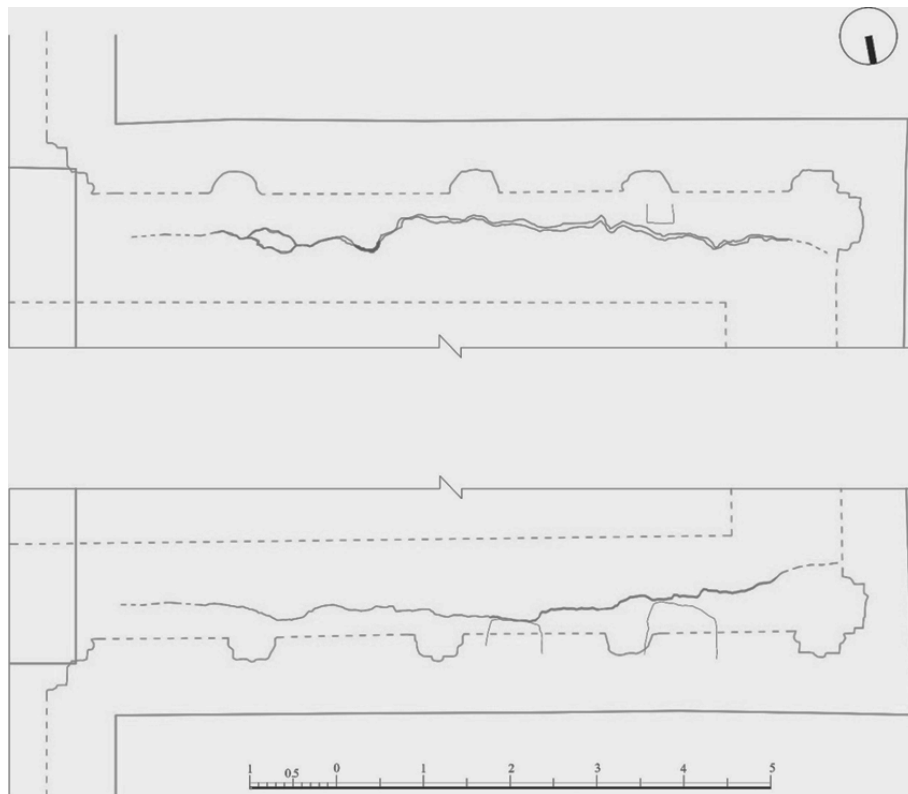
Figure 2. Plan of the course of the longitudinal cracks of the South (top) and North (bottom) wall, (drawing by Architect Lasha Shartava)

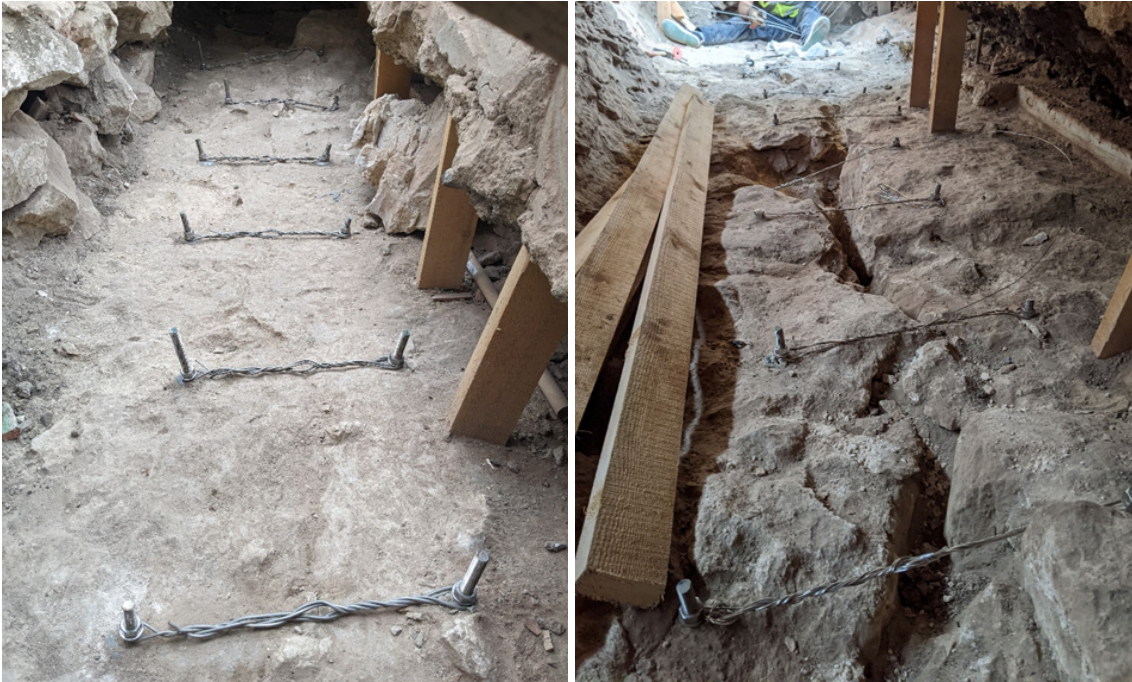
Figure 3. The stitching of the longitudinal cracks on the Northern (left) and Southern (right) walls (photos by Architect Lasha Shartava).

fasten the stainless steel rods. After that, the metal rods were connected with stainless steel wires (diameter 3mm).

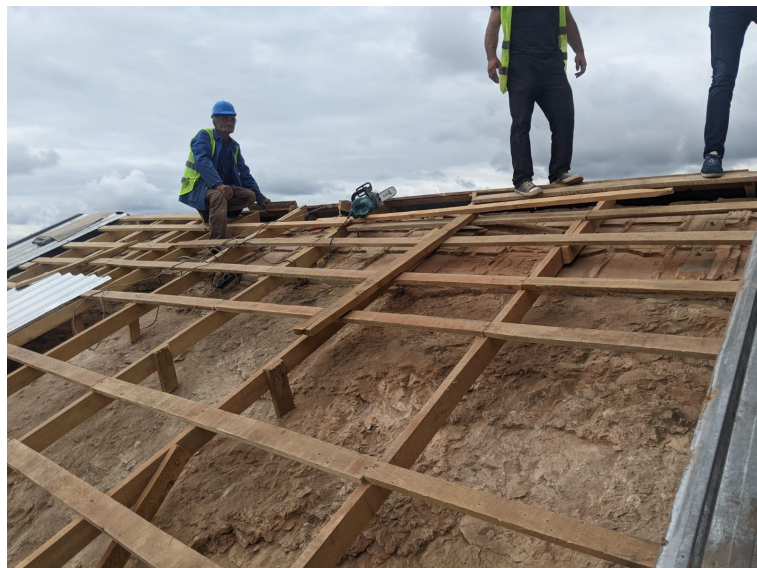
After securing the top of the walls with the stitching, the removal of a great part of the covering continued. 65% of the total West Arm's roof area has been removed.

Figure 4. The WA pitch after the removal of the external layers of the roof, and before covering it back with the tin temporary cover (photo by Architect Lasha Shartava).

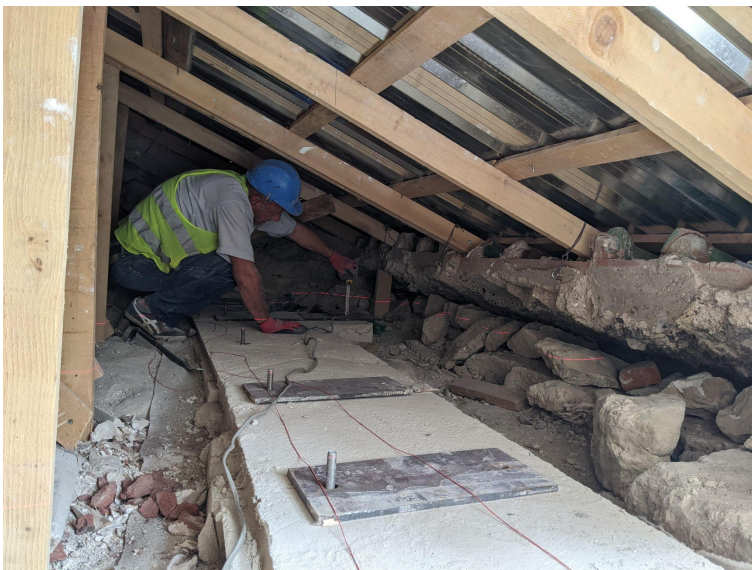
Figure 5. The lime levelling layer for the anchoring and operations to install the anchors of the temporary cover (photo by Architect Lasha Shartava).

The anchoring of the temporary roof was particularly accurate as the roof would be anchored to the top part of the walls of an ancient building. Particular attention was paid to the compatibility of materials and the reversibility of the intervention. A structural lime mortar (MasterEmaco S 285 TIX) was used to level the surface of the anchoring. The lime layer was poured over a geotextile layer.

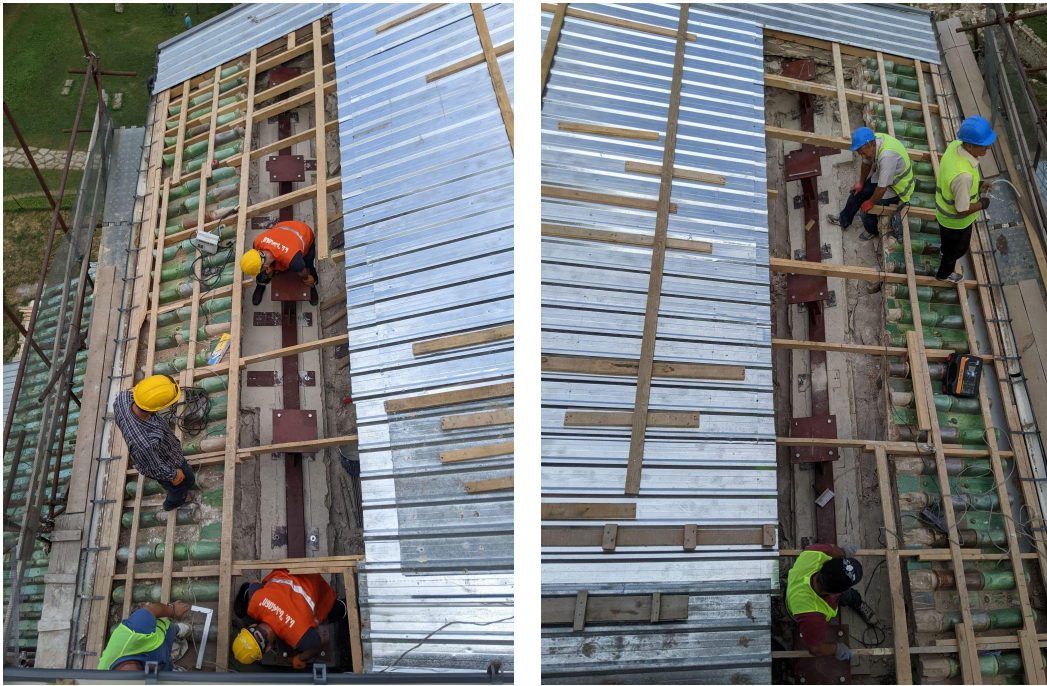
Figure 6. The anchoring of the temporary cover for both pitches (photos by Architect Lasha Shartava).

At the end of a long and careful study process, in order to distribute the loads evenly, a longitudinal metal square pipe (horizontal beam) was used on which the bases of the supporting columns of the temporary roof were fixed, five per pitch.

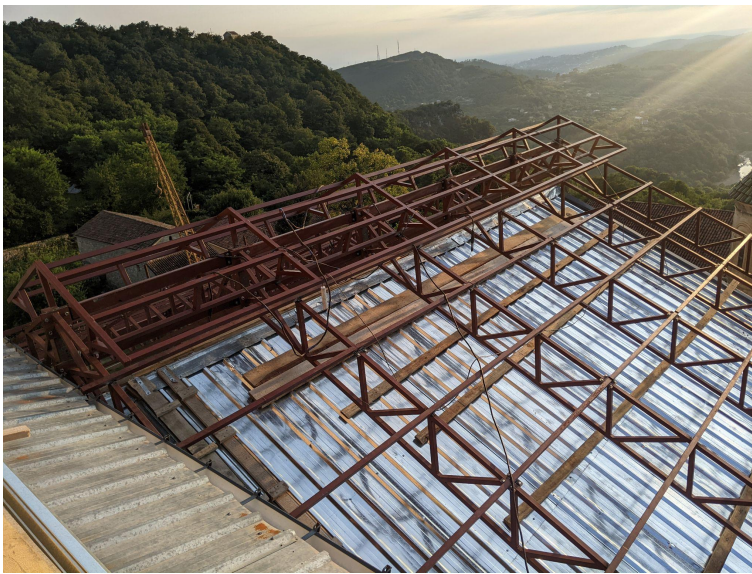
Figure 7. The metal trusses with the pre-fabricated structure on the ridge of the pitches, useful for the chimney effect (photo by Architect Lasha Shartava).

To support the covering layer, five metal trusses were installed by means of a crane. A prefabricated metal structure was installed on the ridge to create a chimney effect needed for ventilation. Metal framed doors were also installed on the sides of the metal structure for inspection.

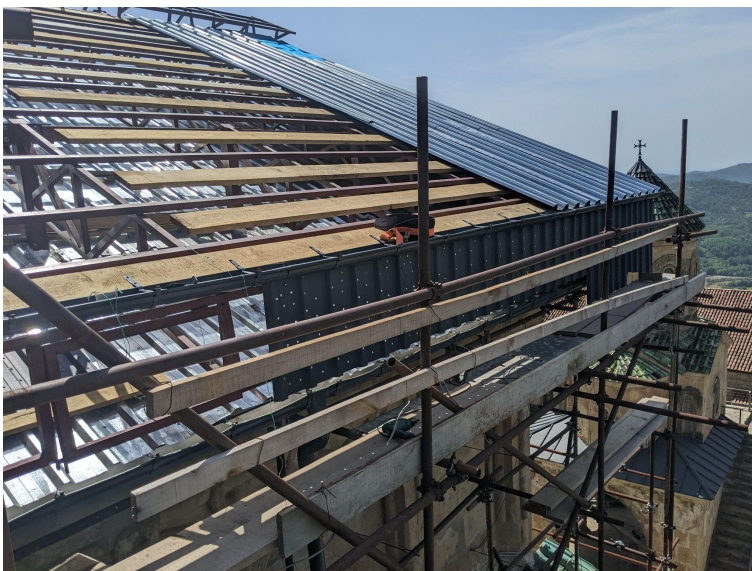
Figure 8. Installation of the tin sheets of the covering and tin sheets with holes to permit ventilation. The perforated sheets are darker to avoid visual impact and glare caused by the reflection of the sun's rays (photo by Architect Lasha Shartava).

Finally, the tin sheets roofing layer was arranged. Under the tin sheets, a layer to avoid condensation was installed. On the sides of the temporary covering, profiled tin sheets with 10mm holes were installed to permit better ventilation of the WA roof.

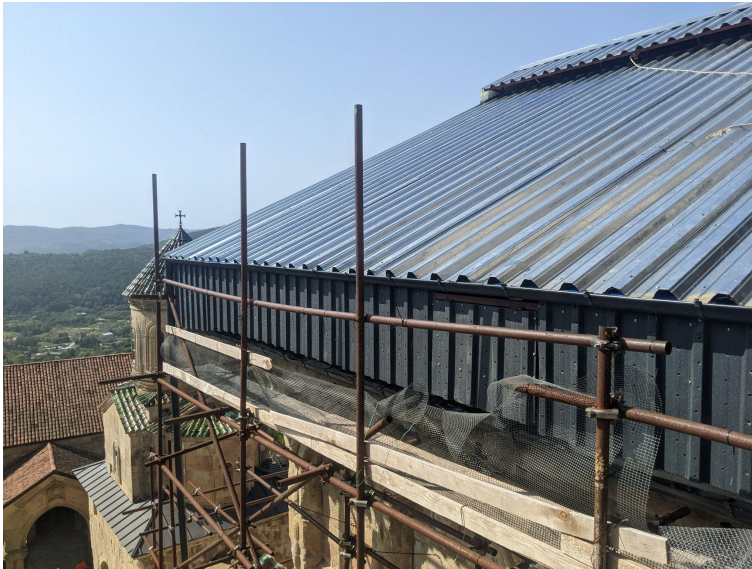
Figure 9. The WA temporary covering, view from the outside (photo by Architect Lasha Shartava).

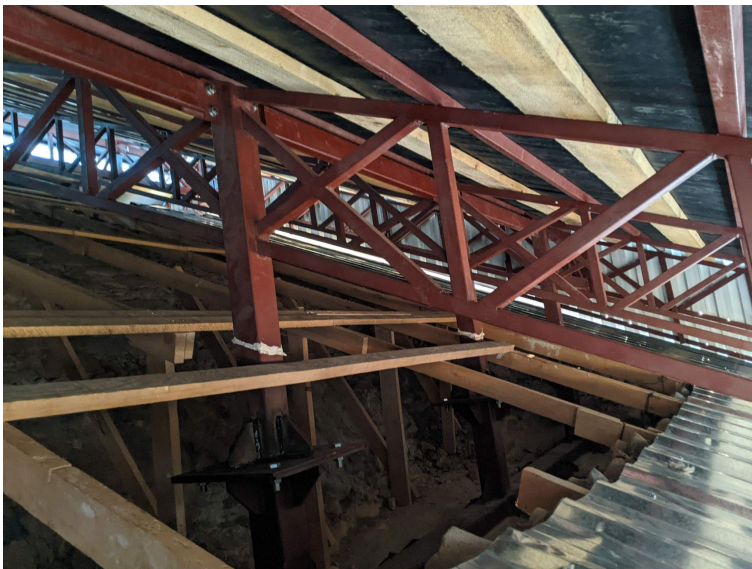
Figure 10. The WA temporary covering, view from the inside (photo by Architect Lasha Shartava).

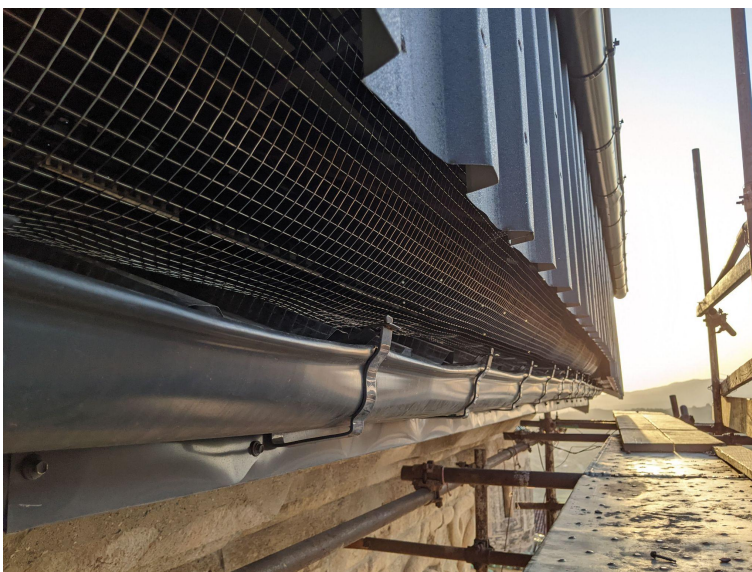
Figure 11. Details of the WA temporary covering: gutter line (photo by Architect Lasha Shartava).

Rainwater pipes and bird-proof metal nets were arranged.

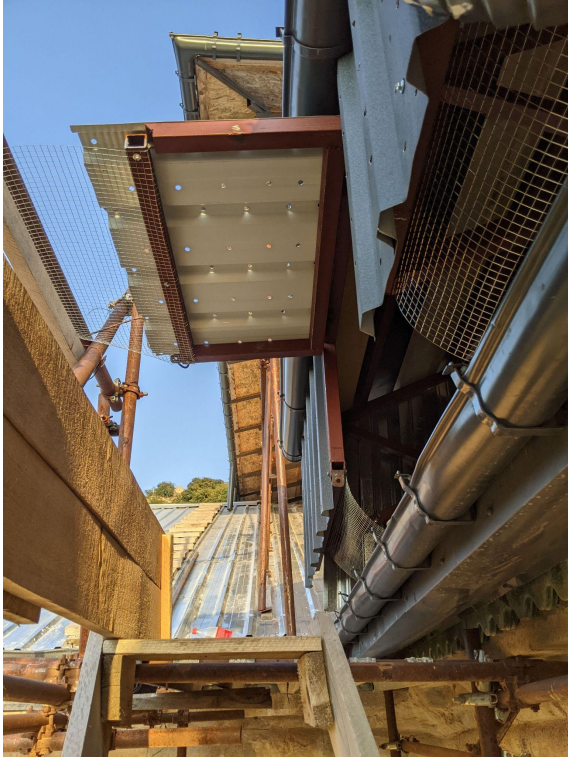
Figure 12. Details of the WA temporary covering: gutter line and opening for internal inspection (photo by Architect Lasha Shartava).

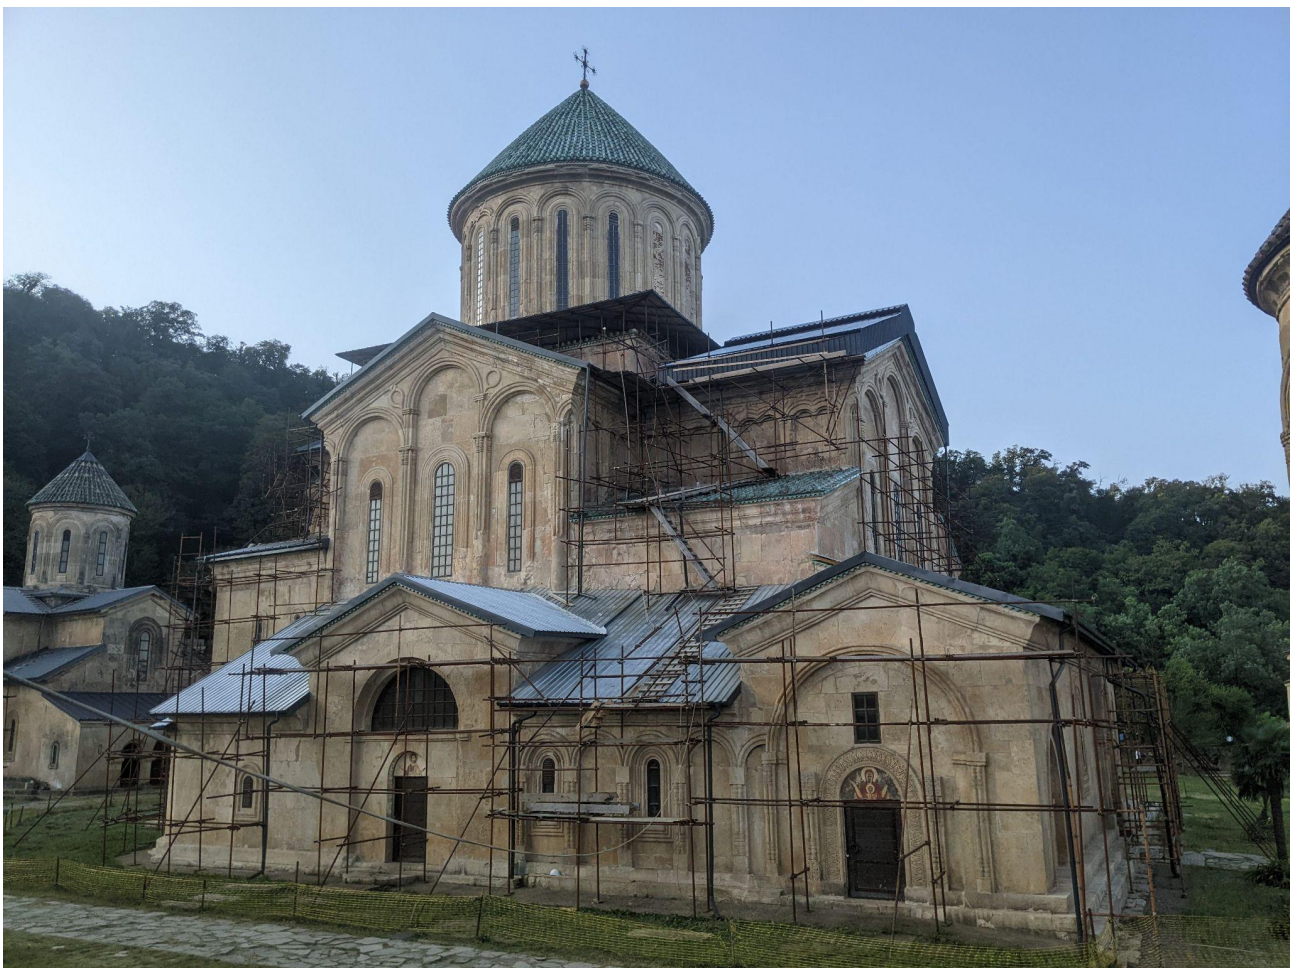
Figure 13. The WA temporary covering, global view (photo by Architect Lasha Shartava).
