## Preservation Measures for Gelati Monastery Cultural Heritage Site

# Restoration of Architectural Structure of the Church of the Virgin at Gelati Monastery

Monthly Progress Report #1
Reporting Period: August 24, 2015 - October 22, 2015

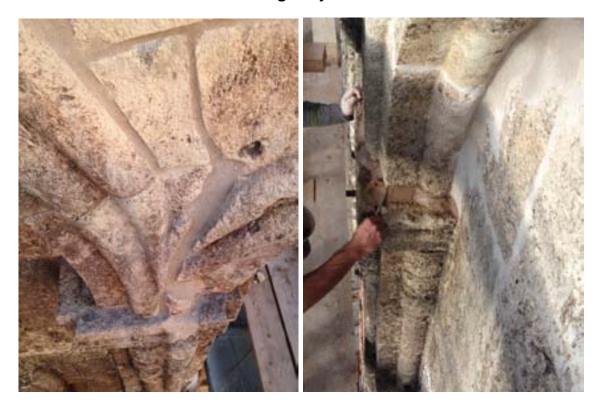
Western facade of the Church of the Virgin at Gelati Monastery

Filling the joints

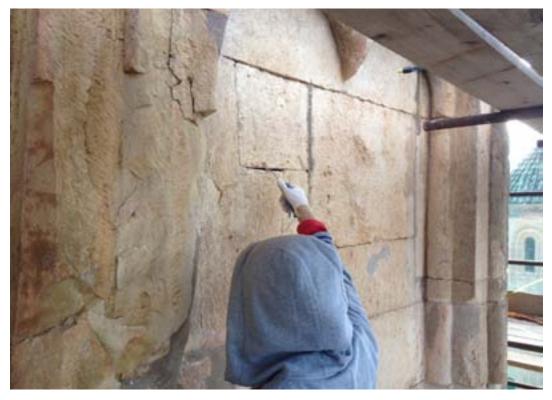
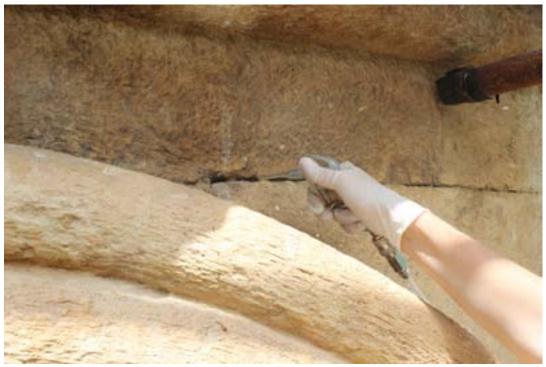
Cleaning of spaces between the stones

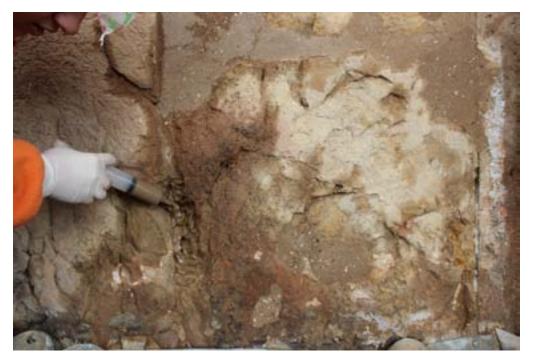
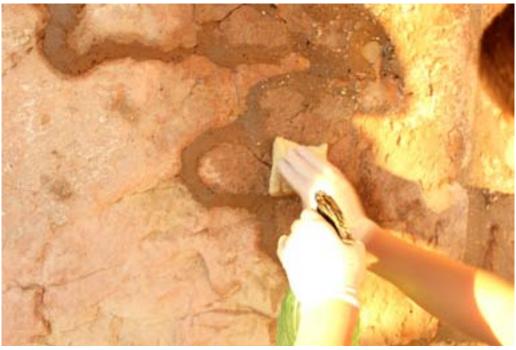
North facade of the Church of the Virgin at Gelati Monastery

# **Consolidation of cracks**

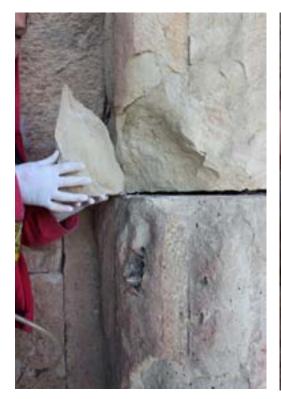
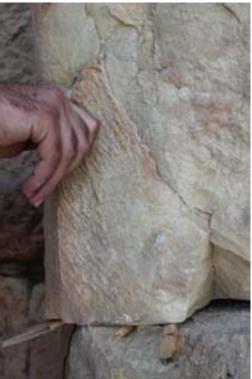
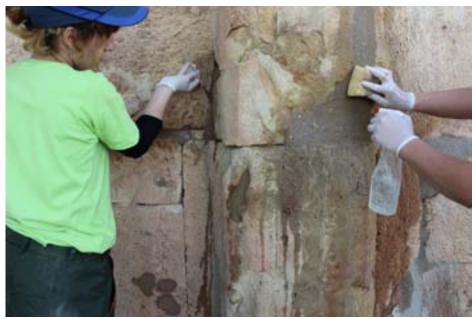
South of the Church of the Virgin at Gelati Monastery

# Reassembling the fragmented parts of the stone

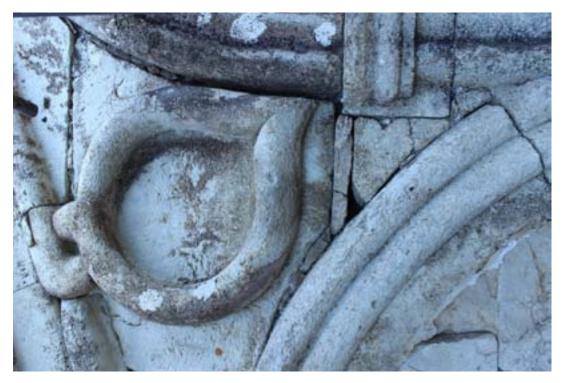
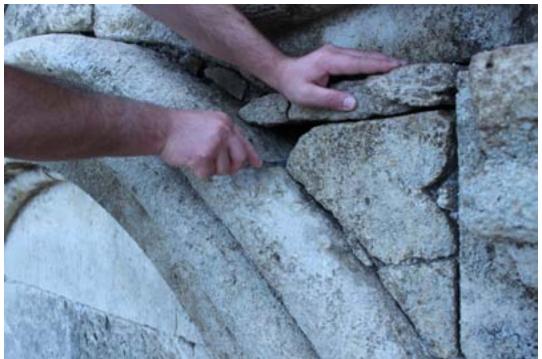
North façade of the Church of the Virgin at Gelati Monastery

# Reconstruction of missing parts of the masonry with lime mortar

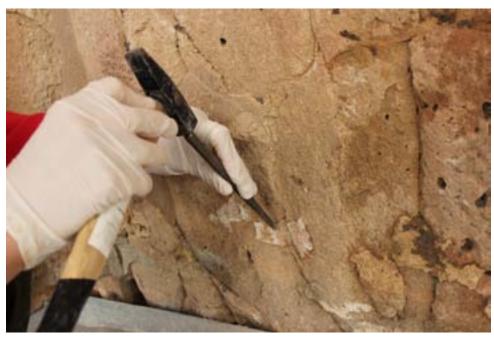
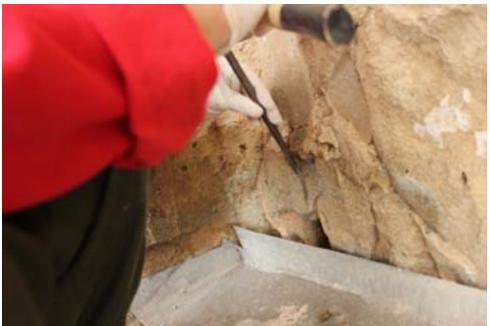
South façade of the Church of the Virgin at Gelati Monastery

# Cleaning of the old fillings

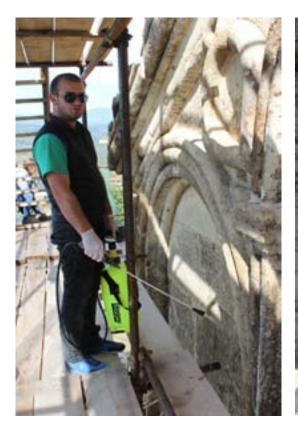
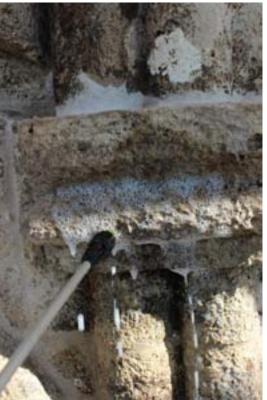
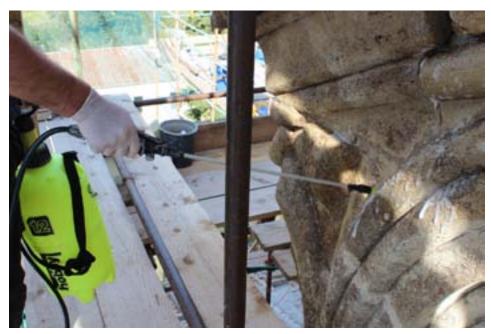
West façade of the Church of the Virgin at Gelati Monastery

# **Treatment with Biocide**
