# Gelati Monastery Church of Virgin KUTAISI - GEORGIA

## Studio Croci & Associati & VI Studio

## STRUCTURAL INVESTIGATIONS

This report presents the results of the investigative surveys conducted between November 2023 and May 2024 on the structures of the "Church of the Nativity" located in the Gelati Monastery complex in Kutaisi, Georgia.

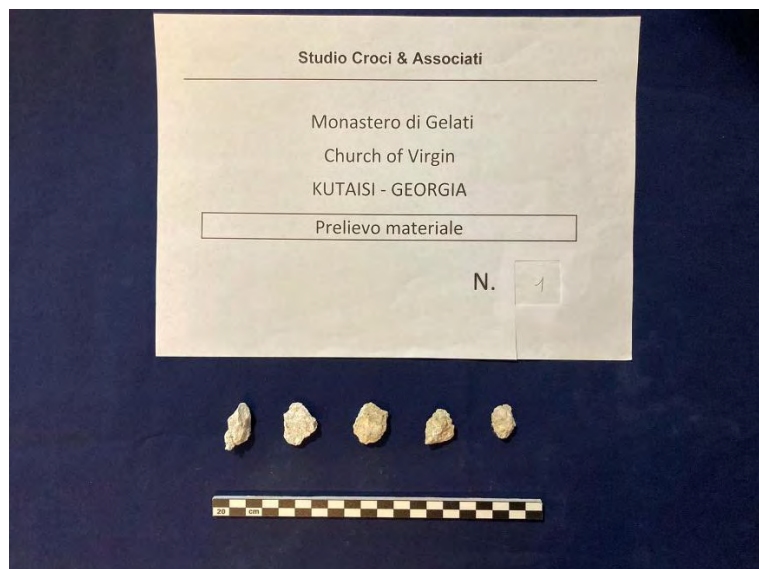
*Mortar sample P-1*

*Macroscopic Description (UNI-NORMAL 12/83)*

| <i>Dimensional Appearance</i> | Silty arenaceous |
| <i>Color</i> | Whitish |
| <i>Cohesion</i> | Slightly tenacious and cohesive |

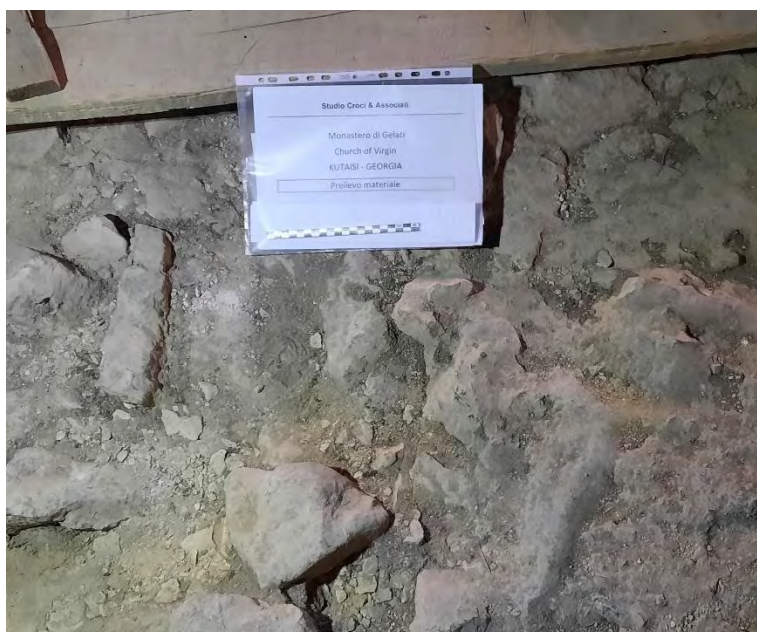
*Mortar sampling P-2*

*Macroscopic Description (UNI-NORMAL 12/83)*

| <i>Dimensional Appearance</i> | Silty arenaceous |
| <i>Color</i> | Whitish |
| <i>Cohesion</i> | Slightly tenacious and cohesive |

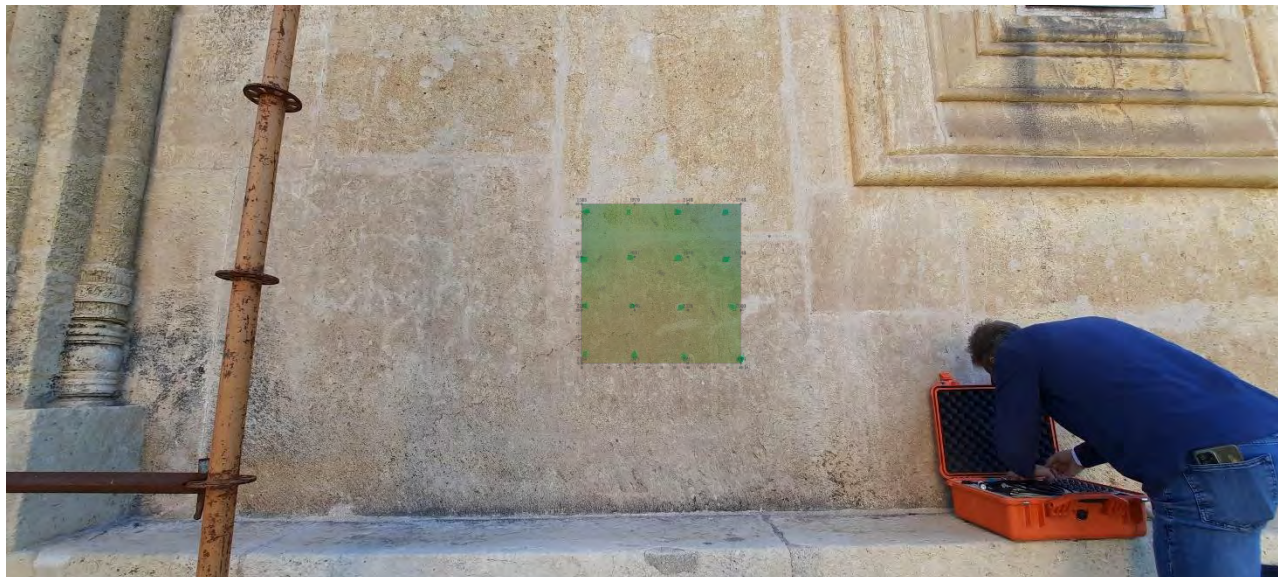
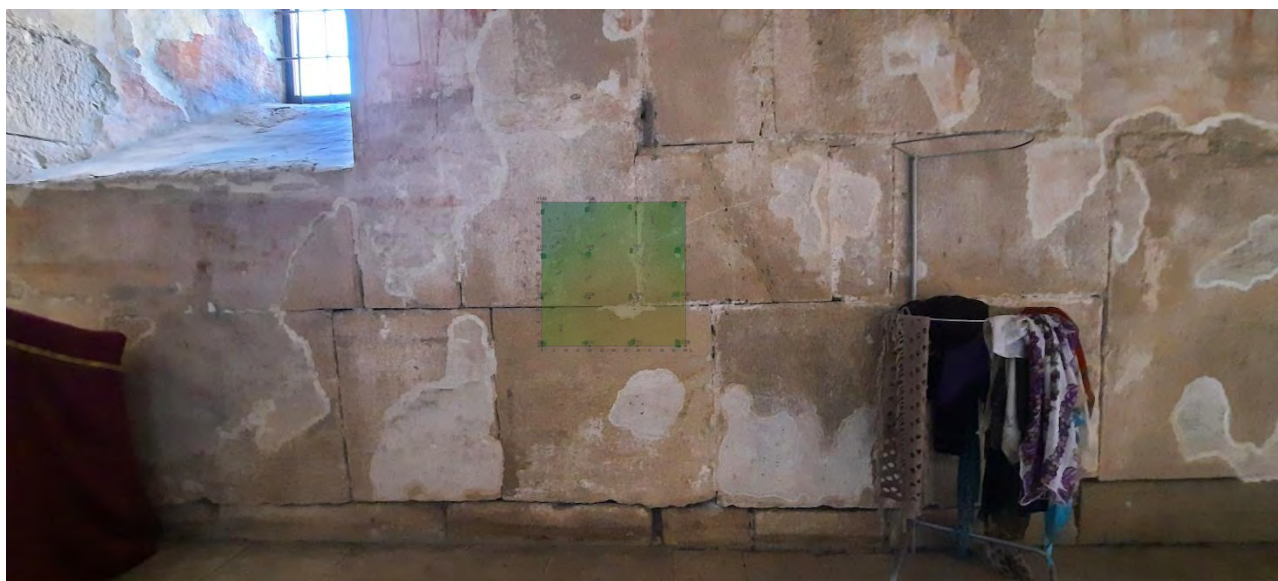
### SONIC INVESTIGATION Sn-1

*Location of the color map on the investigated element*

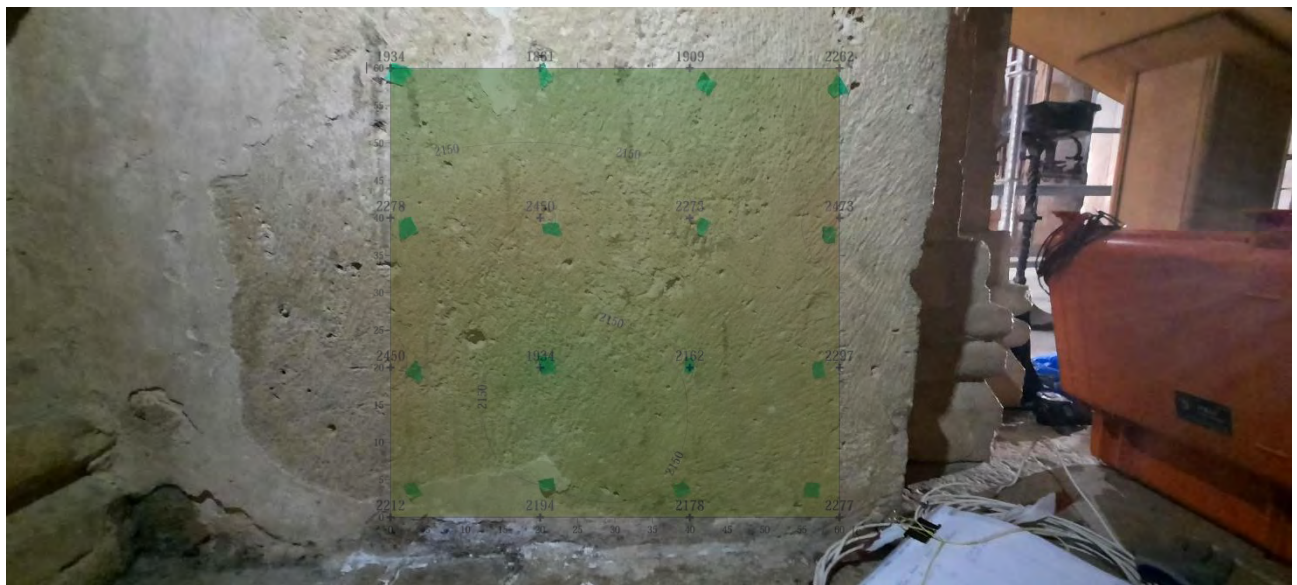
### Sonic investigation S-2

*Location of the color map on the investigated element*

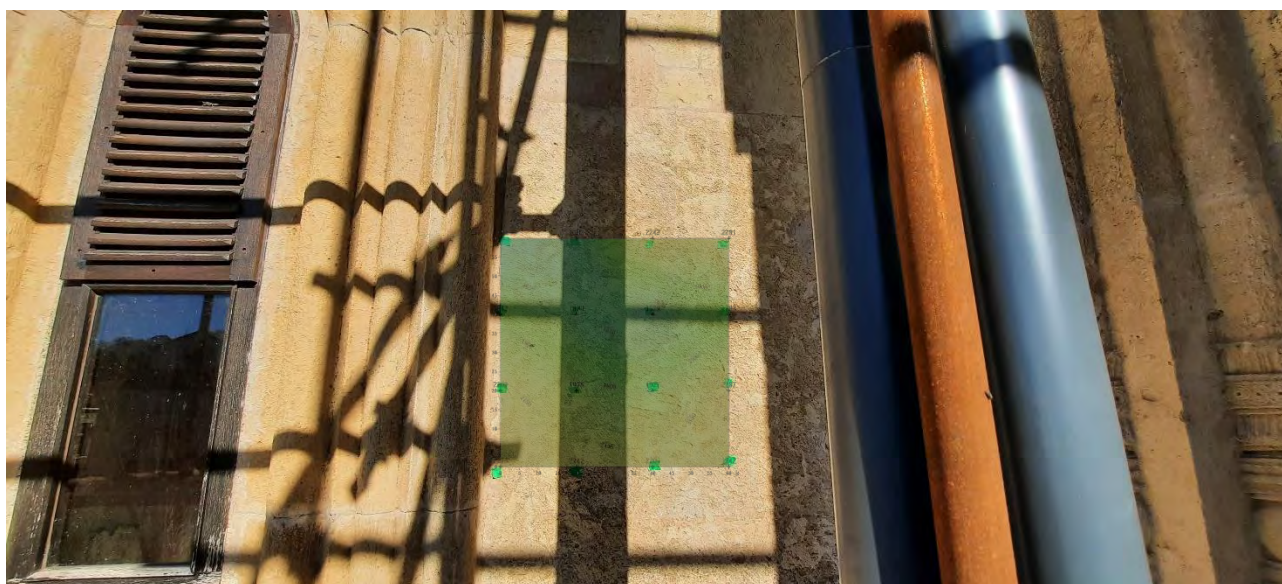
### Sonic investigation S-4

*Location of the color map on the investigated element*

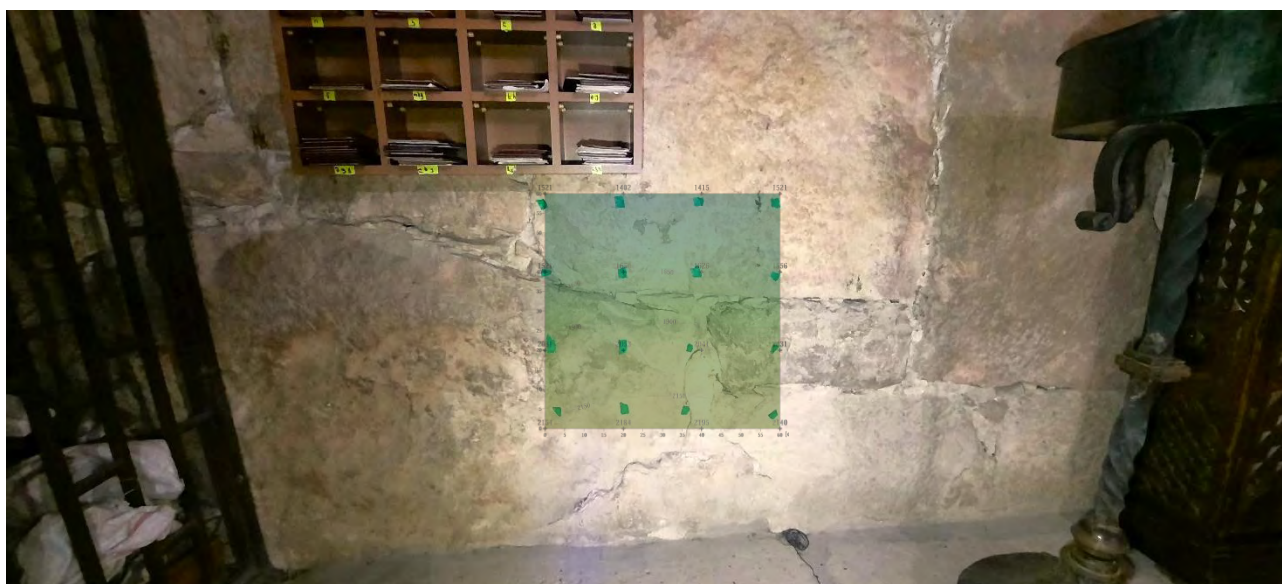
### Sonic investigation S-5

*Location of the color map on the investigated element*

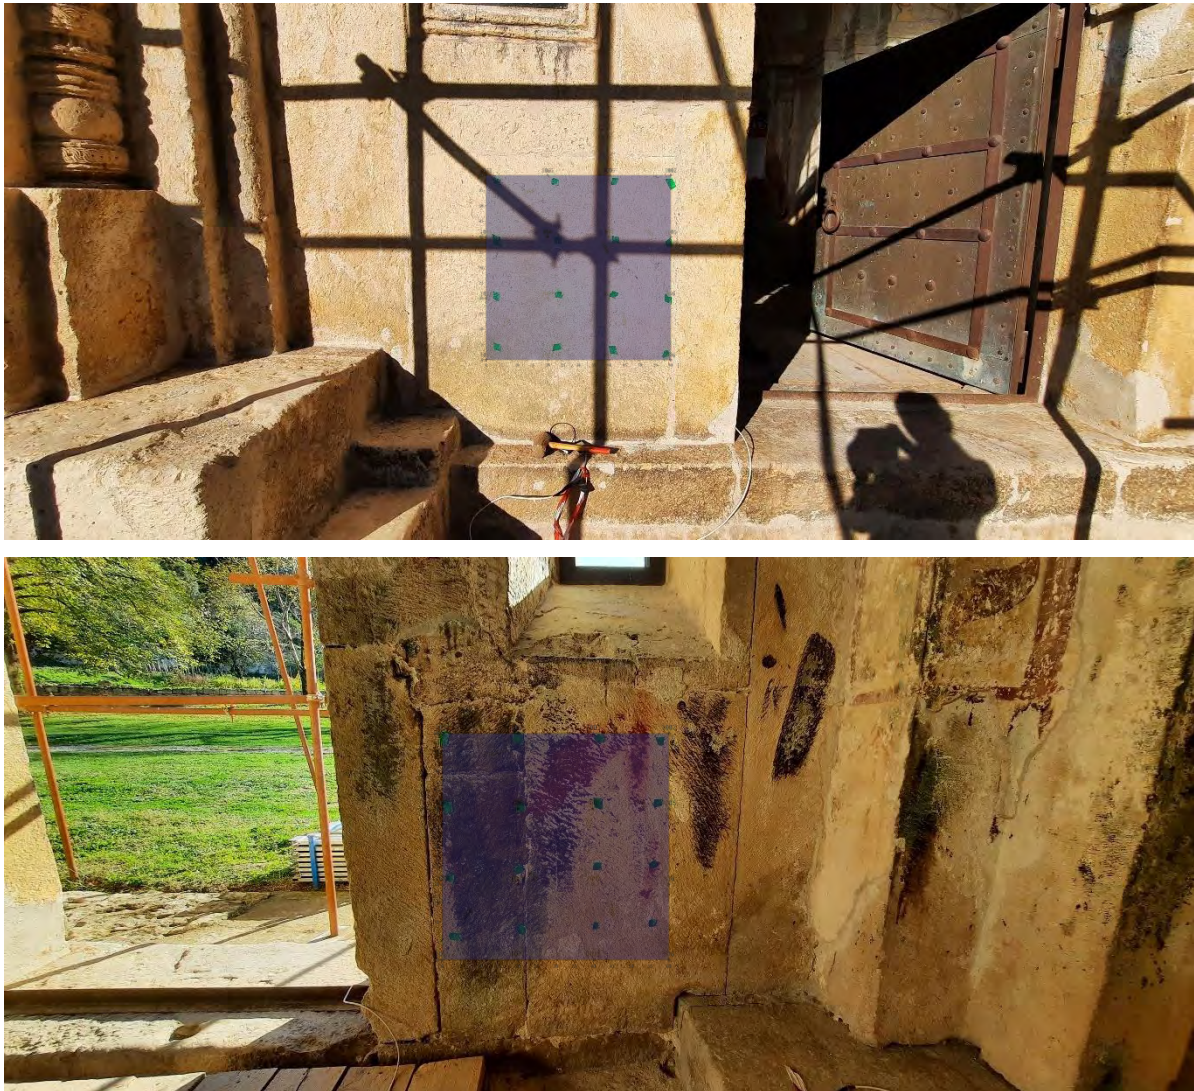
### Sonic investigation S-6

*Location of the color map on the investigated element*

From the results of the sonic investigations it is possible to see how the lowest values of the velocity propagation were recorded by the S-6 test.

The masonry investigated therefore presents less performing characteristics.

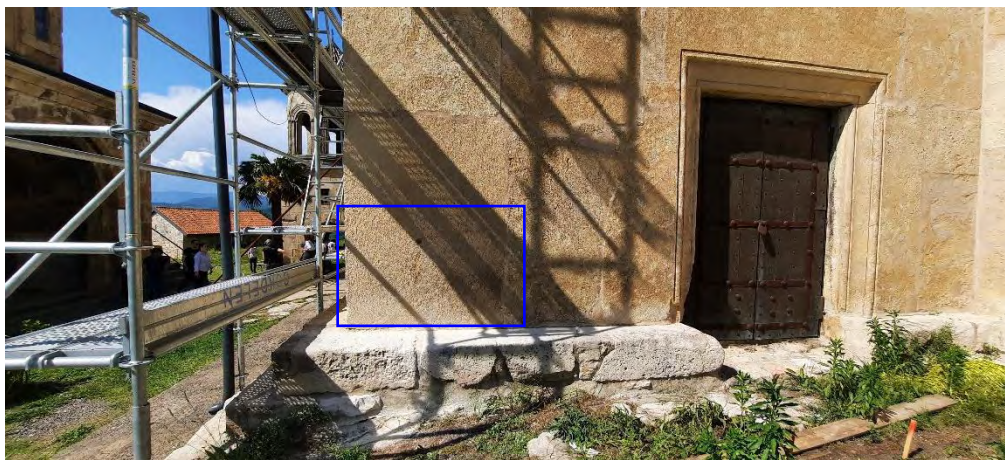
The videoendoscopic investigation V10 has affected the external wall, right close to the east corner of the building.

The test allowed us to verify that the external corner block, which is visible from outside and constitutes the external face of the three-layered masonry, has an L shape.
