University of Applied Sciences  
Department of Conservation and Restoration  
Science Laboratory

**Church of the Virgin (Gelati)  
Salt analyses – Part I**

Potsdam, 22.03.2024

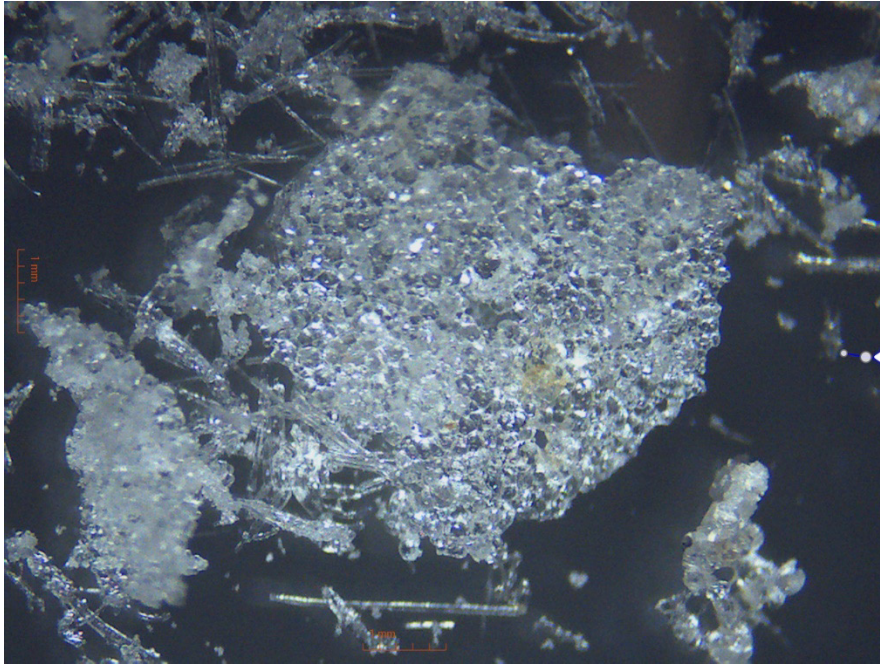
Description: granular crystals (partly agglomerated to a crust) and whisker (fig. 1).

fig. 1: Sample 1, granular crystals agglomerated to a crust and whiskers (Moticam S1)

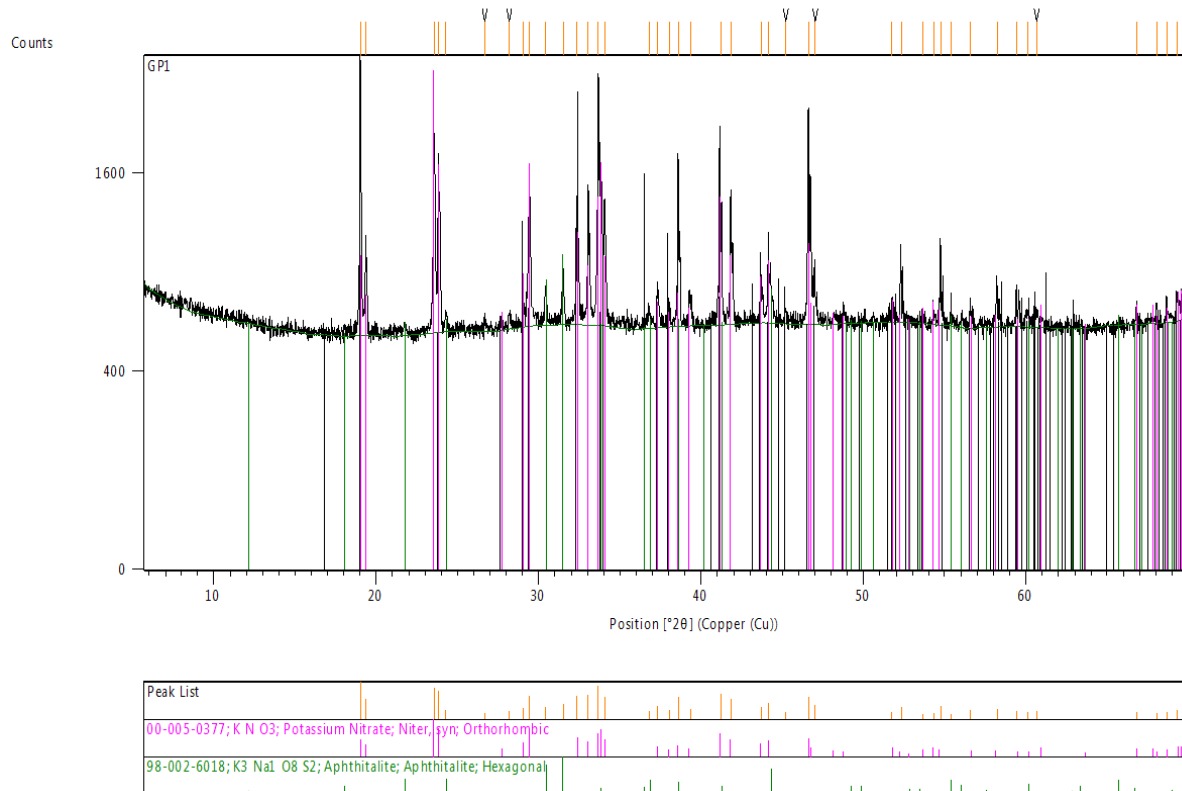
Result: mostly niter [ $\text{KNO}_3$ ] and to a much lower degree aphtitalite [ $\text{K}_3\text{Na}(\text{SO}_4)_2$ ] (fig.2).

fig. 2: Sample 1, XRD spectrum

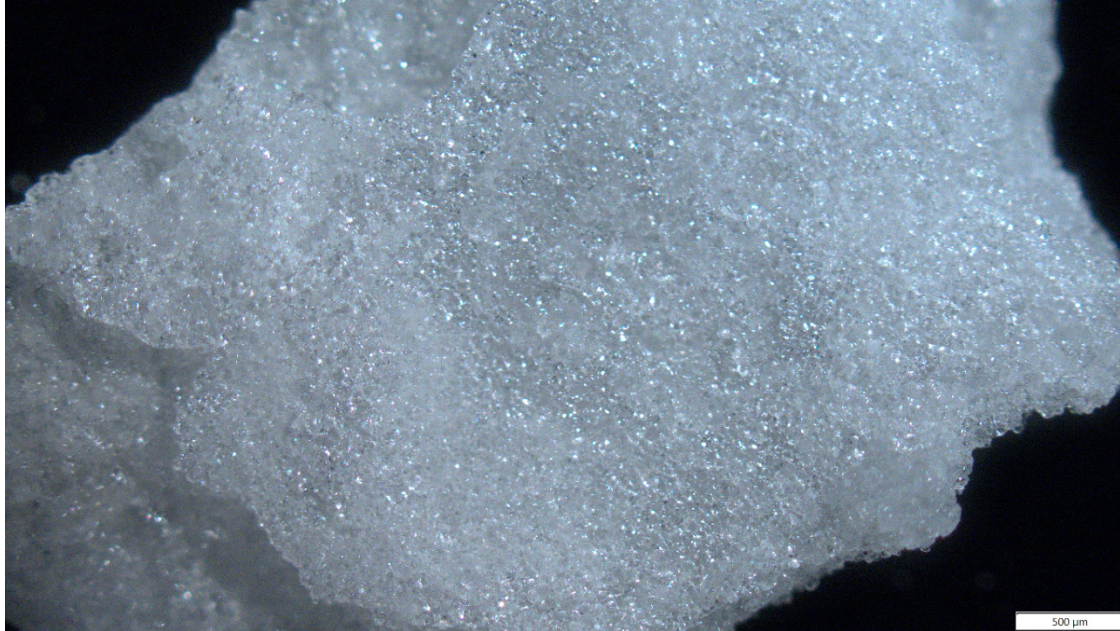
Description: up to 1mm thick compact white crusts (fig. 3) consisting of transparent small crystals, similar to the agglomerated granular crystals as in sample 1.

fig. 3: Sample 2, up to 1mm thick compact white crust (DF)

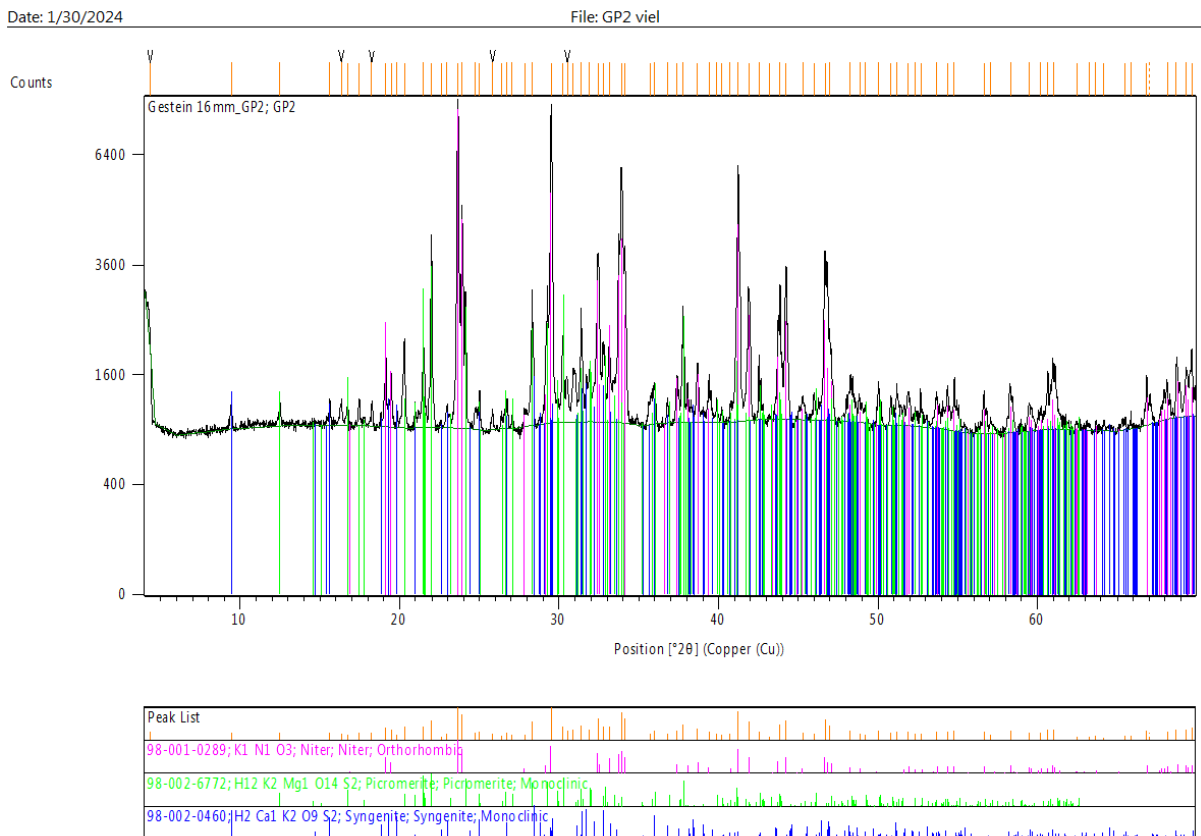
Result by XRD: mostly niter [ $\text{KNO}_3$ ], less picromerite [ $\text{K}_2\text{Mg}(\text{SO}_4)_2 \cdot 6\text{H}_2\text{O}$ ] and to a much lower degree syngenite [ $\text{K}_2\text{Ca}(\text{SO}_4)_2 \cdot \text{H}_2\text{O}$ ] (fig. 4).

fig. 4: Sample 2, XRD spectrum

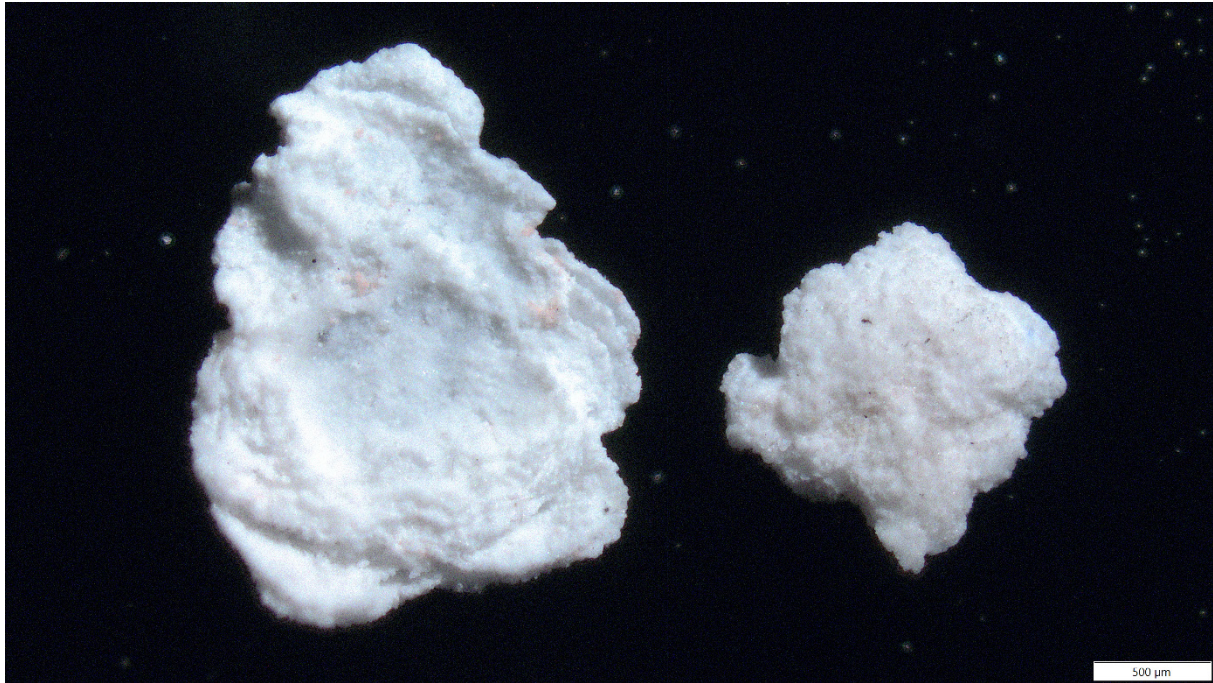
Description: thin crusts and fine-grained white salts, some particles are reddish (fig. 5).

fig. 5: Sample 3.1, thin white crusts with some reddish particles (DF)

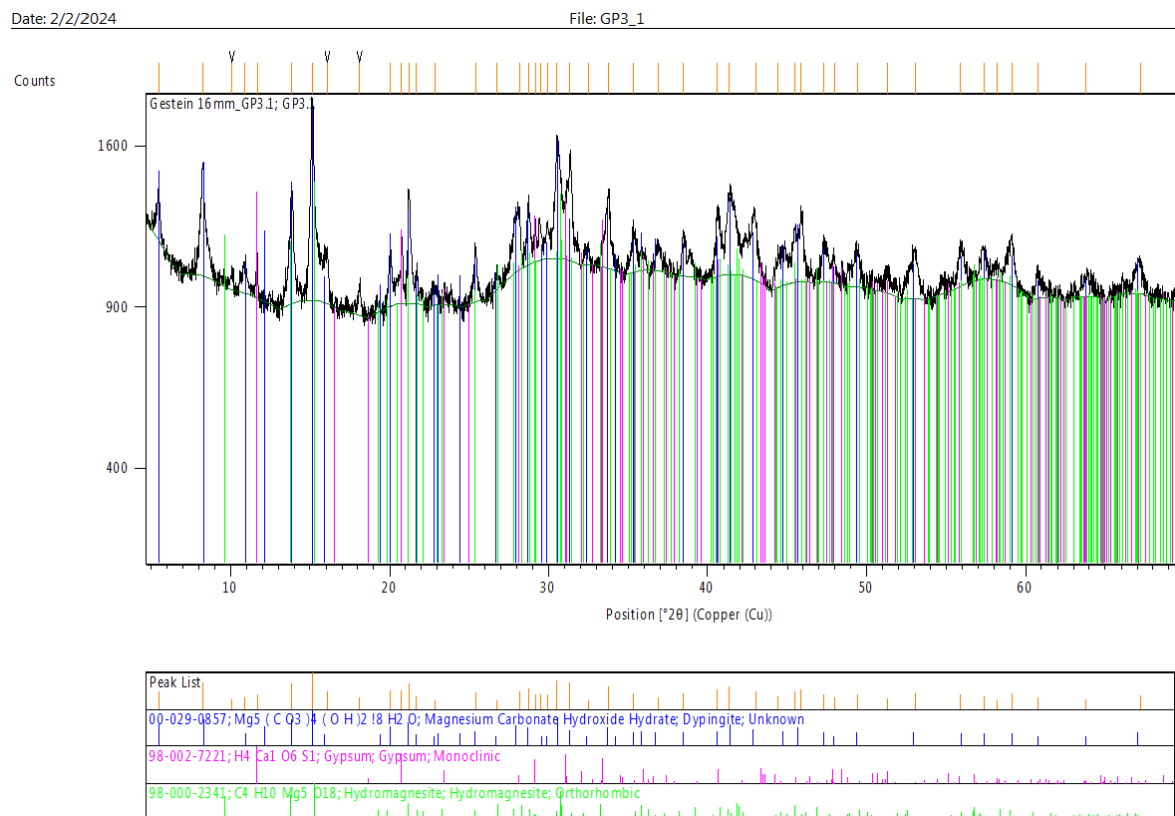
Result by XRD: mostly dypingite  $[\text{Mg}_5(\text{CO}_3)_4(\text{OH})_2 \cdot 5\text{H}_2\text{O}]$  and to a lower degree gypsum  $[\text{CaSO}_4 \cdot 2\text{H}_2\text{O}]$ , maybe small amount of hydromagnesite  $[\text{Mg}_5(\text{CO}_3)_4(\text{OH})_2 \cdot 4\text{H}_2\text{O}]$  (fig. 6).

fig. 6: Sample 3.1, XRD spectrum

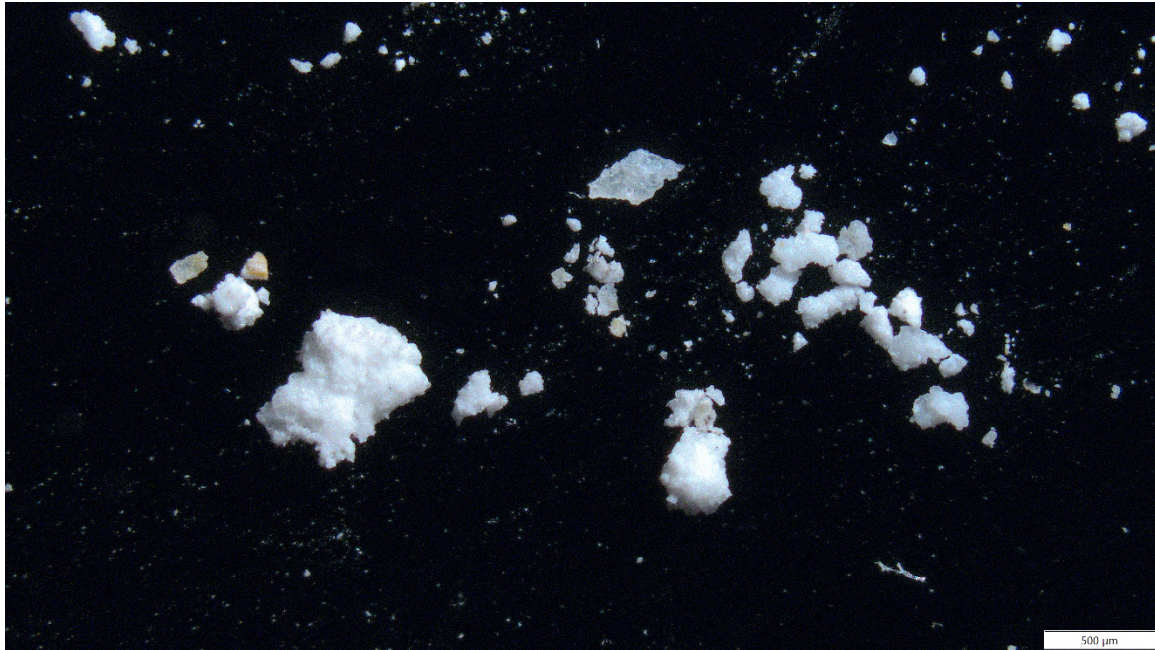
Description: white small relative hard particles (parts of a crust?), some are yellowish (fig. 7).

fig. 7: Sample 3.2, white small relative hard particles (DF)

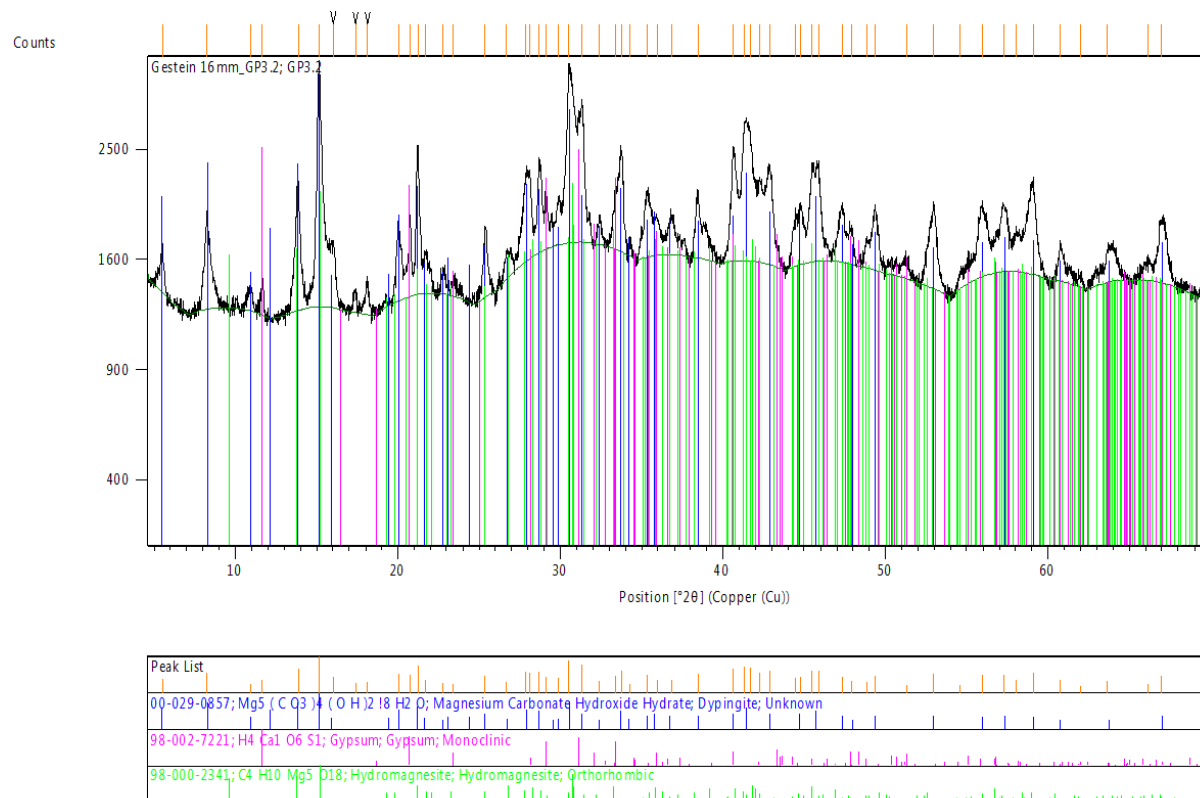
Result by XRD: mostly dypingite  $[\text{Mg}_5(\text{CO}_3)_4(\text{OH})_2 \cdot 5\text{H}_2\text{O}]$  and to a lower degree gypsum  $[\text{CaSO}_4 \cdot 2\text{H}_2\text{O}]$ , maybe small amount of hydromagnesite  $[\text{Mg}_5(\text{CO}_3)_4(\text{OH})_2 \cdot 4\text{H}_2\text{O}]$  (fig. 8).

fig. 8: Sample 3.2, XRD spectrum, similar to sample 3.1

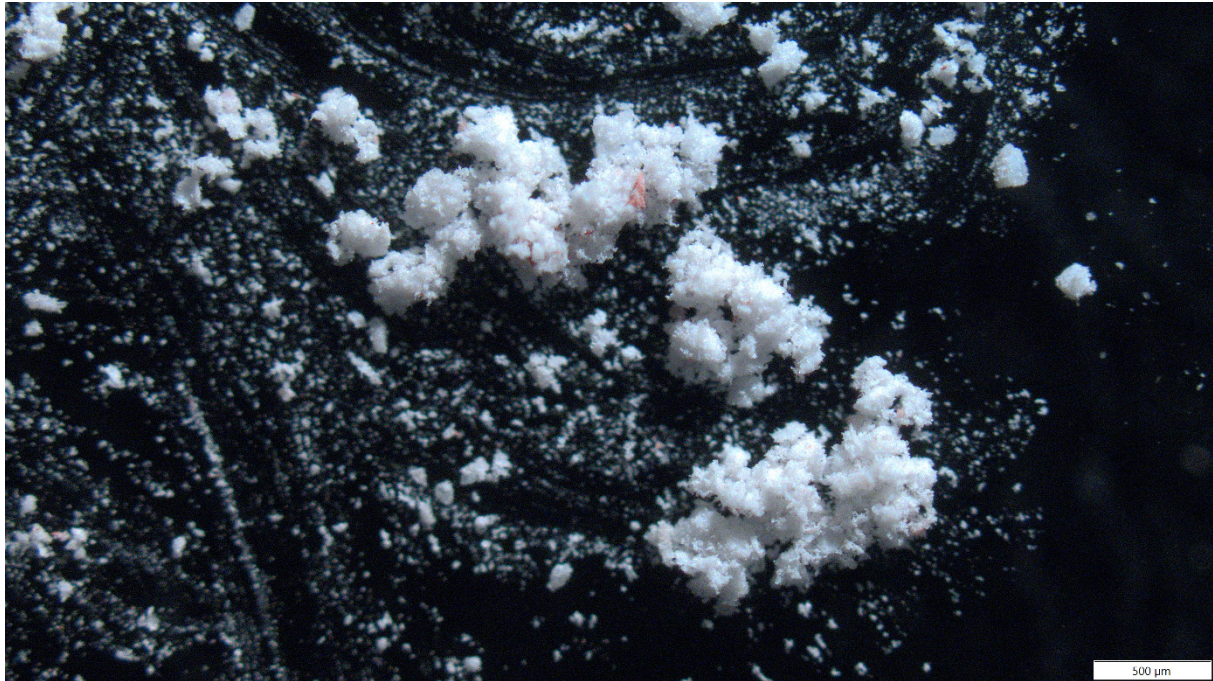
Description: white small fluffy particles, a few are reddish (fig. 9).

fig. 9: Sample 4, white small fluffy particles (DF)

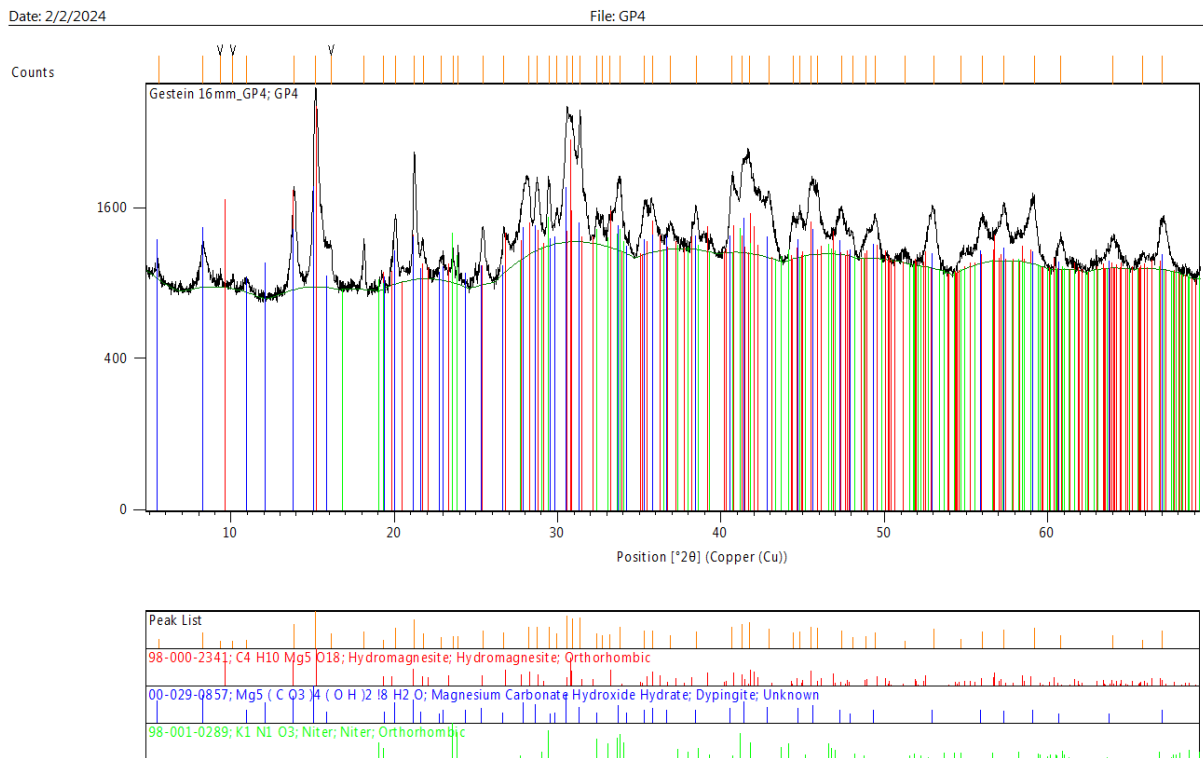
Result by XRD: mostly hydromagnesite [ $Mg_5(CO_3)_4(OH)_2 \cdot 4H_2O$ ], to a lower degree dypingite [ $Mg_5(CO_3)_4(OH)_2 \cdot 5H_2O$ ] and maybe a small amount of niter [ $KNO_3$ ] (fig. 10).

fig. 10: Sample 4, XRD spectrum

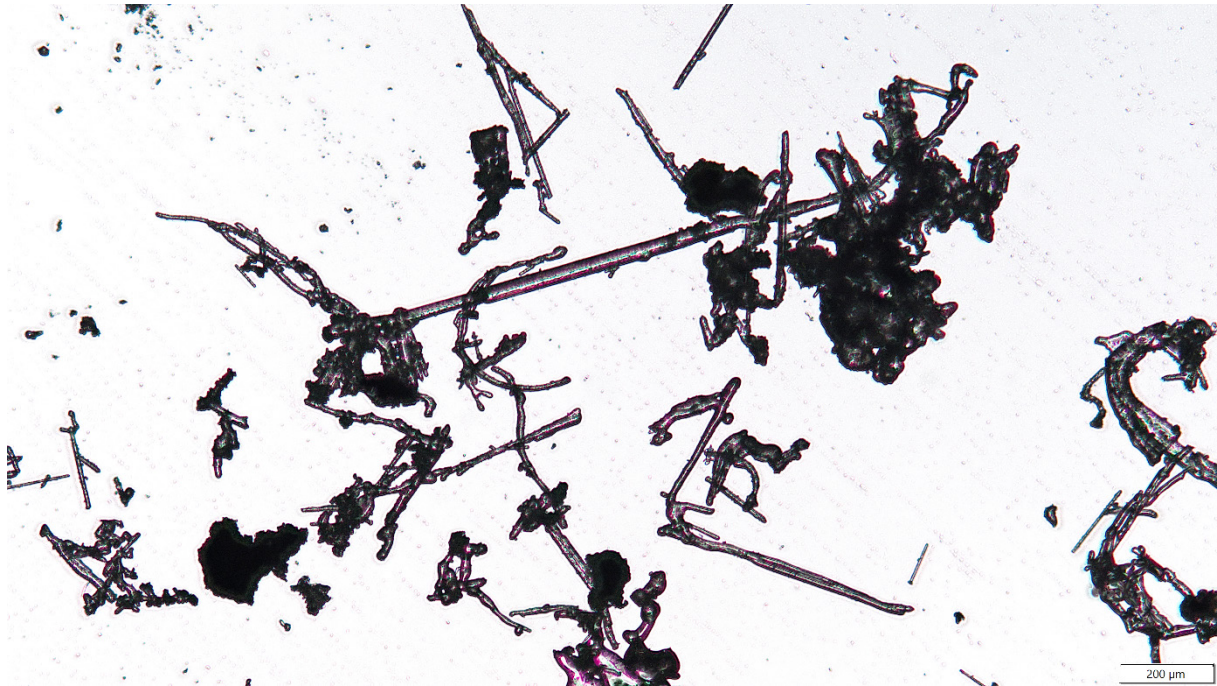
Description: mostly whisker and some granular crystals (fig. 11) – similar to sample 1

fig. 11: Sample 5, mostly whisker and some granular crystals (II-pol oil) – similar to sample 1

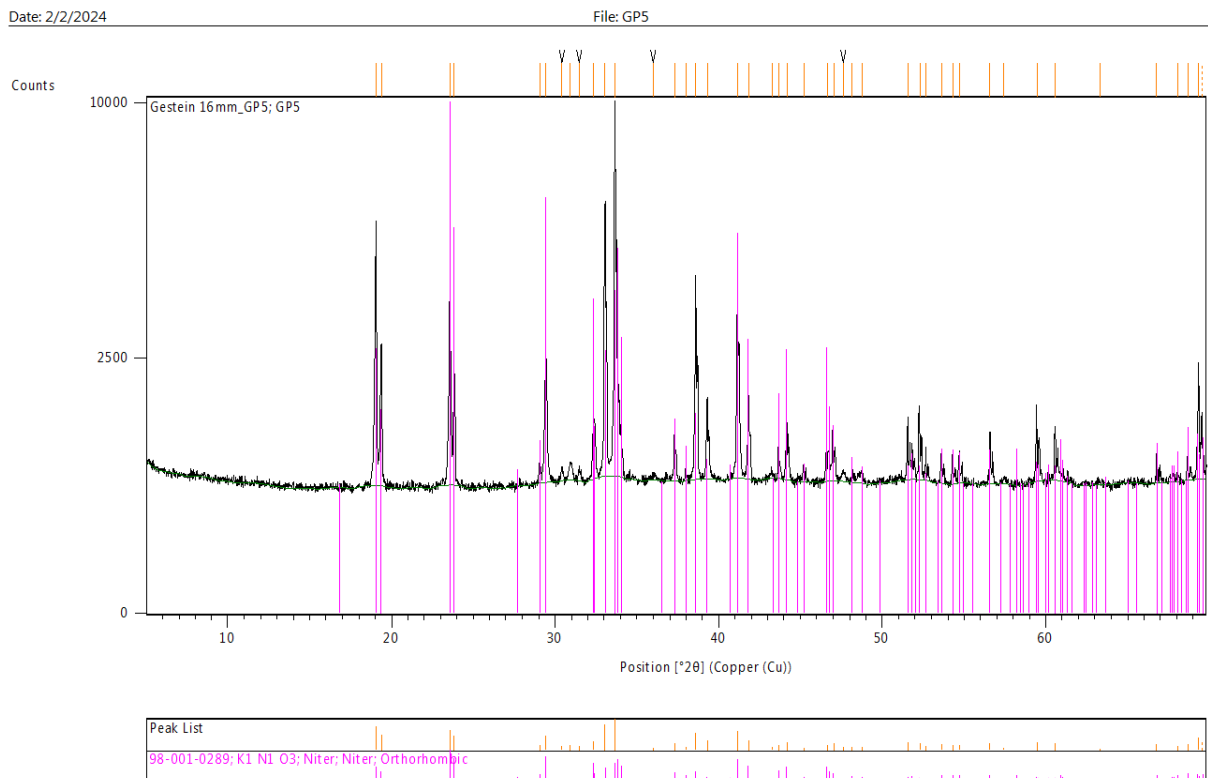
Result: niter [ $\text{KNO}_3$ ] (fig.12).

fig. 12: Sample 5, XRD spectrum

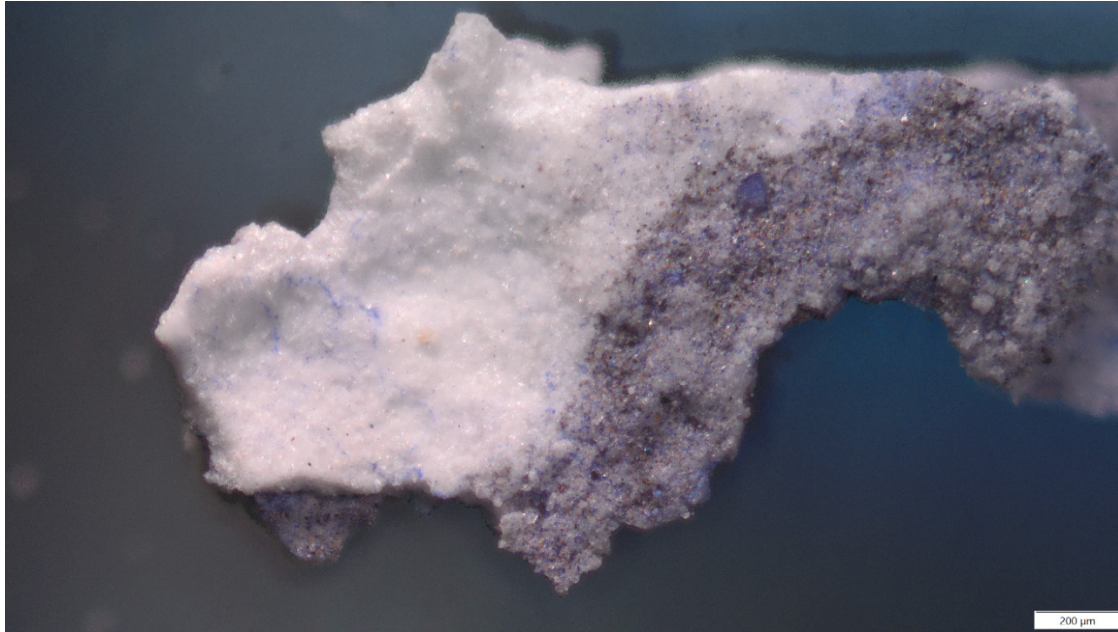
Description: white crust with blue paint layer particles (fig. 13).

fig. 13: Sample 6, white crust with blue paint layer particles (DF)

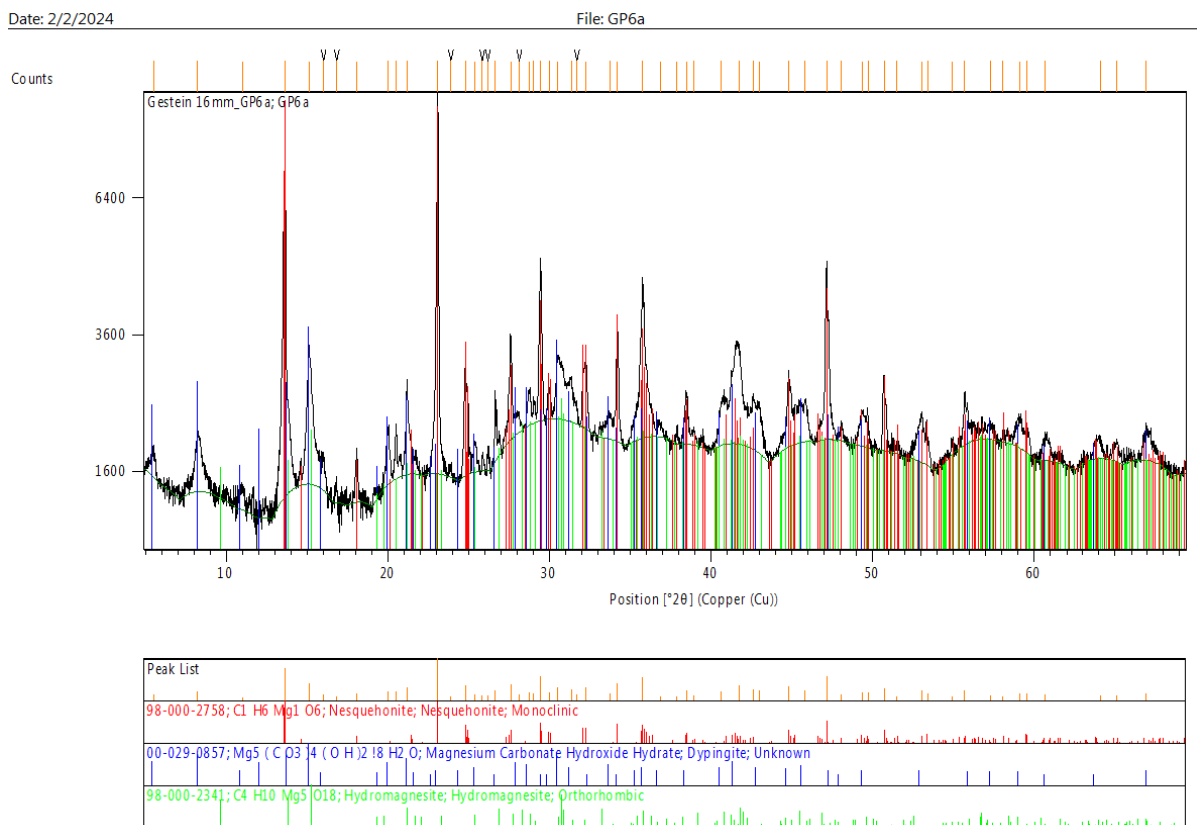
Result by XRD: mostly nesquehonite [ $\text{MgCO}_3 \cdot 3\text{H}_2\text{O}$ ], to a lower degree dypingite [ $\text{Mg}_5(\text{CO}_3)_4(\text{OH})_2 \cdot 5\text{H}_2\text{O}$ ] and maybe a small amount of hydromagnesite [ $\text{Mg}_5(\text{CO}_3)_4(\text{OH})_2 \cdot 4\text{H}_2\text{O}$ ] (fig. 14).

fig. 14: Sample 6, XRD spectrum

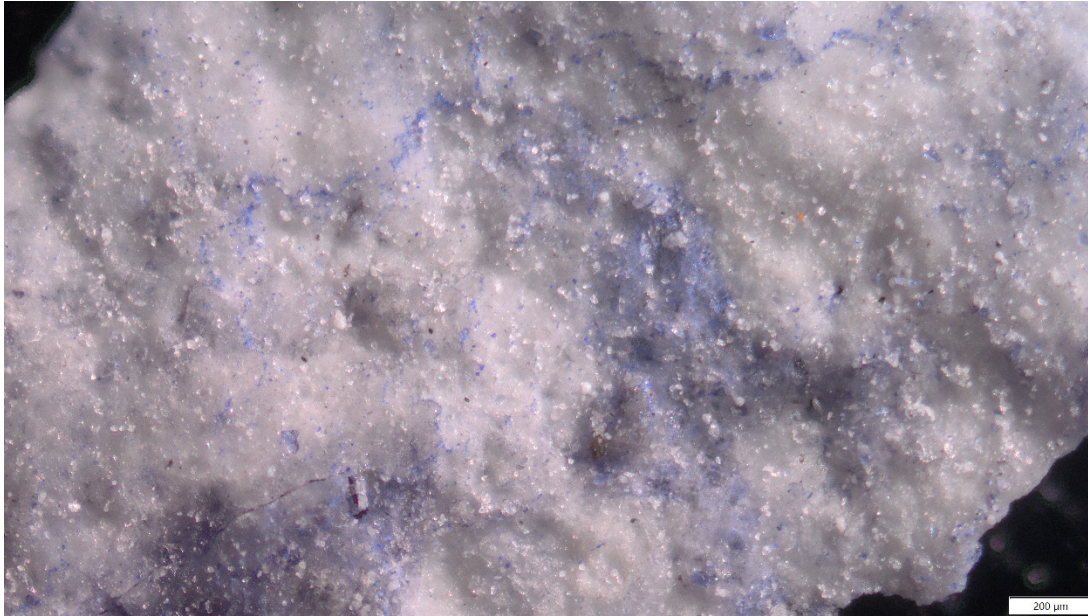
Description: white, partly transparent crust with blue paint layer particles (fig. 15) – similar to sample 6.

fig. 15: Sample 7, white, partly transparent crust with blue paint layer particles (DF)

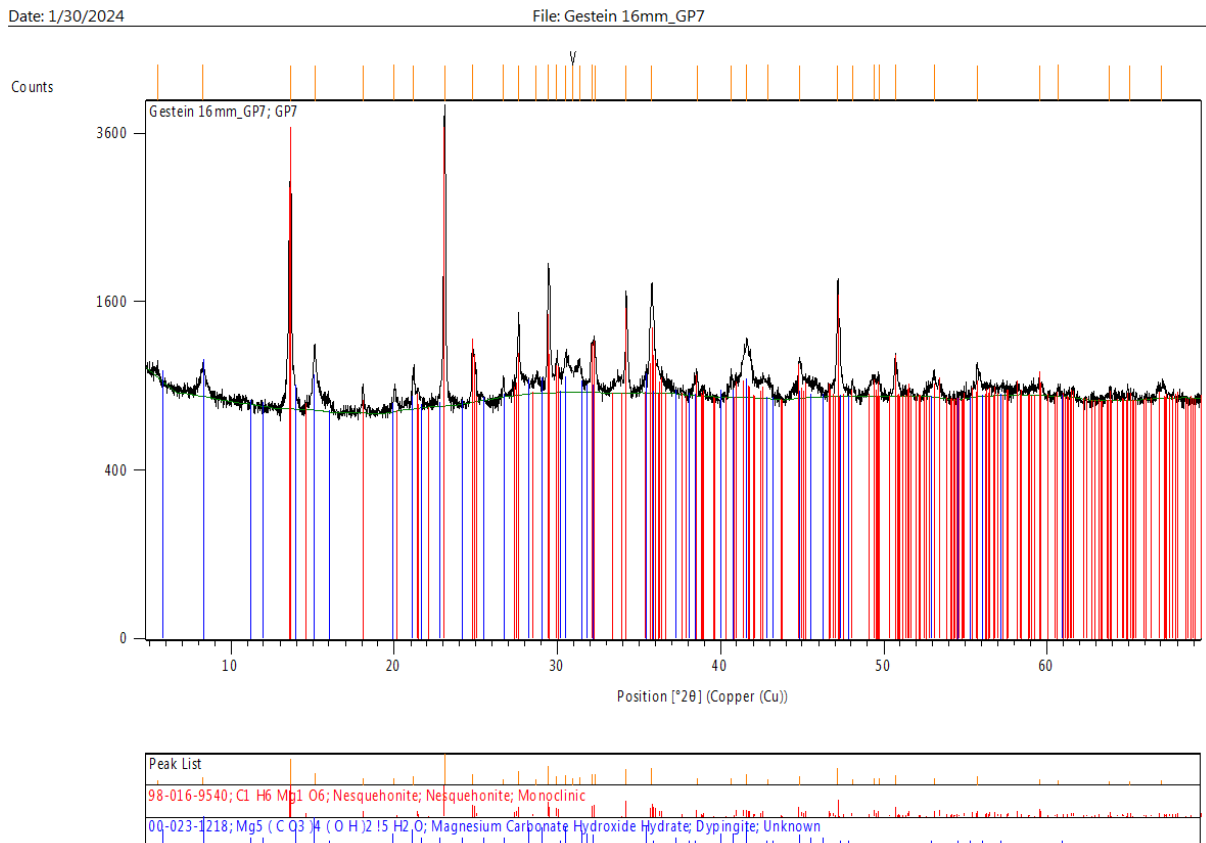
Result by XRD: mostly nesquehonite  $[\text{MgCO}_3 \cdot 3\text{H}_2\text{O}]$ , to a lower degree dypingite  $[\text{Mg}_5(\text{CO}_3)_4(\text{OH})_2 \cdot 5\text{H}_2\text{O}]$  (fig. 16).

fig. 16: Sample 7, XRD spectrum

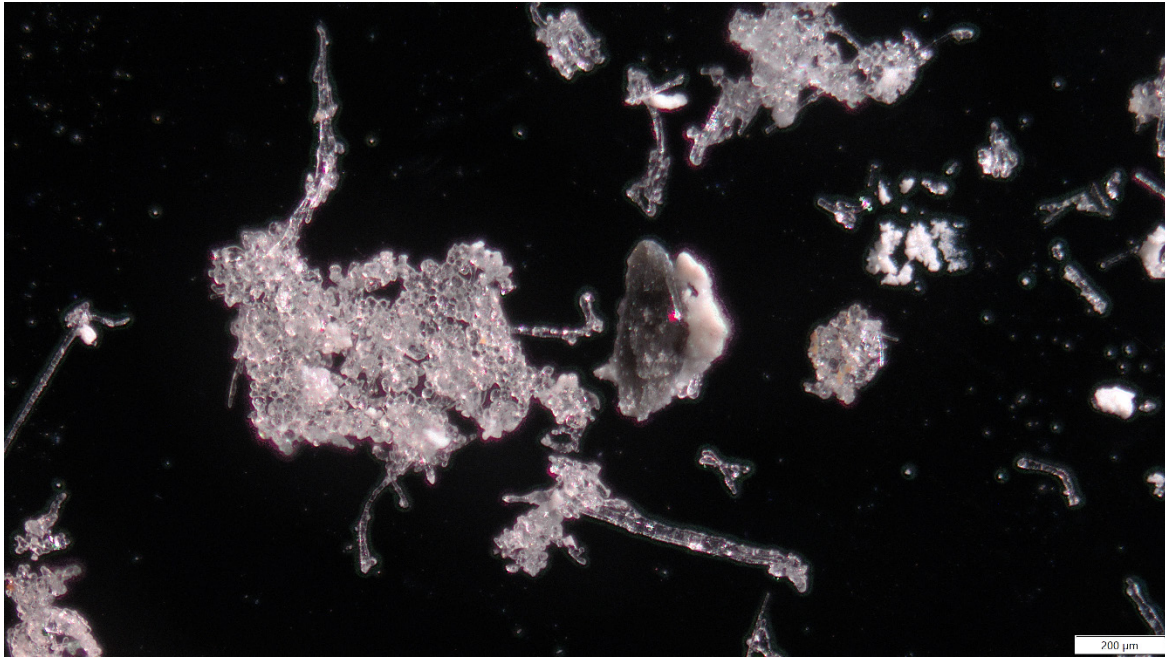
Description: granular crystals (partly agglomerated to a crust) and whisker (fig. 17) – similar to sample 1 and 5.

fig. 17: Sample 8, granular crystals and whisker (DF) – compare to sample 1 and 5

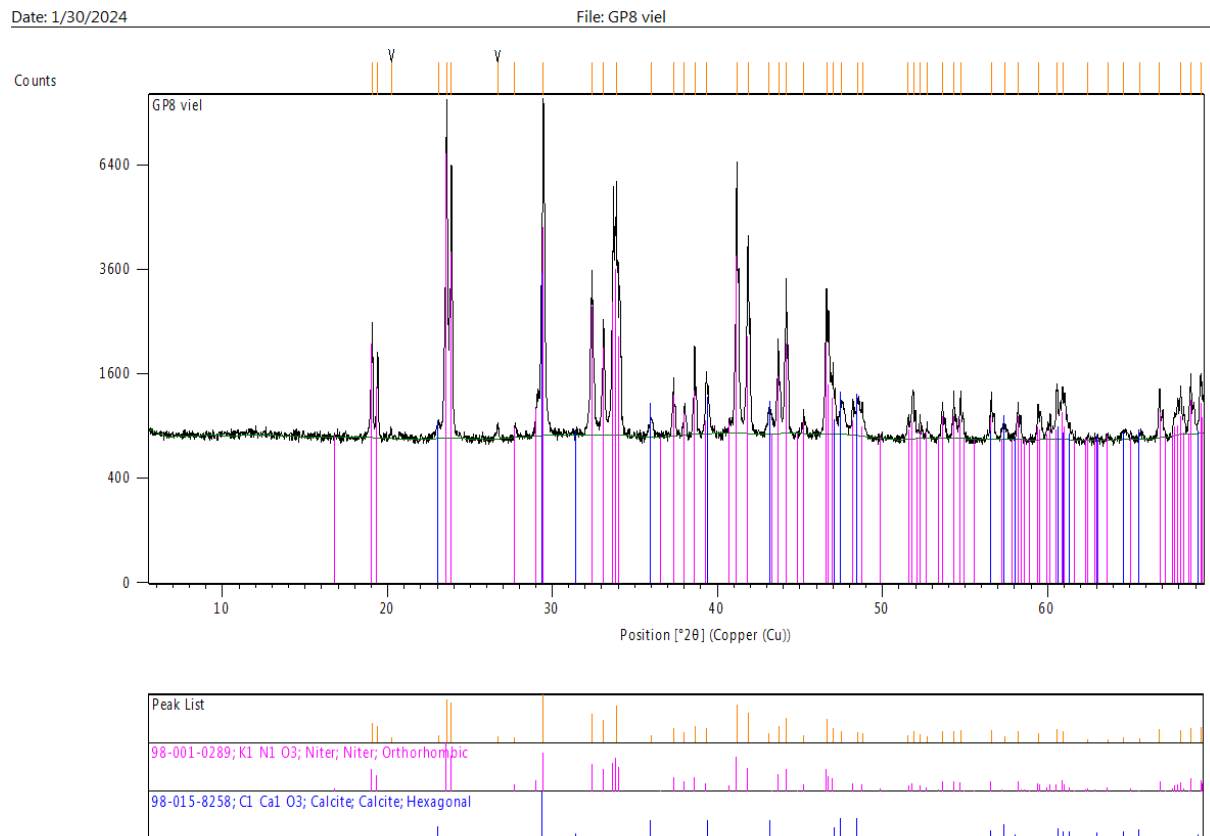
Result: niter [ $\text{KNO}_3$ ] (fig. 18), calcite [ $\text{CaCO}_3$ ] probably derives from the plaster or paint layer.

fig. 18: Sample 8, XRD spectrum

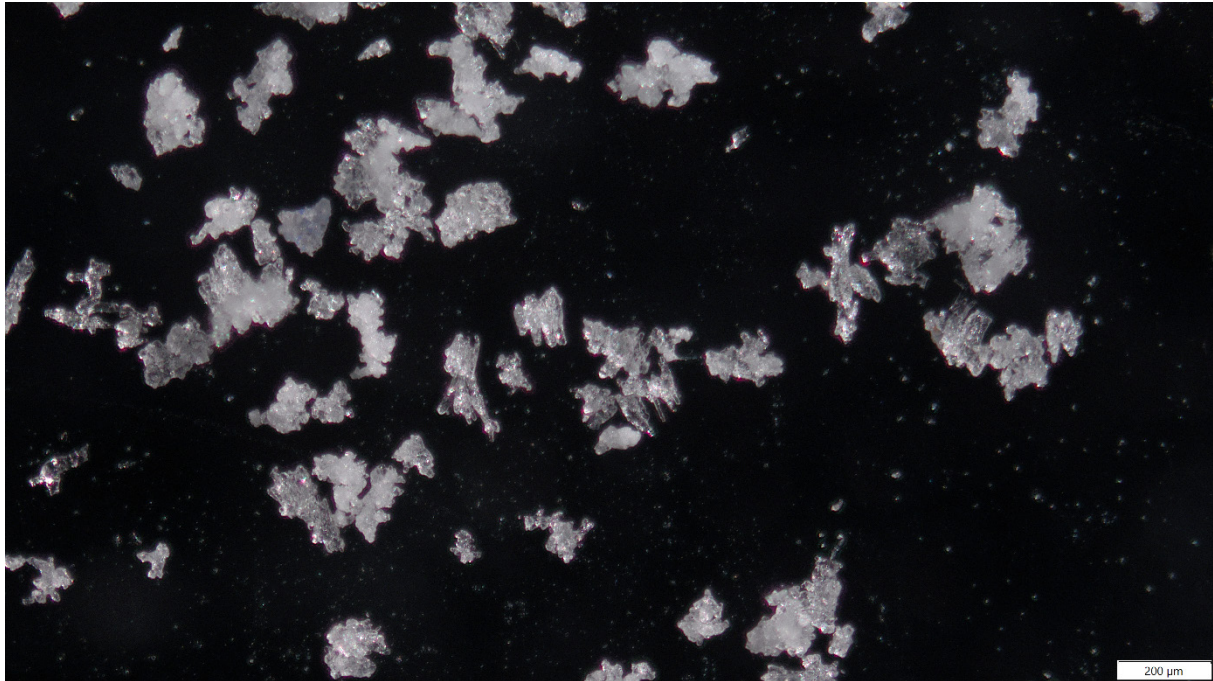
Description: transparent granular and short columnar crystals (whisker) (DF) (fig. 19).

fig. 19: transparent granular and short columnar crystals (whisker)

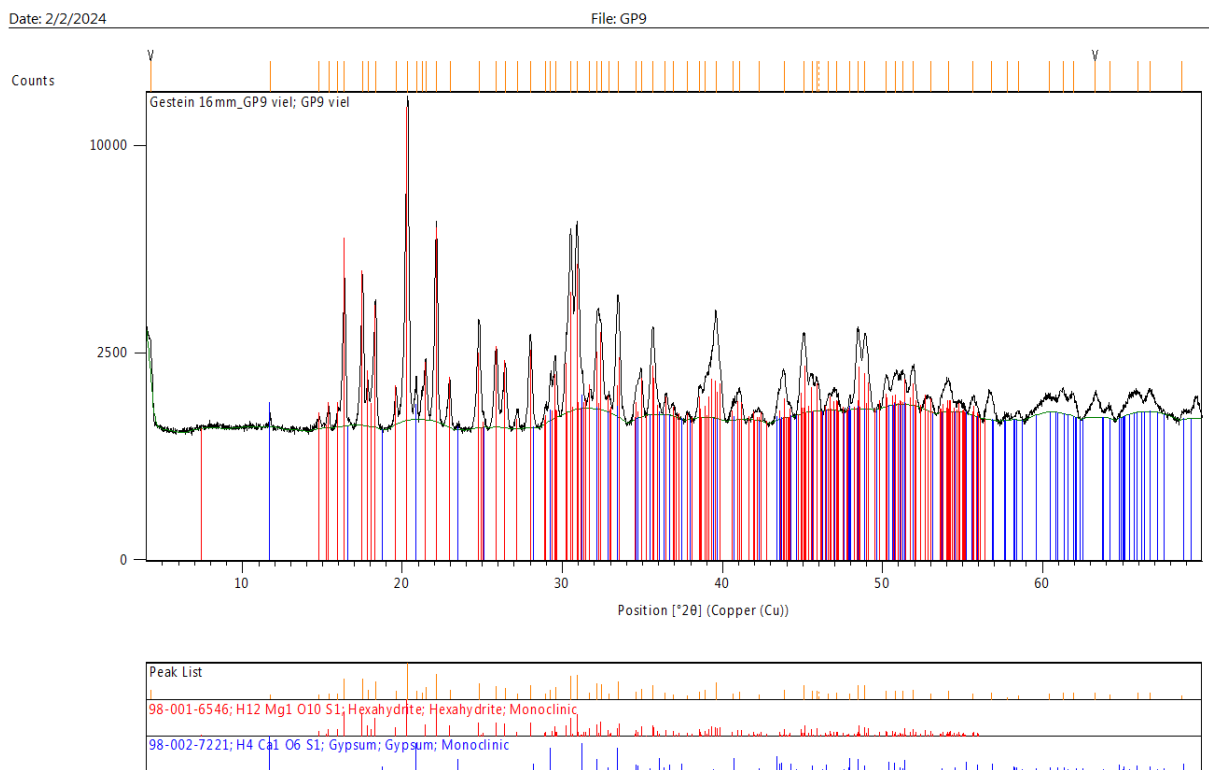
Result by XRD: mostly hexahydrite [ $\text{MgSO}_4 \cdot 6\text{H}_2\text{O}$ ] and to a much lower degree gypsum [ $\text{CaSO}_4 \cdot 2\text{H}_2\text{O}$ ] (fig. 20).

fig. 20: Sample 9, XRD spectrum

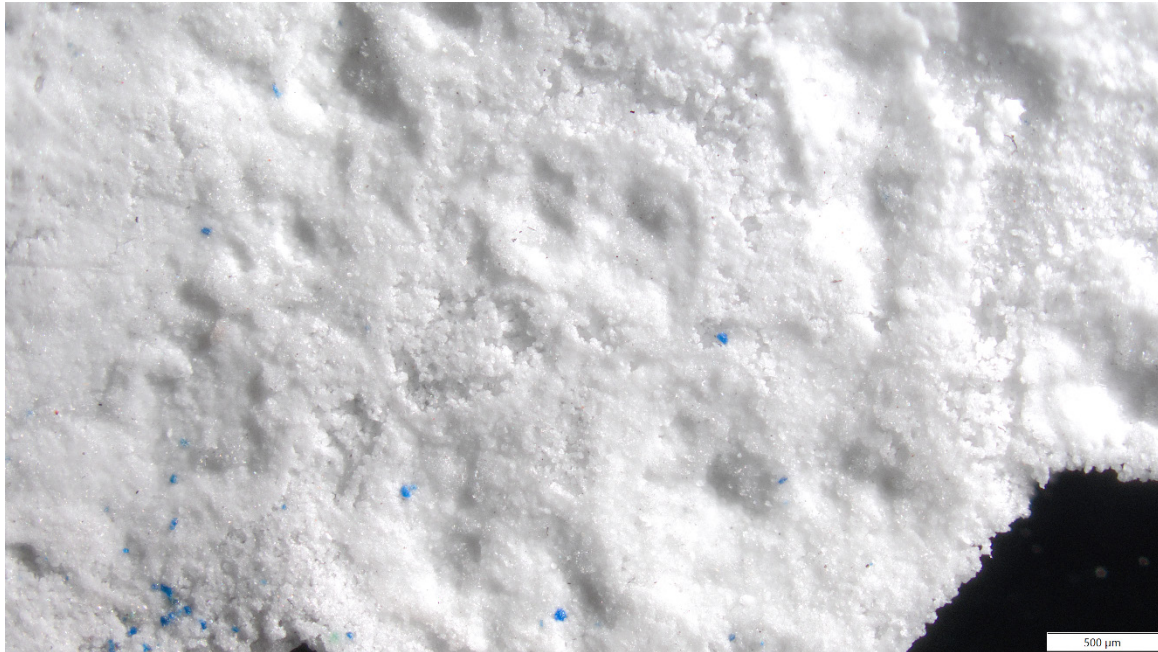
Description: white crust with blue particles (fig. 21) – similar to sample 6 and 7.

fig. 21: Sample 7, white, partly transparent crust with blue paint layer particles (DF)

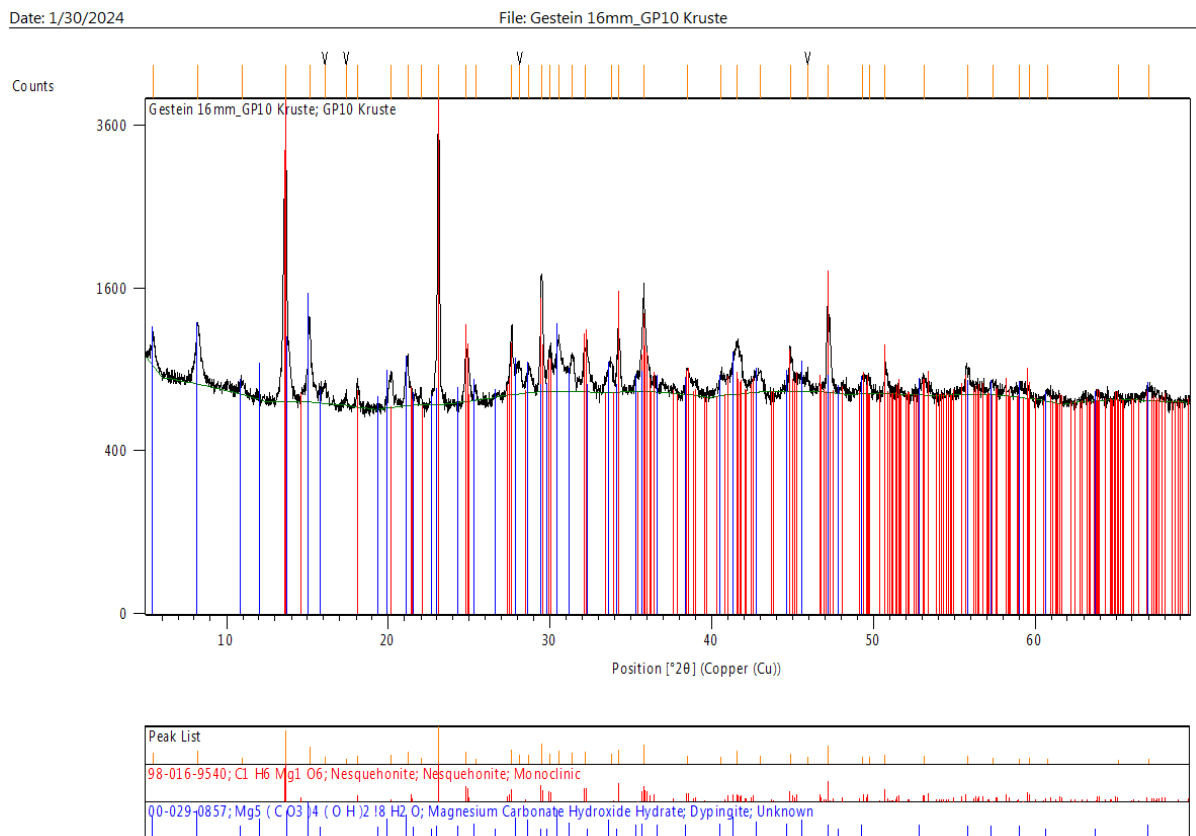
Result by XRD: mostly nesquehonite [ $\text{MgCO}_3 \cdot 3\text{H}_2\text{O}$ ], to a lower degree dypingite [ $\text{Mg}_5(\text{CO}_3)_4(\text{OH})_2 \cdot 5\text{H}_2\text{O}$ ] (fig.22).

fig. 22: Sample 10, XRD spectrum
