## **Technical assignment for conducting engineering-geological survey**

Site name – Gelati Monastery Complex Rehabilitation Project.

# Results of engineering geological survey conducted on the Gelati Monastery Complex site

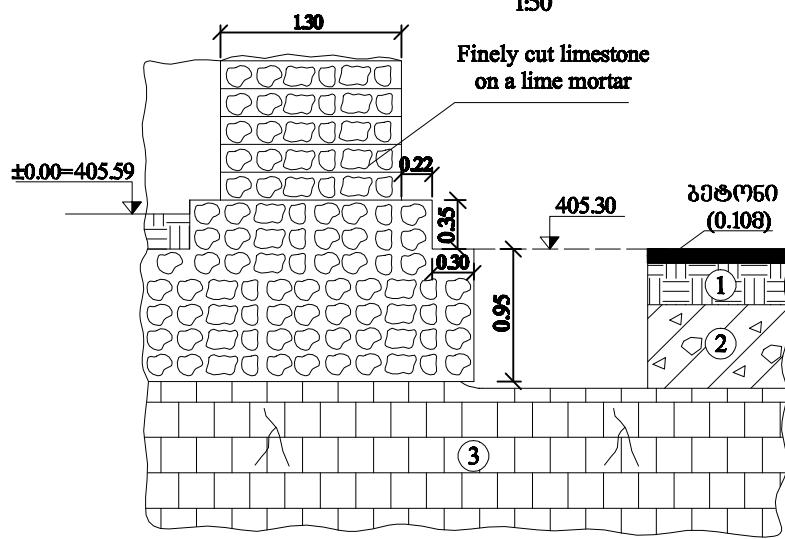
### Section of the foundation

Shaft №20							
№№	Layer depth		layer intensity	Ground surface and base point level	Section 8-80 1:50	Humidity	groundwater level anbd measurement date
	from	to					
1	0.00	0.70	0.70	400.30

2	0.70	1.40	0.70	399.60		88.9%	10.00.2018
3	1.40	1.50	0.10	399.50

All information about the foundations (dimensions, configuration, base-soil) is given in the graphic material (sheets №№ 3-10) - under the geological-lithological logs of the test pits - on the drawings of the foundations, made on a scale of 1:50. The foundations of the buildings are also indicated on geological cross-sections.

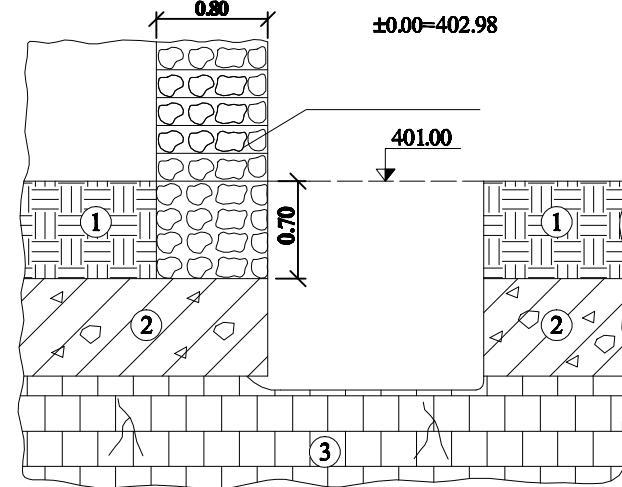
## Section of the foundation 1:50

NNE	Layer depth		layer intensity	Ground surface and base point level	Section Ө-Ө0 1:50	Humidity	groundwater level anbd measurement date	
	from	to					858.	2023
1	0.00	2.10	2.10	403.20

The shaft was not cut deep due to the presence of the earlier building foundation

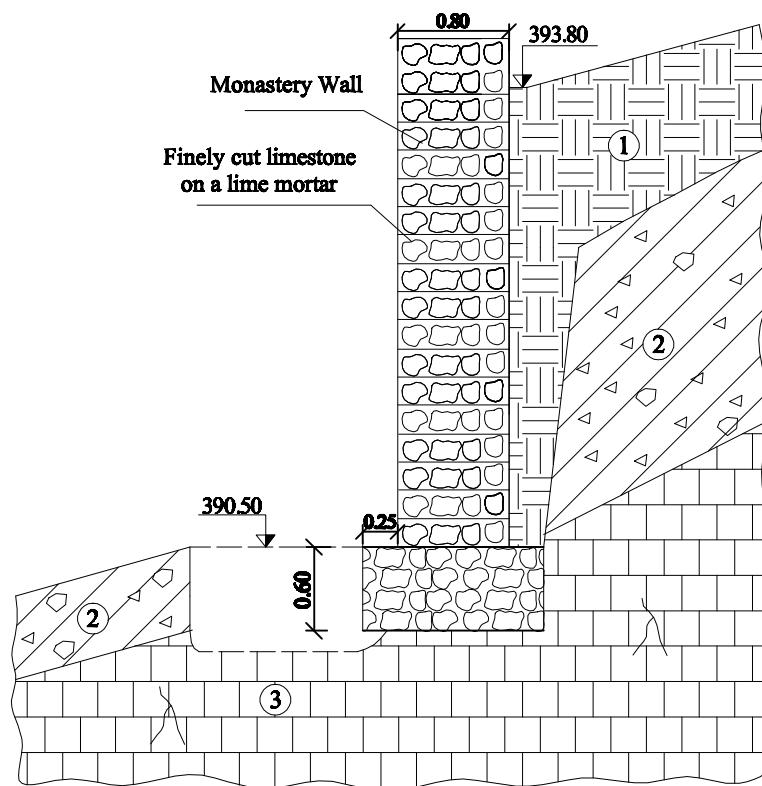
## Section of the foundation 1:50

NNE		Layer depth		layer intensity	Ground surface and base point level	Section 0-00 1:50	Humidity	groundwater level anbd measurement date	
from	to							390.50	390.50
1	0.00	0.60	0.60		389.90			2	
2	0.60	0.75	0.15		389.75			3

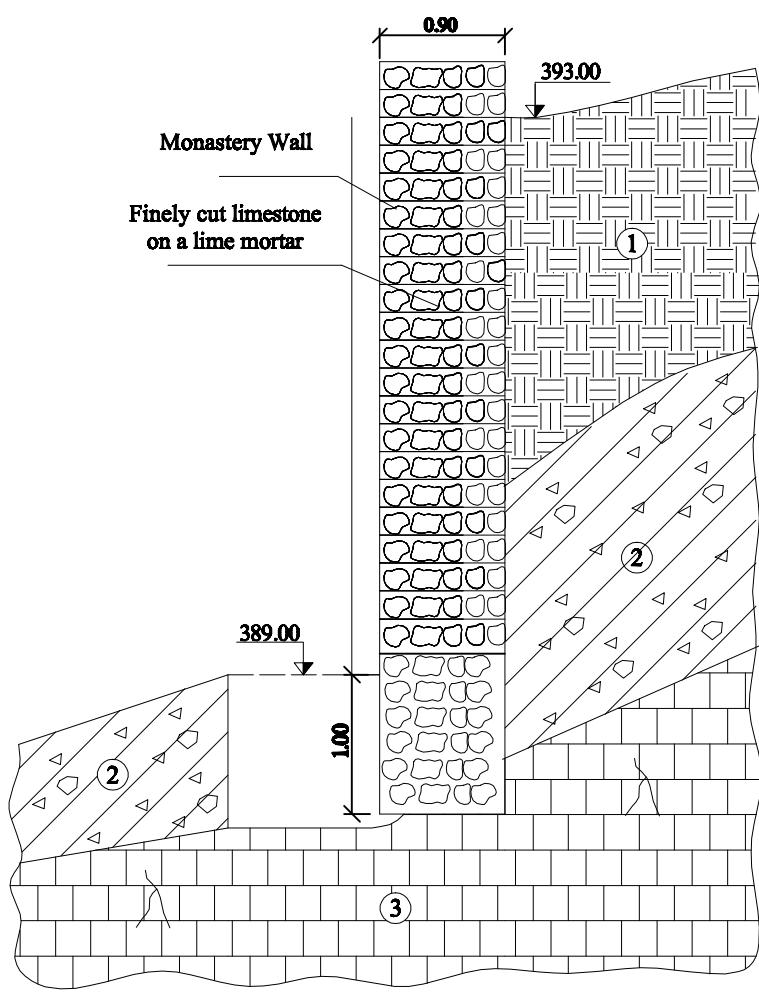
Section of the foundation  
1:50

№№	Layer depth		layer intensity	Ground surface and base point level	Section 0-00 1:50	Humidity	groundwater level anbd measurement date
	from	to					
				389.00			
1	0.00	1.00	1.00	388.00			
2	1.00	1.00	0.10	387.90

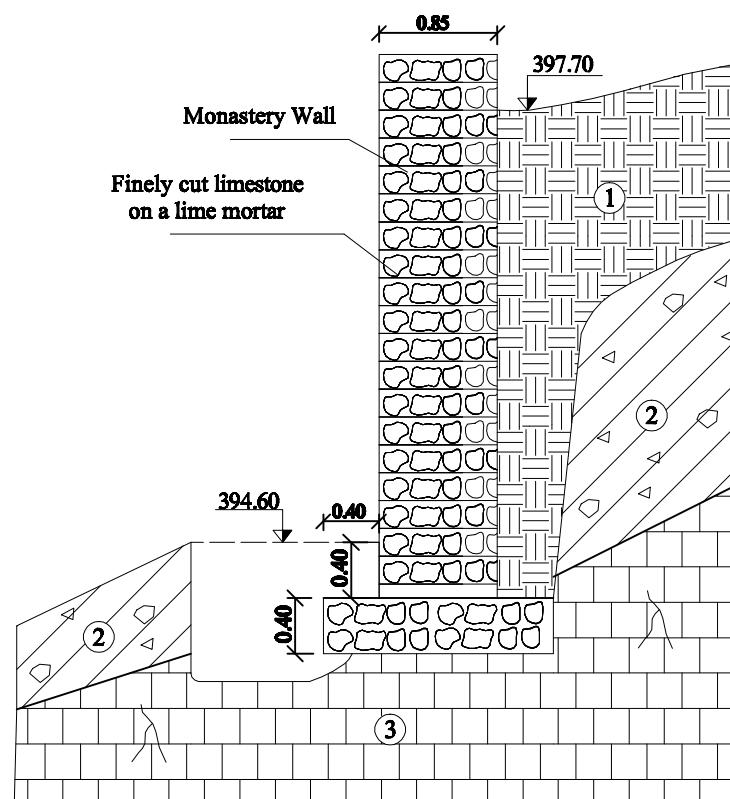
Section of the foundation  
1:50

Shaft №27

№№	Layer depth		layer intensity	Ground surface and base point level	Section 0-00 1:50	Humidity	groundwater level anbd measurement date
	from	to					
				394.60			
1	0.00	0.80	0.80	393.80			
2	0.80	1.00	0.20	393.60

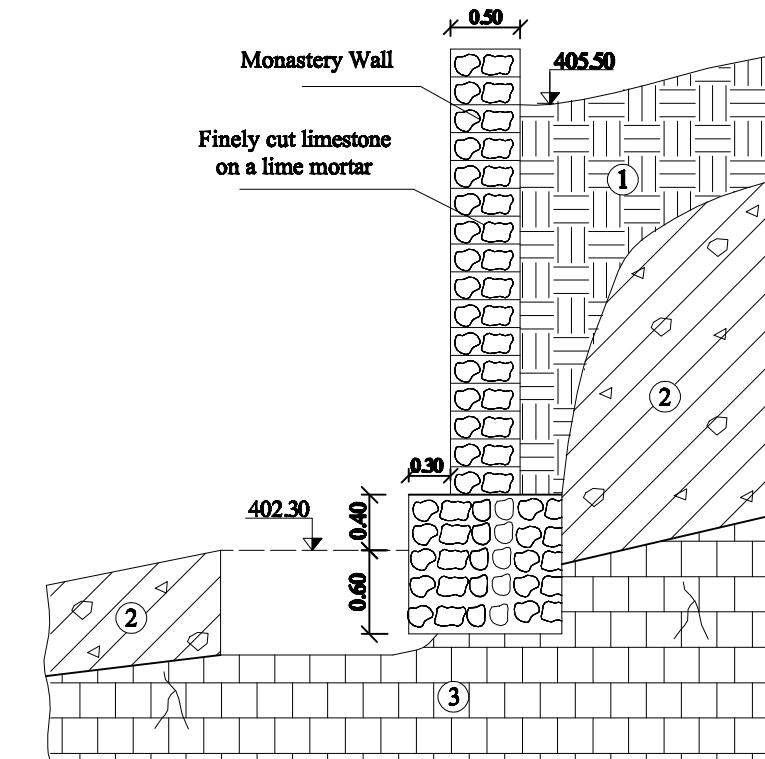
Shaft №28

№№	Layer depth		layer intensity	Ground surface and base point level	Section 0-00 1:50	Humidity	groundwater level anbd measurement date
	from	to					
				402.30			
1	0.00	0.60	0.60	401.70			
2	0.60	0.75	0.15	401.55

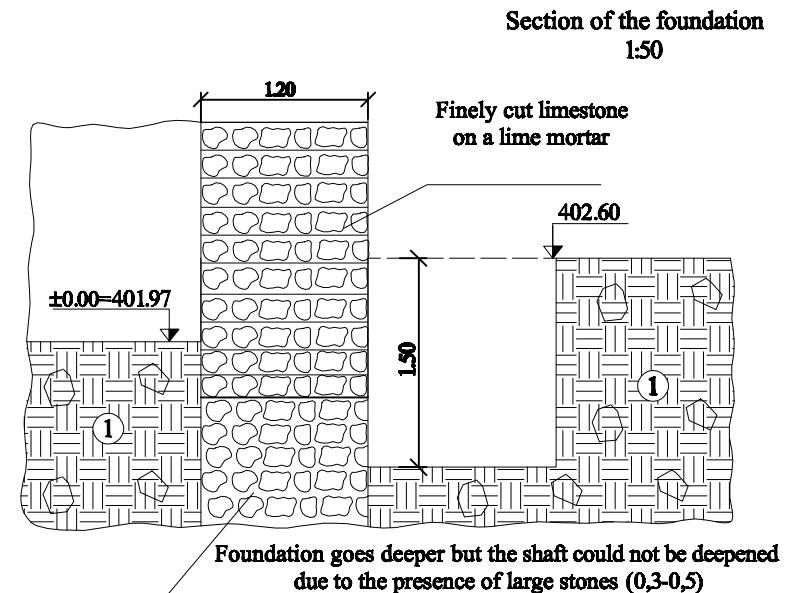
### Loose Gravel with clay and gravel mix

Clay brown, halfsolid-plastic with gravel and single stones (30-40%)

main rock - limestone, dolomitized, with kracks

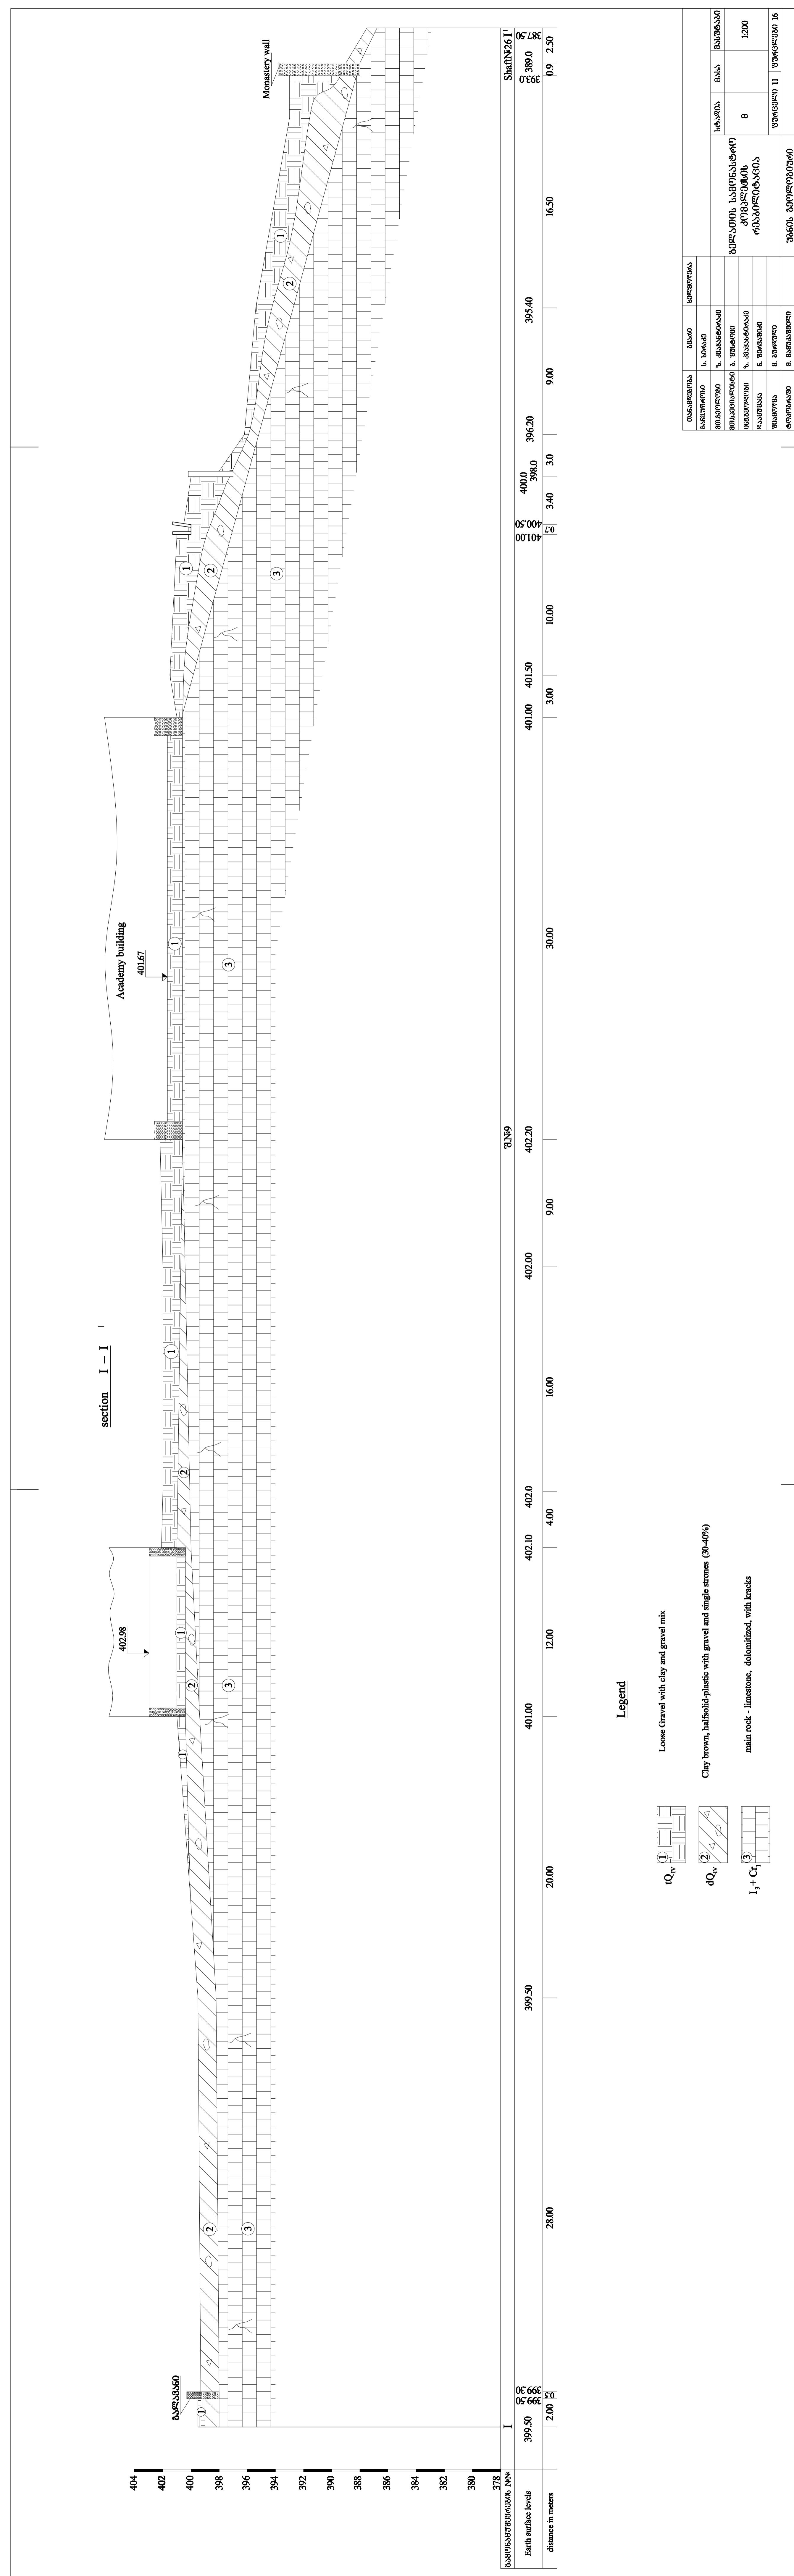
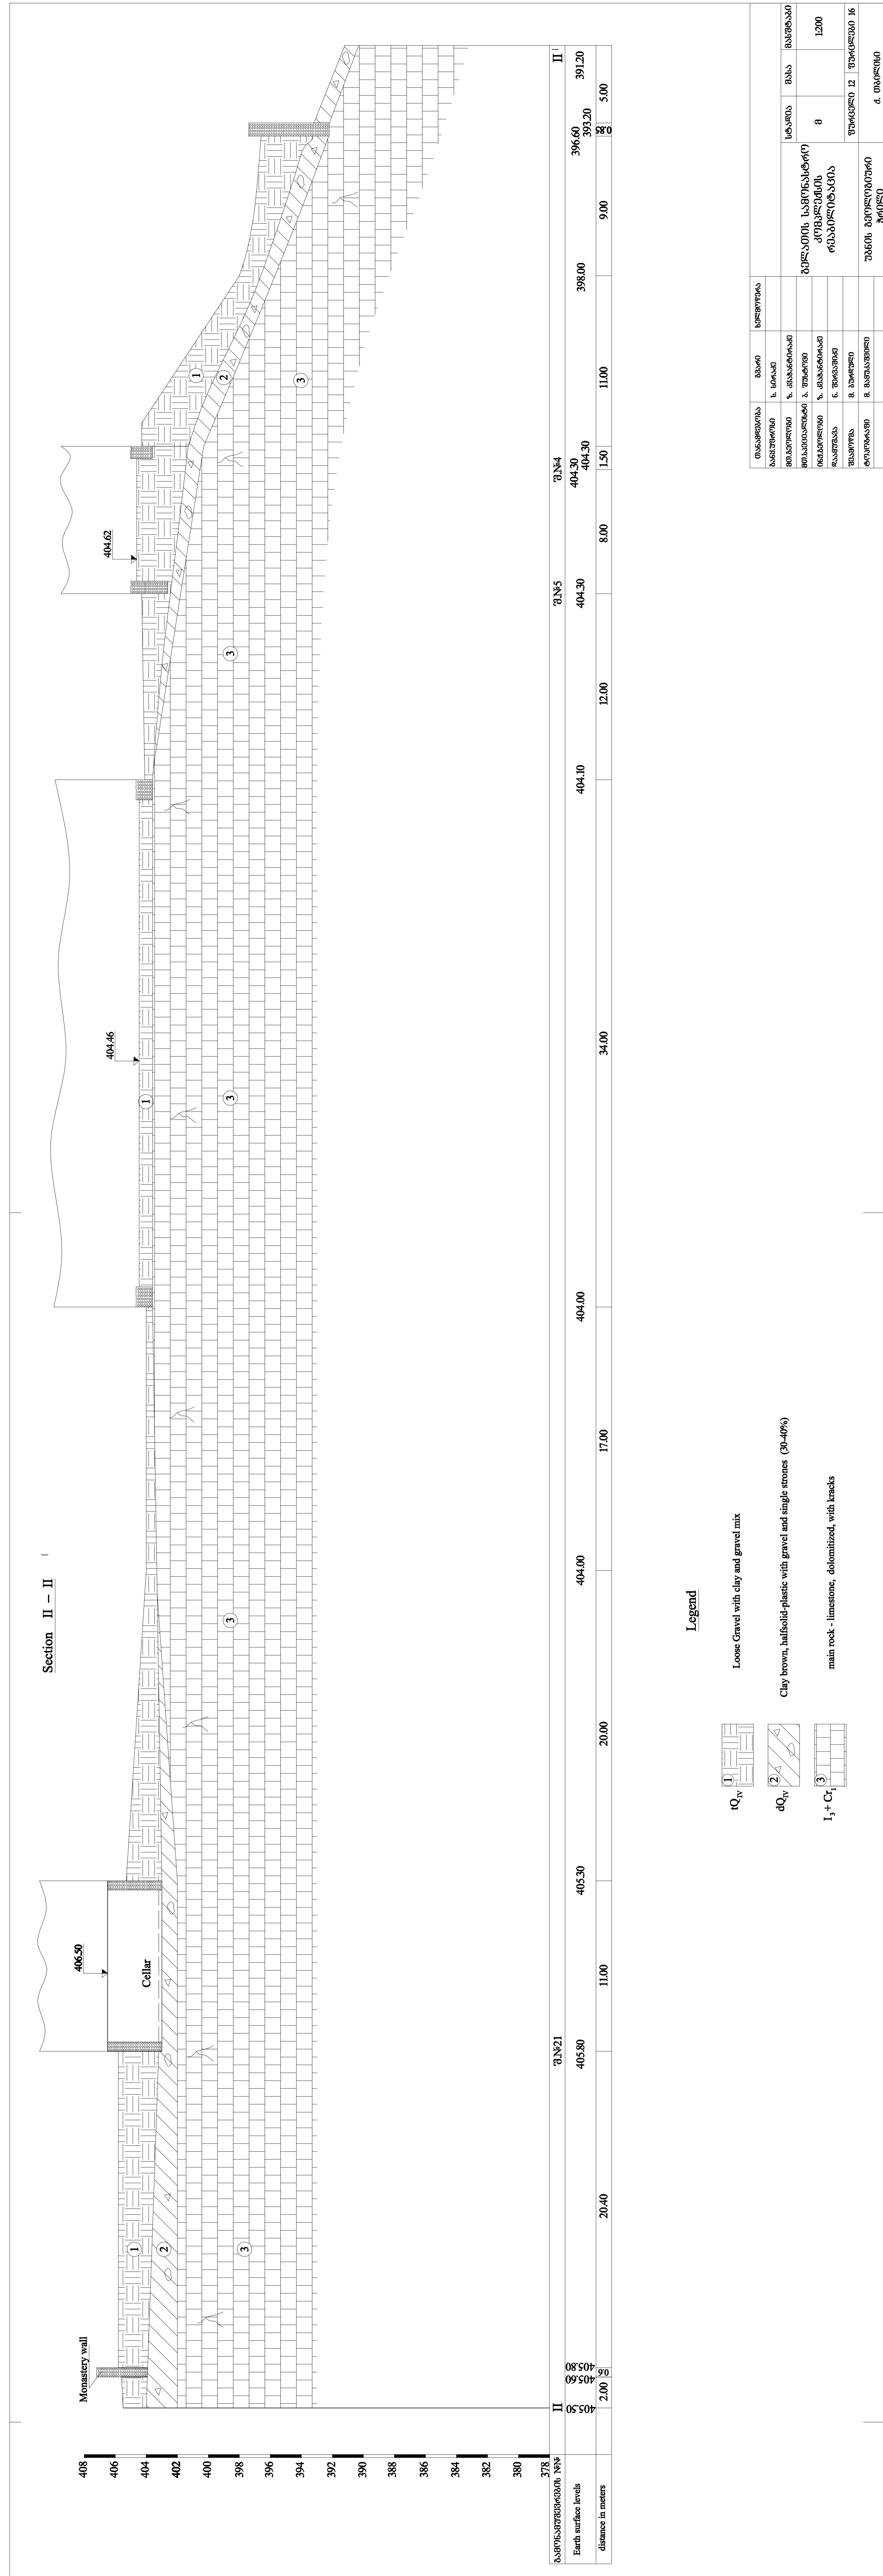
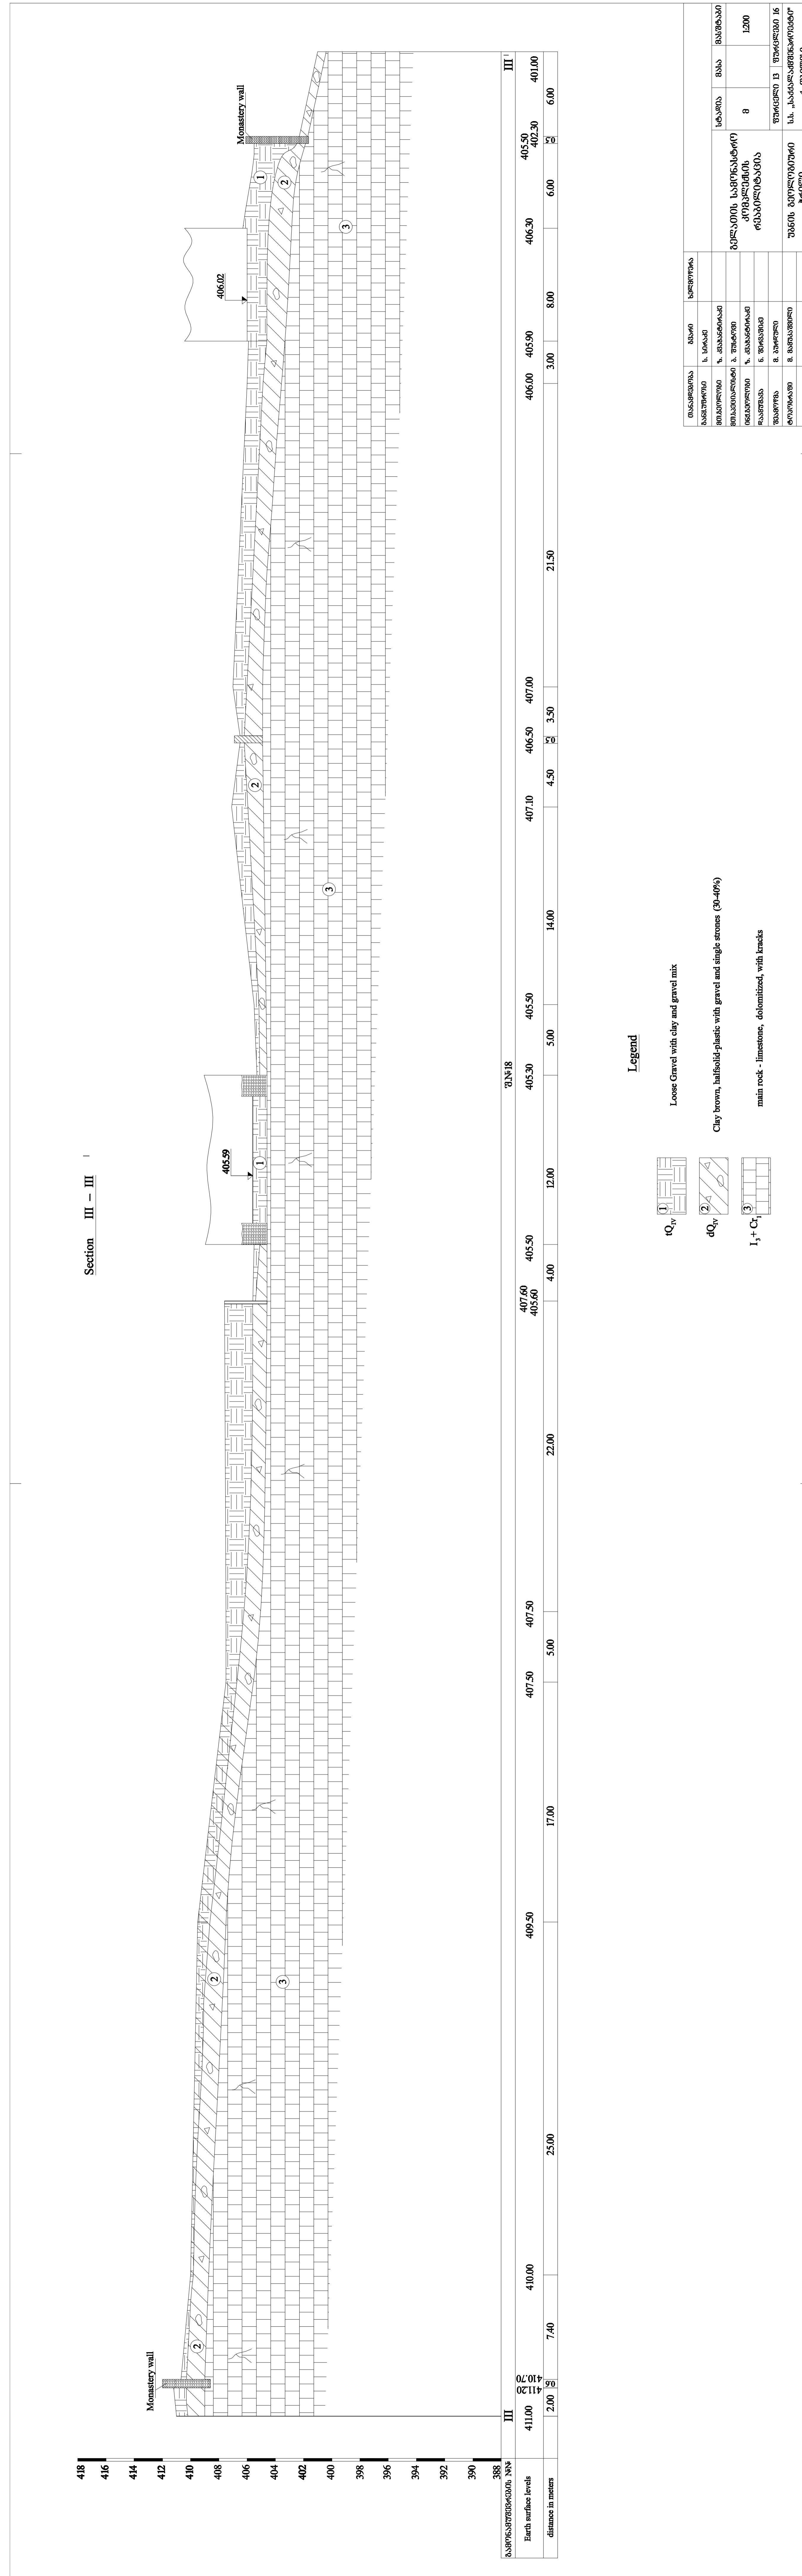
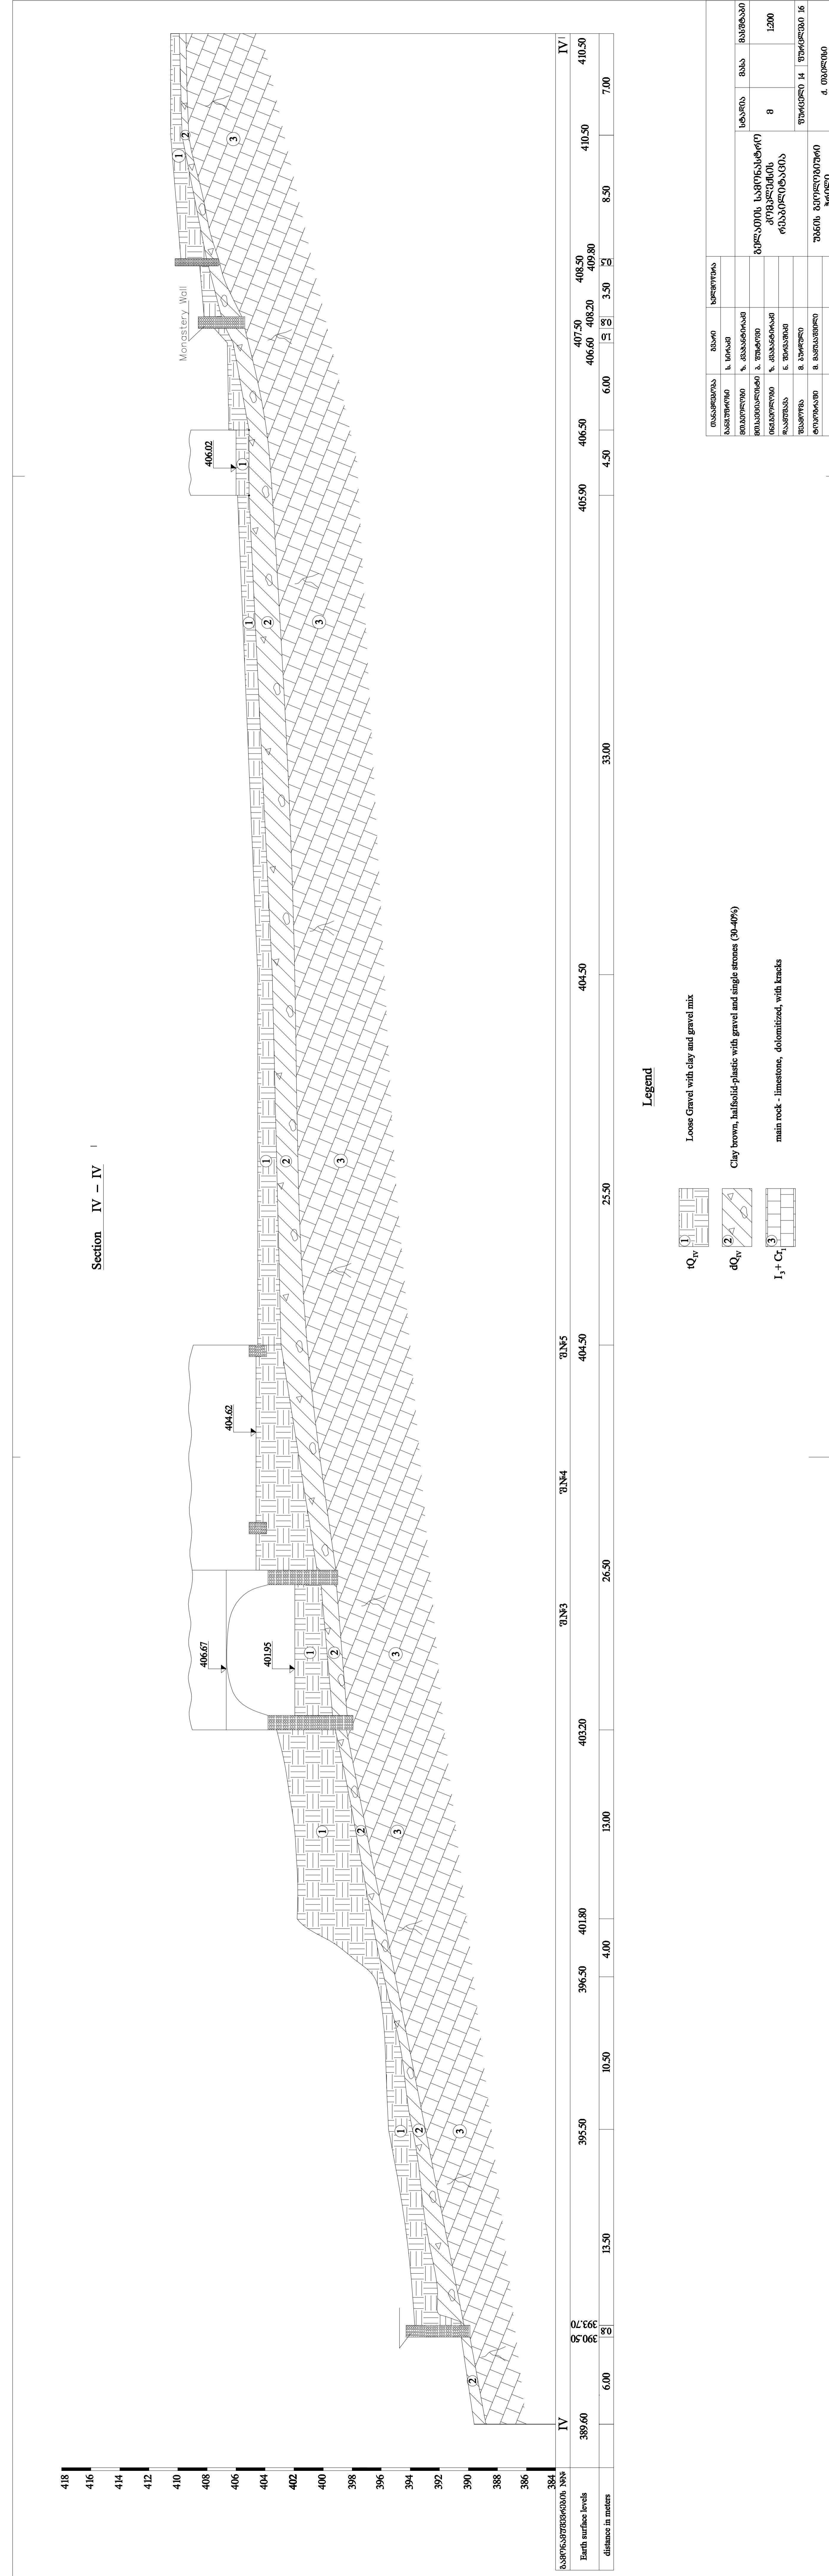
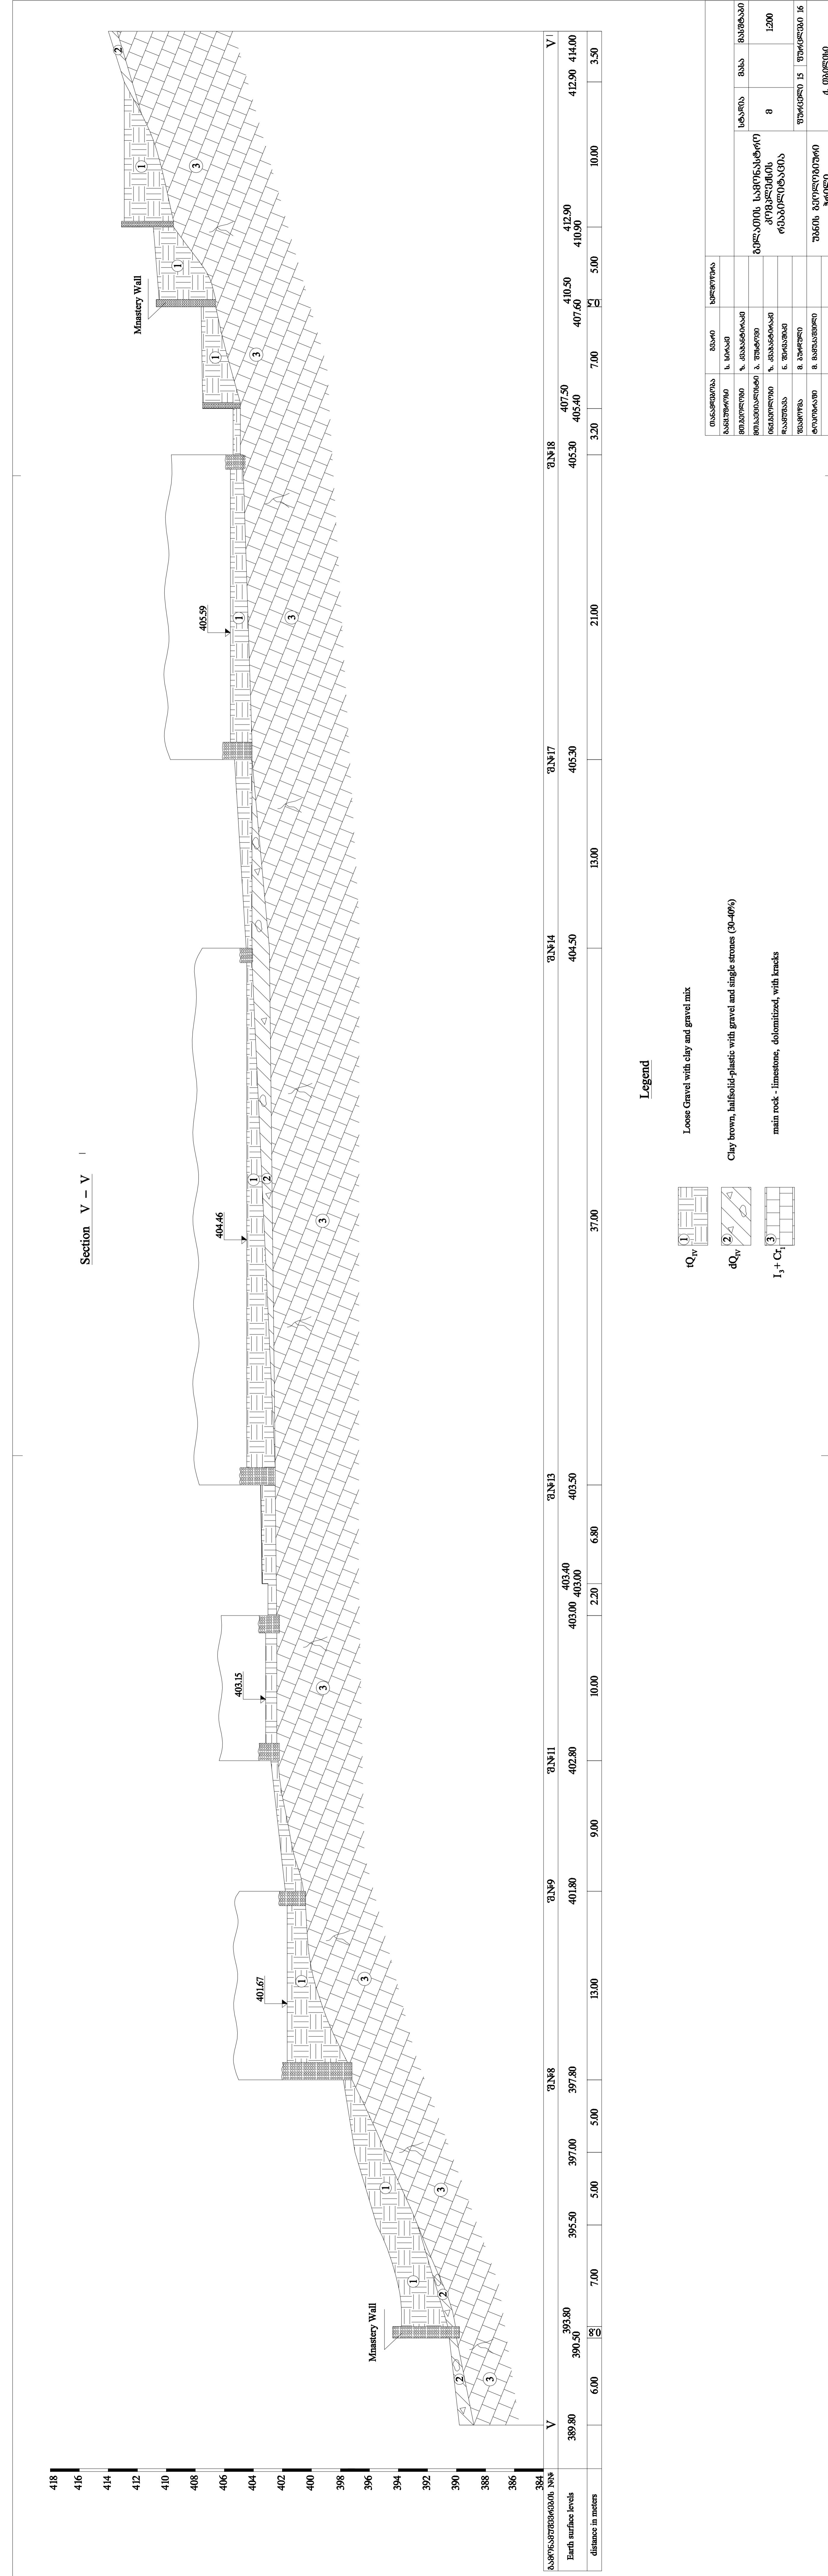
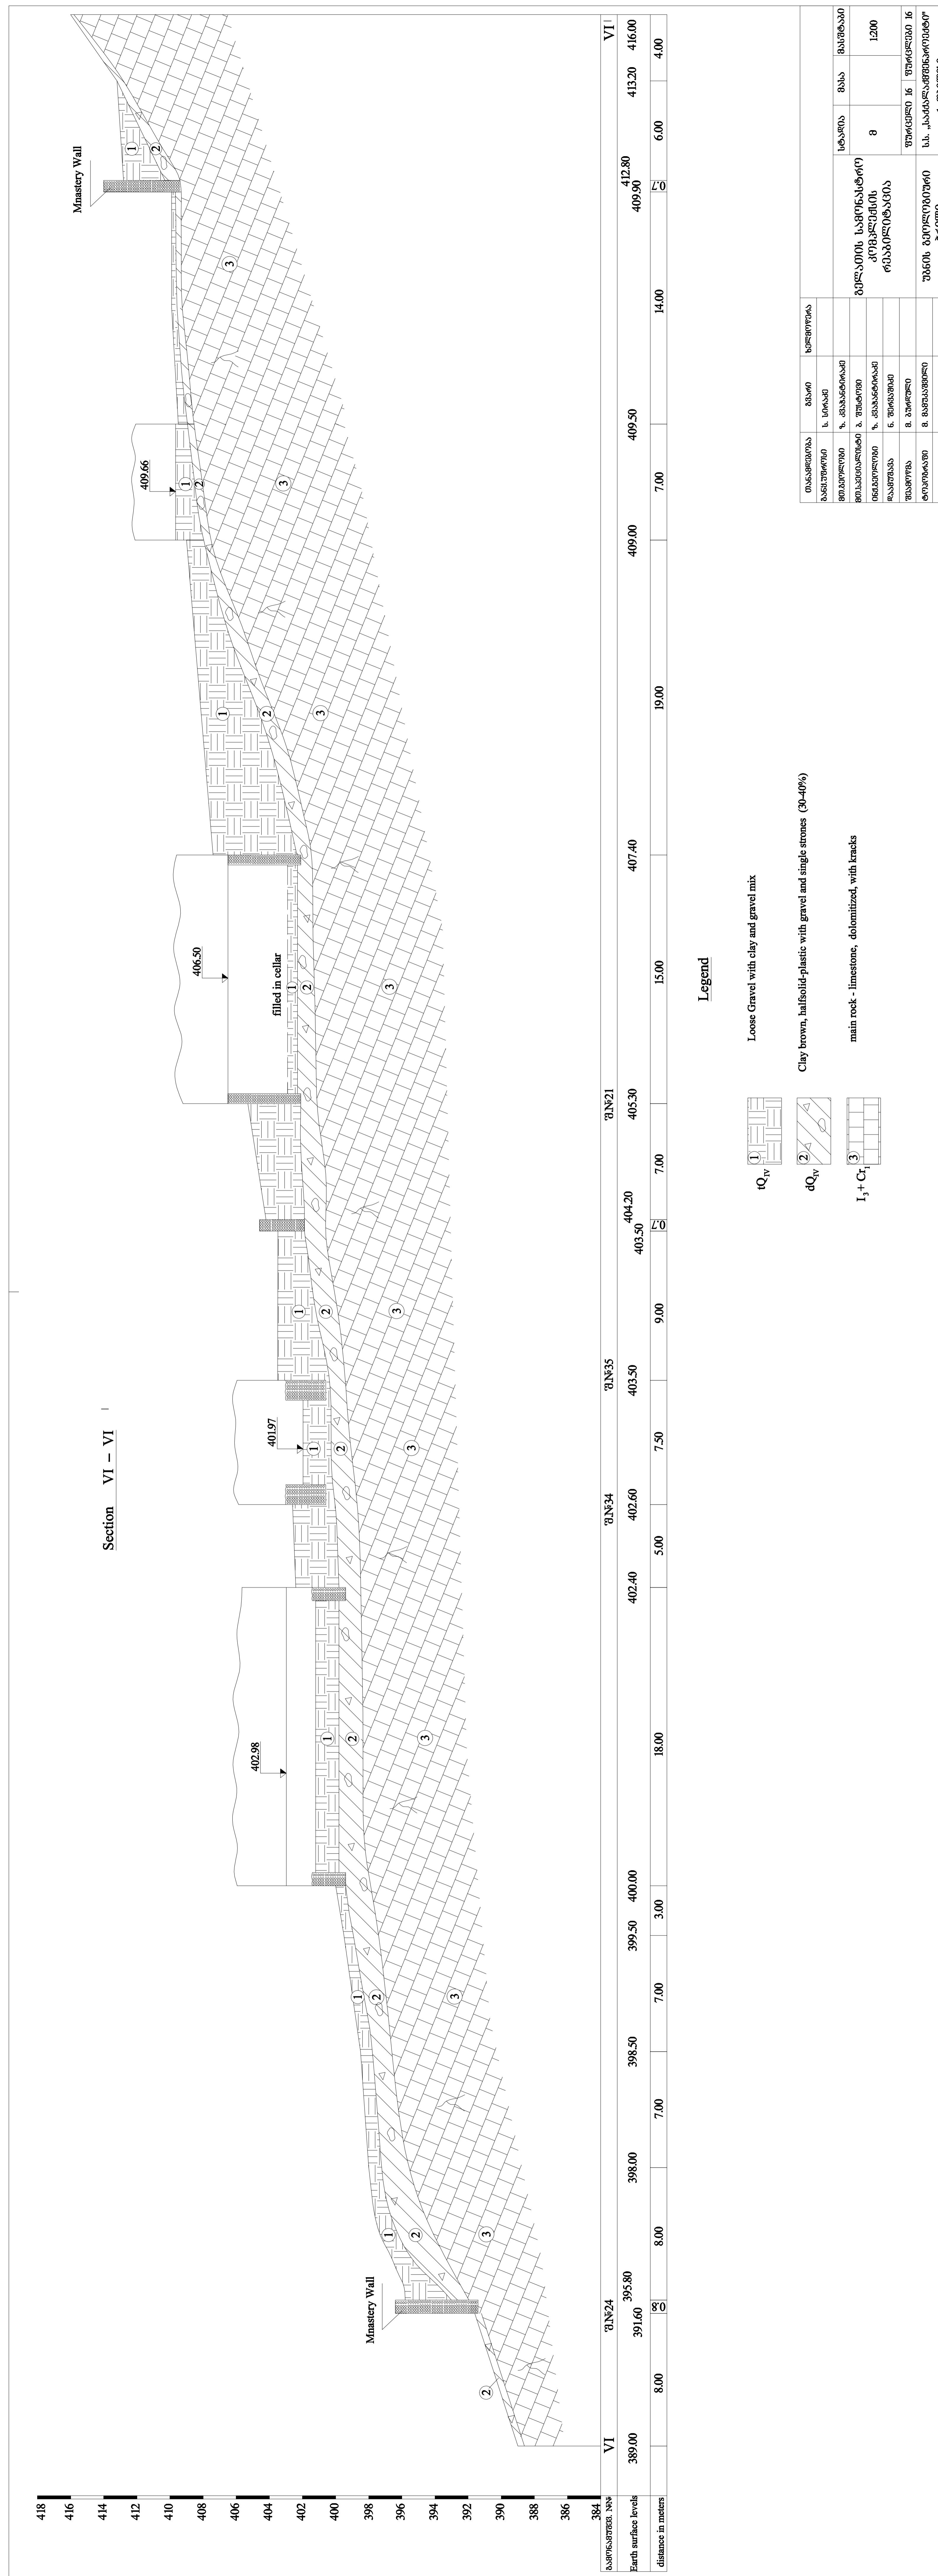
- Geological-lithological logs of the test pits, with foundation cross-sections. (sheets №№ 3-10);
- Longitudinal and transverse geological cross-sections of the complex area (sheets №№ 11-16).

The cross-section lines are drawn on all the main buildings of the monastery ensemble, in order to better represent the geological and foundation conditions. The geological cross-sections are also oriented on the bedding elements - dip and strike of the bedrock, and accordingly, the rock inclination on the cross-section is shown without distortion along the strike - horizontally, along the dip - with maximum inclination (the cross-section lines are slightly rotated relative to the strike and the correction angle is also insignificant).
