# Report on the Safeguarding and Conservation of Gelati Monastery

## World Heritage Site, Georgia

### Overview

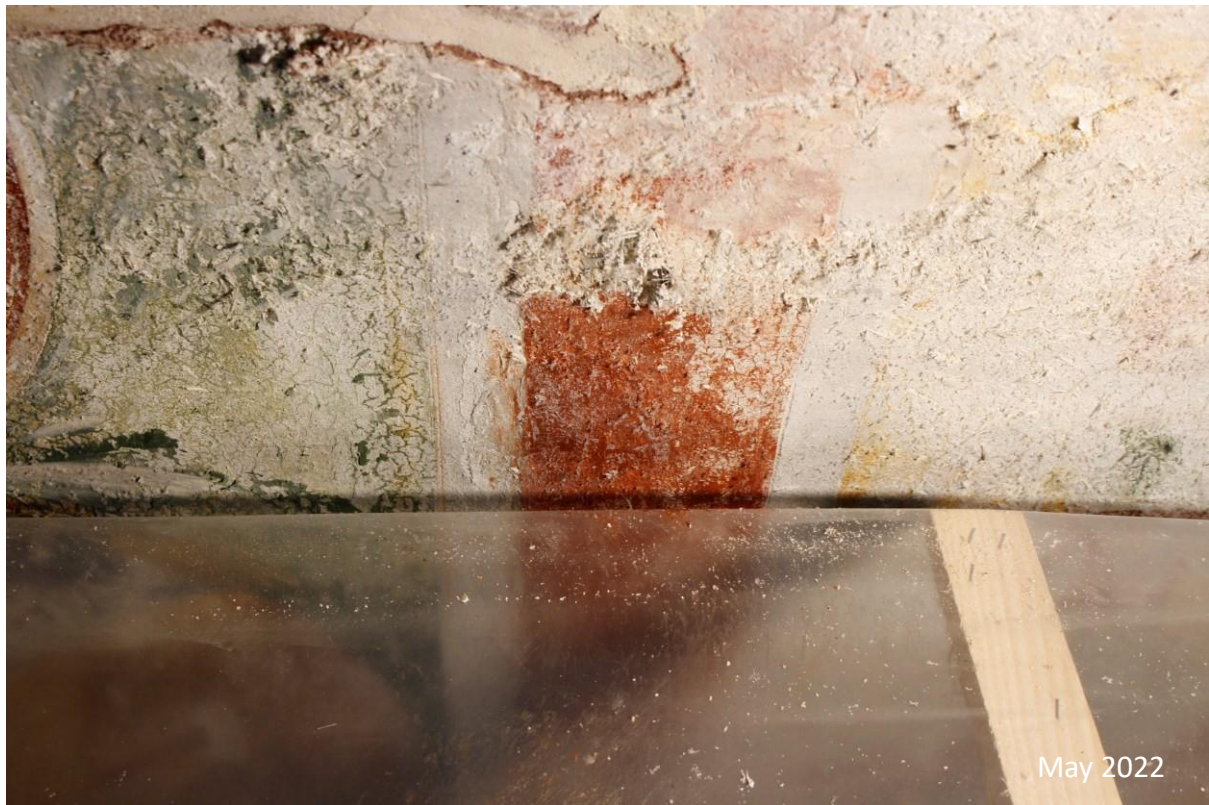
Figure 1 Active deterioration is apparent with widespread presence of crystallised salts on the surfaces of the paintings and ongoing paint loss, seen here on 2 May 2022 with newly accumulated paint fragments on the plastic sheeting.

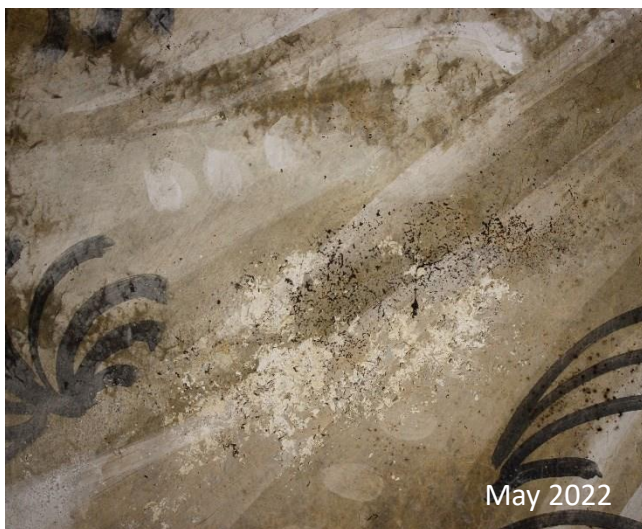
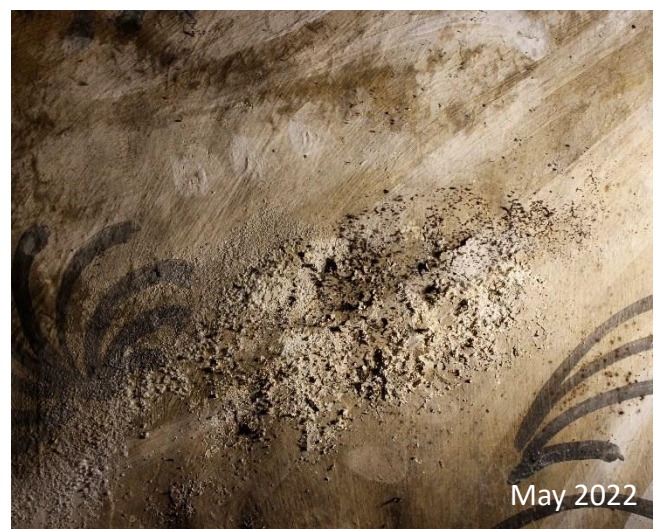
Figure 2a and 2b. Area of microbiological growth and salt efflorescence in incident (left) and raking light (right) on the east face of the vault on the west arm.

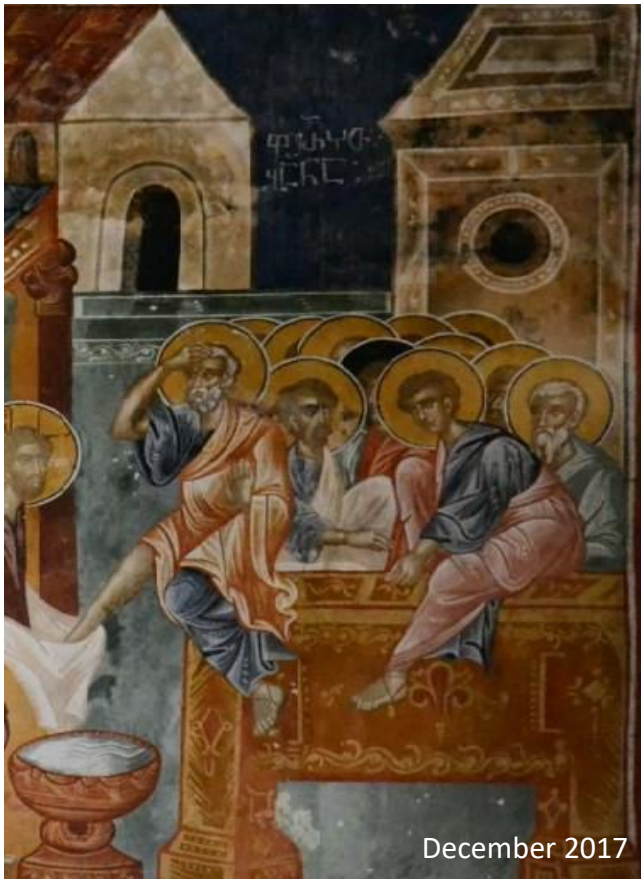
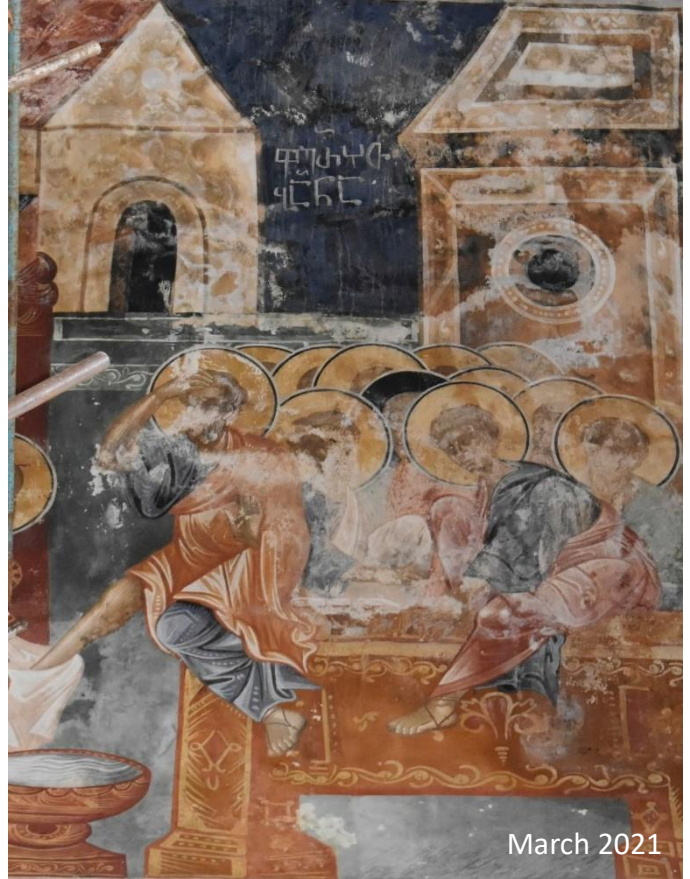
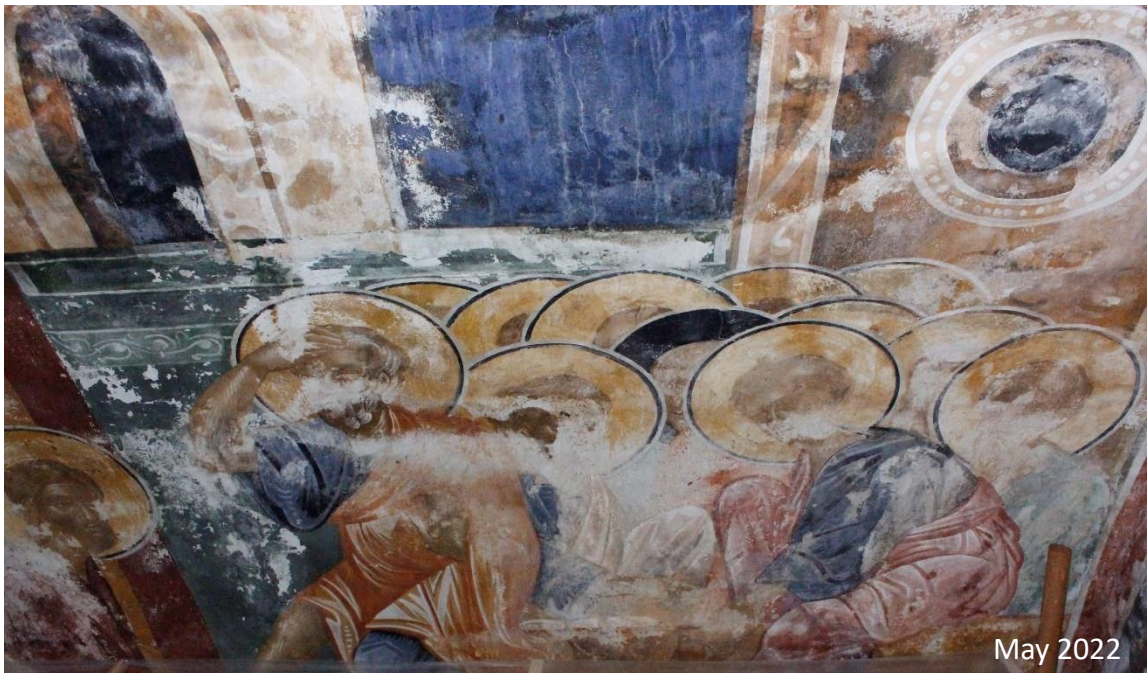
Figure 3a, 3b and 3c. Images of the west arm vault, south side in December 2017, March 2021 and May 2022 show the severity and ongoing nature of the current deterioration due to moisture and salt activity.

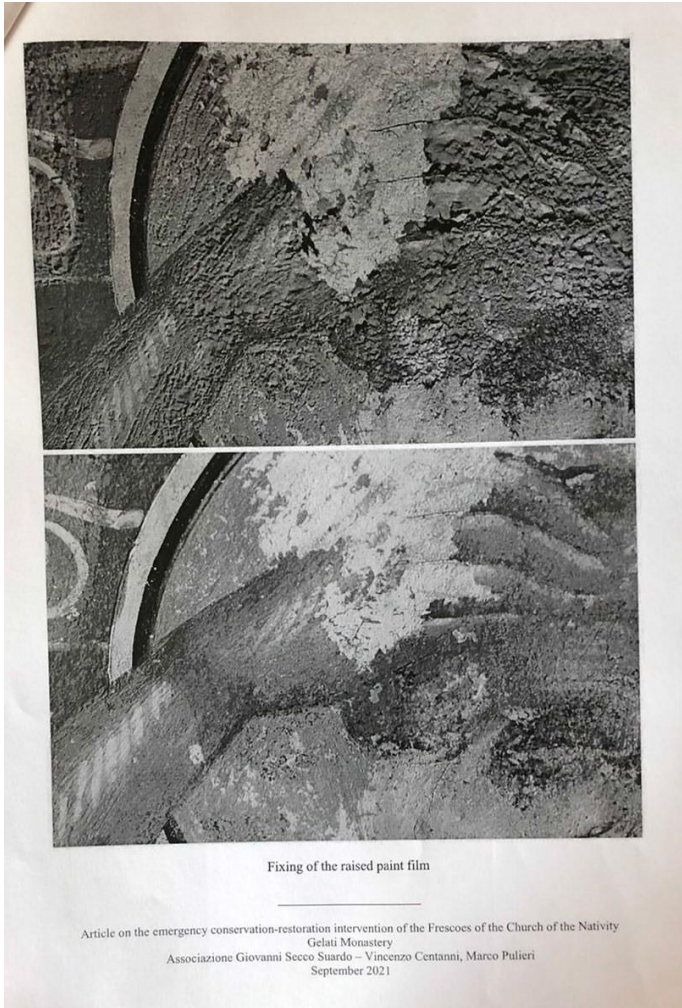
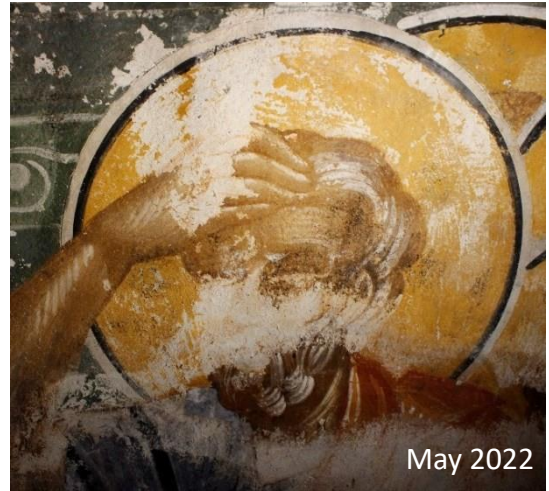
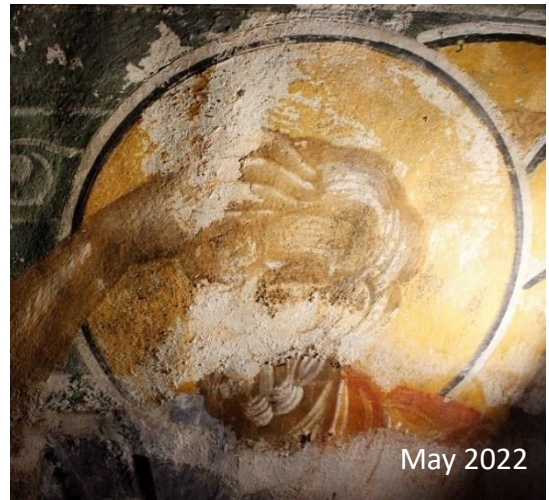
Though complete documentation of treatments undertaken in June and September 2021 was not available, salt efflorescence was observed in one of the recently treated areas during the May 2022 on-site inspection (see Figures 4a-c). Close monitoring of the condition of all treated areas was not provided and should be regularly undertaken and fully documented with macrophotography and raking light images.<sup>6</sup>

Figure 4a. Black and white images (above, left) show before and after treatment undertaken in September 2021 to desalinate and fix areas of flaking paint. Figure 4b and 4c. Color images (above, right) show the same area in incident (top) and raking light (below) in May 2022. Salt efflorescence appears to be recurring in the lower right raking light image. Moreover, the black areas of microbiological growth on the left of the face suggest that the surface is damp.

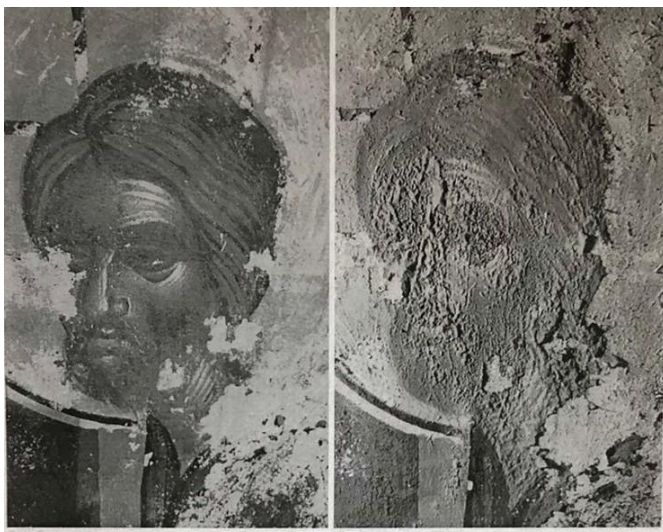
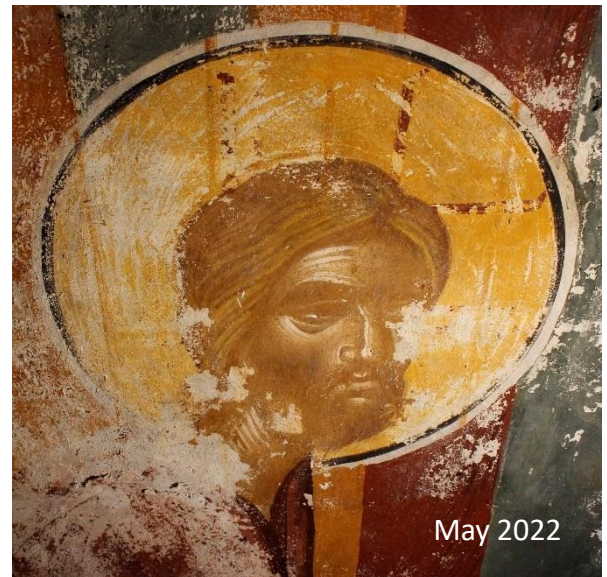
Figure 5a. Black and white (above, left) show before and after treatment undertaken in September 2021 to desalinate and fix areas of flaking paint. Figure 5b. Color images (above, right) show the same area (n.b. the black and white images have been flipped) in May 2022. Treated areas should be carefully monitored to assess any change in condition.
