Gelati Monastery Complex

The Church of the Nativity of the Virgin Mary

Wall Painting Technology and Condition Assessment & Documentation

December 2023

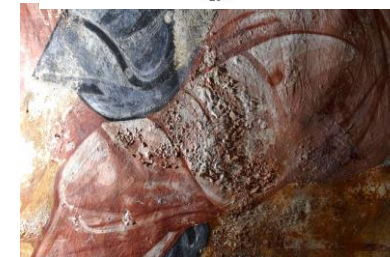
To the left: photos taken before and after conservation. Buchukuri M. the Church of the Nativity of the Virgin Mary, Gelati - report of the conservation/restoration works of the XVI century wall paintings in the west arm arch 2022, pages. 22,23

Bottom left photos: Photos taken at the same locations on October 14, 2023. Preserved areas show more severe forms of deterioration.

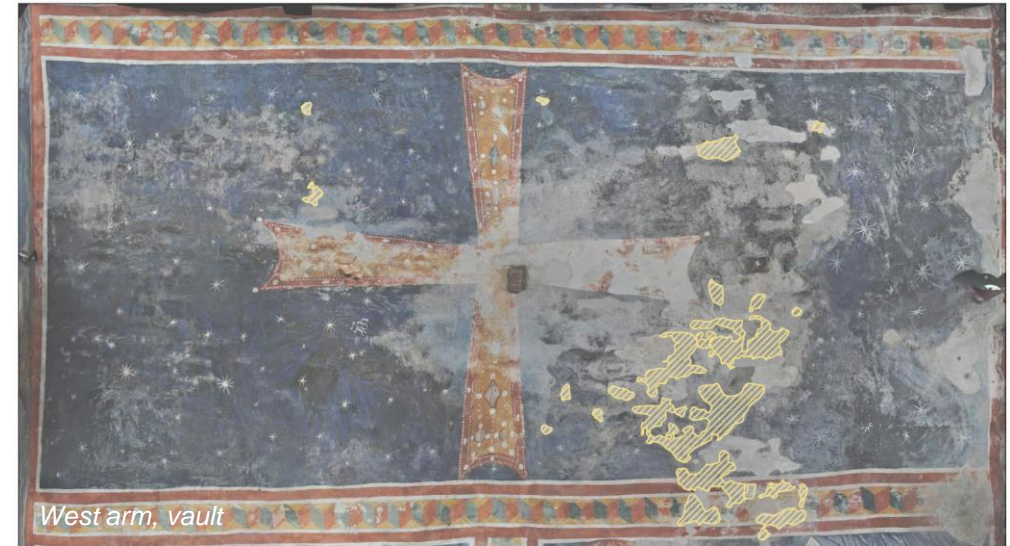
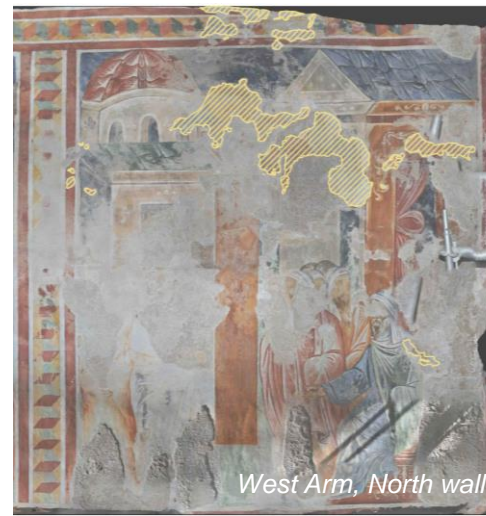
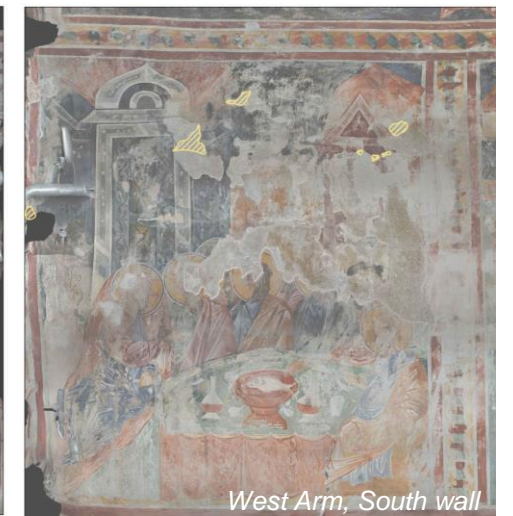
above: Areas of early paint layer distribution are marked in yellow

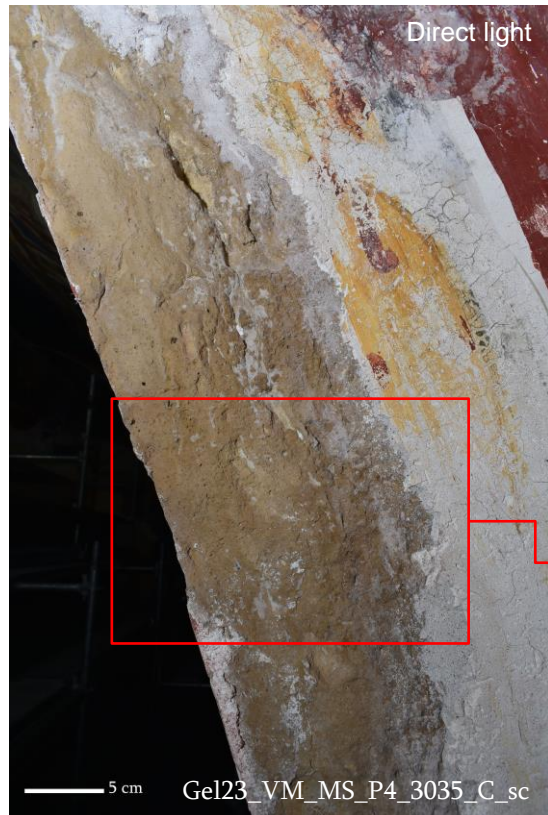
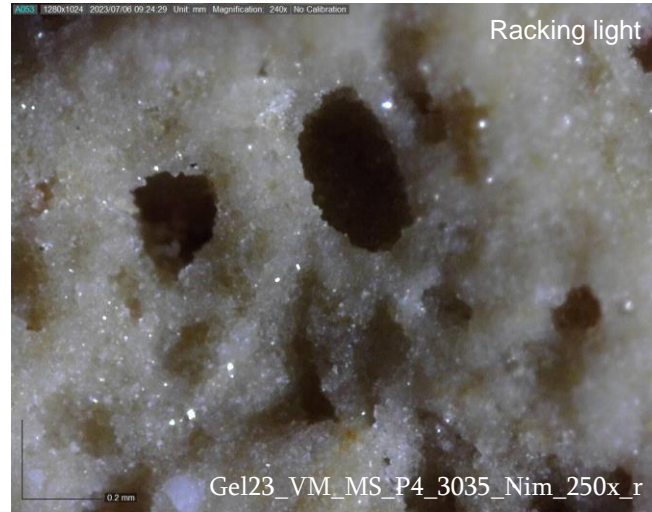
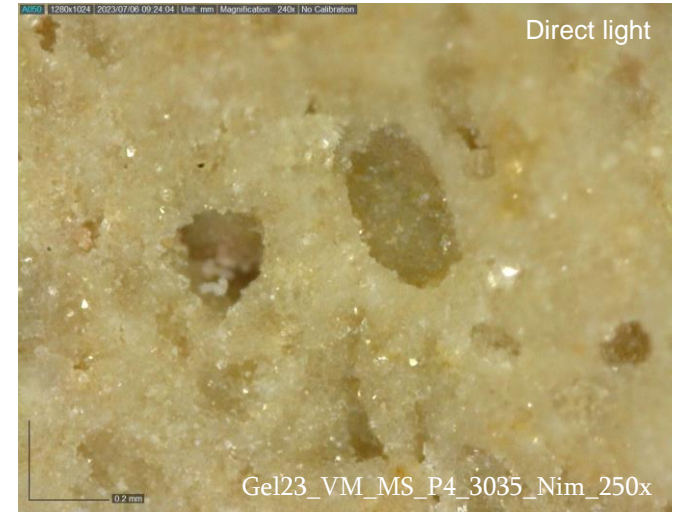
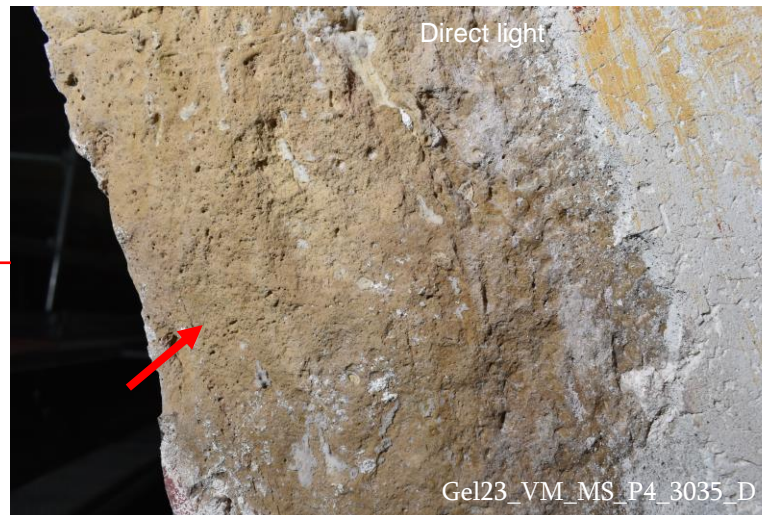
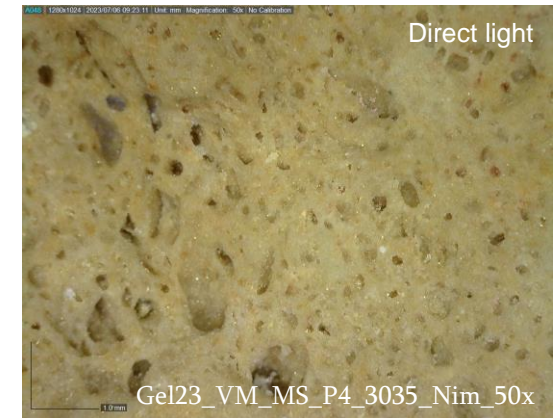
Primary support (stone) subtype 3

Right and bottom : North part of the arch of the west arm of the main space, context and macro photos, as well as microscopic photos at 50x and 250x magnification. The photos illustrate an example of sub-type 3 of the primary support (stone).

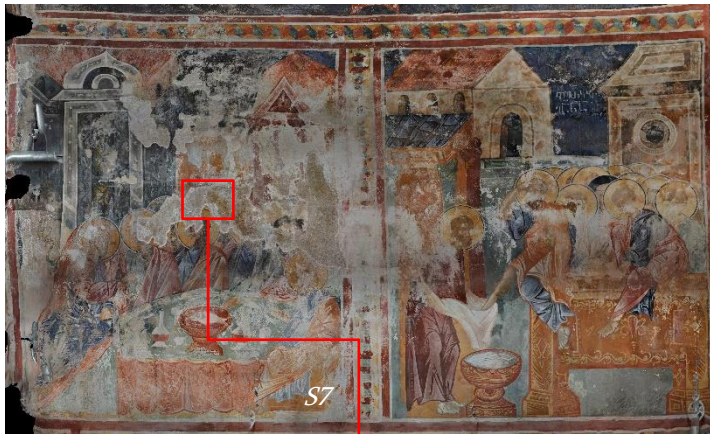
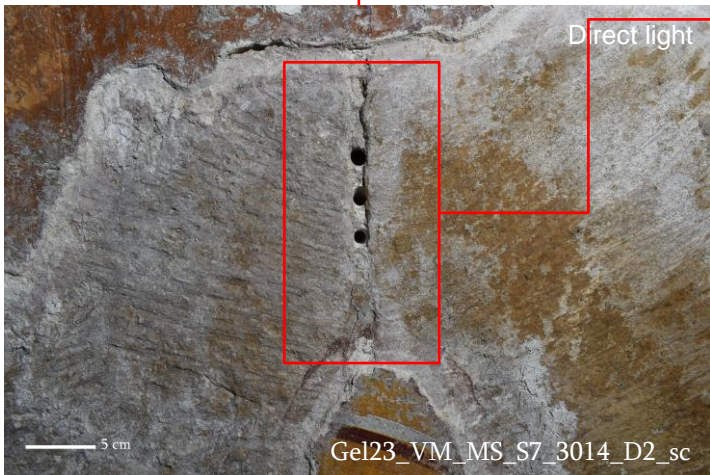
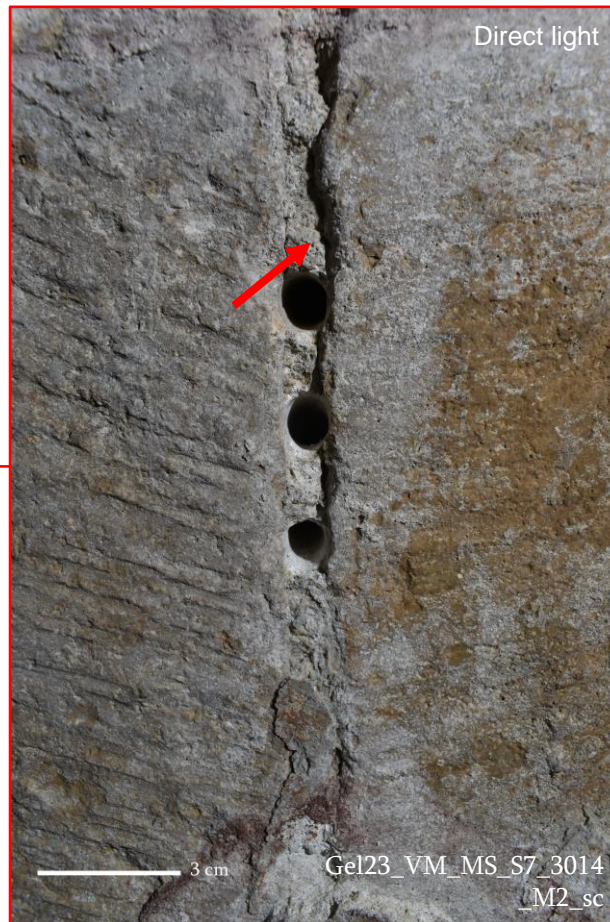
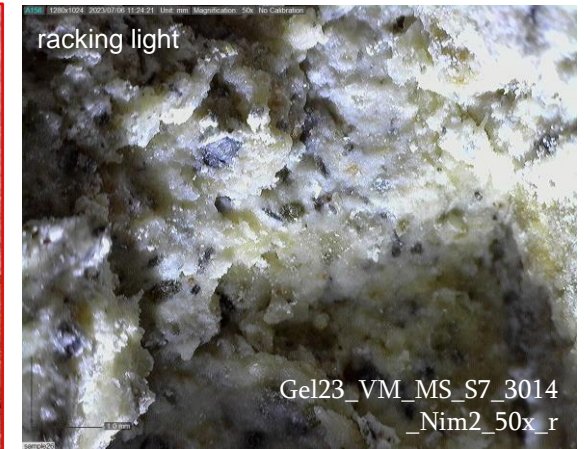
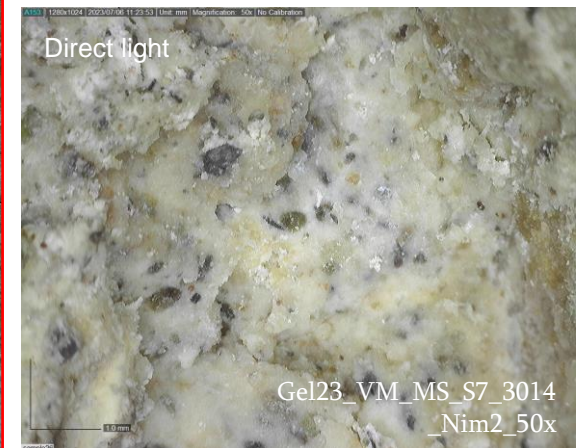
Mortar

photos: South wall of the west arm of the main space, context, detail and macro photos. Also, microscopic photos at 50x and 250x magnification. The photos illustrate the mortar in the stone joints (similar to the plaster of early wall painting, see the plaster type 4.2.1.2)

Note: The holes shown in the photos are traces of invasive studies carried out by Studio Massar in 2021-22.

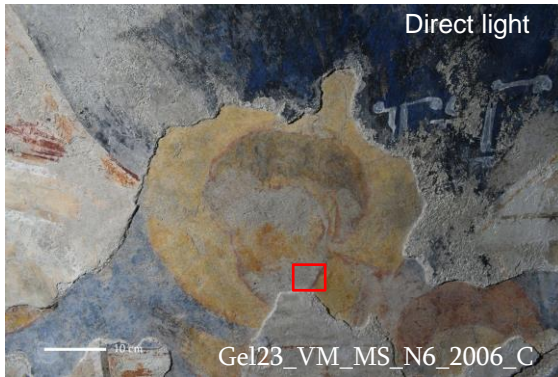
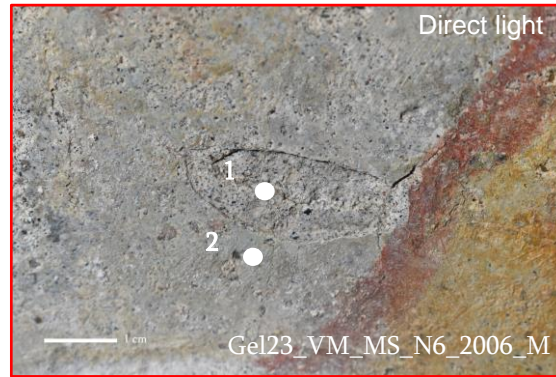
left: Microscopic photo at 50X magnification Stratigraphy of the plaster layer.
1 - the main plaster layer
2 - preparatory layer.

above: context photo, fragment of an early layer, painting of a figure, west arm, north wall, scene N6.

above: Macro photo, stratigraphy of the early painting layer. 1 - the main plaster layer
2 - preparatory layer.

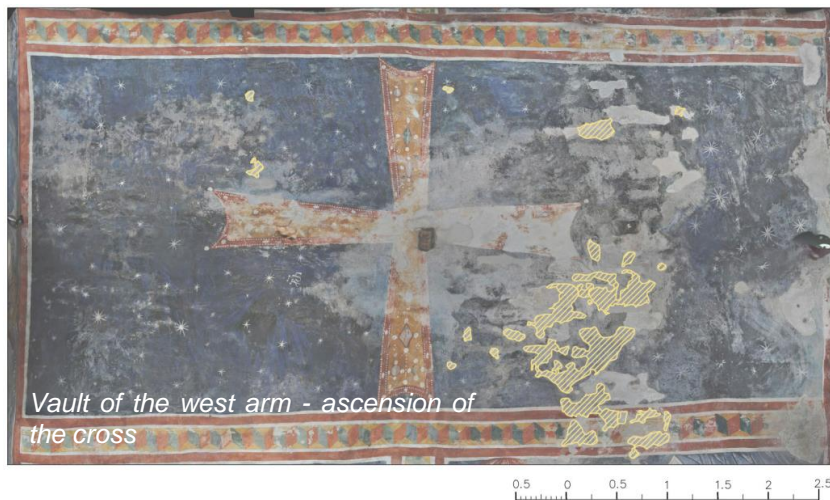
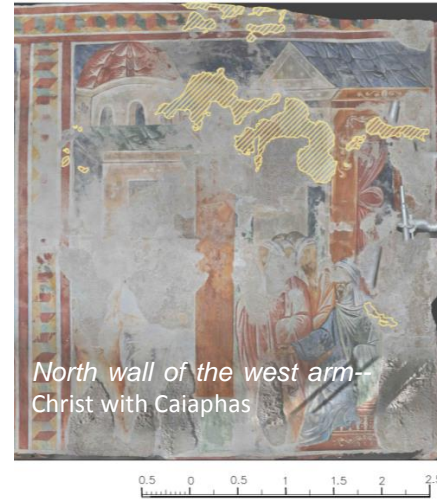
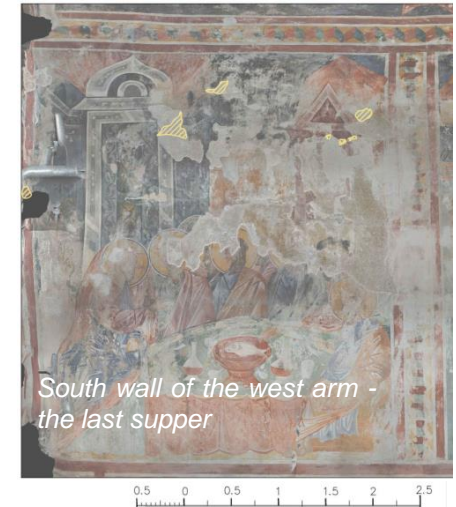
below: the areas of of early pain layer distribution are marked in yellow on the graphic documentation

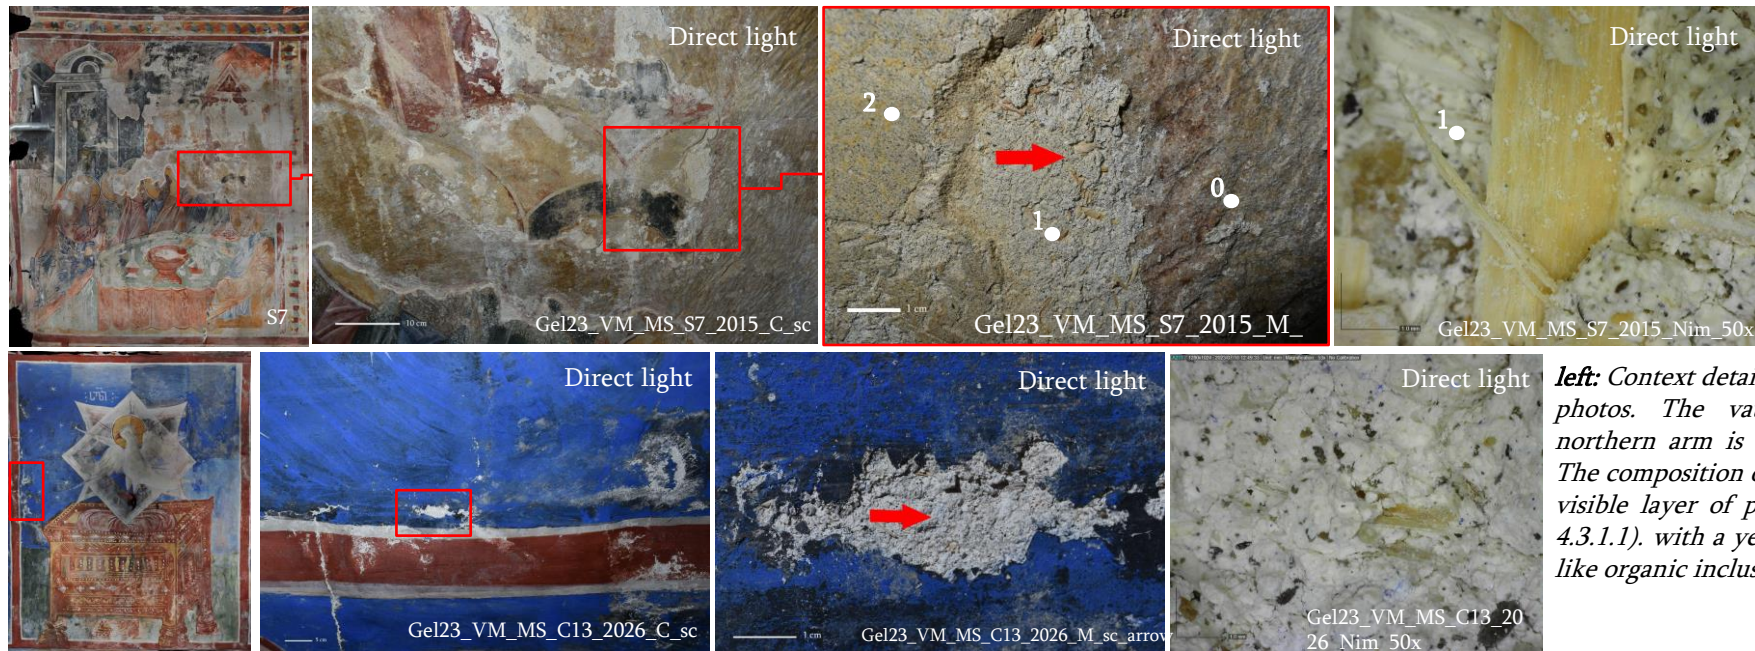
On the bottom: South wall of the western arm, S7 Stratigraphy: Lower layer (1) of plaster - type 4.3.1.1 - macro and micro photos.

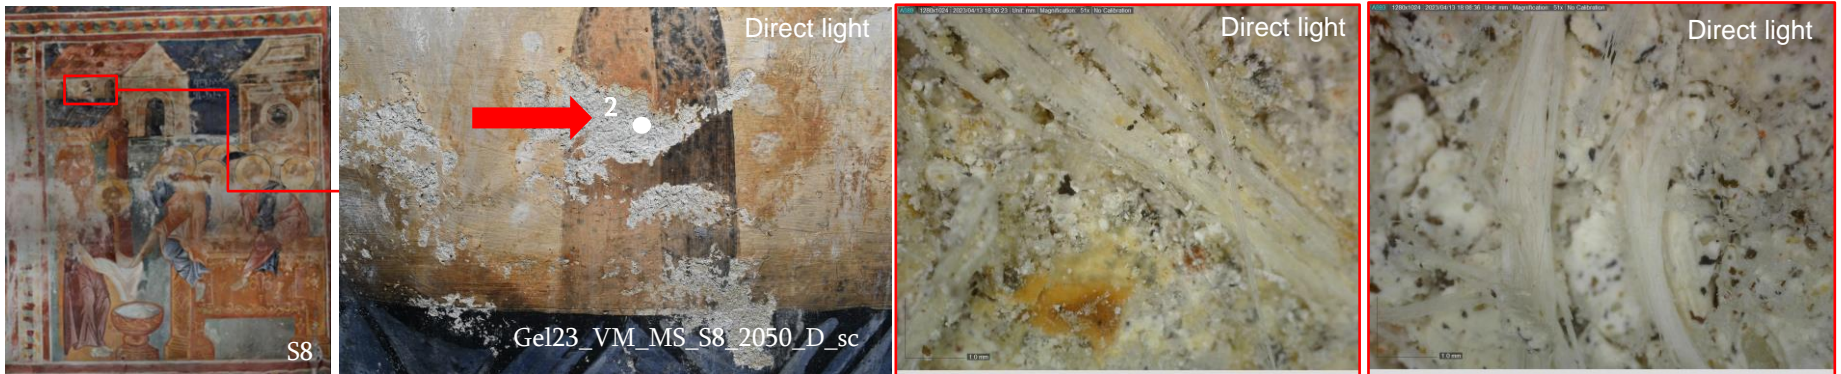
Type 2 - plaster, along with the binder, contains a large amount of inorganic aggregate inclusions and organic, yellow straw-like, plate-based inclusion and whitish coloured, transparent organic fibres. Distribution: Upper plaster layer of West Arm. See examples below.

right: Context detail and macro photos. The southern wall of the western arm. The composition of the upper visible layer of plaster (type 4.3.1.2). With yellow colored inclusion and white fiber.

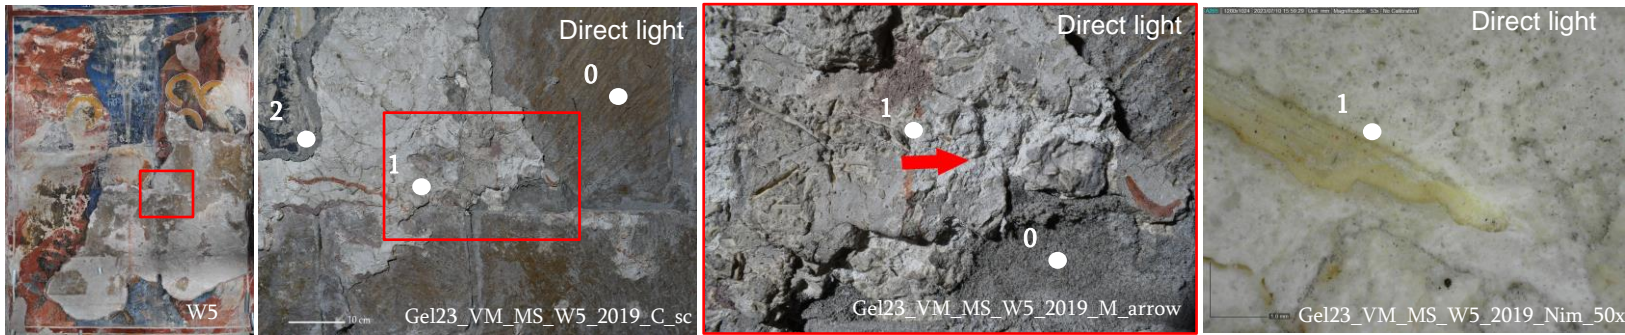
type 3 plaster - consists of a white binder and plant-based straw-like inclusions. Distribution: lower plaster layer of the west wall of the south arm, scenes of the third register of the west arm. See examples below.

left: The only filling of the lower layer of the western wall of the southern arm (type 4.3.1.3) is a yellow plant inclusion.

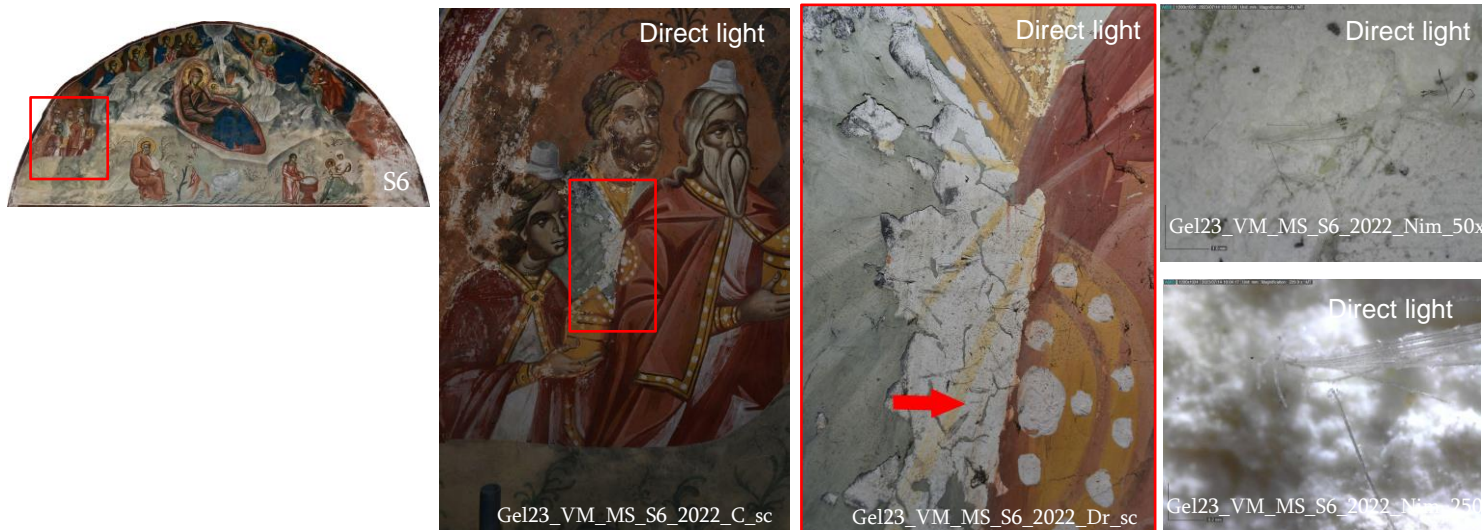
type 4 plaster, along with the binder, it contains a small amount of inorganic aggregate inclusions and organic white transparent fibres. Distribution: Upper south Arm. See examples below.

left: The plaster layer (type 4.3.1.4) of the southern wall of the southern arm. A small amount of inorganic aggregates and white/transparent organic fibres are used as fillers.

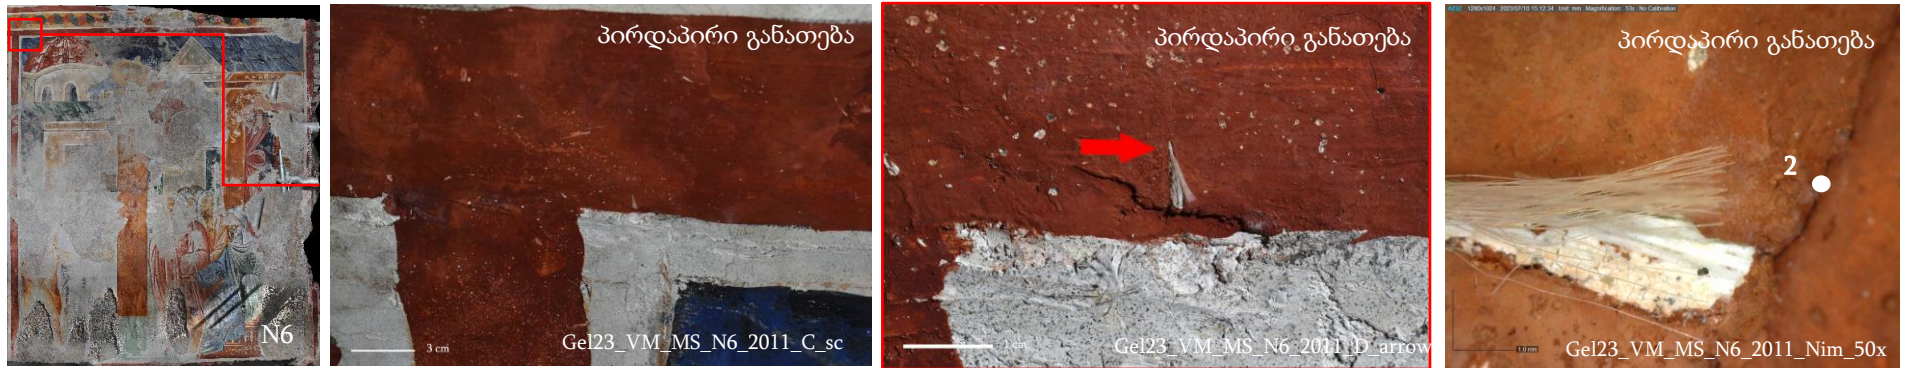
Up : The upper layer of the north wall of the western arm (type 4.3.1.5). A large amount of inorganic aggregates and white/transparent organic fibres are used as fillers. The inorganic components of the plaster are similar to types 3.2.1.1 and 4.3.1.2.

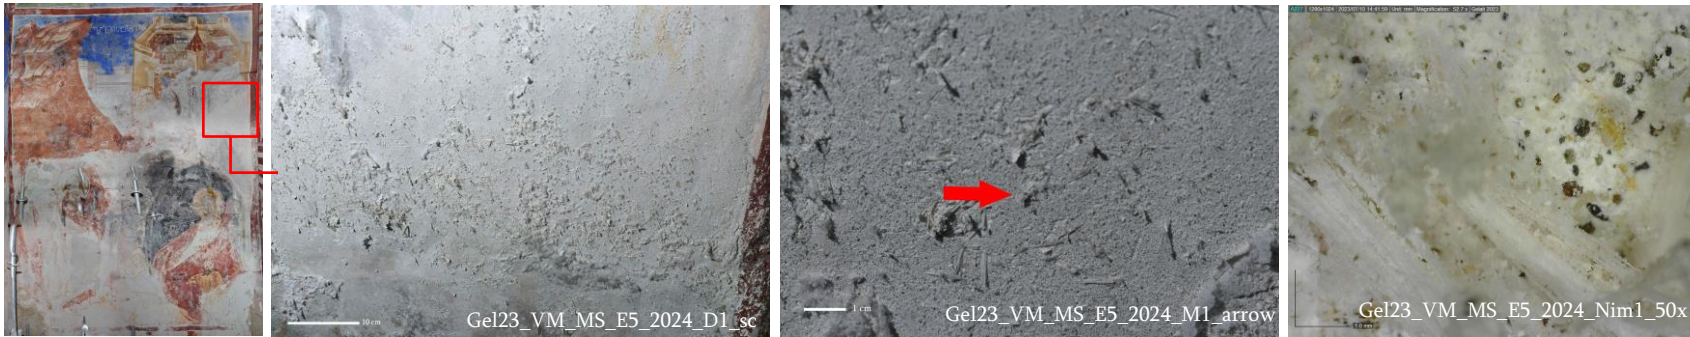
Up : The layer of plaster (type 4.3.1.5) of the northern wall of the northern arm. A large amount of inorganic aggregates and white/transparent organic fibres are used as fillers. The inorganic components of the plaster are similar to types 3.2.1.1 and 4.3.1.2.

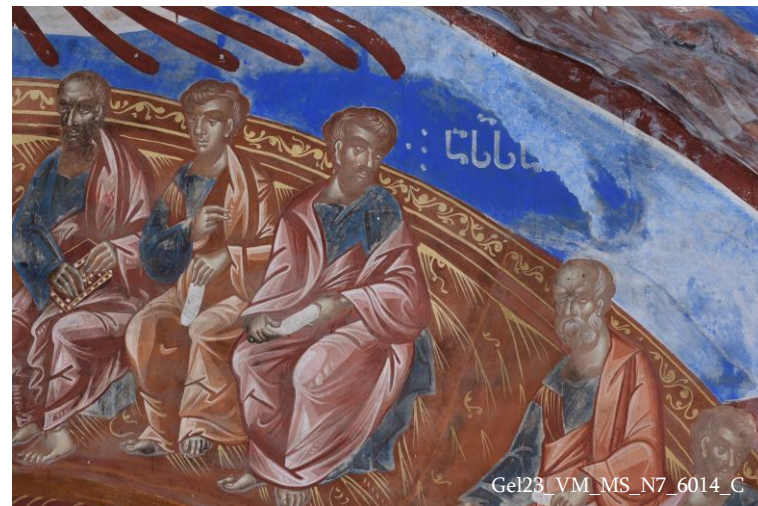
Three types of blue are visually distinguished on the paint layer: **dark blue** (type 1), **light blue** (type 2) and **greenish blue** (type 3).

left: A scene on the north wall of register IV of the north arm with different types of blue

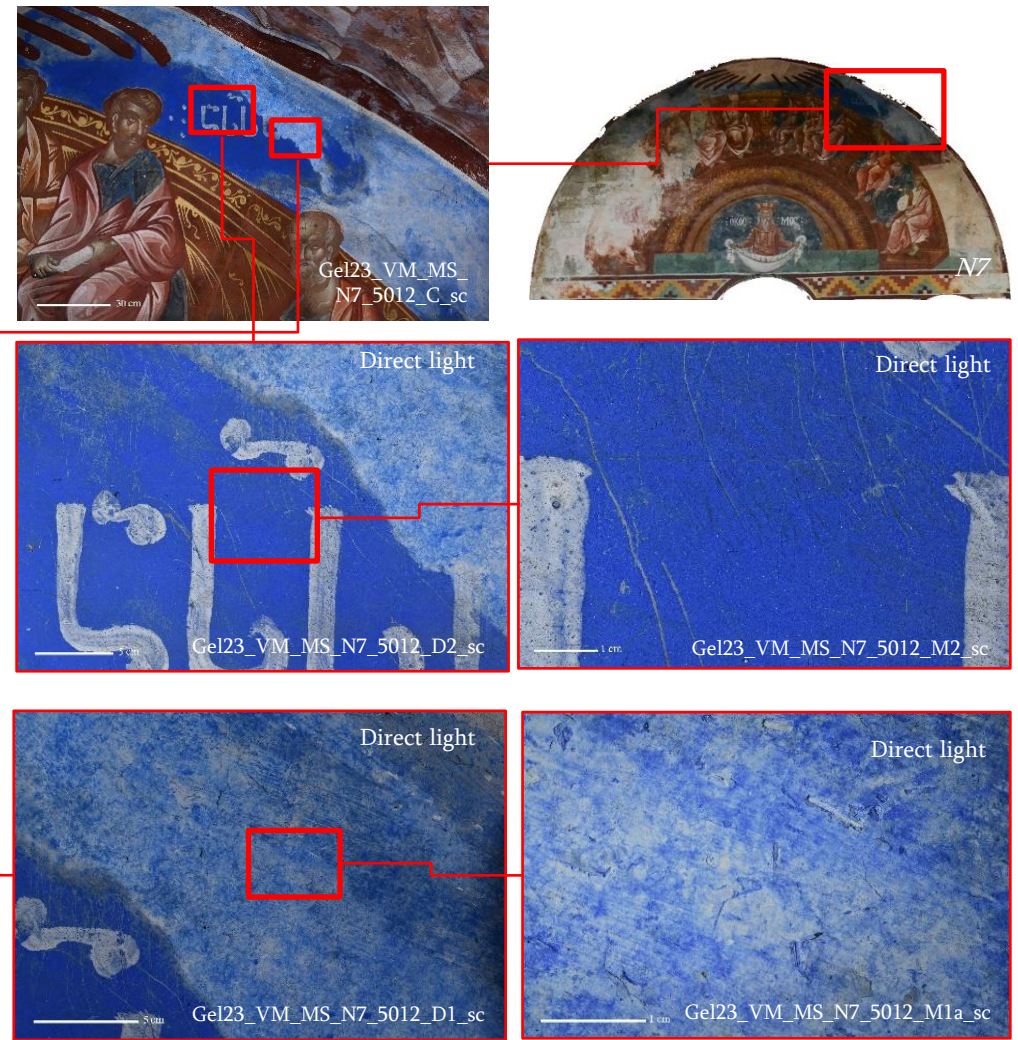
Light blue (type 2)

up: On the north wall of the north arm a sky background can be found, which is done in light blue (type 2). The photo clearly shows the difference in the paint layer between damaged and undamaged areas.

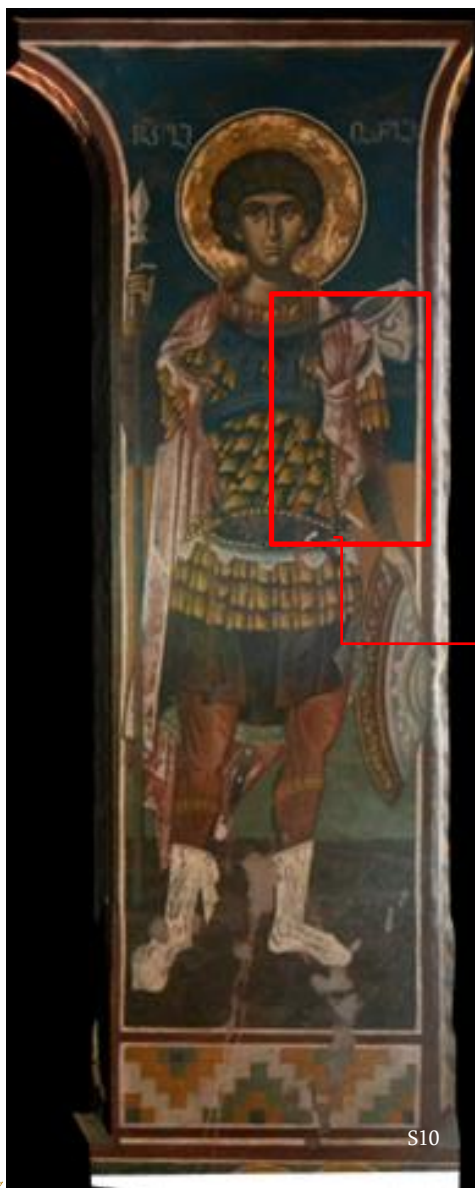
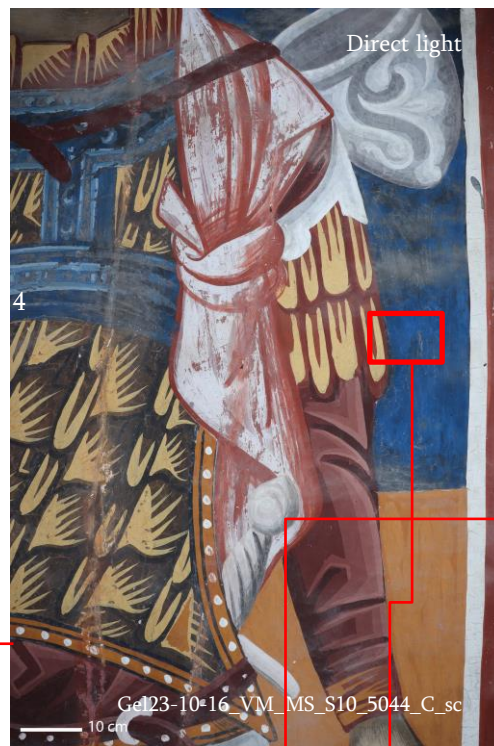
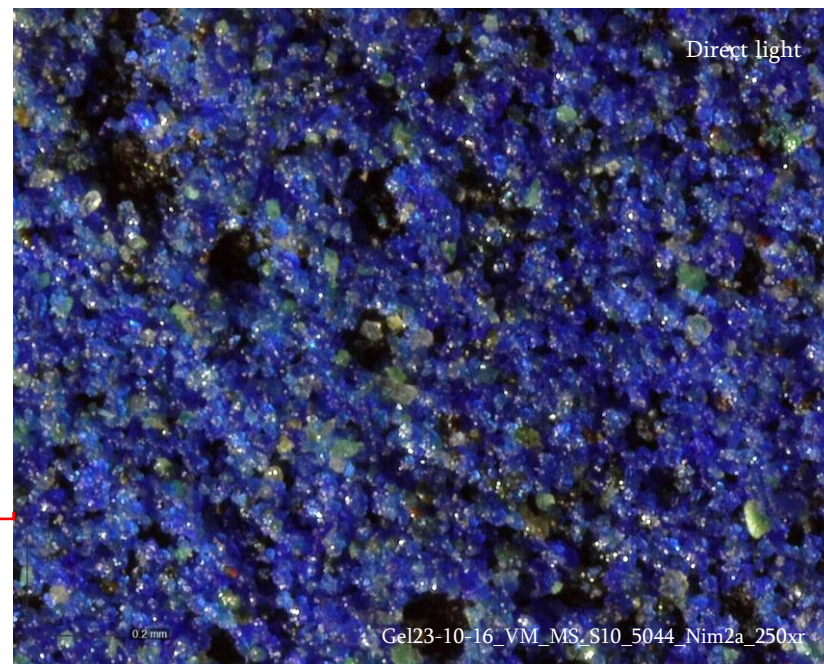
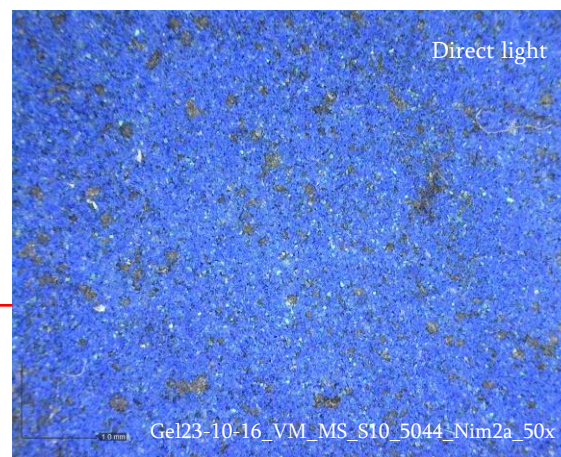
Greenish blue (type 3)

Up and left: Register III of the south arm, using greenish-blue (type 3) for the background on the south wall. At X250 magnification, the green particles which are typical for this type of blue, are clearly visible.

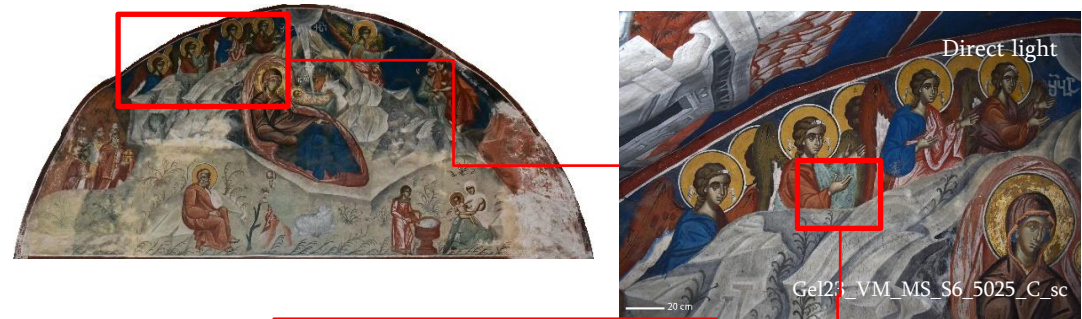
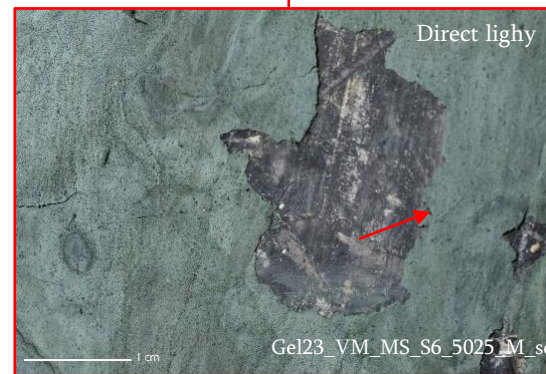
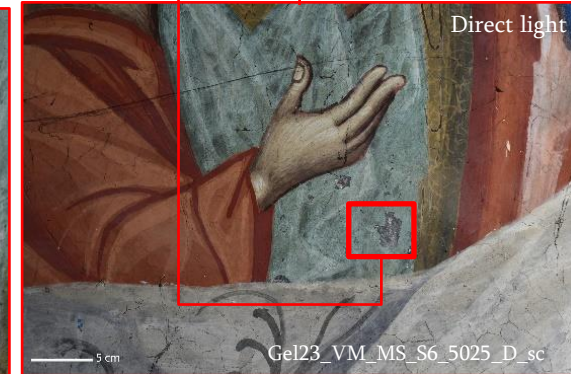
Up.: he southern wall of the southern vault. In the nativity scene, the angel's dress is done with green, on a black suit.

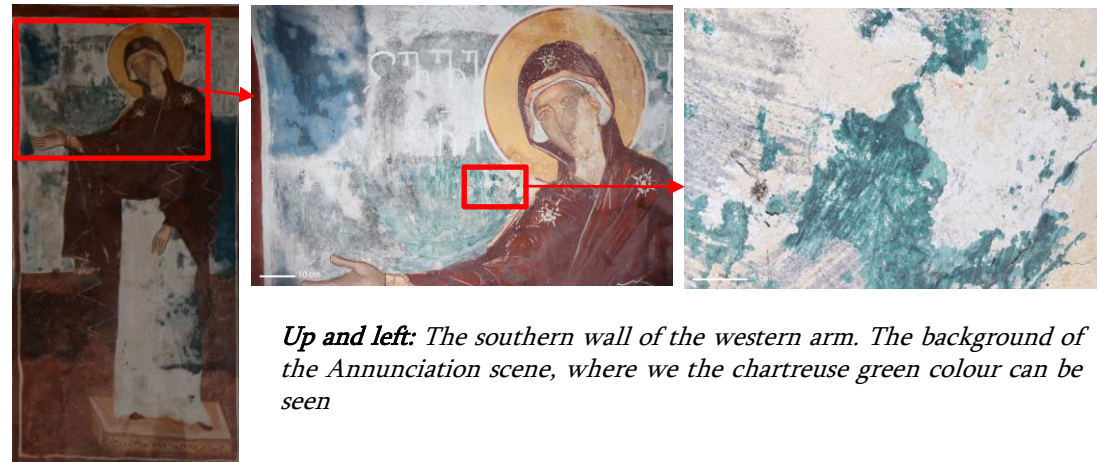
It is worth noting that on the western wall of the third register of the western arm, on the composition of the Annunciation, chartreuse green can be seen in the background, which is very different both in general tone and in structure from the rest of the paints. Presumably this is the result of later repair or some pigment alteration. Additional studies are needed.

Up and left: The southern wall of the western arm. The background of the Annunciation scene, where we the chartreuse green colour can be seen

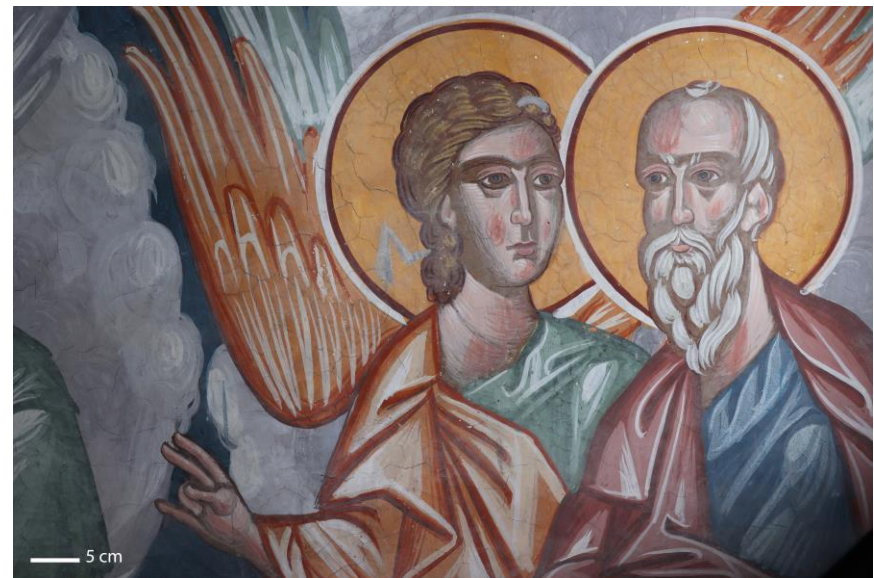
The mixed colours include different shades of pink, composed by mixing wine red with white pigment, as well as many shades of light orange.

up: A scene on the north wall, third register of the west arm with various types of red and orange

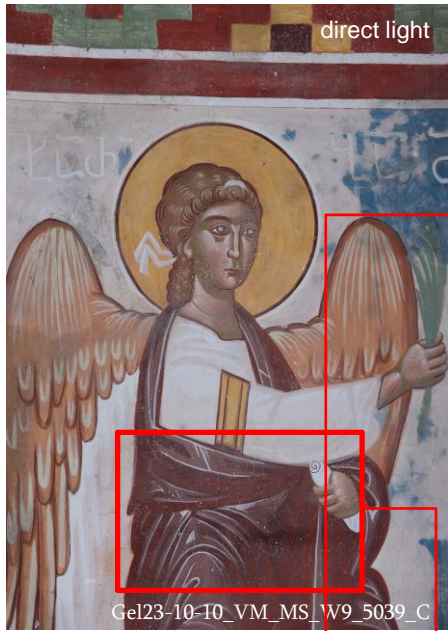
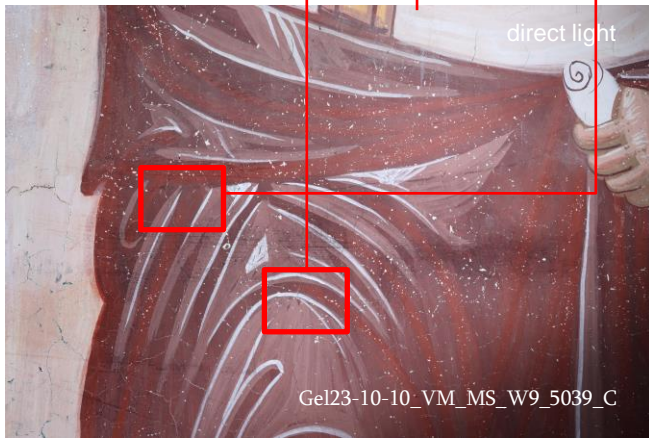
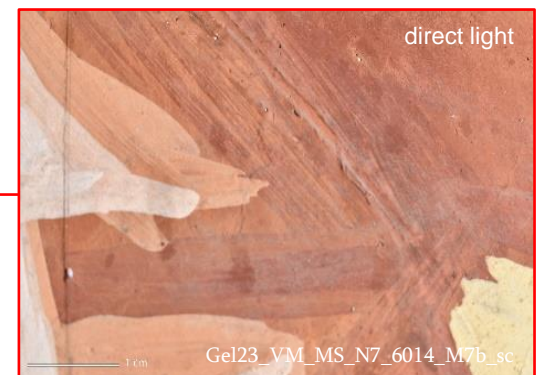
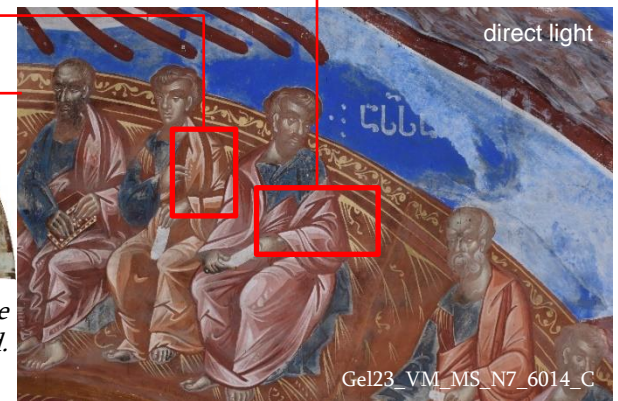
Up and right: North wall of north arm. The clothes of the apostles are made of different shades of red.

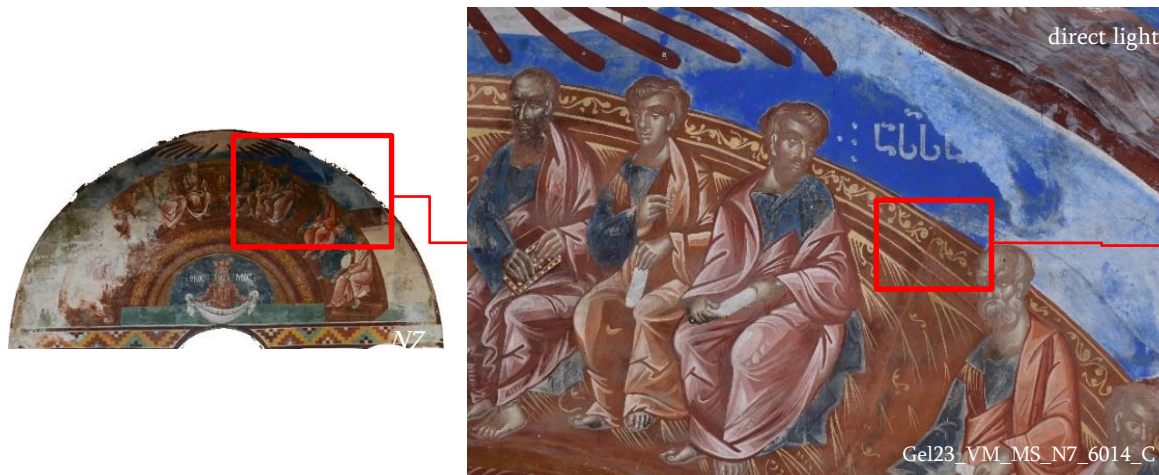
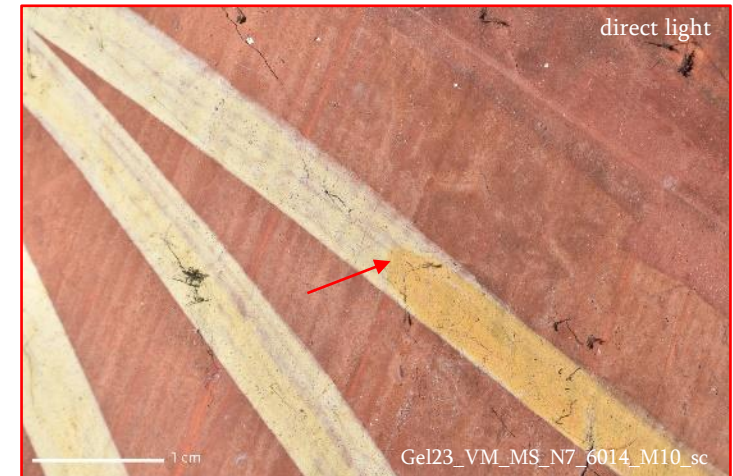
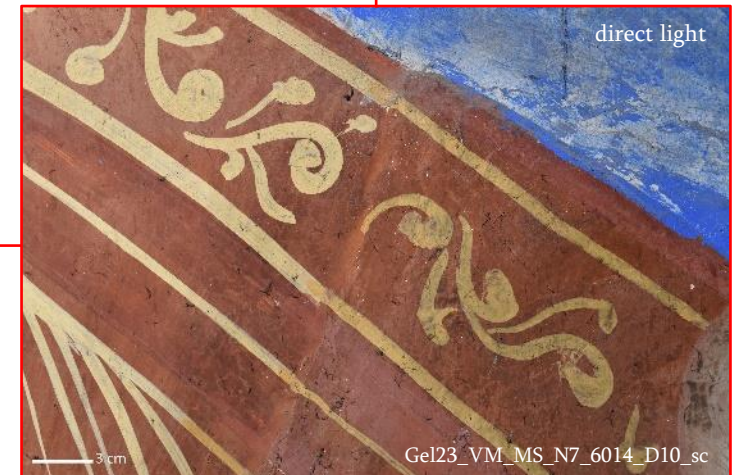
Down and to the left: whitsun scene on the north wall of the north arm - decorative elements are made with type 2. yellow On the scene we see a plaster joint. It should be noted that its one type of yellow, although different tones are used on different plasters,
