University of Applied Sciences Potsdam
Department of Conservation and Restoration
Science Laboratory

Church of the Virgin (Gelati)
Salt analyses – Part II

Potsdam, 25.07.2024

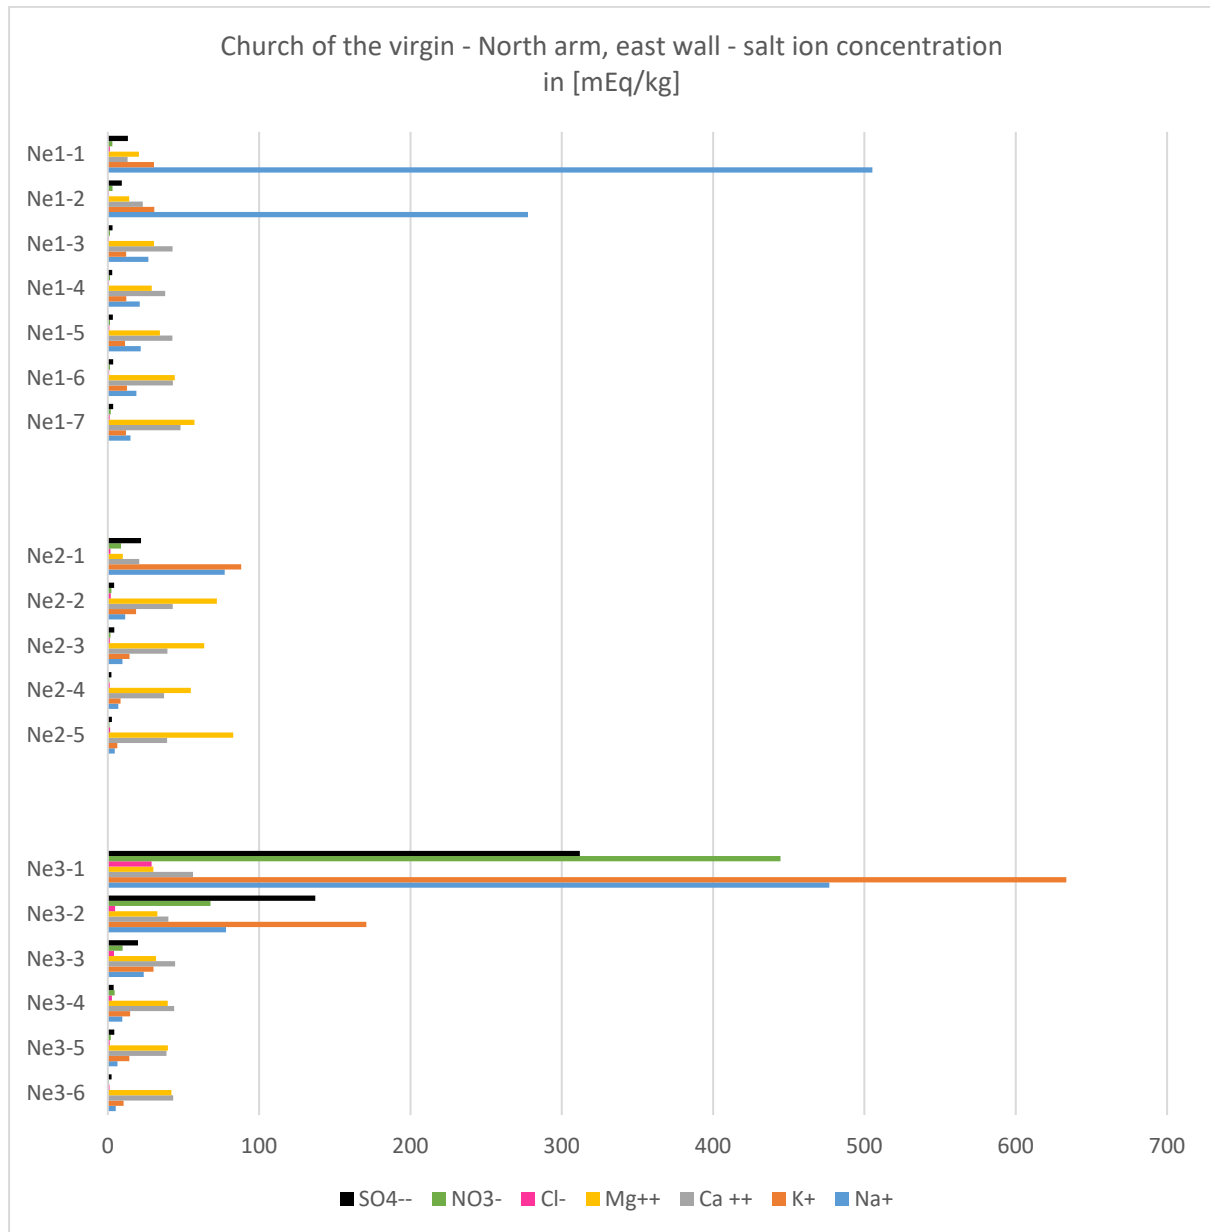
From Fig. 1 it is clear that a heterogeneous salt ion distribution can be observed at different heights in the north arm on the east wall, with the salt ions being enriched particularly in the plaster layers at the front, while significantly fewer salt ions are found in the dolomite stone.

Fig. 1: Overview of the salt ion distribution in the north arm on the east wall in height and depth profiles. The highest concentration shown at each height is the foremost depth (Nex-1), then further down follow the other depths.

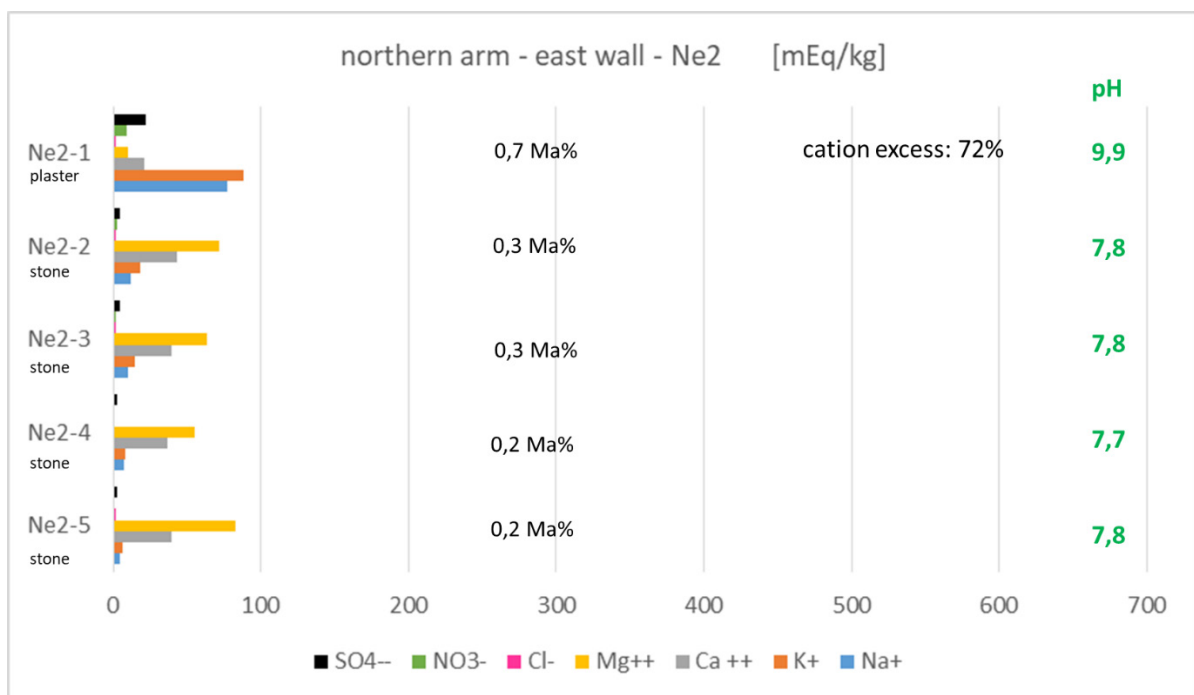
Fig. 3: Salt ion distribution in the depth profile at the location Ne2, explanation see Fig. 1. In this area of the wall the overall salt content is low

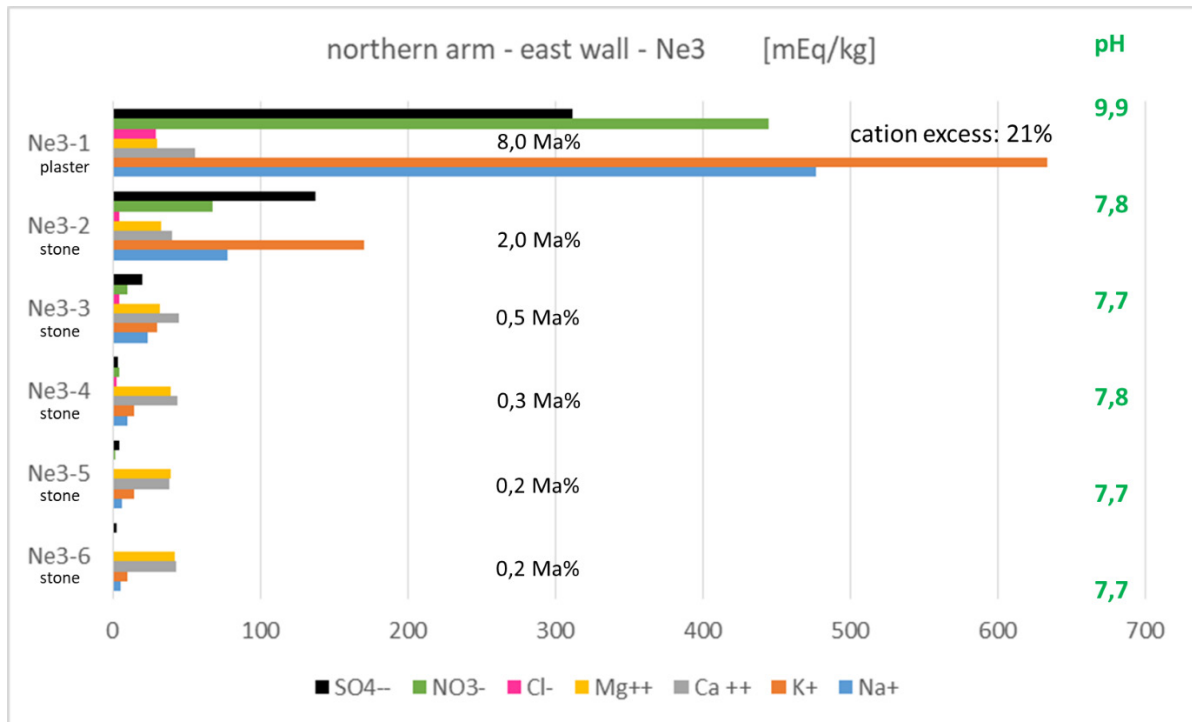
In the profiles Ne3 and Nw1, high concentrations of potassium, sodium, nitrate and sulfate are noticeable in the plaster. Calcium and magnesium play no role here, although dolomite rock is present in the background.

Fig. 4: Salt ion distribution in the depth profile at the location Ne3, explanation see Fig. 1. The salt content in the plaster is very high and the cation excess of about 20% is plausible, since the anion carbonate is not measurable and dolomite stone is in the background.

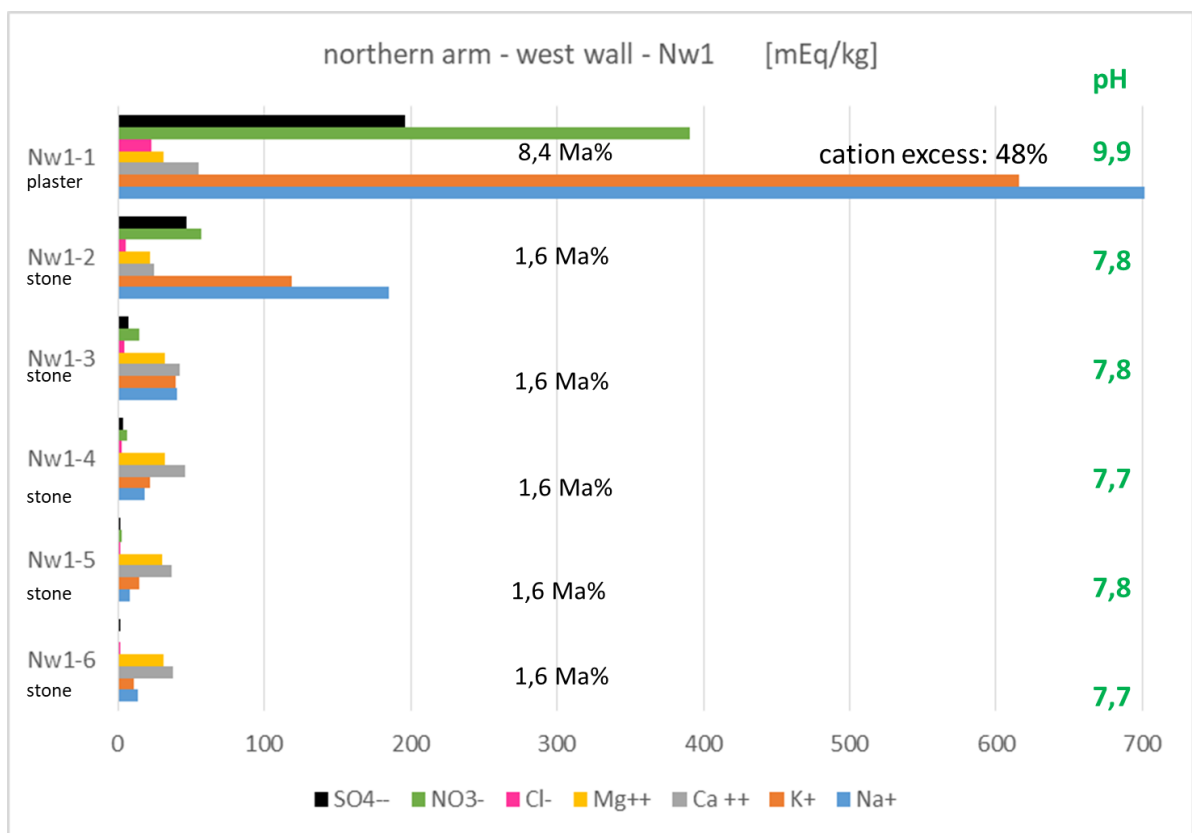
Fig. 5: Salt ion distribution in the depth profile at the location Nw1, explanation see Fig. 1. The salt content in the plaster is very high. Here, the cation excess is too high at about 50%, which means that an important anion was not detected in the analysis. As with location Ne1, there is also a high proportion of sodium here, and an overall high alkali content.

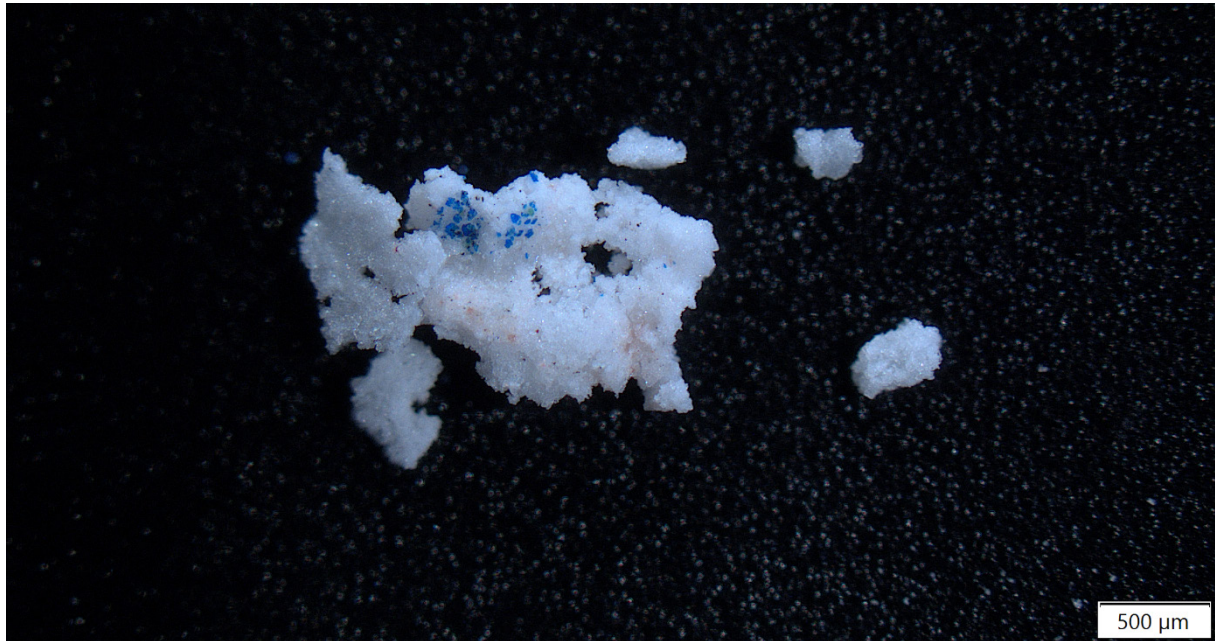
Sample 13 – Location: South Arm, vault, C12

Fig. I-5: Sample 13: white crust with blue particles

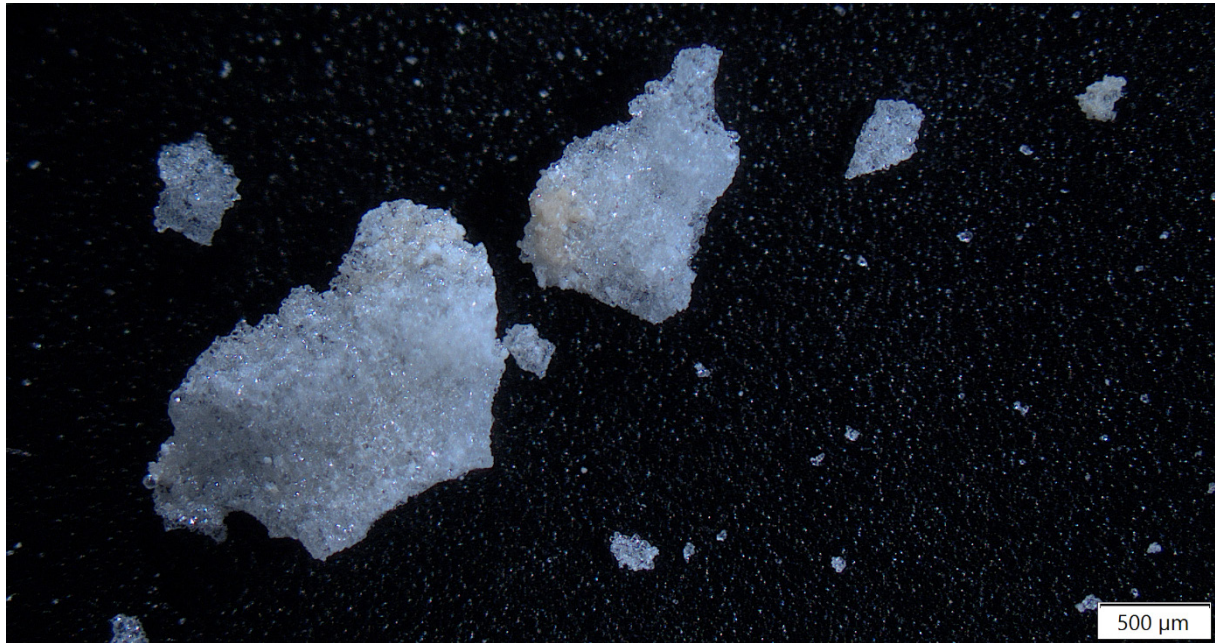
Sample 15 – Location: North Arm, West wall, IV register, W7

Fig. I-9: Sample 15: granular crystals agglomerated to a white crust

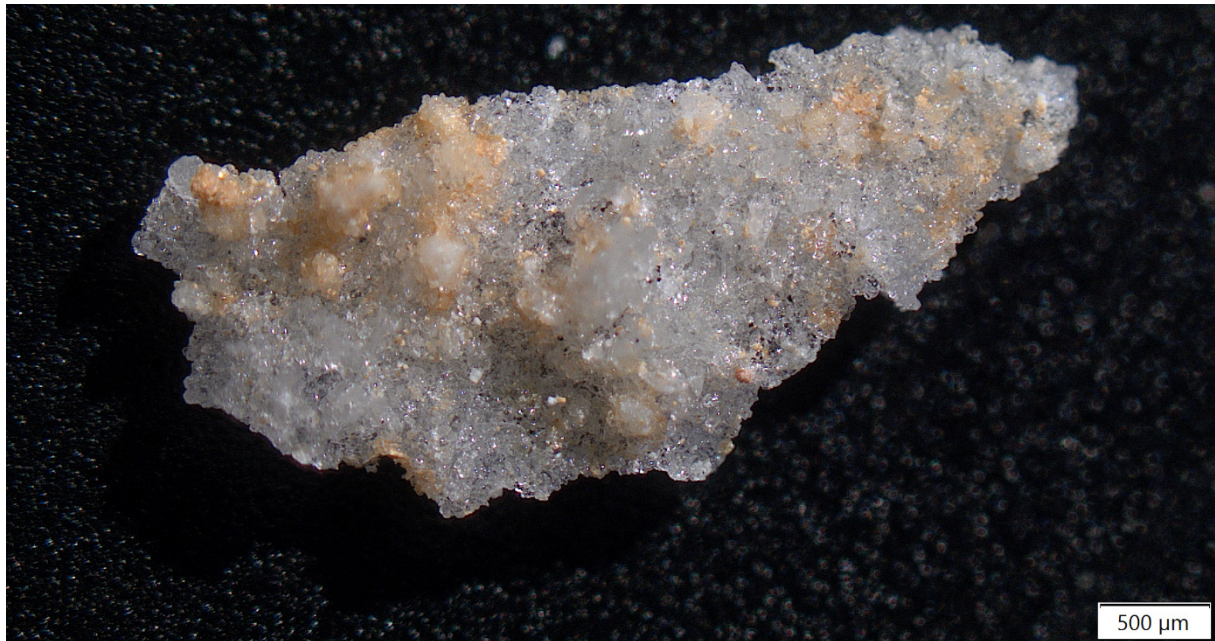
Sample 16 – Location: North Arm, West wall, IV register, W7

Fig. I-11: Sample 16: granular crystals agglomerated to a crust with ochre particles

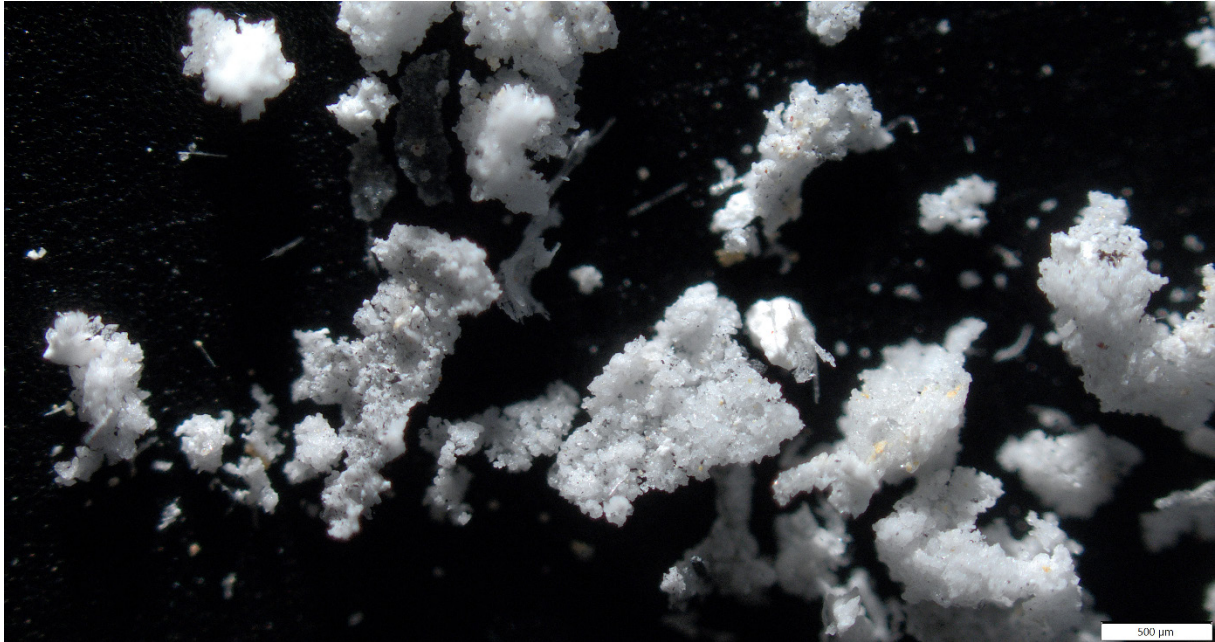
Sample 20 – Location: St. George, North wall, Donor

Fig. I-19: Sample 20: white crusts and some whisker

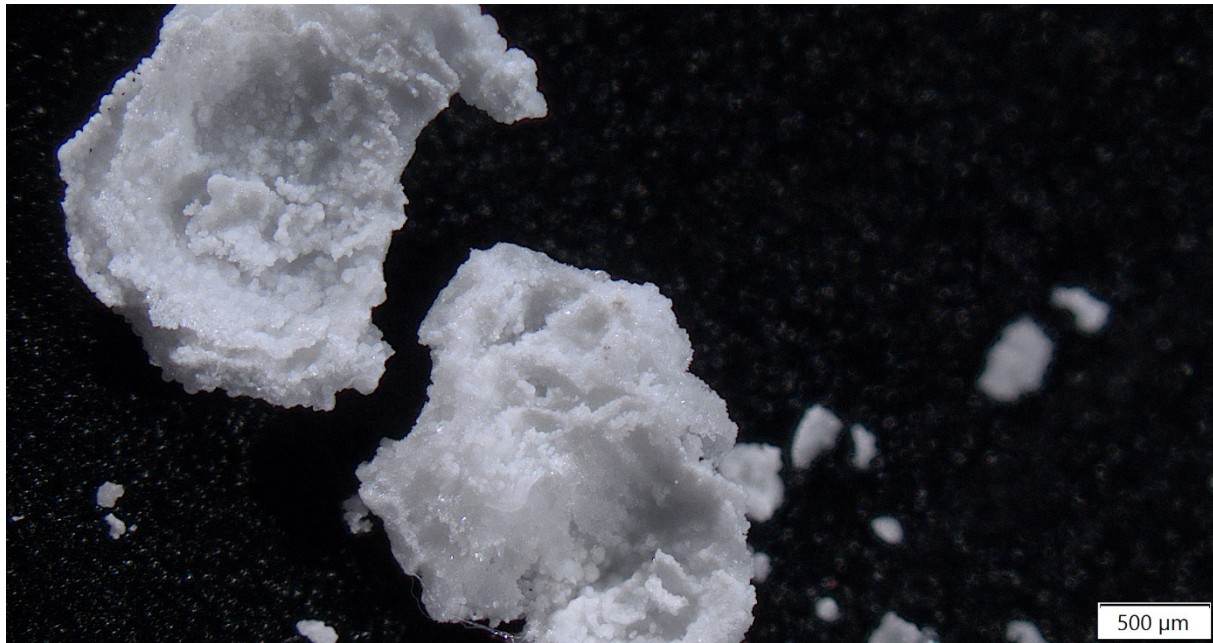
Sample 21 – Location: NW chapel West Arch (Wa), 5

Fig. I-21: Sample 21: white spots or postule

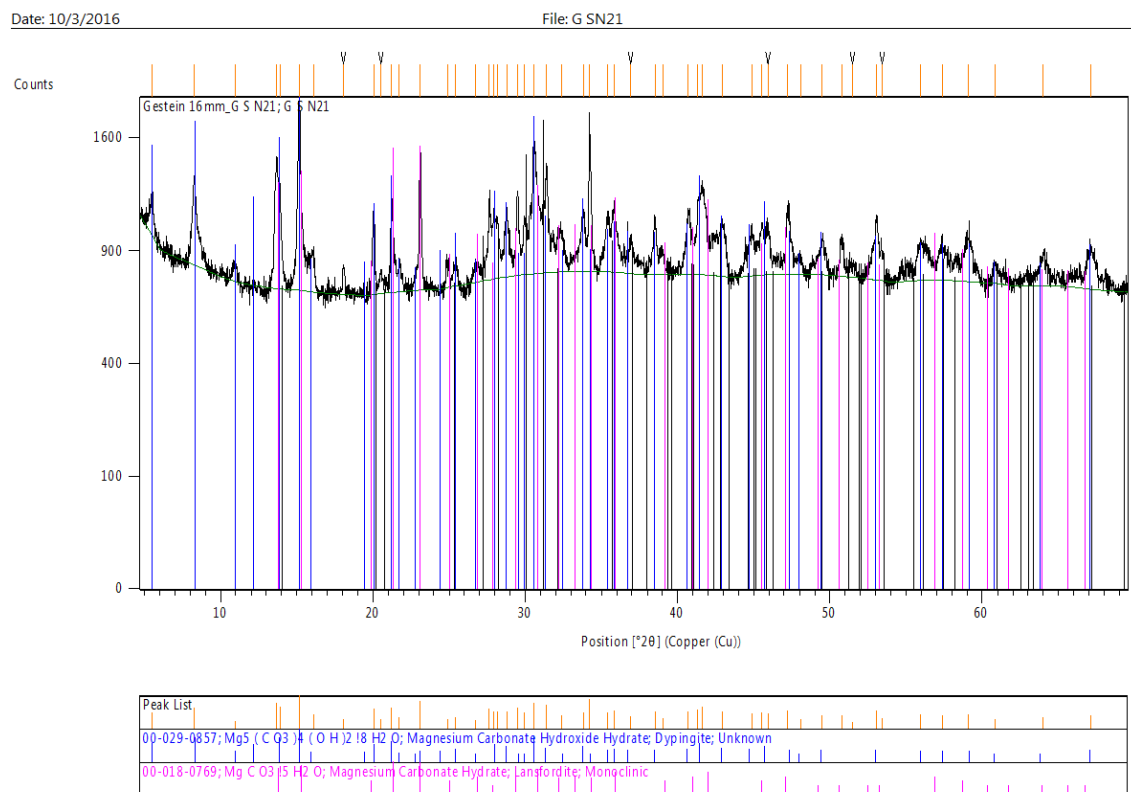
Fig. I-22: Sample 21, XRD spectrum

Result by XRD: dypingite [$\text{Mg}_5(\text{CO}_3)_4(\text{OH})_2 \cdot 5\text{H}_2\text{O}$] and lansfordite [$\text{MgCO}_3 \cdot 5\text{H}_2\text{O}$] (Fig. I-22).

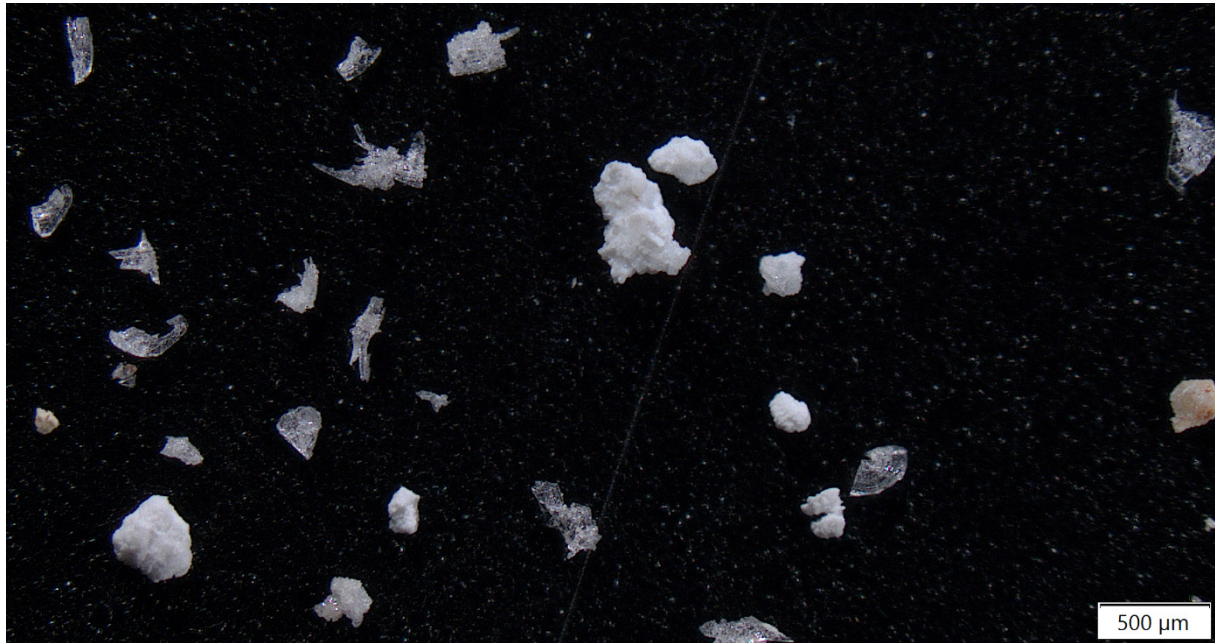
Sample 22 – Location: NW Chapel, North Wall, N10

Fig. I-23: Sample 22: white flakes and transparent whisker

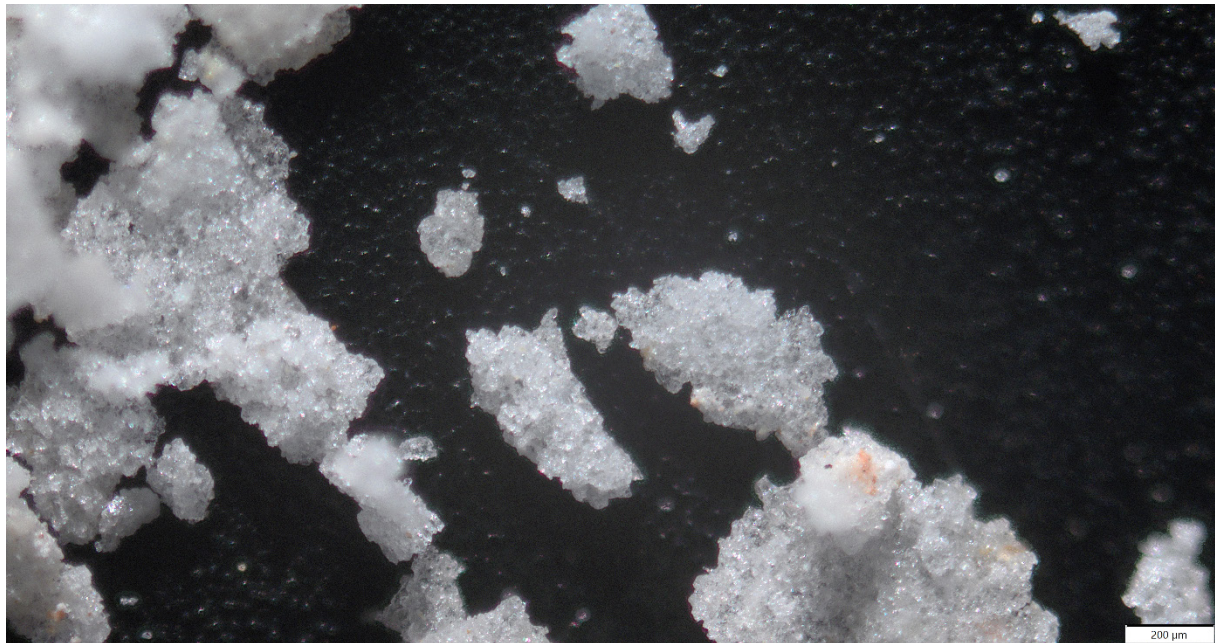
Sample 23 – Location: NW Chapel, NW Iconostasis

Fig. I-25: Sample 23: granular crystals agglomerated to a crust

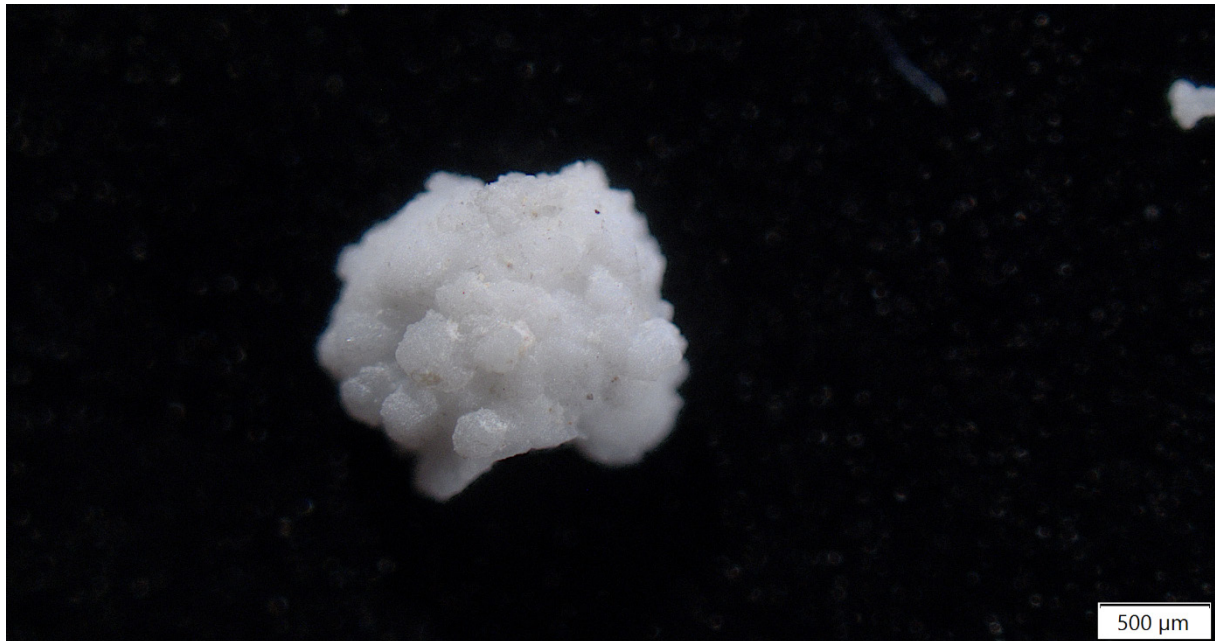
Sample 24 – Location: NW Chapel, South Wall, S7

Fig. I-27: Sample 24: white granular crystals agglomerated to a crust, here cauliflower like

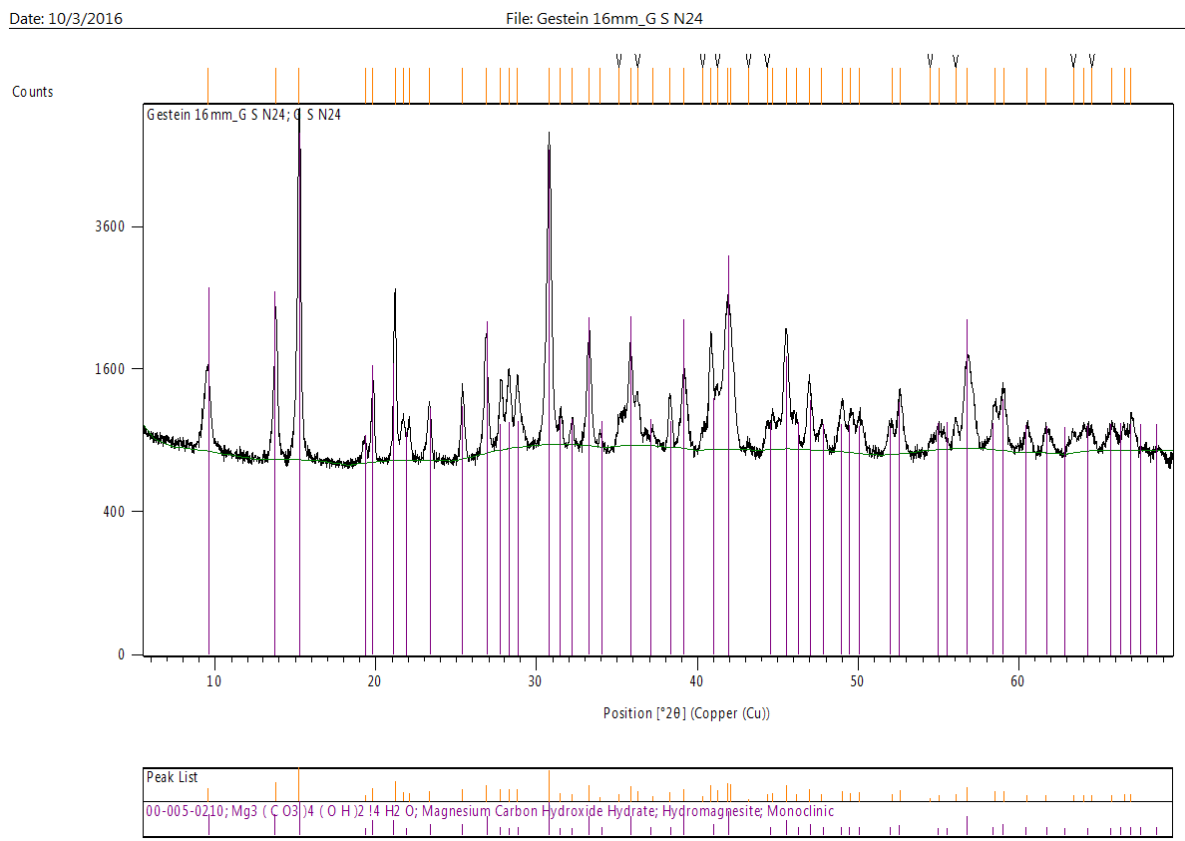
Fig. I-28: Sample 24, XRD spectrum

Result by XRD: hydromagnesite $[\text{Mg}_5(\text{CO}_3)_4(\text{OH})_2 \cdot 4\text{H}_2\text{O}]$ (Fig. I-28)
