Church of the Nativity of the Virgin, Gelati Monastery, Georgia

Wall painting conservation programme

Rickerby & Shekede
May 2025

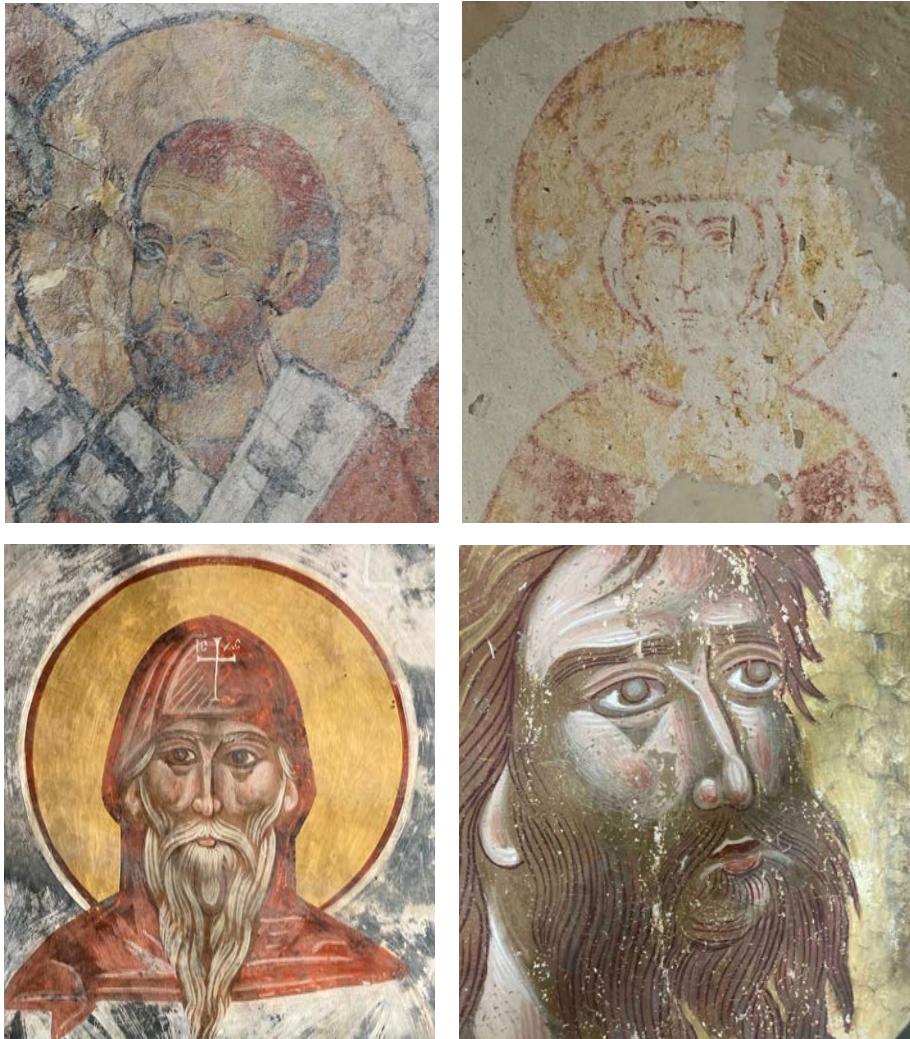
Above: The wall paintings comprise several schemes spanning the 12th to the 18th centuries, each one characterized by different original technologies, conditions and states of deterioration.

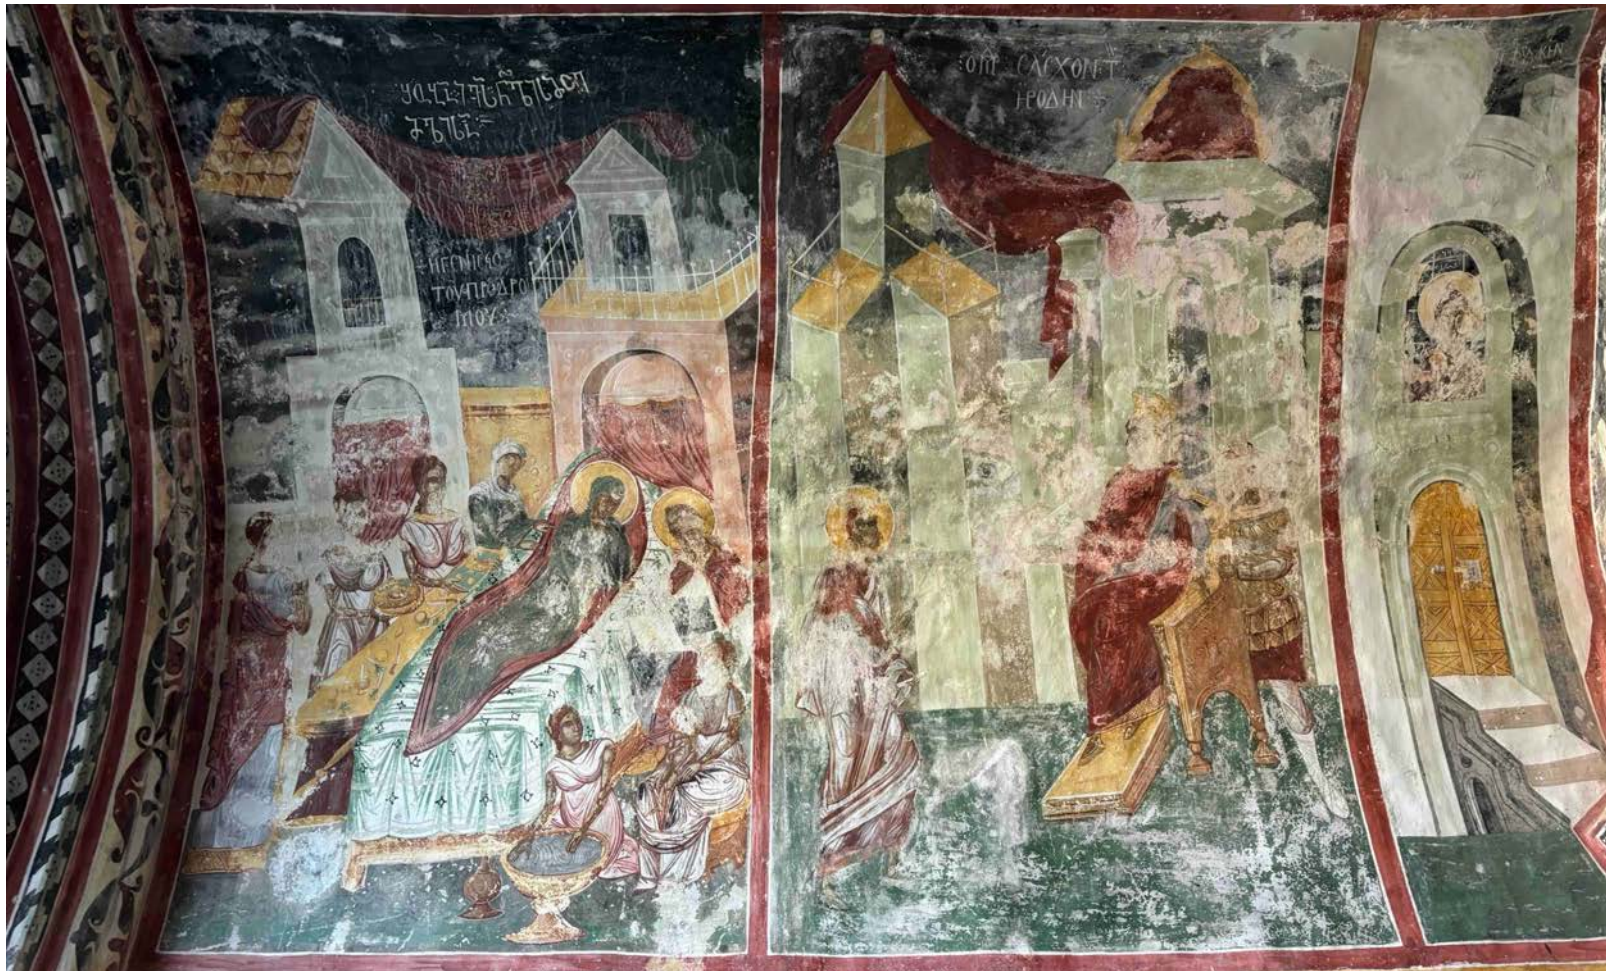
Above: The vault of the North Entrance showing effects of rainwater infiltration and transportation of damaging salts. This typifies inherent conditions in many parts of the Gelati complex

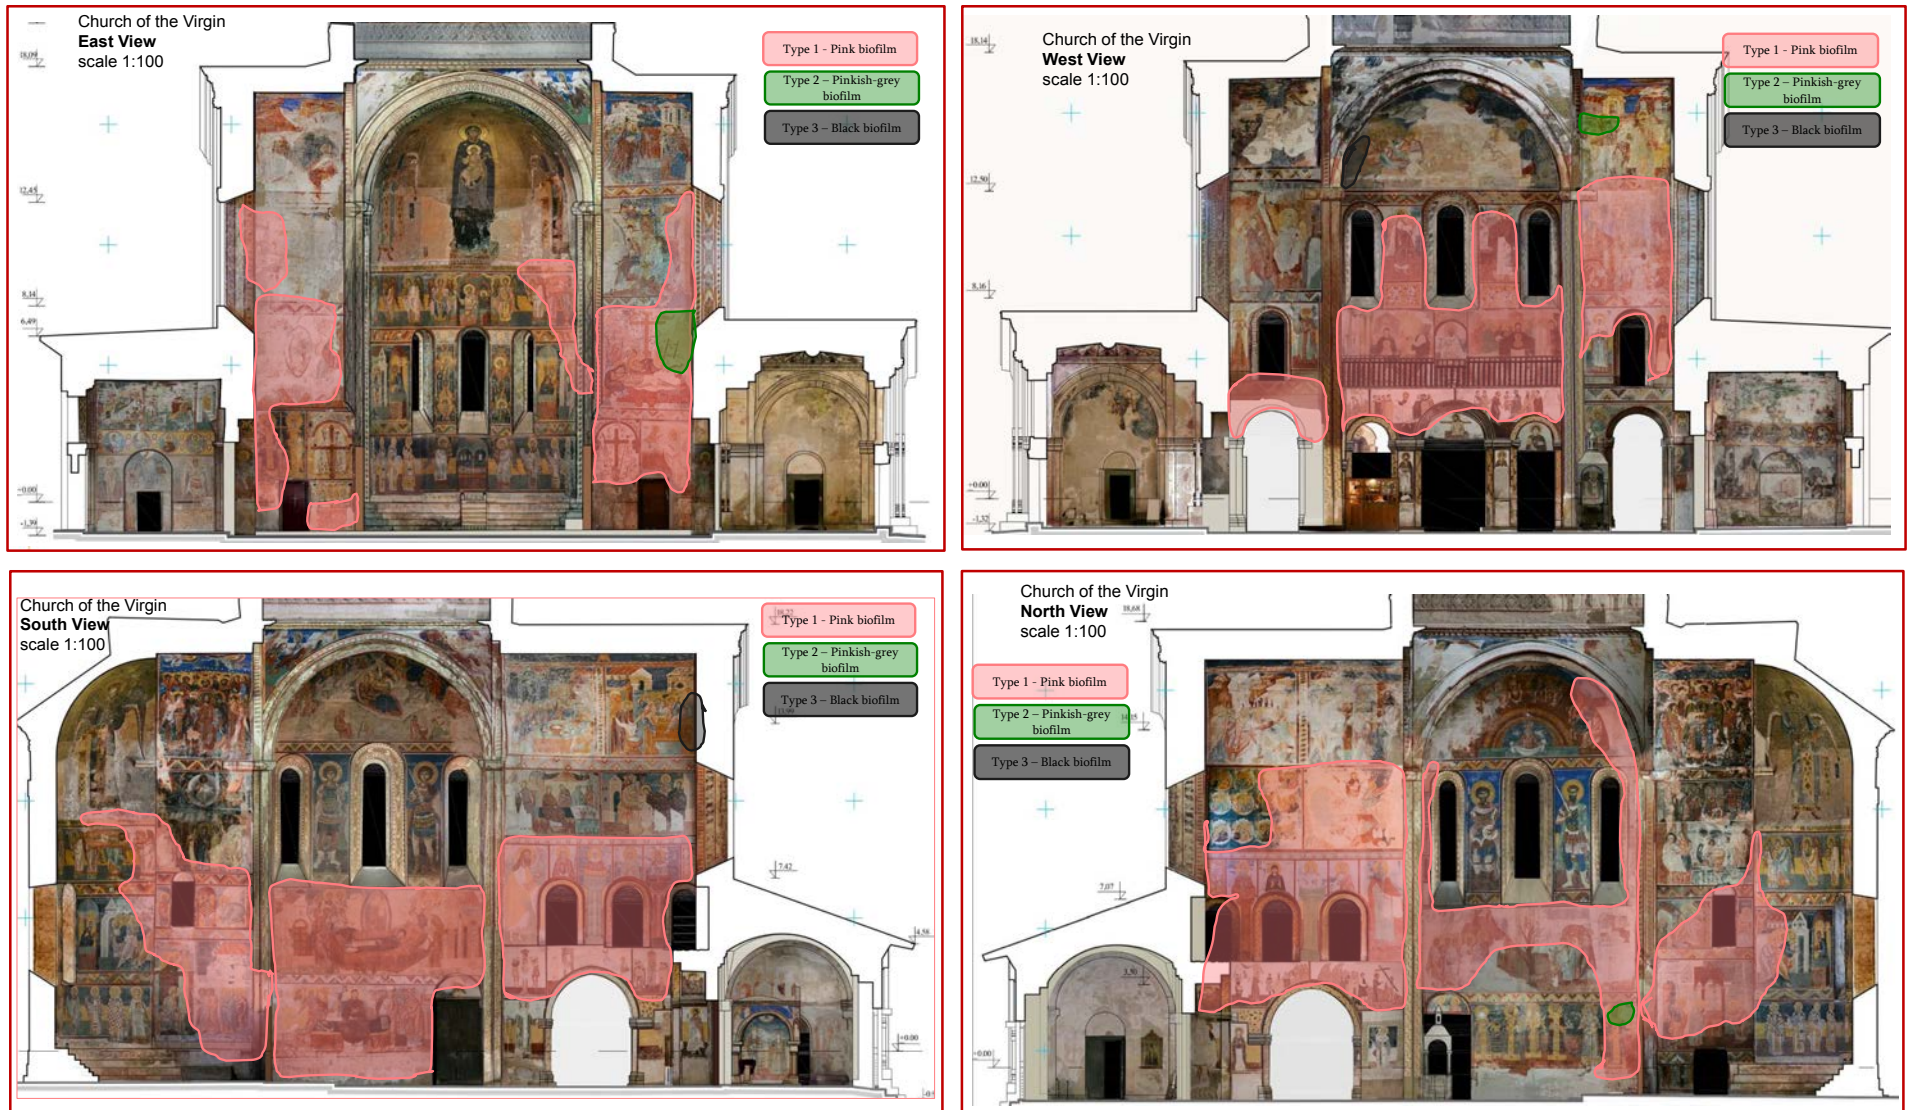
Above: Graphic documentation showing extent of different forms of biological colonization throughout the Gelati complex.

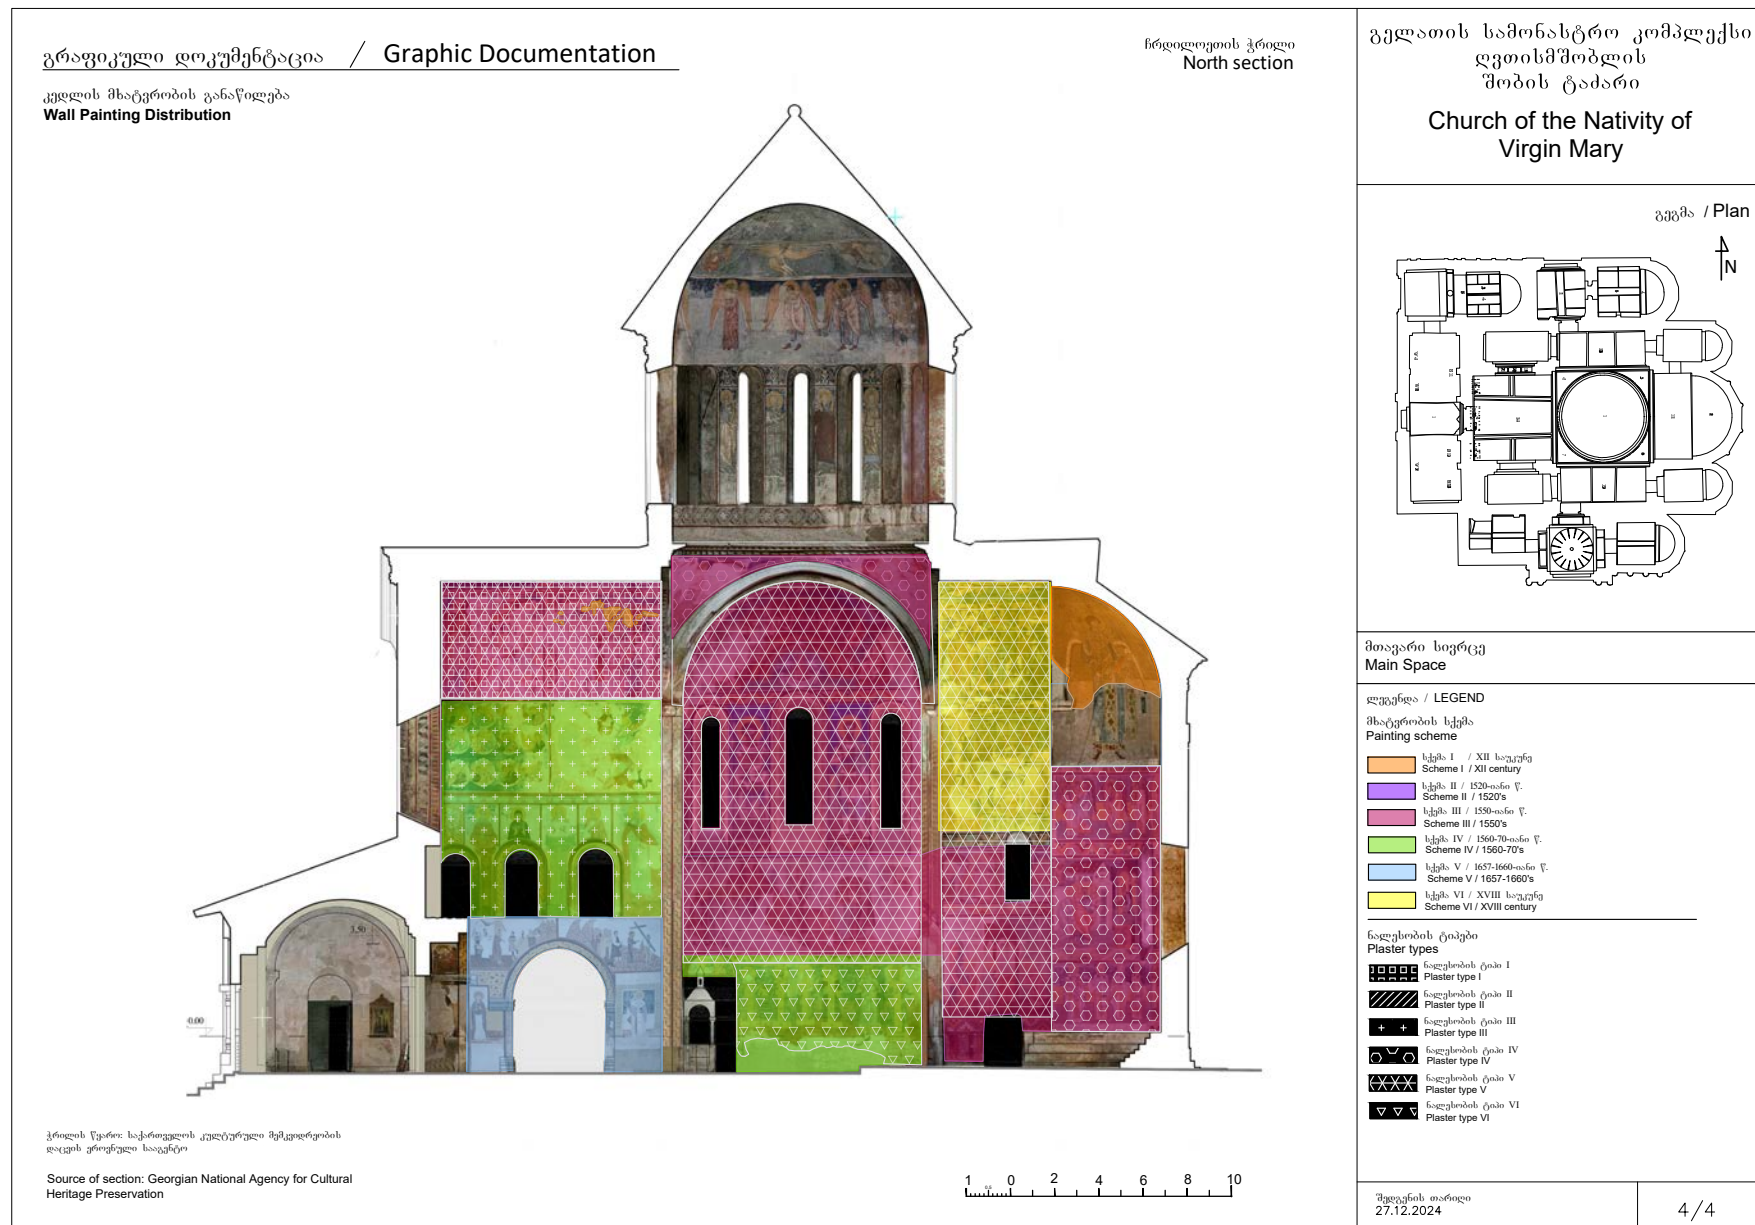
Above: Graphic documentation of the north section of the Main Church showing the distribution of different phase of painting spanning the 12th to 18th centuries. Each of these painting phases is characterized by different original technologies which influence their current condition and states of deterioration.

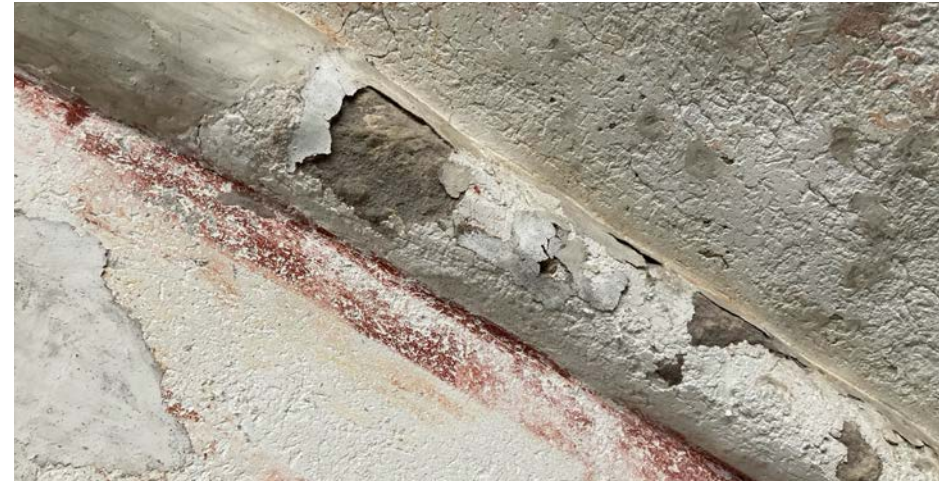
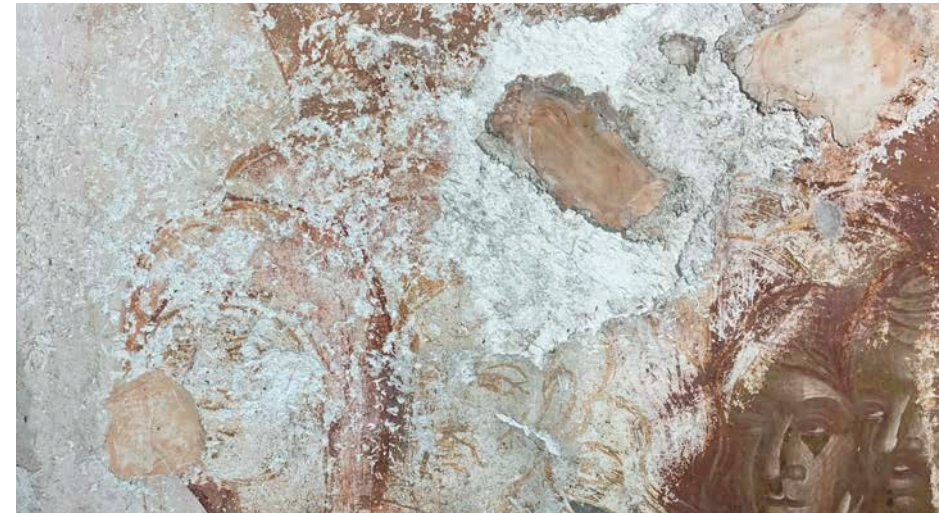
Above: The failure of many previous repairs indicates that a different conservation approach is now required. In the top image, collapse of the repairs has caused loss of surrounding original plaster. In the bottom image, a previous repair remains in place while the surrounding original plaster it was meant to secure is lost.

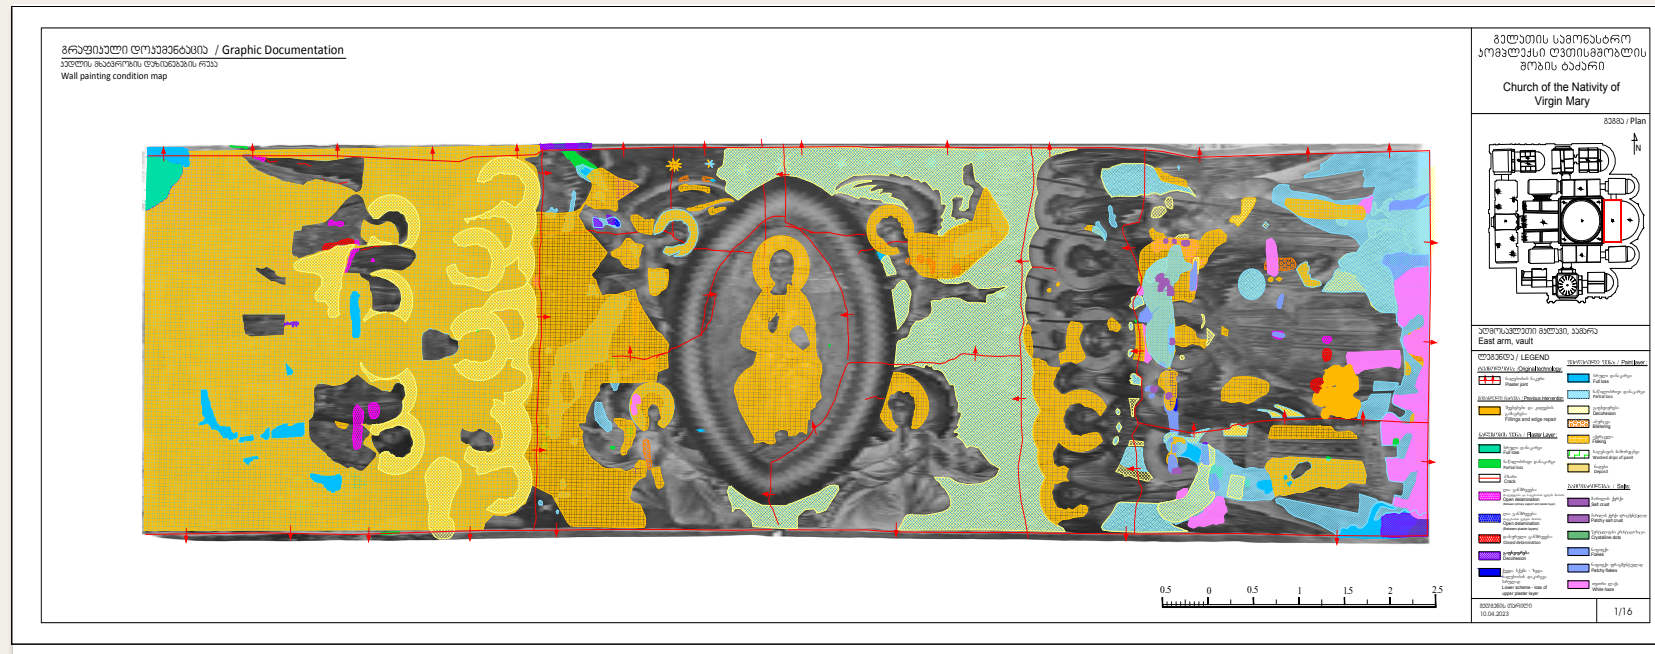
Above: An example of the graphic documentation of conditions being carried out for all the Gelati wall paintings, providing a comprehensive record of their state of conservation.

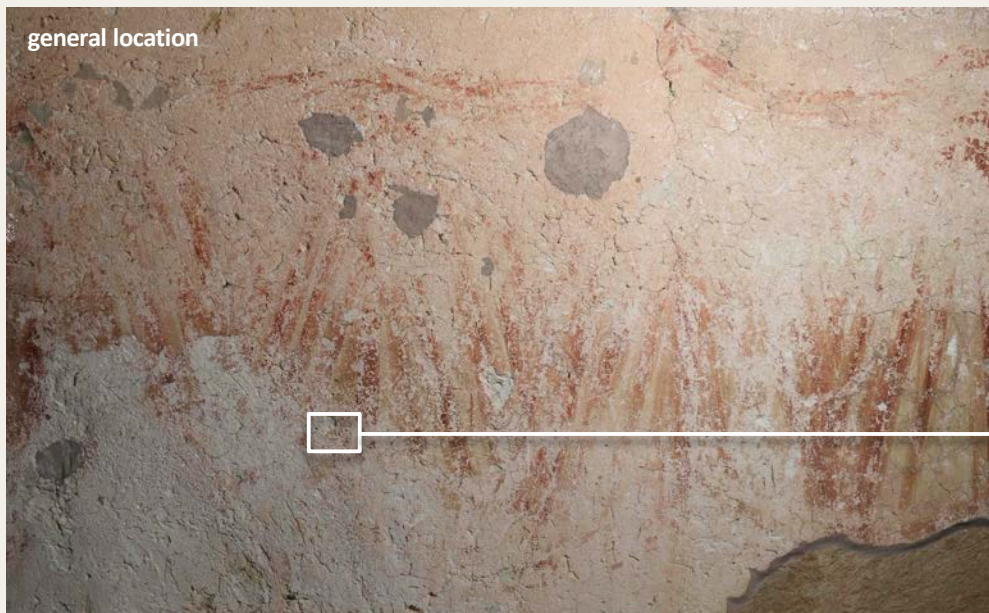
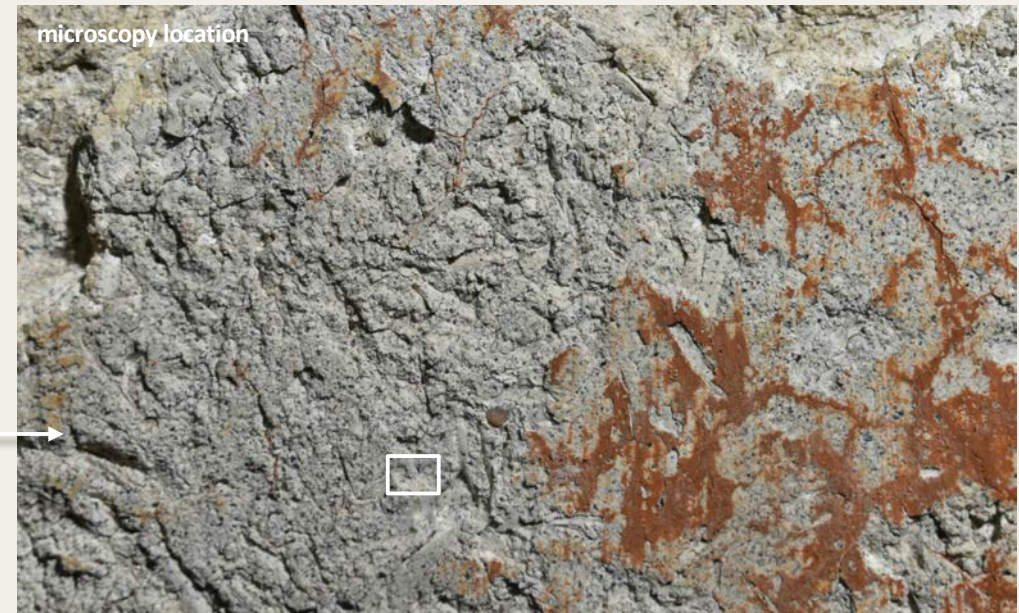
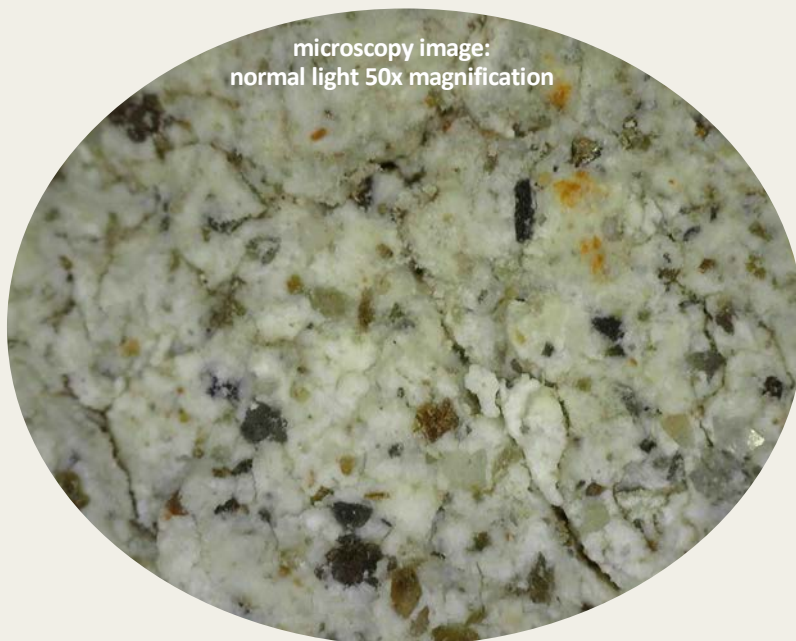
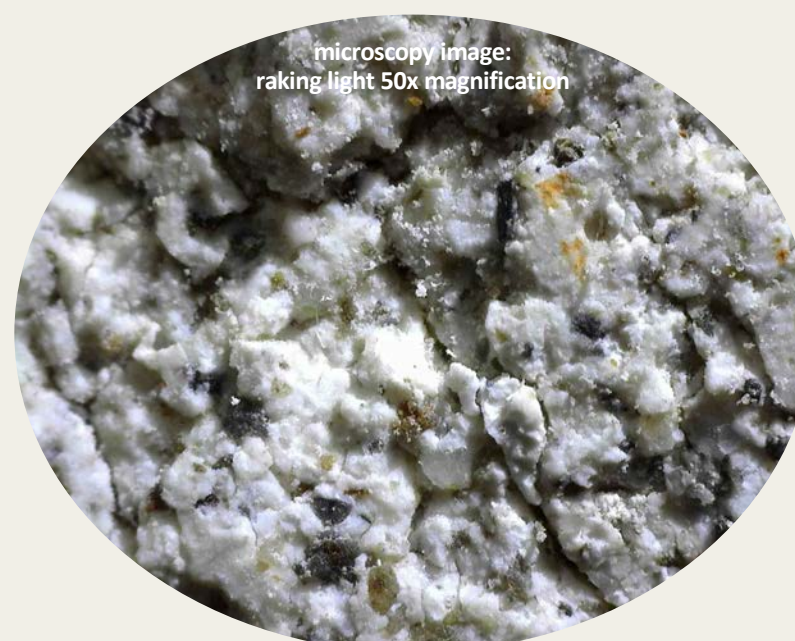
Images this page: example of characterization of original plasters using in-situ digital photo-microscopy. These investigations not only extend knowledge of the nature of the original plaster materials but also help inform the formulation of new repair materials.

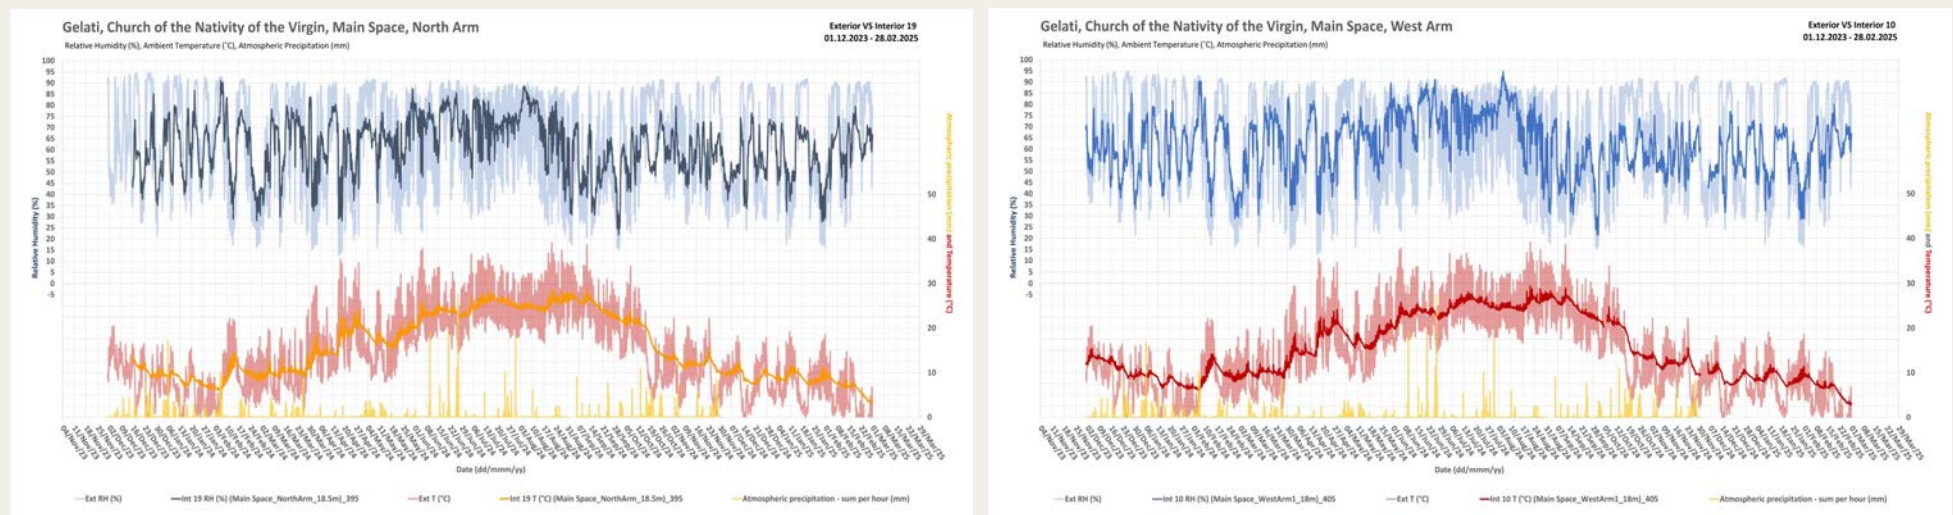
Above: Examples of graphed environmental data collected from the North Arm and West Arm of the Main Church.

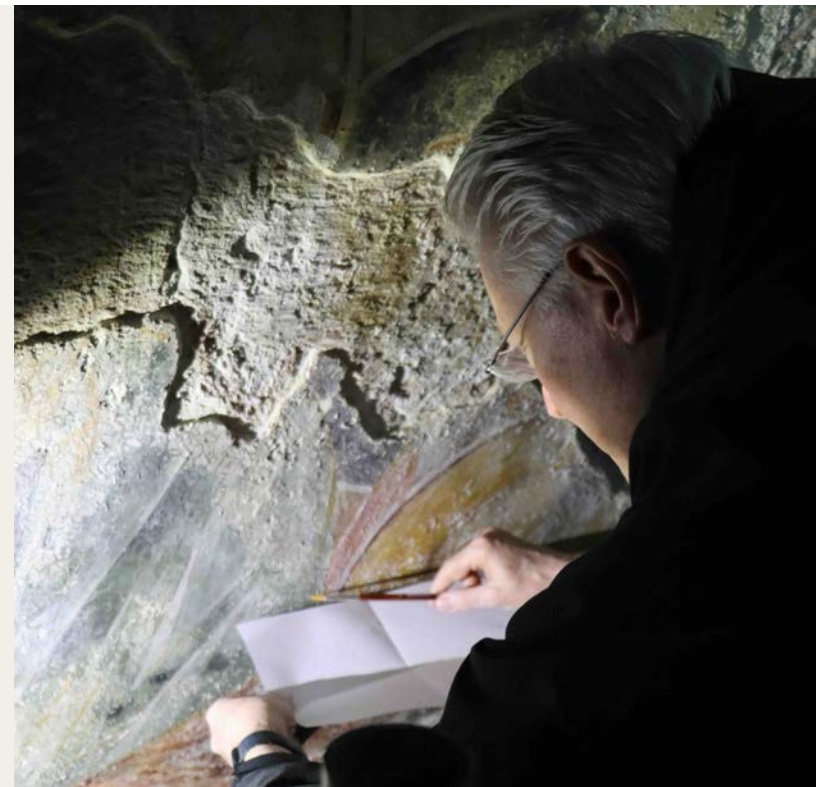
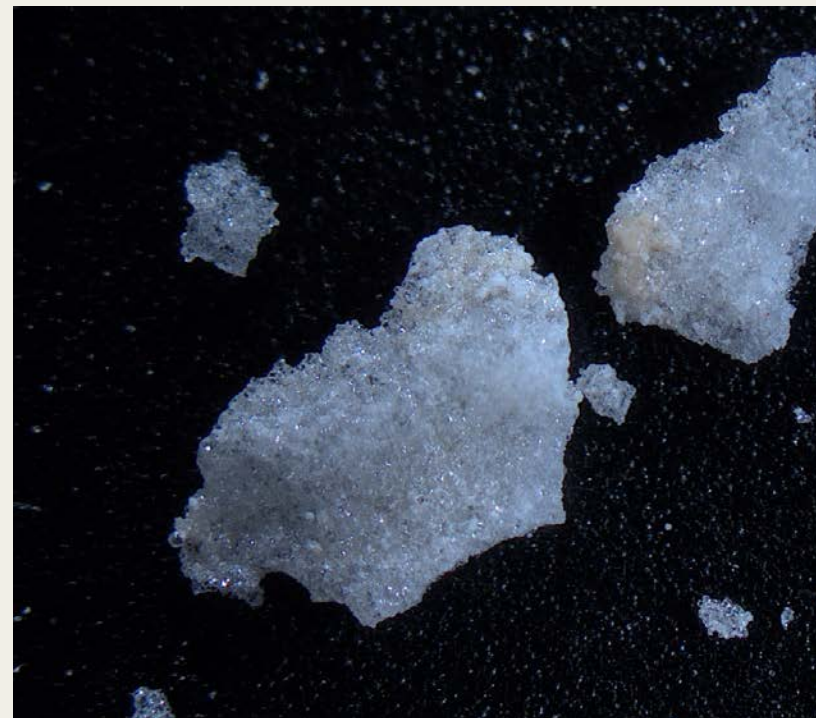
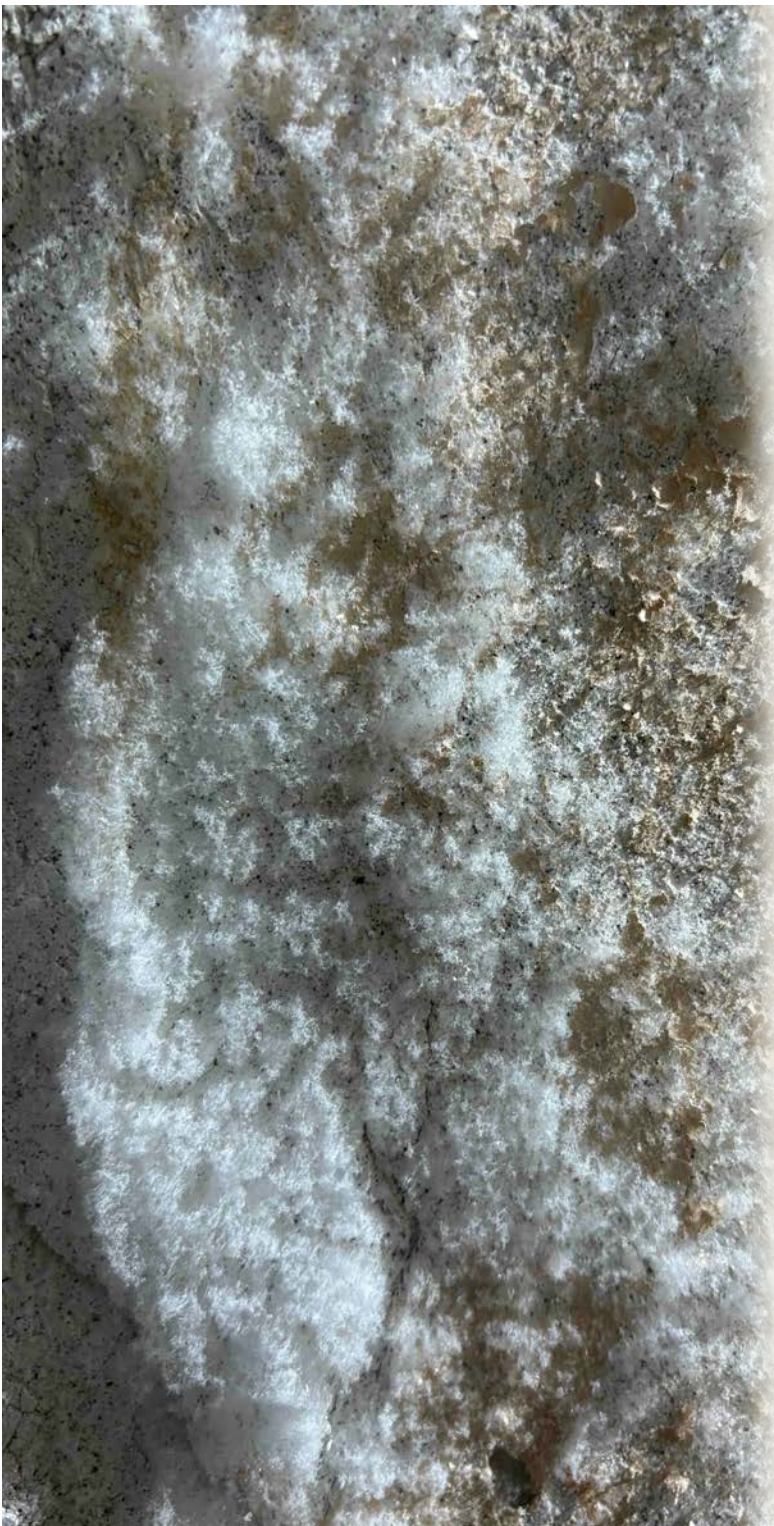
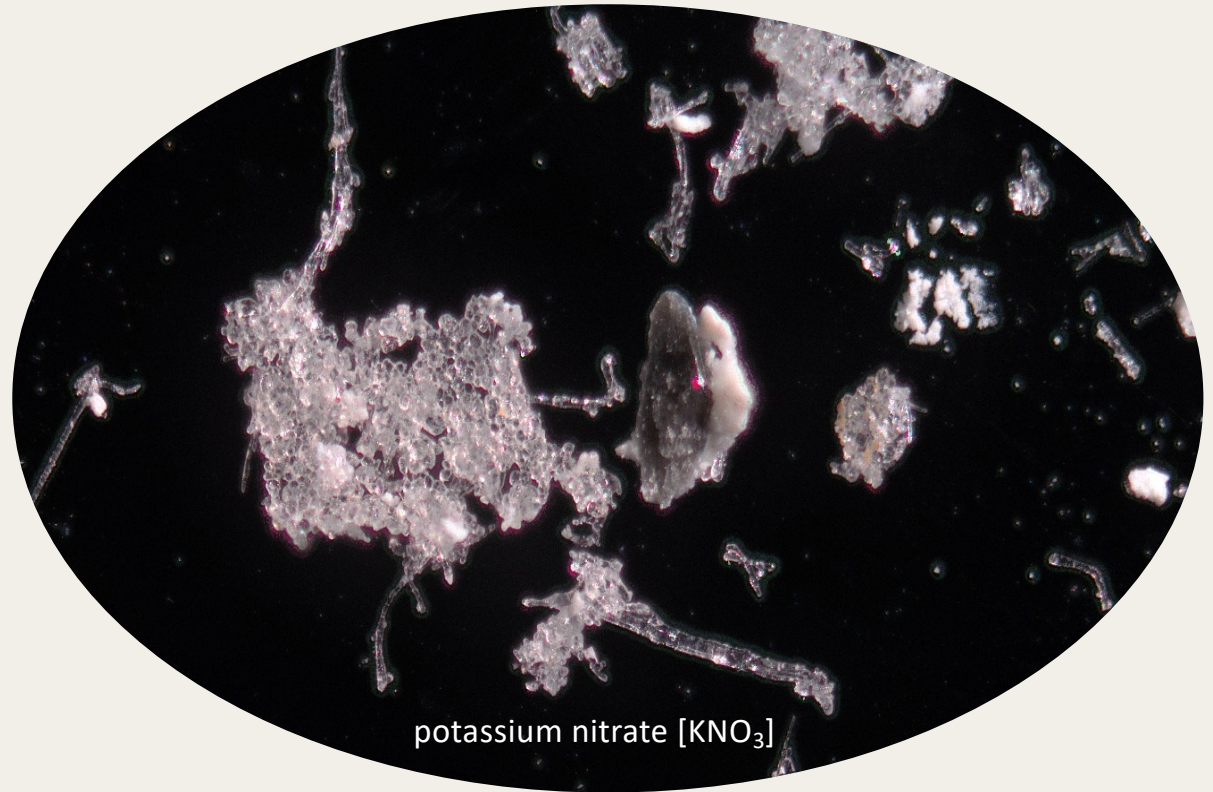
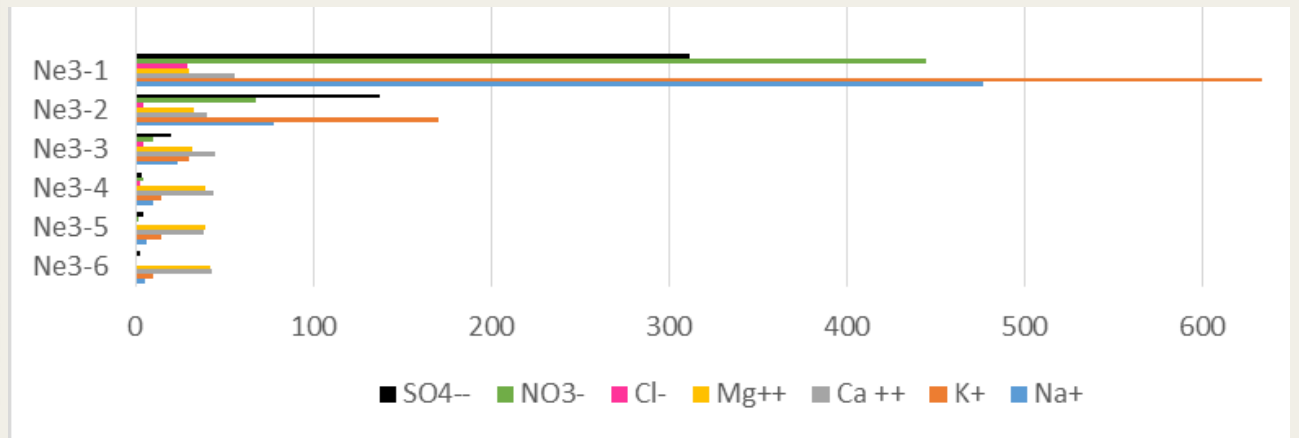
Images this page: salts are a principal cause of damage to the wall painting at Gelati (left). The main crystallizing salts have now mostly been identified. The sources of some salts, including for potassium nitrate (top), are still under consideration. Analysis of incremental core samples indicates that salt content greatly reduces with depth (bottom), indicating that salt reduction procedures can be incorporated into the treatment programme.

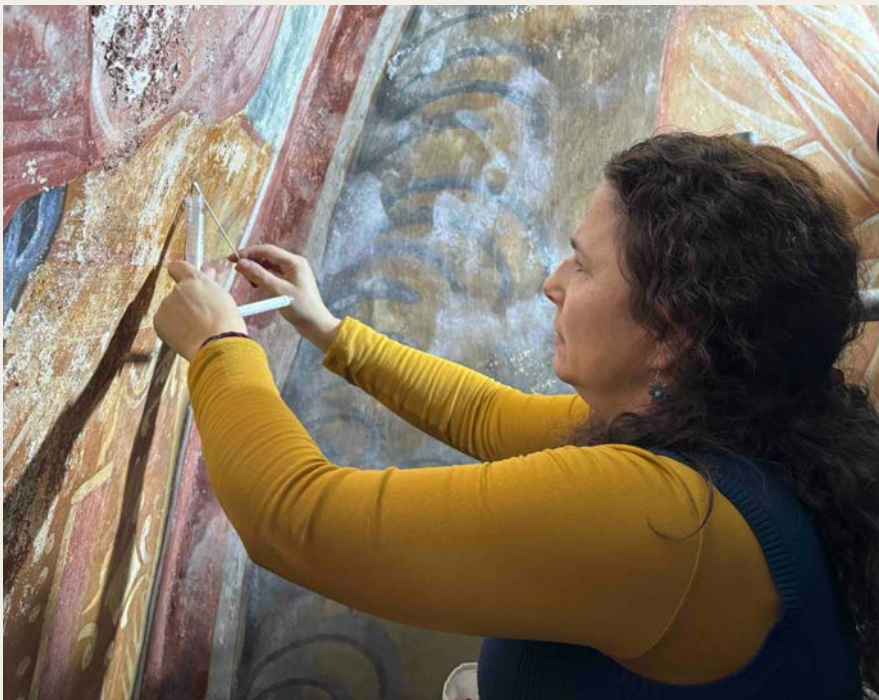
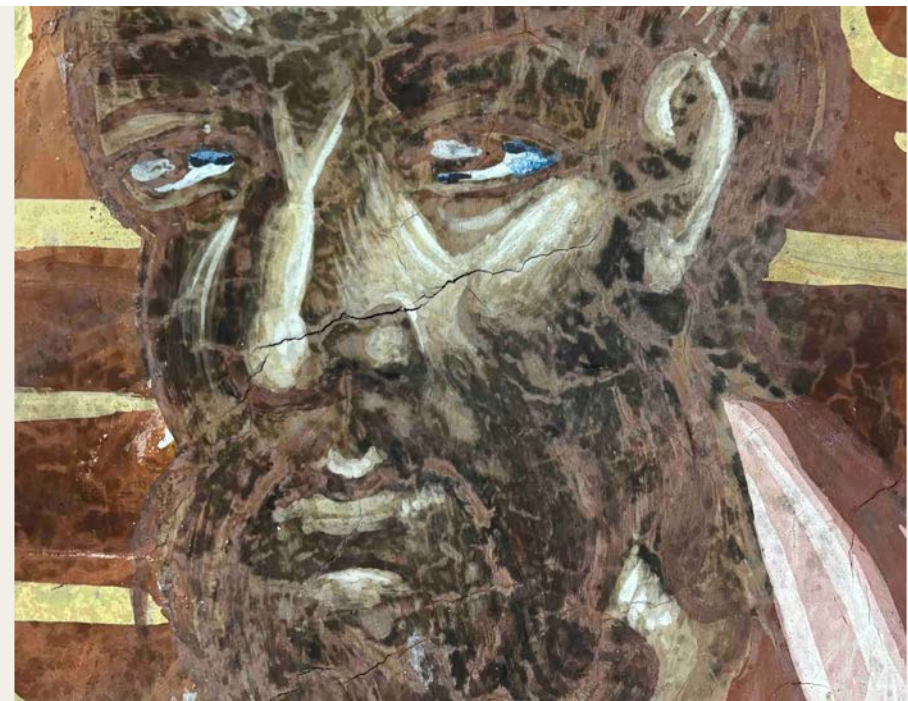
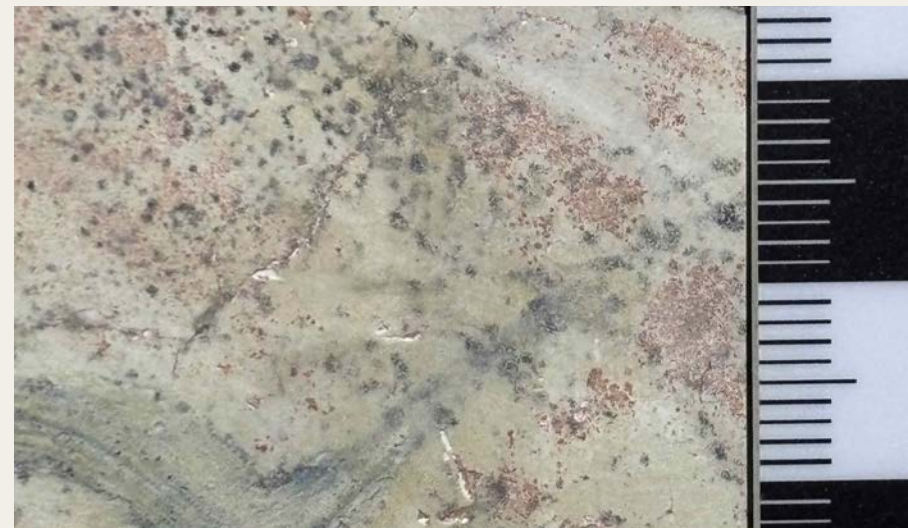
Above: microorganisms are present on the paintings in many diverse forms, such as the dark mottling seen on the figure in the top image. An example of biological colonization at a micro-level is shown in the bottom image. Impacts have not been fully explored, a task that requires specific expertise. Left: Dr Daniela Isola of the University of Tuscia, Viterbo, Italy, shown here taking a biological sample, has been engaged for this role.

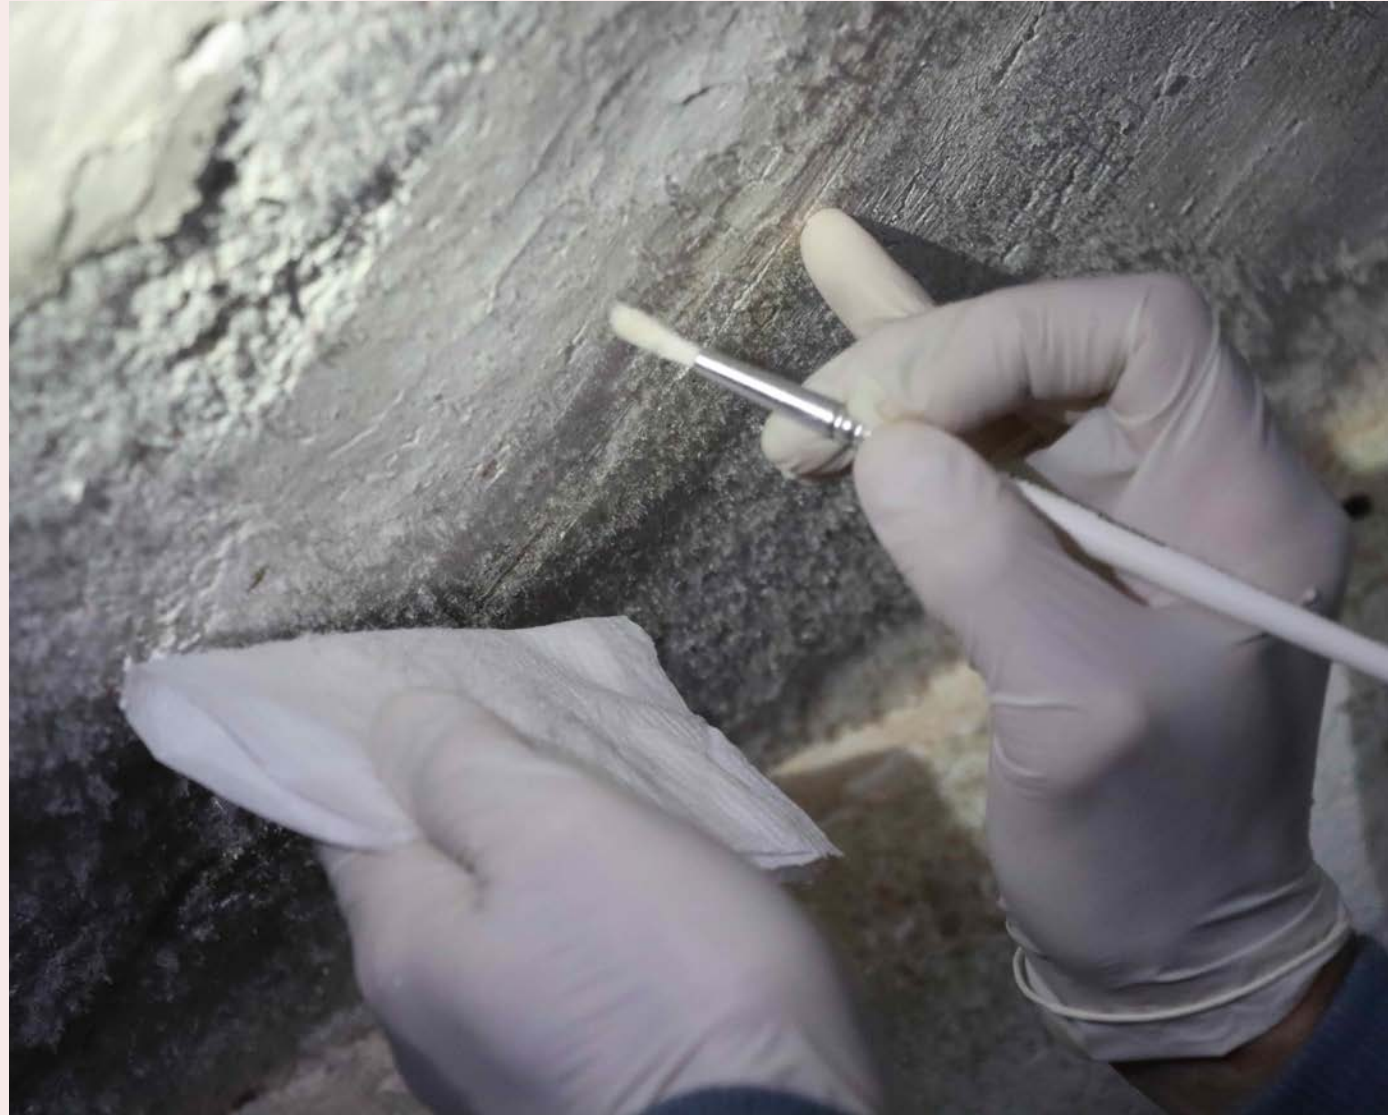
Mechanical salt removal

Salt contamination occurs over large expanses of painting and plaster. Much of this is present as solid veils and crusts on the paintings or is deposited at sub-surface levels within the plasters. But very large areas are also covered by superficial salt deposits. These contaminants are removed by gently brushing. While this is a relatively simple procedure, it must be done with great care, given the fragility of the deteriorated original materials. Several precautions are followed. Removal is carried out gradually, using a variety of soft nylon brushes. Only white brushes are used so that if any original colour is inadvertently removed, this can be quickly ascertained and the process halted or adapted. Similarly, salts are brushed onto a dampened absorbent white pad so that removed materials can be checked. Use of the dampened pad also helps to 'catch' removed salts and prevent their redeposition. Ongoing surveillance of treated areas is carried out from one work campaign to the next to check for the reappearance of salts. If this occurs, removal procedures are repeated. In general, little or no recontamination has been found. The benefits of removing excess salts from the wall painting system are not to be underestimated.

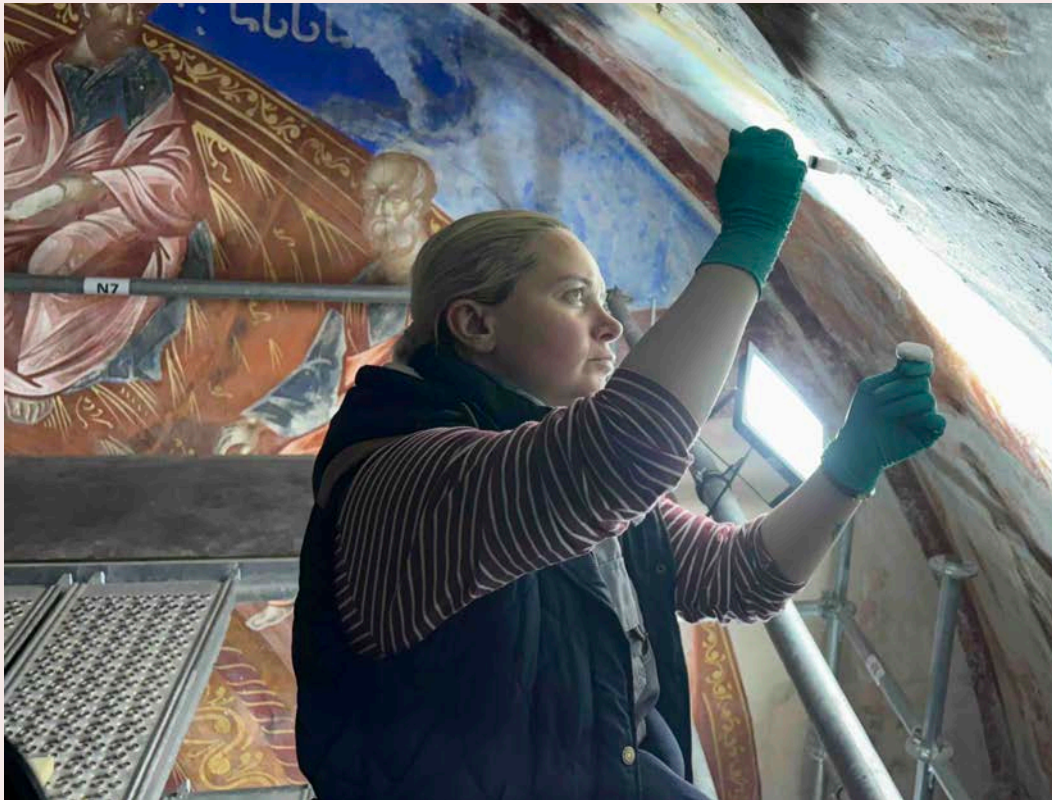
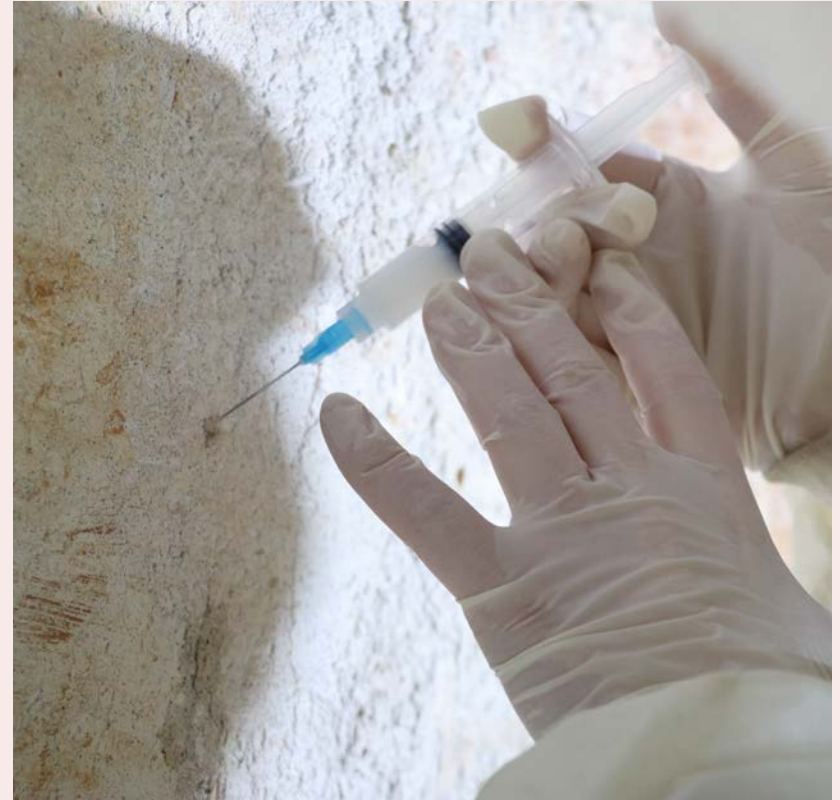
Consolidation and paint flake fixing

Nano-lime dispersed in alcohol is used for consolidation. Colloidal dispersions of Ca(OH)_2 nanoparticles offer a number of advantages: as a lime-based system, compatibility with the original plaster and limewash materials is maintained; proven efficacy in limiting carbonation of the nano-lime particles by CO_2 before they have been deposited in the substrate; appropriate penetration depth, strength, hardness, surface cohesion, capillary absorption, etc.; and little or no change of internal pore structures, so that effective porosity is maintained in the original materials. Nano-limes have been widely studied and verified in terms of their stability, and performance and working properties. The consolidant is used in different concentrations (eg, 5, 10, 25 and 50 g/l) and solvent types (eg, ethanol and N-propanol) to accommodate the variable conditions that are encountered across the plasters and paintings at Gelati. Testing and usage have also established the efficacy some nano-lime formulations for relaying and securing paint flakes. This has the benefit that film-forming adhesives can be avoided.
