Church of the Nativity of the Virgin, Gelati Monastery, Georgia

Wall painting conservation programme

Rickerby & Shekede
May 2025

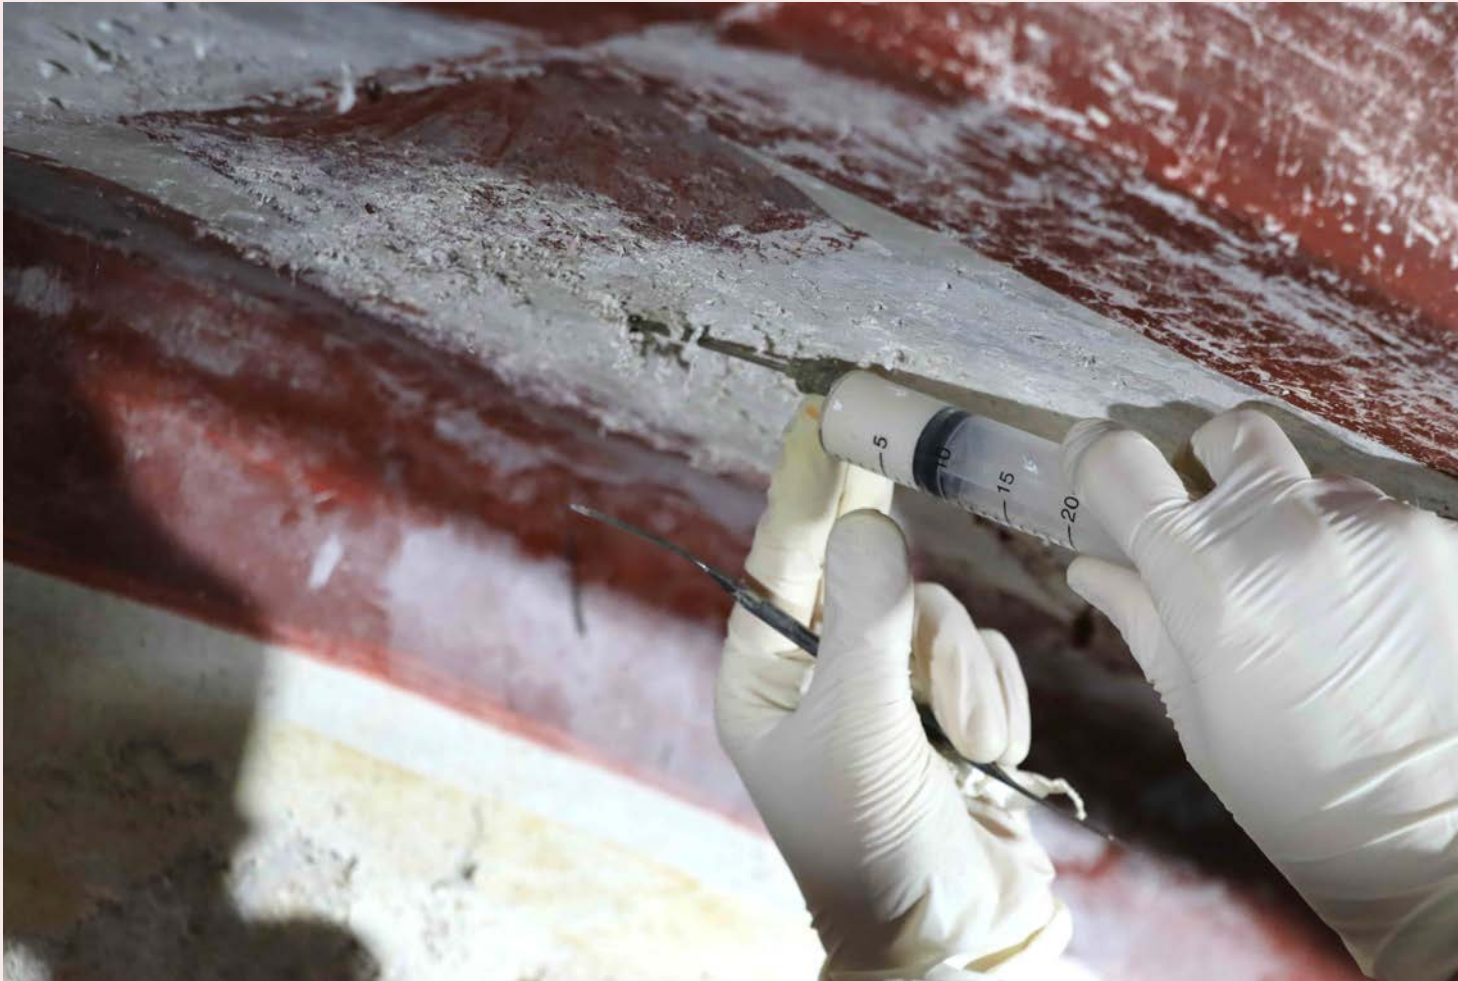
Some conditions of plaster disaggregation cannot be adequately treated with the nano-lime consolidant, and a customised 'micro-grout' is used instead (which is delivered as droplets from a pipette or syringe). This is formulated to consolidate/bridge larger loose particles at exposed plaster edges, for example. The 'micro-grout' comprises 1 part lime, 1 part chalk powder and 1 part pumice ($<240\text{ }\mu\text{m}$), + alcohol : water (1:1 v/v), the latter added to achieve desired dilution/consistency for different conditions. Dilution with alcohol is intended both to reduce risks of activating salts and to facilitate easy application.

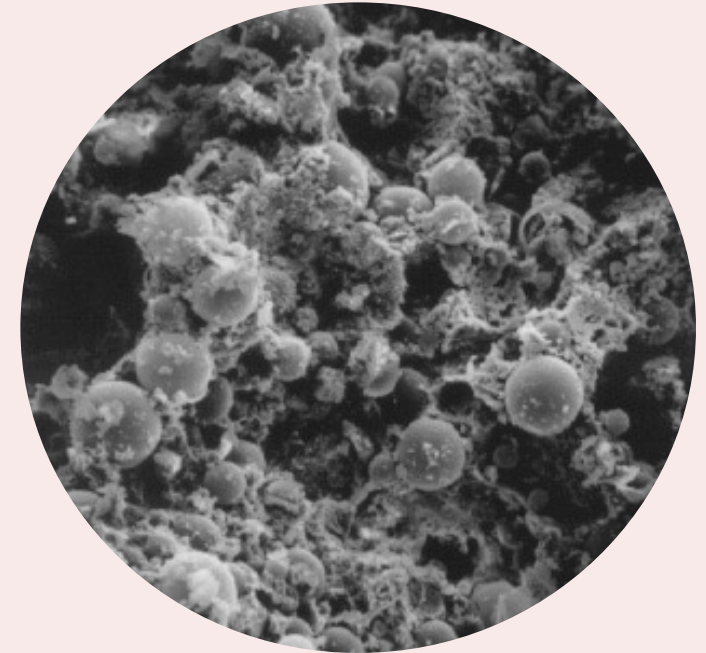
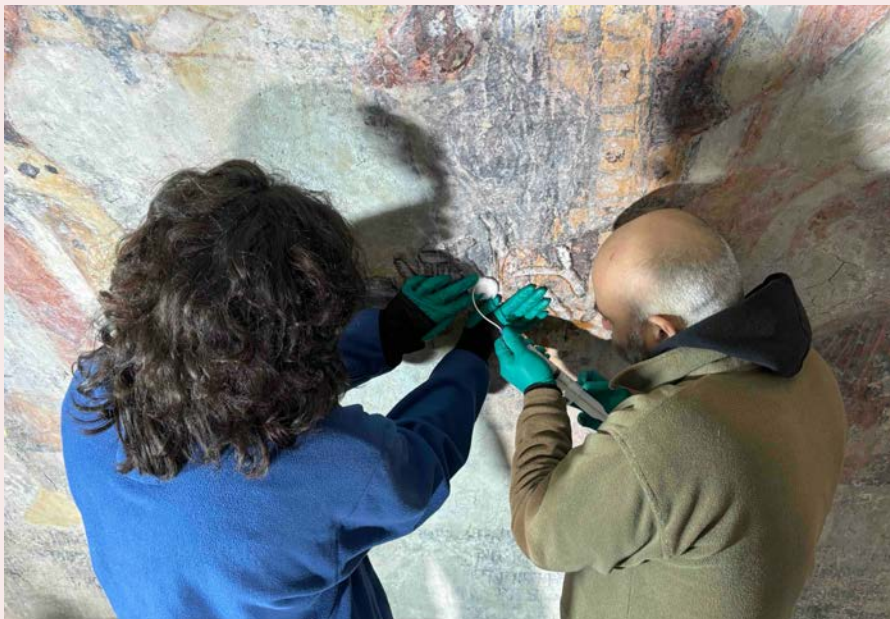
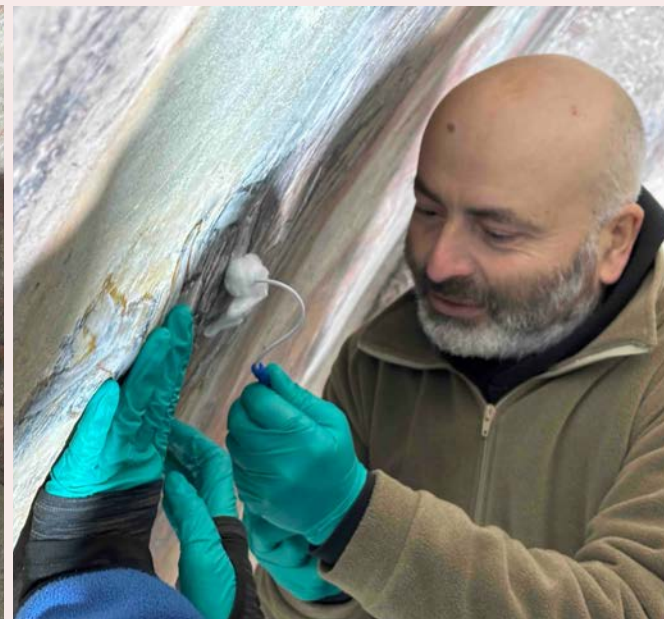
Images this page: SEM image of the customized grout, showing the distribution of its filler components in the lime matrix (top right). Grouting of the 12th-century paintings in the Narthex, March 2025 (bottom left).

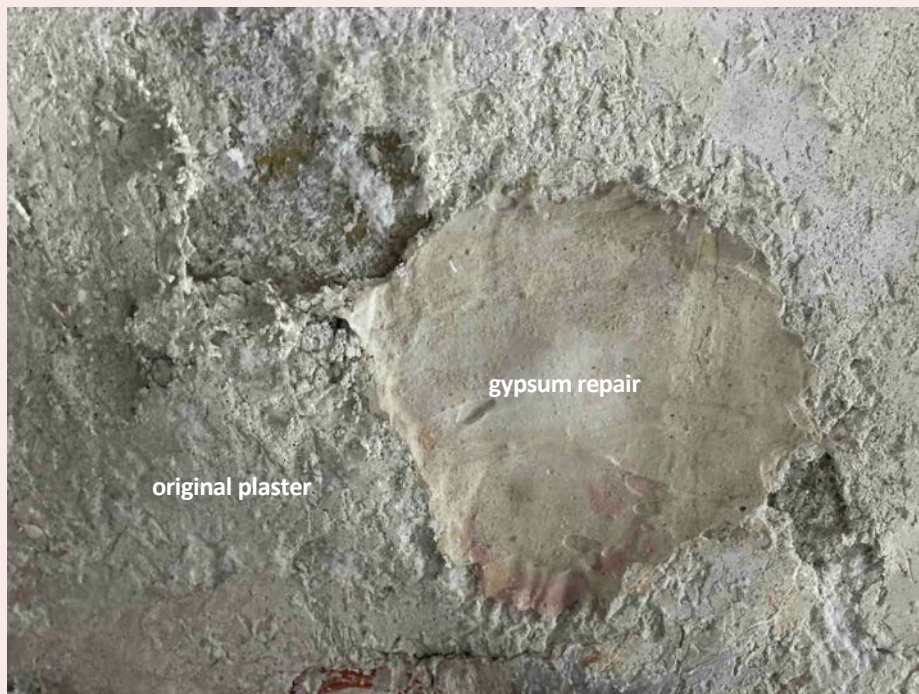
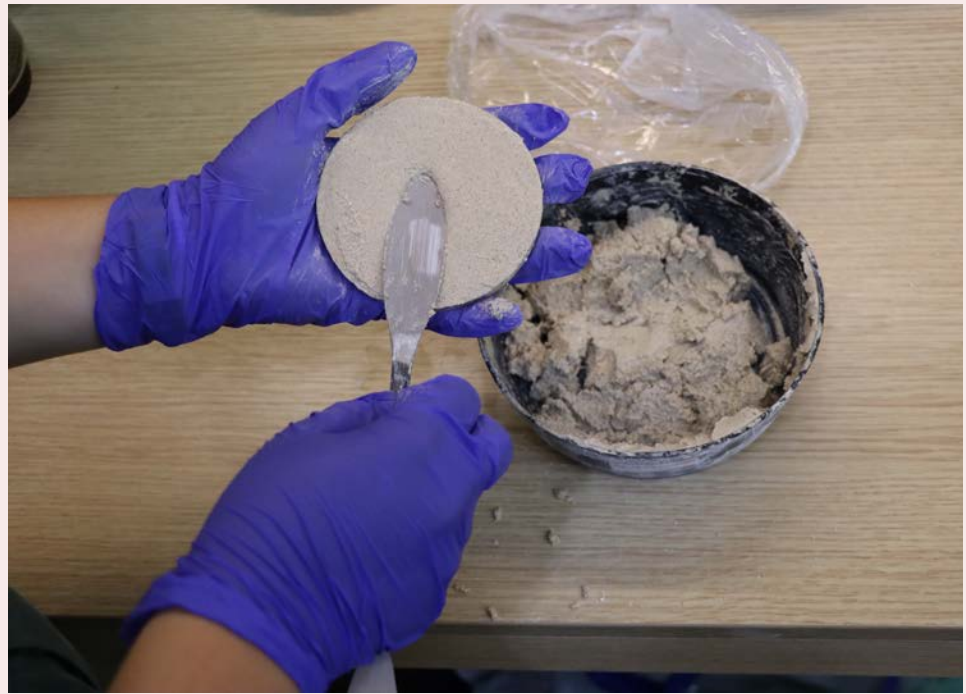
Above: Many previous repairs are too strong compared with the weaker original plasters, and interfaces of deterioration and failure have been pushed into surrounding areas (left). New repairs are carefully formulated to avoid these risks, using information about the nature of the original plasters and carrying out laboratory testing to determine appropriate performance characteristics and working properties (right).

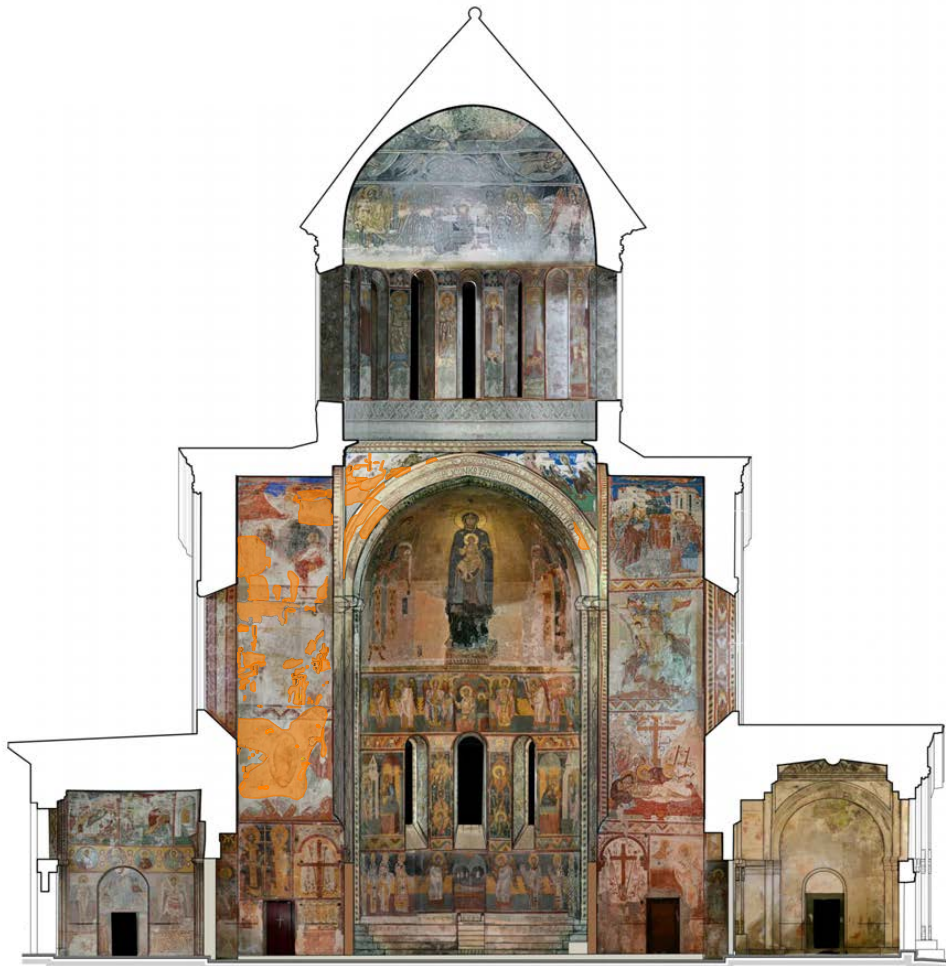
Above: Example of graphic documentation showing the east side of the Main Church and the extent of general stabilization treatments completed between 2023 and March 2025 (shaded in orange).

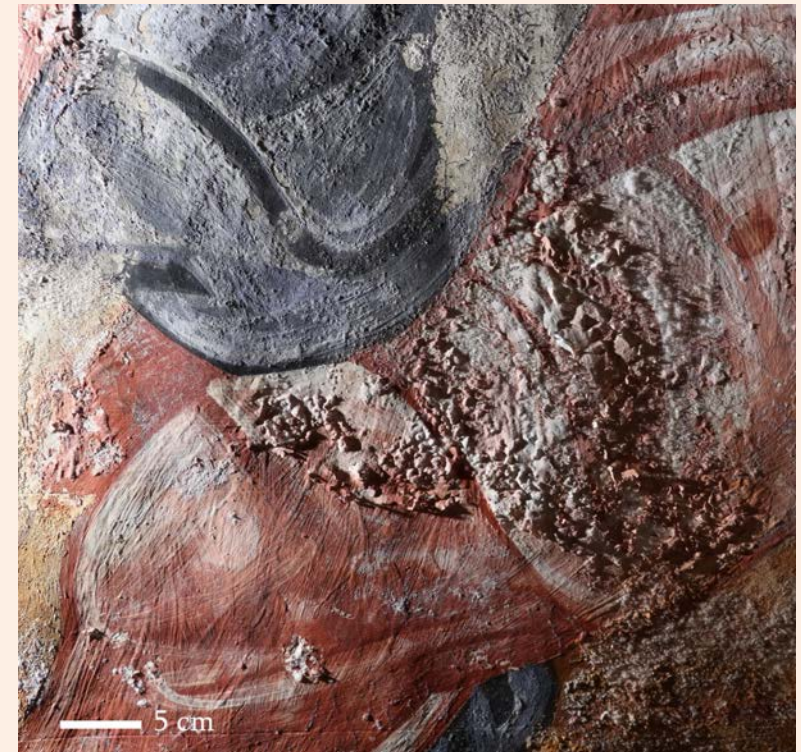
Above: A critical area in the West Arm of the Main Church.

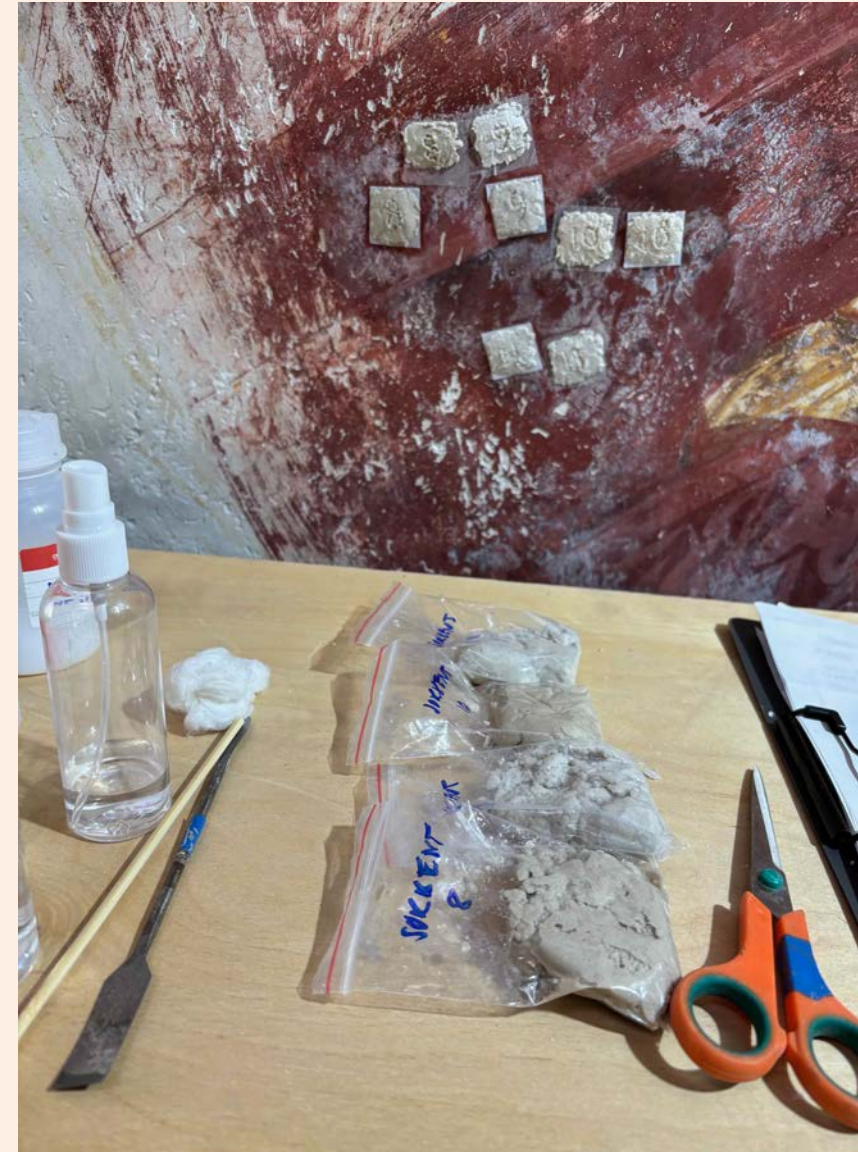
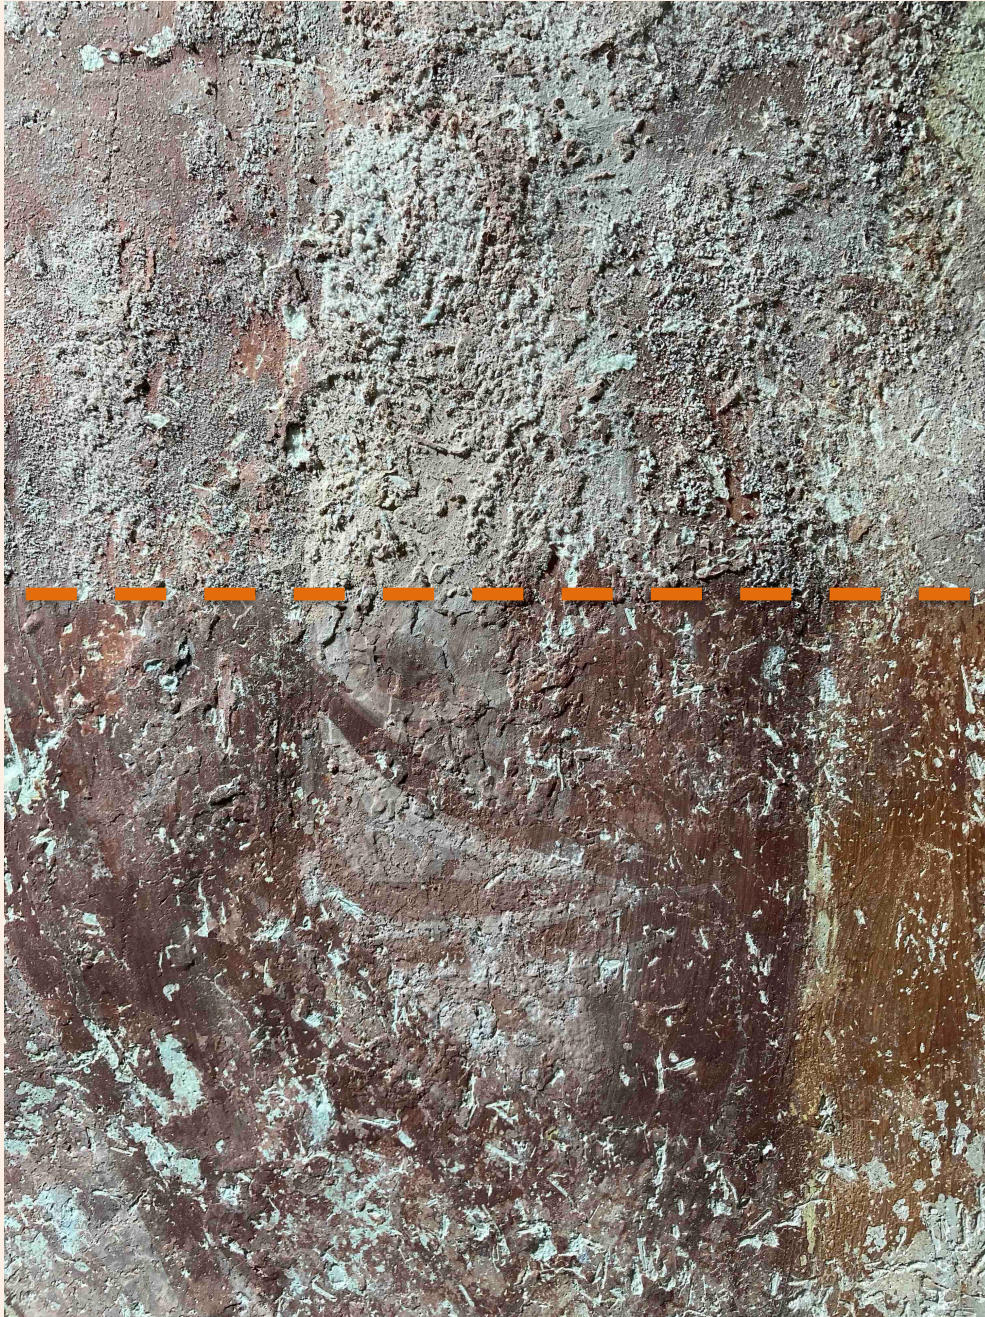
Main Church, North Arm, West Wall: this area of painting is critically undermined by salt contamination, which has resulted in extensive disruption. The severity of the conditions places it outside the normal scope of the main treatment procedures. In July 2024 trials were begun to combine stabilization treatments (ie, consolidation, 'micro-grouting') with salt reduction. Working through a lens tissue intervention layer, disrupted painting is pressed over with a dampened sorbent pad. This both relays the raised flakes and removes excess salts, which analysis shows are present mainly at the surface. The treated lower half (below the dashed orange line) was reevaluated in March 2025 and new salt crystallization is minimal and confined to very small parts. Based on these results, treatment will be cautiously continued in July 2025 in this and similar critical areas (including in the West Arm), in association with long-term surveillance of results and targeted salts analysis.

Right: Main Church, North Arm, East wall: in-situ testing of poultice formulations for salt reduction, March 2025.

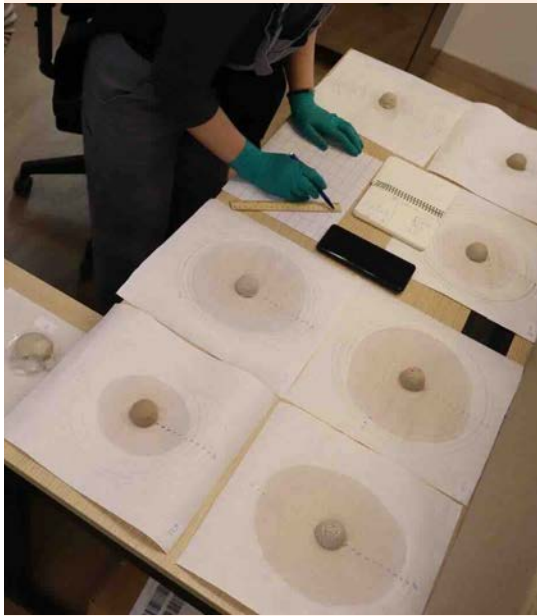
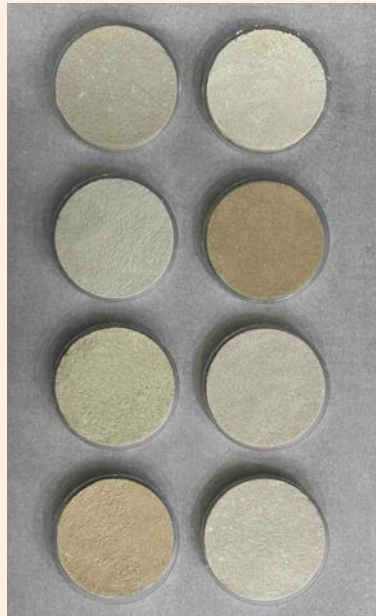
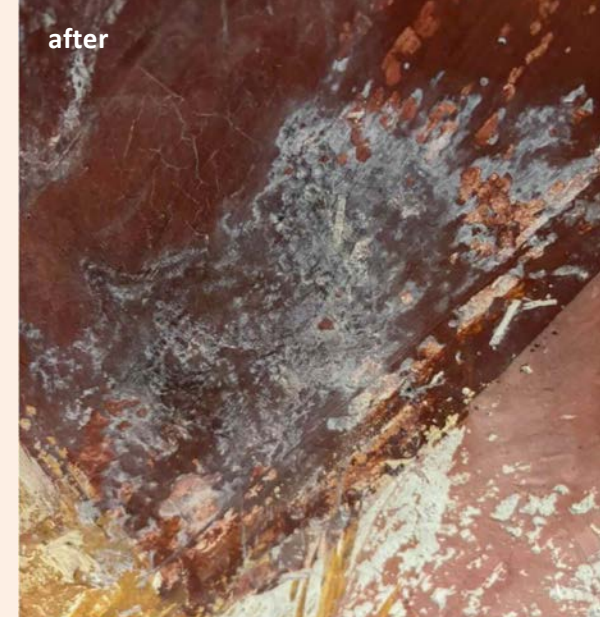
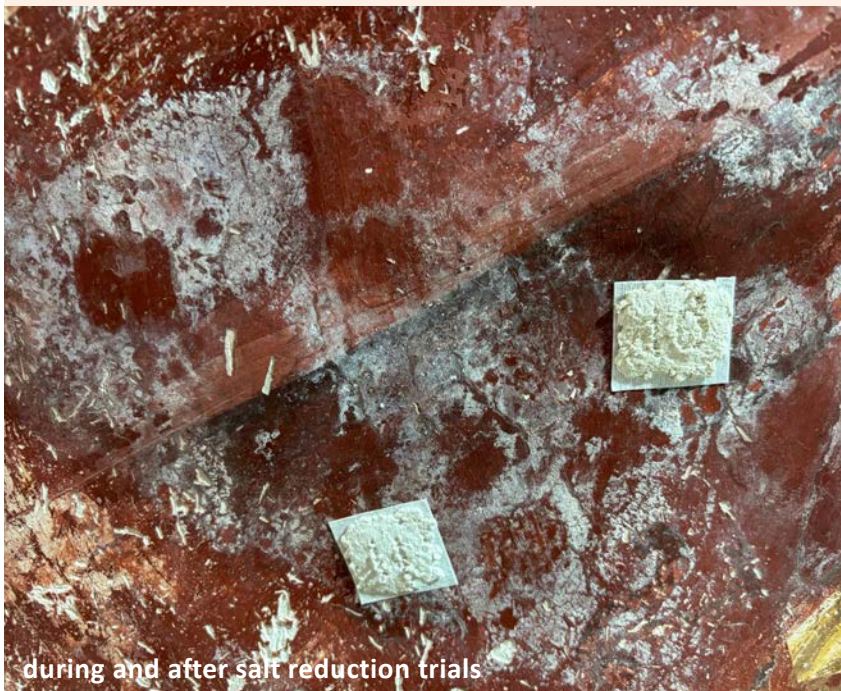
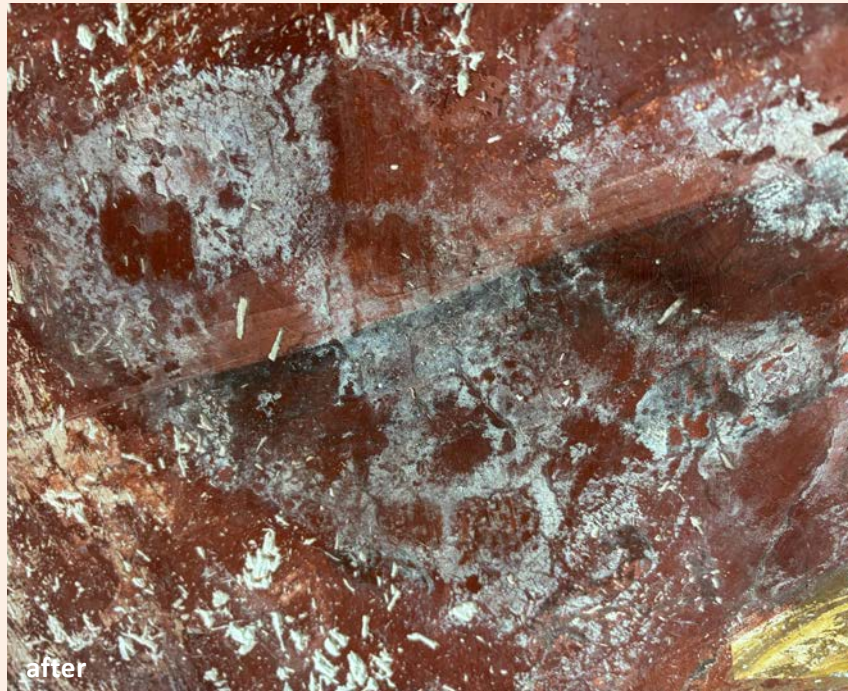
Top Left: Testing and formulation of sorbent poultices in the laboratory, March 2025.

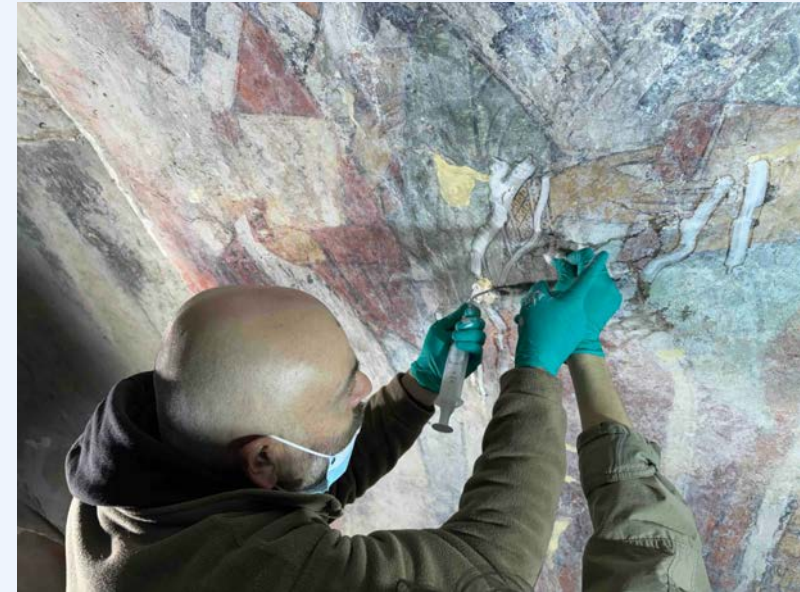
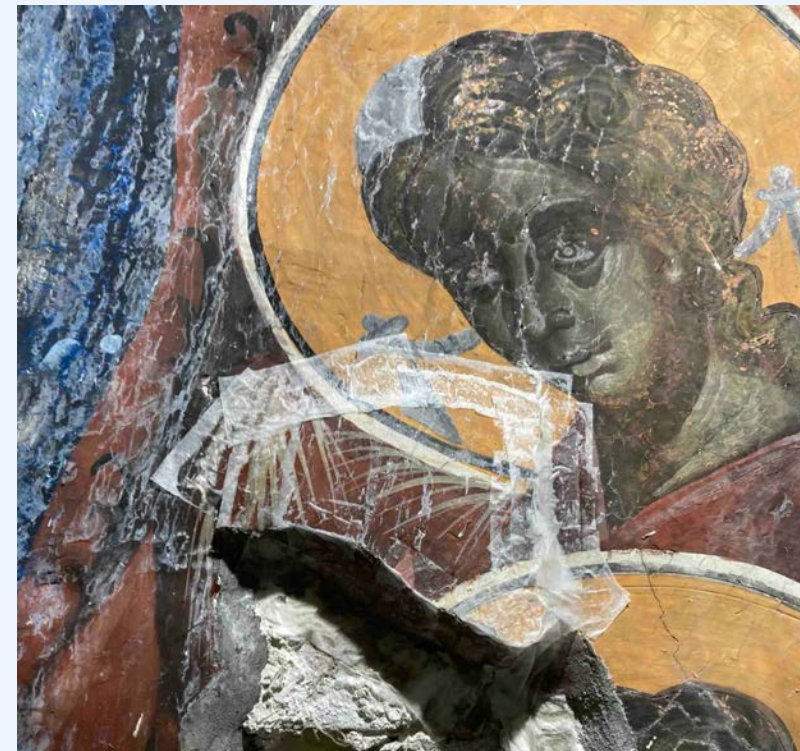
Right: Injection grouting of separated plaster in the 12th century scheme in the Narthex, March 2025 (top). Facings applied to temporarily secure plaster separation on the vault of the South Arm (bottom).

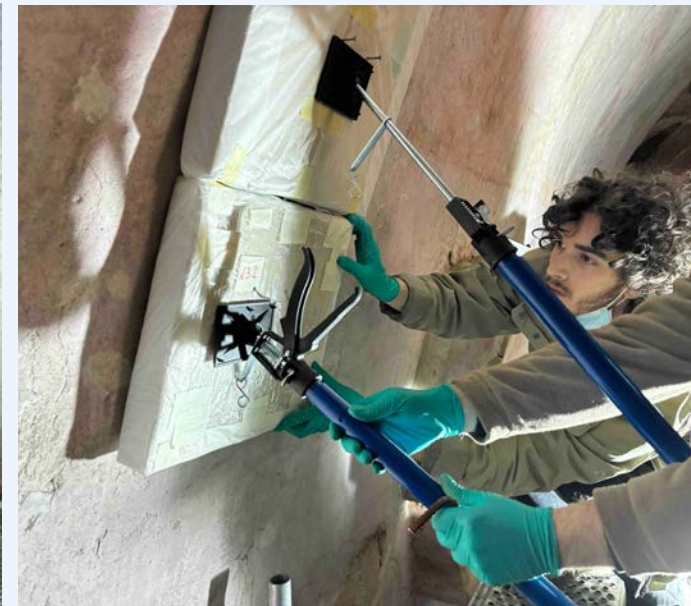
The condition assessment of the 12th century painting in the Narthex, only completed in February 2025, identified extensive areas of critical plaster separation (top left). Over a 3-week period in the following month, an intensive campaign of injection grouting was launched to tackle the problem (top right). Approximately 12 litres of grout was injected and in total about 4.5 square metres of separated plaster was resecured. In a new initiative, grouting was combined with salt reduction. Absorbent presses were prepared on site (bottom left) and placed over individual grout areas with tensioned presses (bottom middle). Sorbent layers in the presses were changed daily (bottom right) and salts analysis carried out of both the grouted plasters and the removed absorbent materials to check on the efficacy of the salt reduction procedures.

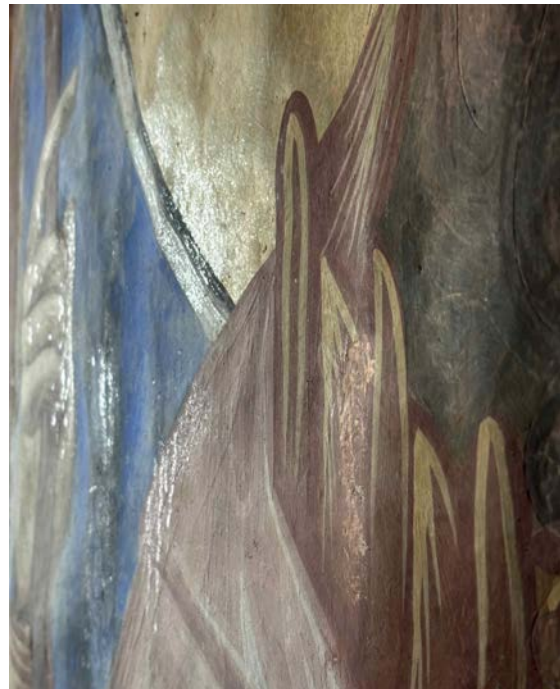
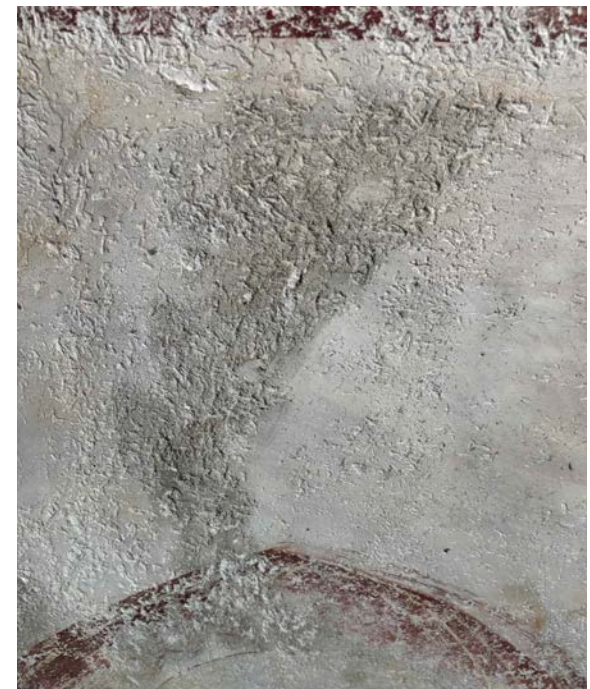
Above: previous materials applied to the paintings include damaging film-forming consolidants and fixatives. From an oblique angle, some are visible as shiny surface residues (left). Elsewhere they have degraded and darkened (right). However, as records of their use are generally lacking, their extent and nature often remain unknown. Analytical investigations are beginning to identify some materials and this process is ongoing.

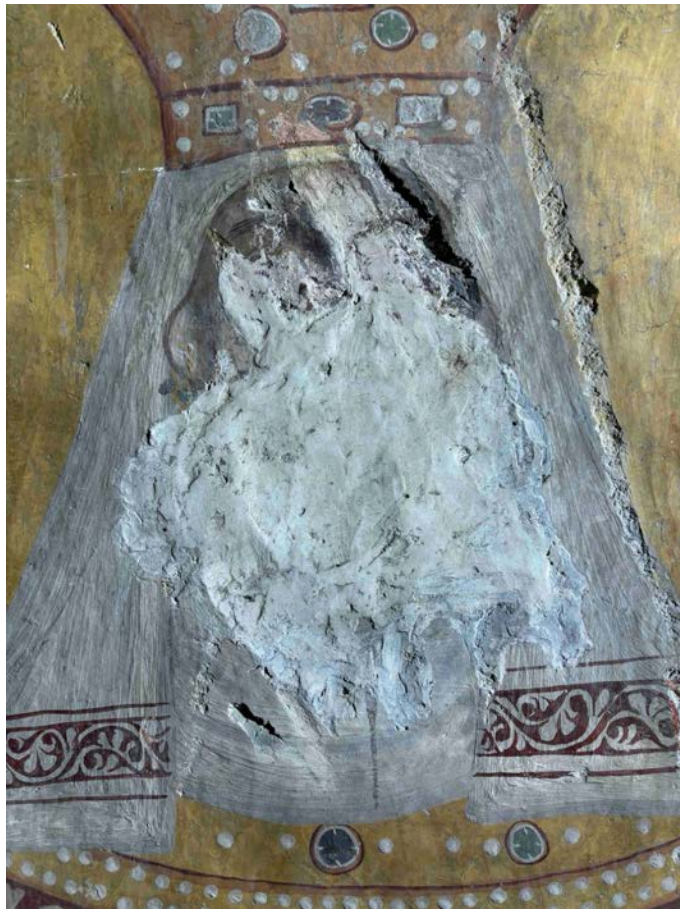
*Above and Right: Looking beyond the primary task of stabilizing the paintings, a range of other issues mainly to do with their poor appearance and presentation need to be considered. Some paintings are disfigured by very poor previous repairs (above). Graffiti is a significant problem for paintings at floor level (right). Provisional treatment plans and projections for these and other outstanding issues are presented for deliberation in **appendices 2 and 3**.*

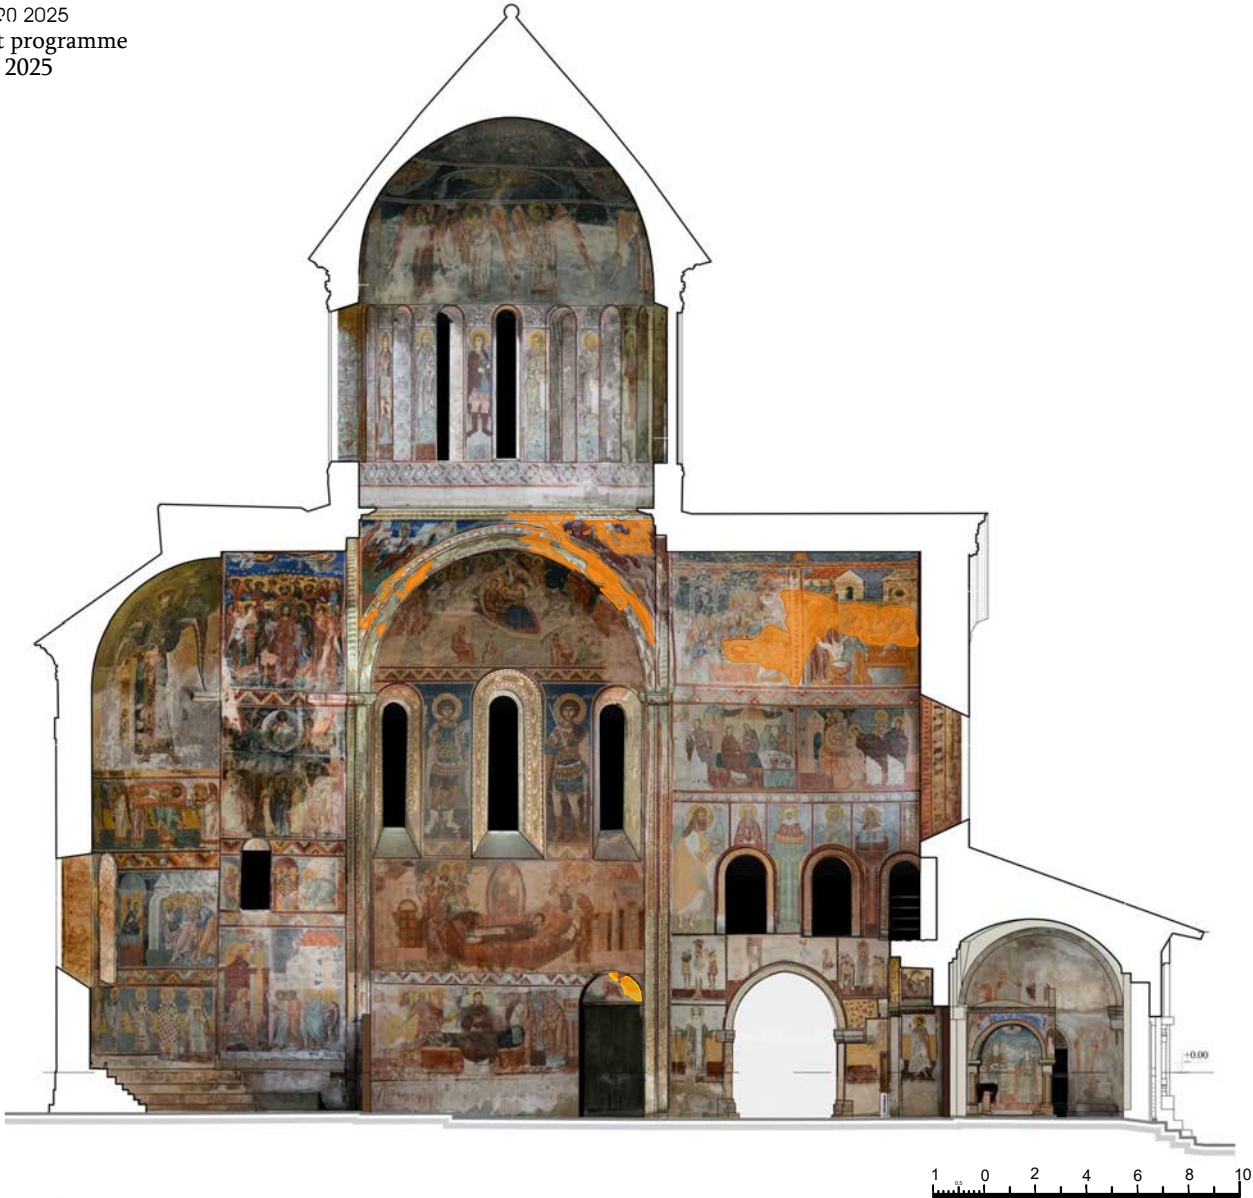
საონკოპრობო ფიზიკური ჩარევების პროგრამა
მარტი 2024 - აპრილი 2025
Remedial treatment programme
March 2024 - April 2025

- Grouting
ჩასხმა (ინექტირება)
- General stabilisation
ზოგადი გამაგრება

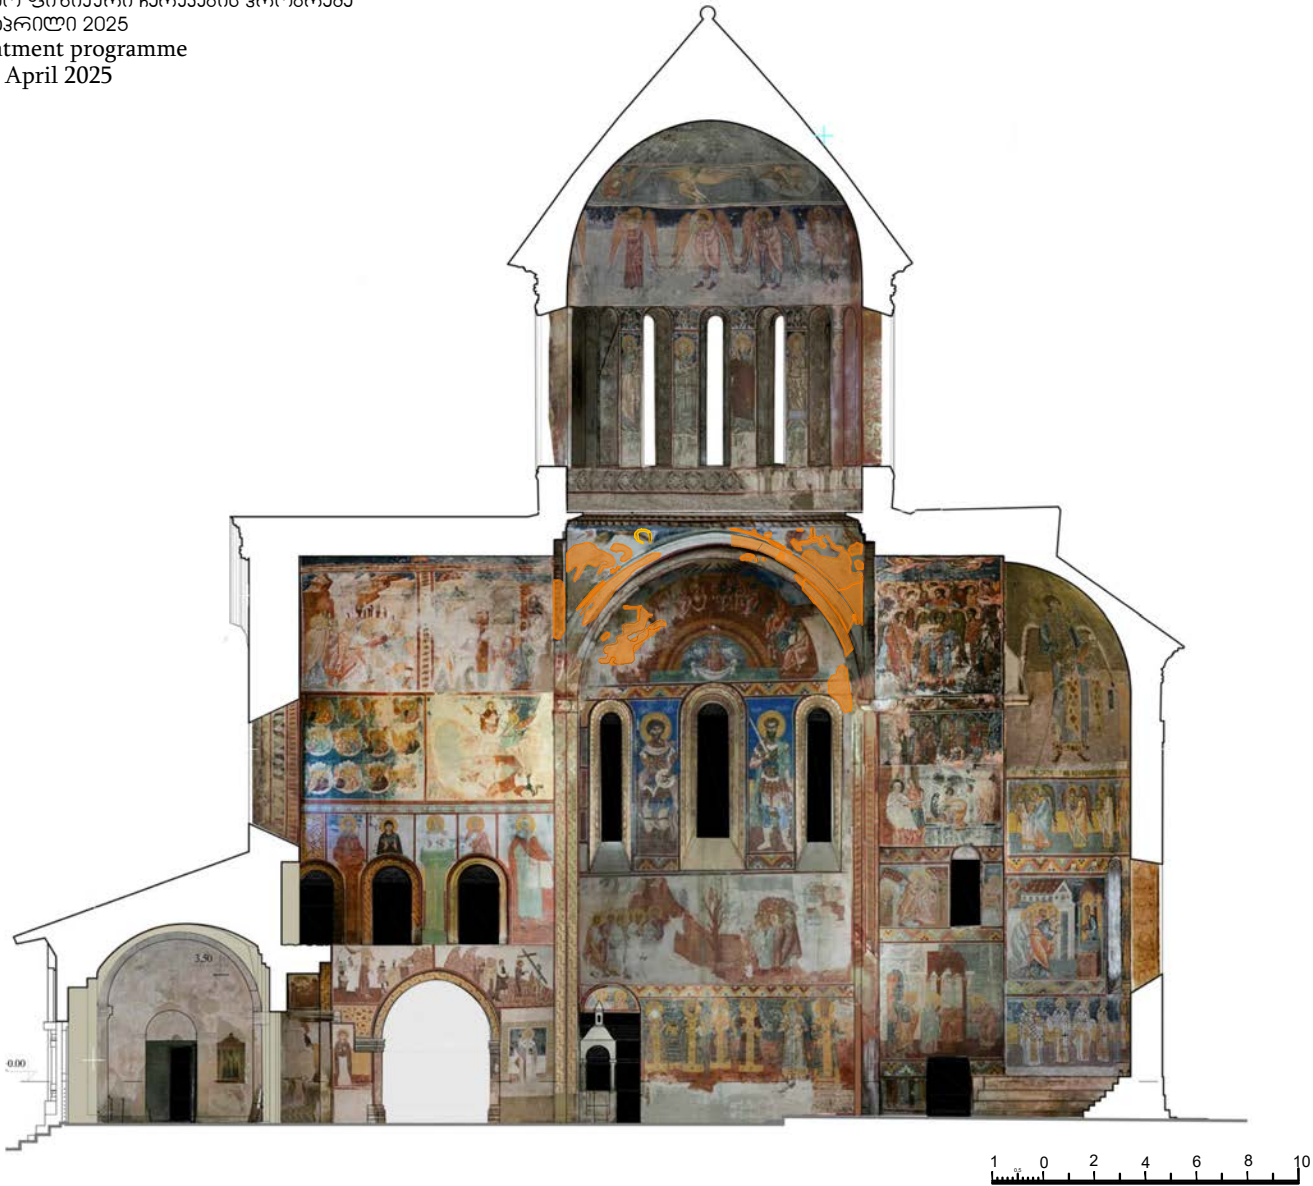
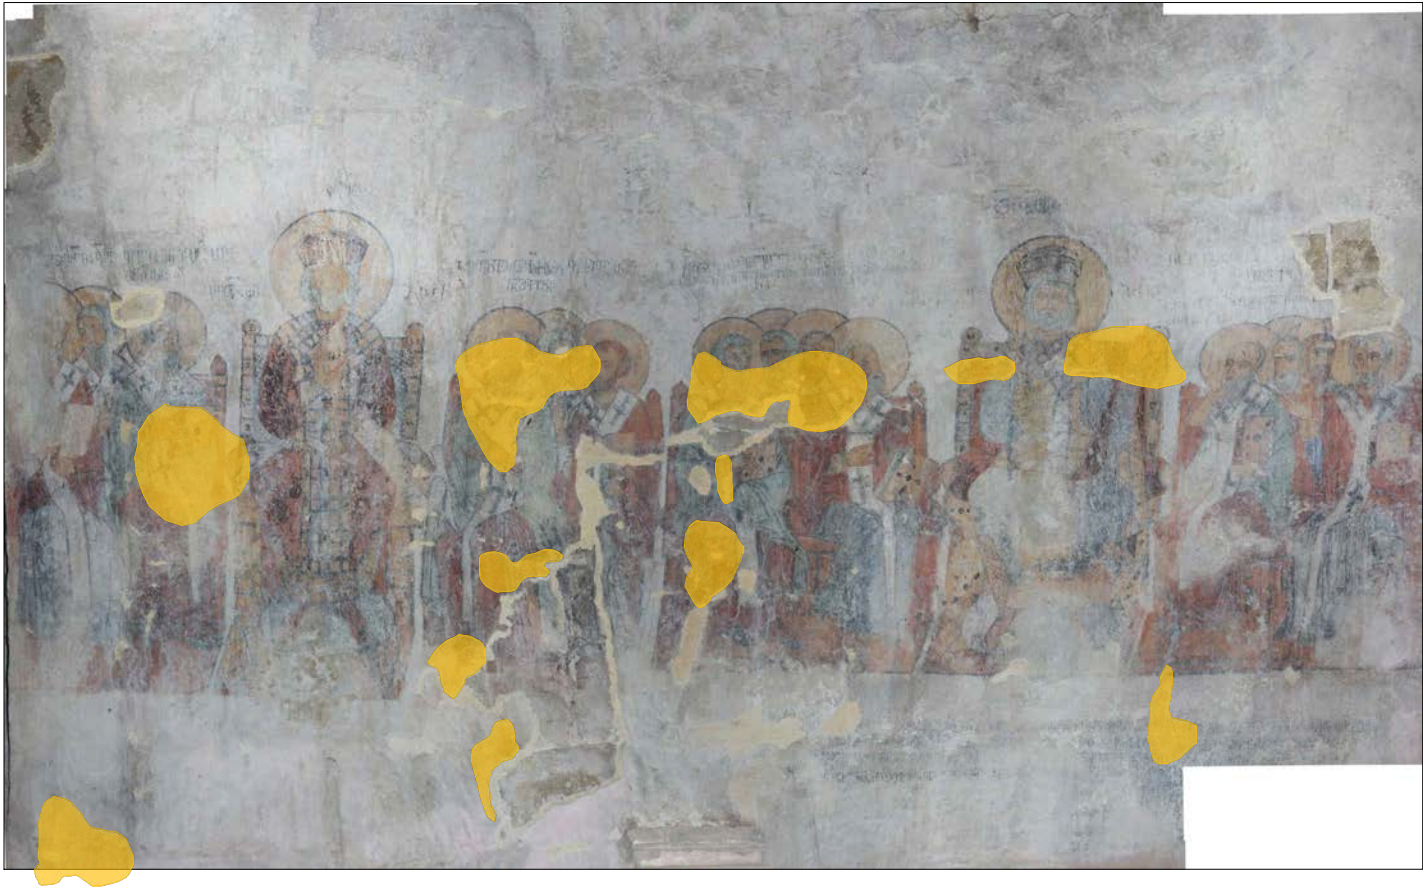
სახოსარკავციო ფიზიკური ჩარევის პროგრამა
მარტი 2024 - აპრილი 2025
Remedial treatment programme
March 2024 - April 2025

- Grouting
ჩასხმა (ინექცირება)
- General stabilisation
ზოგადი გამაგრება

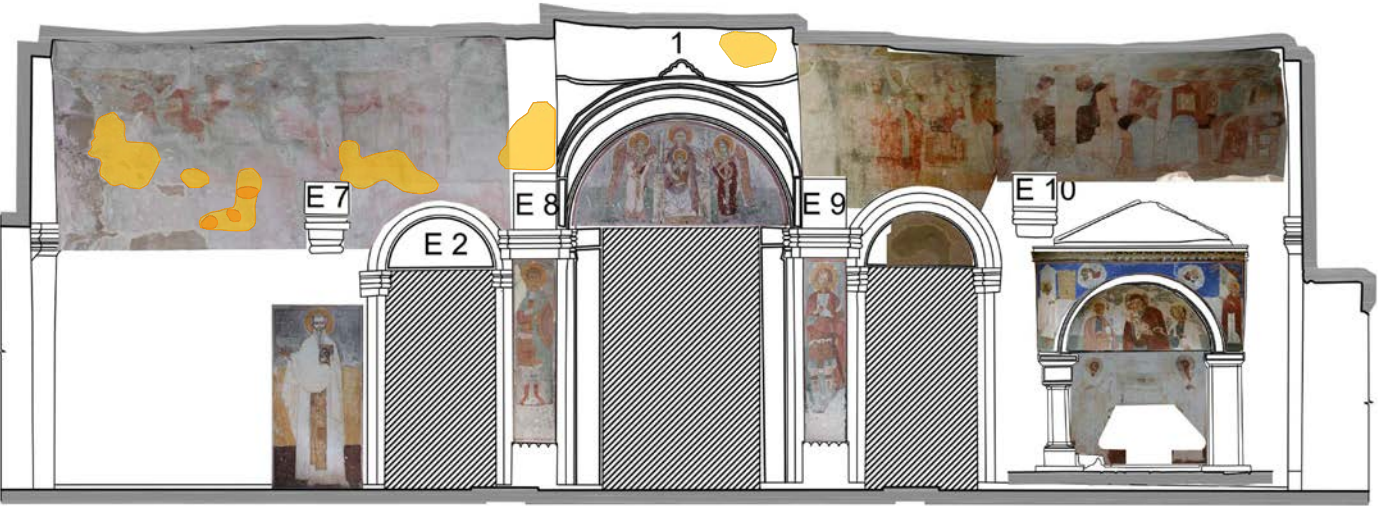
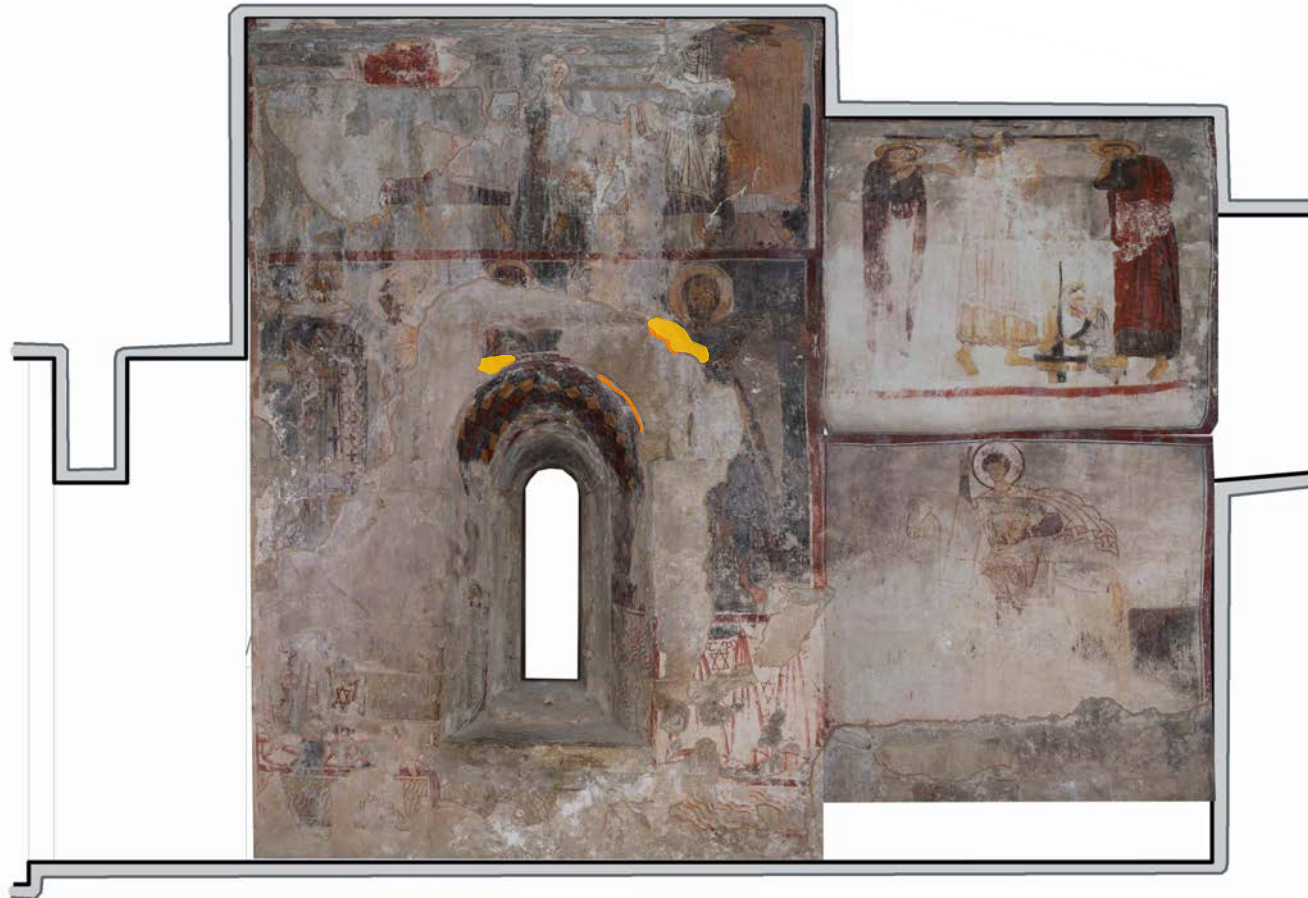
სამხრეთის ჯიშლი
South section

- Grouting
ჩასხმა (ინექტირება)
- General stabilisation
ზოგადი გამაგრება

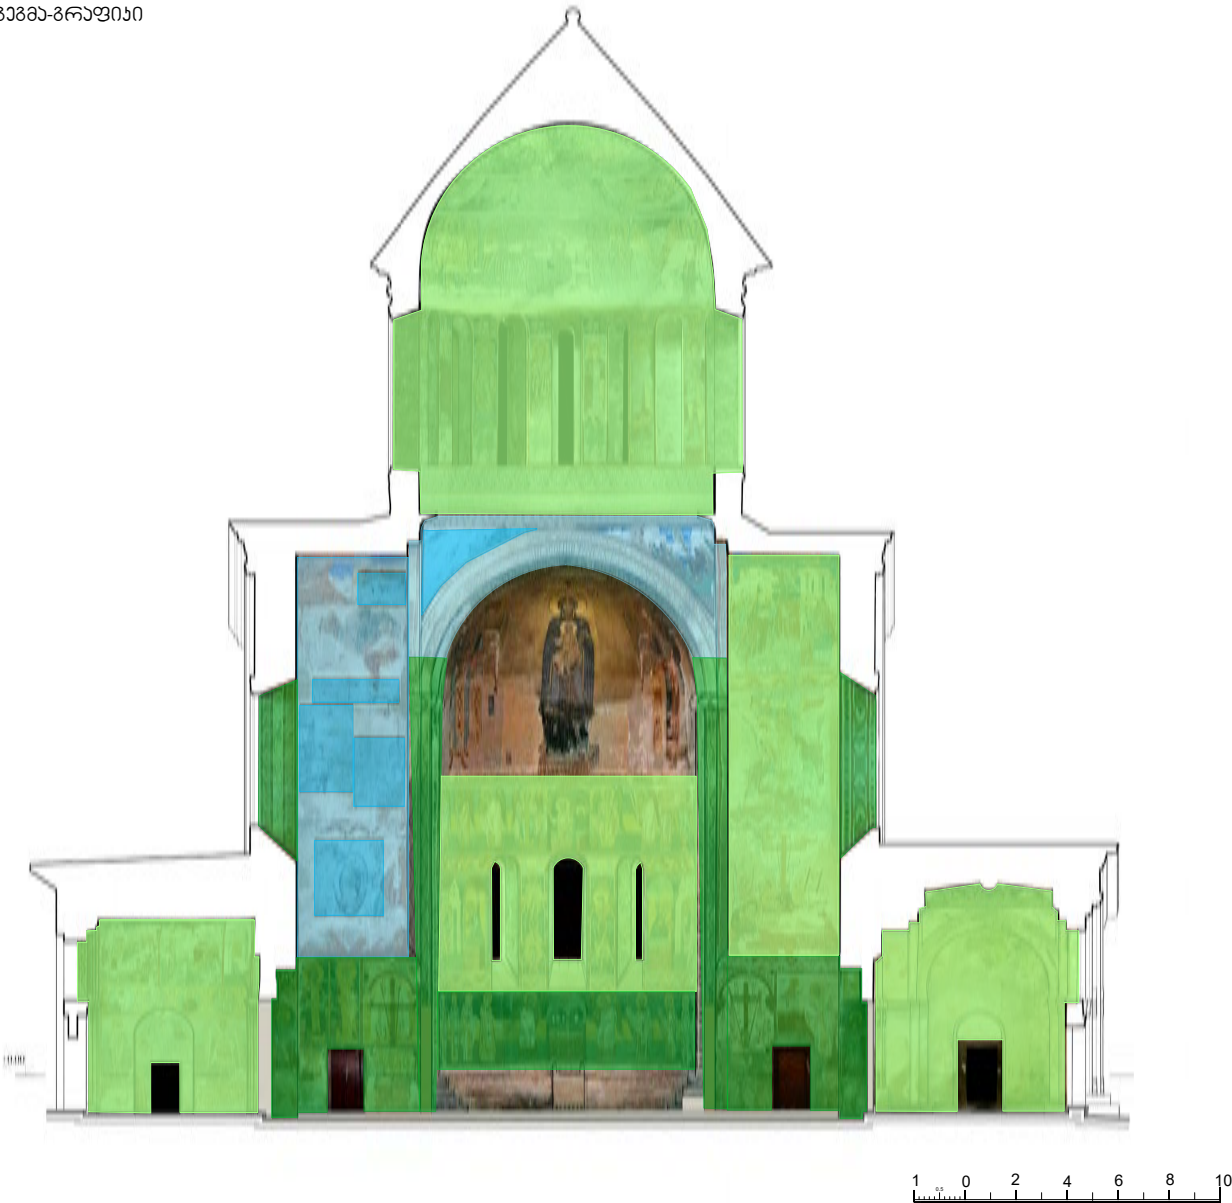
Conservation timeline 2024-2030
2024-2030 წლების - საკონსერვაციო გეგმა

- Completed treatments 2024-2025
შესრულებული ჩარევები 2024-2025
- Ongoing treatments 2025
მიმდინარე ჩარევები 2025
- Planned treatments 2026-2029
დაგეგმილი ჩარევები 2026-2029
- Planned treatments 2030
დაგეგმილი ჩარევები 2030
