Church of the Nativity of the Virgin, Gelati Monastery, Georgia

Wall painting conservation programme

Rickerby & Shekede
May 2025

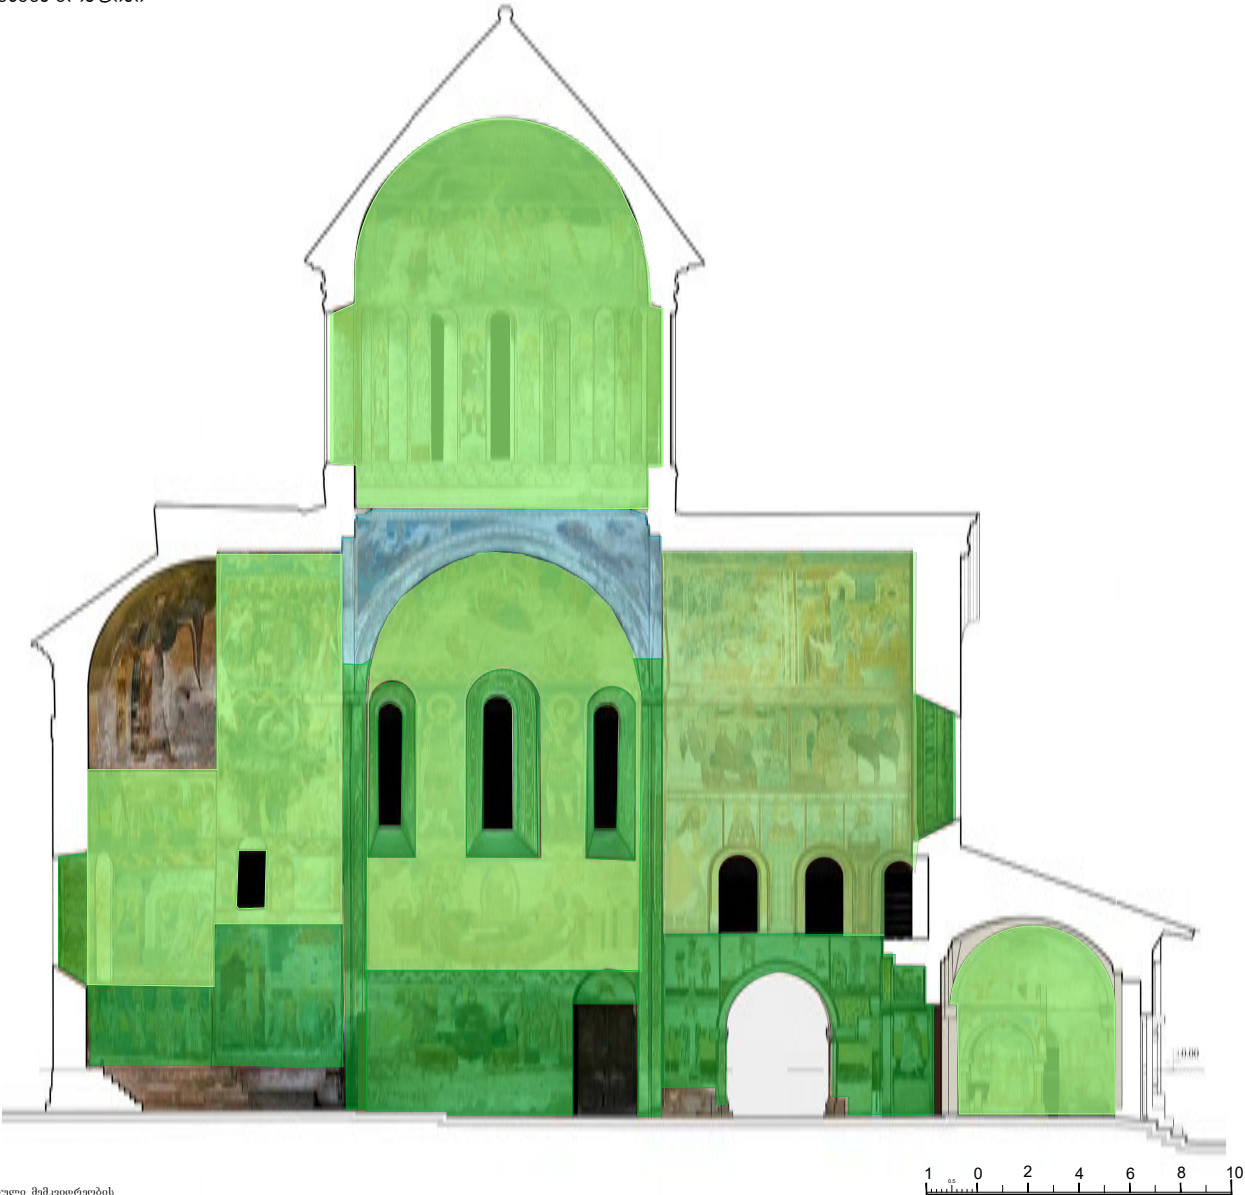
Conservation timeline 2024-2030
2024-2030 წლების - საკონსერვაციო გეგმა

- Completed treatments 2024-2025
შესრულებული ნარევები 2024-2025
- Ongoing treatments 2025
მიმდინარე ნარევები 2025
- Planned treatments 2026-2029
დაგეგმილი ნარევები 2026-2029
- Planned treatments 2030
დაგეგმილი ნარევები 2030

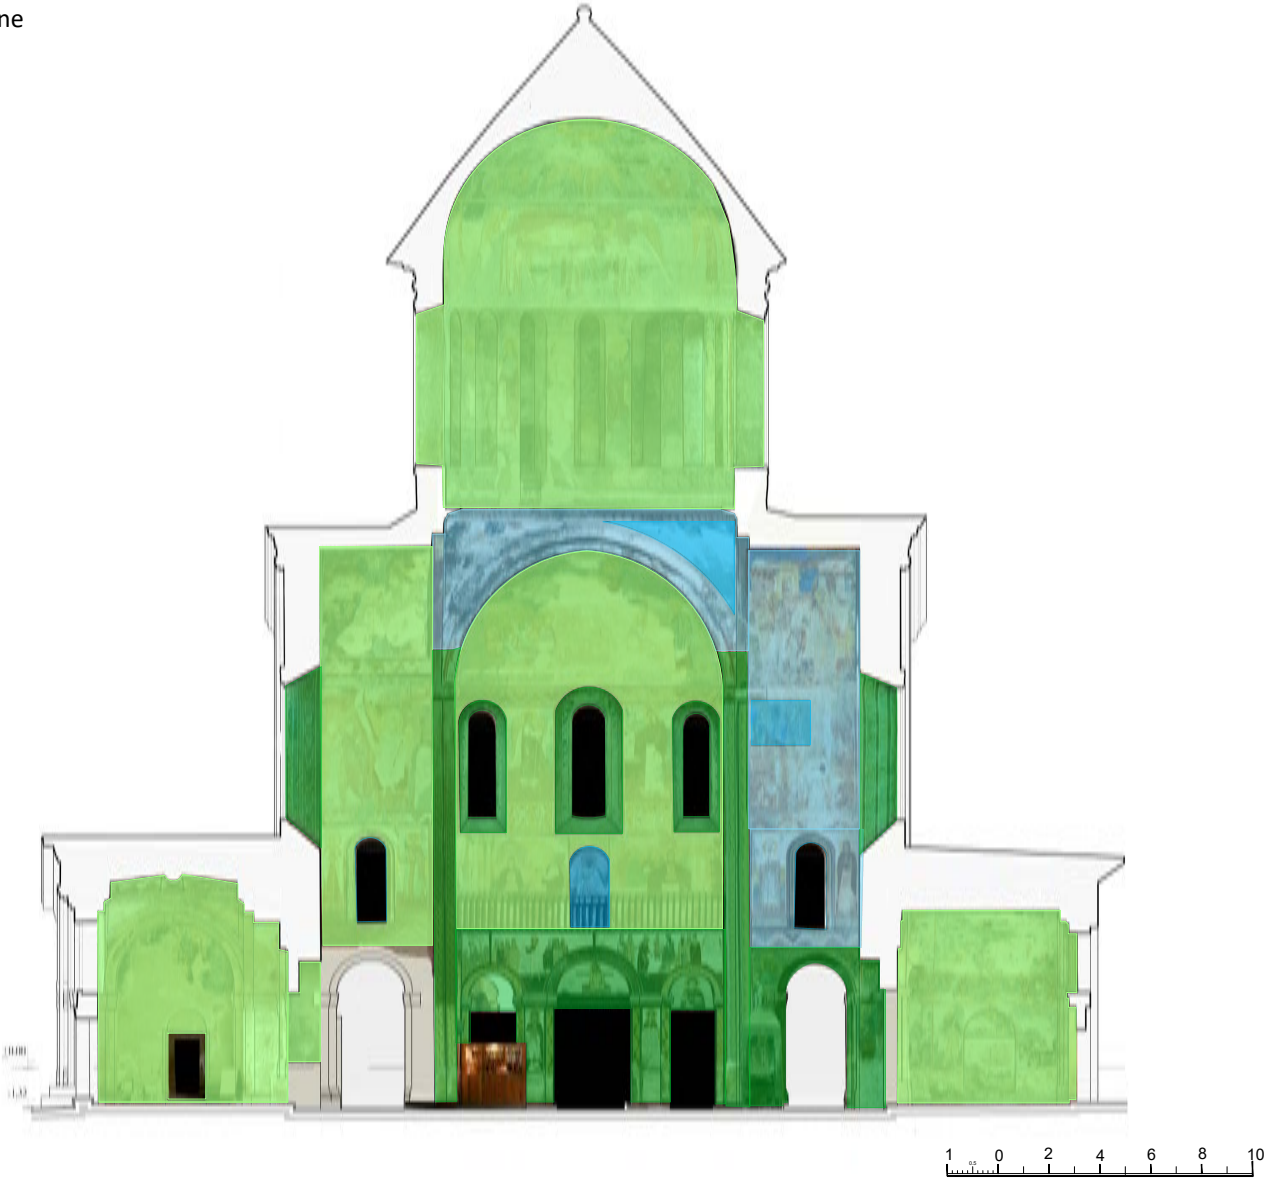
Conservation timeline 2024-2030
2024-2030 წლების - საკონსერვაციო გეგმა

- Completed treatments 2024-2025
შესრულებული ჩარევები 2024-2025
- Ongoing treatments 2025
მიმდინარე ჩარევები 2025
- Planned treatments 2026-2029
დაგეგმილი ჩარევები 2026-2029
- Planned treatments 2030
დაგეგმილი ჩარევები 2030

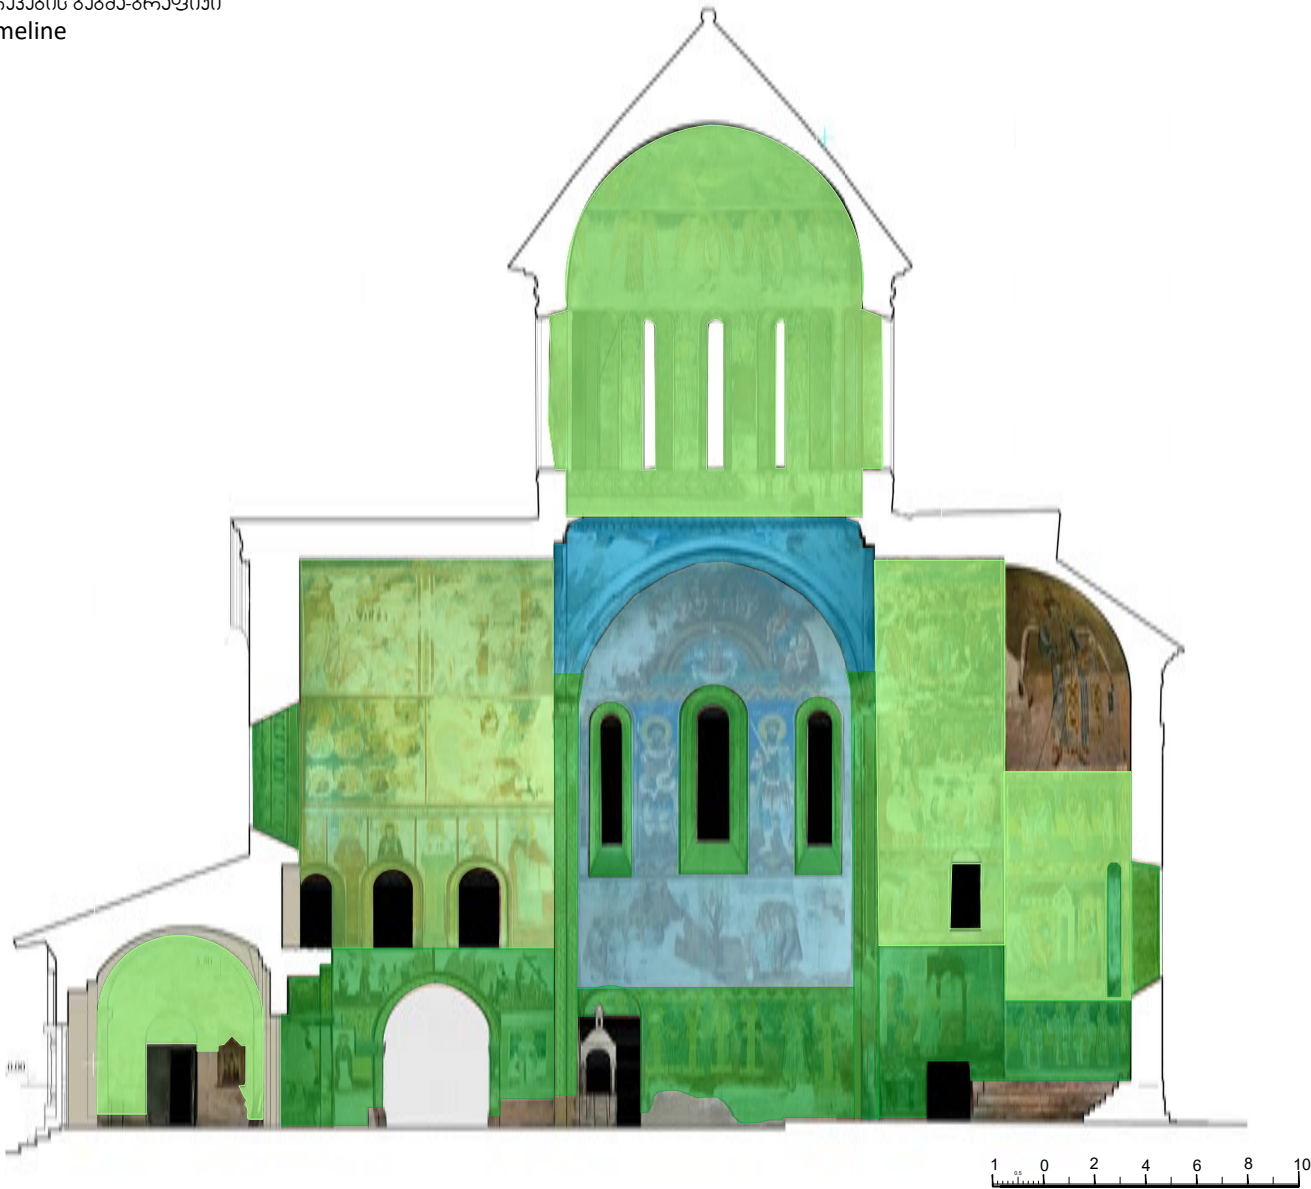
Conservation timeline 2024-2030
2024-2030 წლების - საკონსერვაციო გეგმა

- Completed treatments 2024-2025
შესრულებული ჩარევები 2024-2025
- Ongoing treatments 2025
მიმდინარე ჩარევები 2025
- Planned treatments 2026-2029
დაგეგმილი ჩარევები 2026-2029
- Planned treatments 2030
დაგეგმილი ჩარევები 2030
