Gelati Monastery Complex
Wall Painting Conservation
Programme

Remedial Treatment

Phase 1

Development of treatment
strategy and methodologies;
Stabilisation of critical areas

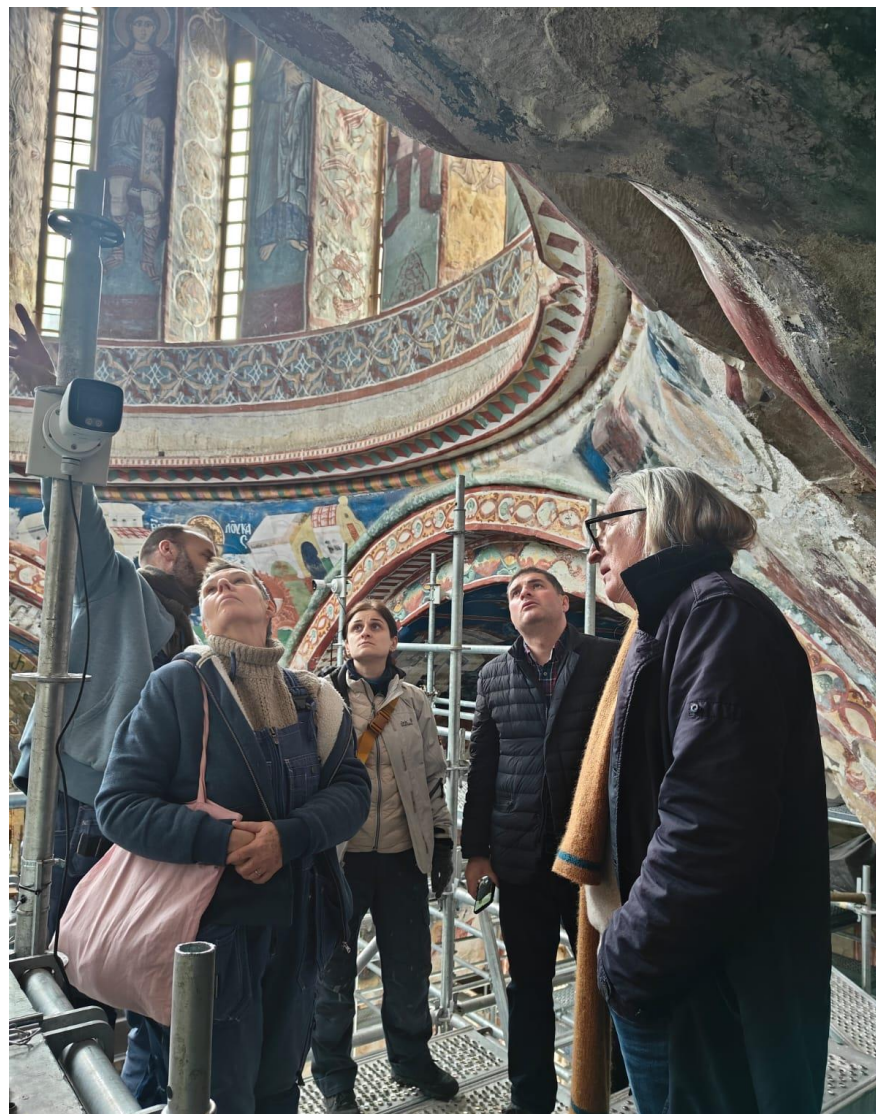
Above Revision of the condition of critical areas by Wall Painting Conservation Supervisors and Gelati Rehabilitation Committee members

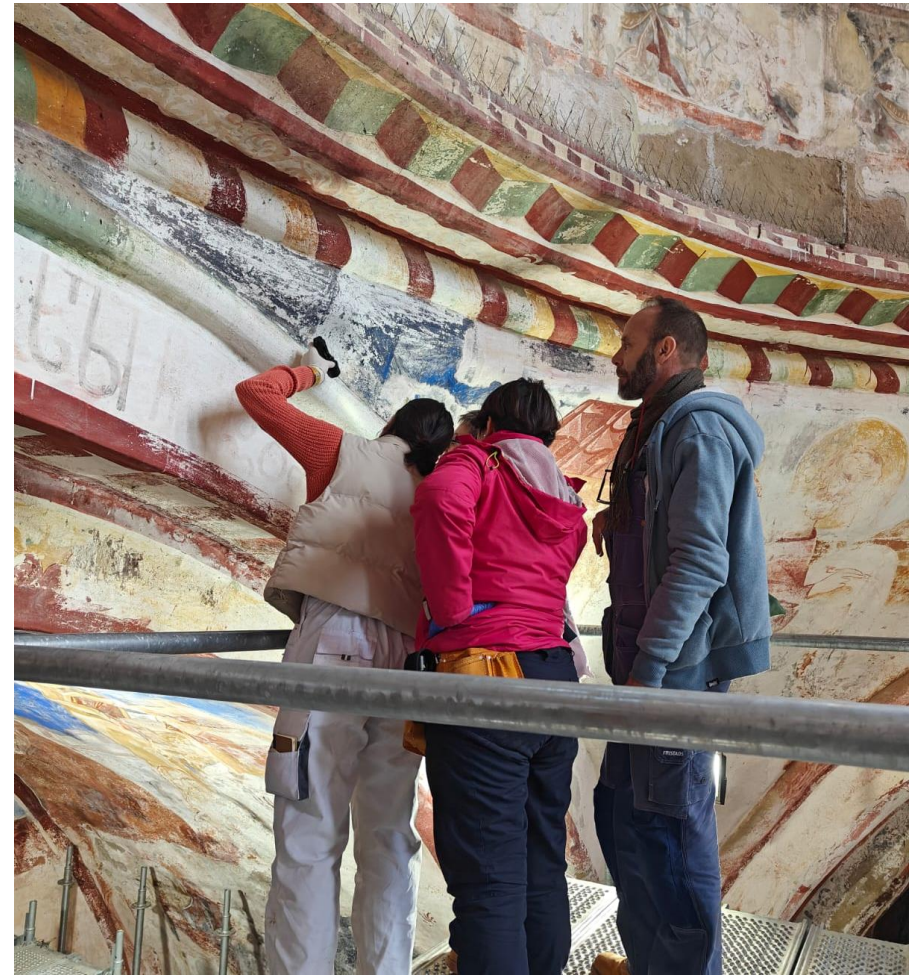
Above: The process of assessing wall paintings and determining the need for urgent conservation intervention. The cause of the damage in the mentioned area is the activity of salts, which causes the painting layer to fall, therefore, for paint stabilisation, it is necessary to select a consolidant that prevents the mobilization of salts.

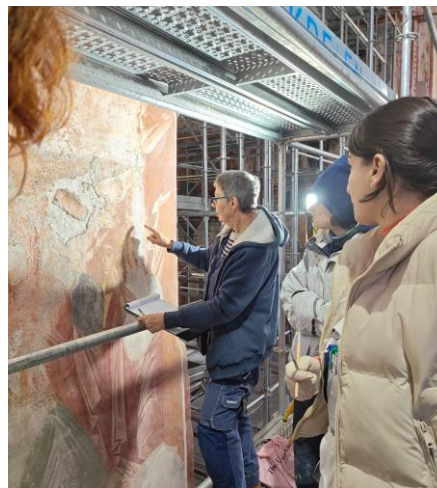
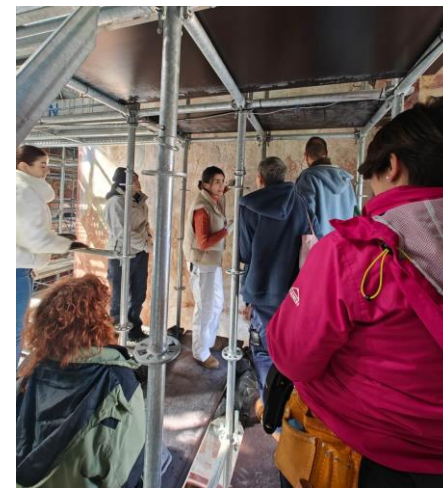
Above: Testing areas for remedial interventions have been selected by supervisors. The areas were selected based on their critical state and need for appropriate conservation interventions. The mentioned locations were used to develop a safe treatment methodology.

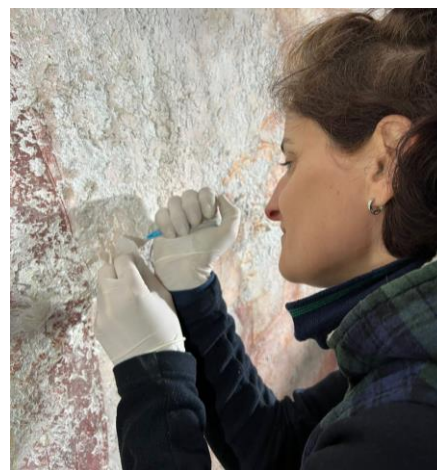
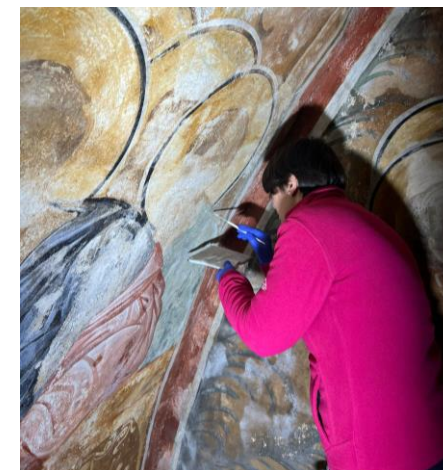
Above: One of the objectives of the remedial treatment undertaken in March 2024 is to develop a methodology. The photos show the working processes of the development of the intervention methodology. Images present the consolidation treatment and mechanical removal of the salt.

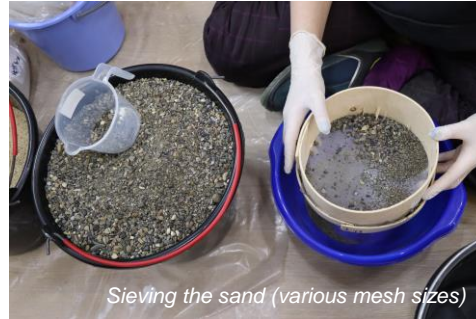
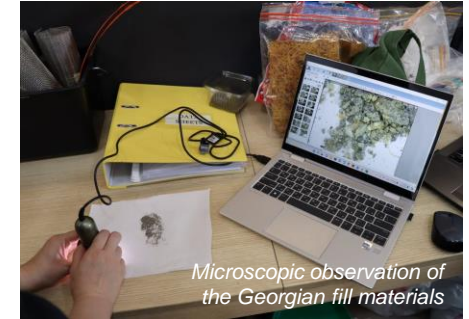
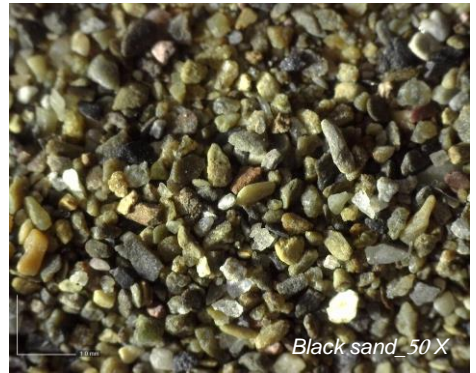
Above: In-situ lab-based investigations - selection process for compatible conservation materials. Microscopic study of Georgian fillers to select according to their characteristics - morphology, color and size.

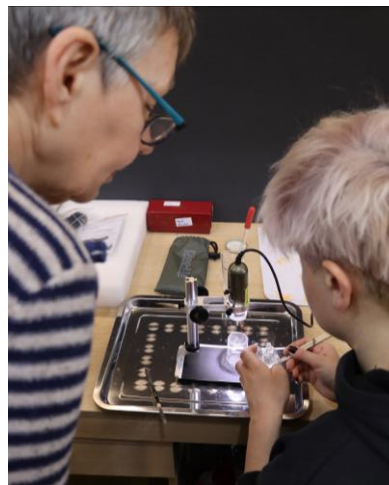
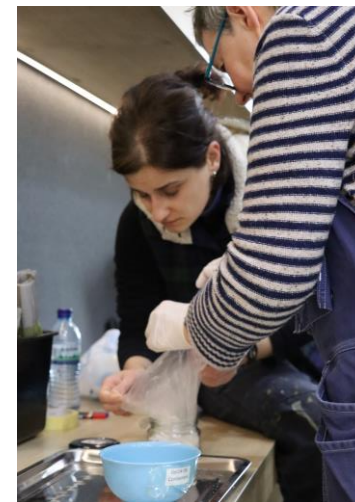
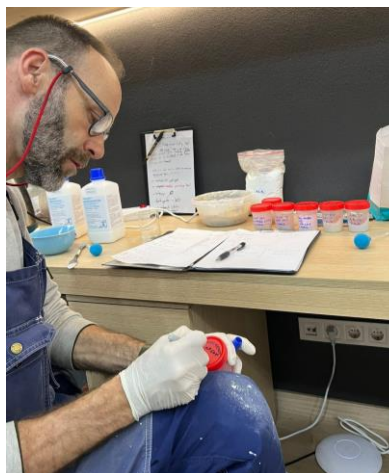
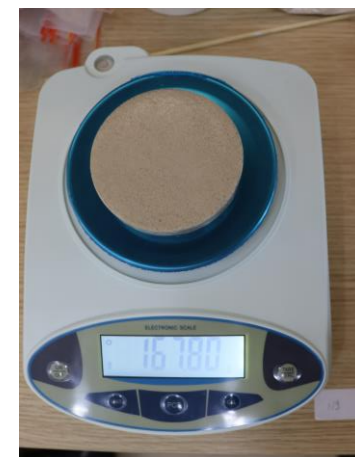
Above: The use of compatible and safe materials is required for the wall painting of the Gelati monastery complex. Based on the principle of minimum intervention, this material should be used minimally (in terms of quantity and scale), but the result should be focused on the maximum. In order to follow these and other criteria, selection-preparation of conservation materials were undertaken through testing in in-situ lab-based environment.

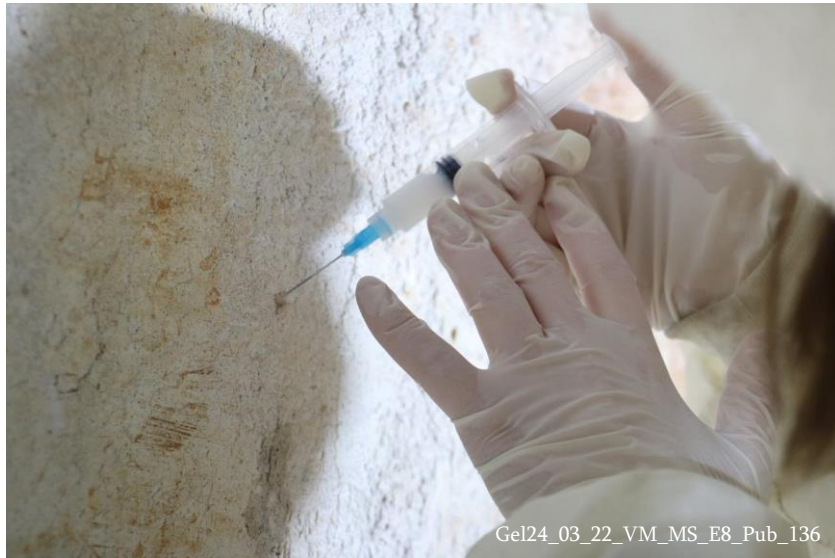
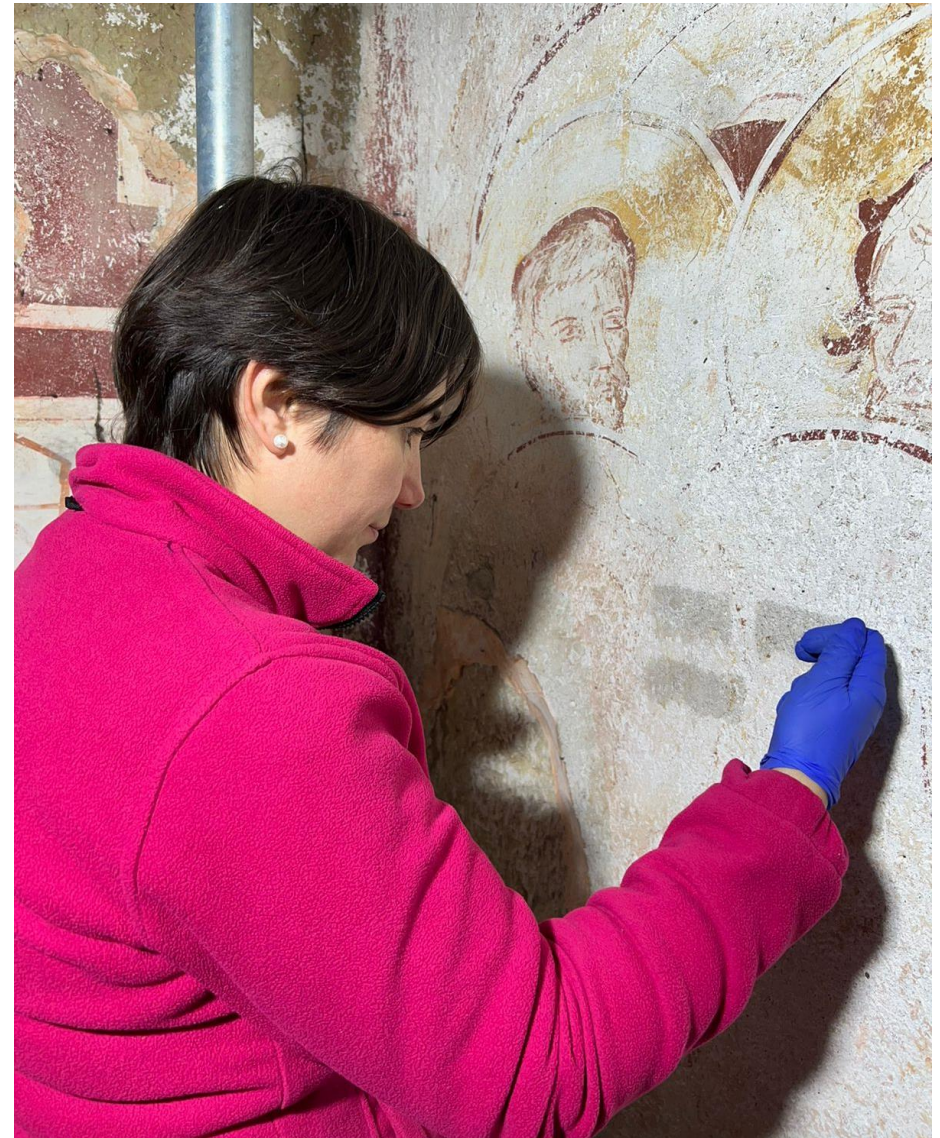
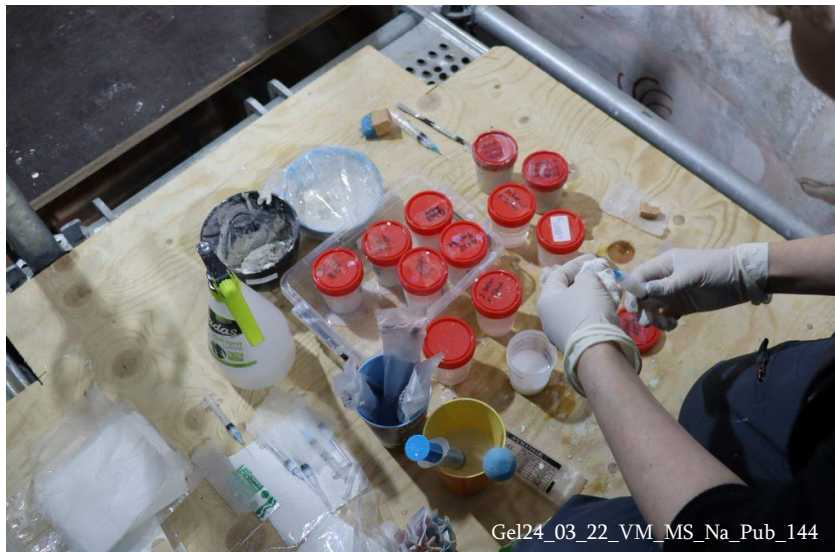
Above: Application of consolidant via syringe and need to allow conservation material penetrate in powdered substrate in pointed areas; Images present process of testing different consolidating materials.

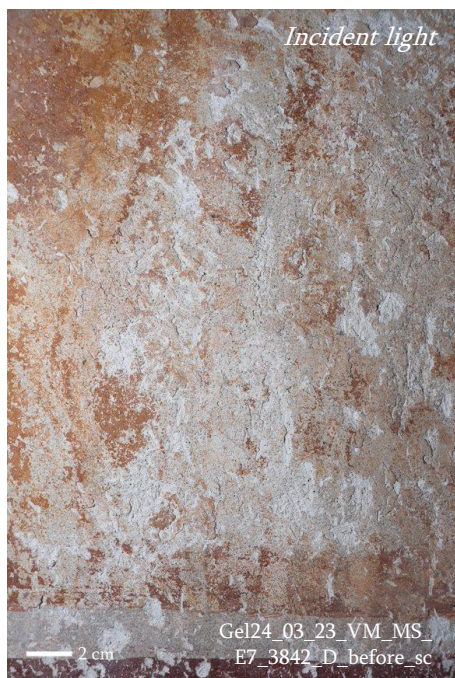
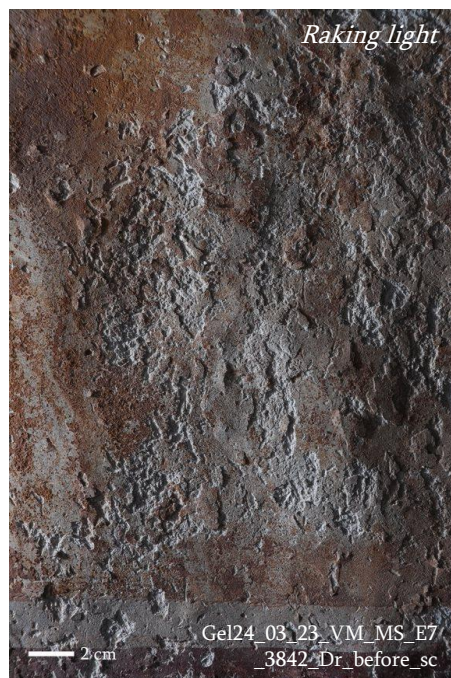
The main space of the Church of the Nativity of the Virgin, North arm, east wall (scene E7),

Above: Photos before plaster consolidation –
In a given area, the plaster layer is powdered, cohesive bond between plaster particles is weakened.
The powdering of the plaster is assessed using application of soft brush. In case of detection the removal of loose plaster particles and its extent, consolidation treatment trial requirements are set.

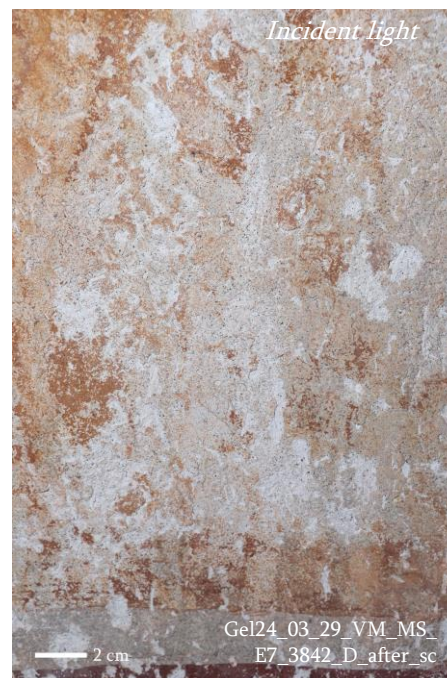
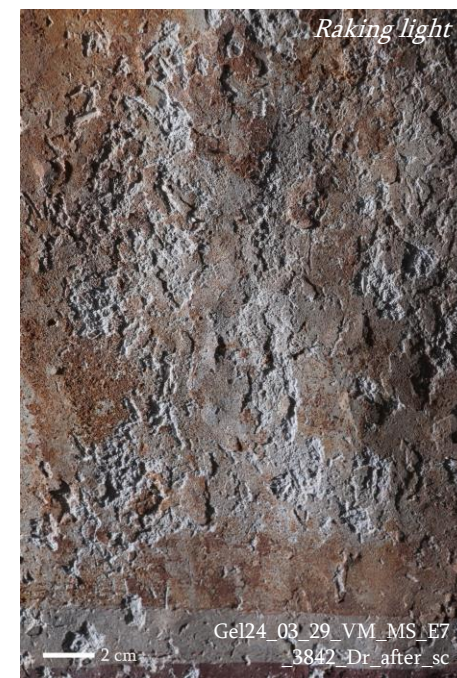
Above: Photos after consolidation of the deteriorated plaster –The area is treated with a consolidant, the consolidant is applied to the surface of the plaster (in the areas of paint loss) through a syringe, during which the needle head is directed towards the surface, the syringe allows the conservator to determine the amount of the consolidant, control the pressure and direction during application. Application of consolidant may occur several times, depending on conservation needs.

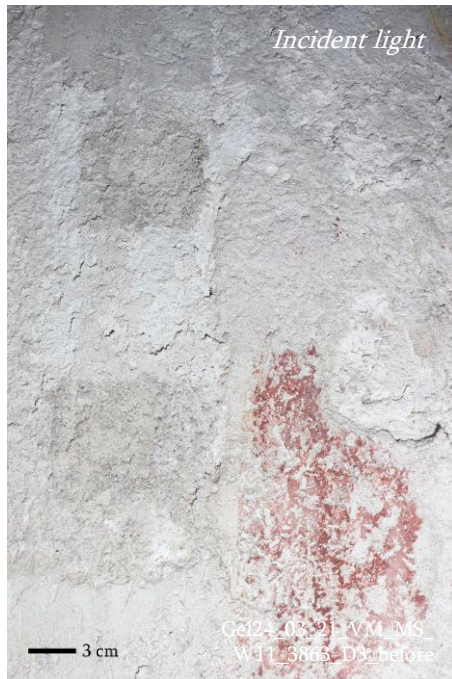
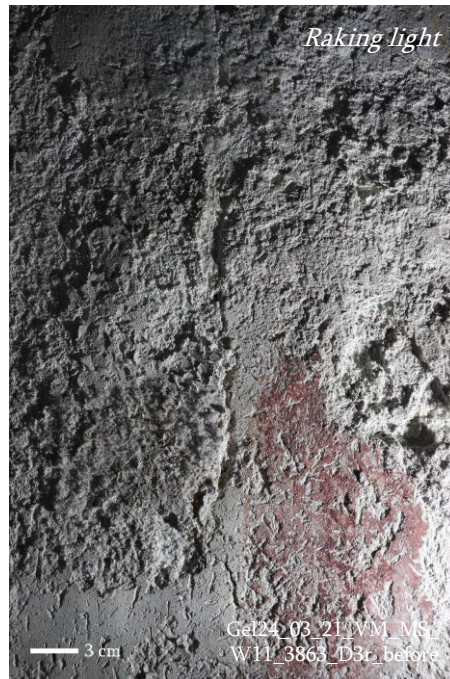
The main space of the Church of the Nativity of the Virgin, North arm, west wall (scene W11),

Above: Photos before plaster consolidation –In addition to the powdering of the plaster on the given section, there are salt activity and painting layer deterioration (powdering, flaking). The main cause of wall painting deterioration are water infiltration and unstable environment.

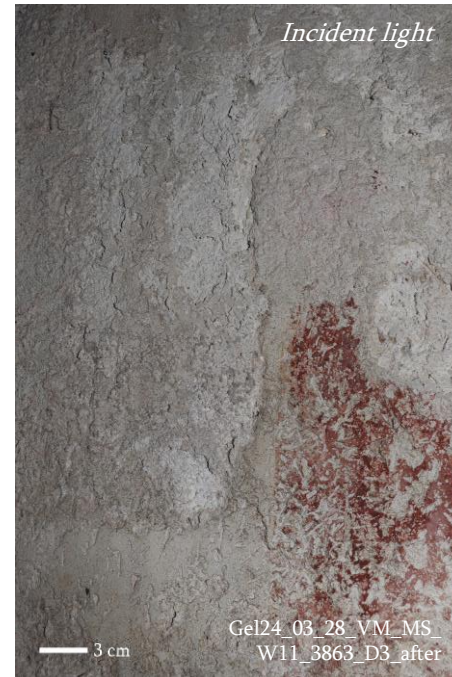
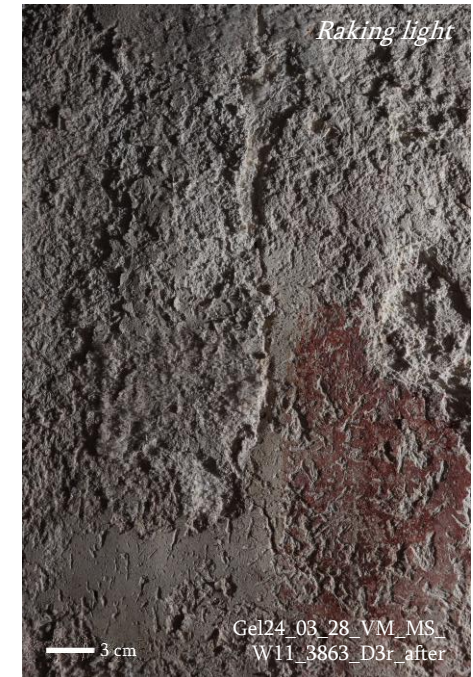
Above: Photos after consolidation of the plaster – In order to restore the cohesive bond, the plaster was treated with a lime-based consolidant compatible (of similar nature) to the original material. The consolidant restores bonds (builds so-called bridges) between the loosened particles of plaster, not only on the surface, but also in the depth of the material (as a result of penetration). The working mechanism of the used consolidant is based on the carbonization process, therefore, its final setting time (compared to acrylic-based consolidants) is longer. The consolidant does not change the texture of the coating, the rough surface of the plaster is preserved, therefore, at the macroscopic level, the result is not reflected visually (on the photo). The hardening and setting of the consolidant is assessed via soft brush (the degree of loose plaster is checked by amount of the removal of the plaster particals).

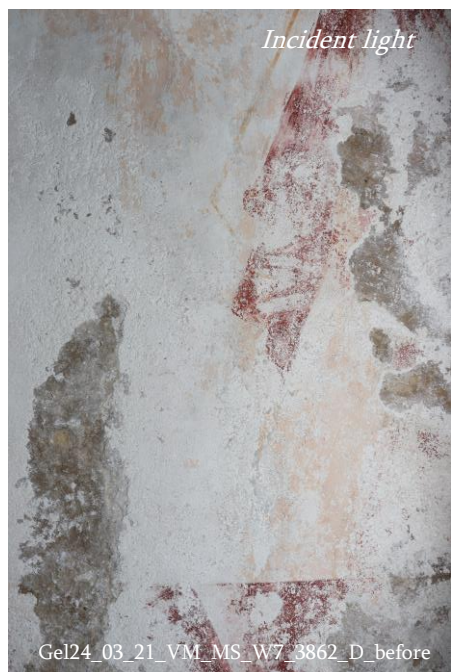
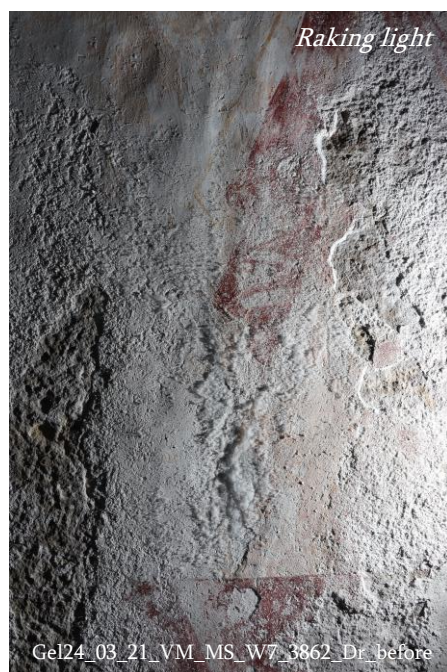
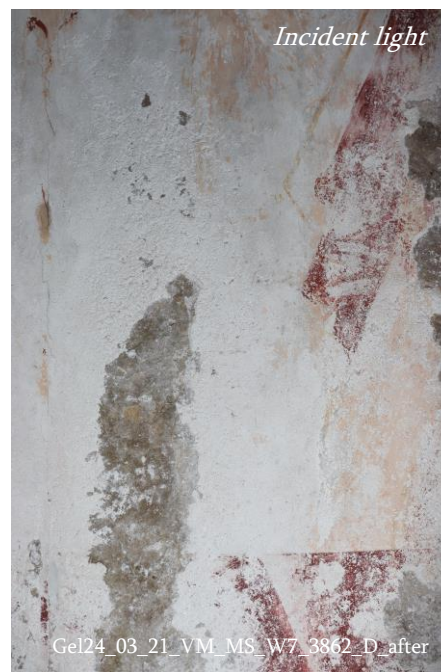
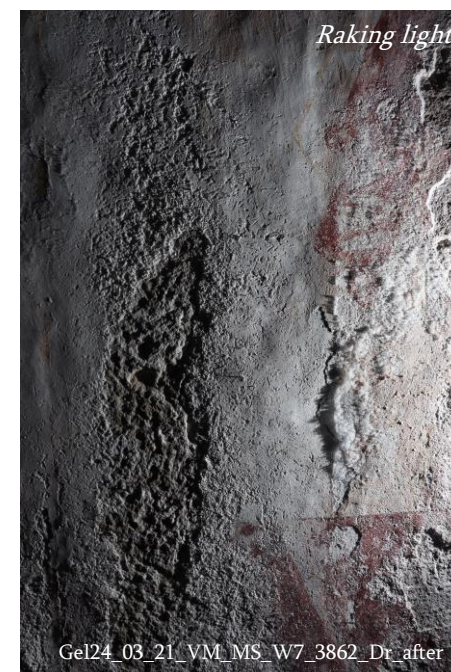
ღვთისმშობლის შობის ტაძრის მთავარი სივრცე, ჩრდილოეთი მკლავი, დასავლეთი კედელი (სცენა W7),
კომბინირებული ჩარევა – ნალესობის ფენის კონსოლიდაცია და მარილების მოხსნა (იხ. 3.5 მარილების შემცირება/ მოხსნა):

Above: Photos before plaster consolidation –The main reason of plaster powdering is the salt activity. We find salts both on the surface and in the wall structure. Due to the complexity of the situation, the section requires both the removal of salts and the consolidation of salty areas. The main outcome of the intervention is to prevent the migration and mobilization of salts.

Above: Photos after consolidation of the plaster – One of the main criteria in the development of the intervention methodology was the minimal addition of water to the structure (to prevent the activation of salts), therefore, nano-lime consolidating materials dispersed in alcohol were added, which, on the one hand, prevents the migration of salts (due to the absence of water), and, on the other hand, the lime content (unlike polymer) does not create impermeable film on the surface of the plaster, therefore the permeability of liquid and gas is maintained in the plaster.

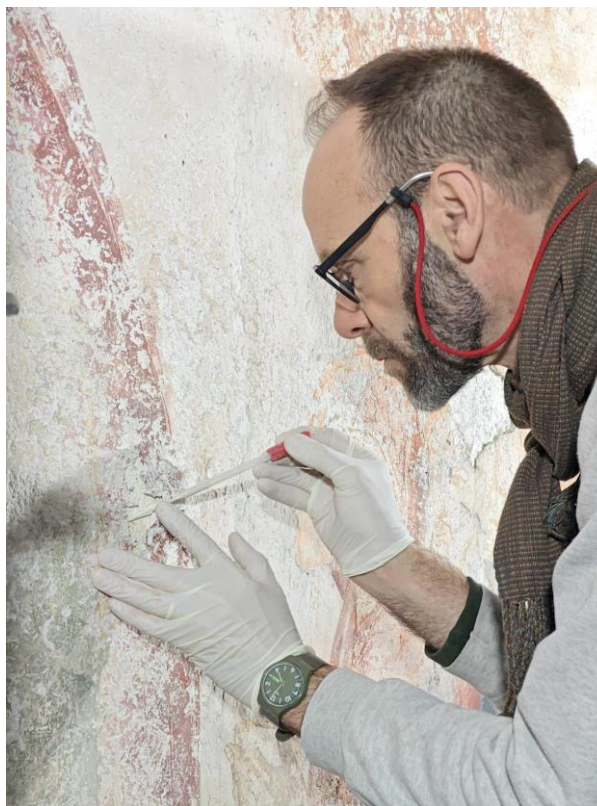
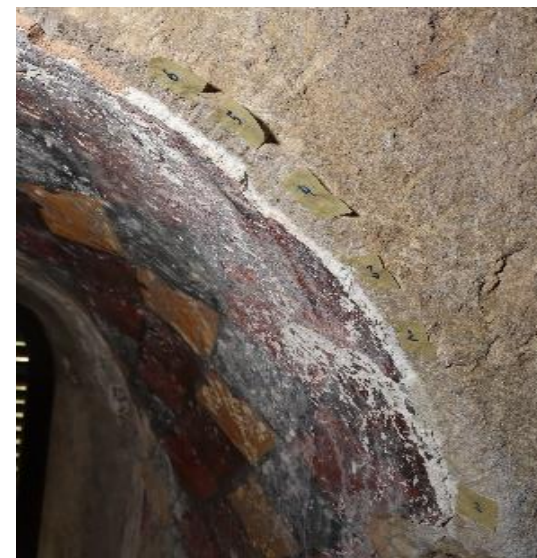
Above and right: Application of a "micro-injection solution" via pipette and testing different micro-injection materials

Some conditions of plaster disaggregation cannot be adequately treated with the nano-lime formulations, and a 'micro-grout' has been developed (to be delivered as droplets from a pipette, or syringe with thick needle). This is intended to consolidate/bridge larger disaggregated particles in deteriorated plasters.

- 1 part lime
- 1 part chalk
- 1 part pumice (0–240 m)
- + added water to desired consistency for effective delivery

"Use of this 'micro-grout', in some cases, requires prior pre-wetting of substrate materials with alcohol:water (1:1v/v). While observable results have so far been good, further testing of the 'micro-grout' will examine using alcohol as a fluidizer, to avoid adding unnecessary water to the deteriorated plasters (and to simplify the two-stage delivery process involving pre-wetting followed by 'micro-grouting').

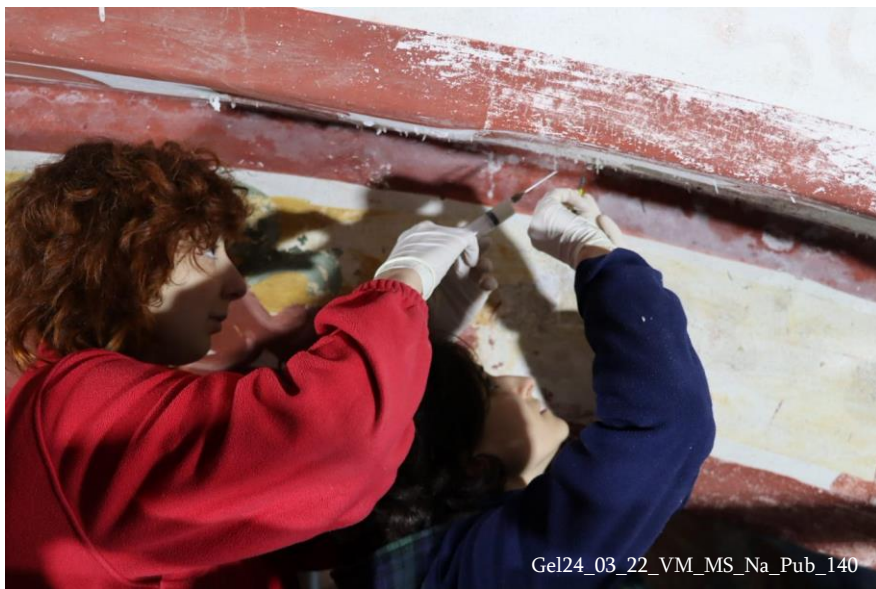
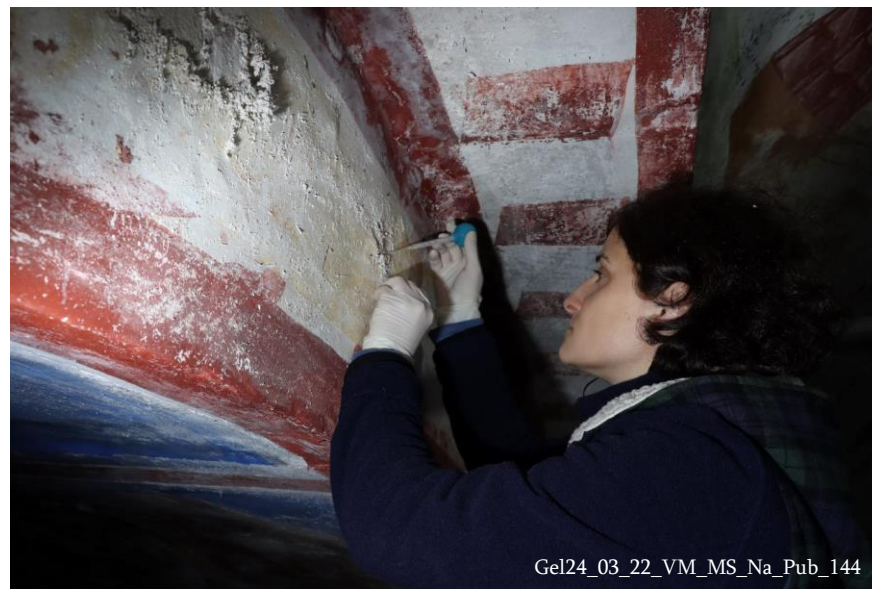
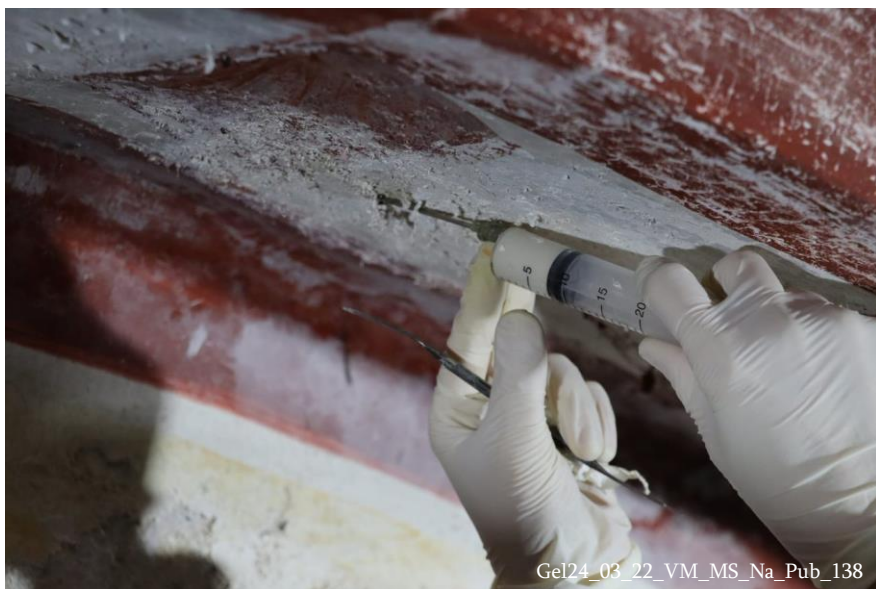
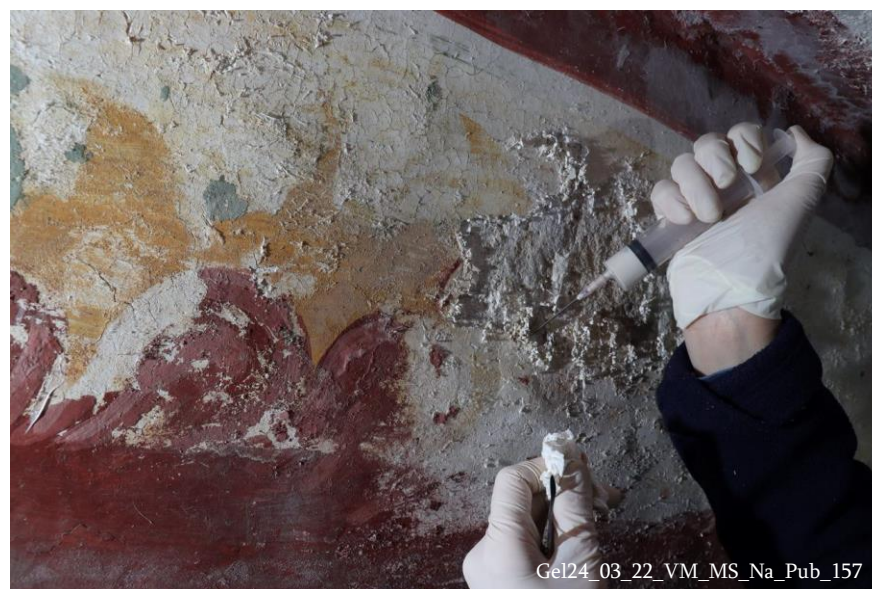
Above: Consolidation of a "micro-grout" solution using a syringe and pipette.

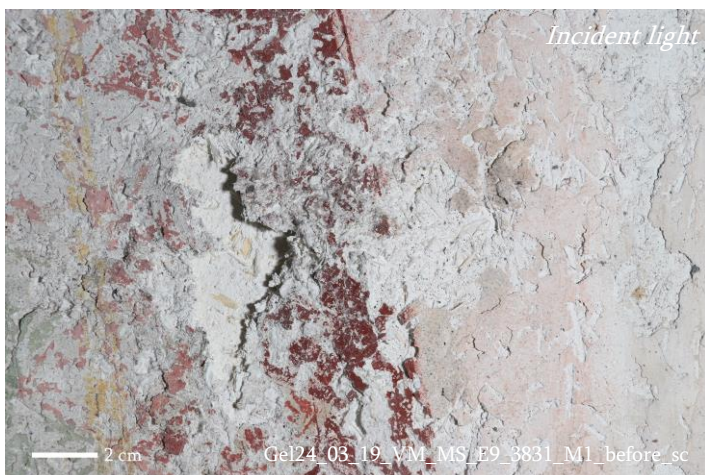
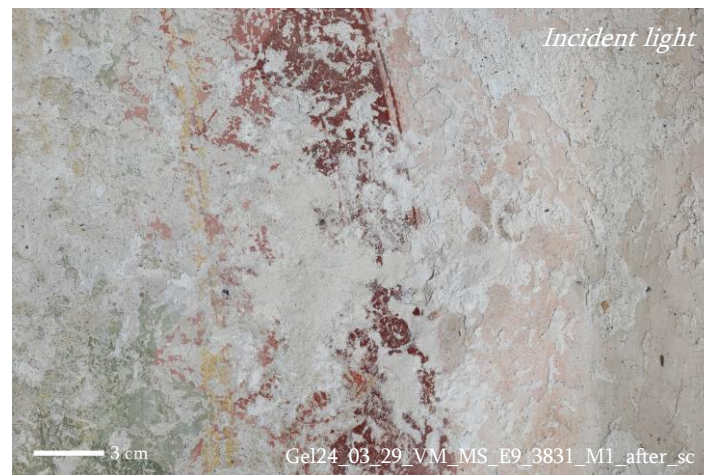
The main space of the Church of the Nativity of the Virgin, North arm, east wall (scene E9), Plaster re-adhesion:

Above: Condition before micro-grouting and filling - The given area has two layers of plaster: lower and upper plaster layer. Those layers are separated by several millimeters (micro delaminations), and the upper layer of the plaster is additionally characterized by micro fragmentation.

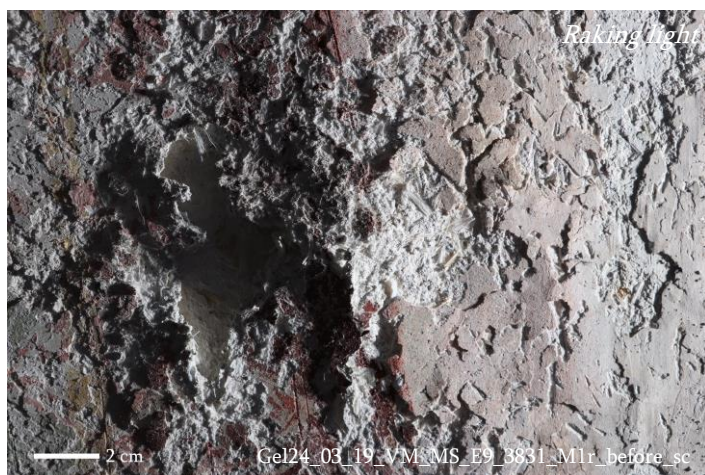
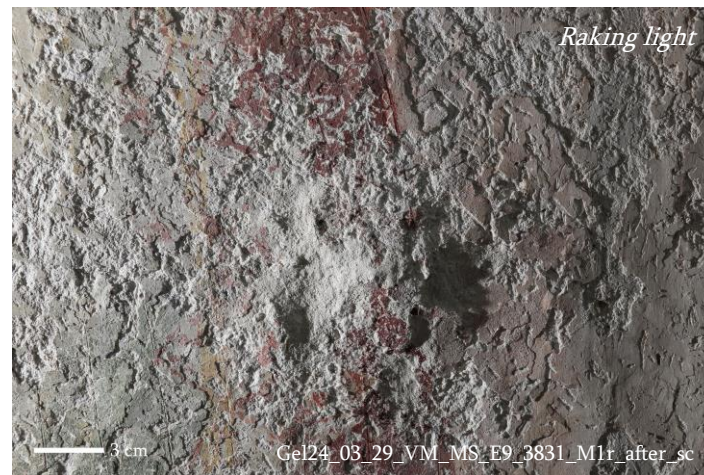
Above: The condition after micro-grout and filling. Mentioned intervention requires following working properties: flow, tack, appropriate density, drying time. The conservation material was developed to have those properties, therefore, micro delaminated areas of the plaster were filled and the adhesive bond between the layers was restored.

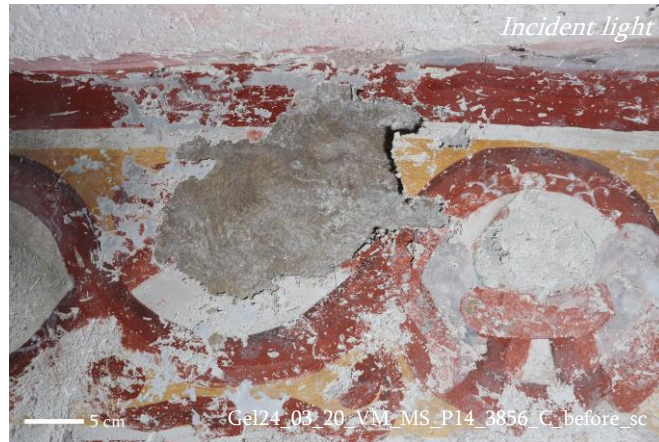
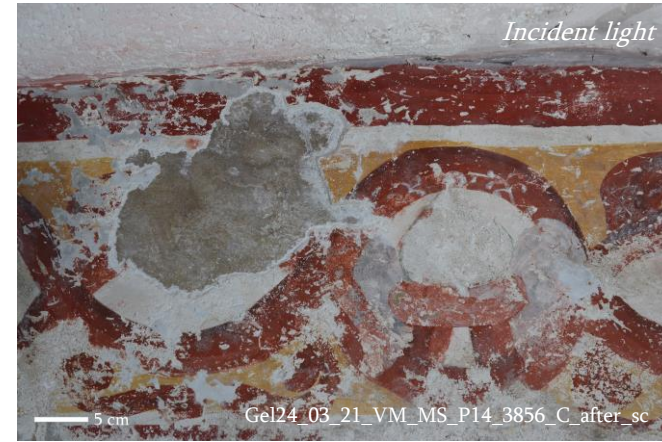
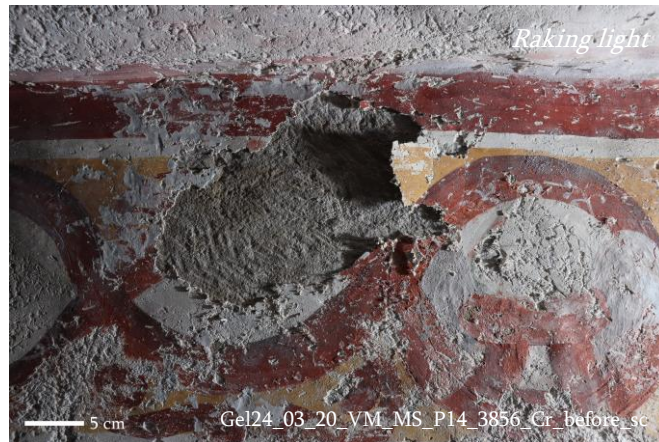
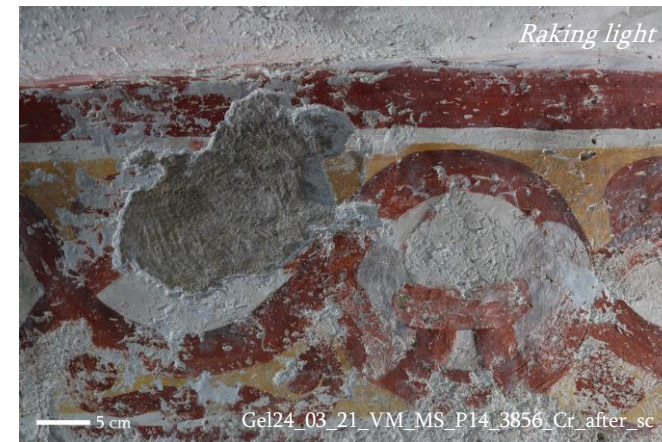
The main space of the Church of the Nativity of the Virgin, west arm, arch, Plaster re-adhesion:

Above: Plaster delamination from primary support. The area is in critical condition, where the half-cm-thick layer of plaster was completely removed from the stone support, and the risk of losing this section of plaster was high.

Above: the condition of the plaster after micro-grouting and edge stabilization - since the bond was preserved on one side of the plaster fragment, it was decided to return/readhere back to its primary support. The mentioned method was selected only as an exception in this specific area. The inner side of the plaster was treated with a micro-grout solution, it was fixed on the stone and the edges were stabilised.

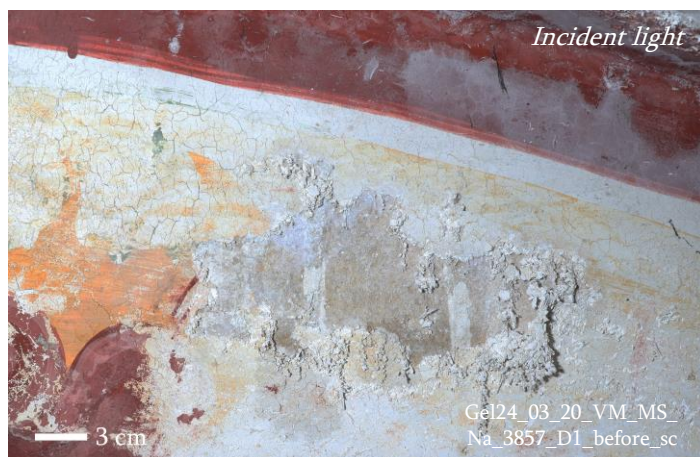
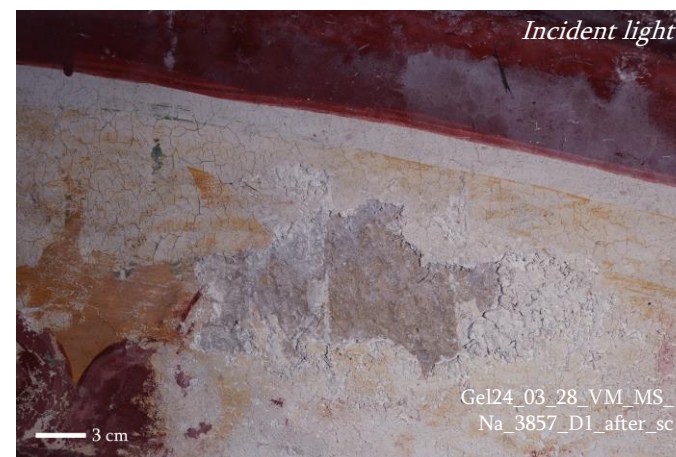
The main space of the Church of the Nativity of the Virgin, north arm, arch, plaster re-adhesion and consolidation:

Above: images before stabilisation – Powdered plaster layer is separated from primary support. Loose plaster fragments are hanging on the organic inclusions.

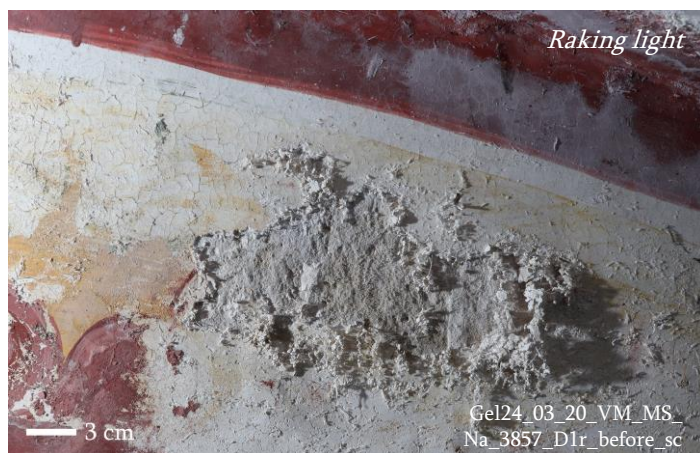
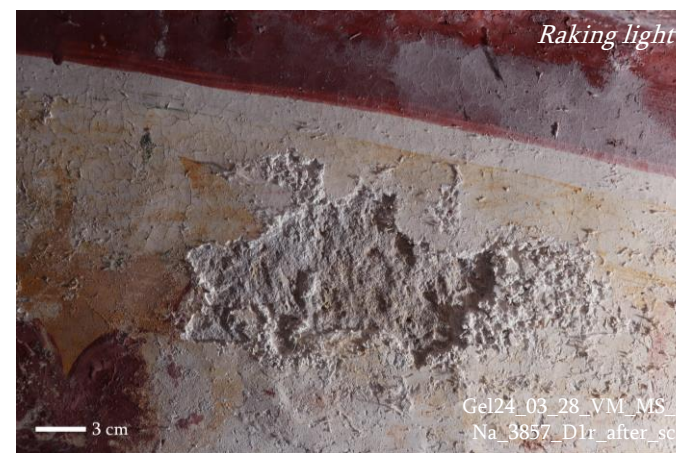
Above: Loose plaster fragments was re-adhered to the wall with micro-grout mixture. The plaster was also consolidated with nano-lime consolidant.

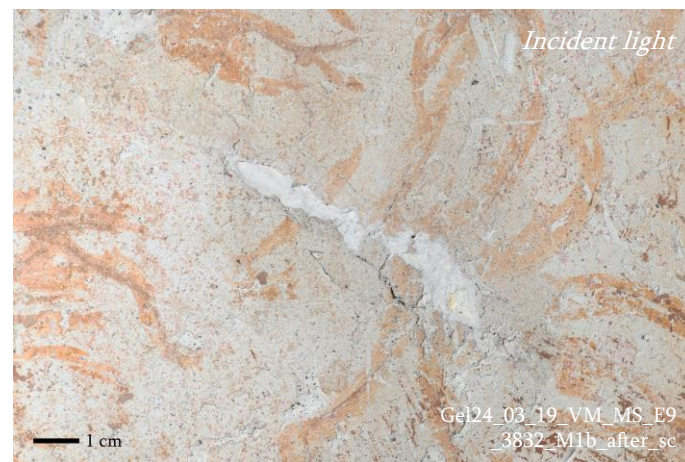
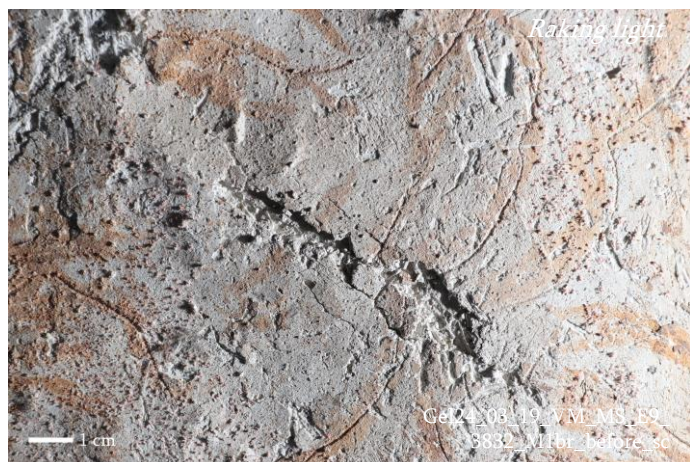
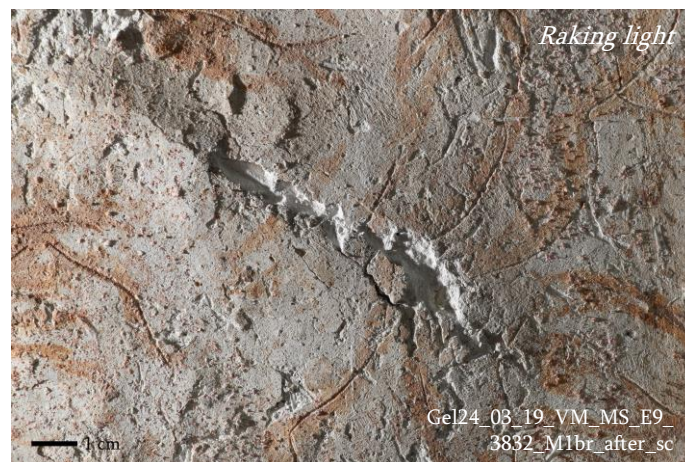
The main space of the Church of the Nativity of the Virgin, North arm, east wall (scene E9), Plaster re-adhesion:

Above: Photos before the plaster treatment – thin layers of plaster are separated and fragmented. Adhesion problem and exposed edges of painted plasters make area under the risk of loss.

Above: Photos after plaster consolidation and micro-grouting - The micro-grout solution re-adhered separated fragments and strengthened the fragile edges. In this area, the evaluation process of the treatment is in progress. In the next stage, it is planned to fill the loss.

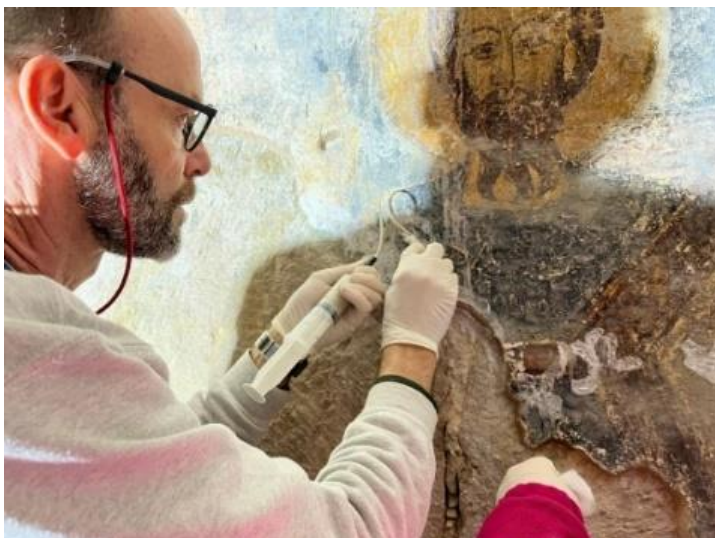
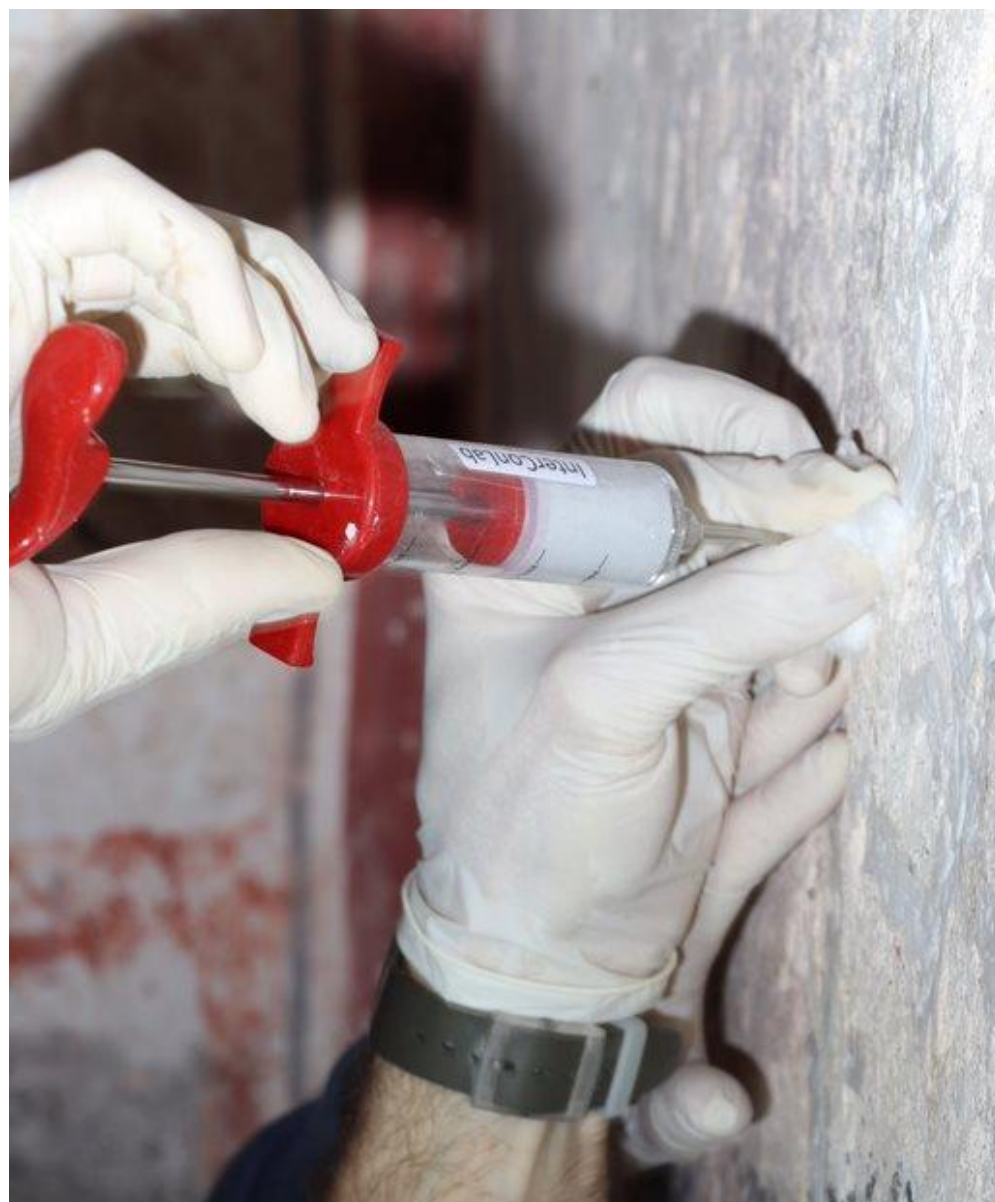
Below and right: Plaster re-adhesion between plaster layers and plaster and the support. Injection of grout mixture with syringe in some cases via catheters , in other cases though the thick needle

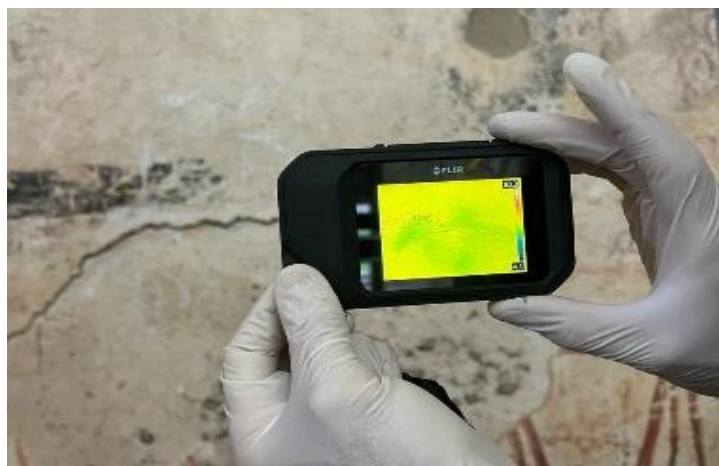
Left: Assessment of injection grouting through Infrared thermography in order to determine grout flow and distribution. Checking on voids.
