Gelati Monastery Complex
Wall Painting Conservation
Programme

Remedial Treatment

Phase 1

Development of treatment
strategy and methodologies;
Stabilisation of critical areas

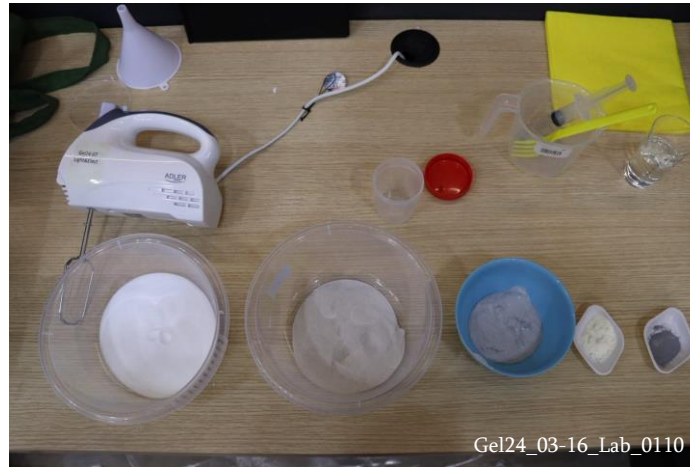
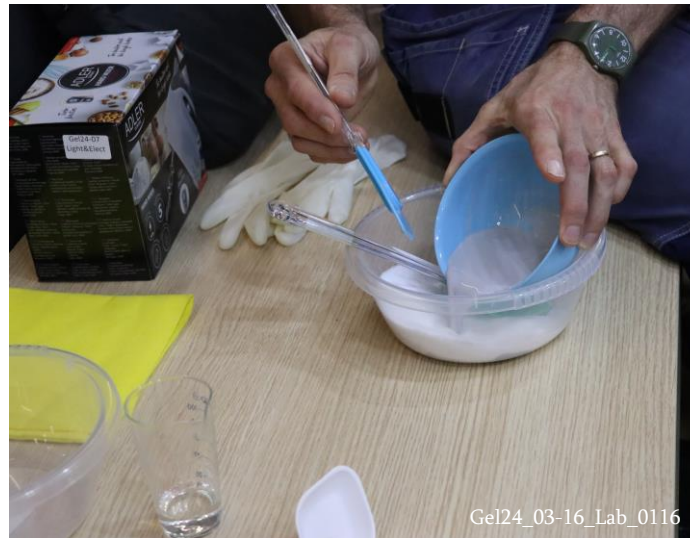
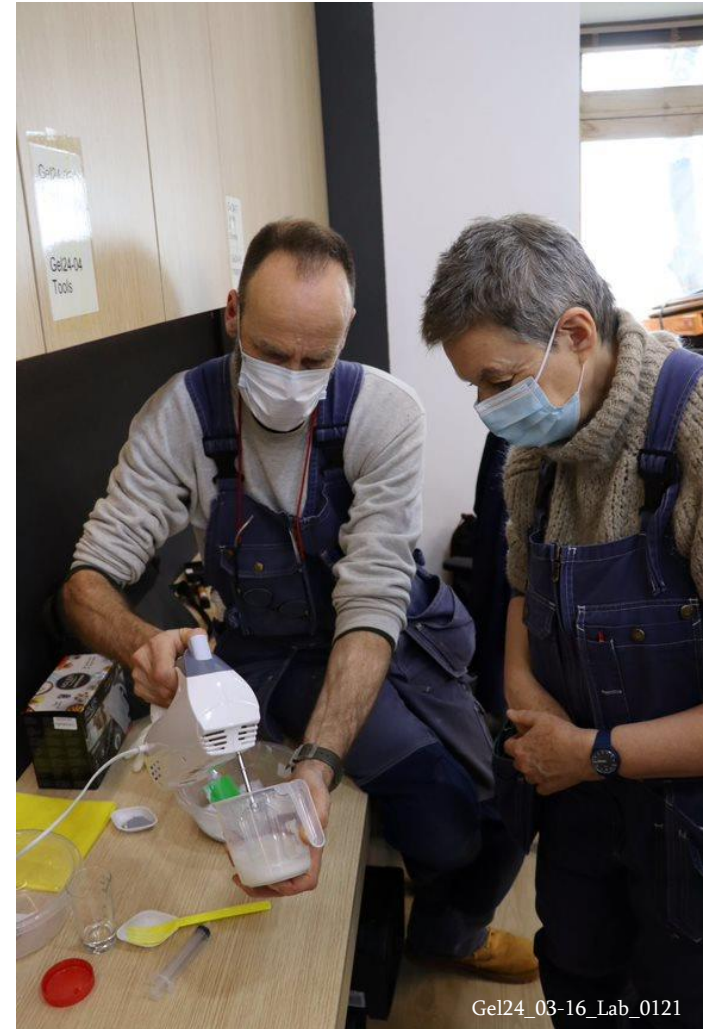
Injection grout preparation in in-situ lab-based conditions.

- Mixing of the dry (fillers) materials
- Mixing of lime and low amount of water
- Gradual adding of the lime mixture to the dry components together with water
- Mixing of the additives (in order to reinforce tackiness and lightness) and adding to the grout mixture.
- Final stage is addition of the volume expander additive.

! The solution needs to be composed of the exact amount of each component; therefore, the necessary technical equipment provided in Gelati lab is necessary: a scale, a mixer, measuring flasks, elastic spatulas, etc.

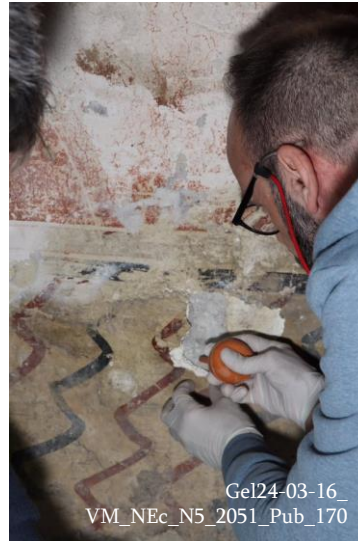
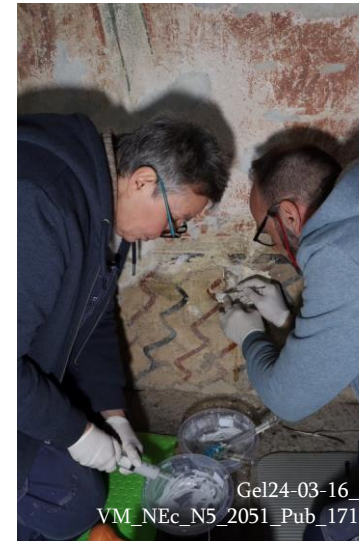
Images: Re-adhesion of the plaster to the primary support.

- *Mechanical cleaning of the void between stone and separated plaster. Cleaning tools (puffer, brush, spatula); Checking the width and depth of the void.*
- *Pre-wetting – for the purpose of cleaning and making injection grout to easier transportation through voids;*
- *Temporarily putting cotton in the voids to prevent grout to come to the surface and allow it to flow in depth.*
- *Delivery of the injection grout through catheter and syringe,*

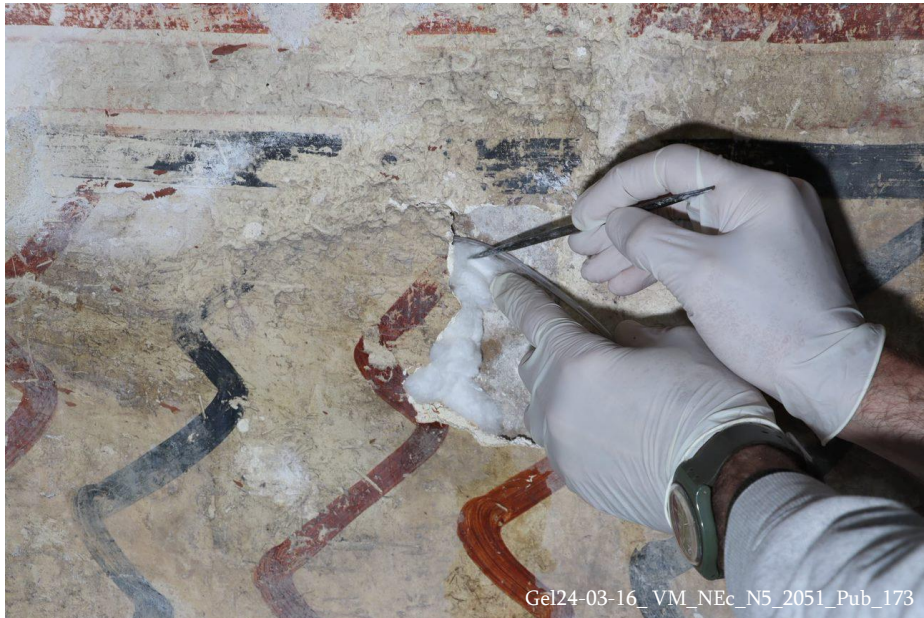
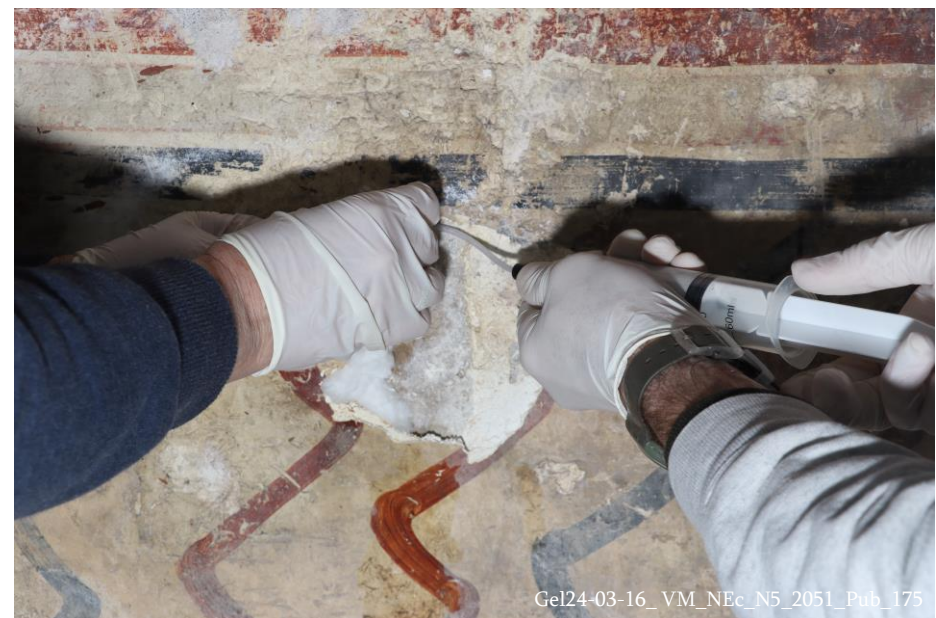
Images: In certain areas, where the risk of loss plaster is high, cyclododecane is applied before injection to temporarily harden the surface and prevent the solution from flowing through cracks. Cyclododecane (C₁₂H₂₄) is a waxy material that sublimates in air and leaves no residue on the painting.

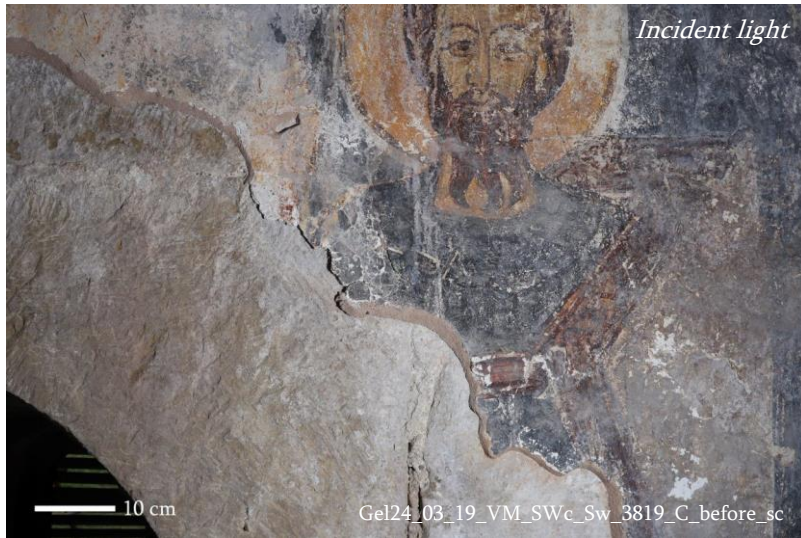
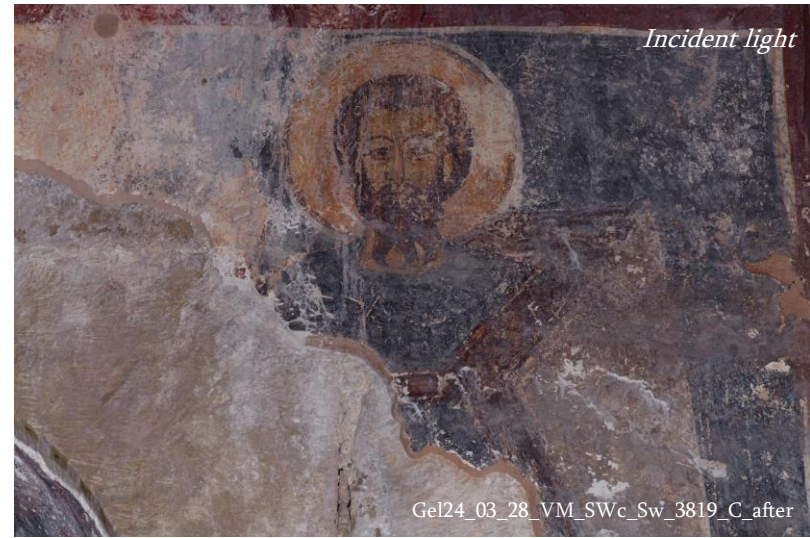
South-west chapel, south wall, Injection grouting for plaster delaminated from primary support

Above: Condition before intervention – loss of previous edge repair and original plaster. Plaster separation from stone support.

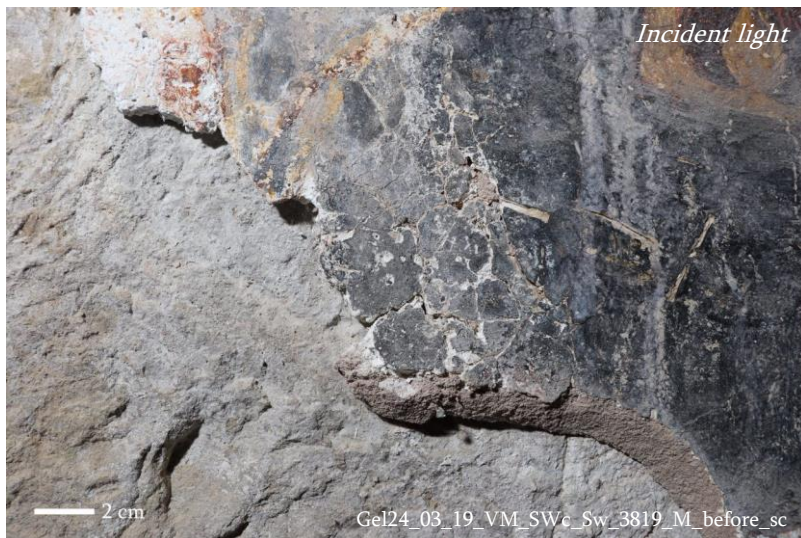
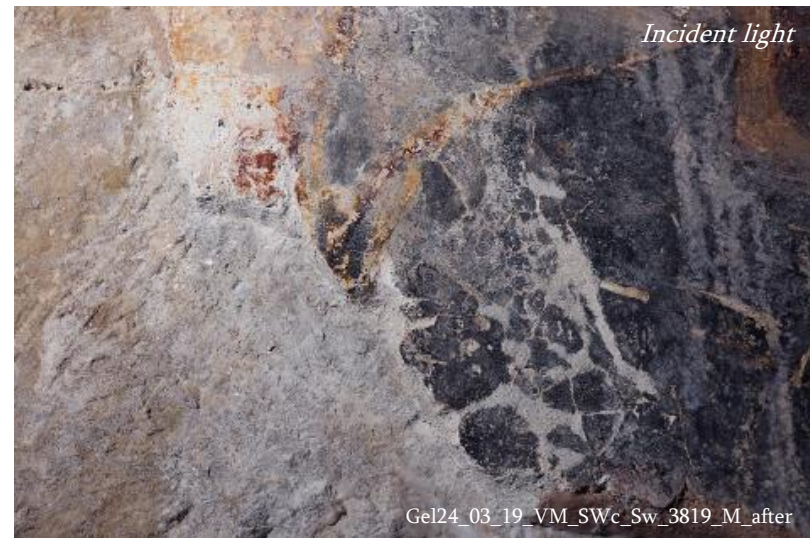
Above: Stabilisation treatments: injection of the lime-based lightweight grout material between plaster and stone. Securing exposed plaster edges with lime-based plaster mixture

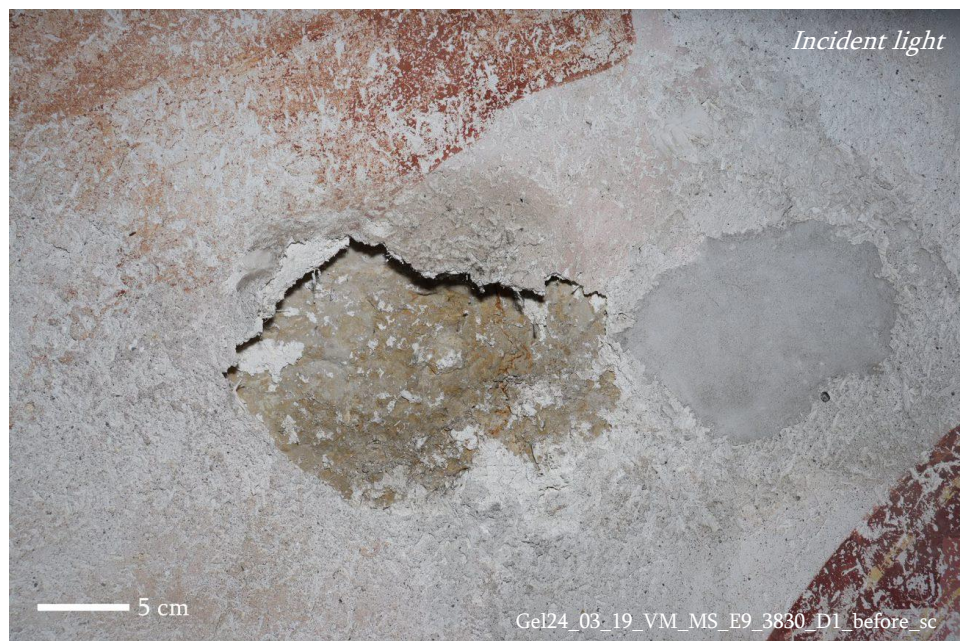
The main space of the Church of the Nativity of the Virgin, North arm, east wall (scene E9), Plaster re-adhesion:

Above image: Wall painting condition, before injection grouting treatment. Plaster bulging from the surface, the gap between plaster and stone is few centimetres.

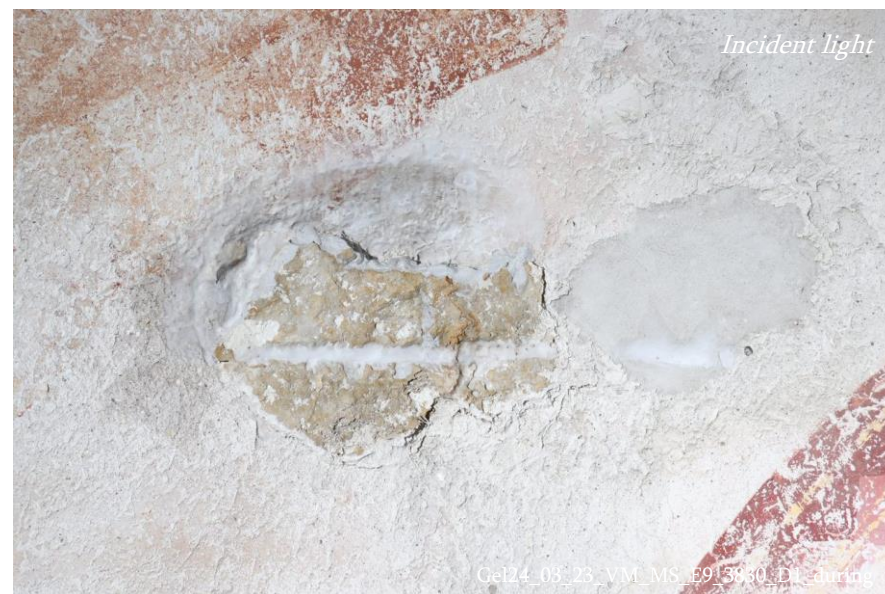
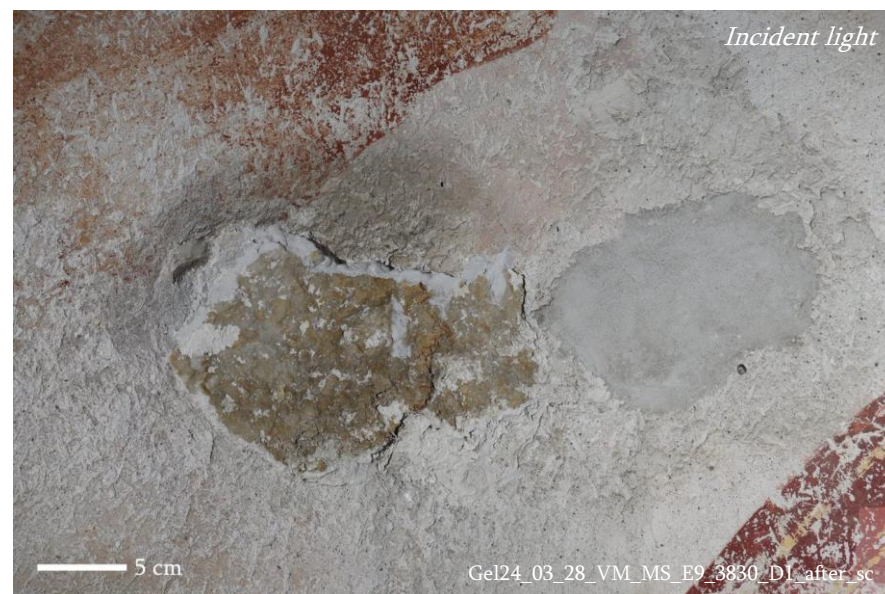
Upper right image: The temporary facing of the plaster, using cyclododecane (white layer on painted plaster).

Lower right image: re-adhesion of the plaster layer to the primary support through filling the gap with injection grout material. For assessing purposes, the area was left without applying edge repair. After assessment of treatment required fills or edge-repairs will be made.

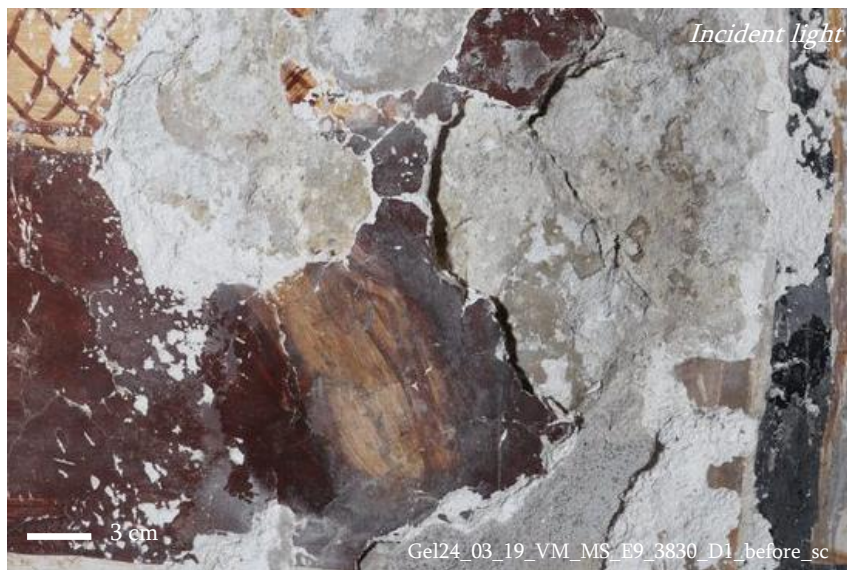
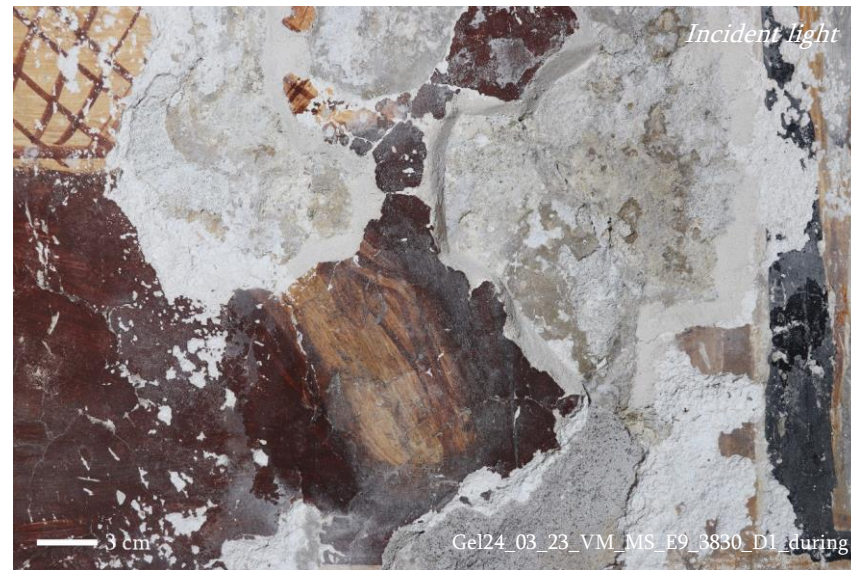
North-east chapel, north wall, plaster re-adhesion

Above: plaster delaminated from stone support.

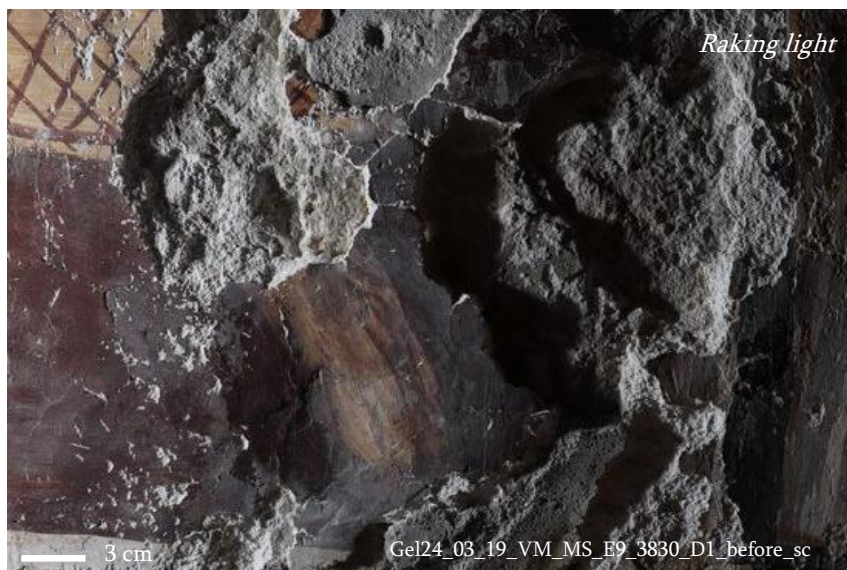
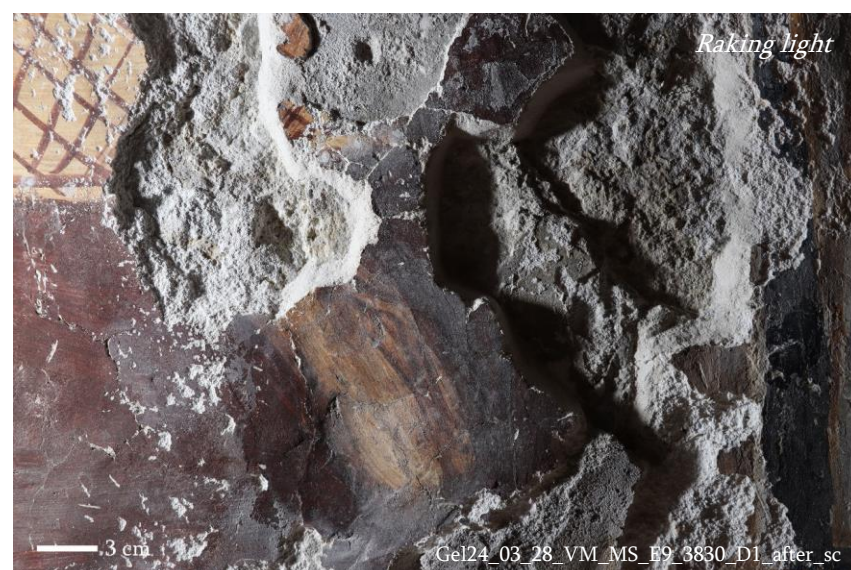
Above: plaster after re-adhesion and edge repair.

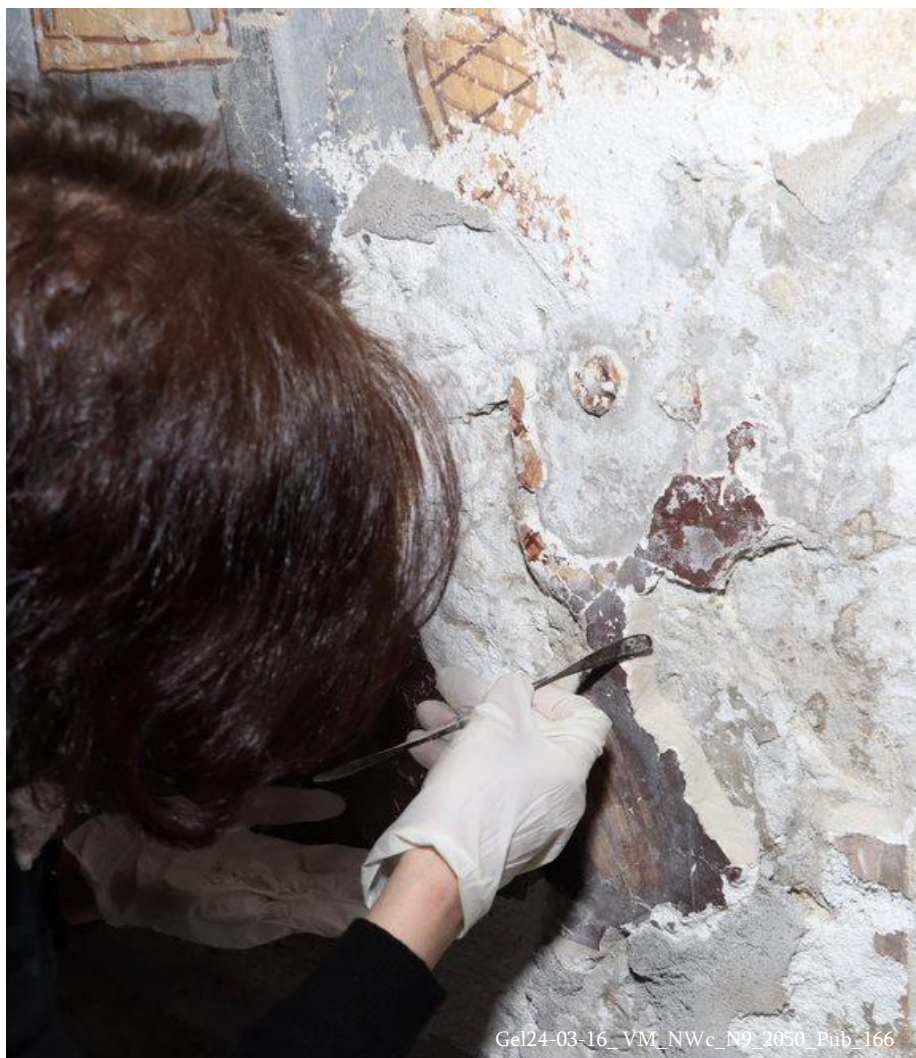
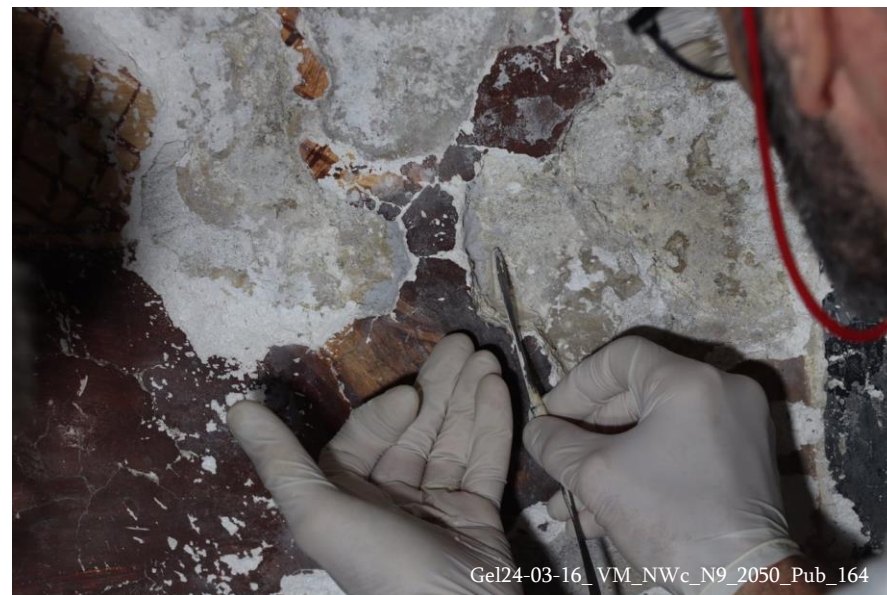
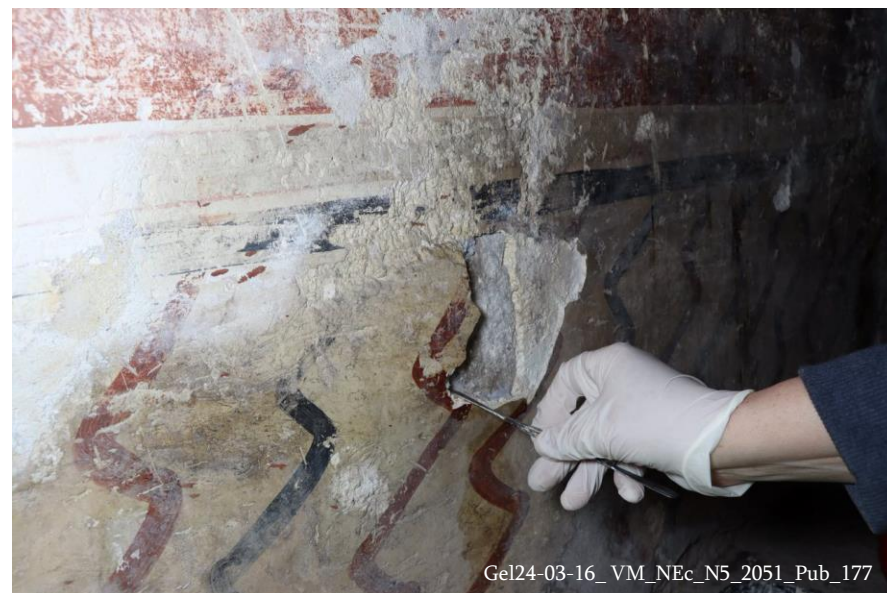
Plaster repairs:

Above and right: Process of edge repairing

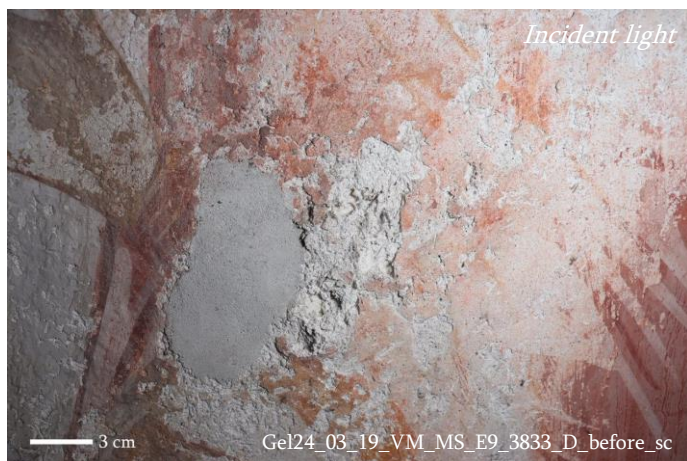
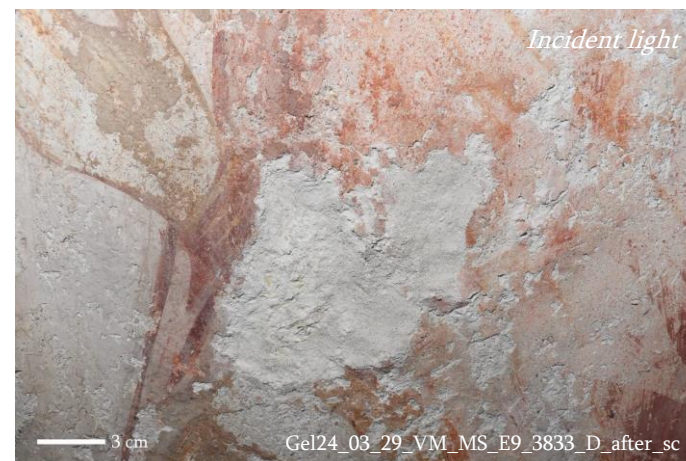
The main space of the Church of the Nativity of the Virgin, North arm, east wall (scene E9), Plaster repair

Above: The state of the plaster before filling –the plaster loss has been filled with repair material in XX c. Afterwards further loss has happened, therefore plaster edges are exposed.

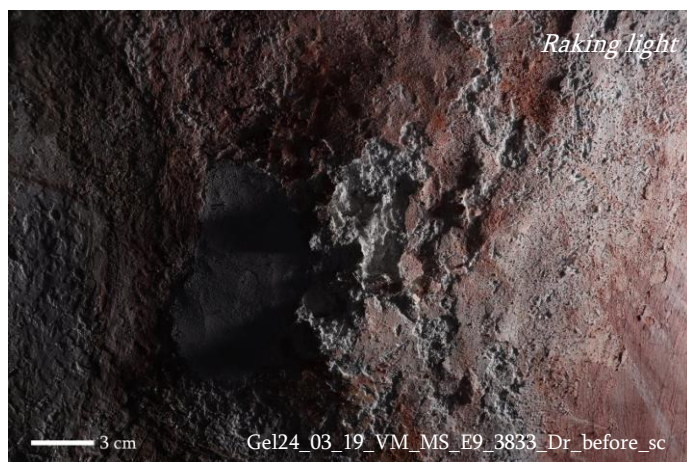
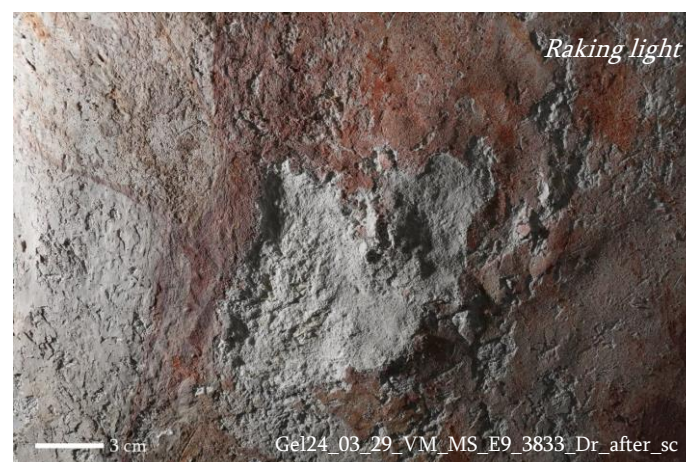
Above: condition after repair – the previous repair has been removed and the original topography of the surface is maintained with new repair material. The visual difference of the filling from the original plaster is achieved by a specific texture. The color of the fill corresponds to the lower layer of the painting and fits into a visually unified context with the painting. (The new filling does not visually focus on the loss of plaster). Used plaster mixture - N16.

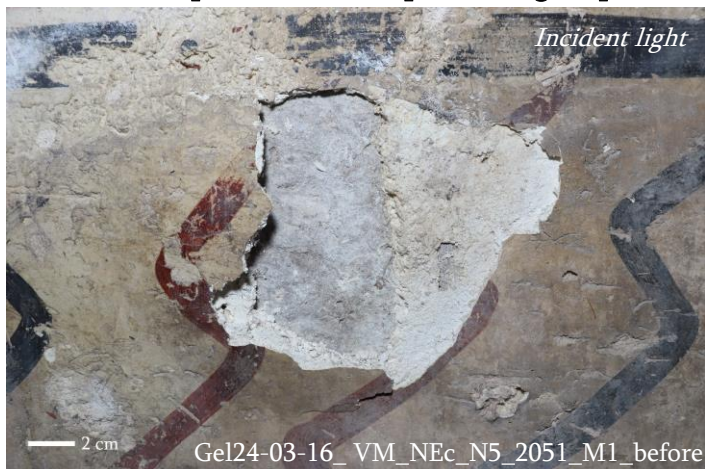
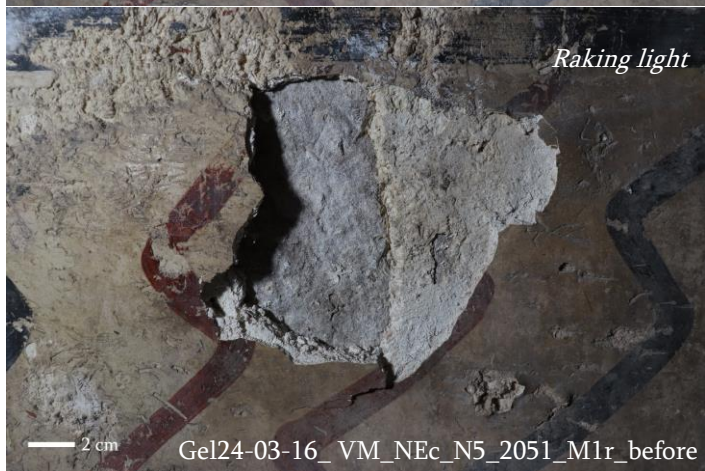
North-west chapel, north wall, plaster edge repair:

Above: The condition of the plaster before injection and edge repair - the plaster is delaminated requires grouting and edge reinforcement.

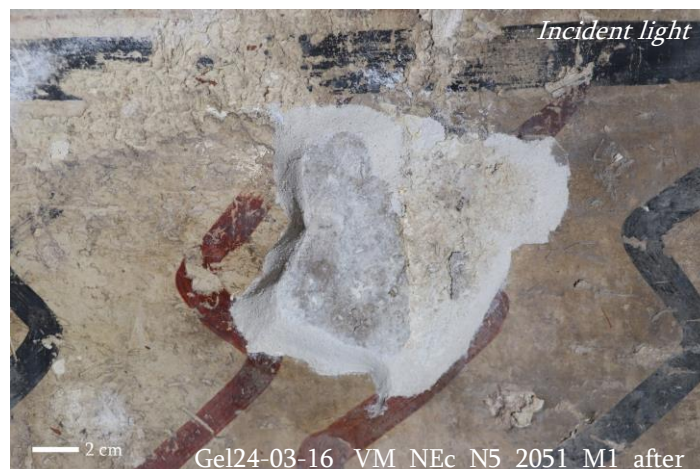
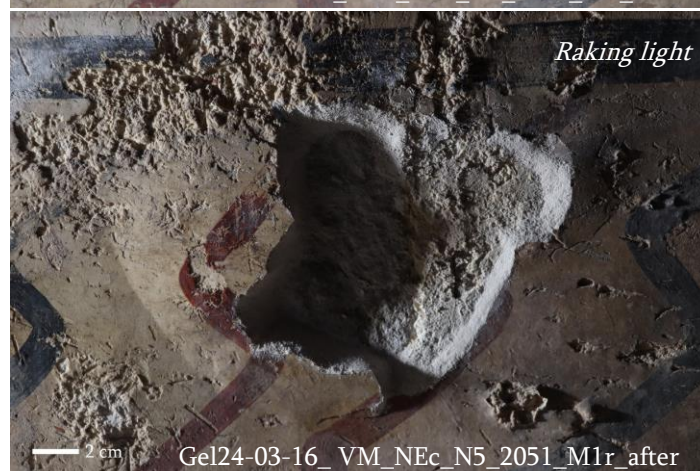
Above: The mentioned location, due to its critical condition, was selected for the following test interventions: injection and selection of the appropriate edge repair mixture.

In the first stage, injection was carried out, and then the edges were repaired using mixture N3. The testing area was evaluated by checking the characteristics, including the aesthetics. Based on the summary of the results, additional test will be proceeded.

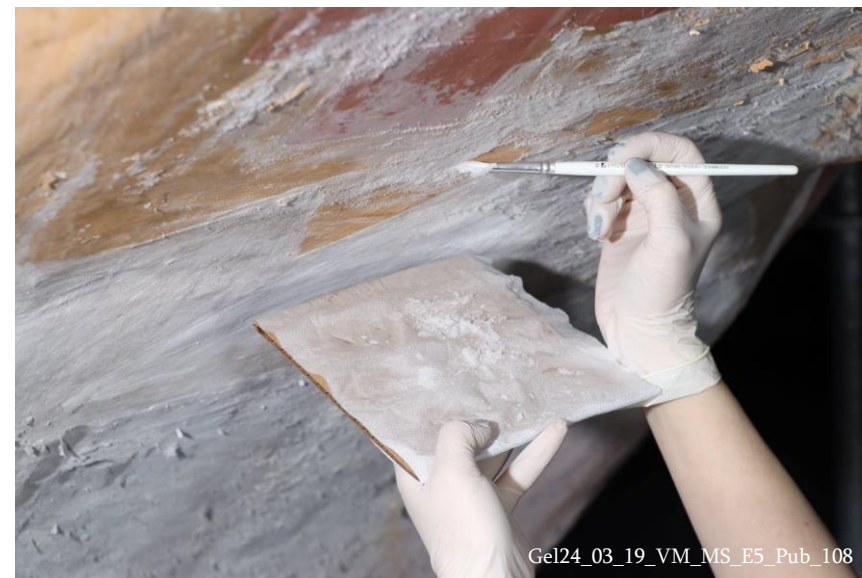
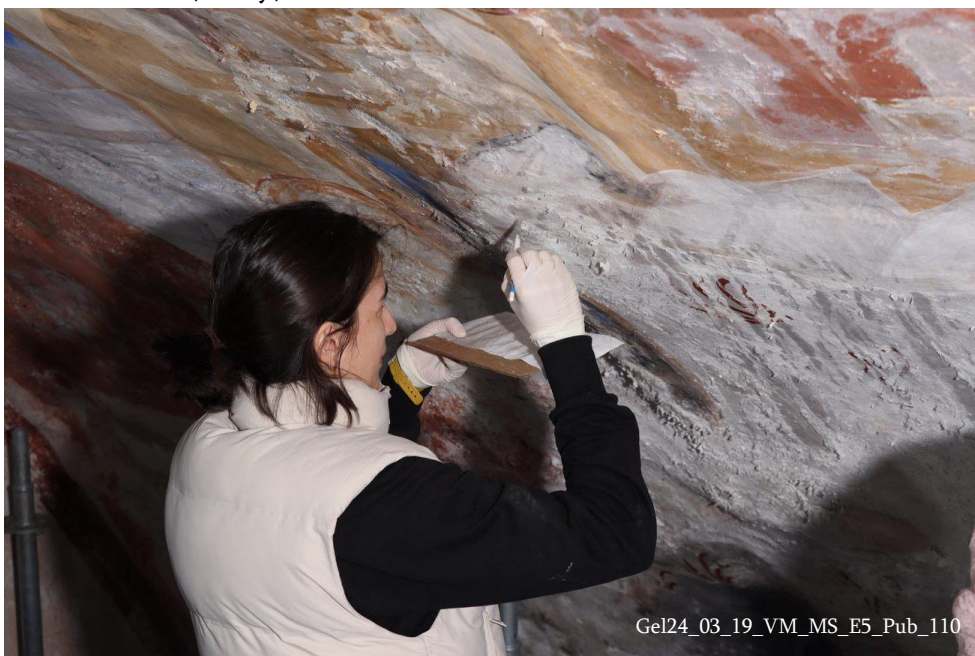
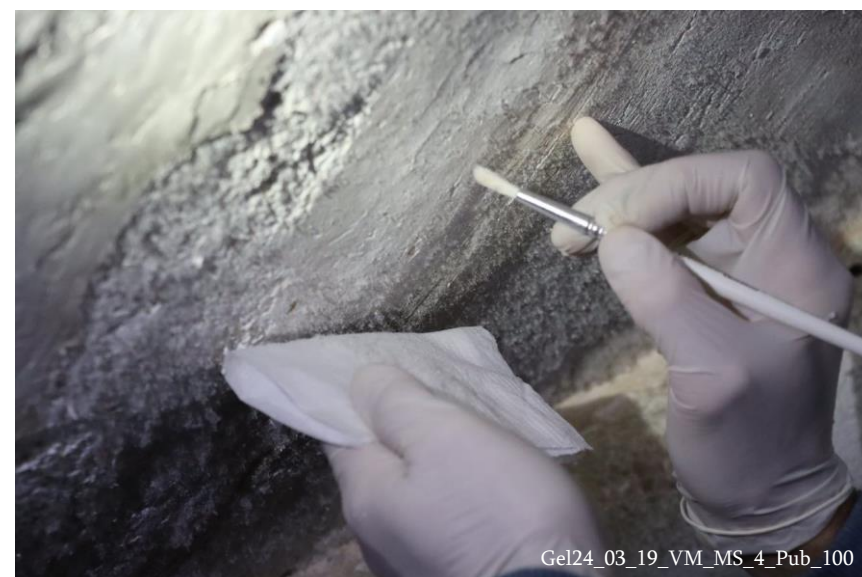
The removal of salts was also carried out for the purpose of monitoring.

The goal of the intervention was to determine the possibility of mechanical (dry) safe removal of salt from the structural system and, at the same time, to determine the frequency (and types) of new salt crystallisation (if any).

Soft small brushes were used to gently remove salt efflorescence. Wet tissue was used to capture the salts to prevent redeposition on the painted surfaces.

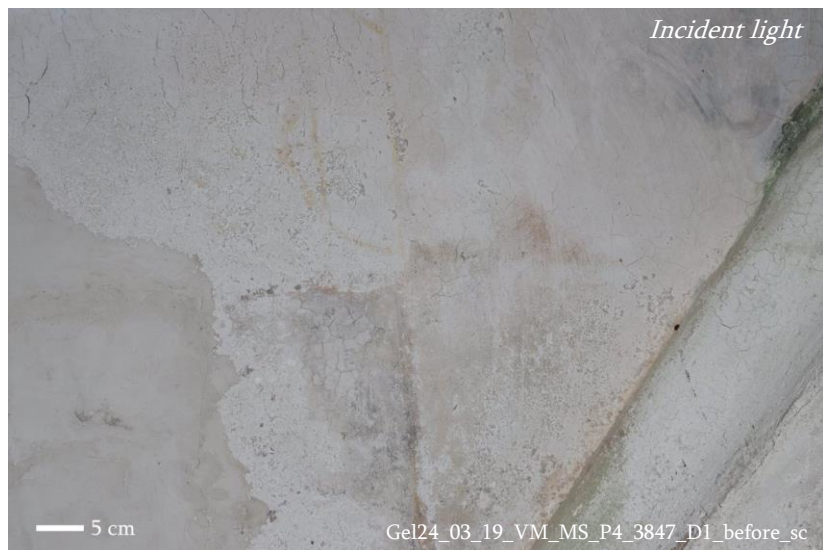
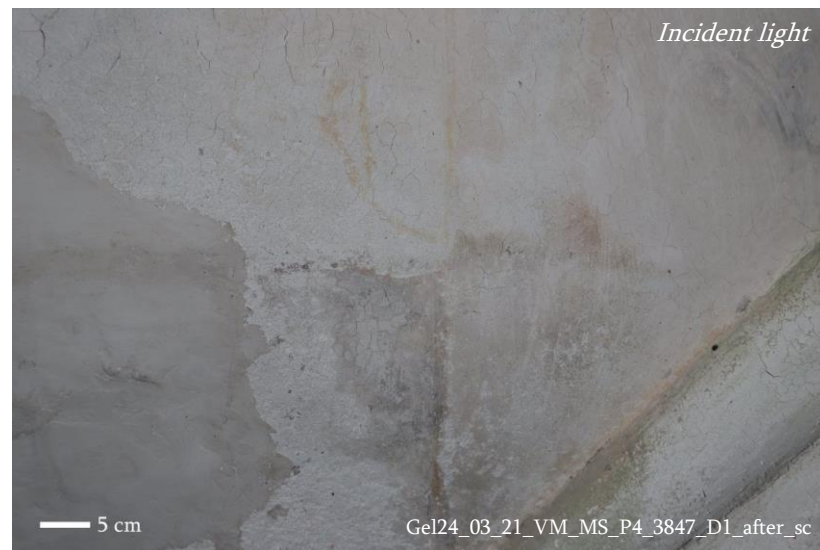
The Church of the Nativity of the Virgin Mary, North-west pendentive, salt reduction.

Above: Condition before salt removal

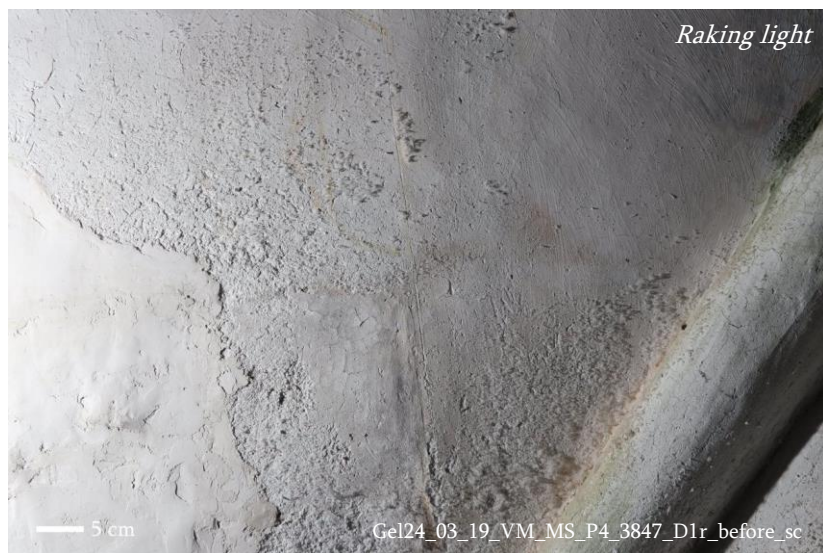
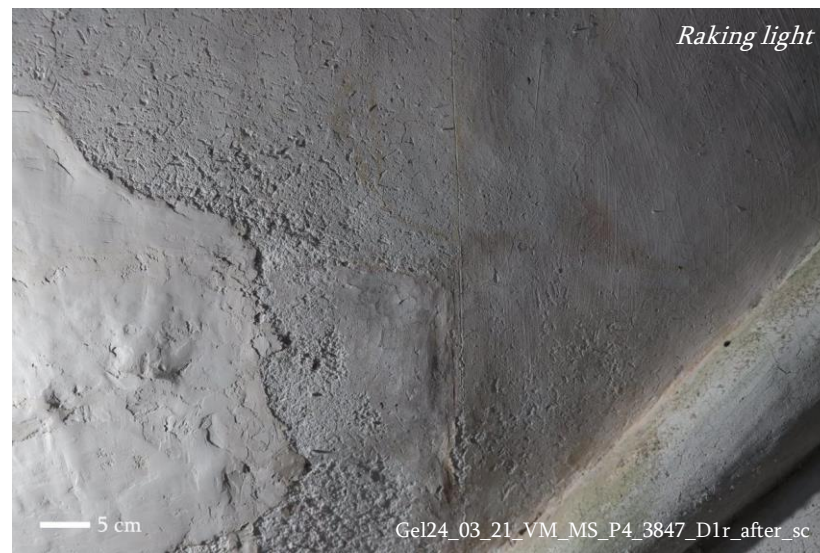
Above: Condition after salt removal

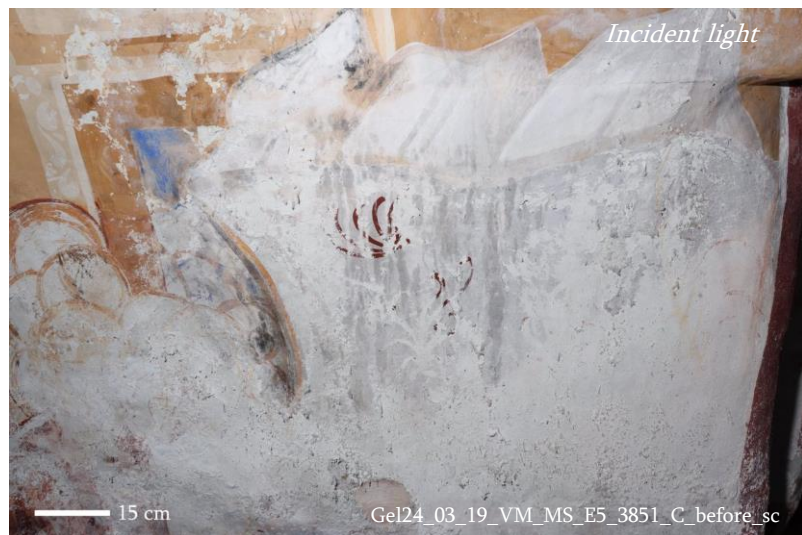
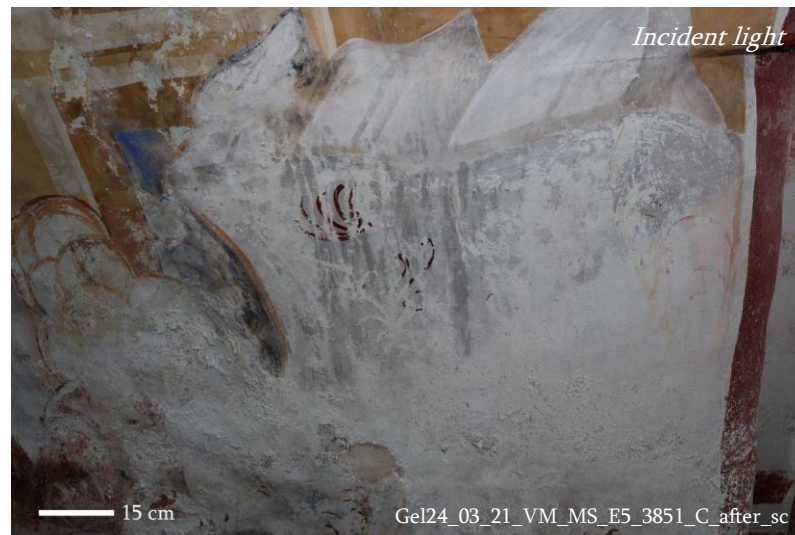
The main space of the Church of the Nativity of the Virgin, North arm, east wall (scene E5)

Above: Condition before salt removal

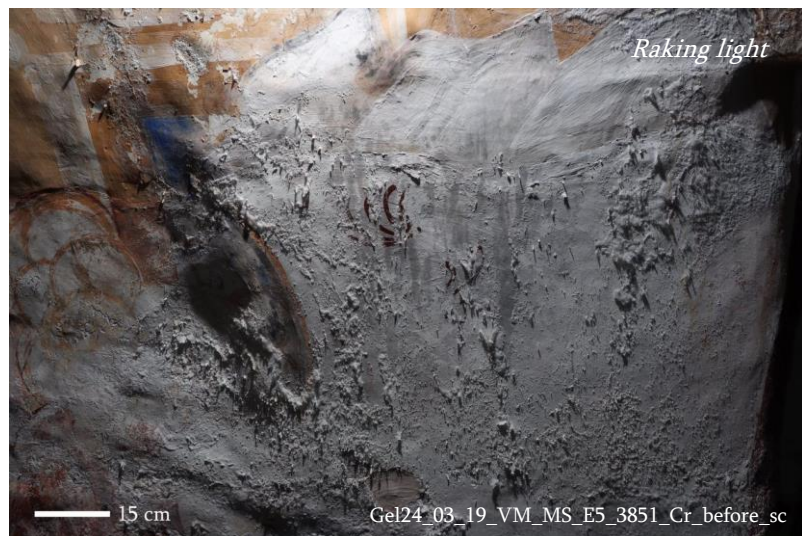
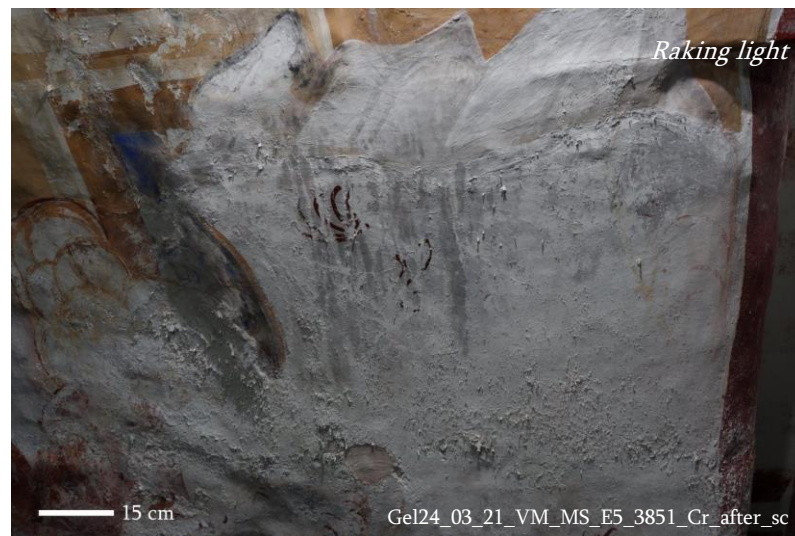
Above: Condition after salt removal

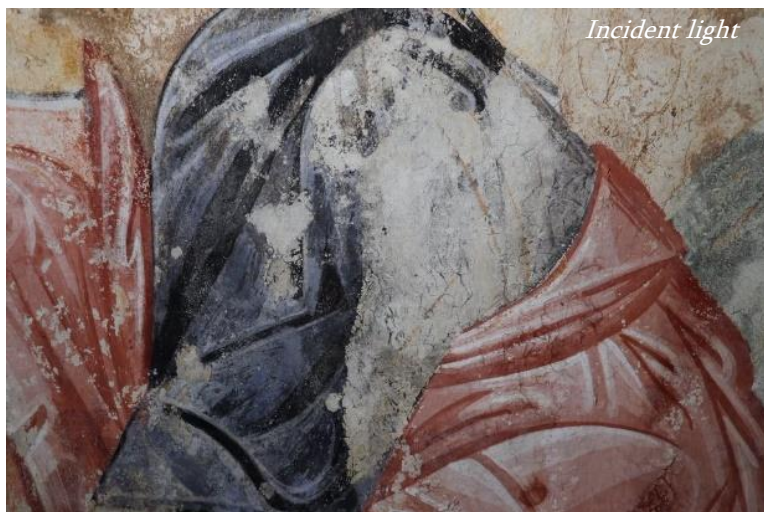
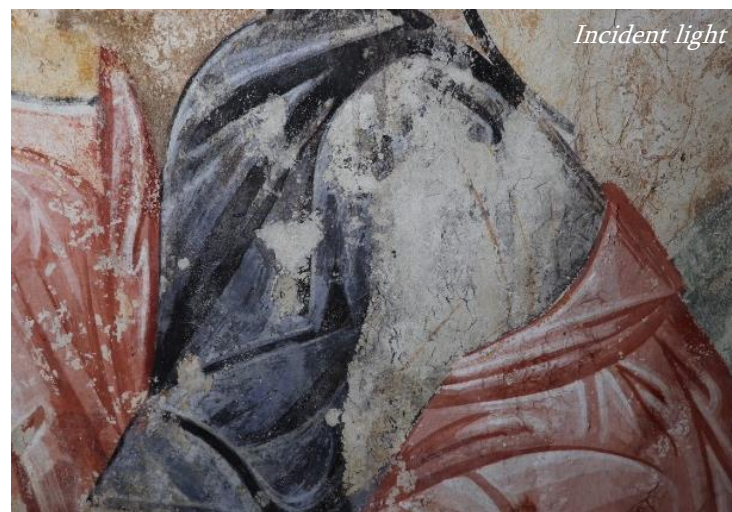
The main space of the Church of the Nativity of the Virgin, west arm, south wall (scene S8)

Above: Condition before salt removal

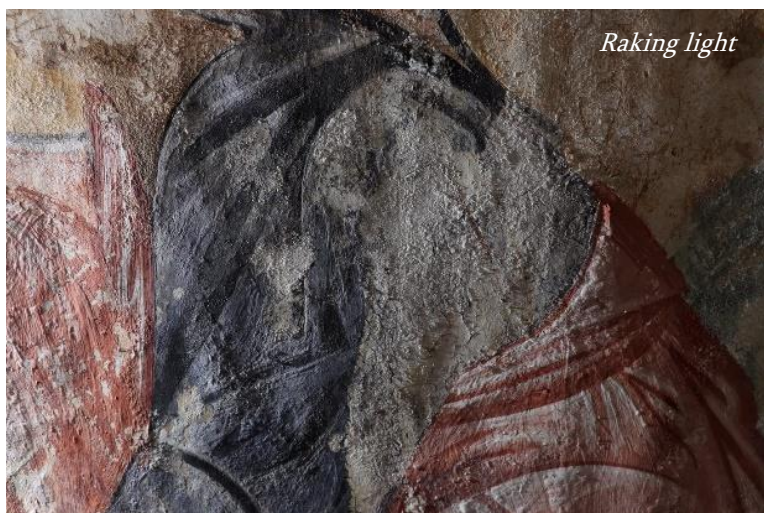
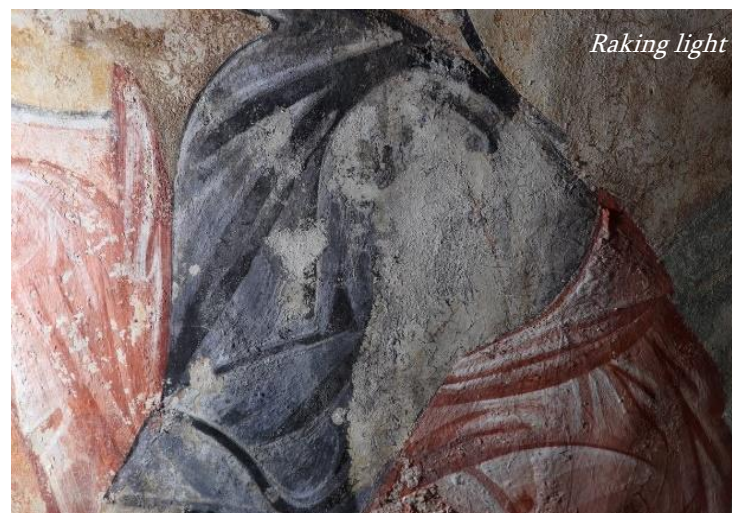
Above: Condition after partial salt removal

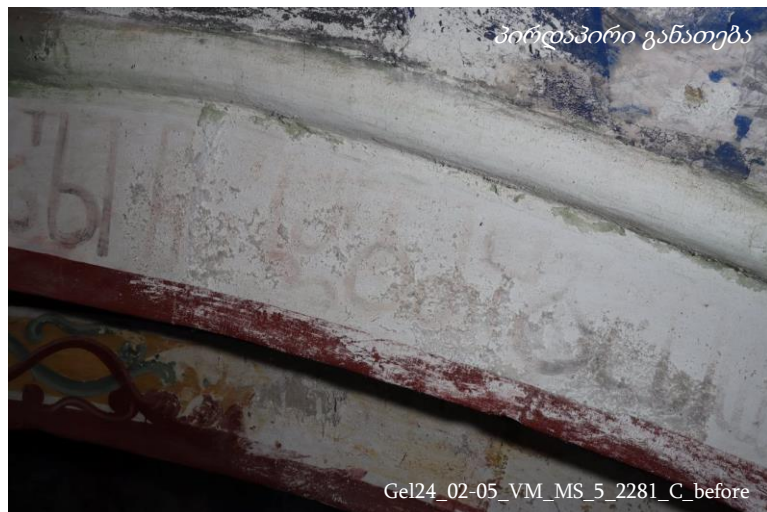
The main space of the Church of the Nativity of the Virgin, north arm, arch, plaster re-adhesion and consolidation:

Above: Condition before salt removal

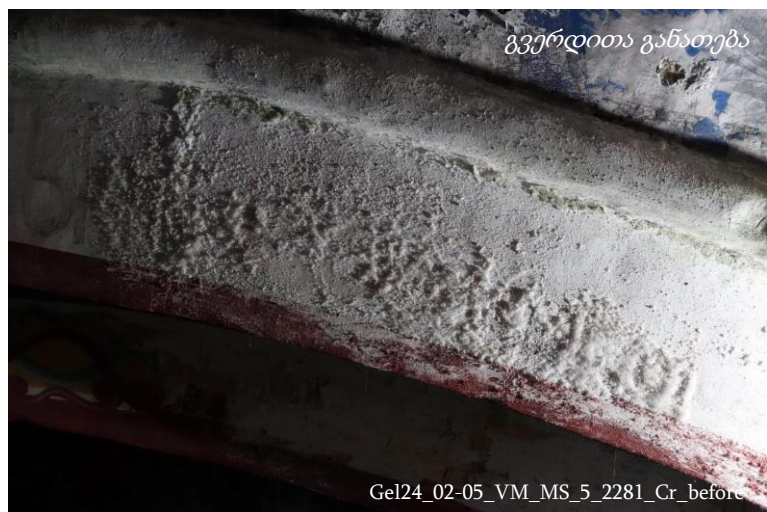
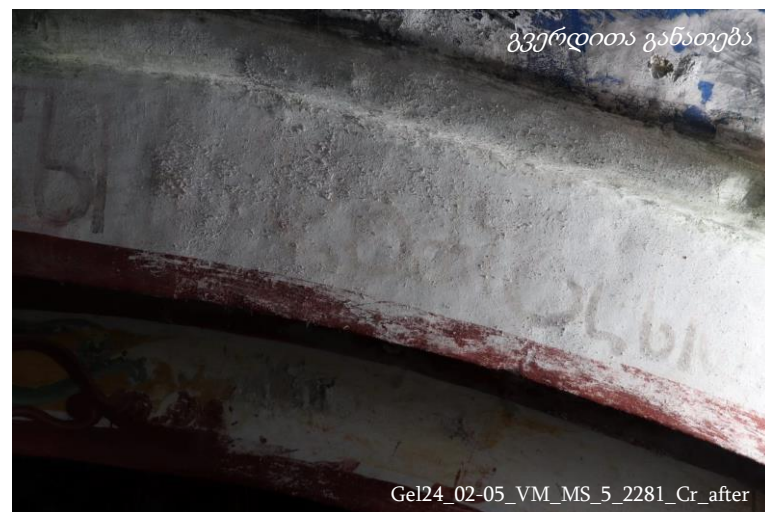
Above: Condition after salt removal

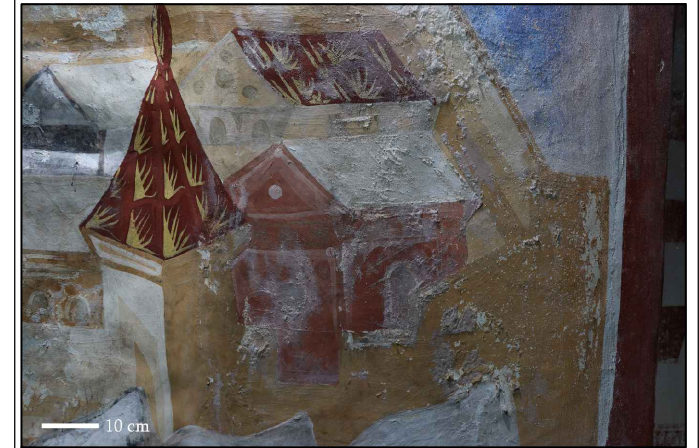
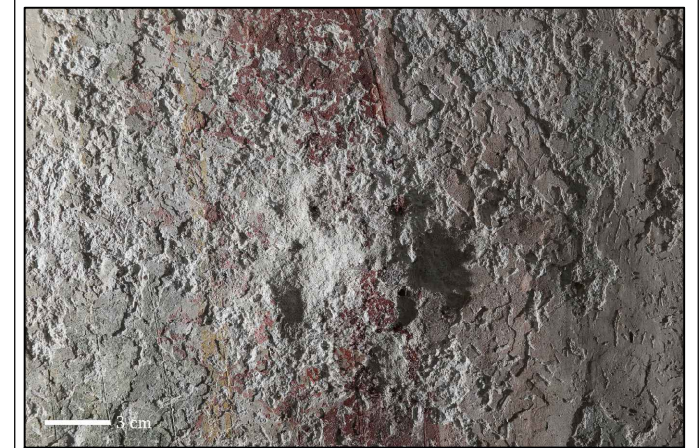
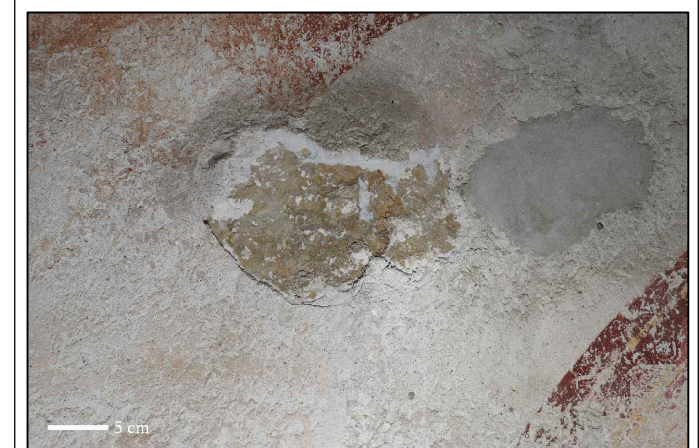
№1, №23
განხორციელებული ჩარევა

მარილის ქარკი და ნაფიფი მოხსნა მკანინურად, რბილი,
სინთეტიკური ფაჩით და ლაგებინ გამოყენებით.
