**REPORT**  
**of the joint World Heritage Centre/ICOMOS/ICCROM**  
**Reactive Monitoring mission**  
**to the World Heritage property 'Gelati Monastery' (Georgia)**  
**23-27 September 2024**

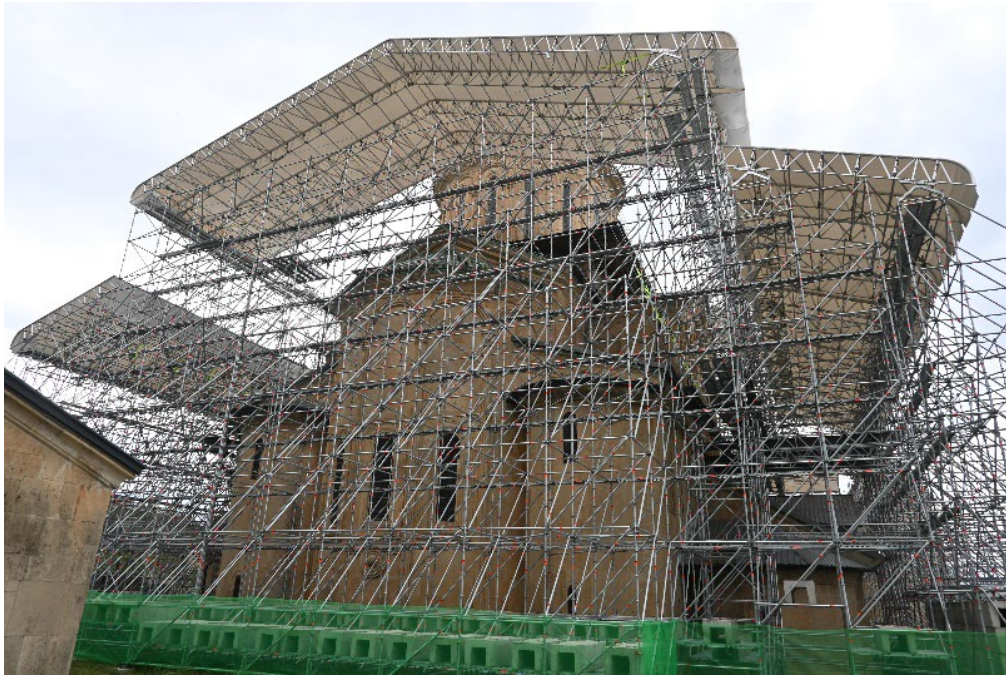
The entire structure is made of two main components, one manufactured in Germany and the other in Georgia. The first one is allowing for the church to be covered from the outside and provides for pathways for workers on the northern and southern facades to safely access the roof. The use of supporting columns that would require iron piers of big size and length and deep foundations, has been avoided, in order not to put at risk archaeological layers. Instead, the solution found entails a big number of aluminium columns anchored in precast reinforced

concrete slabs laid on the ground surface. To avoid wind pressures, additional concrete weights were added in the lower parts of the structure. While the 2022 mission noted that “the sufficient overhanging of the temporary protective roof, installing gutters and reusing the rainwater drainage system did the most to prevent water from collecting at the base and from flowing on the facades of the building” (p. 22), it should be noted that the larger new overall protective cover will reduce significantly the use of the gutters and downspouts of the temporary roofing, as well as the existing rainwater drainage system.

*Fig.1. View of the overall cover from the east*

The mission recommends completing the overall protective cover as soon as possible along with the completion of the external scaffolding to enable undertaking the activities recommended by the 2022 Advisory mission, such as the removal of the deficient tile roof to allow the drying of the extrados of the building, but also to allow thorough inspections of all the building's external wall surfaces.

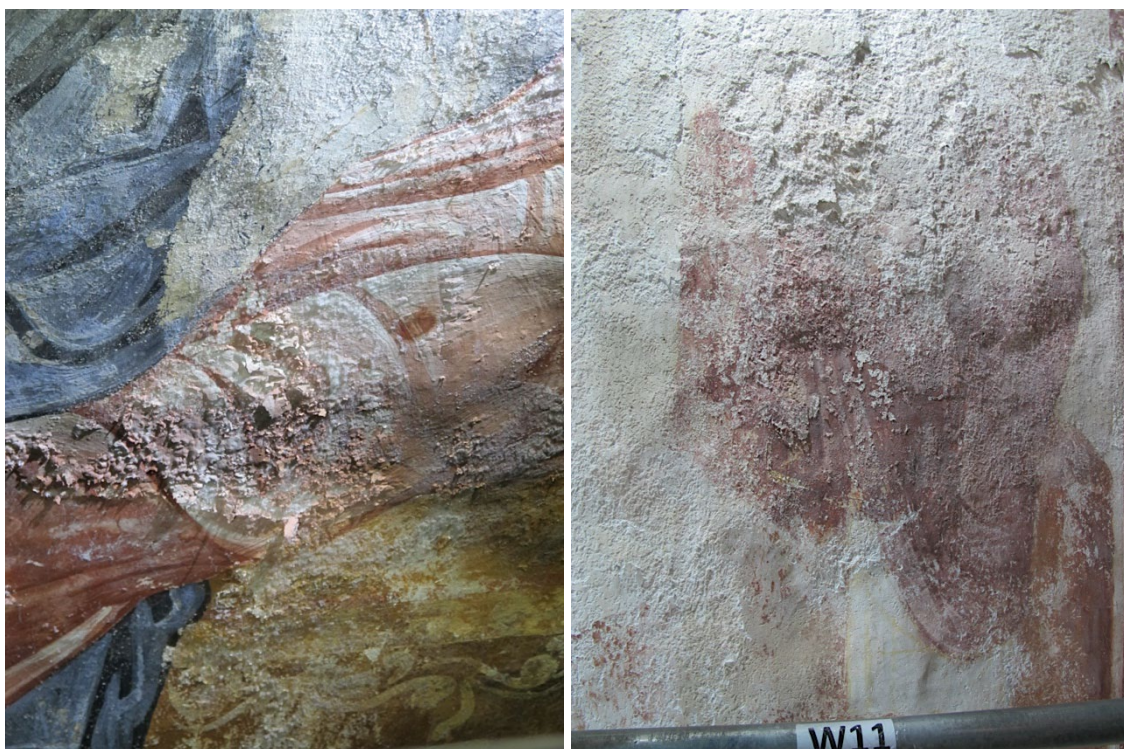
*Fig. 3, 4. Flaking, scaling and powdering of paint layer*

There are many very fragile areas of the paint layer, which could be lost without an immediate intervention. The mission team learned that no intervention on the paint layer is planned in the areas treated by the previous team of restorers. No clear reason has been given for this

- Do not any longer delay emergency interventions on the paint and preparatory layers of the decoration, which are in a state of precariousness and face the risk of crumbling/falling in several areas of the surfaces.
- While continuing monitoring, allow for a brief review time, to go through, combine together, and understand the results of all the investigations undertaken in order to draw conclusions and design a holistic conservation programme, following these steps:
  - rapidly re-read the different studies, possibly by topic (for example: origin of infiltrations, disposal and collection of rainwater, relative humidity values, macroclimate / microclimate, etc.),
  - summarize the conclusions individually,
  - identify priorities,

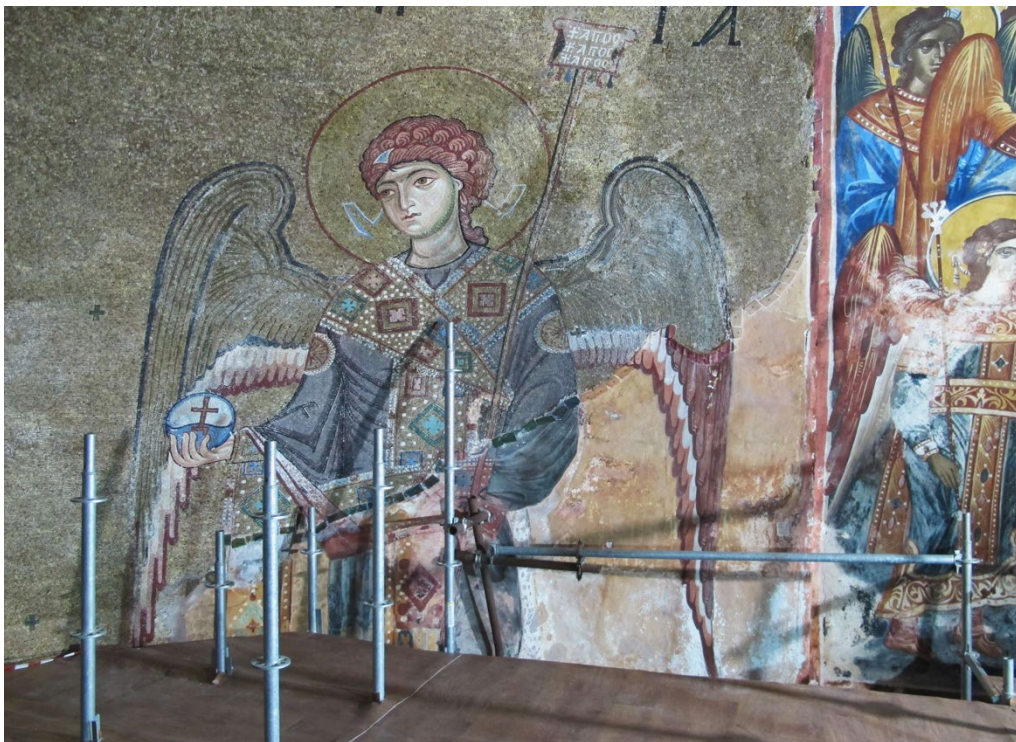
*Fig. 5. Angel on the right side of the mosaic. The diagonal black line marks where the upper part of the mosaic meets the lower part which is painted*

On initial inspection, the mosaic surface appeared to be in good overall condition, largely complete with only minor gaps where tesserae are missing, and with minimal visible soiling. However, investigations of the mosaic's state of conservation undertaken by Roberto Nardi, a prominent mosaics conservator from Italy, and his highly qualified team from the Archaeological Conservation Centre in Rome have revealed severe damages and various previous restorations requiring a very complex intervention. Roberto Nardi emphasised during the online meeting with the mission team that “the mosaic, the apse, the church and its structures, and the external environment constitute a single, interconnected system” – a perspective that underpins his study, the scientific investigations carried out and in great part

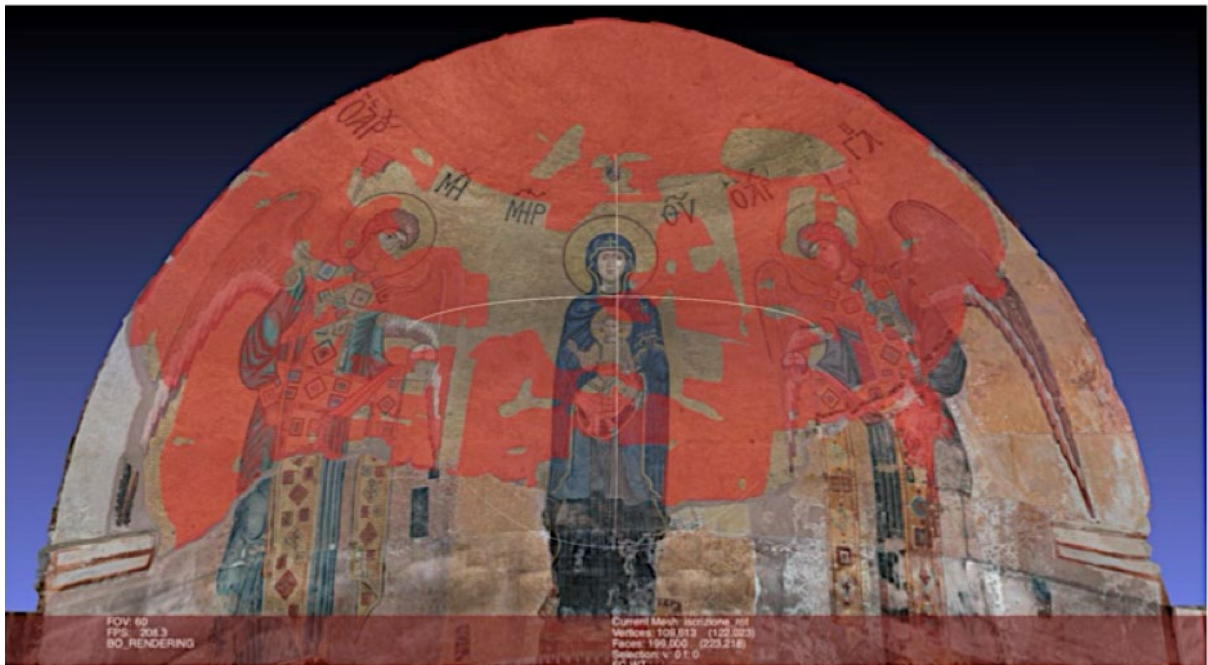
During the mission team's online meeting with Roberto Nardi, a graphical vision of the extension of the detachment was presented together with a video of the internal inspection realized with a flexible video endoscope. Additional tests have been realized to evaluate the consolidation (superficial and deep), the salt extraction, the cleaning and a final finishing for the treated areas.

*Fig. 6. Map of the large detachments for the 85% of the surface (from R. Nardi - Interim Report, 24 July 2024)*

The mission recommends submitting the executive conservation plan of the mosaic to the World Heritage Centre for review by the Advisory Bodies within the holistic conservation programme.

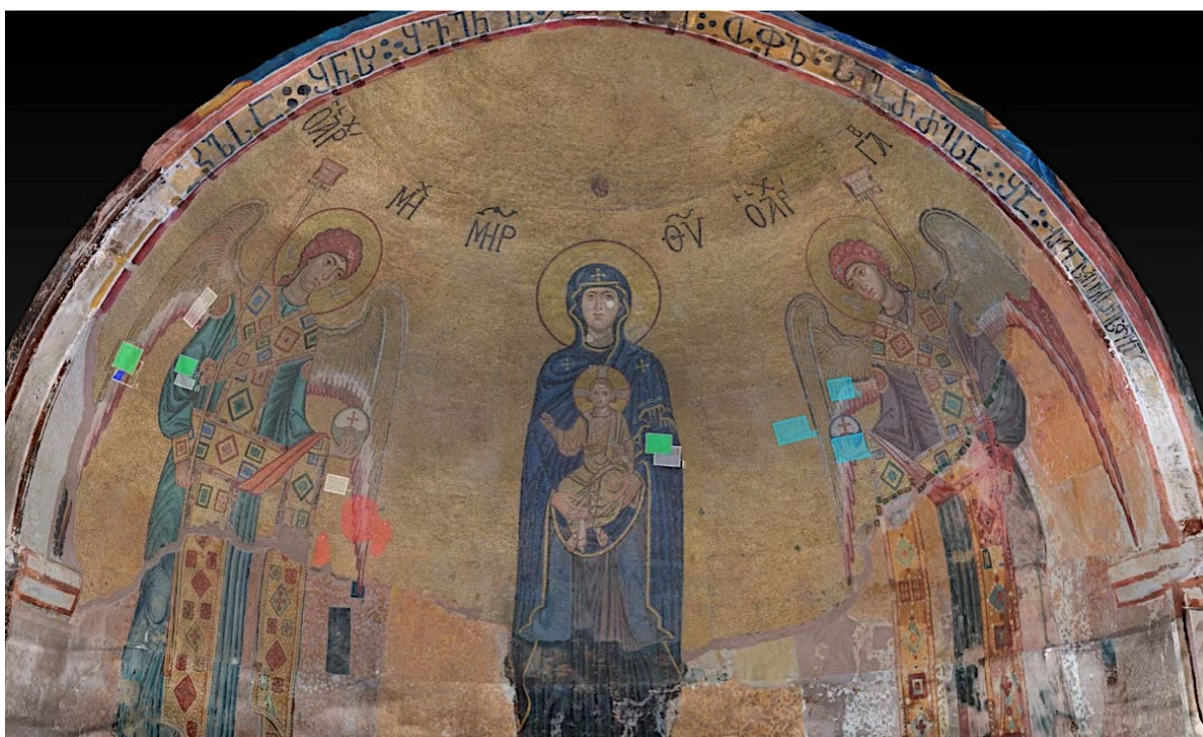
Fig. 9. Map of the treatment tests (from R. Nardi - Interim Report, 24 July 2024)

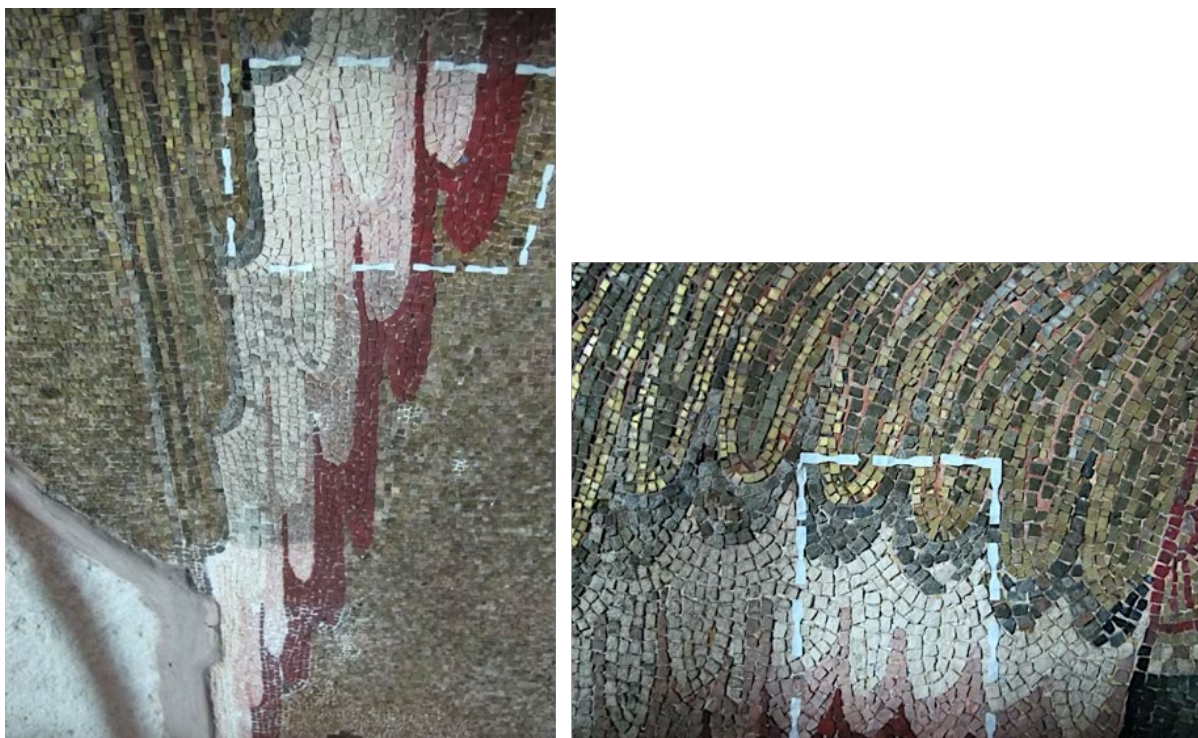
*Fig. 10, 11. Cleaning tests (from R. Nardi - Interim Report, 24 July 2024)*

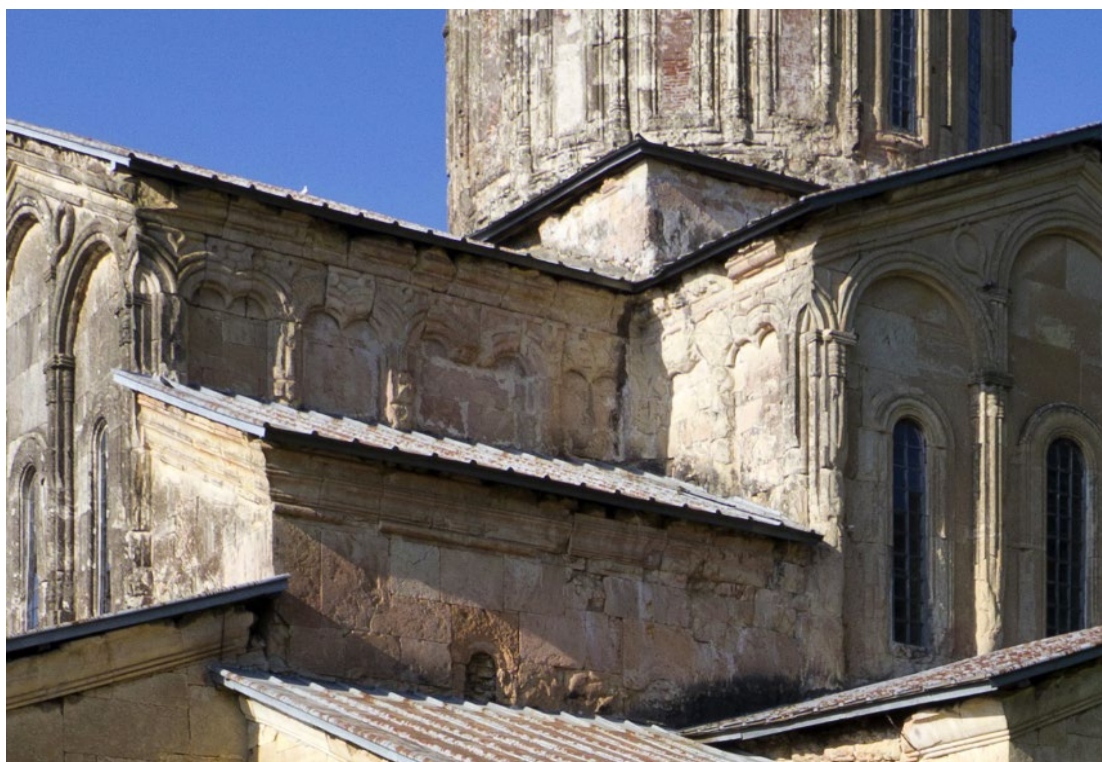
In the images of the different reports, the surface decay of the stone facades is very visible. The information provided in the reports does not show a clear connection between the damage on the external surfaces and the damage (both old and new) inside the Main Church. For this reason, mapping these areas is necessary to improve the understanding of potential connections.

*Fig. 12. 2011 Photos of Gelati Main Church by Pino Dell'Aquila*

The mission team considers that the direct causes of the internal decay of the mural paintings are still not clearly identified in relation to the conditions of the exterior surfaces of the building. For this reason, the mission recommends implementing a comprehensive Stone Conservation Programme in two phases:
