The Mosaic of the Virgin Mary Monastery of Gelati, Georgia Conservation-Restoration Project

FINAL REPORT
PREVENTIVE CONSERVATION
Activities carried out during October 2025 – April 2026

Roberto Nardi
Centro di Conservazione Archeologica - Roma

APRIL 2026

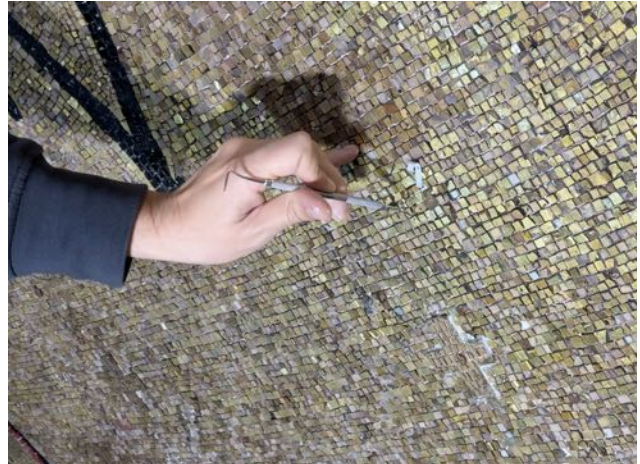
1. Review of the state of the tesserae and securing: the tiles were individually verified, and any detachments or fragility was highlighted using colored labels to proceed with preliminary fixings. The work was carried out on individual tiles and limited areas with a syringe using PLM SM diluted with water. All collected information updated the documentation produced during the planning phase.

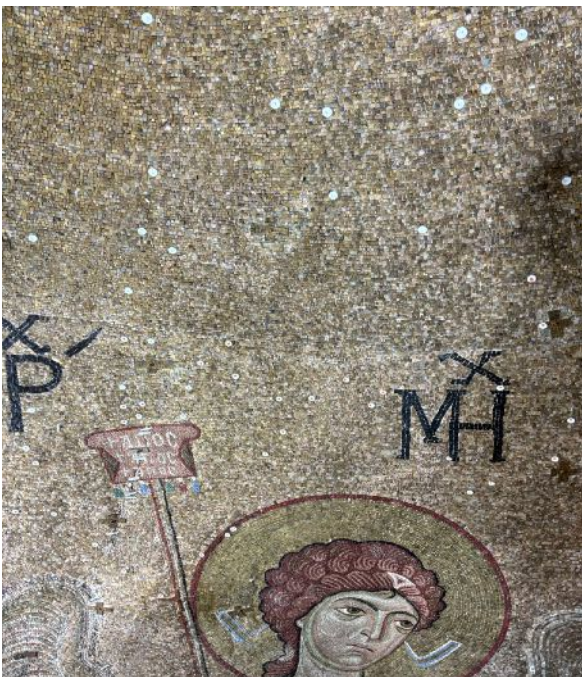
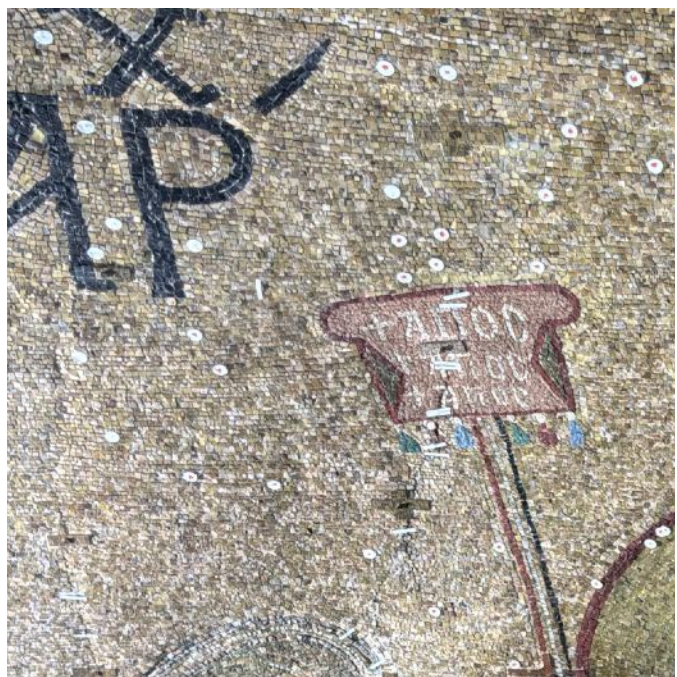
3. Review the setting-bed layers, pointing consolidation: in areas with instability of multiple tesserae, consolidation was carried out by infiltrating hydraulic mortar into the interstitial spaces.

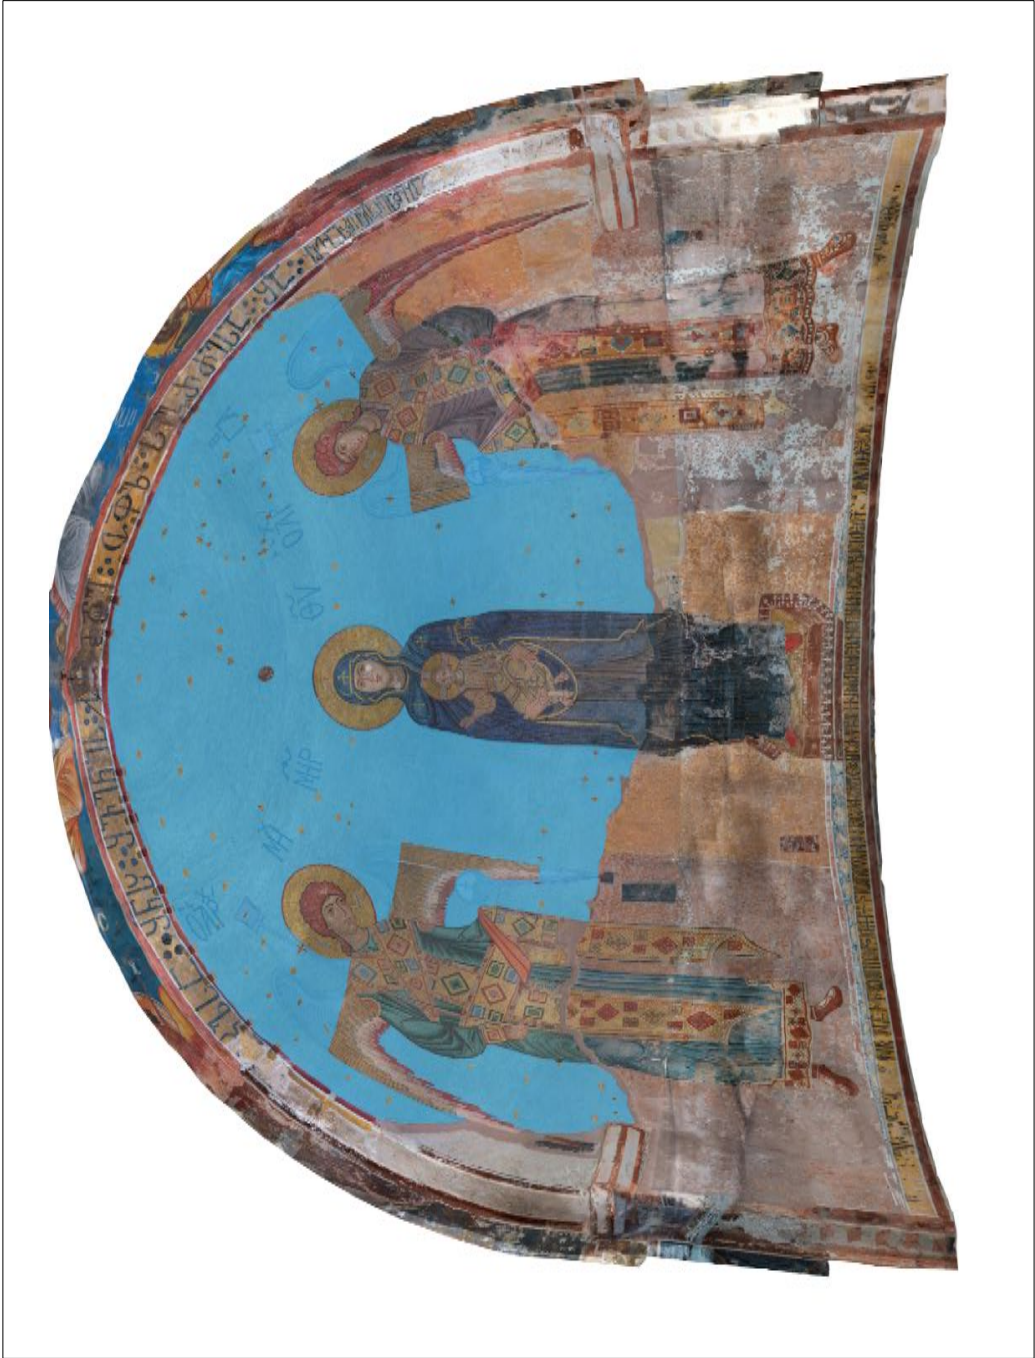
■ Pre wet cleaning

- Pre-wet cleaning: on very limited areas where the presence of the brass pins from the 1980s restoration allows for safe intervention, pre-wet cleaning was performed in order to remove the most superficial and weakly coherent dirt. Deposits present in the interstitial spaces were also removed with gentle mechanical action using soft-bristled brushes, natural sponges, and finishing with scalpels.

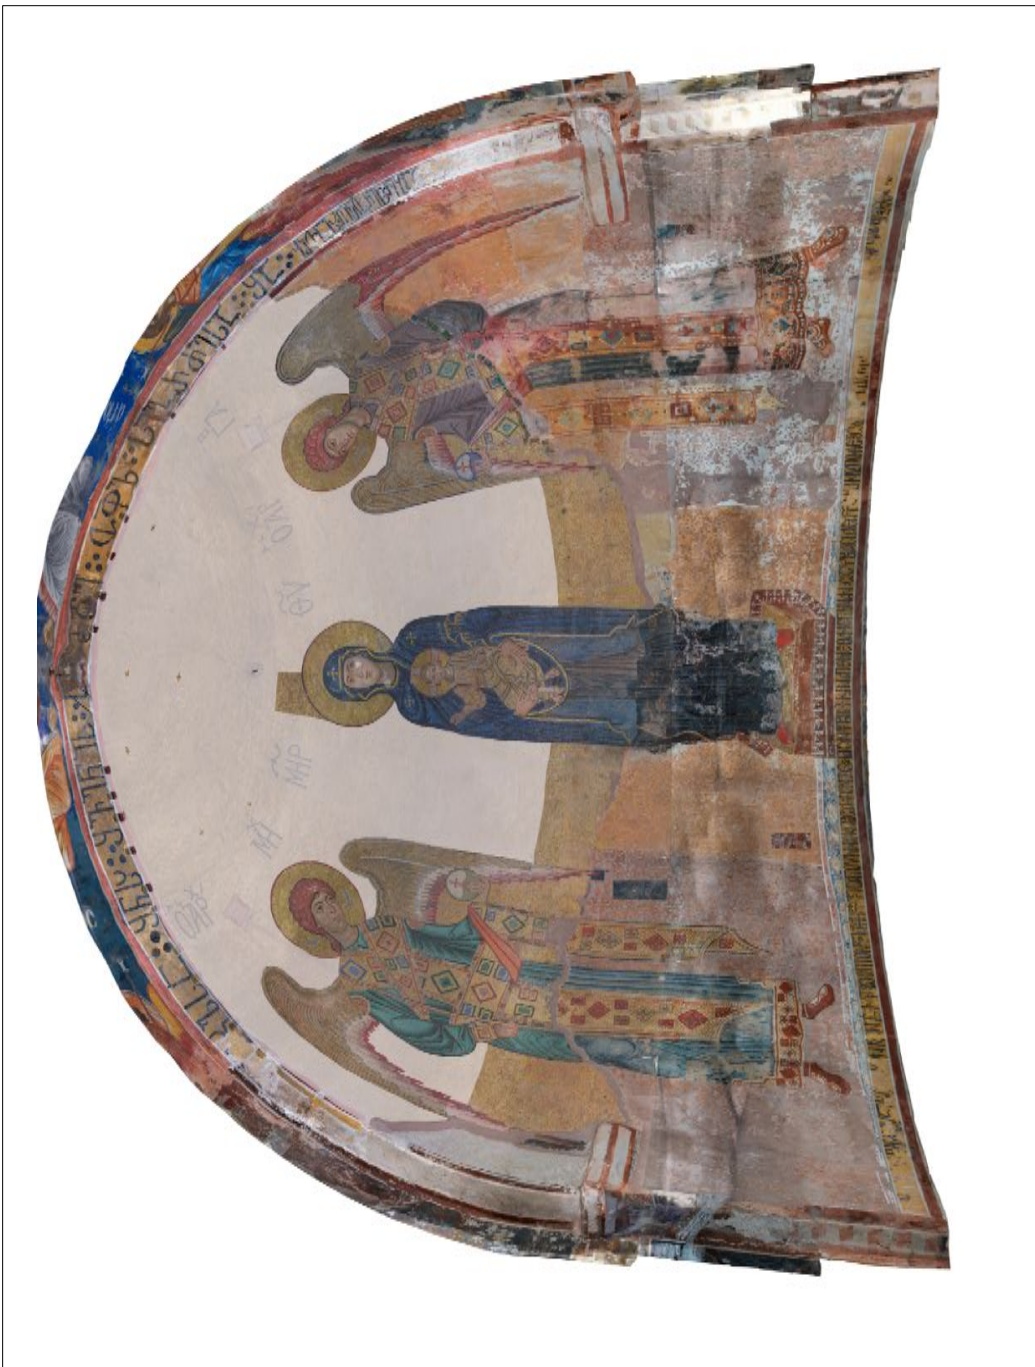
Gauzing

Veiling of the mosaic with cotton gauze: all areas affected by the severe detachment of the mosaic from the masonry structure of the upper apse bowl (see map in red) were protected by applying a layer of cotton gauze directly onto the mosaic surface. This operation was carried out using: Aquazol 500 diluted in water because its low level of toxicity. It was decided to apply one single layer of cotton gauze because this will make the mosaic easier to read for future treatments. Specifically, this will allow for consolidation of the mosaic's deeper layers without removing the glaze.

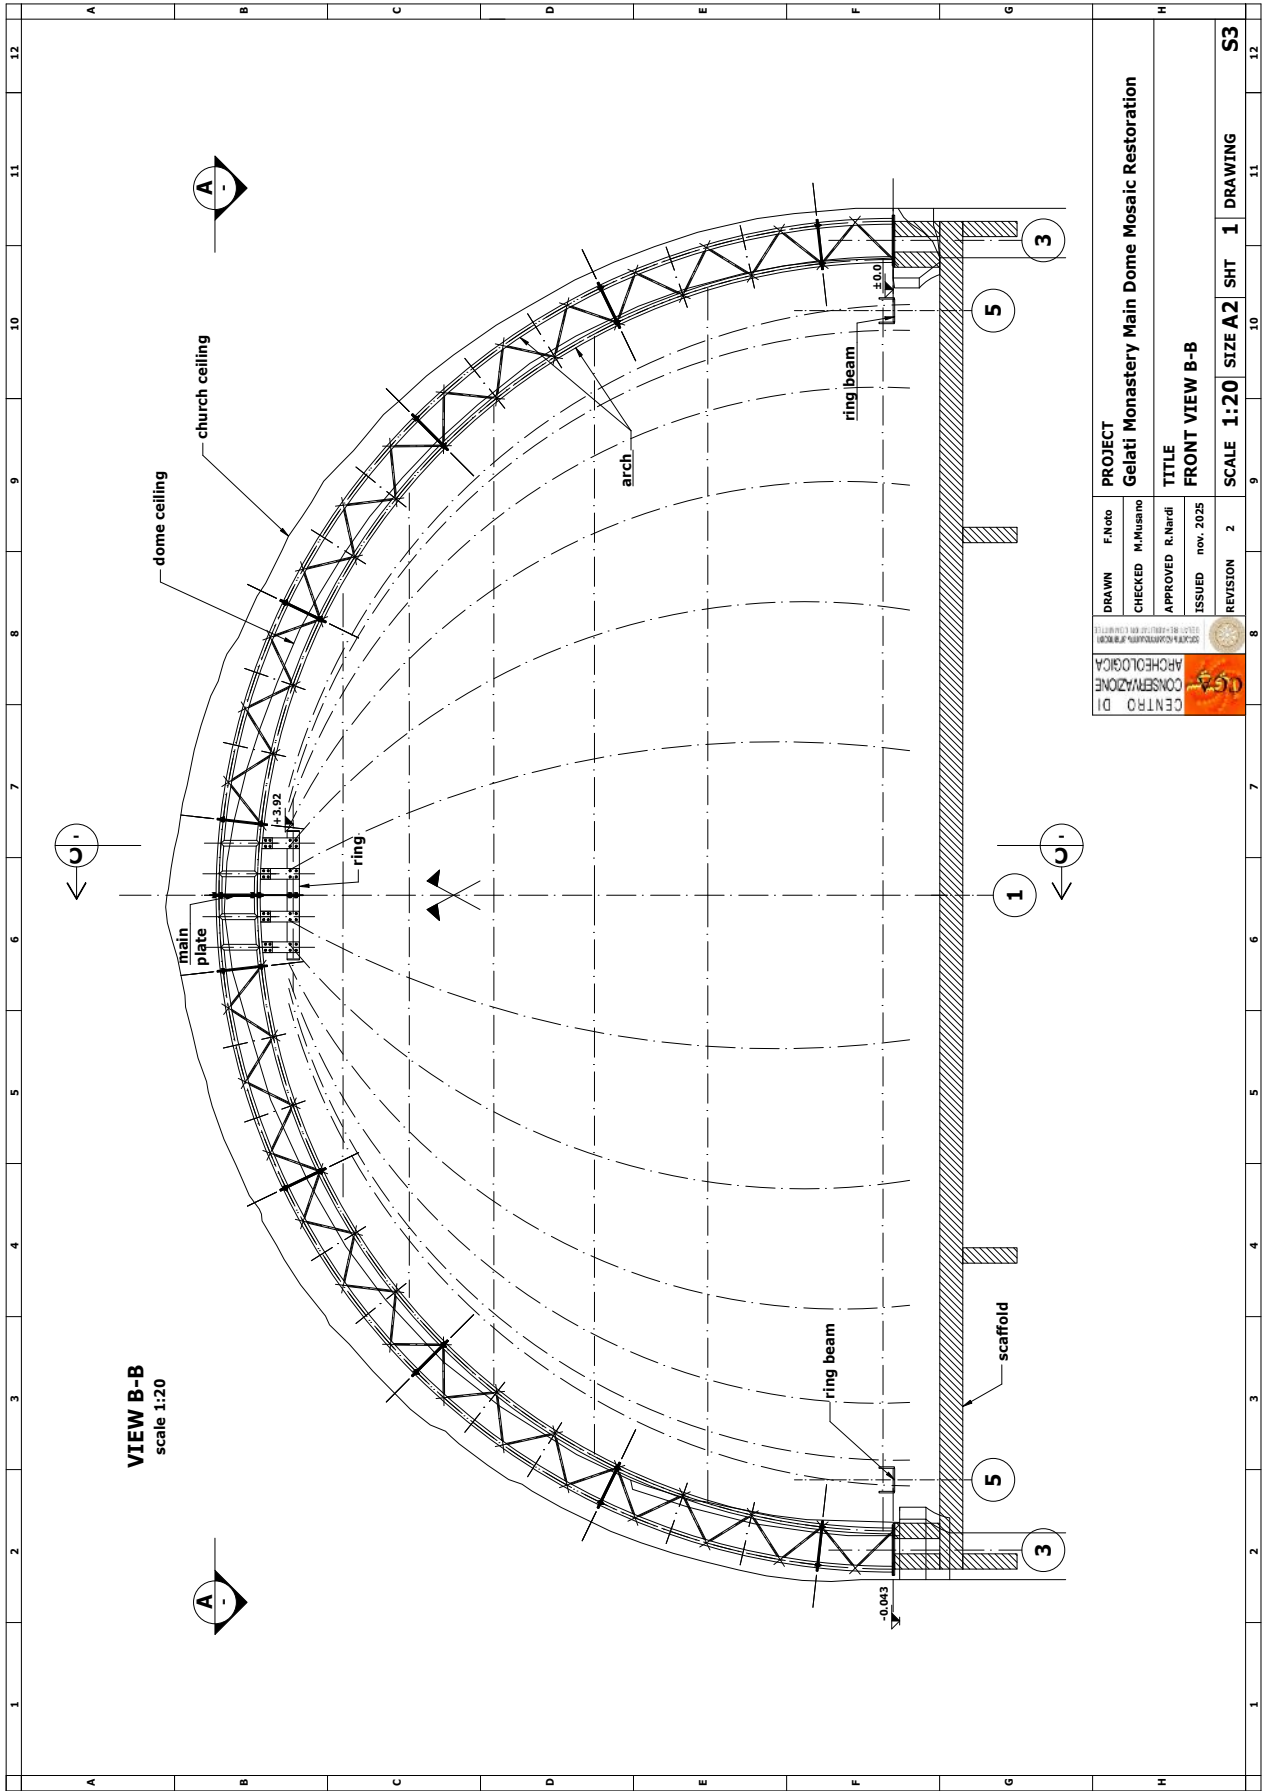
SECTION C-C
scale 1:20

The upper section of the support structure was manufactured in Rome. Massimo and Emanuele Canale oversaw the production of the elements and performed a complete initial assembly in the factory to verify the accuracy of the design and the alignment of the connections. Once the system's efficiency was verified, the structure was dismantled and prepared for overland transport to Georgia.
