## **SIX-MONTH REPORT ON CLIMATE, MICROCLIMATE AND ENVIRONMENTAL DIAGNOSTICS**

**ST. GEORGE CHURCH - GELATI MONASTERY - GEORGIA**

**REPORTING PERIOD: JANUARY – JUNE 2026**

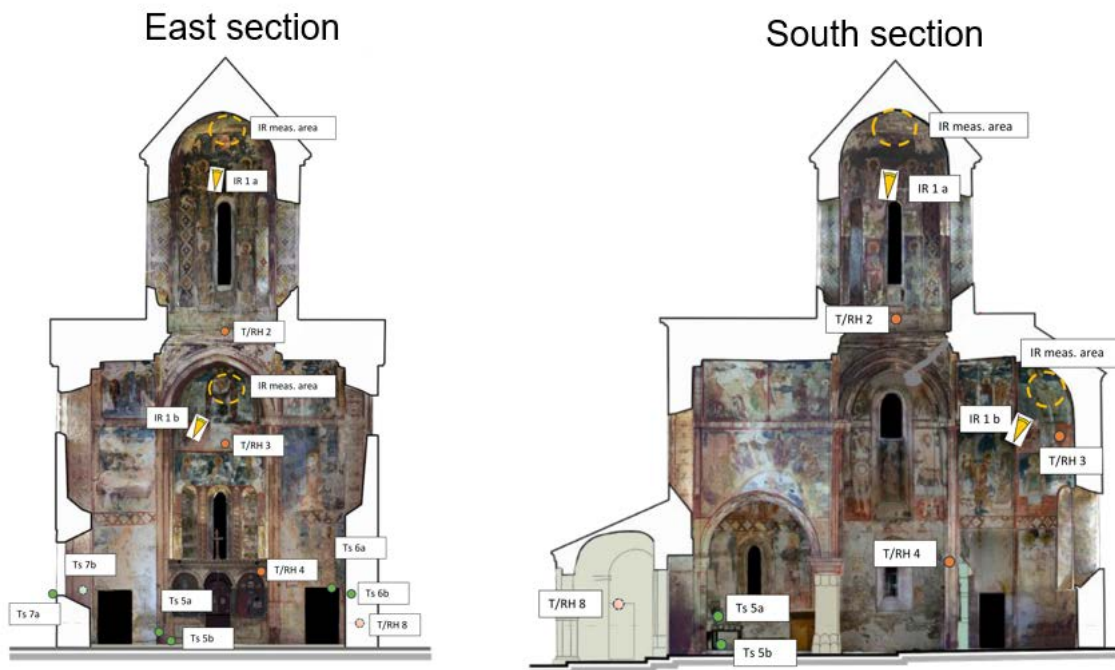
## 2. SENSOR LOCATION

The figure below shows the locations of the monitoring sensors within the church, as represented in the east and south sections. The indoor air-temperature and relative-humidity sensors are positioned beneath the dome (sensor 2), in the upper part of the church (sensor 3), in the lower part of the church (sensor 4), and in a separate lateral room near the entrance (sensor 8). The corresponding surface-temperature probes monitor the dome (sensor 1a), the vault (sensor 1b), the entrance masonry (sensor 5a), and the floor (sensor 5b). Four additional surface-temperature sensors are installed on the external walls, one on each orientation: west (sensor 6a), south (sensor 6b), east (sensor 7a), and north (sensor 7b). The outdoor sensor provides the external reference conditions used for comparison.

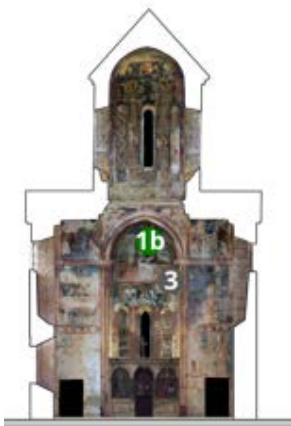
### Vault Surface temperature

Also the sensor T<sub>3</sub> shows some peaks, but these are smaller, regular, wider and seem related to external meteorological factors.

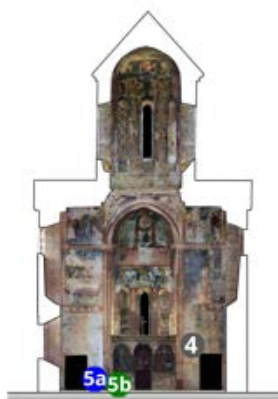
## Entrance and ground floor surface temperature

The sensor  $T_4$  located in the lower church shows a large variability, likely linked to infiltration of external air.
