## ICOMOS Technical Review

<b>Property</b>	<b>Bagrati Cathedral and Gelati Monastery</b>
<b>State Party</b>	<b>Georgia</b>
<b>Property ID</b>	<b>710</b>
<b>Date inscription</b>	<b>1994</b>
<b>Criteria</b>	<b>(iv)</b>
<b>Project</b>	<b>Proposal for reinforcing the base of the drum of the dome of Gelati monastery</b>

ICOMOS received a report on the *Project of the Arrangement of the Metal Belt on the Bottom Point of the Drum at the Church of the Virgin of Gelati Monastery*, submitted to the World Heritage Centre by the State Party on 20 July 2015.

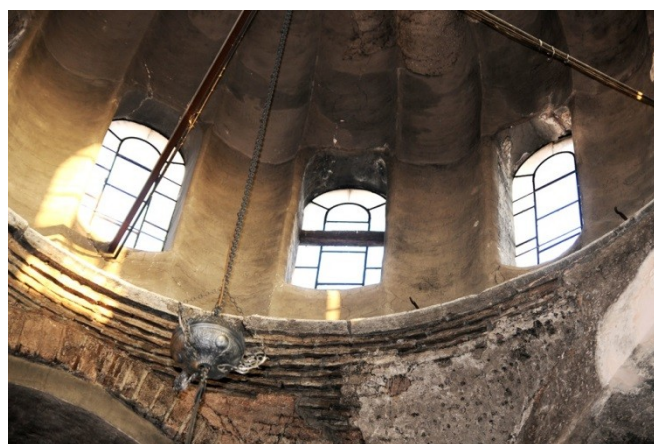
In this regard, and in order to encourage the research on strengthening the stability of the cupola of the monument to this direction, it should be noted that the use of similar wood tie-beams during the construction of the drum window openings is well known in Byzantine architecture (e.g. Mother of God Kosmosoteira Church near Evros River, Greece, built by Isaakios Komnenos, 1152 – Figure 1).

**Figure 1.** Wood tie-beams on the windows of Mother of God Kosmosoteira Church, Greece

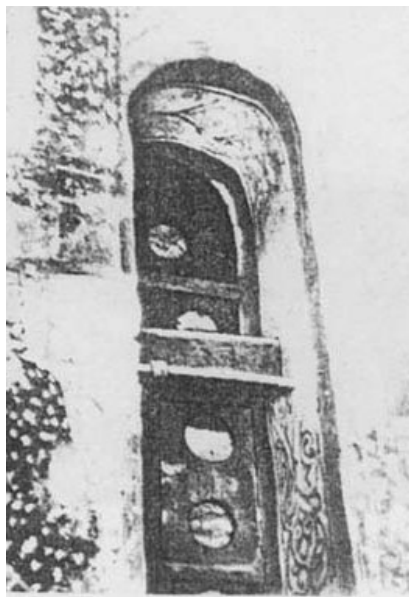
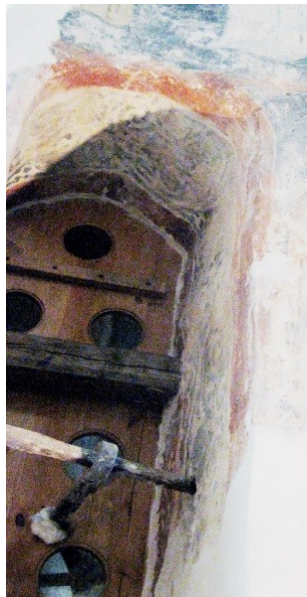
Novgorod, Mother of God *katholikon* (1119) in St. Anthony monastery: window with preserved medieval (and restored) wooden window-sill, Figures 2, 3; Smolensk - Church of Archangel Michael (1180-97), Figure 4).

**Figures 2, 3.** Novgorod - Mother of God *katholikon* in St. Anthony monastery: window with preserved medieval and restored timber window-sill

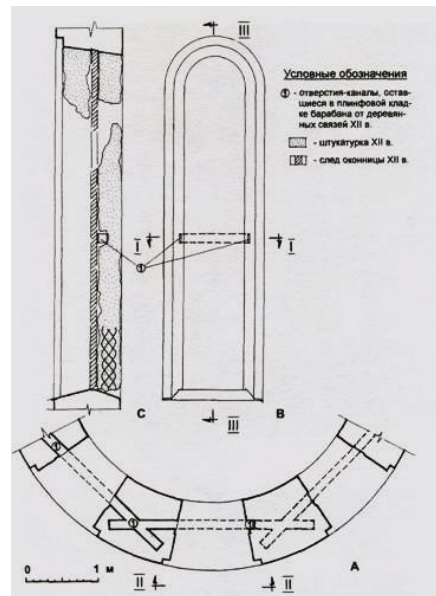
**Figure 4.** Smolensk - Church of Archangel Michael: wood tie-beams for fixing the window sills

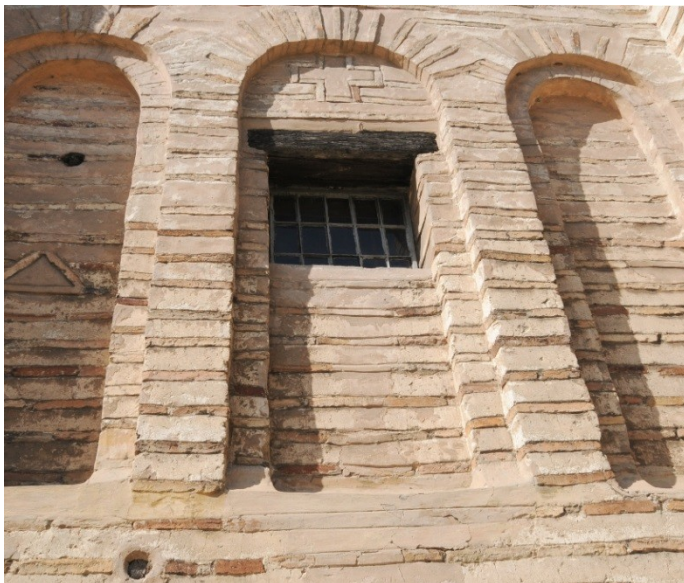
The wood tie-beams were used in some cases, additionally, as lintels on the limitation of window openings, while strengthening the construction with partial walling (e.g. Kiev- Church of the Saviour in Berestovo (1113–1125), Figure 5; Novgorod, Mother of God *katholikon* (1119) in St. Anthony monastery, Figure 6).

**Figure 5.** Kiev - Church of the Saviour in Berestovo: northern wall windows

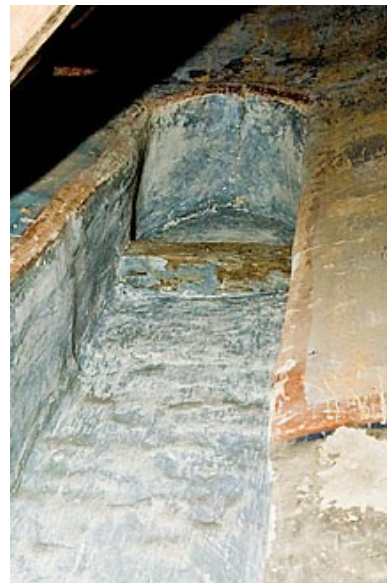
**Figure 6.** Novgorod - Mother of God *katholikon* in St. Anthony monastery: walling of window opening s

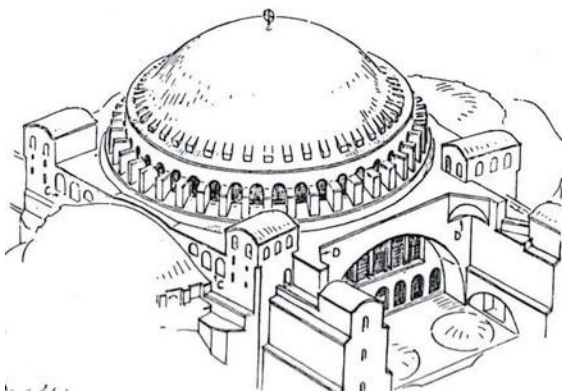
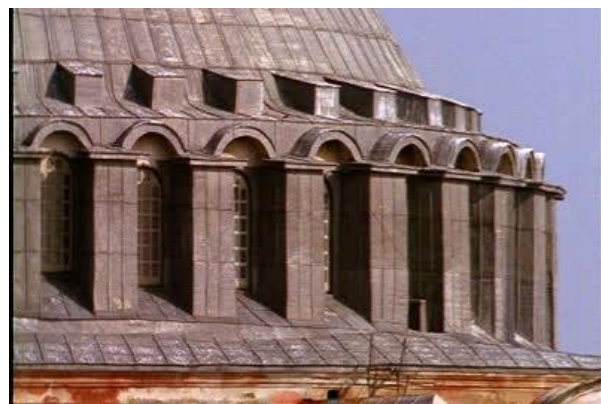
Let us remember (from a historical point of view) the strengthening works which were carried out similarly on the piers of the drum of St. Sophia in Constantinople, after the collapse of the original dome and during its reconstruction with a more normal hemispherical shape with a 6 m. raising up (559 AD - Figures 9, 10).

**Figures 9, 10.** St Sophia in Constantinople – reinforcement of the piers between the windows, after the collapse of the original dome in 559

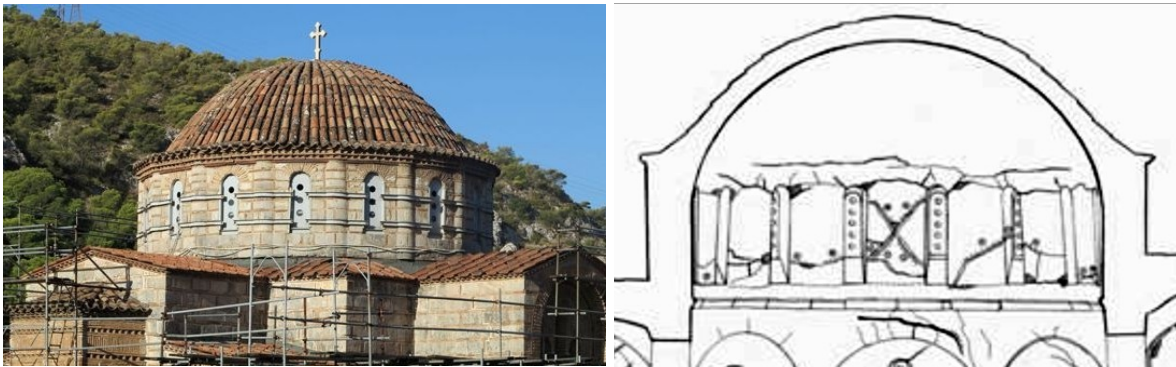
The Daphni Monastery (with its famous mosaics, inscribed on the World Heritage List in 1990) is situated on a Neocene tectonic graben, on the western side of the Athens basin. The church was built in 11th century AD. Large-scale damages were reported in the 13<sup>th</sup> and 14<sup>th</sup> centuries. In 1889 and 1897, after the damage caused by earthquakes (estimated magnitudes of 6,7 and 7,0 on the Richter scale), restoration was carried out on the church. The heavily damaged dome and its drum were removed and reconstructed. Three concentric iron rings (I – beams) were inserted at the base of the dome's drum. The mosaics were cleaned and consolidated. These interventions helped the monument to survive until the end of the 20<sup>th</sup> century. Unfortunately, extensive damage occurred during the latest Athens earthquake (September 7th, 1999 – 5,9 g) especially to the drum and particularly to the masonry piers of the drum (which are lower and wider than those in the Gelati monastery *katholikon*). As emergency interventions, specially-designed steel elements were constructed to brace the windows and confine the masonry piers on two levels, with special care taken to assure the in situ assemblage of all these structures without harming the mural mosaics (Figures 11, 12, 13).

**Figure 11.** Daphni monastery, Greece: Specially designed steel elements to brace the windows and confine the heavily damaged masonry piers

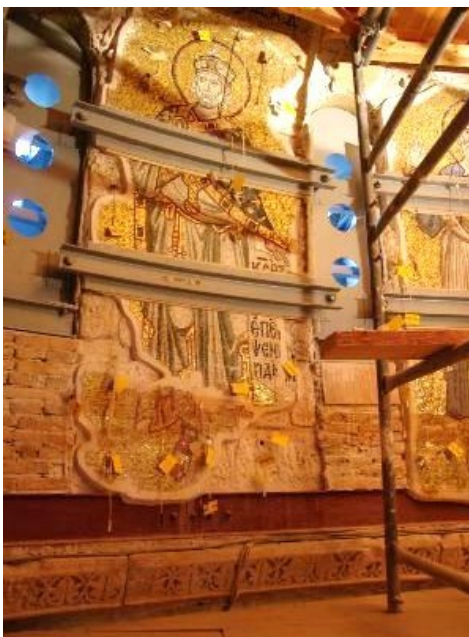
**Figure 12.** Steel elements to confine on two levels the masonry piers. Note the old I – beam on the lower part.

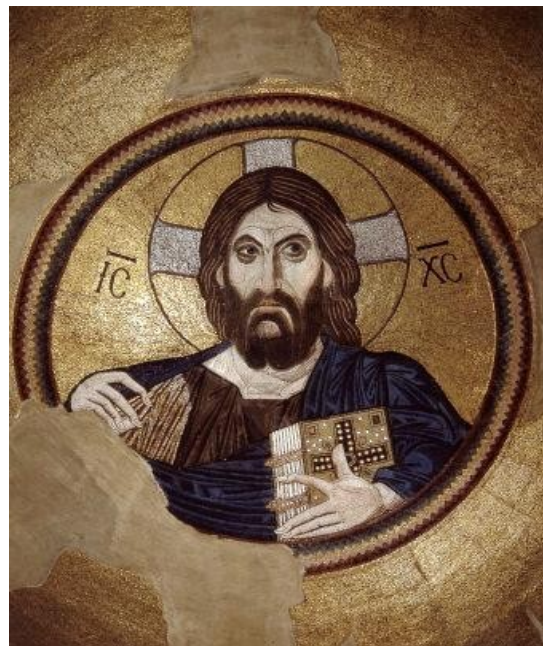
**Figure 13.** The famous Pantocrator on the cupola's Daphni monastery *katholikon*
