Ref.: CLT/WHC/EUR/20/12998

**საგანი: მსოფლიო მემკვიდრეობის ძეგლის - "გელათის მონასტრის"
საკონსერვაციო მდგომარეობა**

On 8 September 2020, the World Heritage Centre transmitted to ICOMOS information submitted by the State Party on the state of conservation of the Church of the Virgin in Gelati Monastery World Heritage property, comprising a letter with two annexes: an information report on the state of conservation of the Church of the Virgin, and the implemented project documentation for the temporary scaffolding and roofing of the Church of the Virgin.

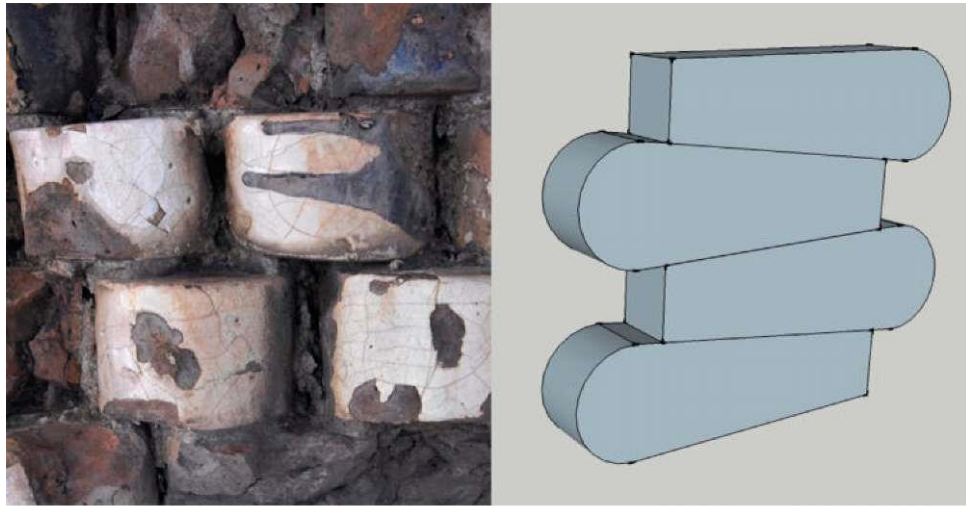
კალციტის მაღალი შემცველობა მაღალი ტემპურატურის ფაზებთან ერთად შეიძლება მიანიშნებდეს არათანაბარ გამოწვაზე, რომელიც გამოწვეულია ჰაერის დაბალი ცირკულაციით, ან აგურის დაგროვებით (Fig. 5B), ან მათი განსხვავებული პოზიციით ღუმელში ცეცხლის მიმართ.

სურ. 5. (A) შავი მინანქრის შავი წვეთები თეთრ მოჭიქულ აგურზე. (B) ღუმელში დაწყობილი აგურის რეკონსტრუქცია გამოწვევის დროს..

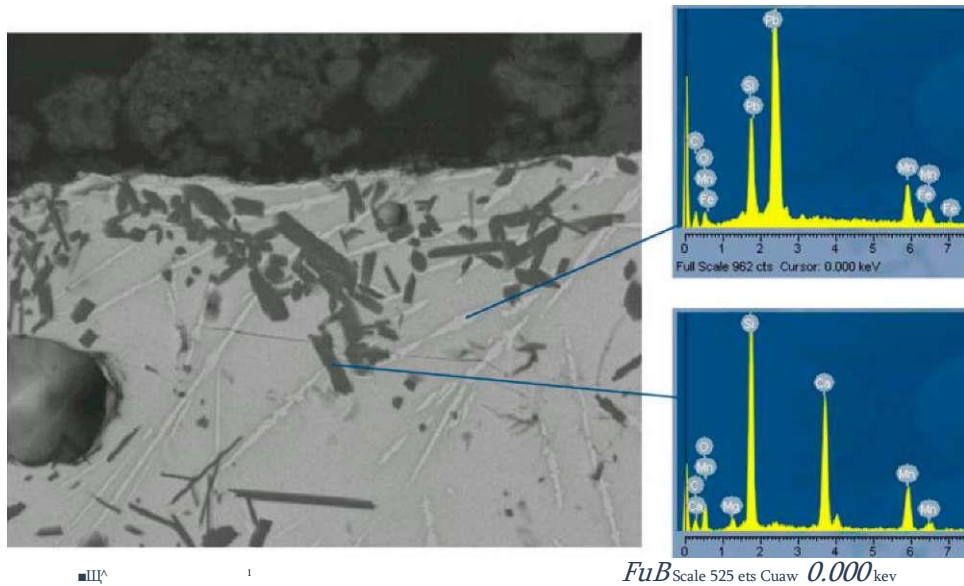
სურ. 6. ნიმუში CD_2. მთელ შავ მინაქარზე ჩანს თხელი კრისტალური მესერი, რომლებიც წარმოიქმნა გამოწვის დროს; შავი მარცვლები შედგება Si, Ca და Mn (ED სპექტრი). ამრიგად, შავი პიგმენტი მიეწერება MnO-FeO ნაერთს.

შავ ჭიქურებში ტყვიის მაღალი შემცველობაა. ანალიზების ნიმუშებს აქვთ განსხვავებული შემადგენლობა (ცხრილი 2): CD_2 აქვს რკინის და ტუტე კომპონენტების მაღალი შემცველობა (FeO 2.8 წონ%), რომლებიც არ არის CD_1-ში. მანგანუმის შემცველობა (MnO დაახლ. 4.0 წონ.%) ერთნაირია ორივე ნიმუშში რაც ჭიქურს მოყავისფრო შავ ფერს ანიჭებს.^{34,35} SEM-EDS ანალიზმა დაადგინა, ძალიან თხელი კრისტალური მესერები არსებობს (განსაკუთრებით გარე კიდეებთან), რომლებიც შეიცავენ გამოწვის შედეგად ფორმირებულ ტყვიას, Mn, Fe, და Si, და შავ მარცვლებს შედგენილ Si, Ca და Mn-ისგან (Fig. 6). მიკროანალიზმა და მიკროსკოპულმა გამოკვლევამ აჩვენა, რომ შავ ჭიქურებში არ იყო გამამუქებელი.

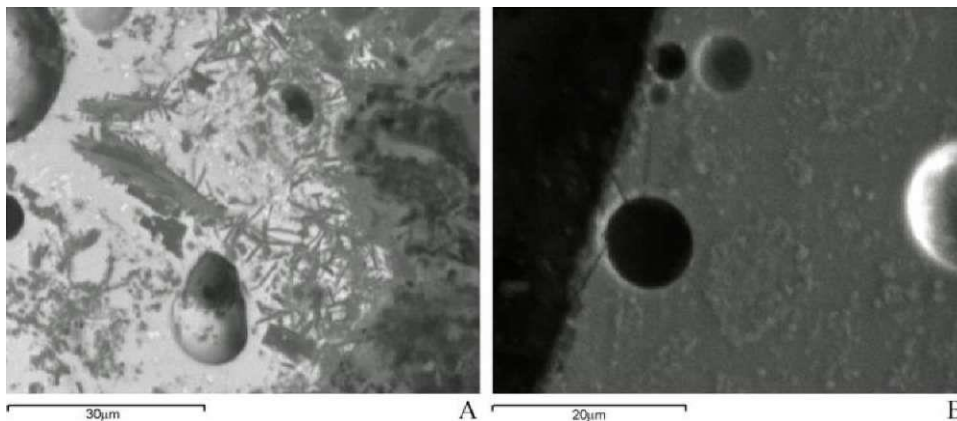
სურ. 7. ნიმუში CD_6. (A) Interface: თიხის სხეულის ილიტის მარცვლებში ჩანს ტყვია-კალიუმის მინდვრის შპატების კრისტალიტების ზრდა. მინანქრის შიგნით შეიმჩნევა კალას ოქსიდის მკვეთრი ჩანარები. (B) კალას ოქსიდის კრისტალების ჰეტეროგენული განაწილება მინანქარში.

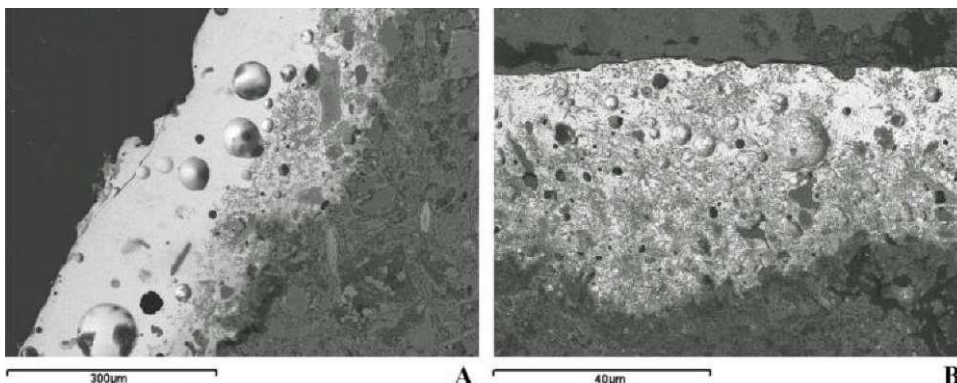
სურ. 8. მინანქრის და ინტერფეისის შრის სისქე. (A) ნიმუში CD _6, რეაქციაში შეუსვლელი კვარცის კრისტალები და კალიუმის-ტყვიის-ალუმინის სილიკატების წაგრძელებული კრისტალები ჩანს ინტერფეისზე. (B) ნიმუში CD_2, გაფართოებული ინტერფეისი ნახშირის ნაწილაკებით, მანგანუმის დიოქსიდით და Fe-ოქსიდის კვალით.

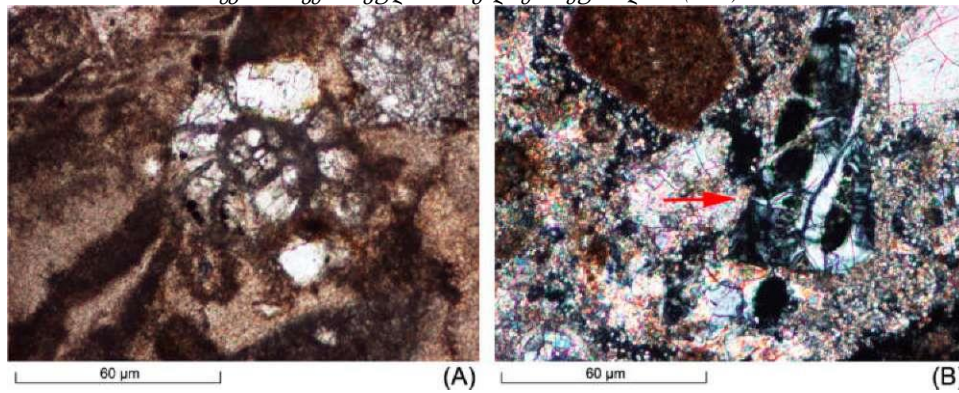
სურ. 10. (A) ნიმუში CD_13. მიკროფოსილები (*პლიოცენის გასტროპოდა*) (ოპტიკური მიკროსკოპი, 10x, გატარებული სინათლე, პარალელური პოლარიზატორები). (B) ნიმუში CD_9. ოფიოლიტის მარცვლი XVI ს. ბოლო, ხსნარში ნაპოვნი (ოპტიკური მიკროსკოპი, 10x, გატარებული სინათლე, ჯვარედინი პოლარიზატორები).

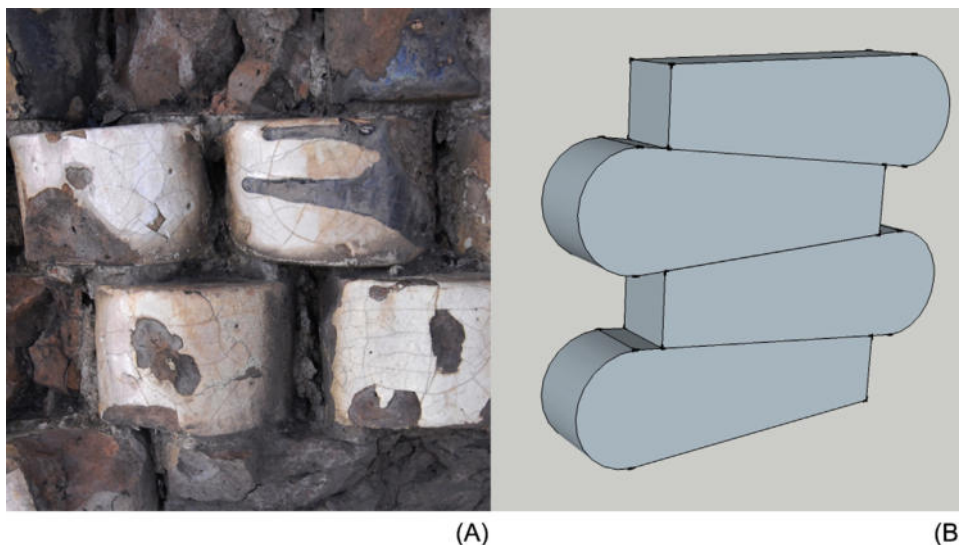
Fig. 5. (A) Black drops of black glaze over some white glazed bricks. (B) Reconstruction of the stacked bricks in the kiln during firing.

The analysis of the characteristic shape of the bricks and the discovery of horizontal glaze casting over some bricks (Fig. 5A), helped to define the production and firing processes: the bricks, still uncooked, were immersed manually in the glaze, stacked as shown in Fig. 6B and fired in the kiln.

Furthermore, the presence of horizontal sagging (Fig. 5A) indicate that the white and black bricks were fired together, stacked on each other.

The presence of diopside, anorthite and gehlenite of neo-formation is indicative of a firing temperature of about 900–950 °C. The high content of calcite in the samples CD_1, CD_2 and CD_14, together with high temperature phases, may be indicative of an uneven firing, caused by a low circulation of the air, a stacking of bricks (Fig. 5B) or a different position in the kiln with respect to the fire.

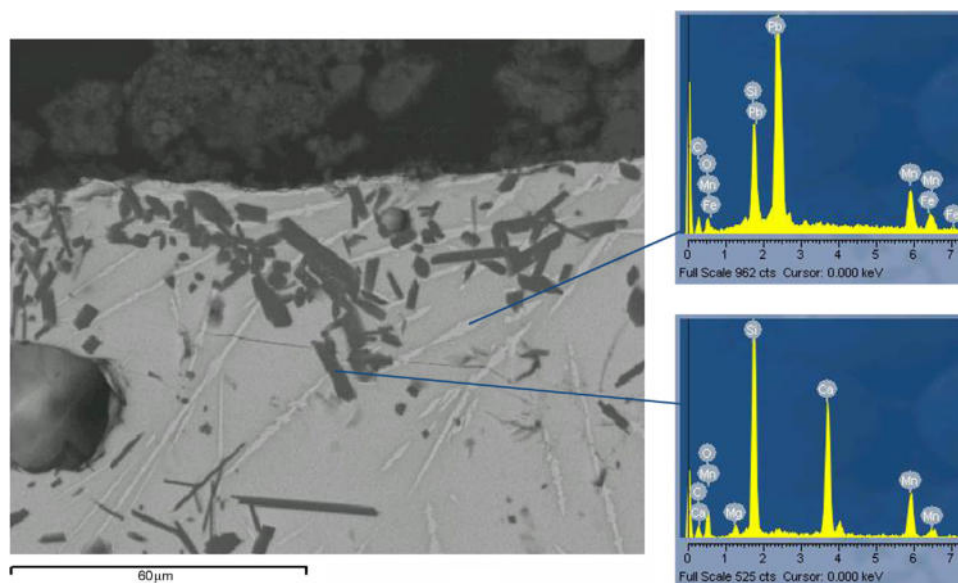
Fig. 6. Sample CD_2. Throughout the black glaze are present thin skeletal crystals formed during the firing; the blacks grains are constituted by Si, Ca and Mn (ED spectrum). Thus, the black pigment is attributable to a MnO–FeO compound.

Black glazes have an high lead content. From the analyses, the samples have different composition (Table 2): CD_2 has an high content of iron (FeO 2.8 wt%) and alkaline components, instead absent in CD_1. Manganese content (MnO about 4.0 wt%) is similar in the two samples and gives the black color, tinged with brown, to the glaze.^{34,35} SEM-EDS analysis evidenced the presence, especially near the external edge, of very thin skeletal crystals containing lead, Mn, Fe, and Si, formed during the firing and black grains constituted by Si, Ca and Mn (Fig. 6). Microanalysis and microscopic examination indicated that an opacifier was not present in black glazes.

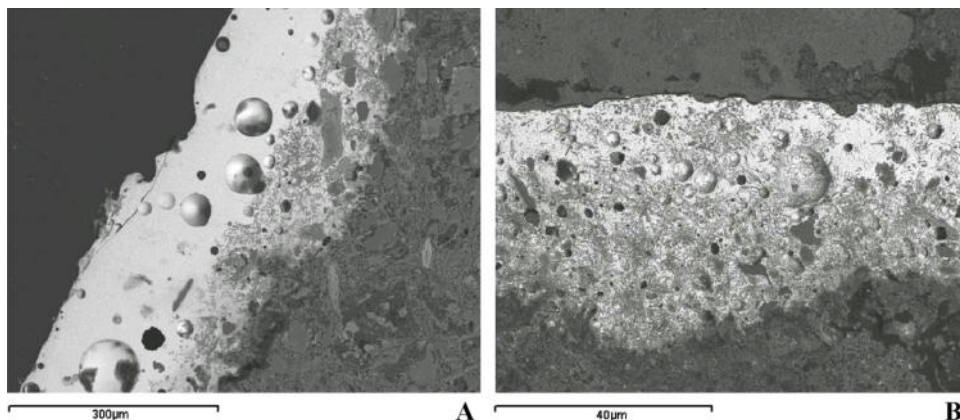
Fig. 8. The thickness of glaze and interface layer. (A) Sample CD_6, unreacted quartz crystals and elongated potassium–lead–aluminum–silicate crystals are present at the interface. (B) Sample CD_2, extended interface with coal particles, manganese dioxide and trace of Fe-oxide.

The noticeable amount of bubbles in the glaze, produced by release of carbon dioxide generated by decomposition of carbonate of the clay, and the large amount of crystals developed at the interface indicate a single firing process (Fig. 8).
