**Safeguarding and conservation of Gelati Monastery
World Heritage Property, Georgia**

Church of the Virgin

**Investigations on the structural hygrometric and micro-environmental
state aimed at safeguarding the internal wall paintings**

Mission Arch. Alessandro Massari of: 06 – 12 November 2021

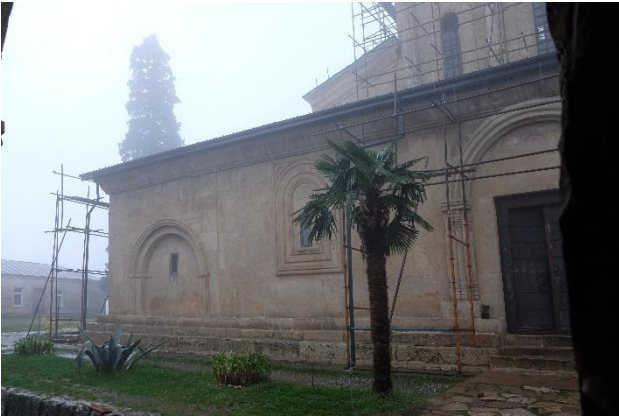
Along the front there are three downspouts (**d1**, **d2**, **d3**, in **Sheet 1**), plus a fourth (**d17**) at the north-west corner of the building, for the disposal of water coming from the current roofs (mostly temporary). The downpipes **d1**, **d2** and **d3**, are free draining on the ground, while **d17** seems to be connected to a sewage system with an unknown outlet (presumably towards the west elevation drop); all are provisional and made of sheet metal (*figures 4 and 5*).

*Figure 4: view of downpipes **d17** and **d1** in operation during the thunderstorm*

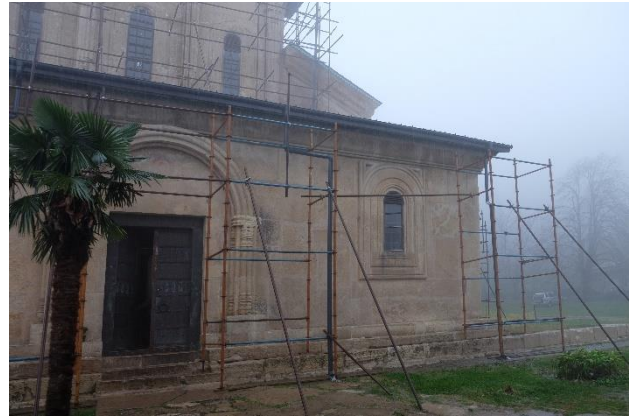
*Figure 5: view of downpipes **d2** and **d3** in operation during the thunderstorm*

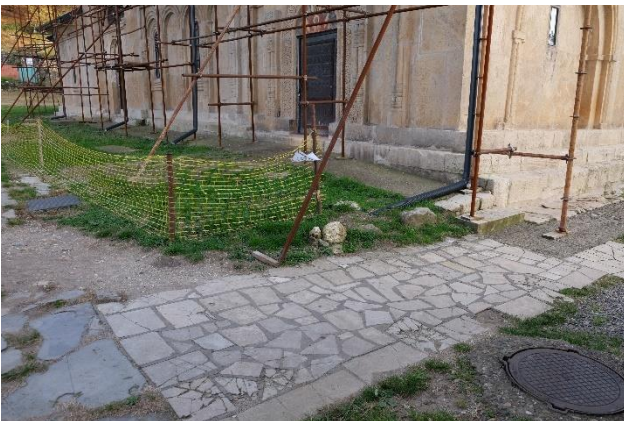
Finally, as mentioned above, the drainpipe **d17**, at the corner with the west façade, appears to be connected to the drainage system without a connecting pit (*figures 7 and 8*).

Figure 7: view of downpipes **d17**, **d16**, **d15** and **d14**

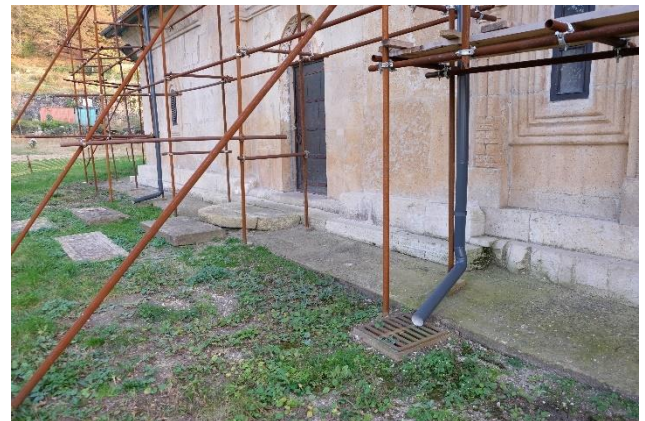
Along the front there are three provisional drainpipes (**d14**, **d15**, **d16**), made of 100 mm diameter sheet metal, for the disposal of rainwater from the actual temporary roofing. The three downspouts discharge water into 3 manholes (**sm-8**, **sm-9** and **sm-10**) with 50 x 50 cm grates, located immediately beyond the modern sidewalk. These manholes, below the grids, are made of vertically placed double cored PEAD pipes sections (300 mm diameter), whereas corrugated drainpipes (approx. 100 mm diameter) connected to them have an unknown destination.

Figure 8: detail view of downpipe **d15** with manhole **sm-9**

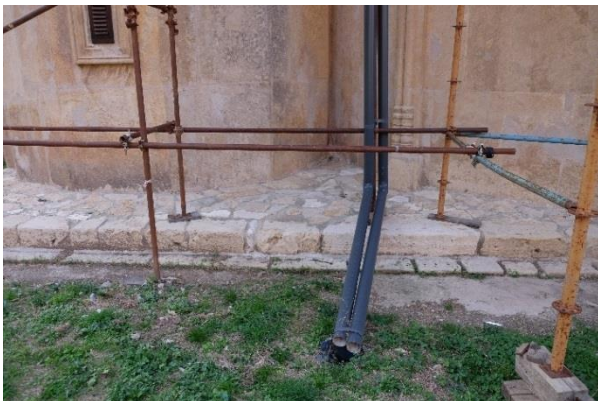
overall slope runs, as aforementioned, from east to west, therefore, tends to convey surface water against the building. There are six (**d7, d8, d9, d10, d11** and **d12**) provisional drainpipes made of 100 mm diameter sheet metal carrying water from the roofs of the central body of the church. Two more downspouts (**d6** and **d13**) channel water from the outer chapels' coverings. The downspouts, which have reached the ground, discharge into five manholes (**sm-3, sm-4, sm-5, sm-6** and **sm-7**), which have no gratings and are presumably connected to drainage networks with uncertain routes (*Figures 10 and 11*).

*Figure 10: detail view of downpipes **d8** and **d9** with the manhole **sm-4***

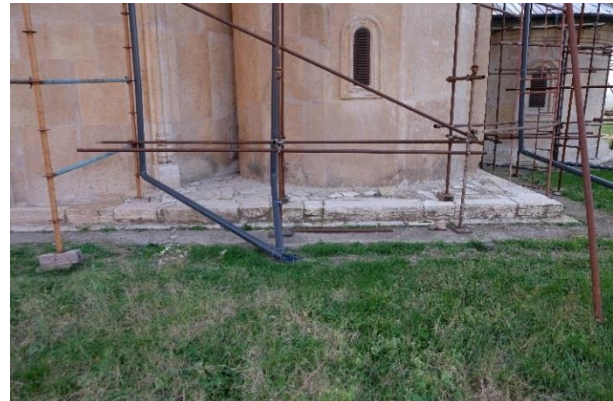
*Figure 11: detail view of downpipes **d10** and **d11** with the manhole **sm-5***

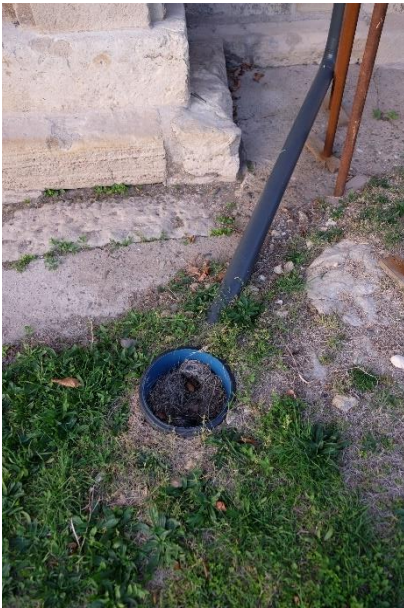
Figure 13: detail view of downpipe **d5** with the manhole **sm-5**

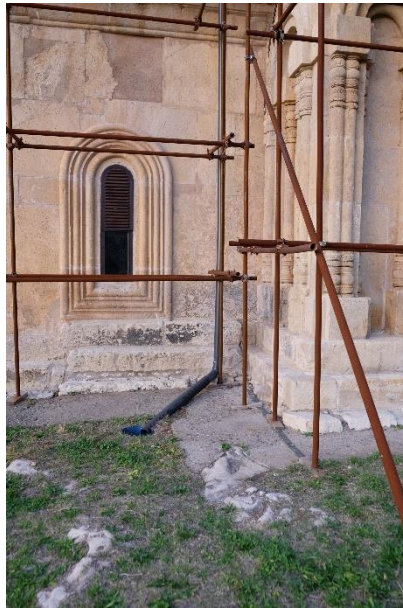
Figure 14: view of downpipe **d4** with the manhole **sm-1**

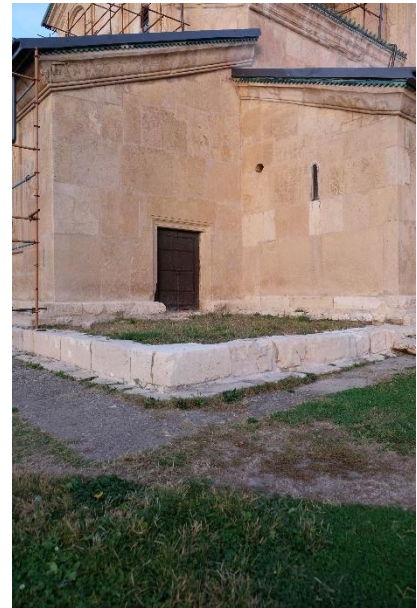
The overall slope of the land runs from east to west. At the base of the building there is a stone stepped plinth composed of two risers and two treads. Next to the plinth, exteriorly, is the modern conglomerate pavement (approx. 1.0 m wide) which, however, tends to disappear below the ground. Along this southern front of the building, there are two temporary downspouts (**d4** and **d5**, 100 mm diameter) which discharge into two circular manholes (**sm-1** and **sm-2**, 300 mm diameter) without gratings, located immediately beyond the low pavement (*figures 13 and 14*). Further away from the building there is another manhole with metal grating (600 x 400 mm) which indicates the presence of a drainage channel coming from the east (the alleged drainage pipe should be the same as the one visible along the north side of the Saint George Church indeed). At the south-west corner of the church there is a sort of foundation (perhaps a preparation for an unbuilt extension) consisting of low stone perimeter walls and an earth filling in direct contact with

the footing of the church (figure 15).

Figure 15: view of the south-west corner of the church

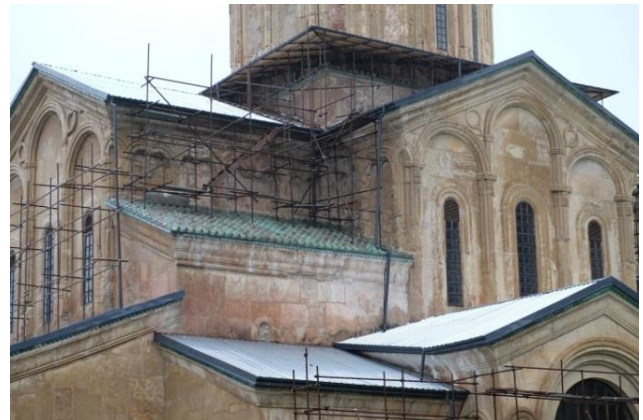
Figure 17: roof of the southern aisle, without temporary covers

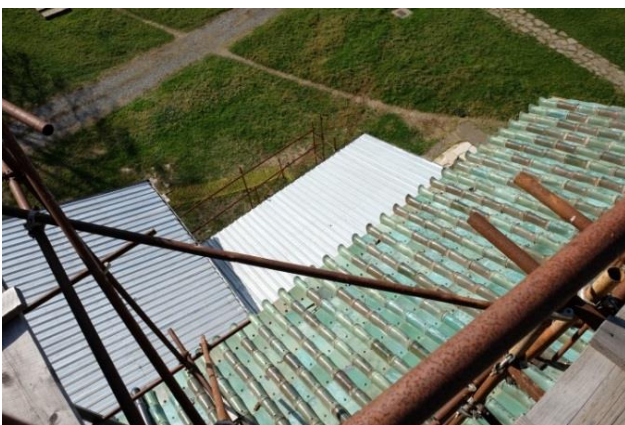
Figure 18: roof of the southern aisle, without temporary covers

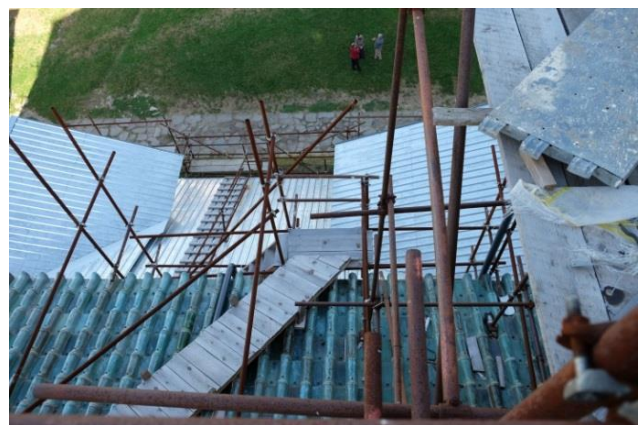
Figure 19: roof of the northern aisle, without temporary covers

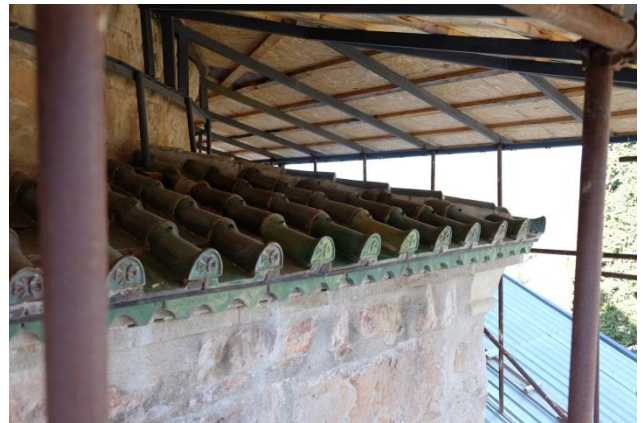
- At survey, all the temporary coverings, except for those over the "spandrels" of the drum, were built immediately above the tiled roof coverings, hence without a significant passage of air between the tiles and the overlying metal sheet (*figures 20, 21, 22 and 23*). This may result in a delay of the drying process, through evaporation, of any water that could have entered below the roof covering as a result of past infiltrations. Similarly, it could also lead to condensation on the underside of the temporary corrugated sheet coverings themselves. Ultimately, it is important to highlight that the very presence of glazed tiles (thus, not very permeable) constitutes an obstacle to the drying process of the underlying structures and can cause interstitial condensation phenomena when particularly high levels of humidity in the substrate material may occur.

Figure 21: structure of temporary roofing shelter, elevated on roofing tiles layer

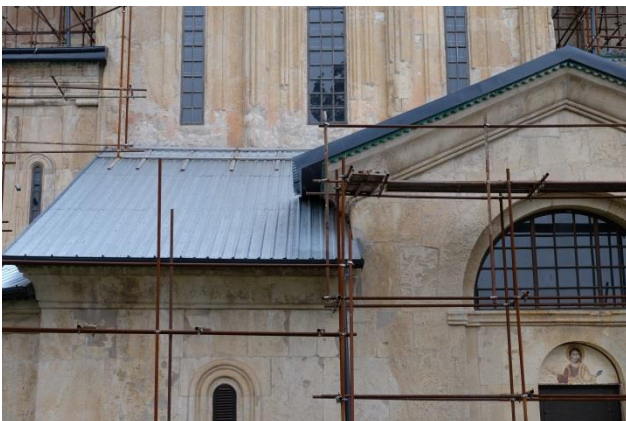
Figure 22: temporary roofing leaning against roofing tiles layer

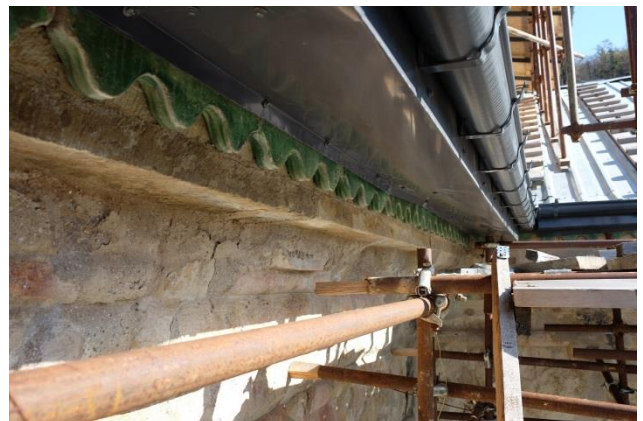
Figure 23: detail view of cornice and the eaves of a temporary roofing leaning against roofing tiles layer

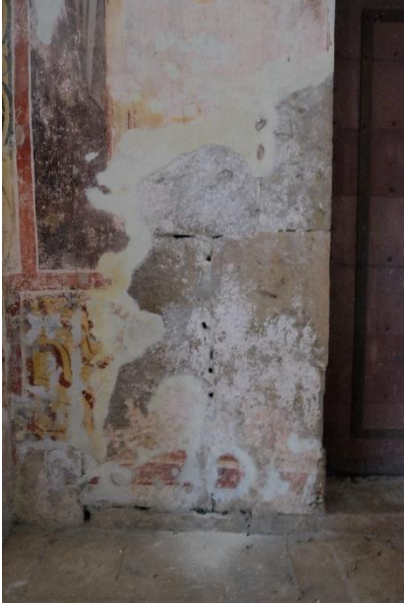
Figure 35: Point A, environment 2, on the side of the north entrance

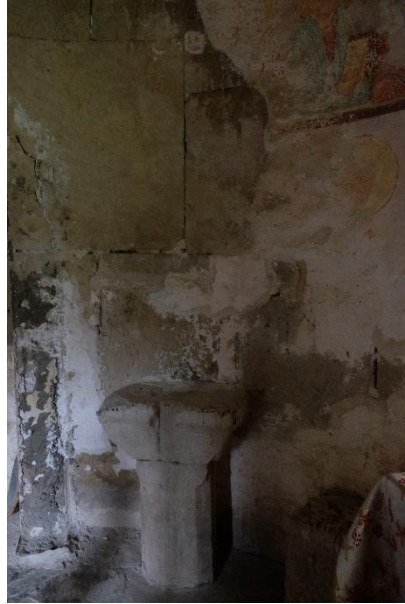
Figure 36: Point B, environment 6, north side of the apsidal hemicycle; point B', efflorescence

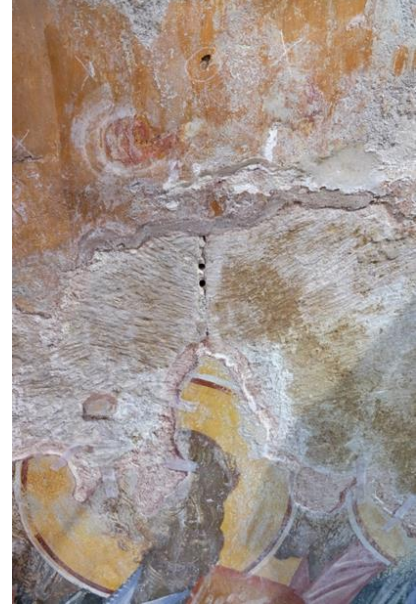
Figure 37: Point C, west wing vault, south side

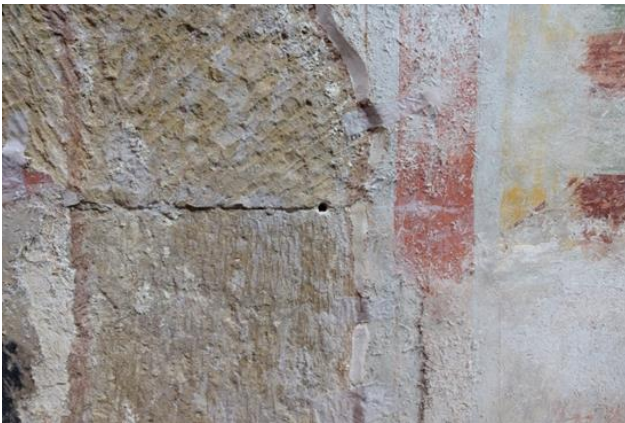
Figure 38: Point D, west wing vault, south side

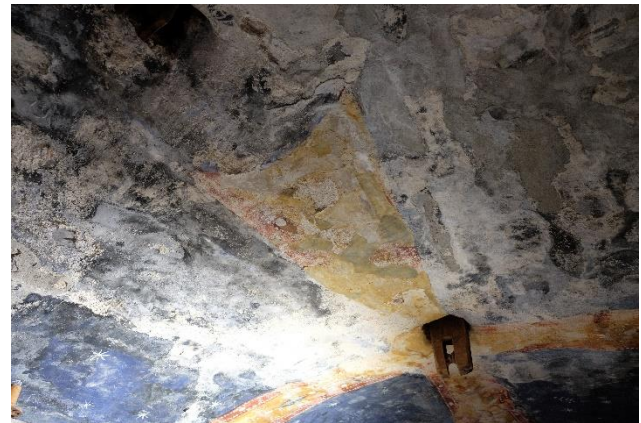
Figure 39: Points E and E', west wing vault, north side (efflorescence)
