**Safeguarding and conservation of Gelati Monastery
World Heritage Property, Georgia**

***Agreement between LEPL "National Agency for Cultural Heritage Preservation of Georgia"
and "ReStruere ltd, Florence University spin-off"***

Deliverable 2

**Findings of the analysis: keynotes based on the results of the studies
conducted by RS and GET**

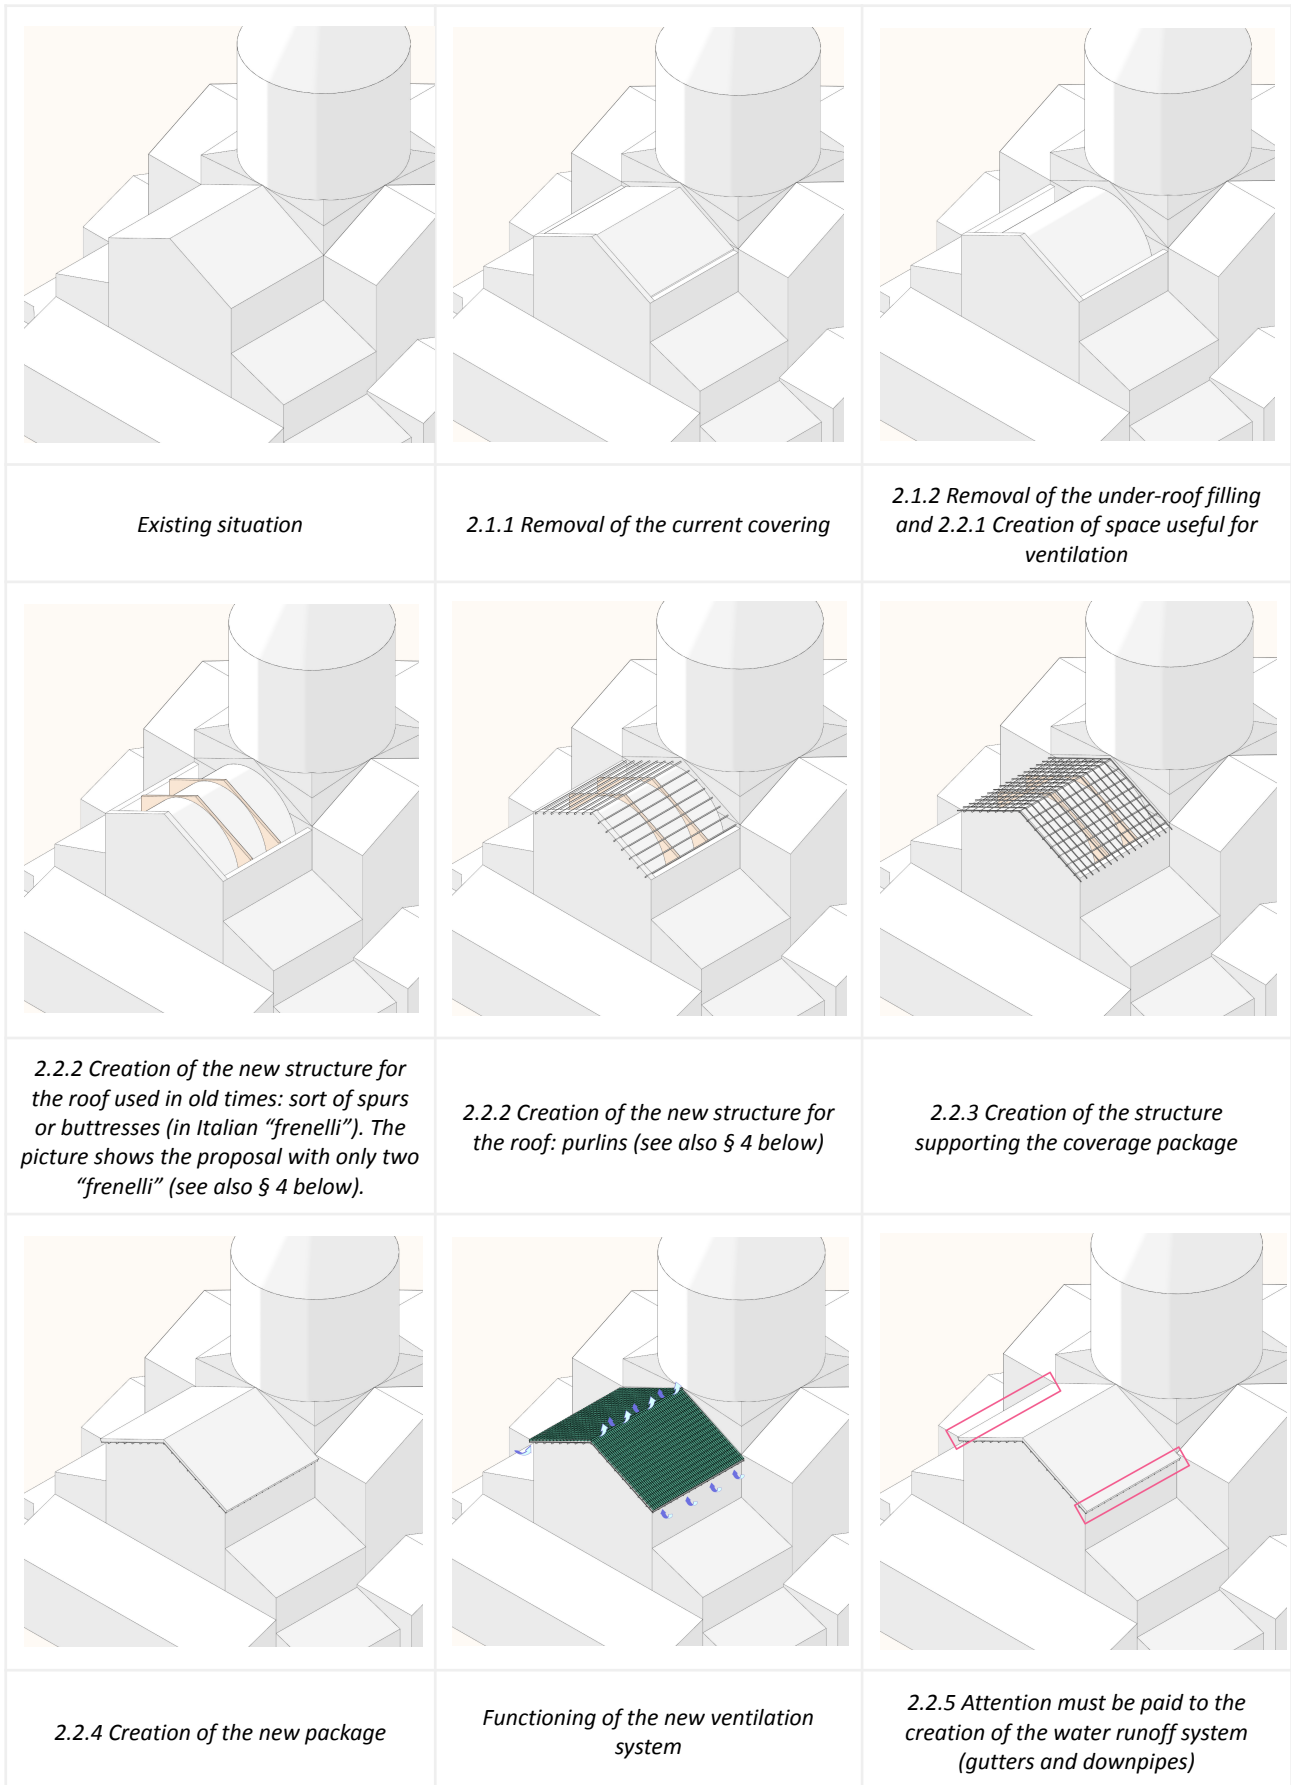
Figure 12 - Scheme of the steps to be followed in the renovation of the roof. The scheme is purely indicative and only shows the West Arm as we currently have the documentation relating to this Arm. We have to expect different situations in the pitches, preparing ourselves to carry out targeted interventions.

Once the main crisis factors have been identified (see § 1.1), it is possible to identify the principles to be followed in the radical renovation of the roof. In particular, we are interested in the activities and solutions that derive from these principles; since we need to identify the design steps needed to secure the Monastery (see Figure 12).

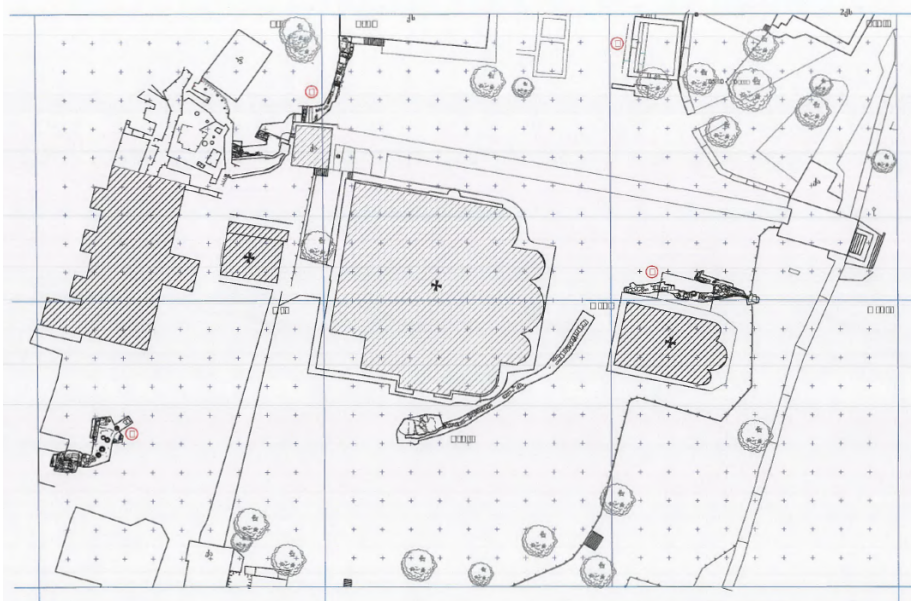
Figure 15 - Plan of the archaeological finds of the ancient water drainage system. From Photo Report on *Drainage Collector restoration-rehabilitation (2018-2019)* (DCR Ph Report) shared by GET

Actually, during archaeological excavations, ancient drainage channels have been found around the Churches of the Monastery (Figure 15). The ancient channels do not cover the entire site but are limited to portions of it. In particular, the ancient system consists only of portions located on the Northern side of S. George Church (Figure 16) and on the South-East of the Virgin Church (Figure 18). The ancient water drainage system is out of order for a long time and, moreover, it is not visible as it is covered by the ground (with the exception of a few stones on the north side of St. George, Figure 17). Its conformation and its state do not suggest the possibility of its rehabilitation.

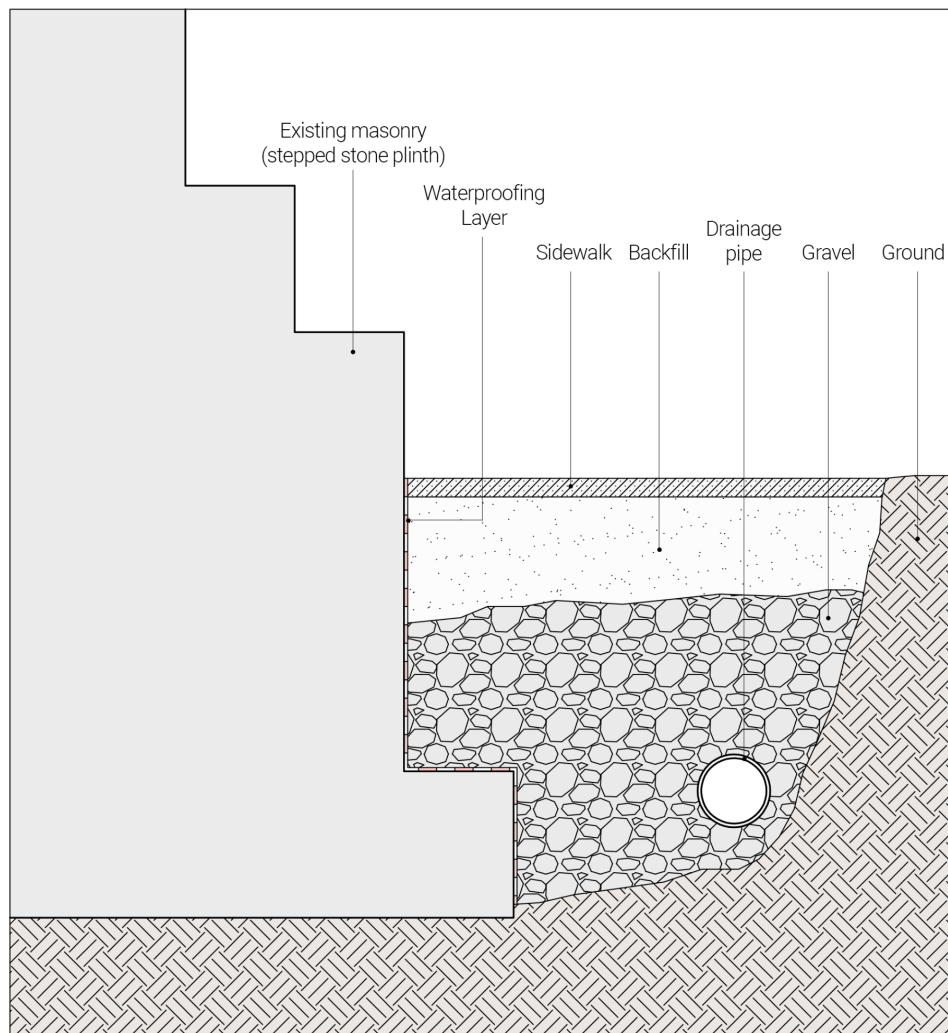
Figure 24 - Scheme of the drainage ditch.

It is important to note that the drawing shows a hypothesis of the Church's foundations. Investigations are needed to identify with certainty the characteristics of the foundation system (construction techniques, type of materials, depth...).

Based on the information collected so far, it is crucial to ensure that the water can flow away from the Churches to preserve the masonries. Works for the protection of the foundation walls are desirable and necessary but, to be sure about the feasibility of a foundation drainage system (such as drainage ditches, Figure 24), it is necessary to better understand the relationship between the Churches with the ground. To achieve this, we advocate the assessment actions proposed by MCT (MCT report), which are:

- to carry out a dimensioned survey of the floors (ground) outside the Churches to check the slopes of the land and identify the current surface water runoff lines;
- to undertake some ground borings to study the foundations (construction techniques, type of materials, depth) and to assess the presumable existence of a superficial rock bank and its planimetric layout. This survey should be performed along the North, East and South fronts;
- specify the water runoff system for the permanent roofs.

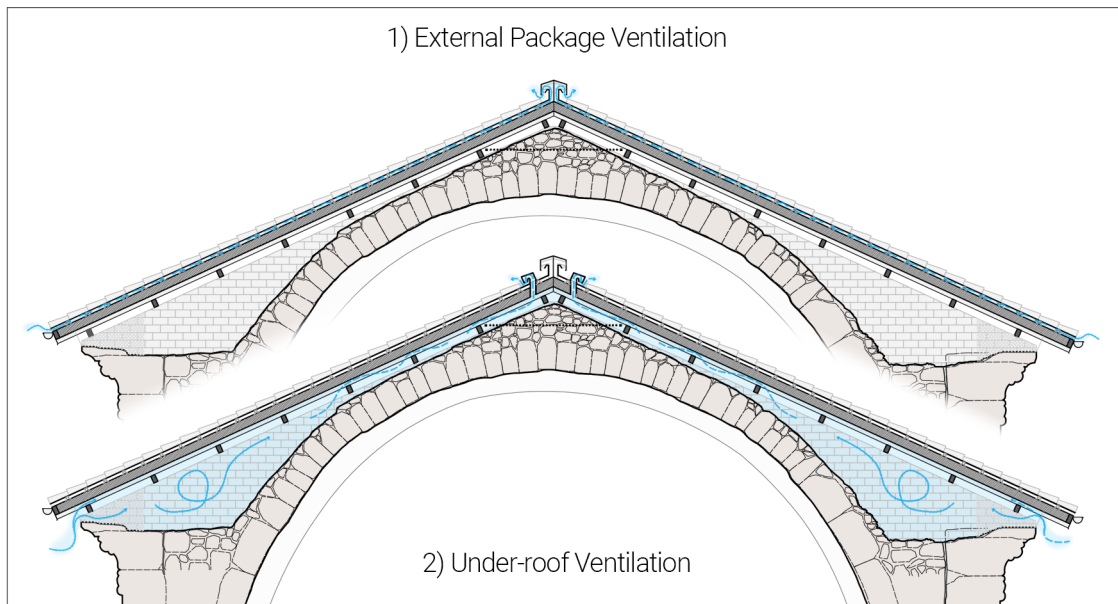
Figure 25 - Scheme of the double ventilation system. The external package ventilation system has to be plentiful, so the airflow outlet will be continuous along all, or almost all, of the ridge line. The under-roof ventilation system can be more moderate, so the airflow inlets and outlets will be punctual. In particular, the number of inlets and outlets requires careful technical evaluations in order to be defined.

The need to guarantee correct and efficient ventilation affects the entire coverage organisation. The ventilation is indispensable to prevent any other moisture problems in the future. A deep discussion with MCT put in evidence that to obtain an optimal roof ventilation system, it is advisable to create two separate circuits for the airflow (Figure 25):

- 1) External Package Ventilation (under-mantle ventilation). The first circuit will allow ventilating of the external package that will make up the roof pitch layers, in order to prevent the roof covering from overheating too much during the summer and from a great cooling down in winter. This ventilation has to be plentiful.
- 2) Under-roof Ventilation. The second circuit will allow ventilating of the under-roof and the extrados of the vaulted system (below which are the frescoes and paintings). This ventilation aims to prevent condensation phenomena and can be more moderate.

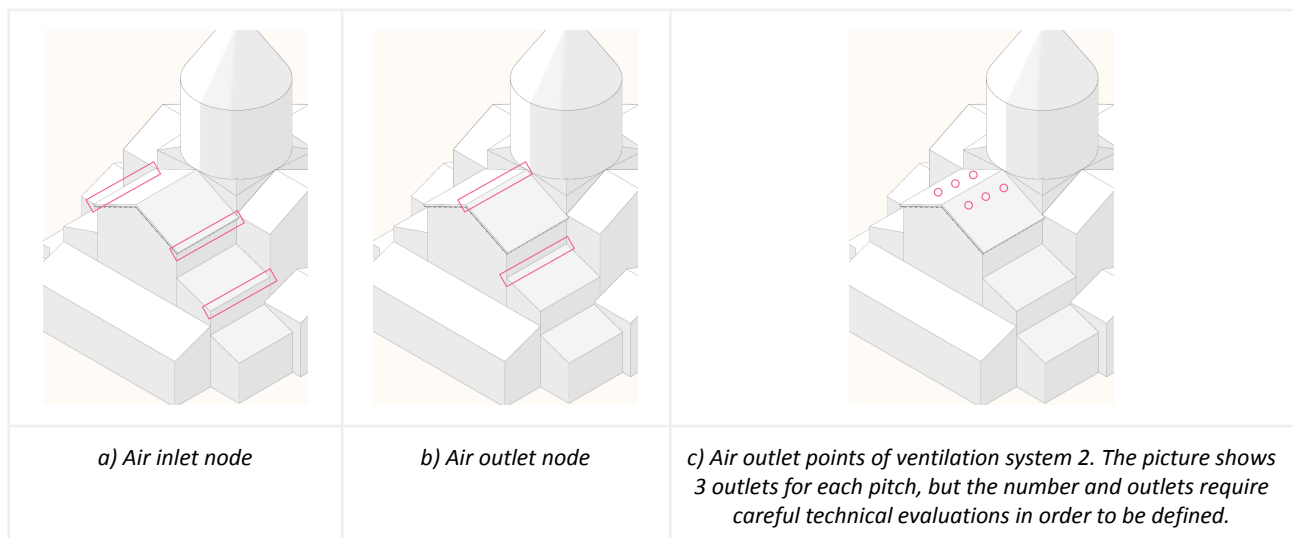
Figure 26 - Position of the ventilation tricky nodes on which to pay attention. Every detail requires in-depth study.

- Air inlet node, at the level of the gutters (Figure 26a);
- Air outlet node, at the ridge for the main arm's pitches and at the intersection with the vertical masonry for the minor arm's pitches (Figure 26b);
- Air outlet node of ventilation system 2, which, having to intersect system 1, must remain separate (Figure 26c).

- An indicative proposal for the position and the shape of the air outlet for ventilation 2 is shown in Figure 26. This element must be carefully designed as it is a tricky node. Moreover, the ventilation 2 outlets could be integrated into the ridge (taking care not to make the two airflows intersect each other) if it is estimated that not the entire length of the ridge line has to be used for the outlet of the ventilation 1 airflow. Any technical possibility in this regard must be investigated in the light of considerations regarding the quantity of air that must flow to ensure proper ventilation.

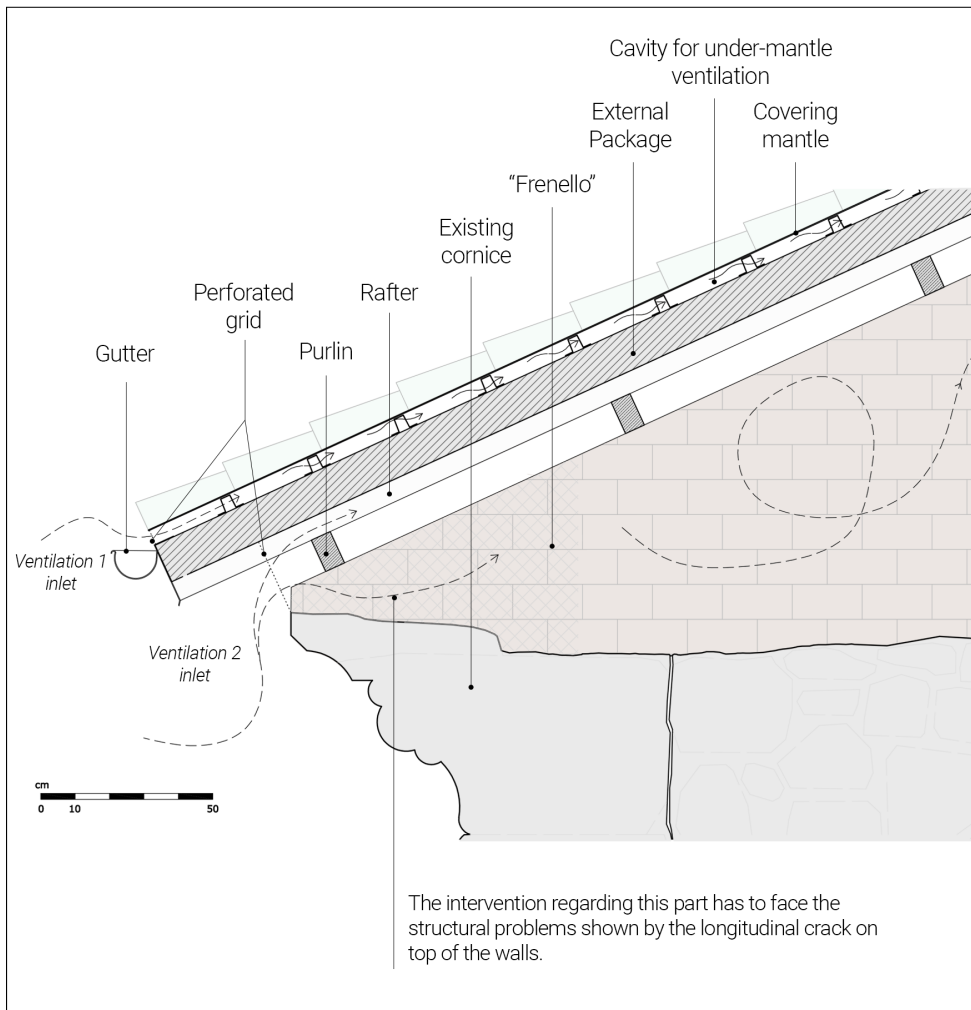
Figure 27 - Detail of the air inlet node.

wall (see Figure 27) must be specifically designed taking into account the need to avoid thrusts on the cornices but also the crucial structural problems highlighted by the discovery of large longitudinal cracks onto the perimetral wall. Such problems have to be addressed altogether within an anti-seismic consolidation design that requires in-depth dedicated studies (which we will work on afterwards).

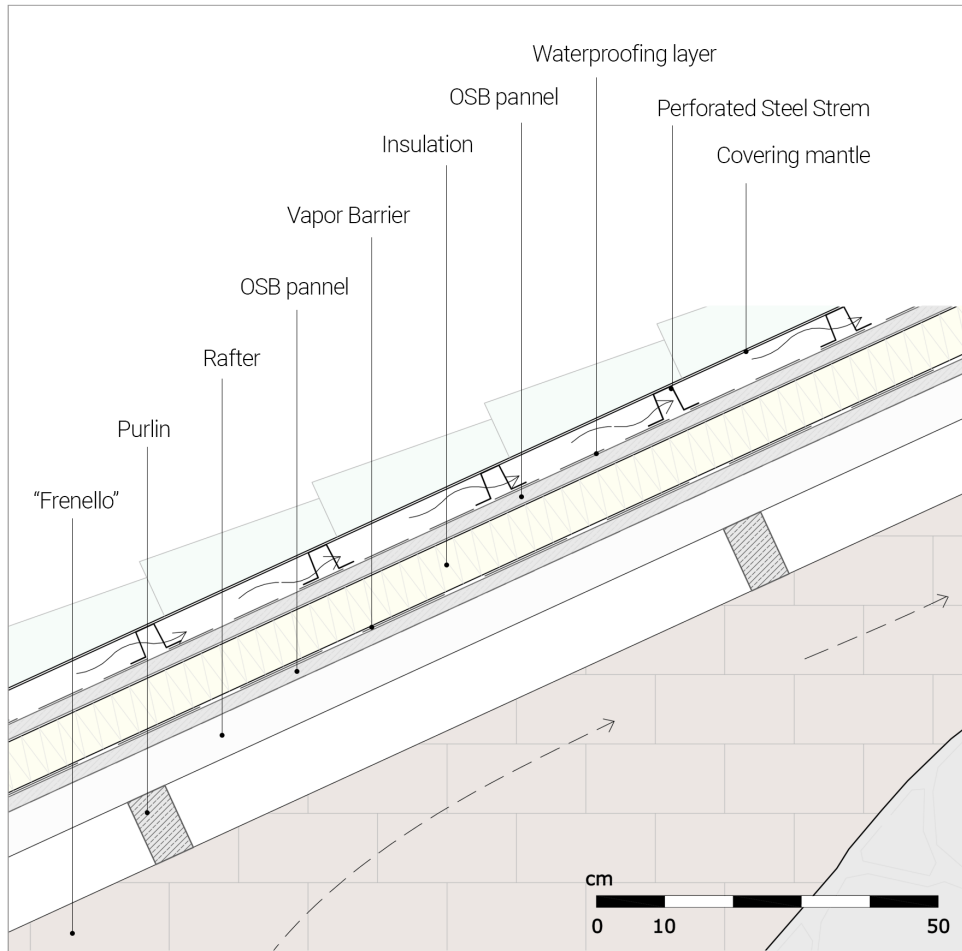
Figure 30 - Detail of the layers of the new external package. The drawing aims to make understandable the different layers needed within the package. The materials and thicknesses of each layer are the subjects of discussion.

The organisation of the outer part of the new covering system depends on the need to create a simple compact coat. The new package has to be comprehensive of (Figure 30):

The covering mantle can be made of tiles or "tiles-shaped" copper. In the second case, it is suggested to use green pre-oxidized copper. This choice has to be weighed in the light of the reflections on the historical-aesthetic and identity compatibility of the Monastery.

Choices to make: Material for the covering mantle (tiles or copper); materials for waterproofing layer. Material and thickness for a thermal insulation layer. This choice is reflected in the presentation and the type of vapour barrier.

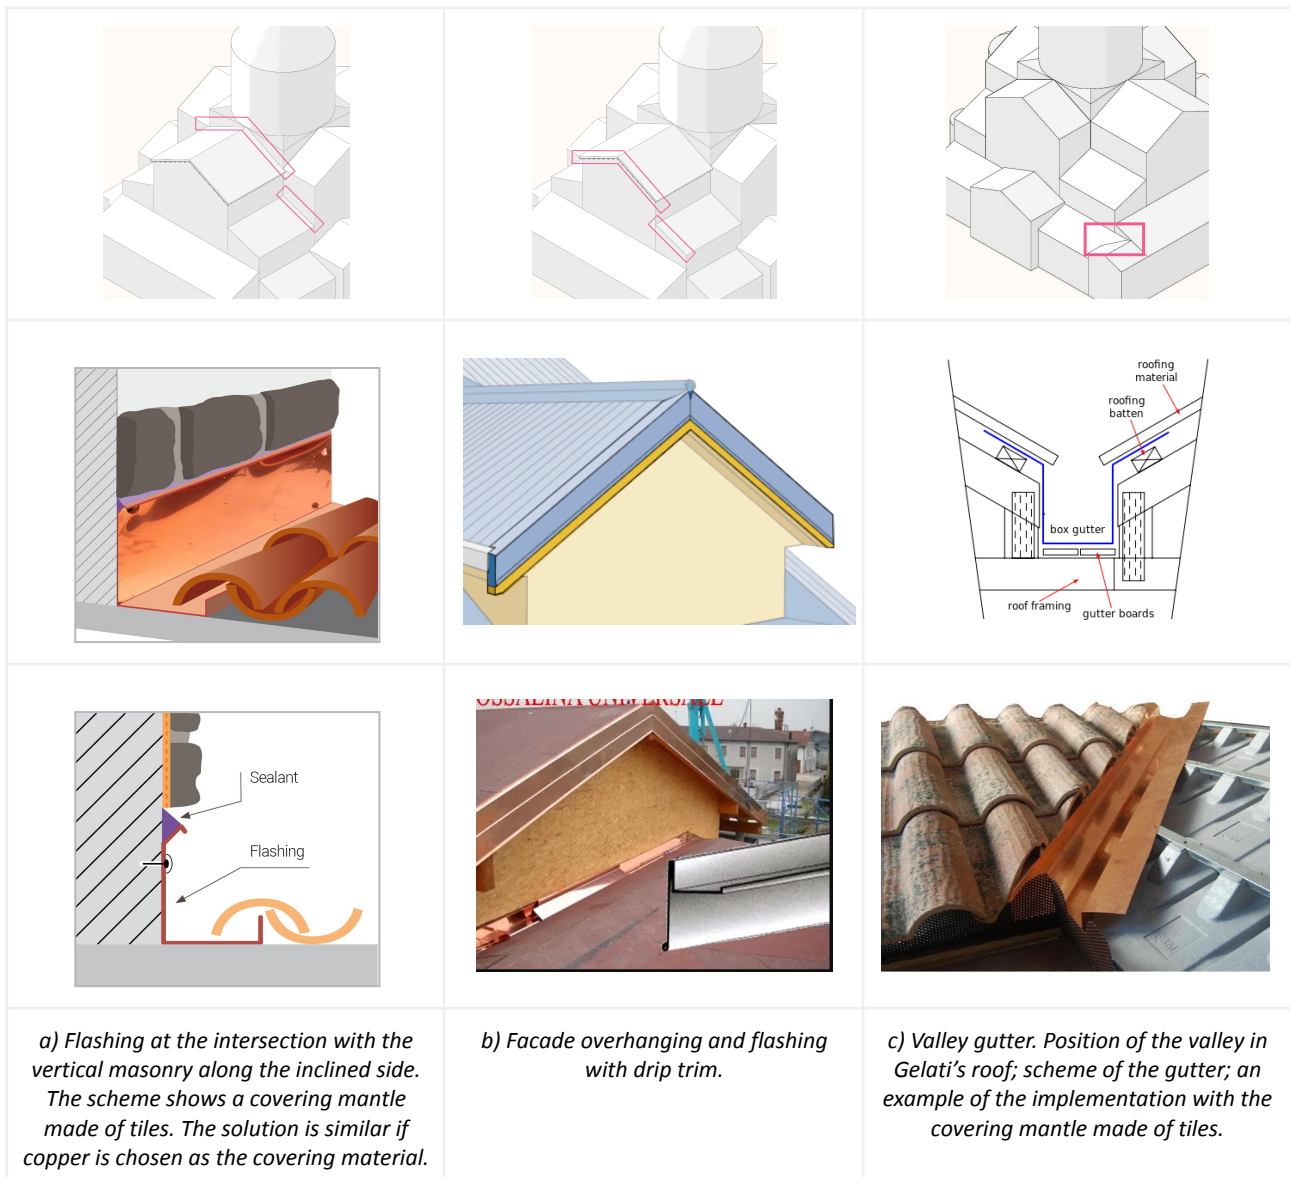
Figure 33 - Scheme of the point of discontinuity regarding the water runoff system. The solutions shown are indicative. Every detail requires in-depth study.

The installation of a system of gutters, flashing and downspouts is essential to prevent future infiltrations and protect the masonry from percolation phenomena. The runoff system has to be designed carefully,

paying particular attention to points of discontinuity (Figure 33), and it will be integrated with the water drainage system to be designed at the ground level in order to drain the water from the Monastery safely and efficiently.
