# გელათის სამონასტრო კომპლექსი Gelati Monastery Complex

**Condition report**  
**Result of meteorological  
disaster**

2024 February 5-6

Report 13/02/2024

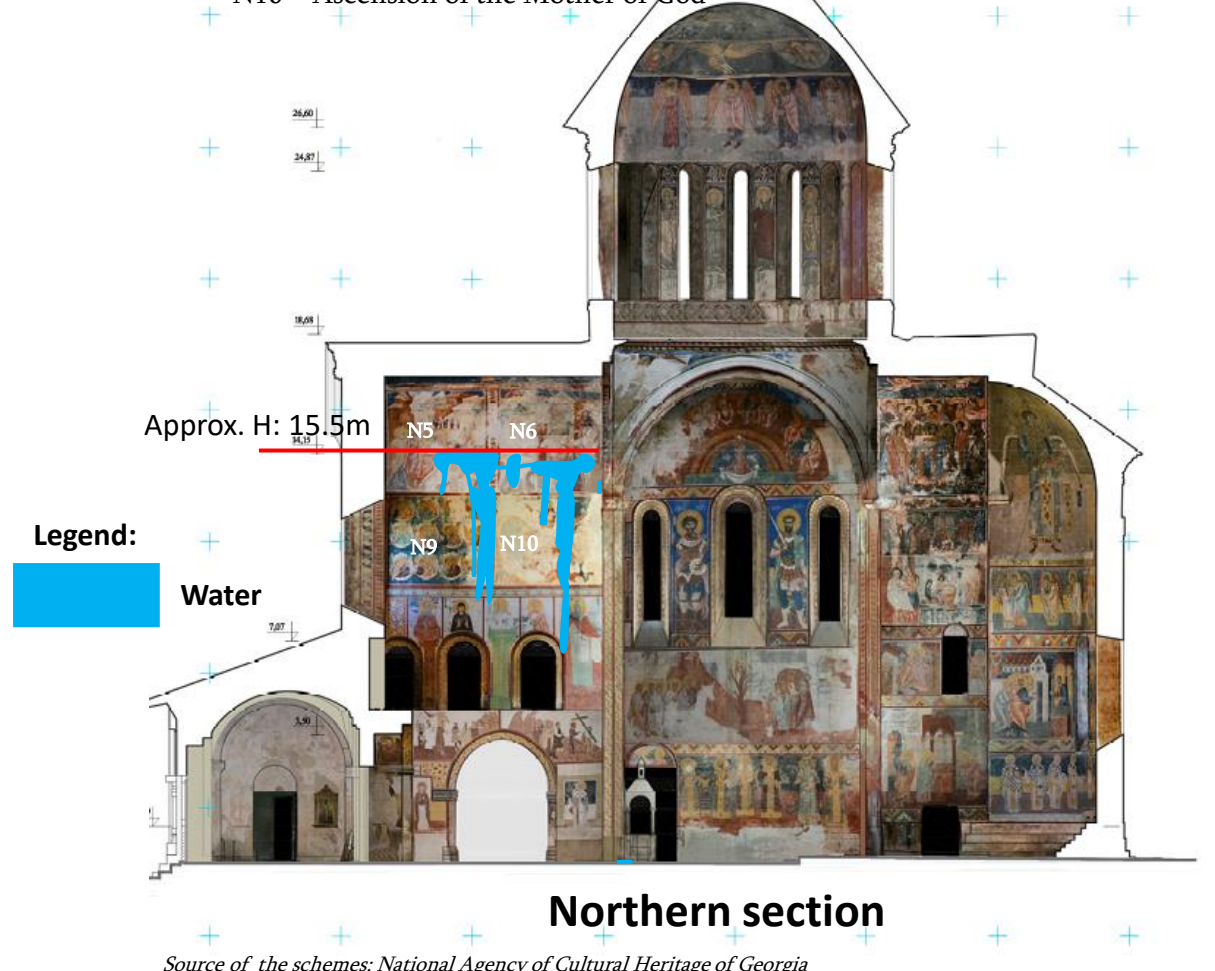
**The Church of Nativity of Virgin Mary**  
**Interior wall paintings**

**Scenes affected by water infiltration:**

- N5 - Kiss of Judas
- N6 - Christ with Caiaphas
- N9 - Gathering of apostles for the Dormition of the Mother of god
- N10 - Ascension of the Mother of God

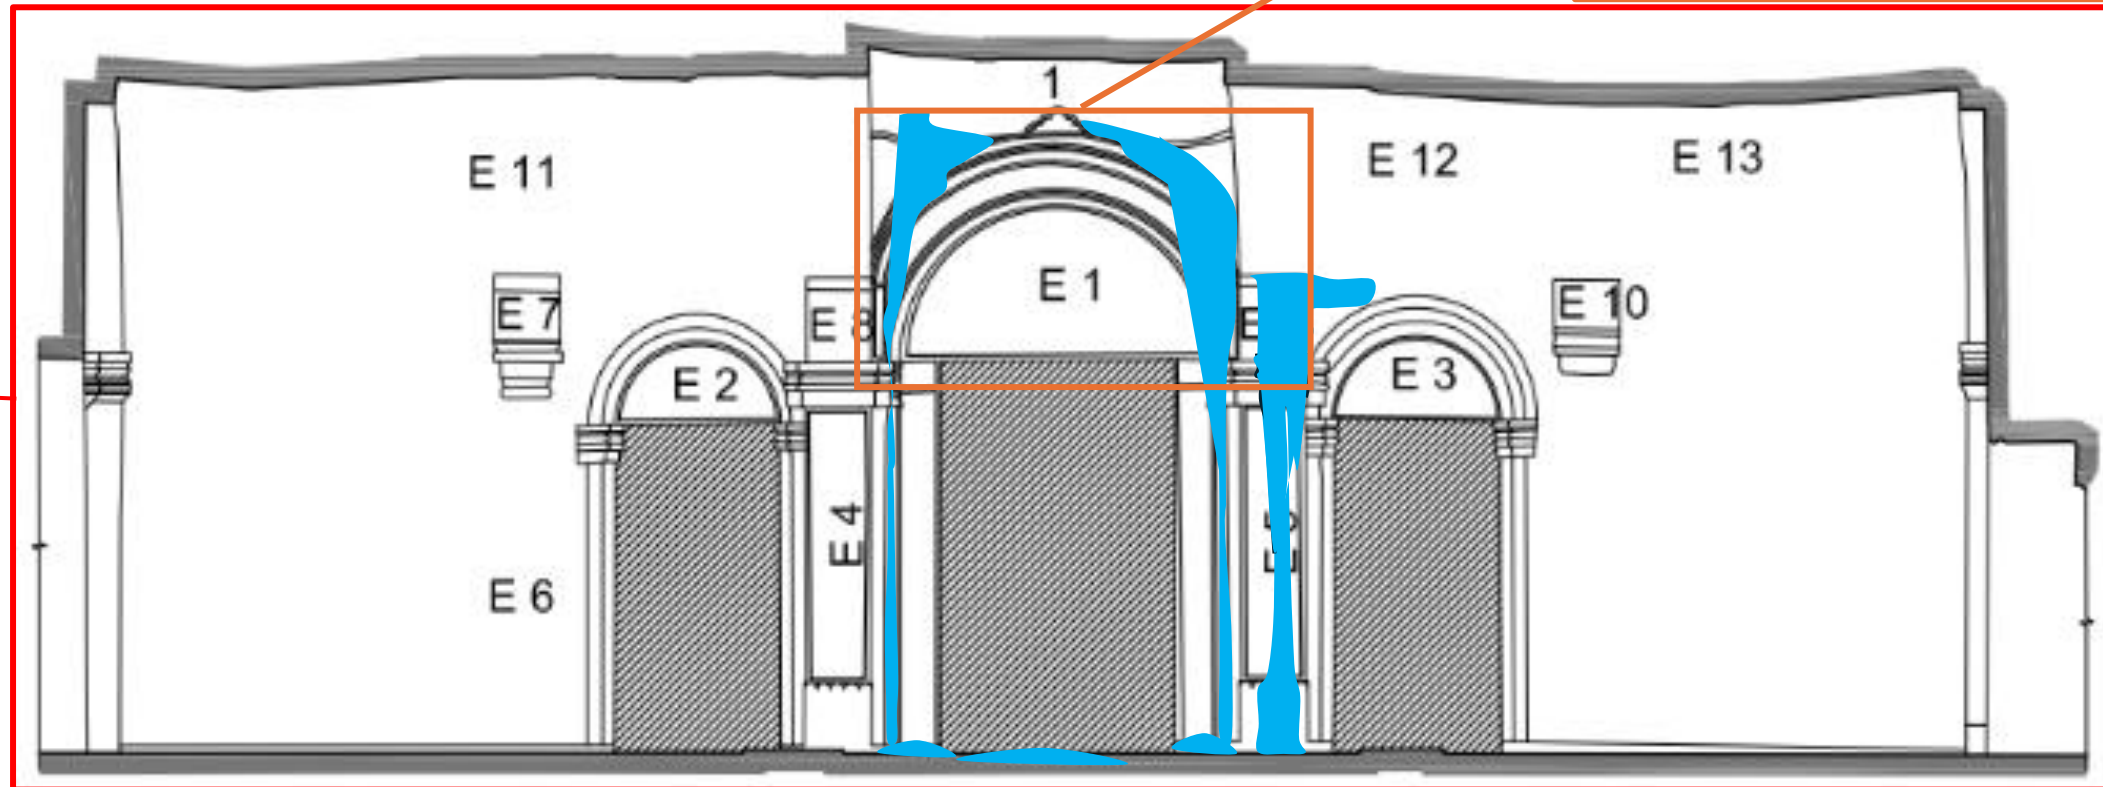
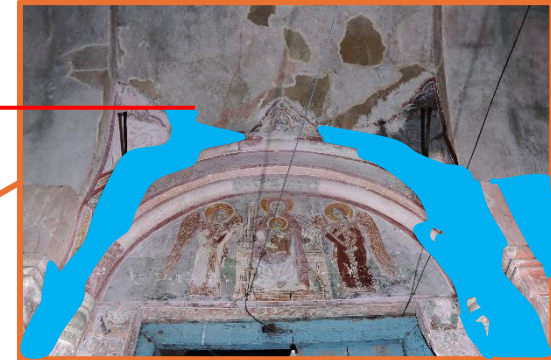
The Church of Nativity of Virgin Mary, Narthex (Western entrance)  
Interior wall paintings

- The large amount of water has been infiltrated in the central part of the east wall of the narthex . Water has partly covered vault, walls and floor. Presumably, the water might have been infiltrated through the joint of the west arm of the main space and a roof of the narthex.

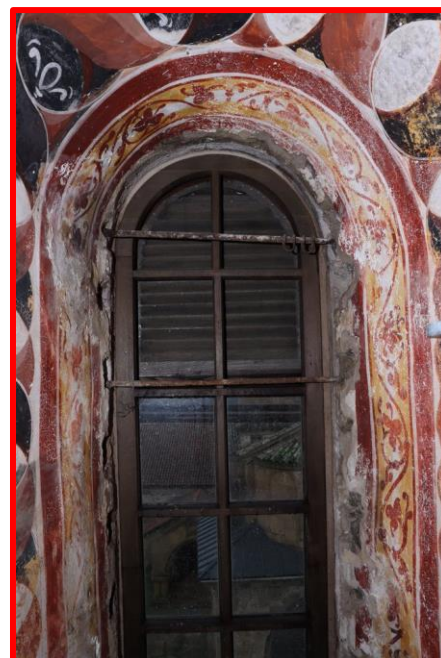
Wooden shutter of the window, interior.

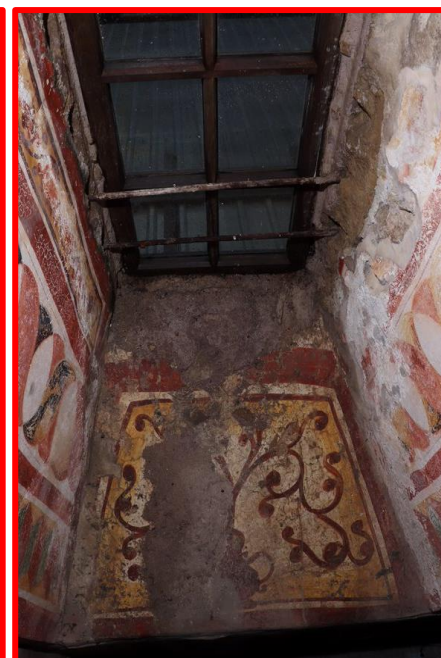
Wet part of the window base, interior.

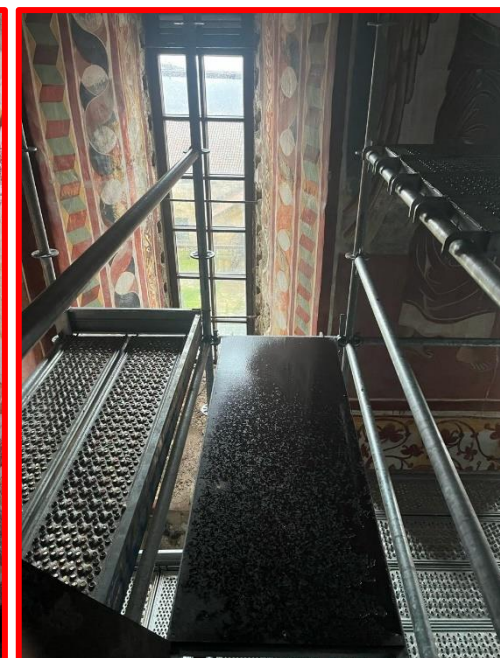
Wet part of the scaffolding. Water was splashed through window shutter.

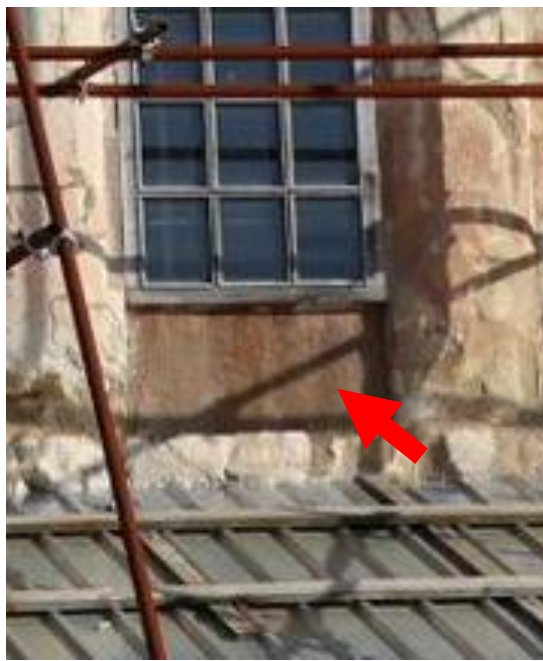
- The central western window of the main space of the west arm does not have a wooden shutter. However, there is a large lime-based fill material underneath the window on the façade. Visually similar fill material is also used in the inner part of the window. Probably, due to the hygroscopicity of the fill material, water has been absorbed from the façade and partly moisturised fill material of the window in the interior space.

Fill material on the western façade.

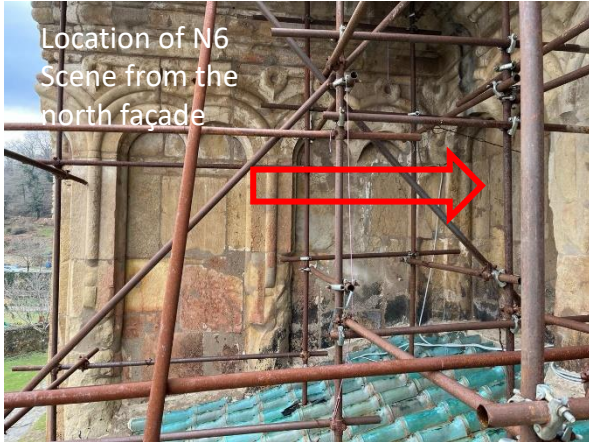
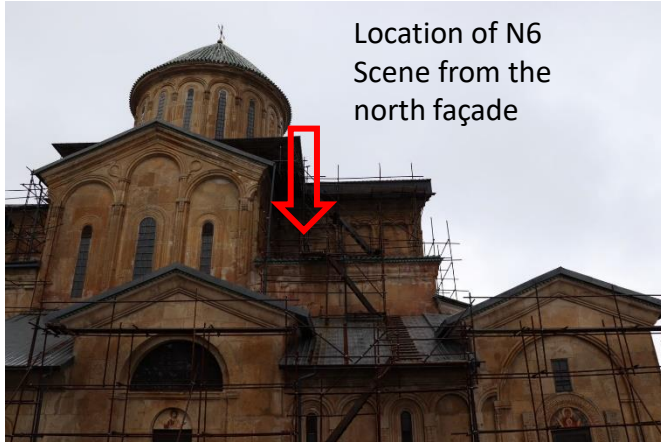
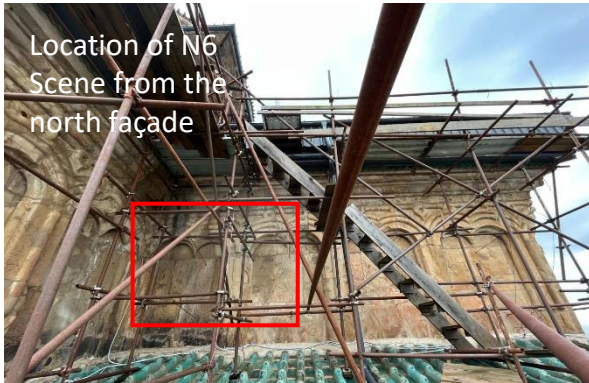
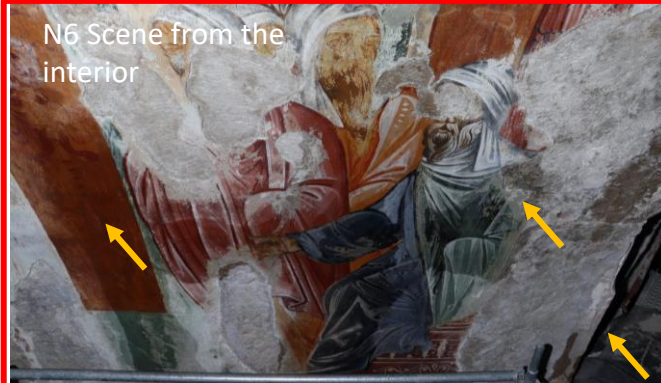
ღვთისმშობლის ტაძარი, მთავარი სივრცე, დასავლეთ მკლავის ჩრდილოეთი კედელი და ჩრდილო-დასავლეთი აფრის კუთხე - ფასადი.

- Water flow has been observed on the vault level (the fourth tier) on the scene of the Christ with Caiaphas (N6) and the north corner of the west arm arch. The flow went on the lower tiers though gravitation.

Below yellow arrows points at the location of the water flow from the interior space (scene N6). The red arrow and frame point at the location of the scene from the northern façade of the west arm. On the right, images represents the temporary roofing of the west and north arms. Blue arrows show direction of the water flow and gaps between roofings, which might be possible source of water infiltration.

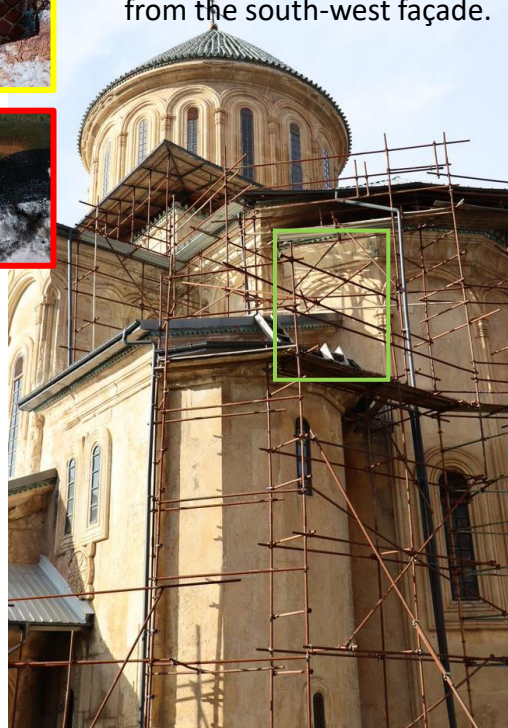
Location of southern archangel from the south-west façade.

Few droplets of the water have been observed on the metal attachments (pins) of the mosaics at the southern archangel's figure on the west arm of the main space (see yellow and red marks).

- The two droplets (one on each plate) of the water could be result of condensation or water infiltration, however, it should be noted that water infiltration has not been visually observed during the assessment,

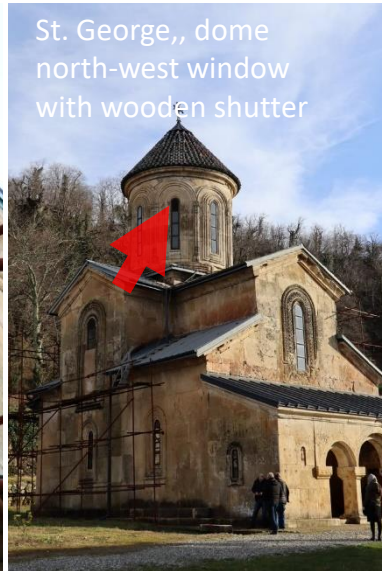
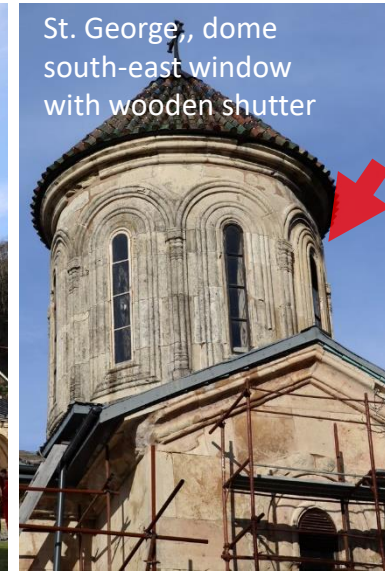
St. George,, dome north-east window made of ceramic tiles with holes

Original ceramic shutter with decorative openings

Wooden shutters

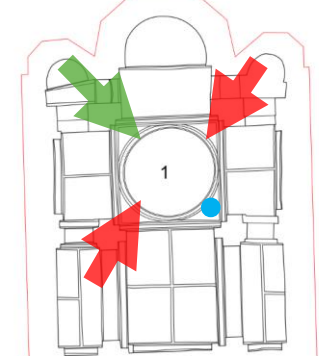
Water flow from the height of 3.4 m, from the capital of the column.

Water has been observed at the main space, on the south-west column. The water flow came from capital of the column (3.4 m height) and followed the eastern side of the shaft.

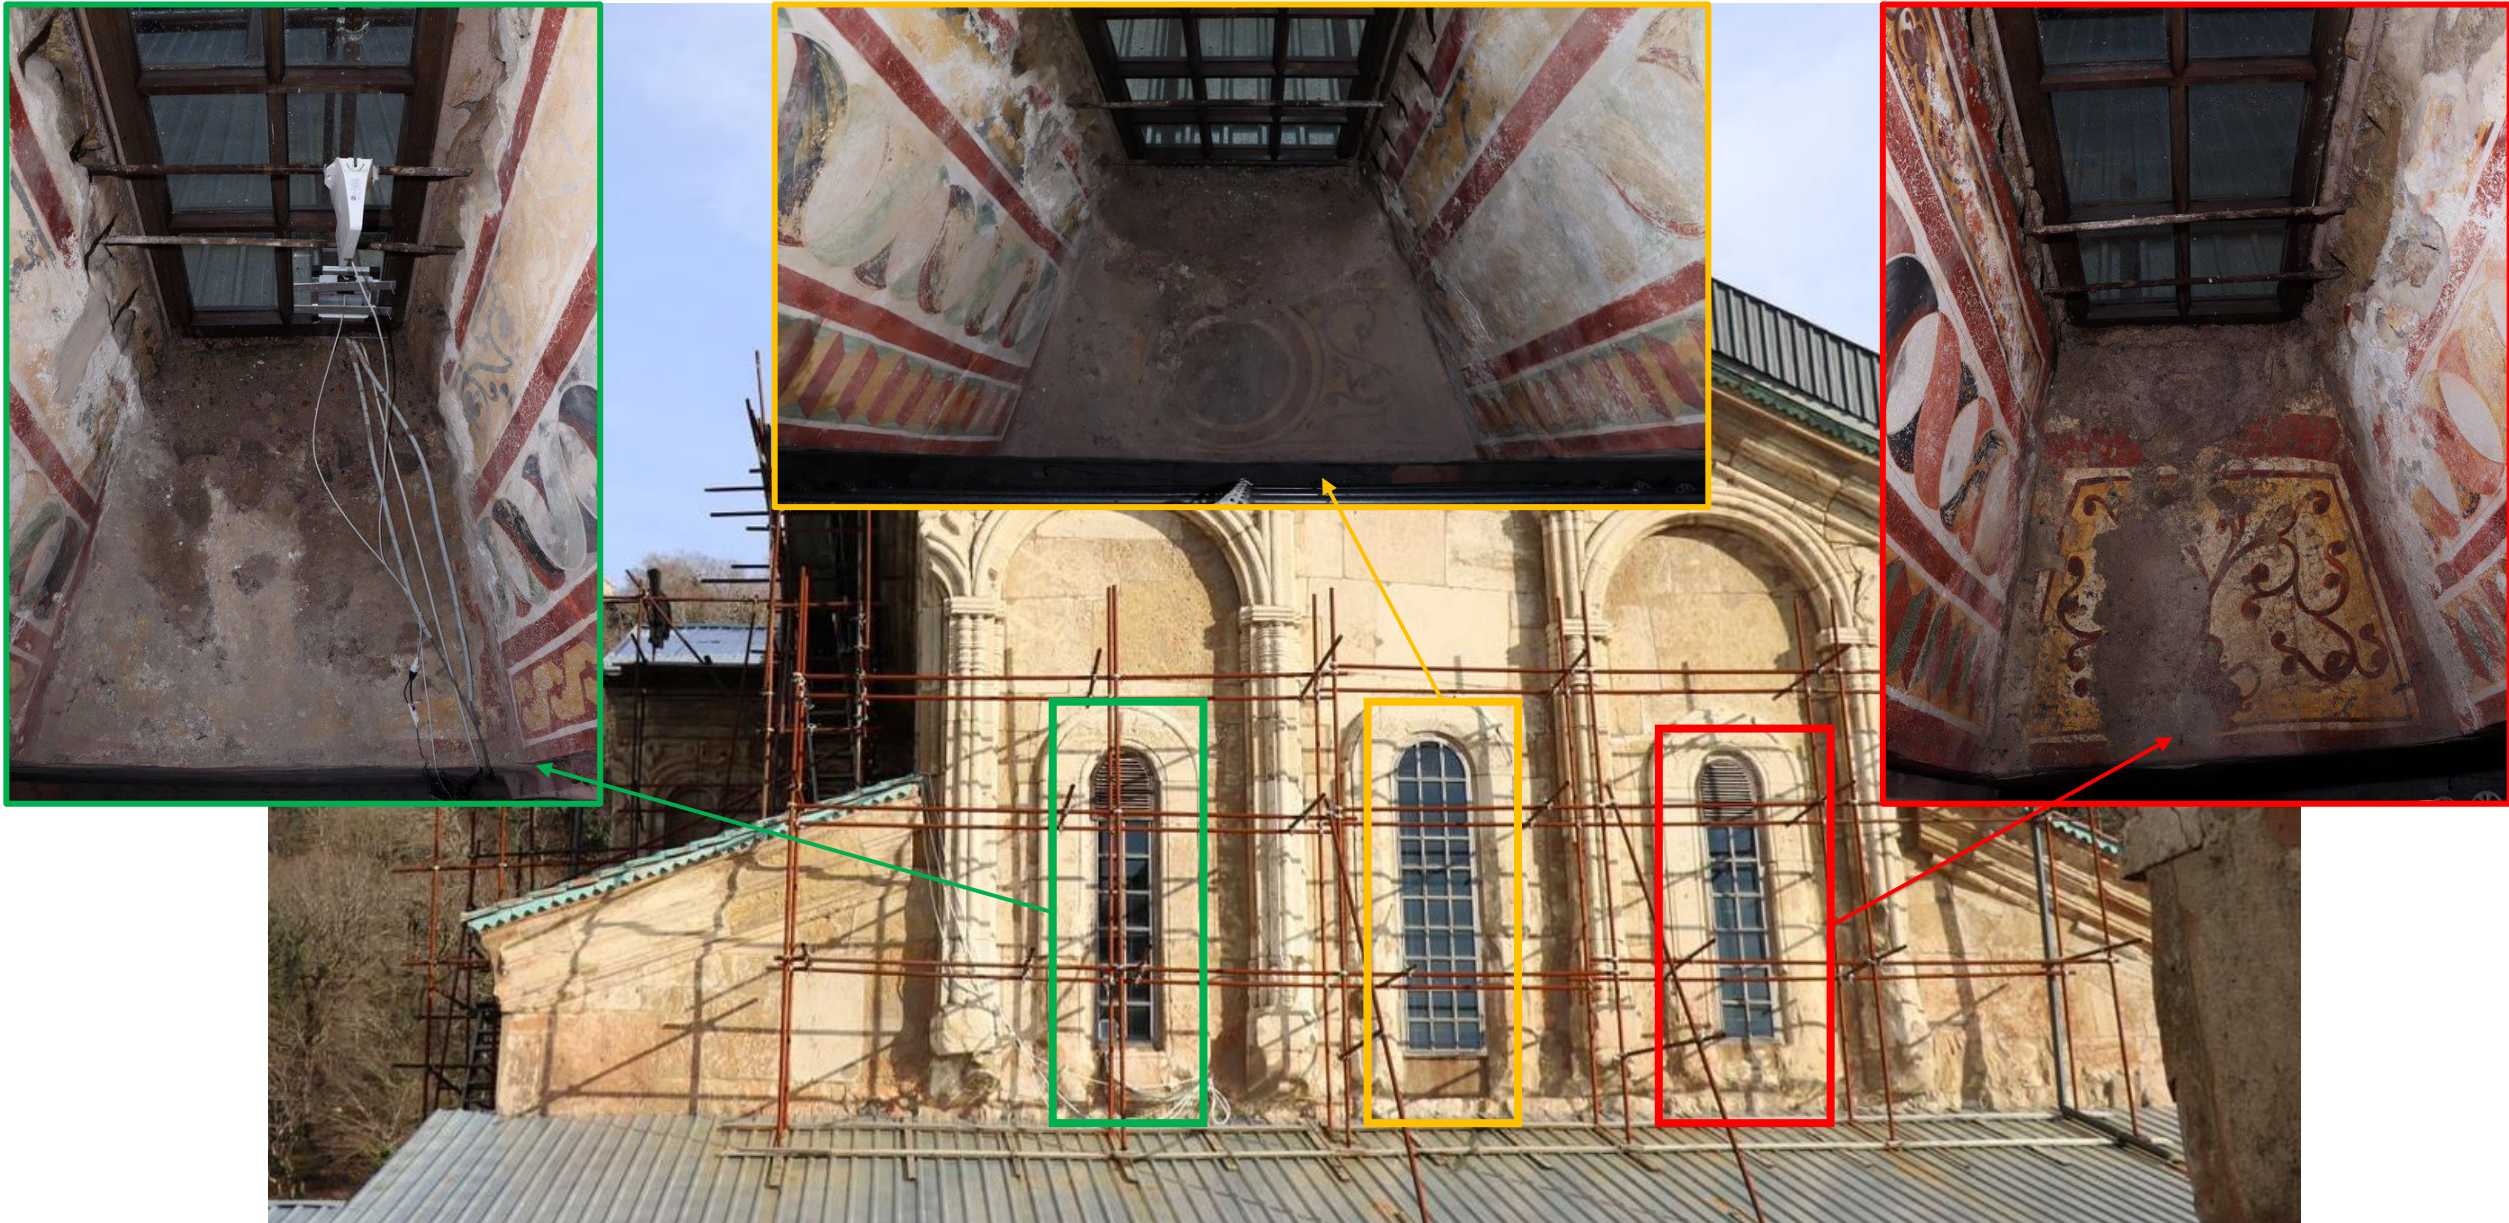
The Church of Nativity of Virgin Mary – West arm of the main space. Locations of the wall paintings affected by rainwater.

**Progressive locations between the period of 6-8 February 2024:**  
 Expansion of the moisture distribution has been observed on the northern wall of the west arm at the main space of the Church of the Virgin from 6<sup>th</sup> to 8<sup>th</sup> of February. Water distribution covered height of the upper 3 tiers and up to 5.5 meter of the width.

In some areas drying process has been observed on the 8<sup>th</sup> of February. The water distribution (moisture stains) followed the masonry on the top tier of the northern wall of the west arm. In some areas, it was visible that water was flowing from the mortars.

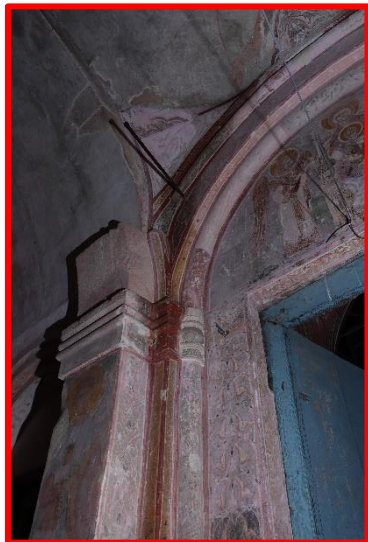
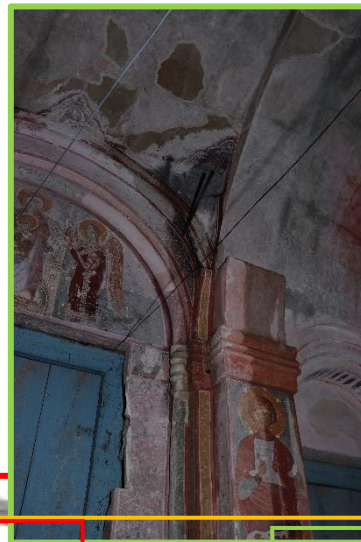
The Church of Nativity of Virgin Mary, Narthex (Western entrance), Interior wall paintings affected by rainwater.

The Church of the Nativity of the Virgin Mary, narthex, The central part of the eastern wall and floor. Scenes: 1, E1, E5, E8, E9, E12	Stable condition of the plaster and paint layers. Historic darkening (staining) of the paint layers.	New darkening of the wall painting layers (moisture containing stains).

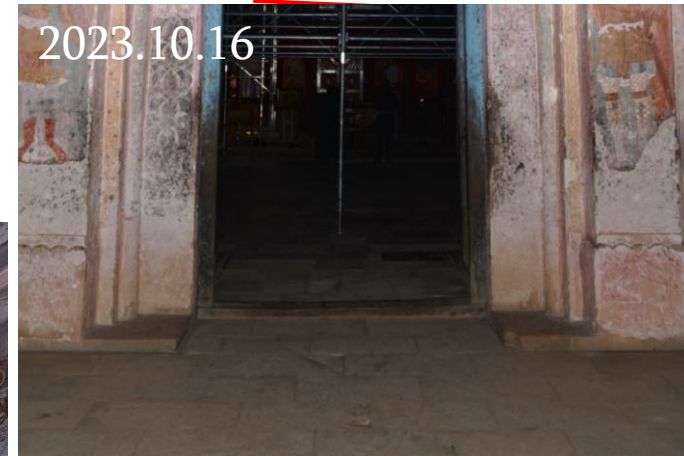
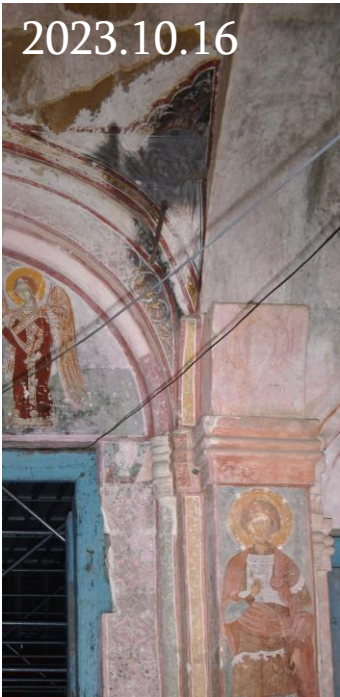
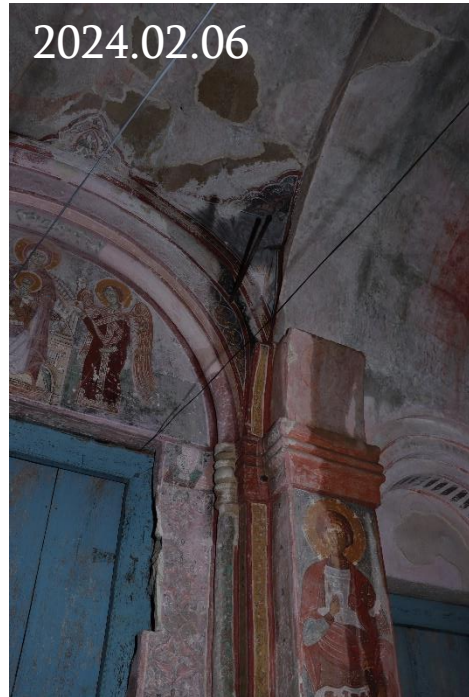
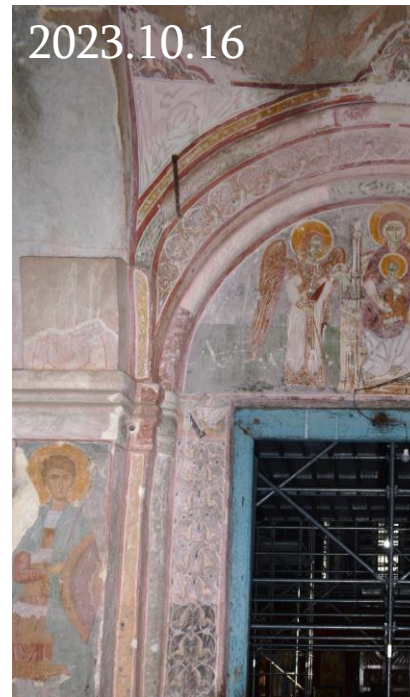
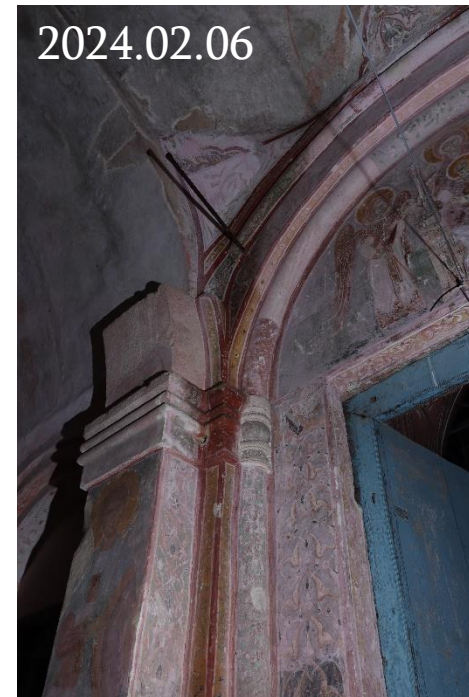
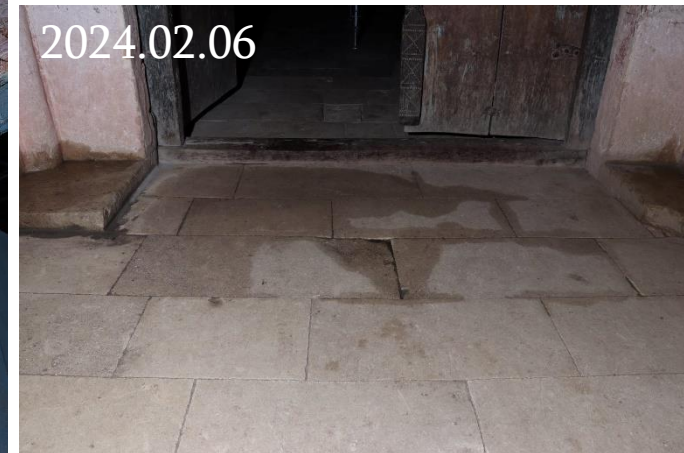
The Church of Nativity of Virgin Mary – Narthex. Images from 2023 and 2024, effect of the rainwater.

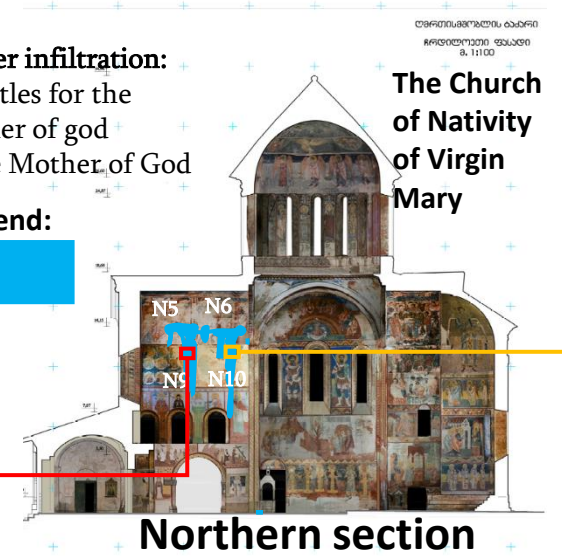
The Church of Nativity of Virgin Mary – Main space, west arm, north wall, third tier, fragments from the scenes N9 – Gathering of apostles for the Dormition of the Mother of god  
N10 – Ascension of the Mother of God.

Wall paintings with water infiltration stains.

Scenes affected by water infiltration:  
N9 – Gathering of apostles for the  
Dormition of the Mother of god  
N10 – Ascension of the Mother of God

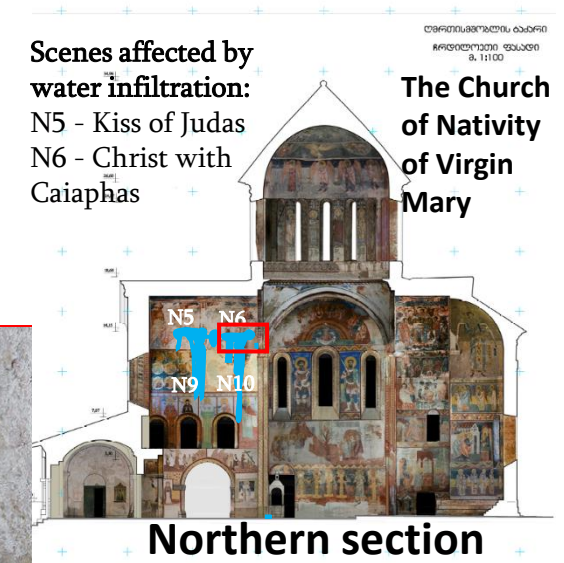
The Church of Nativity of Virgin Mary – Main space, west arm, north wall, forth tier, fragments from the scene N6 Christ with Caiaphas. Water distribution follows the masonry. Joints between the stones (through mortar) are the main/easiest sources/paths of the water coming on the surface of the wall paintings.

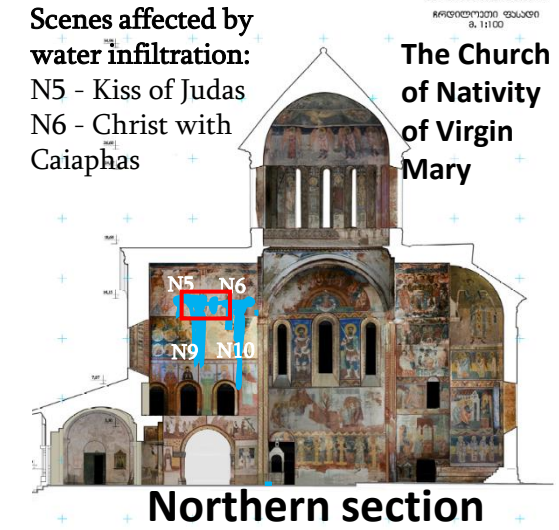
The Church of Nativity of Virgin Mary – Main space, west arm, north wall, forth tier, fragments from the scene N6 Christ with Caiaphas. Water distribution follows the masonry. Joints between the stones (through mortar) are the main/easiest sources/paths of the water coming on the surface of the wall paintings.

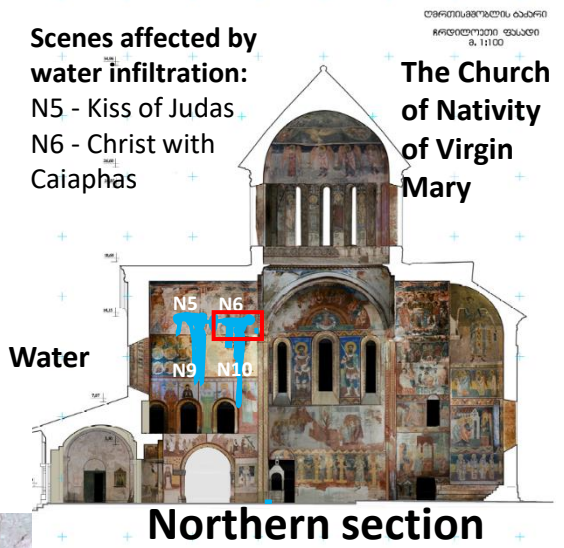
The Church of the Virgin Mary, main space, west arm, vault level, northern corner of the arch. On the 8<sup>th</sup> of February compared to the condition on 6<sup>th</sup> of February water coverage has been increased. See arrows on the below images.

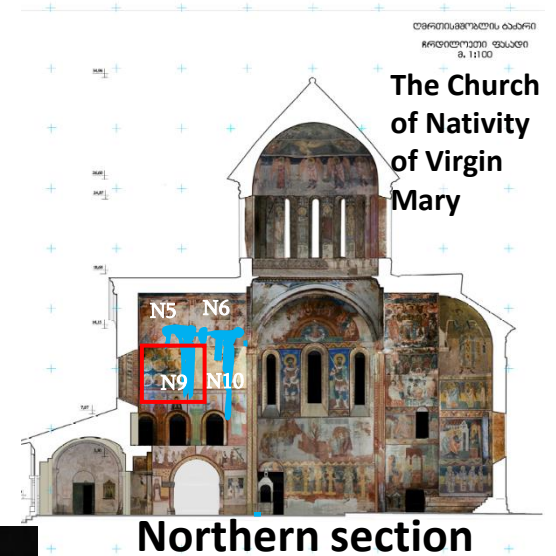
The Church of the Virgin Mary, west arm, north wall, third tier, scene of Gathering of apostles for the Dormition of the Mother of god. The boarder of the water distribution is provided in red lines. On the 8<sup>th</sup> of February (image below left) compared to the condition on 7<sup>th</sup> of February (image below right) water coverage has been increased.

Scenes affected by water infiltration:  
N9 – Gathering of apostles for the Dormition of the Mother of god  
N10 – Ascension of the Mother of God

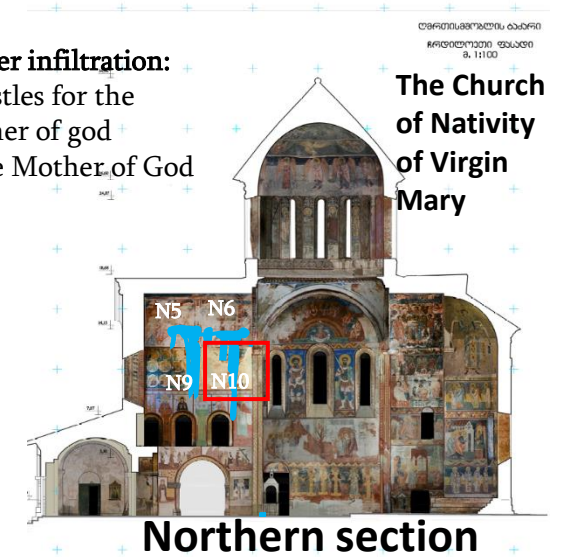
The Church of the Virgin Mary, west arm, north wall, third tier, scene of Ascension of the Mother of God. The boarder of the water distribution is provided in red lines. On the 8<sup>th</sup> of February (image below left) compared to the condition on 7<sup>th</sup> of February (image below right) water coverage has been increased.

Scenes affected by water infiltration:  
N9 – Gathering of apostles for the  
Dormition of the Mother of god  
N10 – Ascension of the Mother of God
